Fire-resistance test on fire collars protecting a concrete slab penetrated by services

Test Report

Author: Peter Gordon
Report number: FSP 2264
Date: 6 July 2022

Sponsored Investigation No. FSP 2264

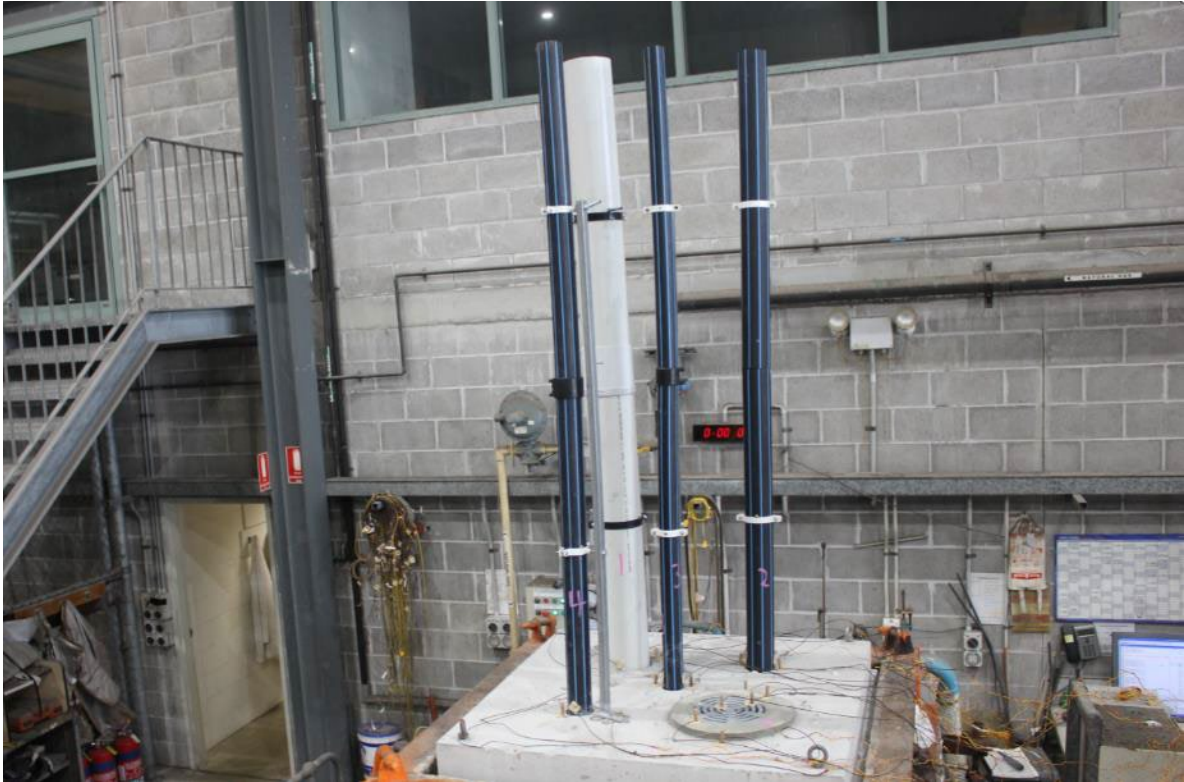
PHOTOGRAPH 2 – UNEXPOSED FACE OF SPECIMENS PRIOR TO TESTING

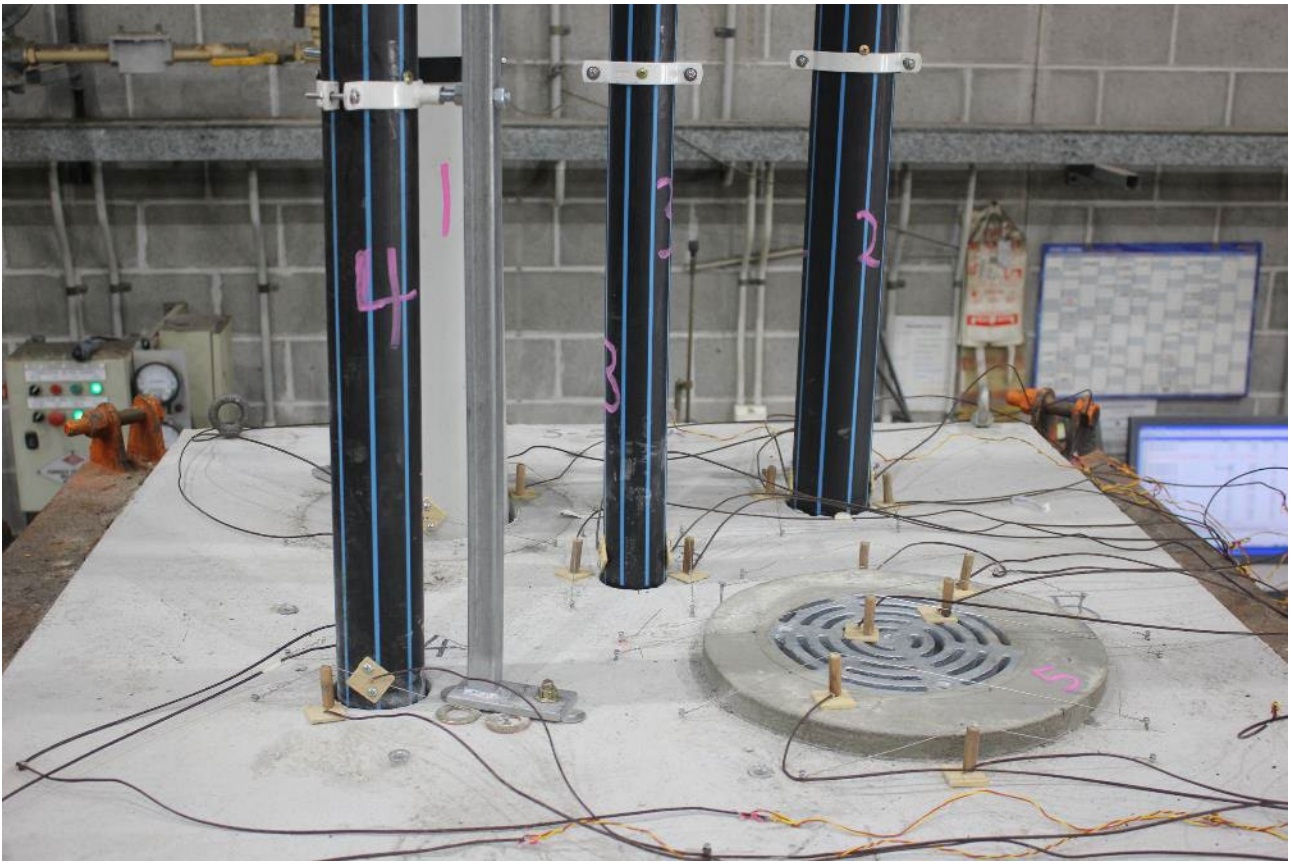
PHOTOGRAPH 3 – UNEXPOSED FACE OF SPECIMENS PRIOR TO TESTING

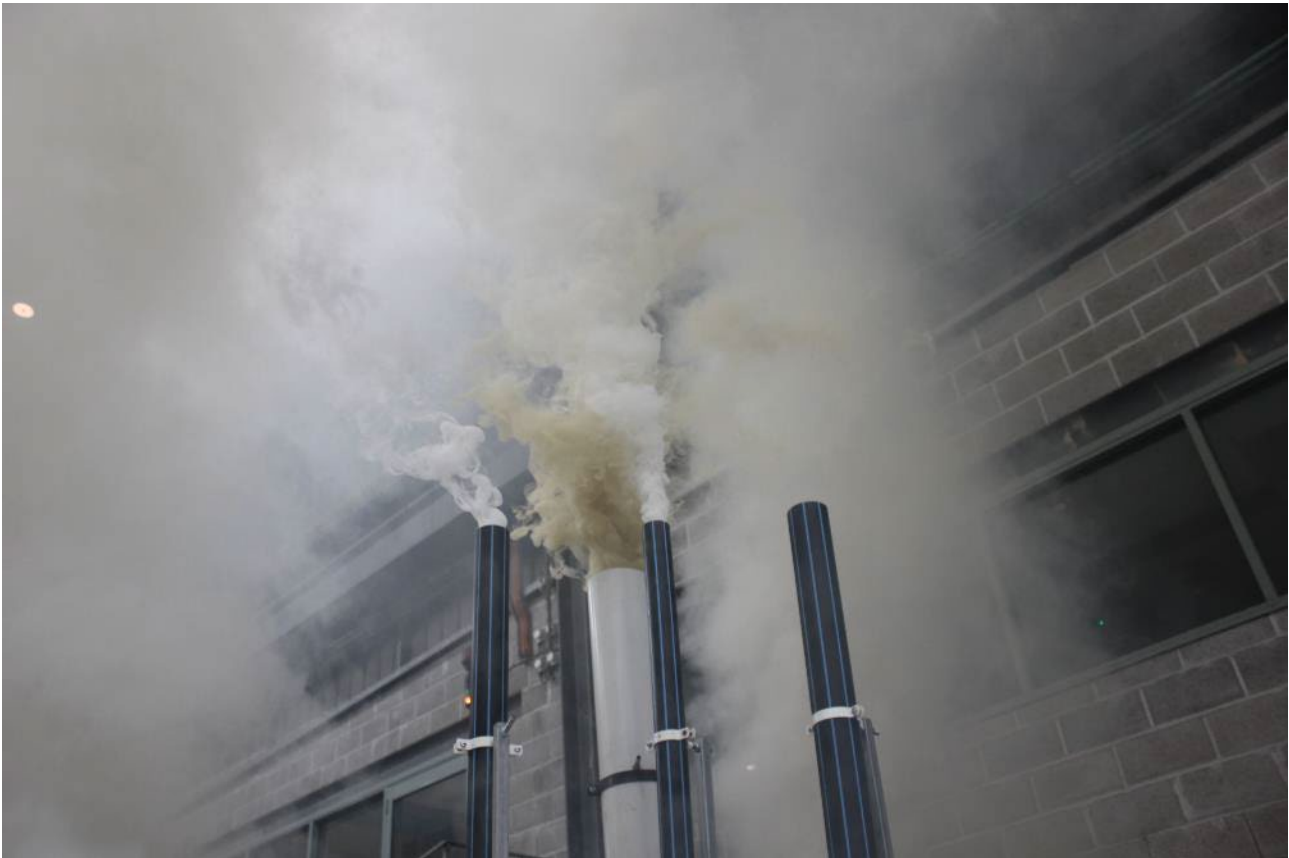
PHOTOGRAPH 4 – SPECIMENS AT 5 MINUTES INTO THE TEST

Time	Observation
2 minutes -	Smoke is being emitted from between the pipe and slab at the base of specimens 2, 3 and 4.
3 minutes -	Smoke has begun fluing from the grate of specimen 5 (floor waste). Cotton pad test applied above the grate – no ignition noted at this time
4 minutes -	Cotton pad test applied above the grate of specimen 5 – no ignition noted at this time.
5 minutes -	Smoke is fluing from the end of the pipe of specimens 1, 3 and 4.
6 minutes -	Smoke is being emitted from between the pipe and collar at the base of specimens 1.
7 minutes -	Smoke has ceased fluing from the end of the pipes of specimen 1, 3 and 4.
8 minutes -	The pipe base of specimen 1 has begun to deform.
9 minutes -	Smoke has resumed fluing from the end of the pipe of specimen 2 for 60 seconds then stopped.
11 minutes -	Smoke has ceased being emitted from between the pipe and slab at the base of specimens 2, 3 and 4.
13 minutes -	Smoke continues to flue from grate of specimen 5.

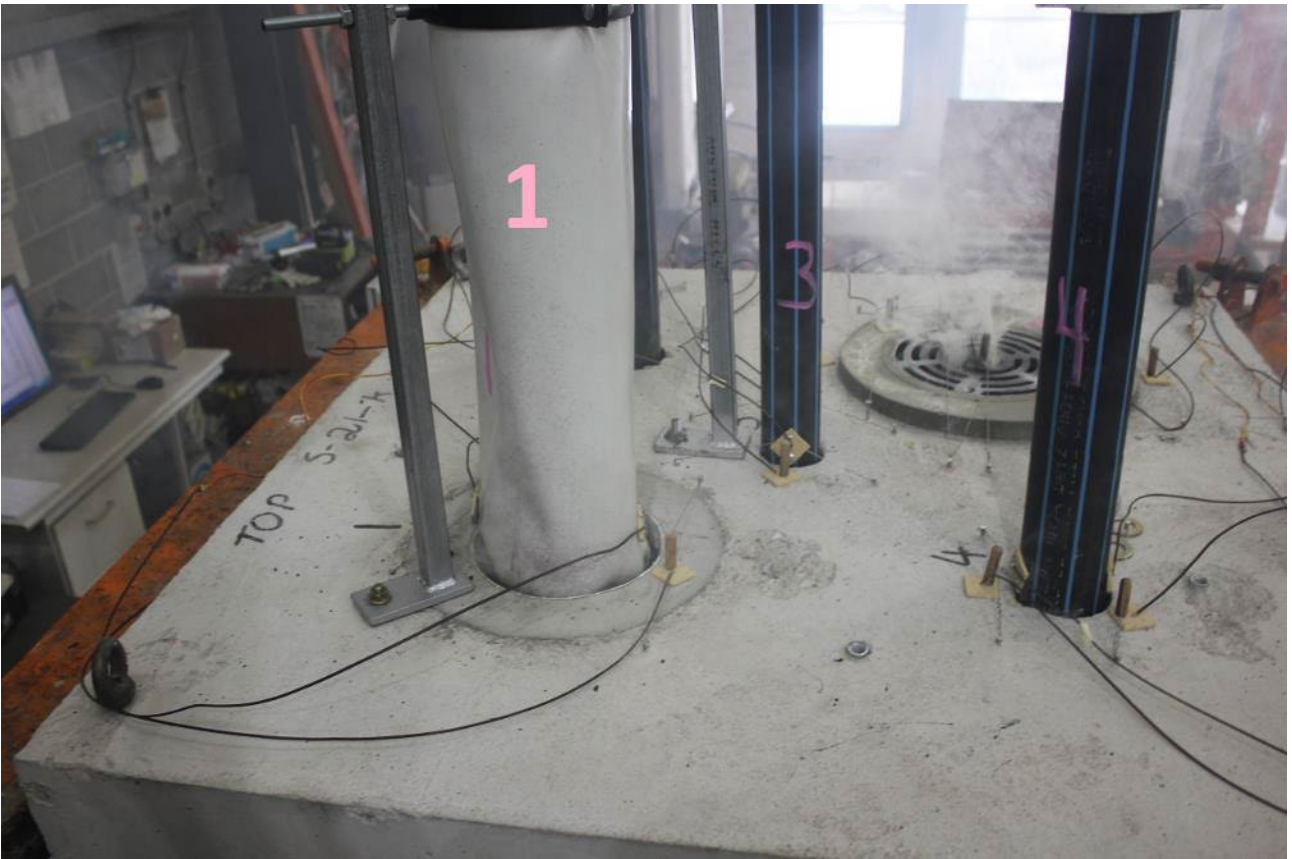
PHOTOGRAPH 5 – SPECIMENS AT 8 MINUTES INTO THE TEST

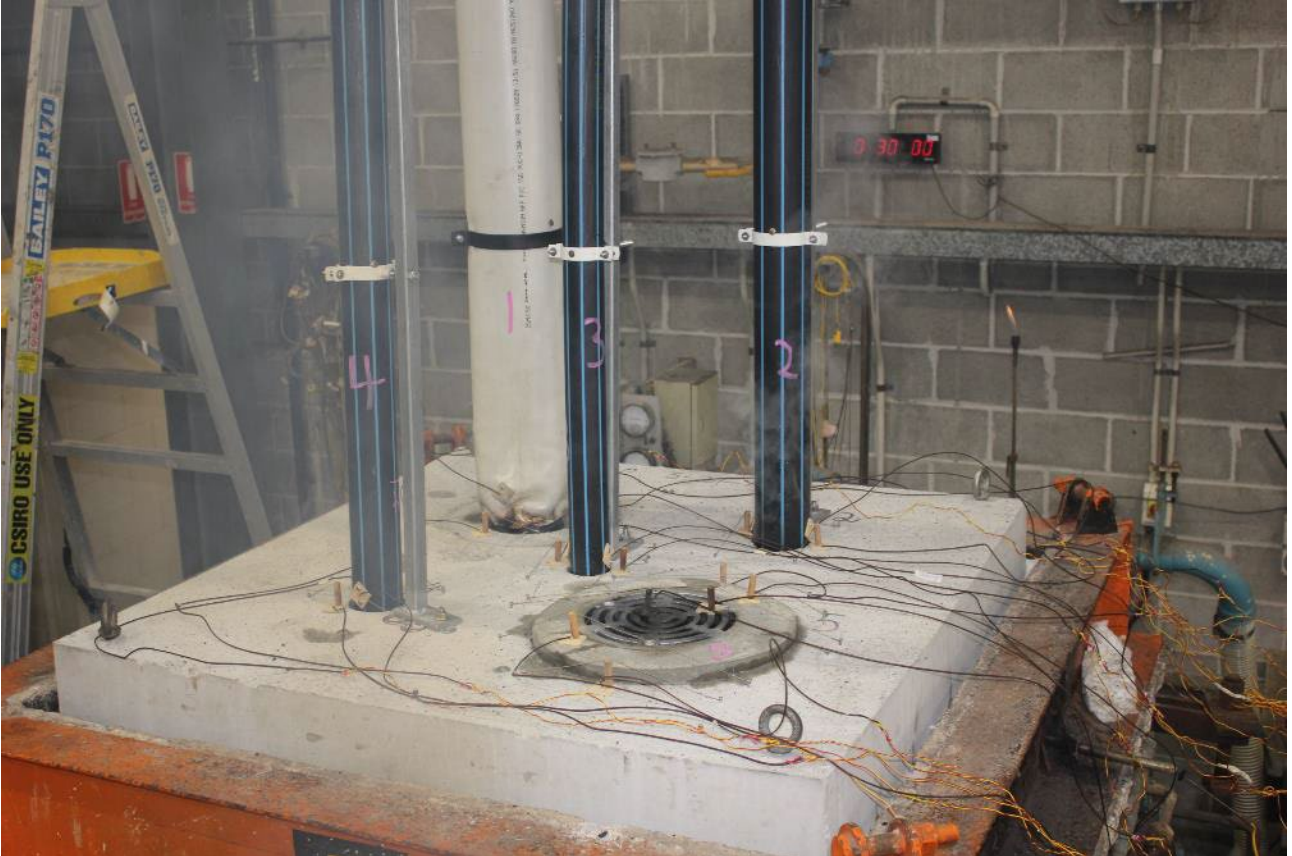
PHOTOGRAPH 6 – SPECIMENS AT 30 MINUTES INTO THE TEST

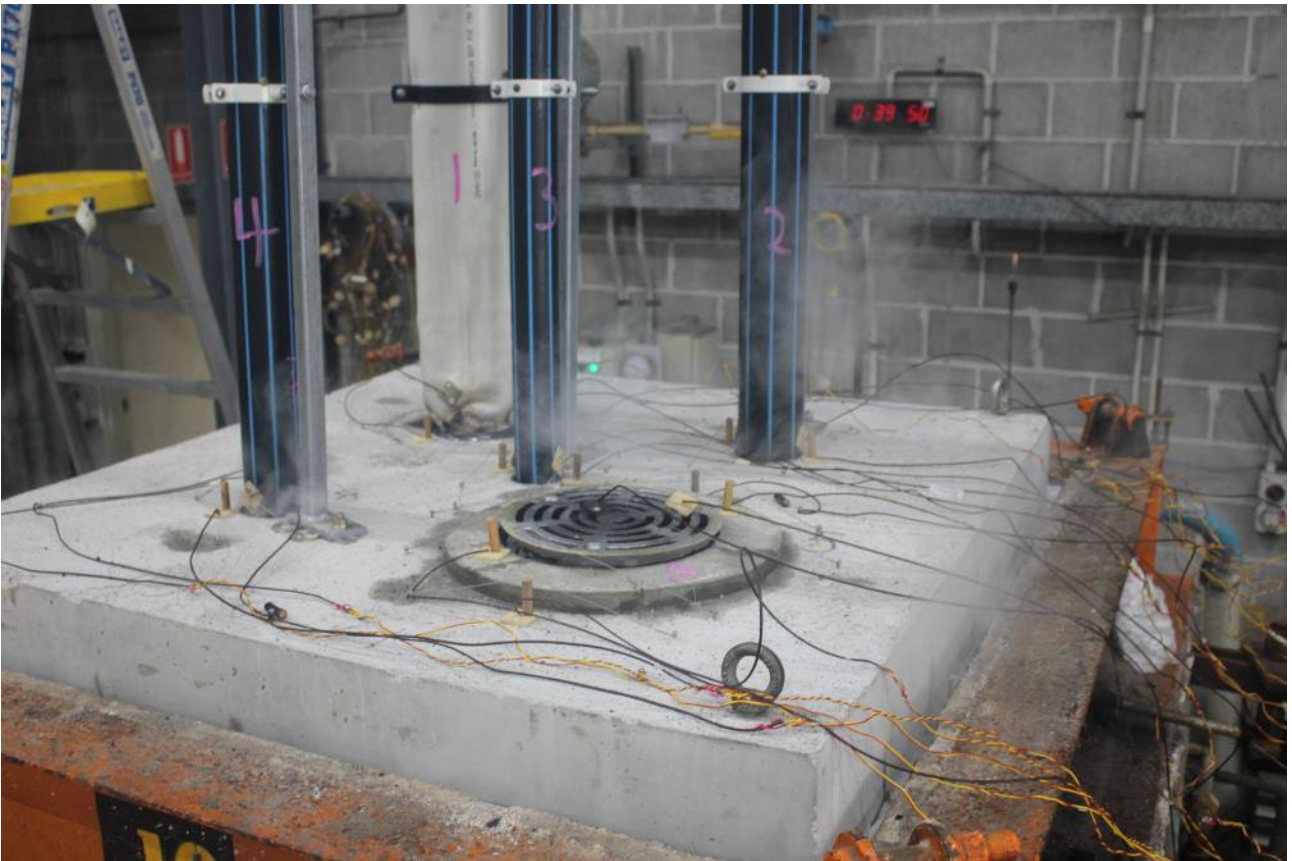
PHOTOGRAPH 7 – SPECIMENS AT 39 MINUTES INTO THE TEST

23 minutes -	Light smoke has resumed being emitted from between the pipe and slab at the base of specimens 2, 3 and 4.
26 minutes -	Moisture has formed on the slab around the base of specimen 5.
39 minutes -	The floor waste grate of specimen 5 has lifted-up away from the slab. Thermocouples 21 and 22 temporarily dislodged from the surface of the grate
44 minutes -	A temperature of 64 degrees was measured on the floor waste grate with the roving thermocouple.
61 minutes -	A temperature of 64 degrees was measured on the floor waste grate with the roving thermocouple.
75 minutes -	The floor waste grate of specimen 5 continues to be pushed up with the fire collar's black rubber ring and intumescent material visible.
145 minutes -	Smoke has resumed fluing from the end of the pipe of specimen 2.
183 minutes -	The collar casing at the base of specimen 1 has begun to melt.
196 minutes -	<u>Insulation failure of Specimen 1</u> - maximum temperature rise of 180K is exceeded on the concrete slab at the base of the specimen, 25-mm from the fire collar casing.

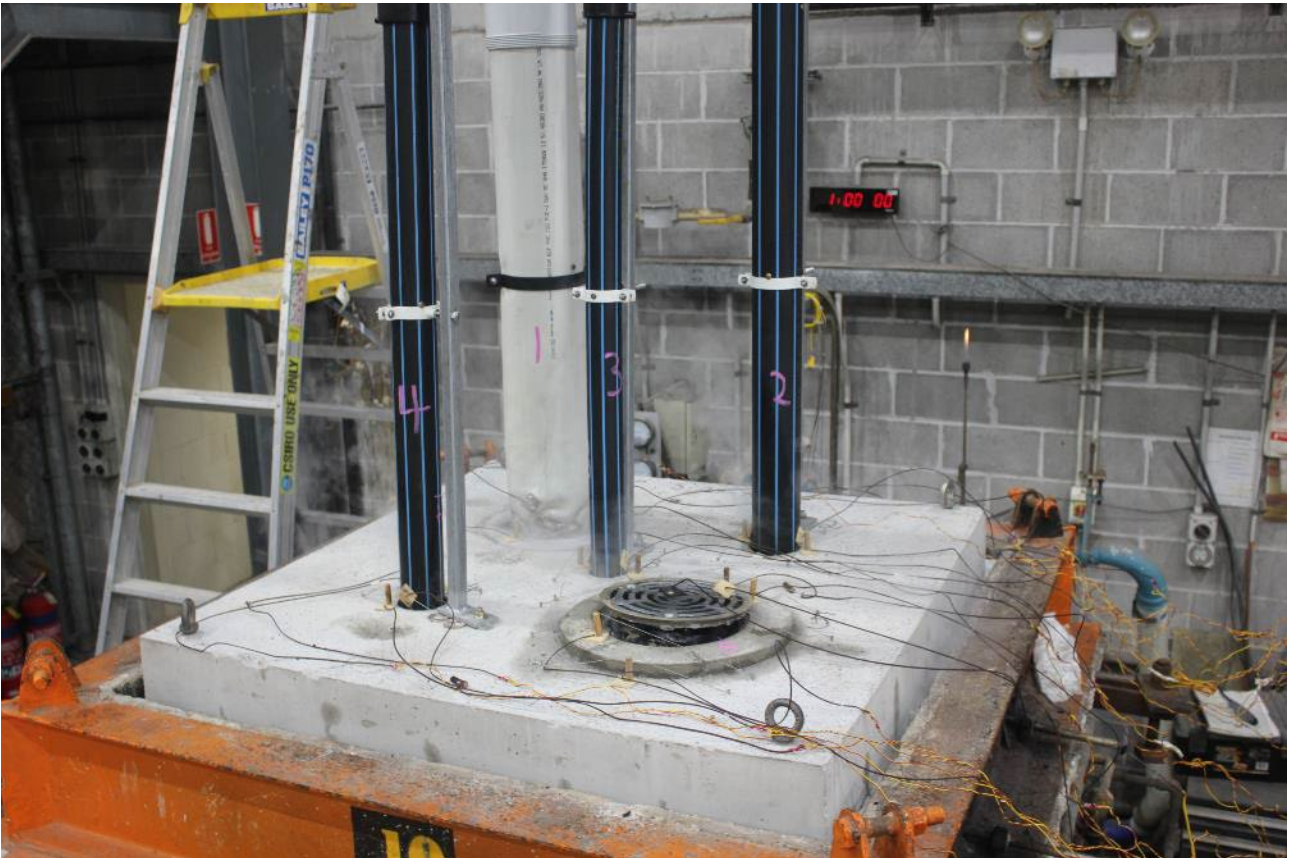
PHOTOGRAPH 8 – SPECIMENS AT 60 MINUTES INTO THE TEST

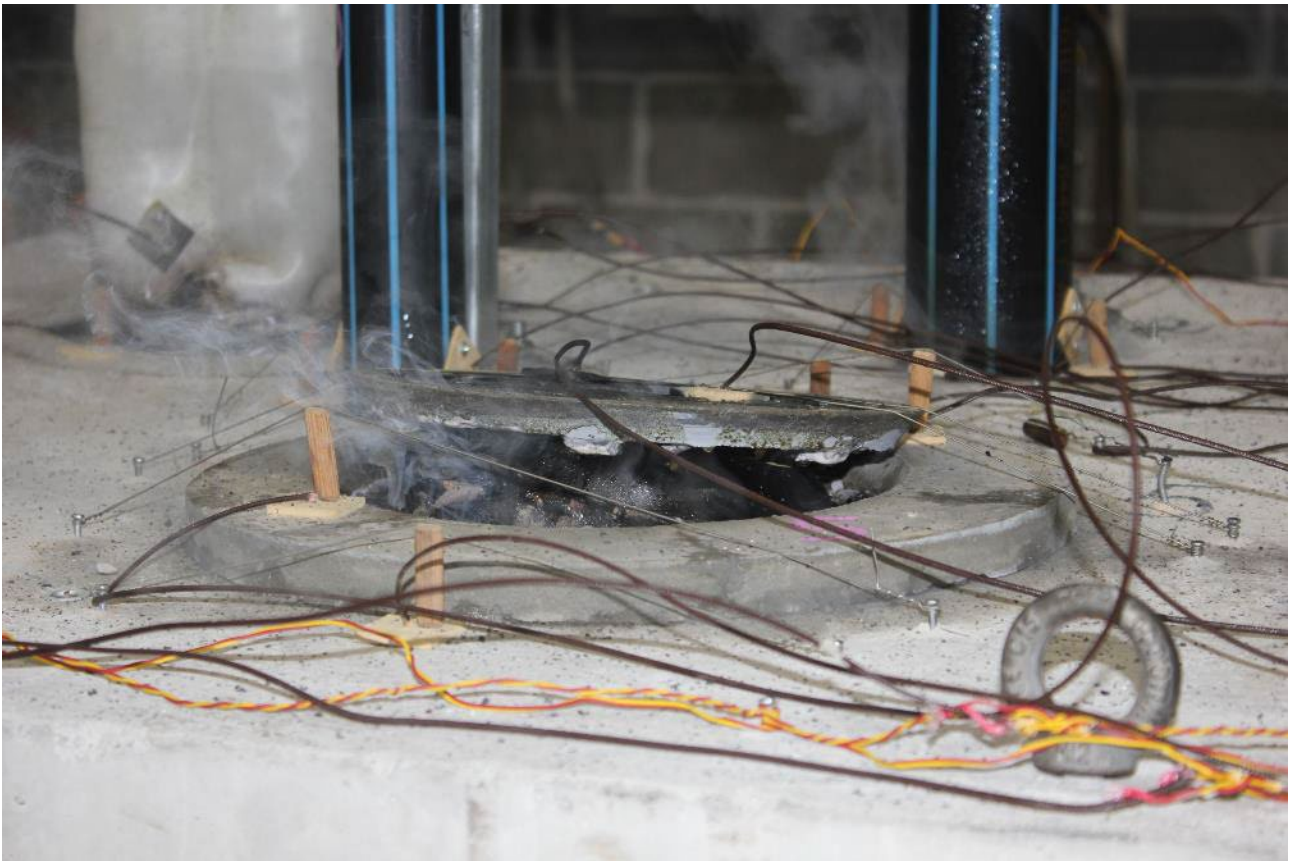
PHOTOGRAPH 9 – SPECIMEN 5 AT 75 MINUTES INTO THE TEST

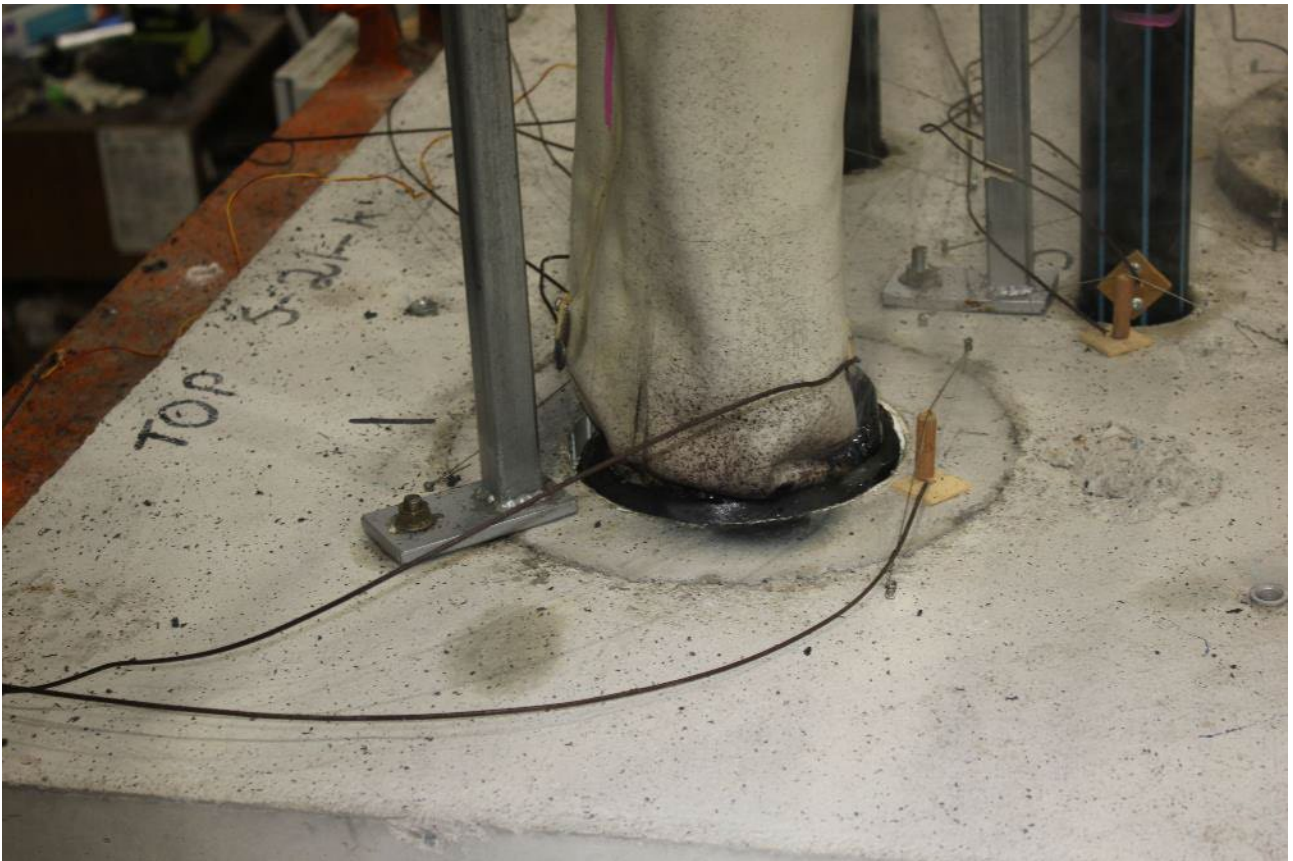
PHOTOGRAPH 11 – SPECIMEN 1 AT 90 MINUTES INTO THE TEST

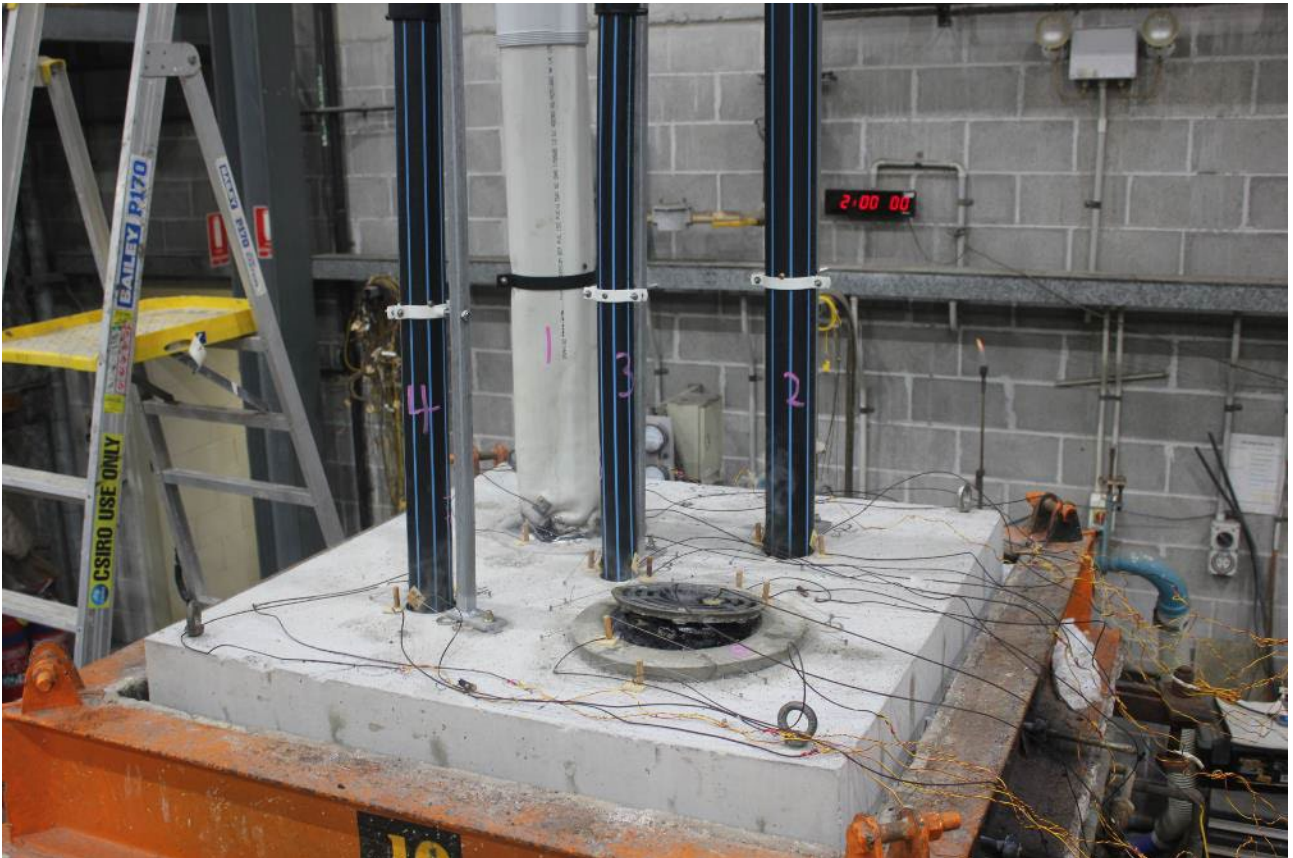
PHOTOGRAPH 12 – SPECIMENS AT 120 MINUTES INTO THE TEST

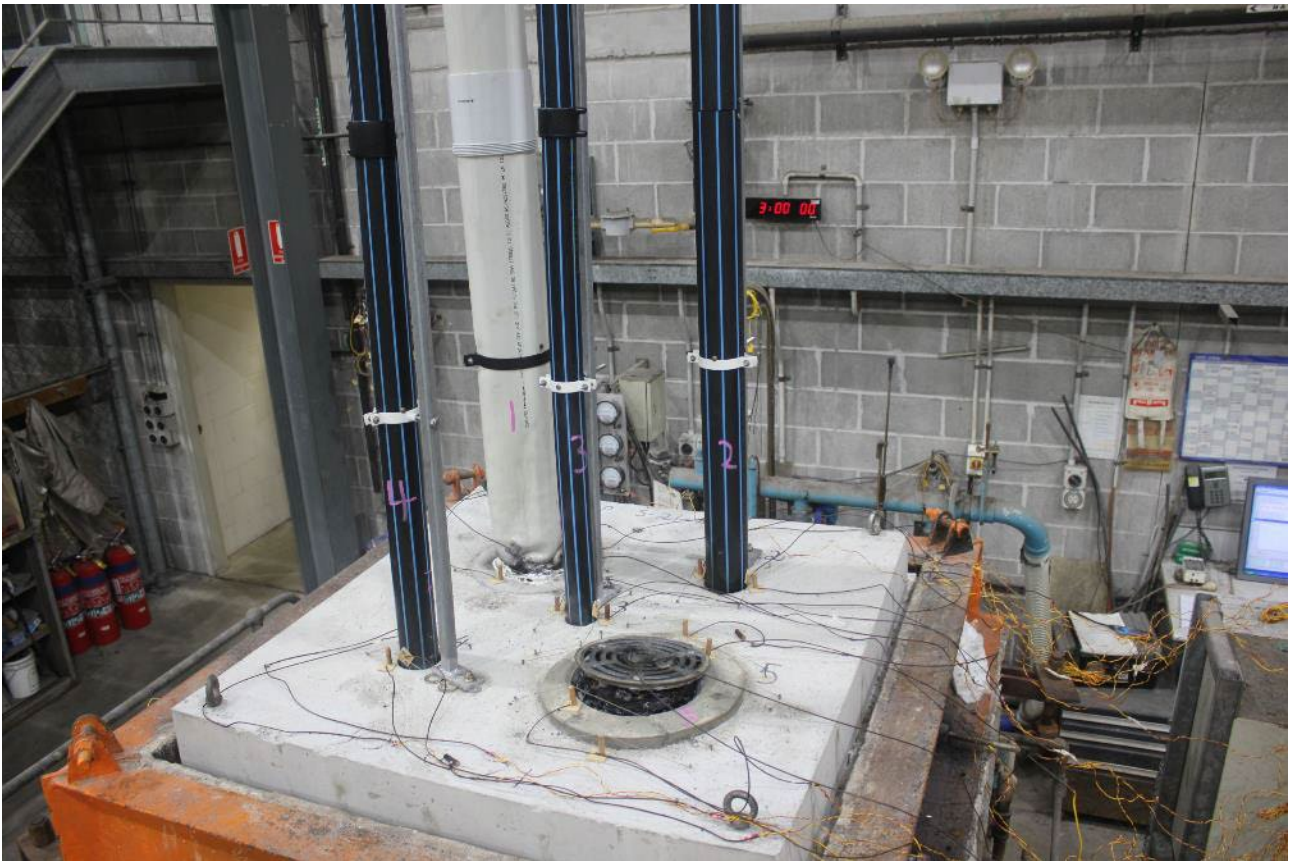
PHOTOGRAPH 13 – SPECIMENS AT 180 MINUTES INTO THE TEST

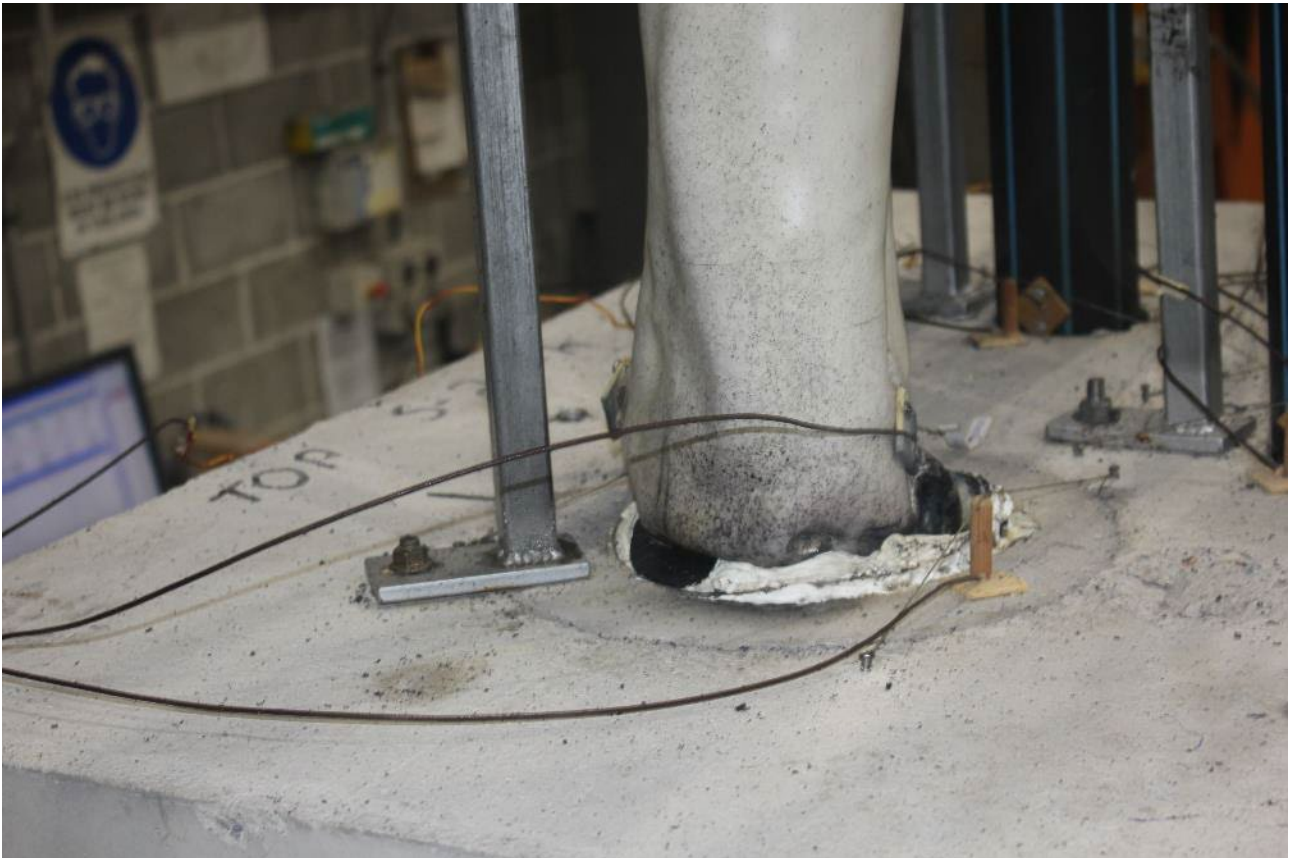
PHOTOGRAPH 14 – THE BASE OF SPECIMEN 1 AT 183 MINUTES INTO THE TEST

Structural adequacy	-	not applicable
Integrity	-	no failure at 241 minutes
Insulation	-	196 minutes

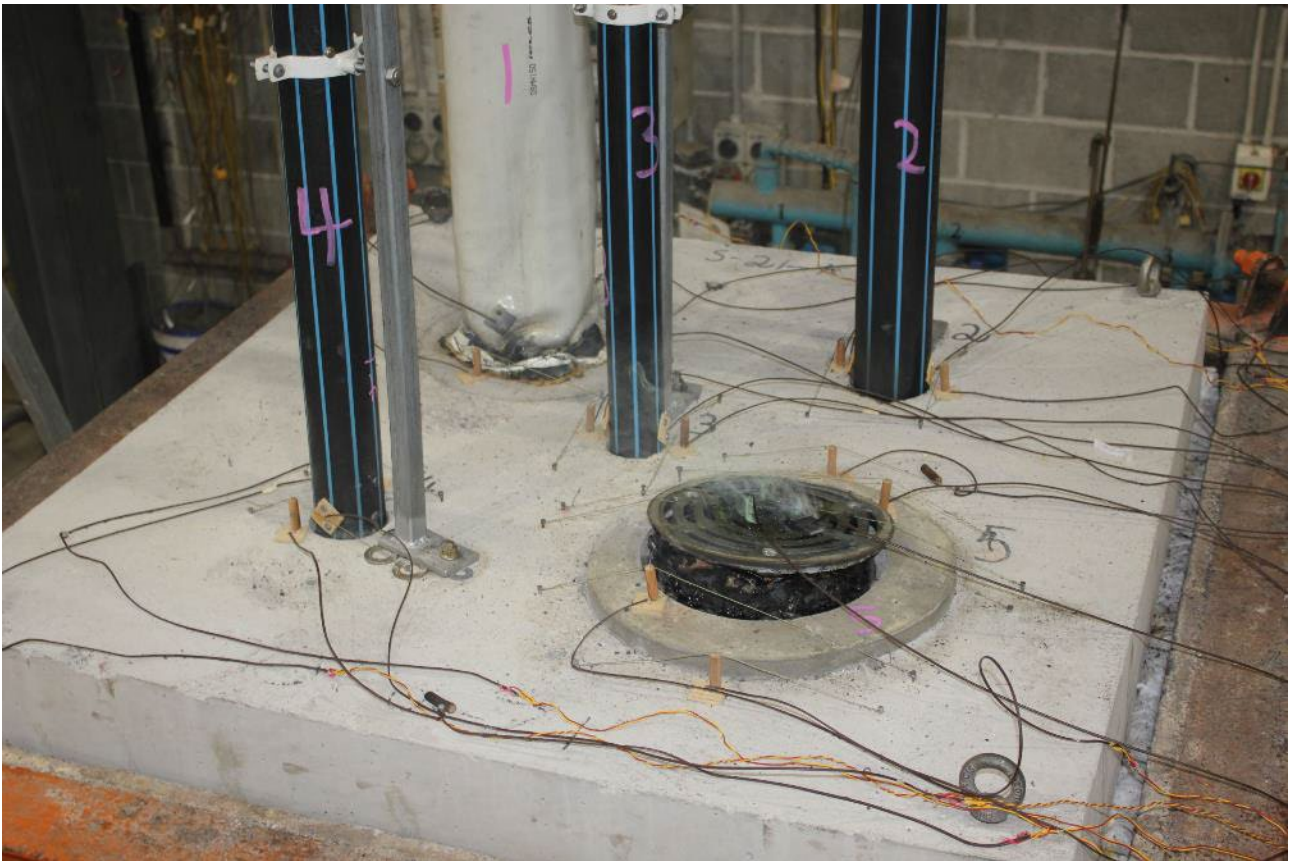
PHOTOGRAPH 15 – SPECIMENS AT 240 MINUTES INTO THE TEST.

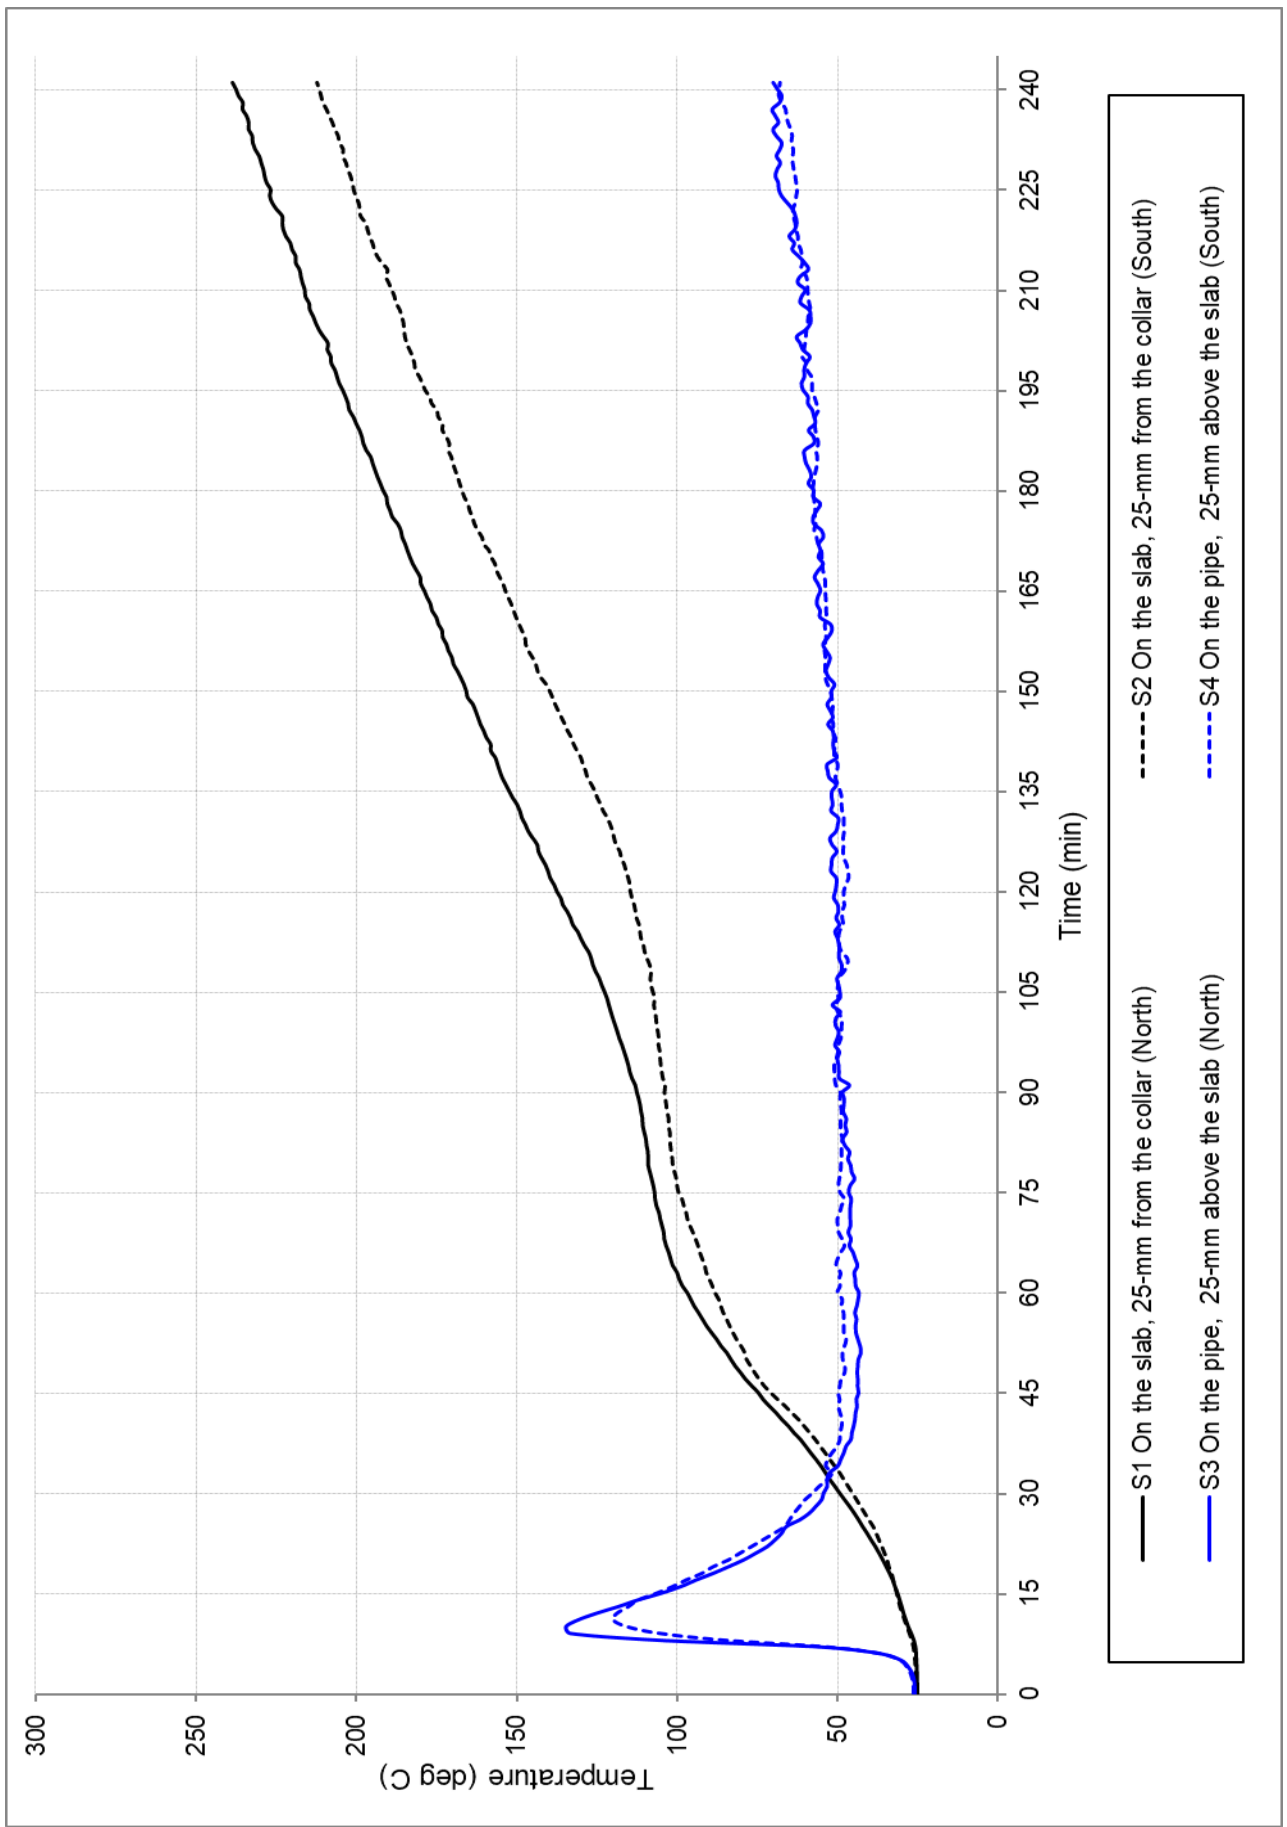
FIGURE 4 – SPECIMEN TEMPERATURE – ASSOCIATED WITH SPECIMEN 1

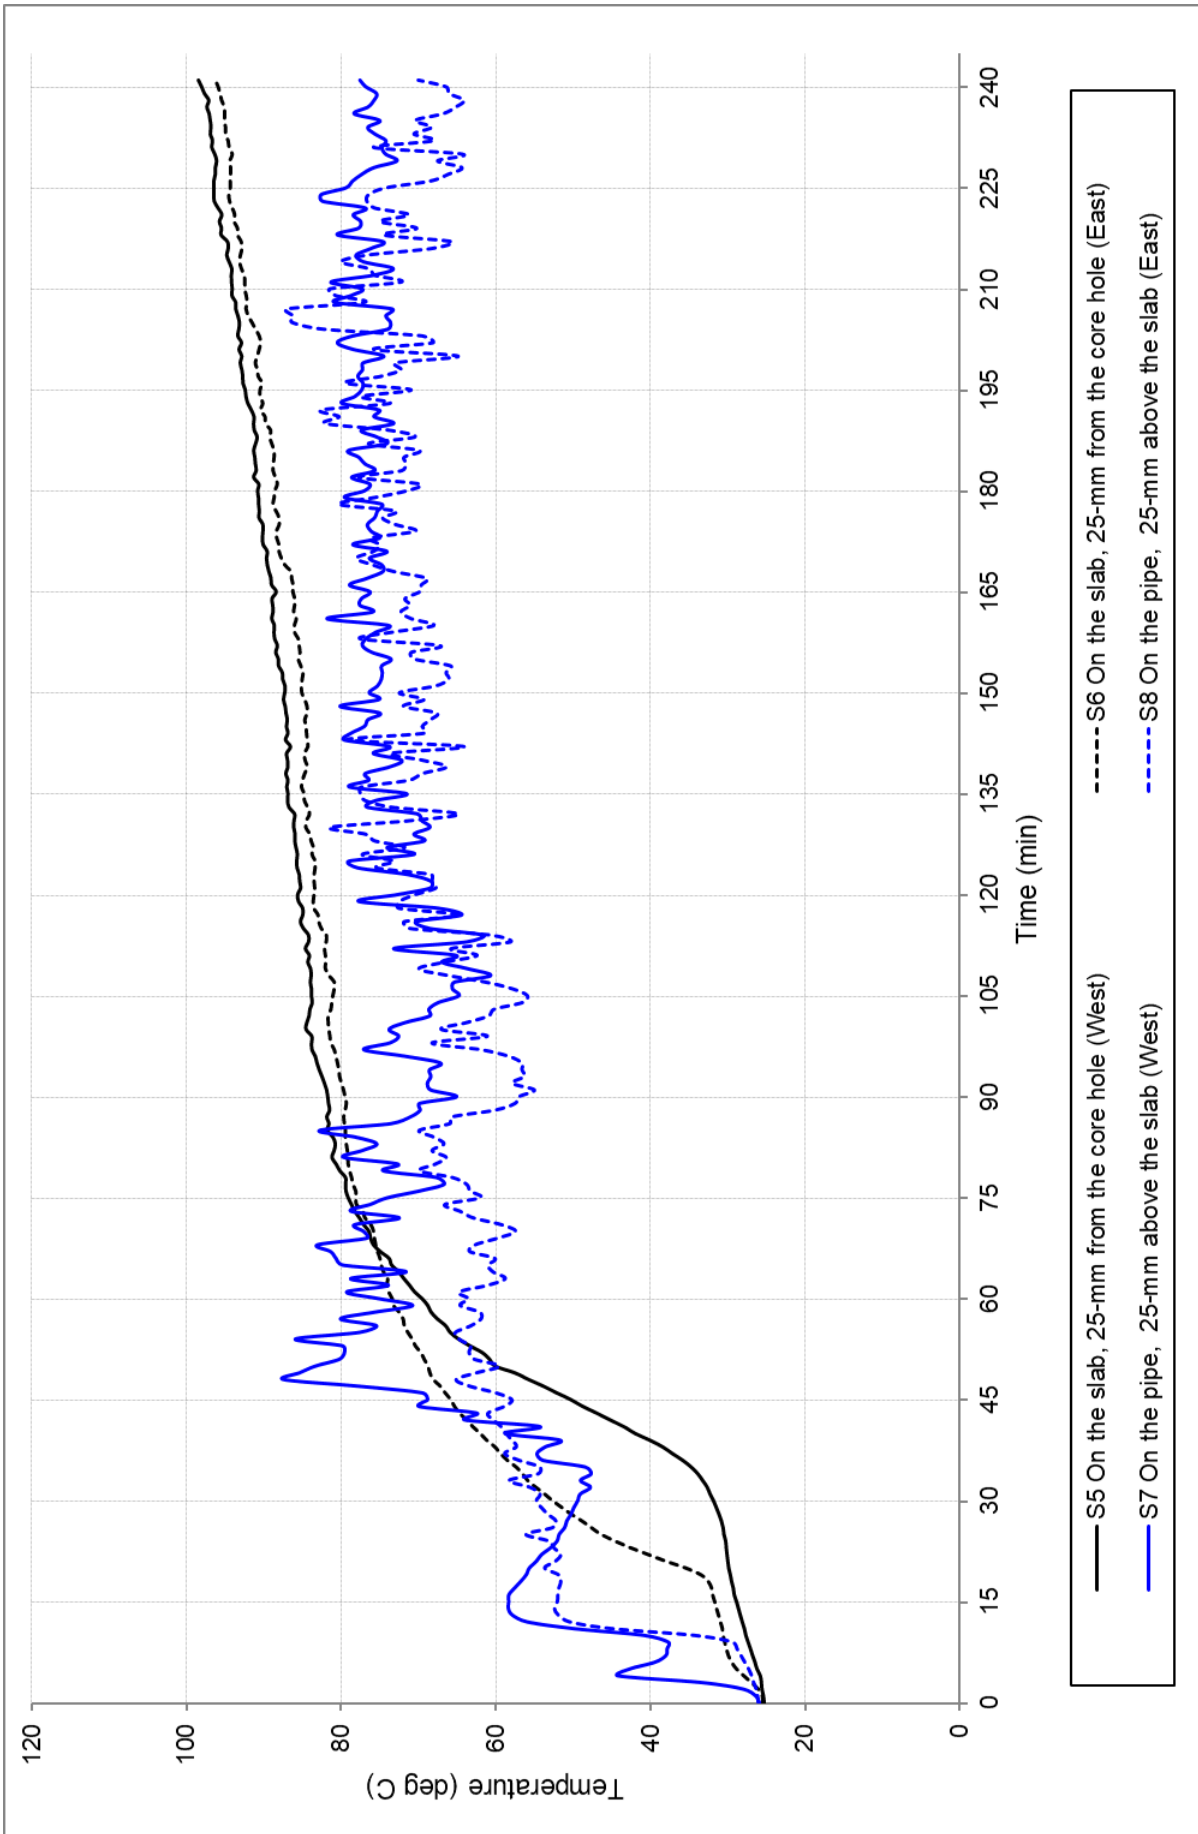
FIGURE 5 – SPECIMEN TEMPERATURE – ASSOCIATED WITH SPECIMEN 2

Structural adequacy	-	not applicable
Integrity	-	no failure at 241 minutes
Insulation	-	no failure at 241 minutes
