Fire-resistance test on fire collars protecting a concrete slab penetrated by services

Test Report

Author: Peter Gordon
Report number: FSP 2135
Date: 21 December 2020

Sponsored Investigation No. FSP 2135

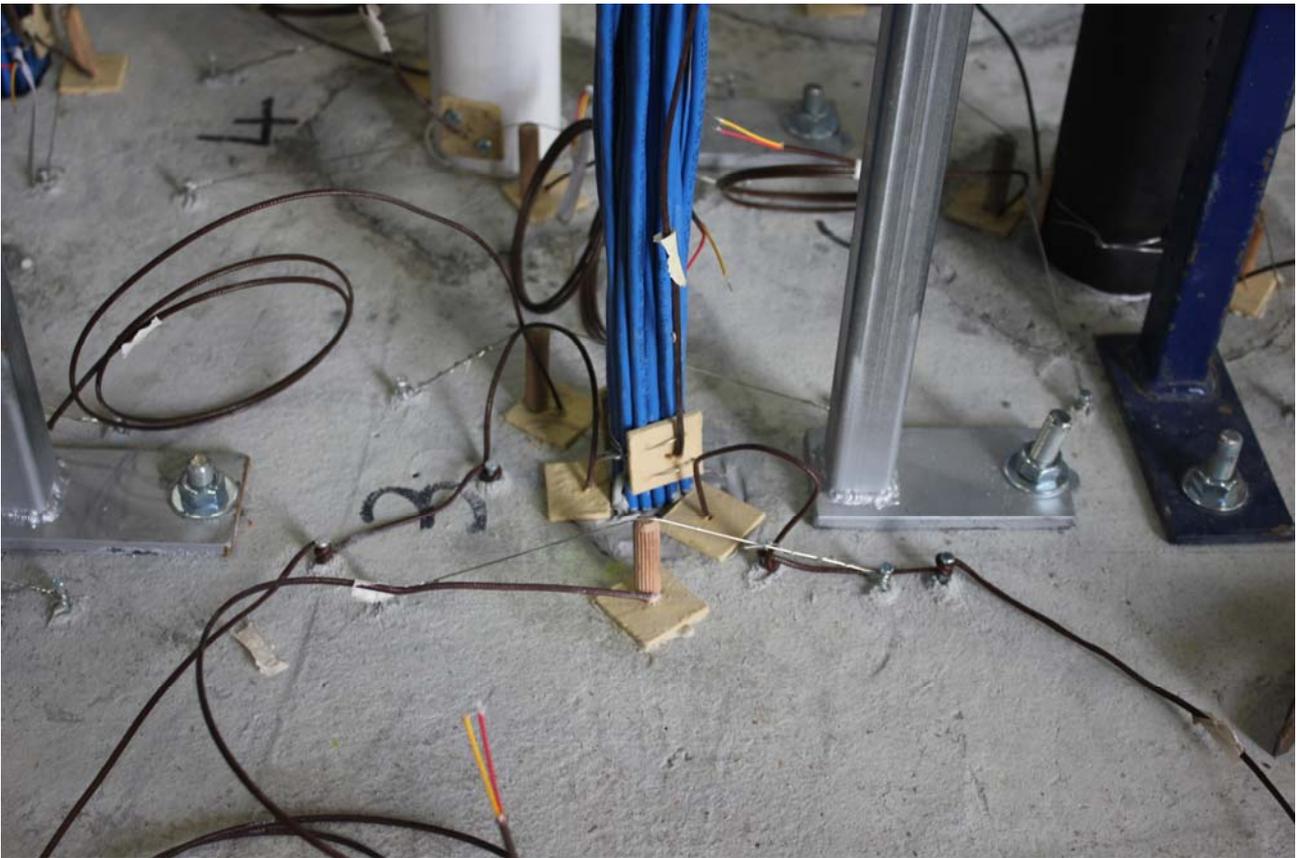
PHOTOGRAPH 3 – UNEXPOSED FACE OF SPECIMEN 3 PRIOR TO TESTING

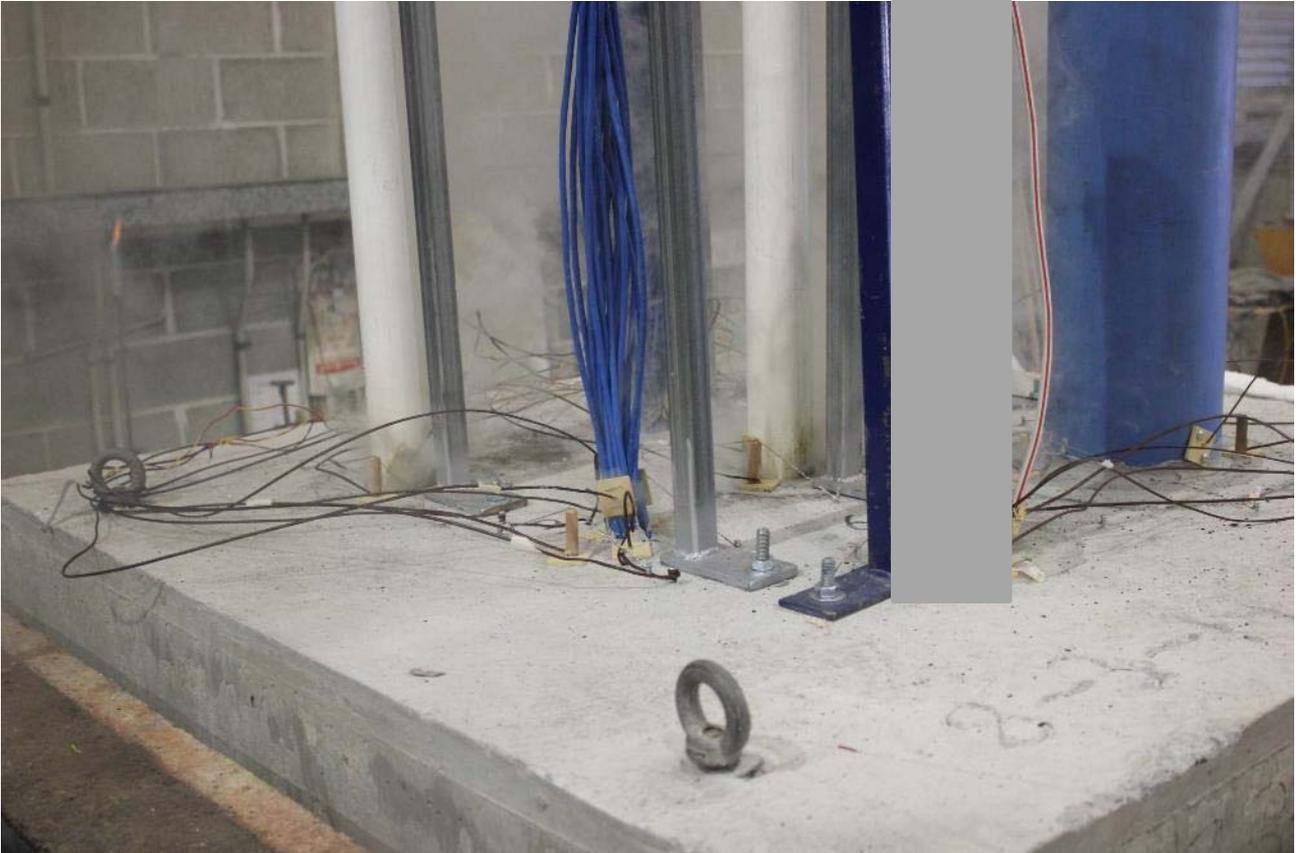
PHOTOGRAPH 4 – SPECIMENS AFTER 4 MINUTES OF TESTING

Time	Observation
30 seconds	- Smoke is being emitted at the base of Specimens 2 and 3.
2 ½ minutes	- Smoke has begun fluing from the end of the PVC conduit of Specimen 1.
3 minutes	- Smoke is being emitted at the base of Specimen 4. The level of smoke fluing at the base of Specimen 2 has reduced.
4 minutes	- Light smoke has begun fluing from the end of the pipe of Specimen 7. Discolouration (smoke staining) is visible on the conduit and pipe at the base of Specimens 1 and 4 (Photograph 4).
5 minutes	- A large volume of smoke is fluing from the end of the pipe of Specimen 7. The level of smoke fluing from the base of Specimen 3 has reduced.

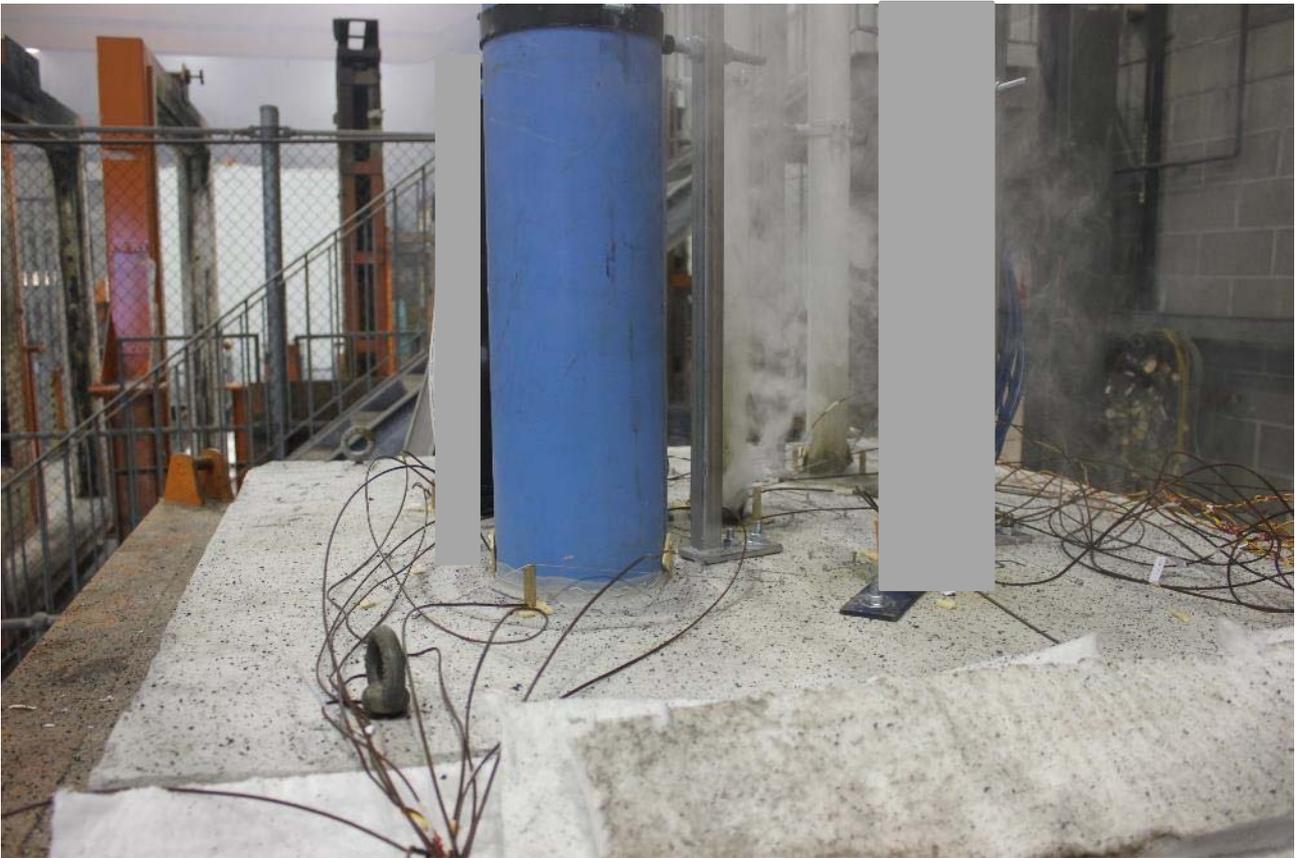
PHOTOGRAPH 5 – SPECIMENS AFTER 12 MINUTES OF TESTING

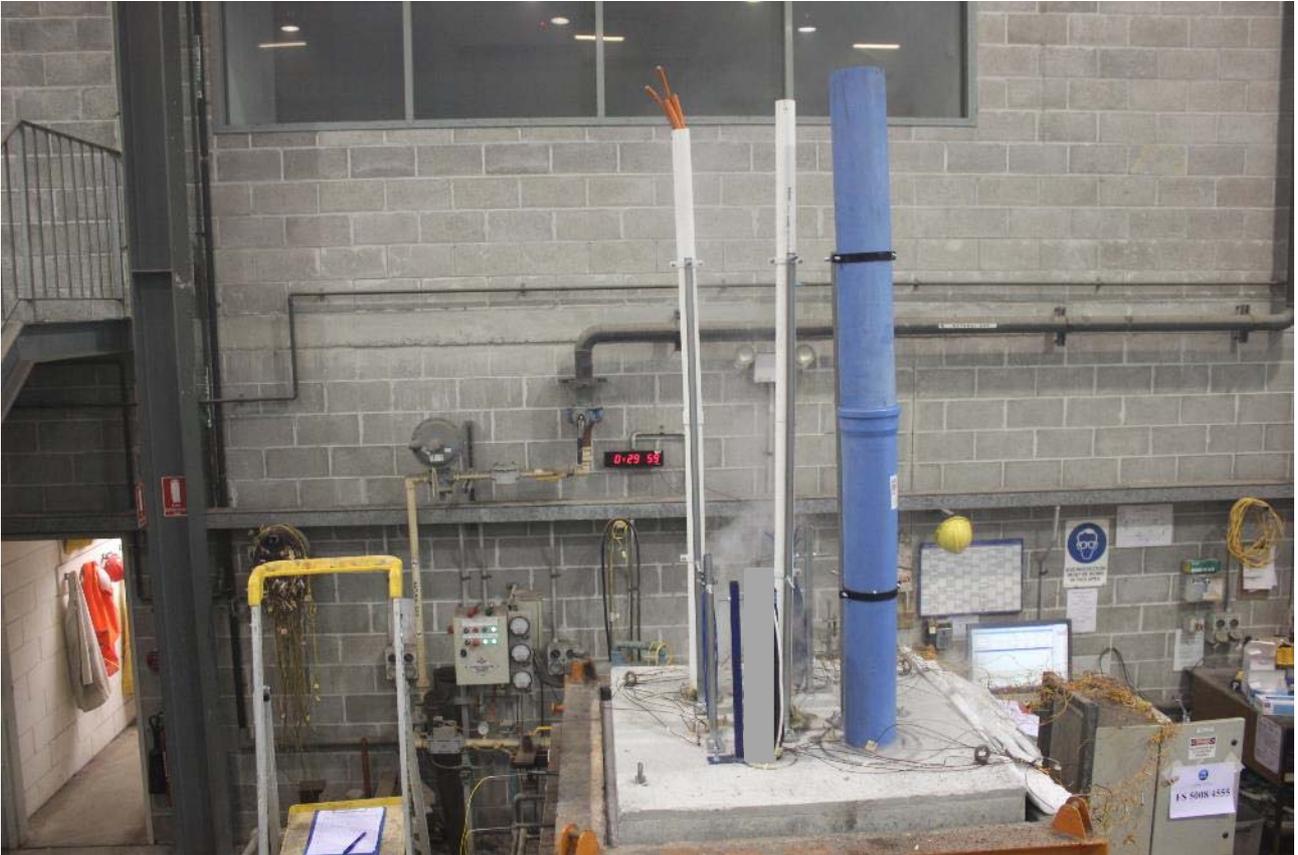
PHOTOGRAPH 6 – SPECIMENS AFTER 30 MINUTES OF TESTING

- 30 minutes - Steam is being emitted from the slab.
- 41 minutes - The level of smoke fluing at the base of specimen 1 has reduced.
- 54 minutes - The sealant around the pipe at the base of Specimen 7 has begun to swell.

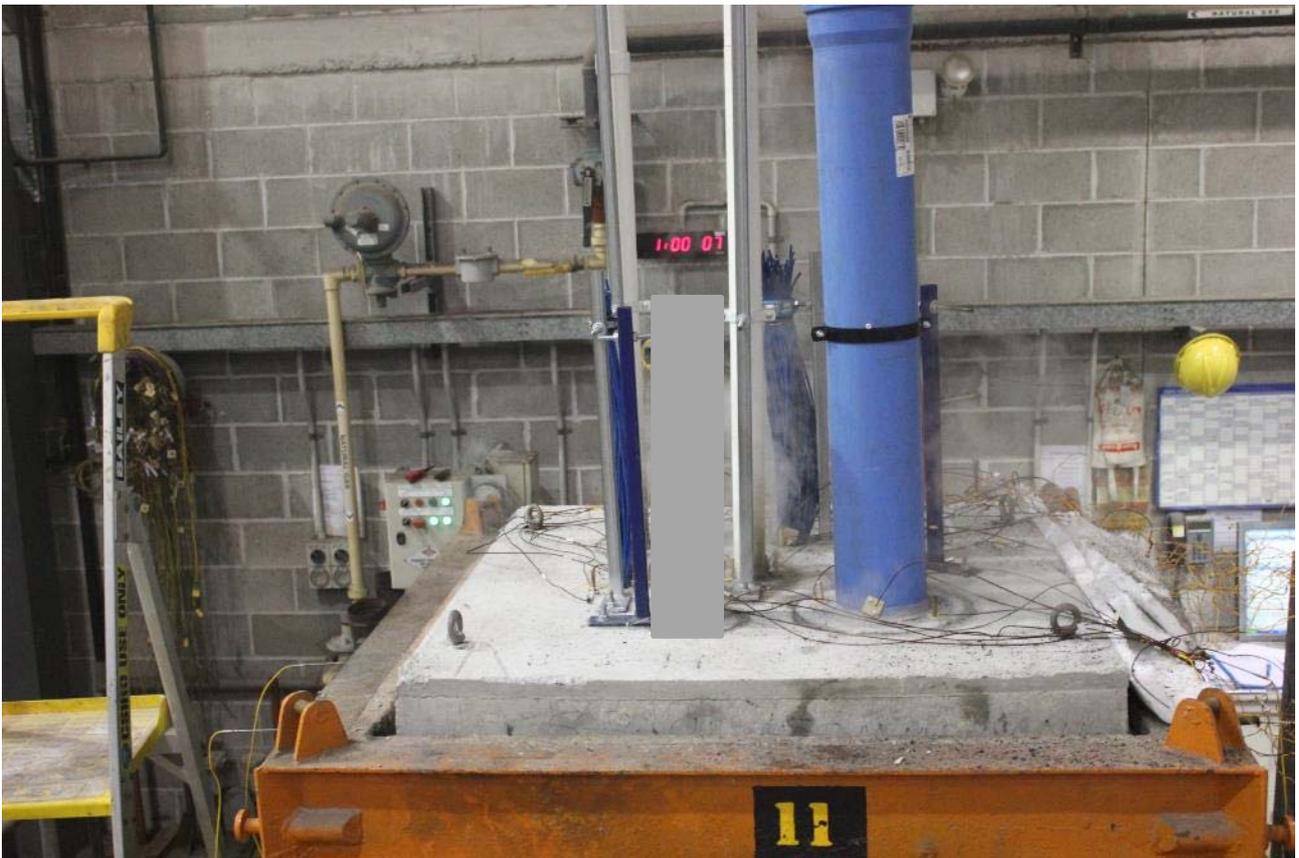
PHOTOGRAPH 7 – SPECIMENS AFTER 60 MINUTES OF TESTING

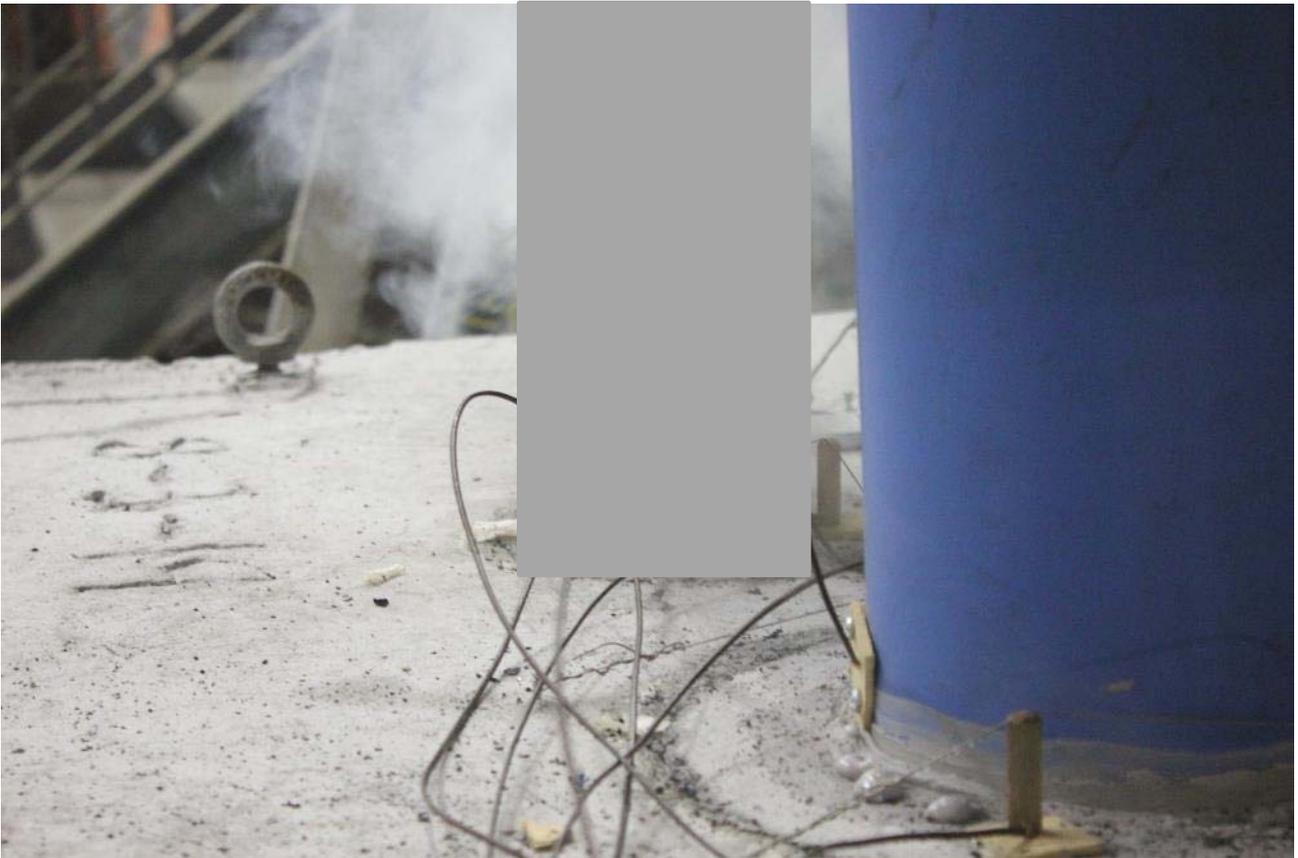
PHOTOGRAPH 9 – SPECIMENS 7 AFTER 111 MINUTES OF TESTING

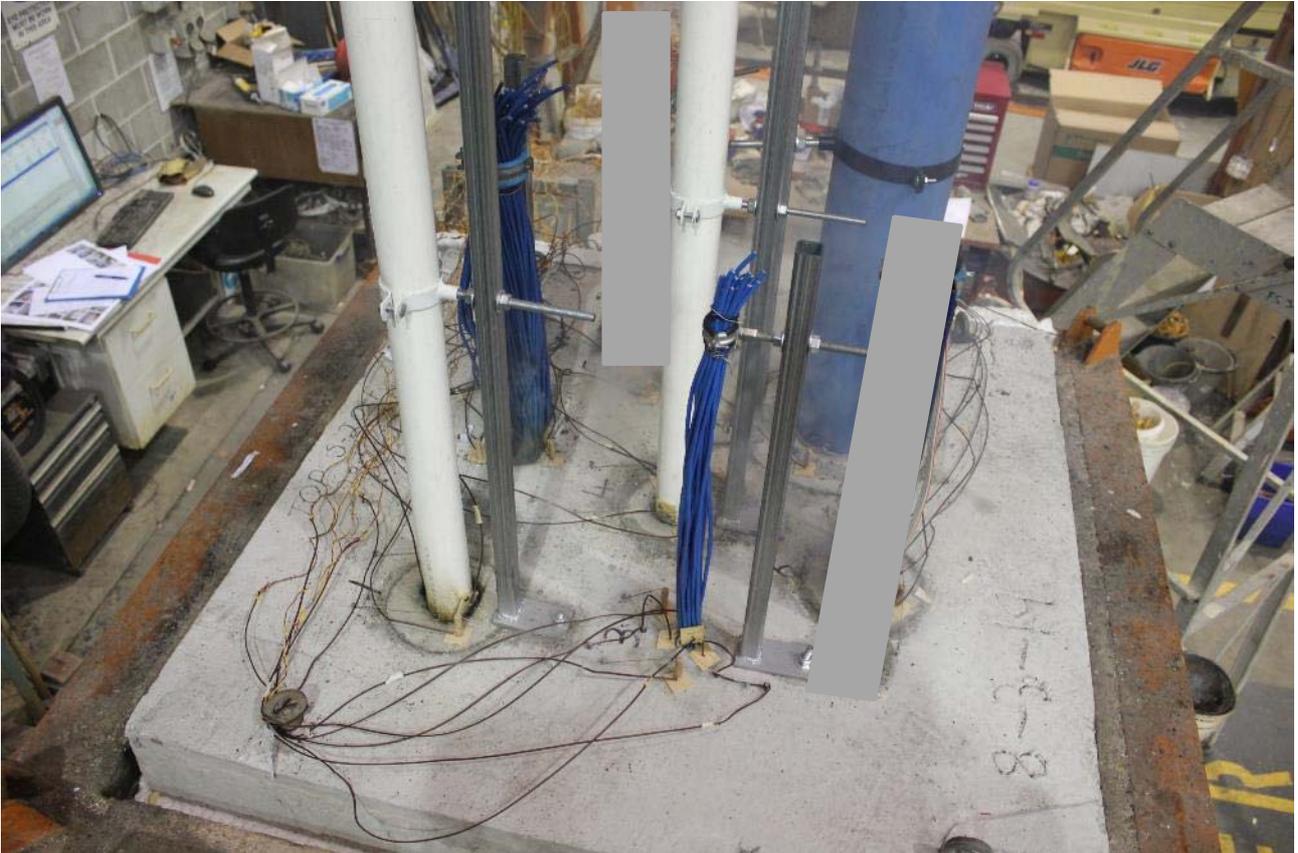
PHOTOGRAPH 10 – SPECIMENS AFTER 120 MINUTES OF TESTING

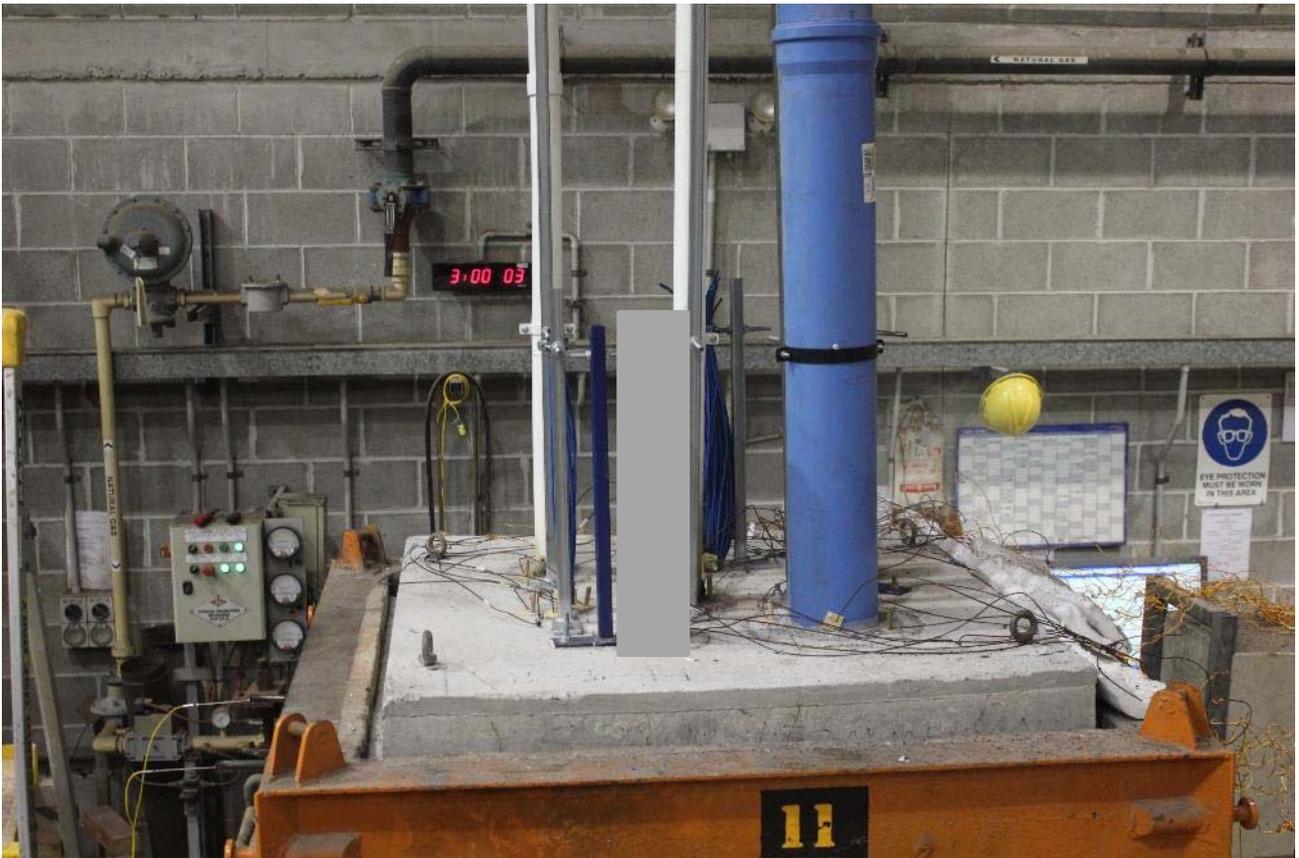
PHOTOGRAPH 11 – SPECIMENS AFTER 180 MINUTES OF TESTING

- 146 minutes - The orange sheath on the cables at the base of Specimen 4 has distorted, discoloured and pushed thermocouple #22 upwards (Photograph 11).

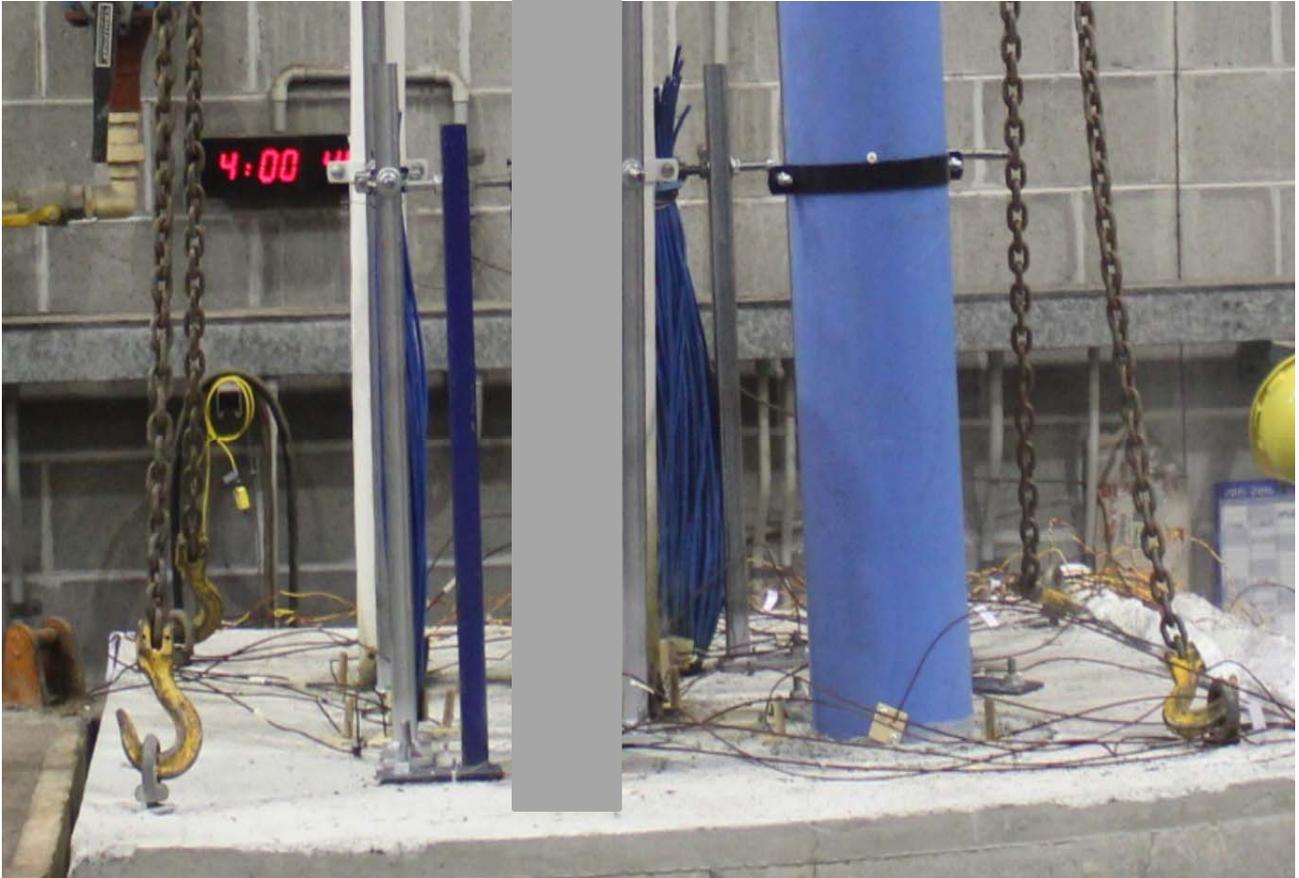
PHOTOGRAPH 12 – SPECIMENS AFTER 240 MINUTES OF TESTING

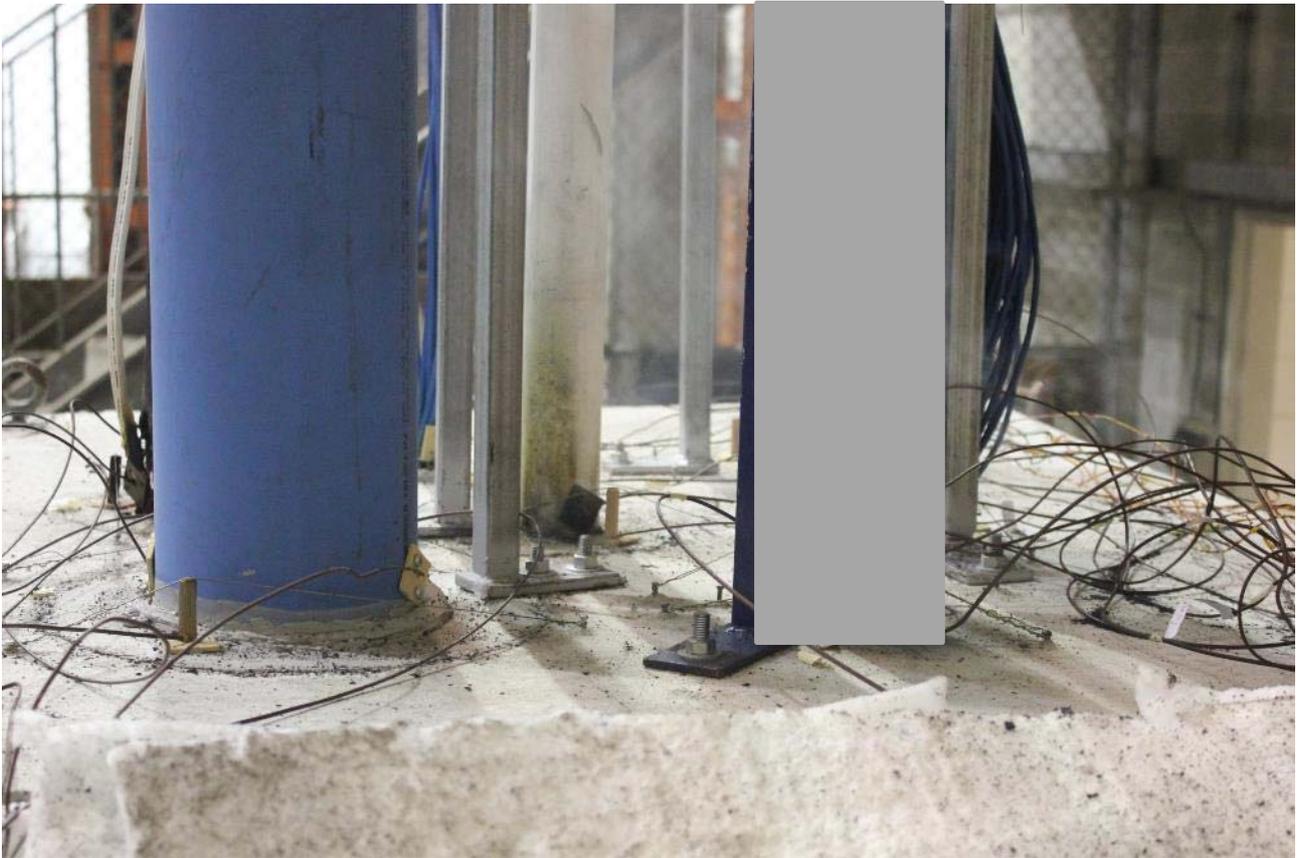
PHOTOGRAPH 13 – SPECIMENS AT THE CONCLUSION OF TESTING

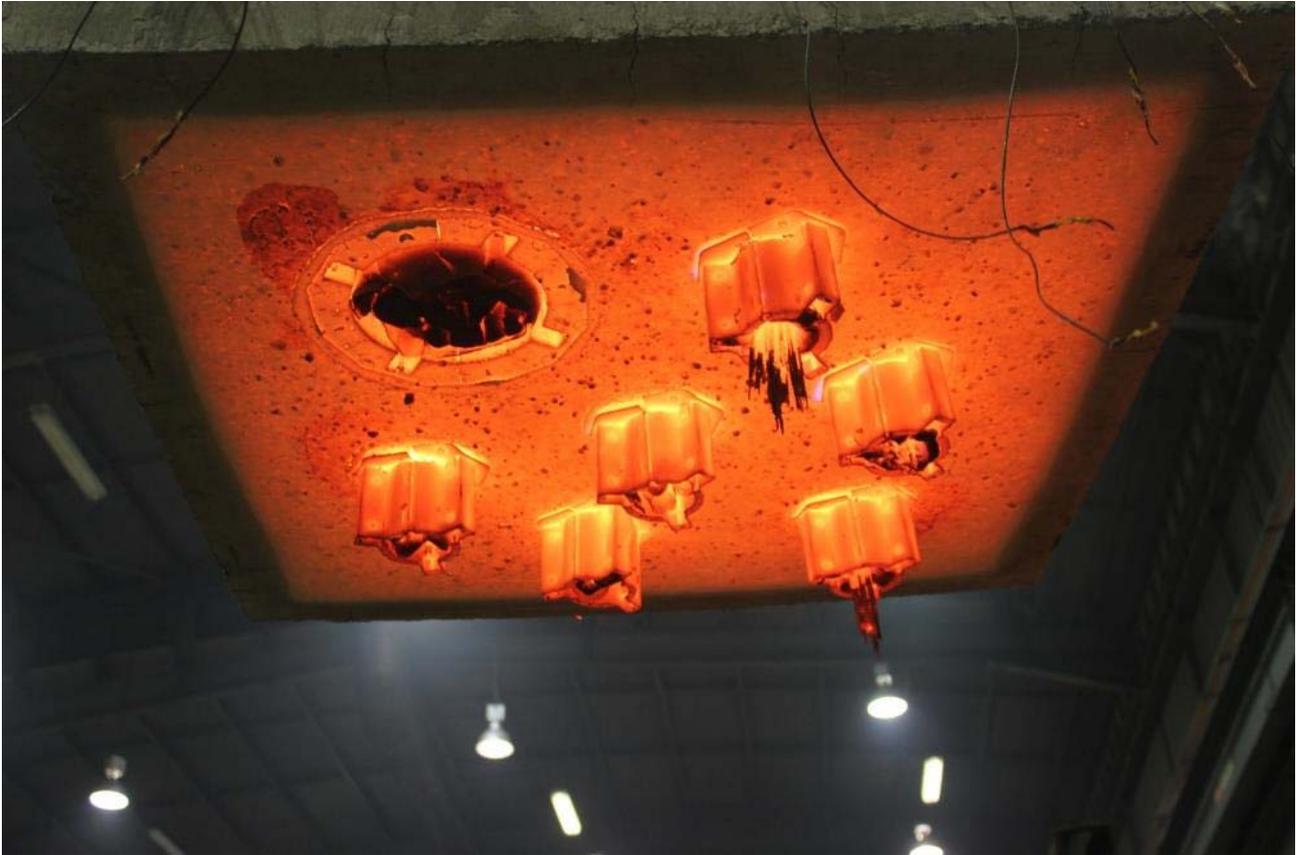
PHOTOGRAPH 14 – EXPOSED FACE OF SPECIMENS AT THE CONCLUSION OF TESTING
