Fire-resistance test on retrofit fire collars protecting a plasterboard wall penetrated by services

Test Report

Author: Peter Gordon
Report number: FSP 2188
Date: 27 April 2021
Client: IG6 Pty Ltd as trustee for the IG6 IP Trust

Sponsored Investigation No. FSP 2188

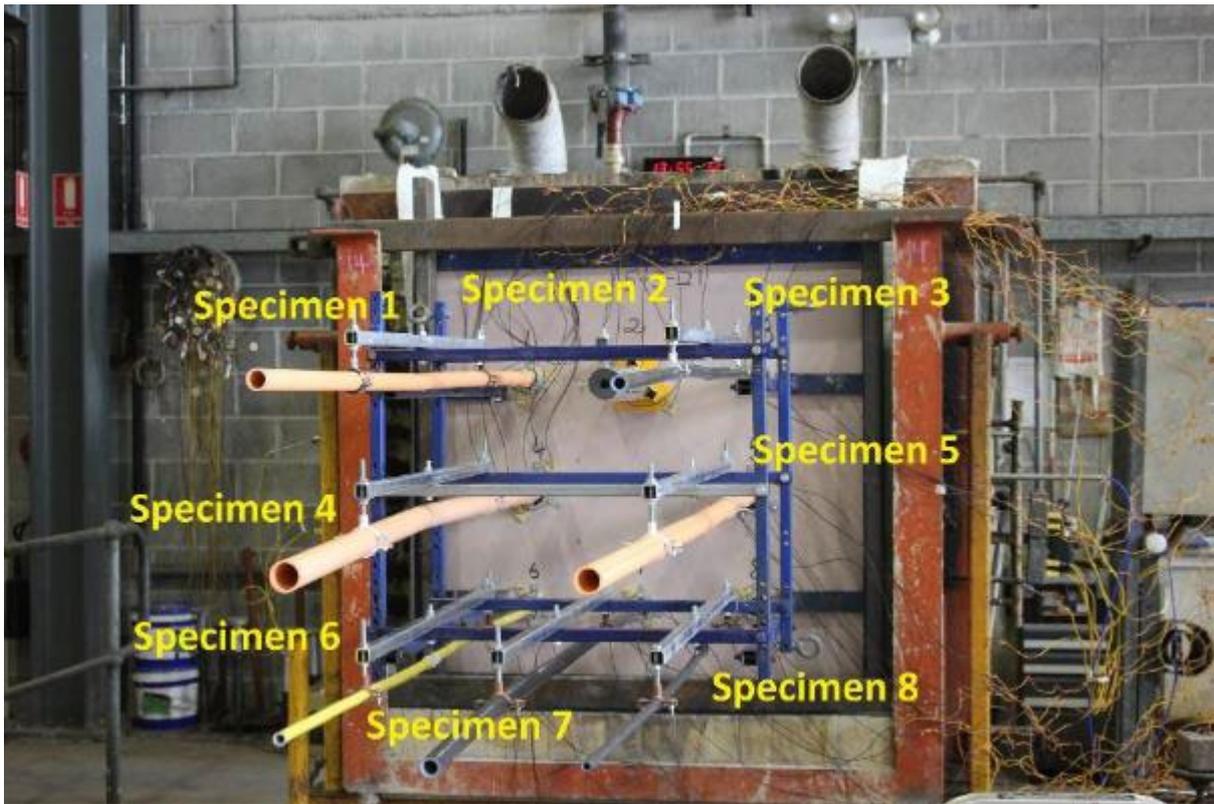
PHOTOGRAPH 1 – UNEXPOSED FACE OF SPECIMENS PRIOR TO TESTING

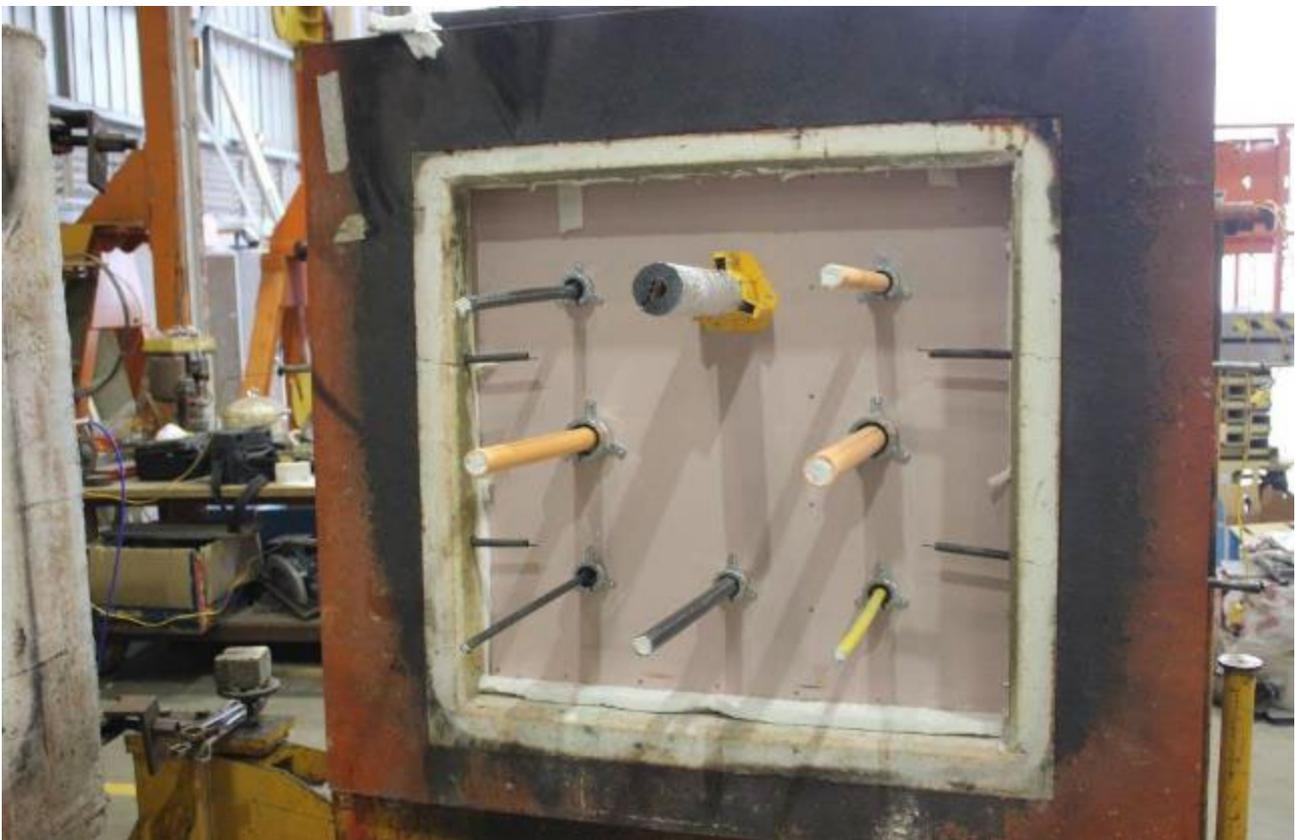
PHOTOGRAPH 2 – EXPOSED FACE OF SPECIMENS PRIOR TO TESTING

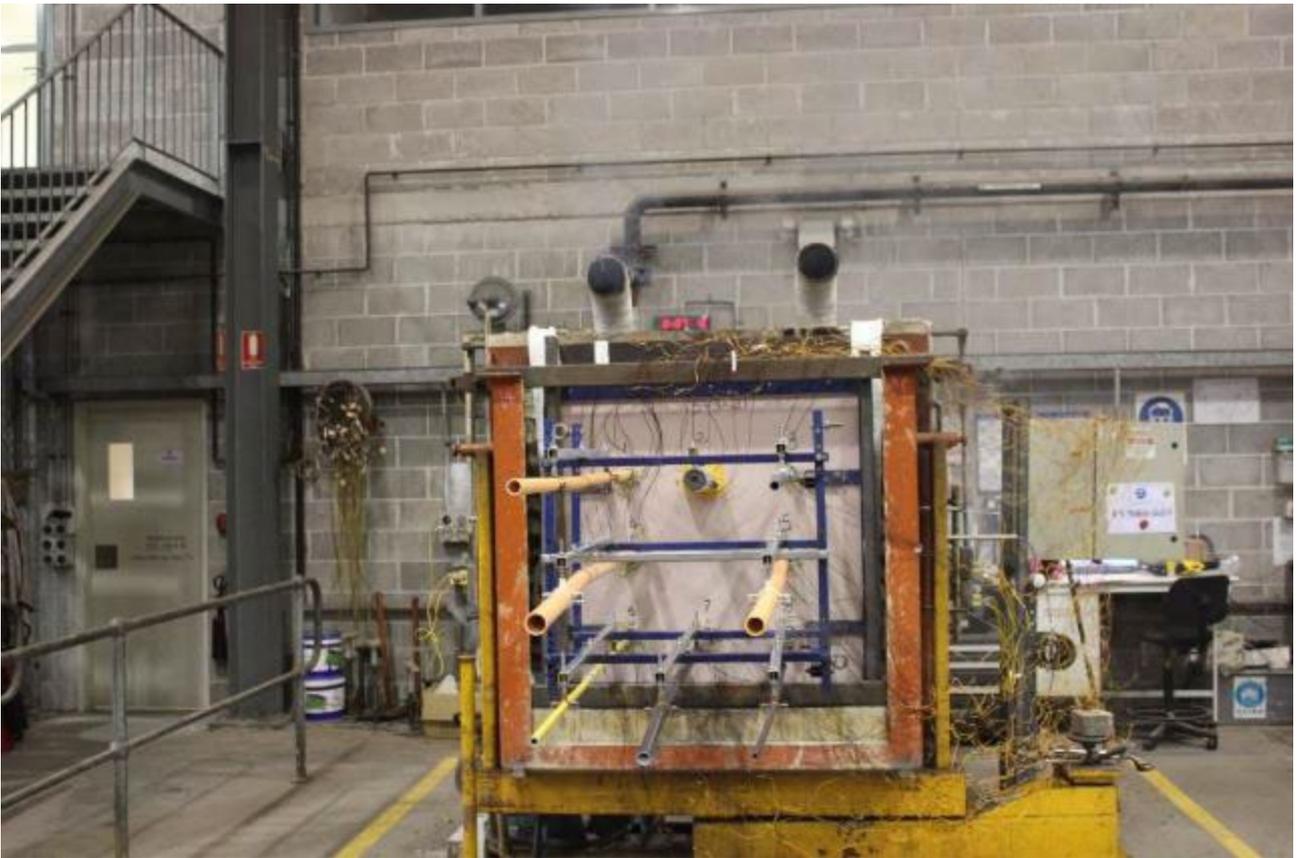
PHOTOGRAPH 3 – SPECIMENS AFTER 7 MINUTES OF TESTING

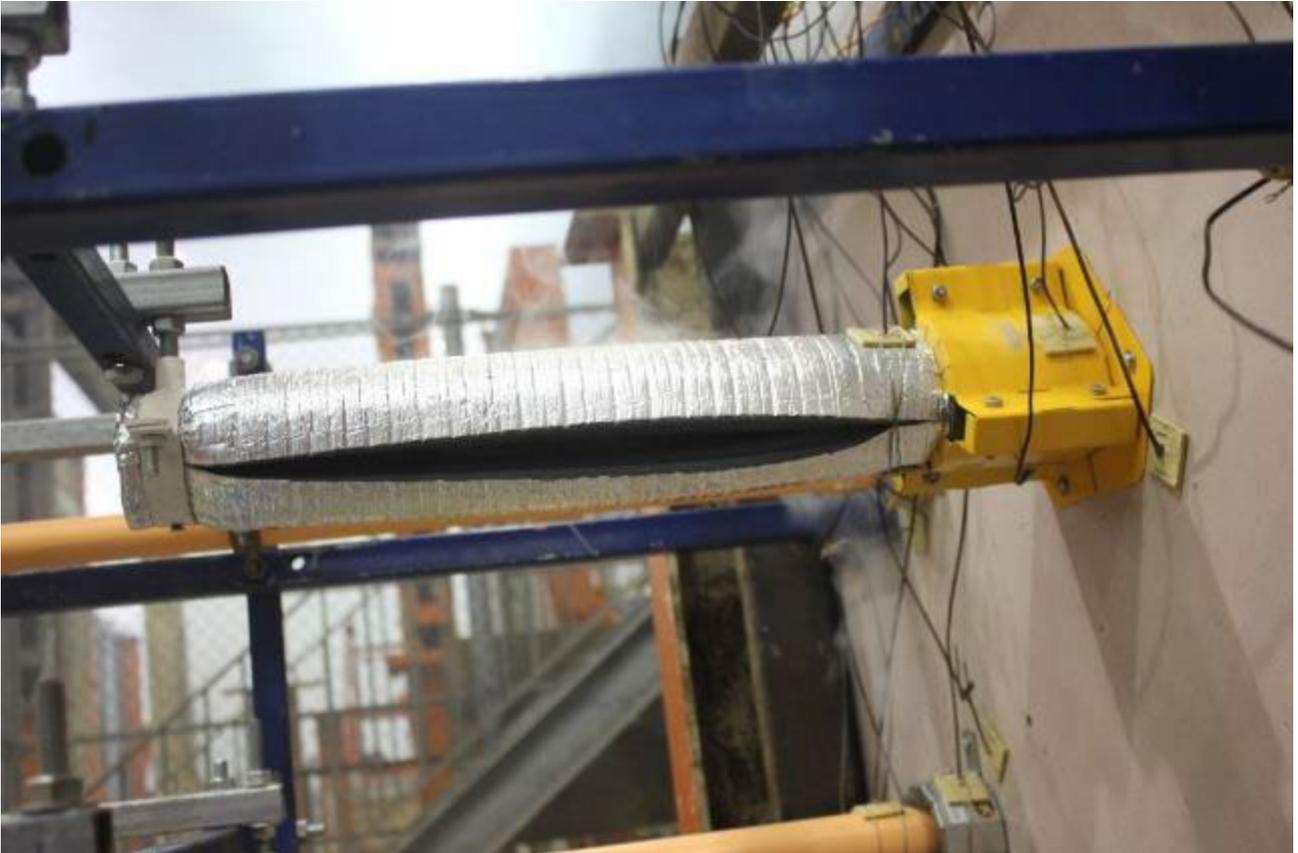
PHOTOGRAPH 4 – SPECIMEN 2 AFTER 21 MINUTES OF TESTING

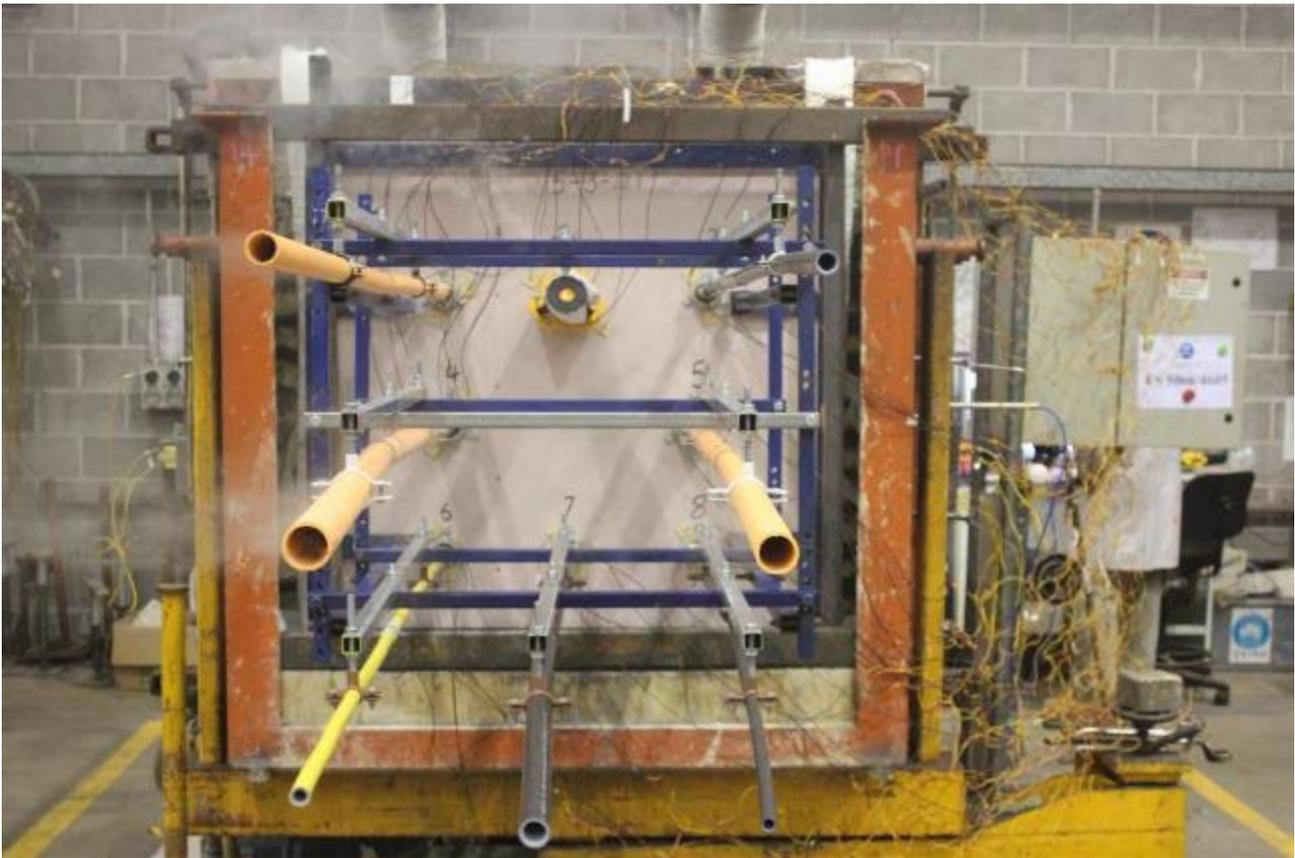
PHOTOGRAPH 5 – SPECIMENS AFTER 30 MINUTES OF TESTING

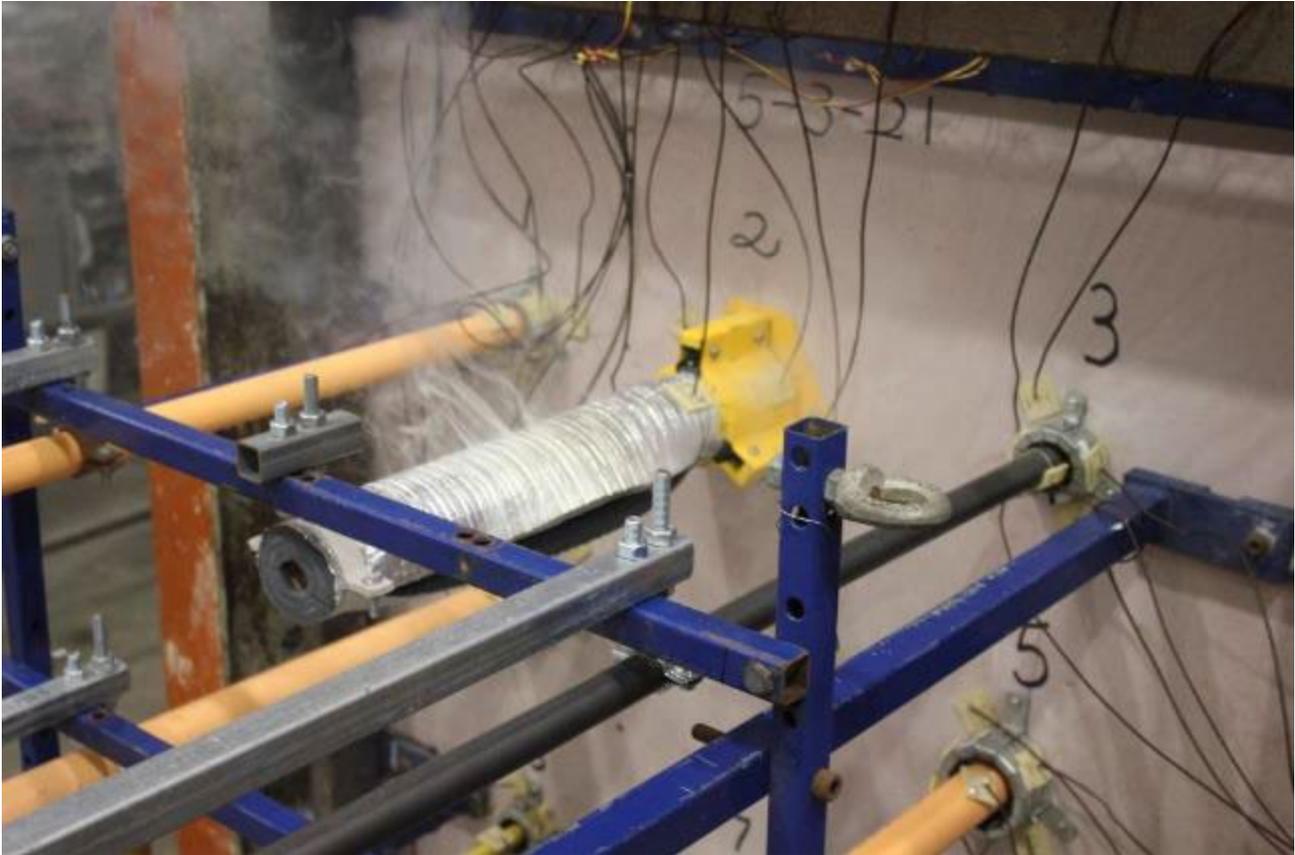
PHOTOGRAPH 6 – SPECIMEN 2 AFTER 31 MINUTES OF TESTING

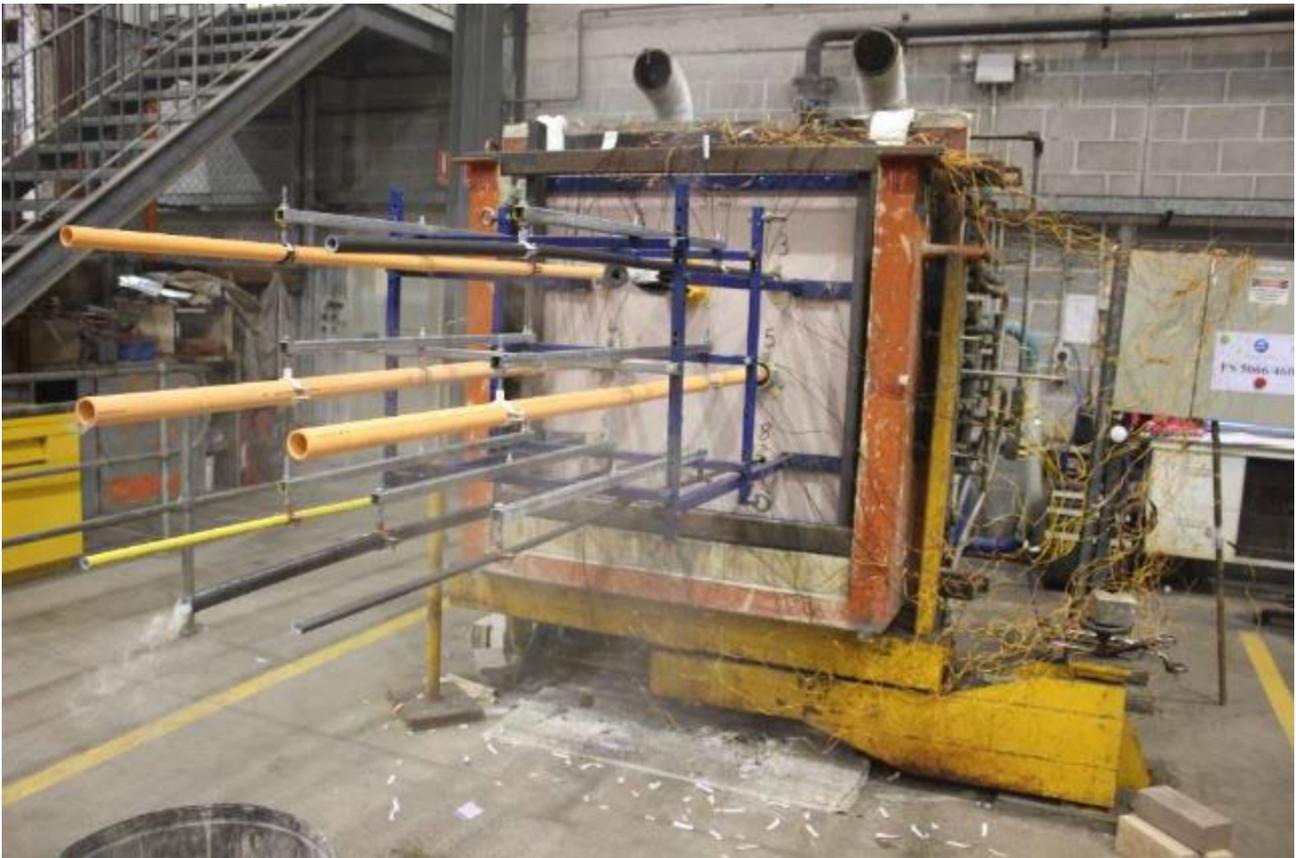
PHOTOGRAPH 7 – SPECIMENS AFTER 60 MINUTES OF TESTING

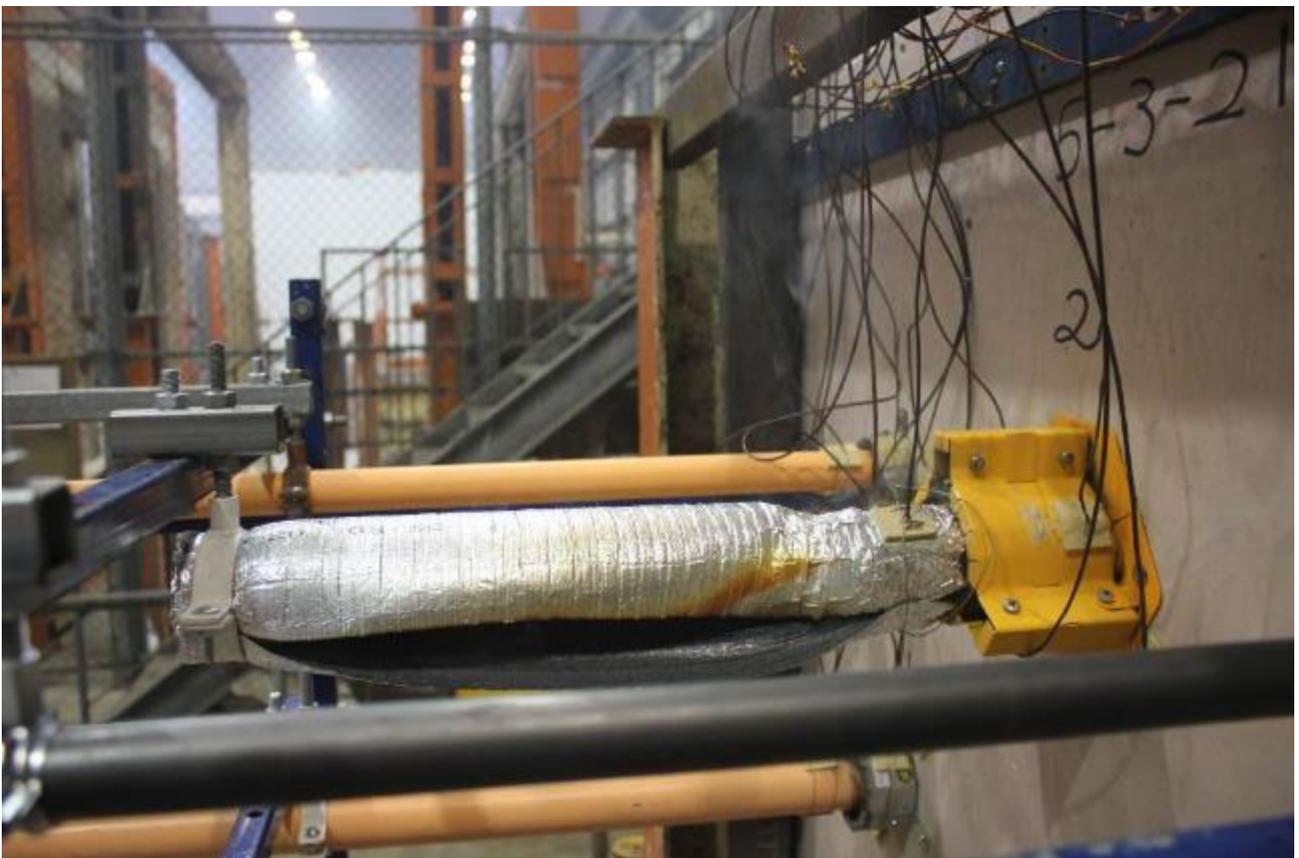
PHOTOGRAPH 8 – SPECIMEN 2 AFTER 69 MINUTES OF TESTING

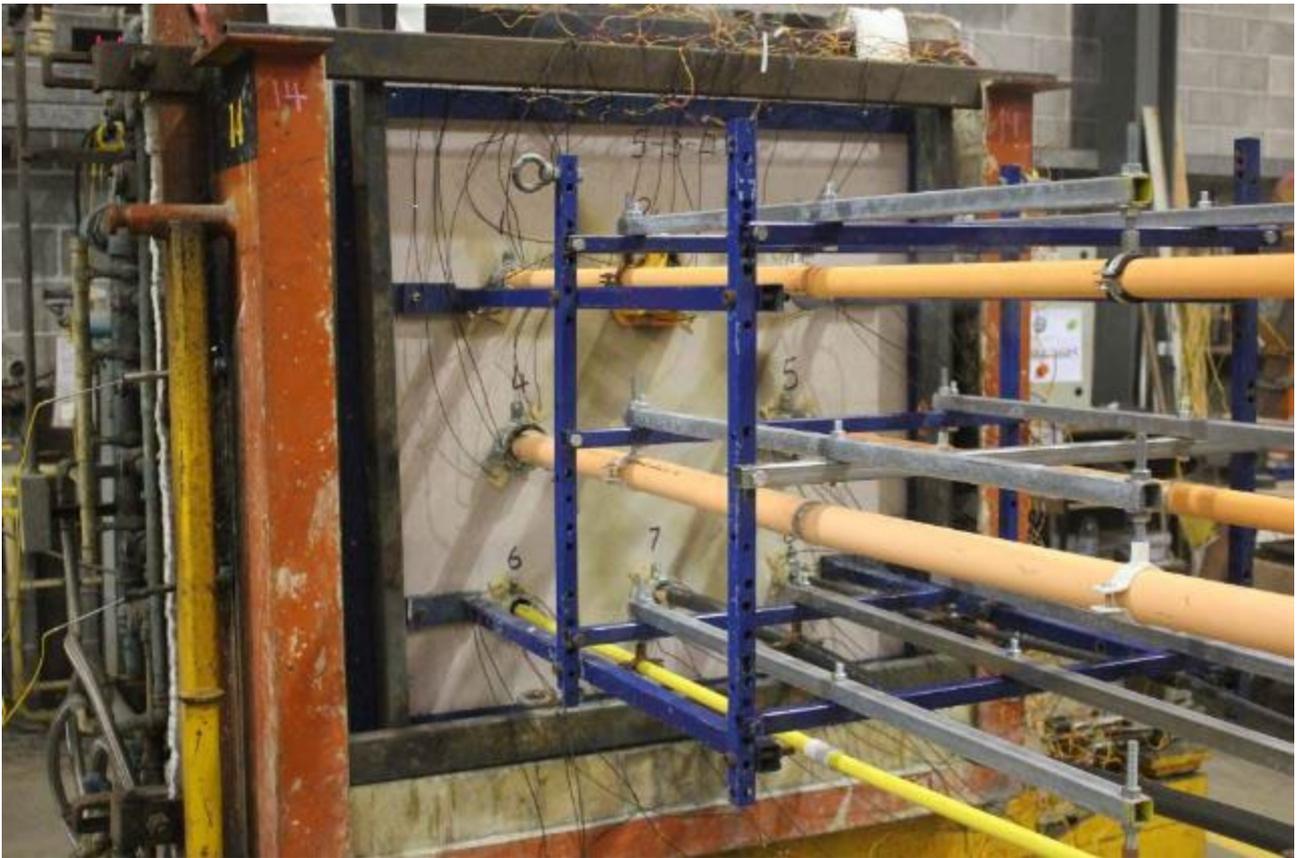
PHOTOGRAPH 9 – SPECIMENS AFTER 69 MINUTES OF TESTING

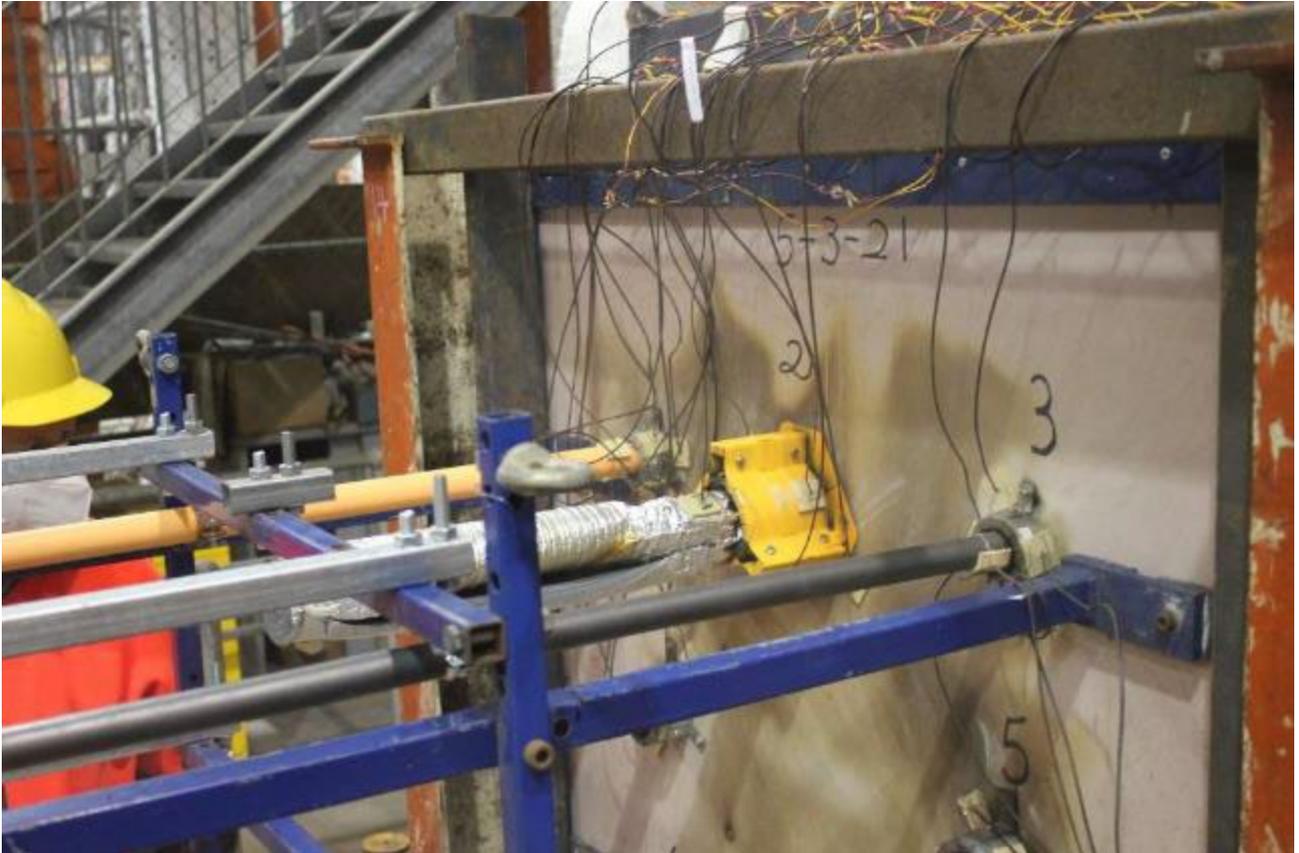
PHOTOGRAPH 10 – SPECIMENS 1, 2 AND 3 AFTER 83 MINUTES OF TESTING

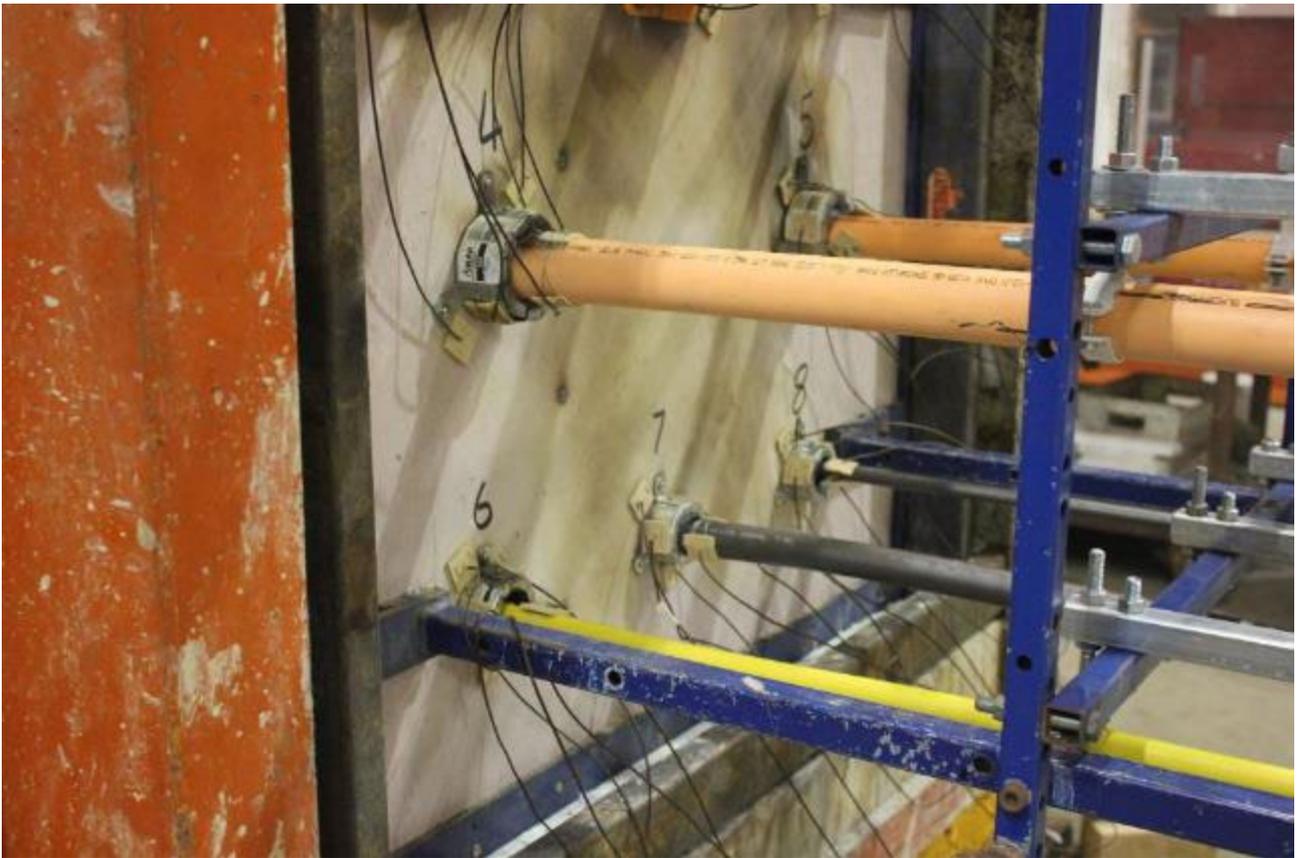
PHOTOGRAPH 11 – SPECIMENS 4, 5, 6, 7, AND 8 AFTER 84 MINUTES OF TESTING

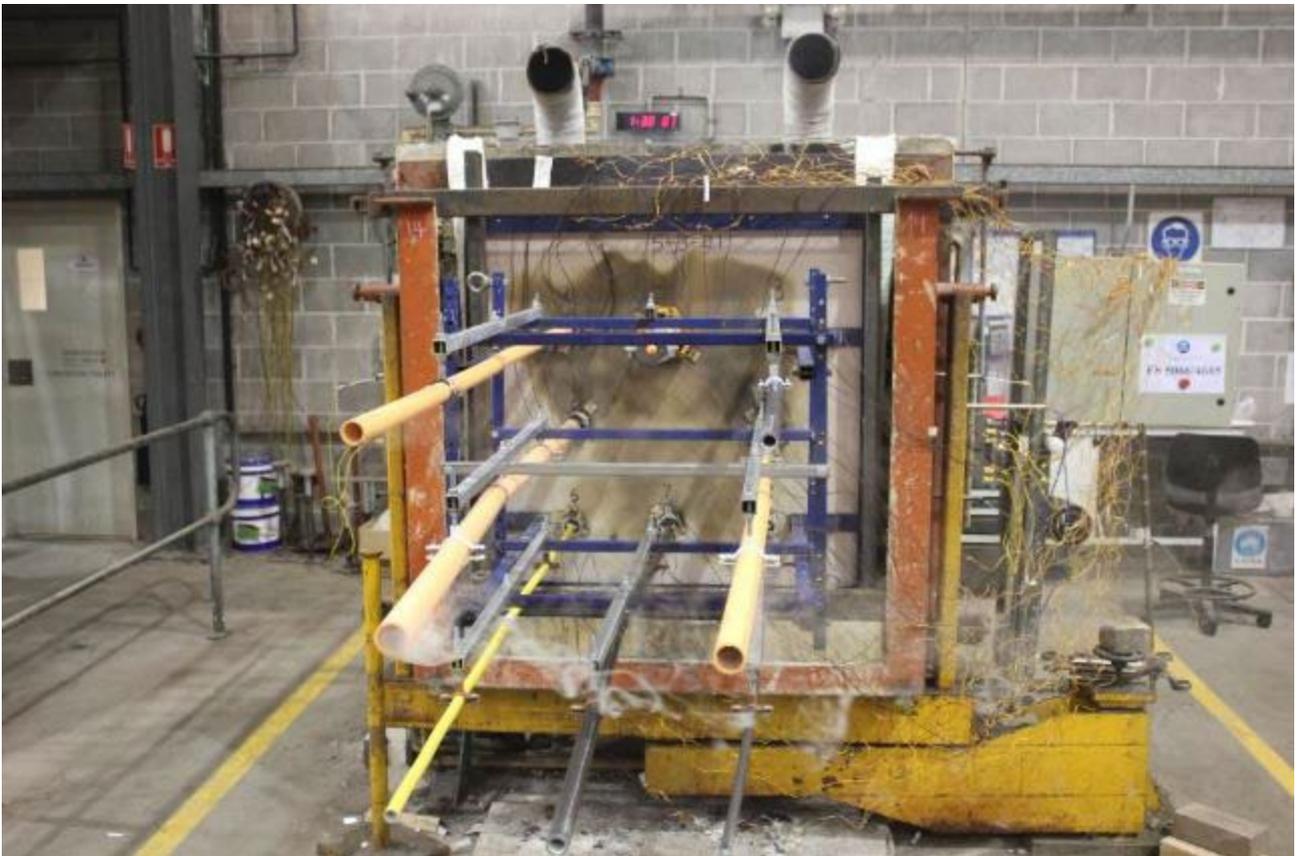
PHOTOGRAPH 12 – SPECIMENS AFTER 90 MINUTES OF TESTING

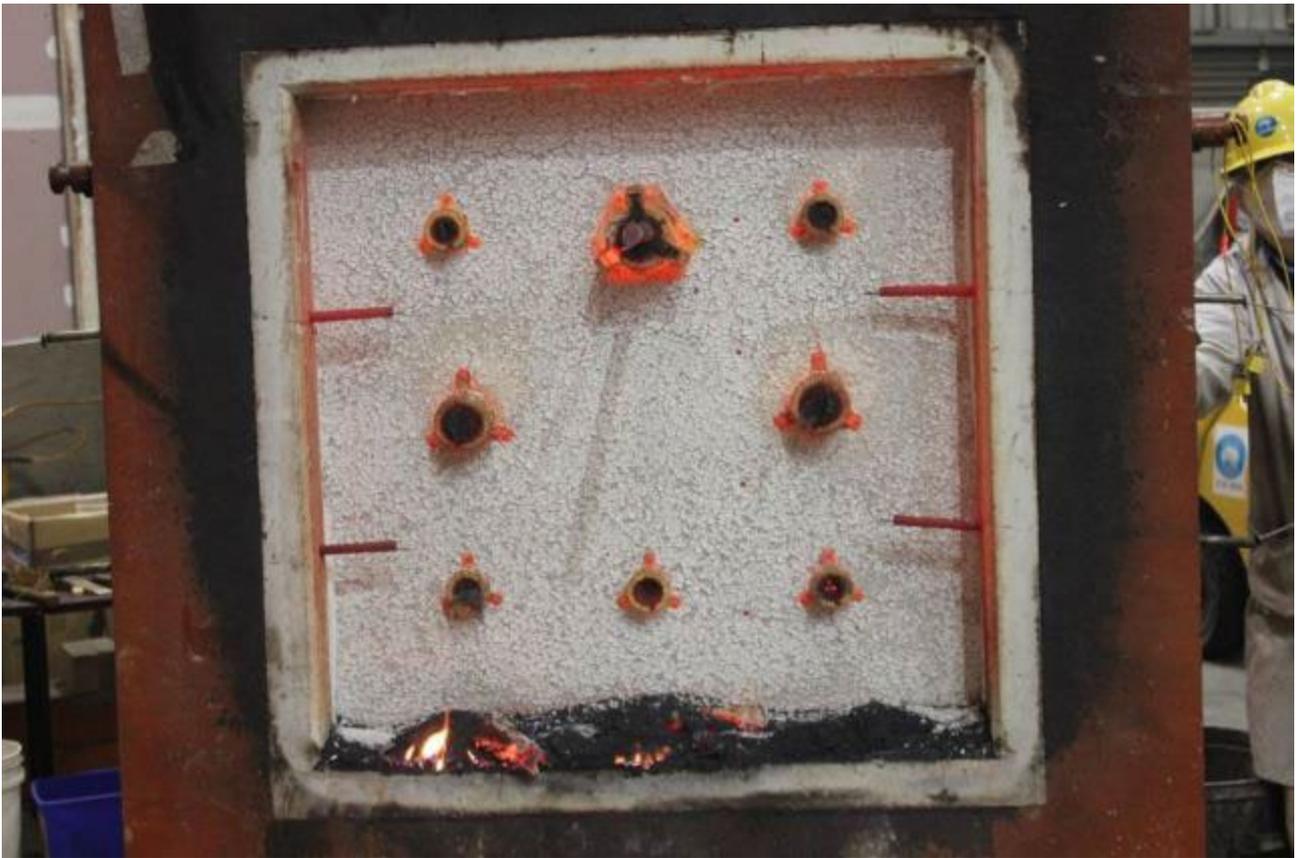
PHOTOGRAPH 13 – EXPOSED FACE OF SPECIMENS AT CONCLUSION OF TESTING

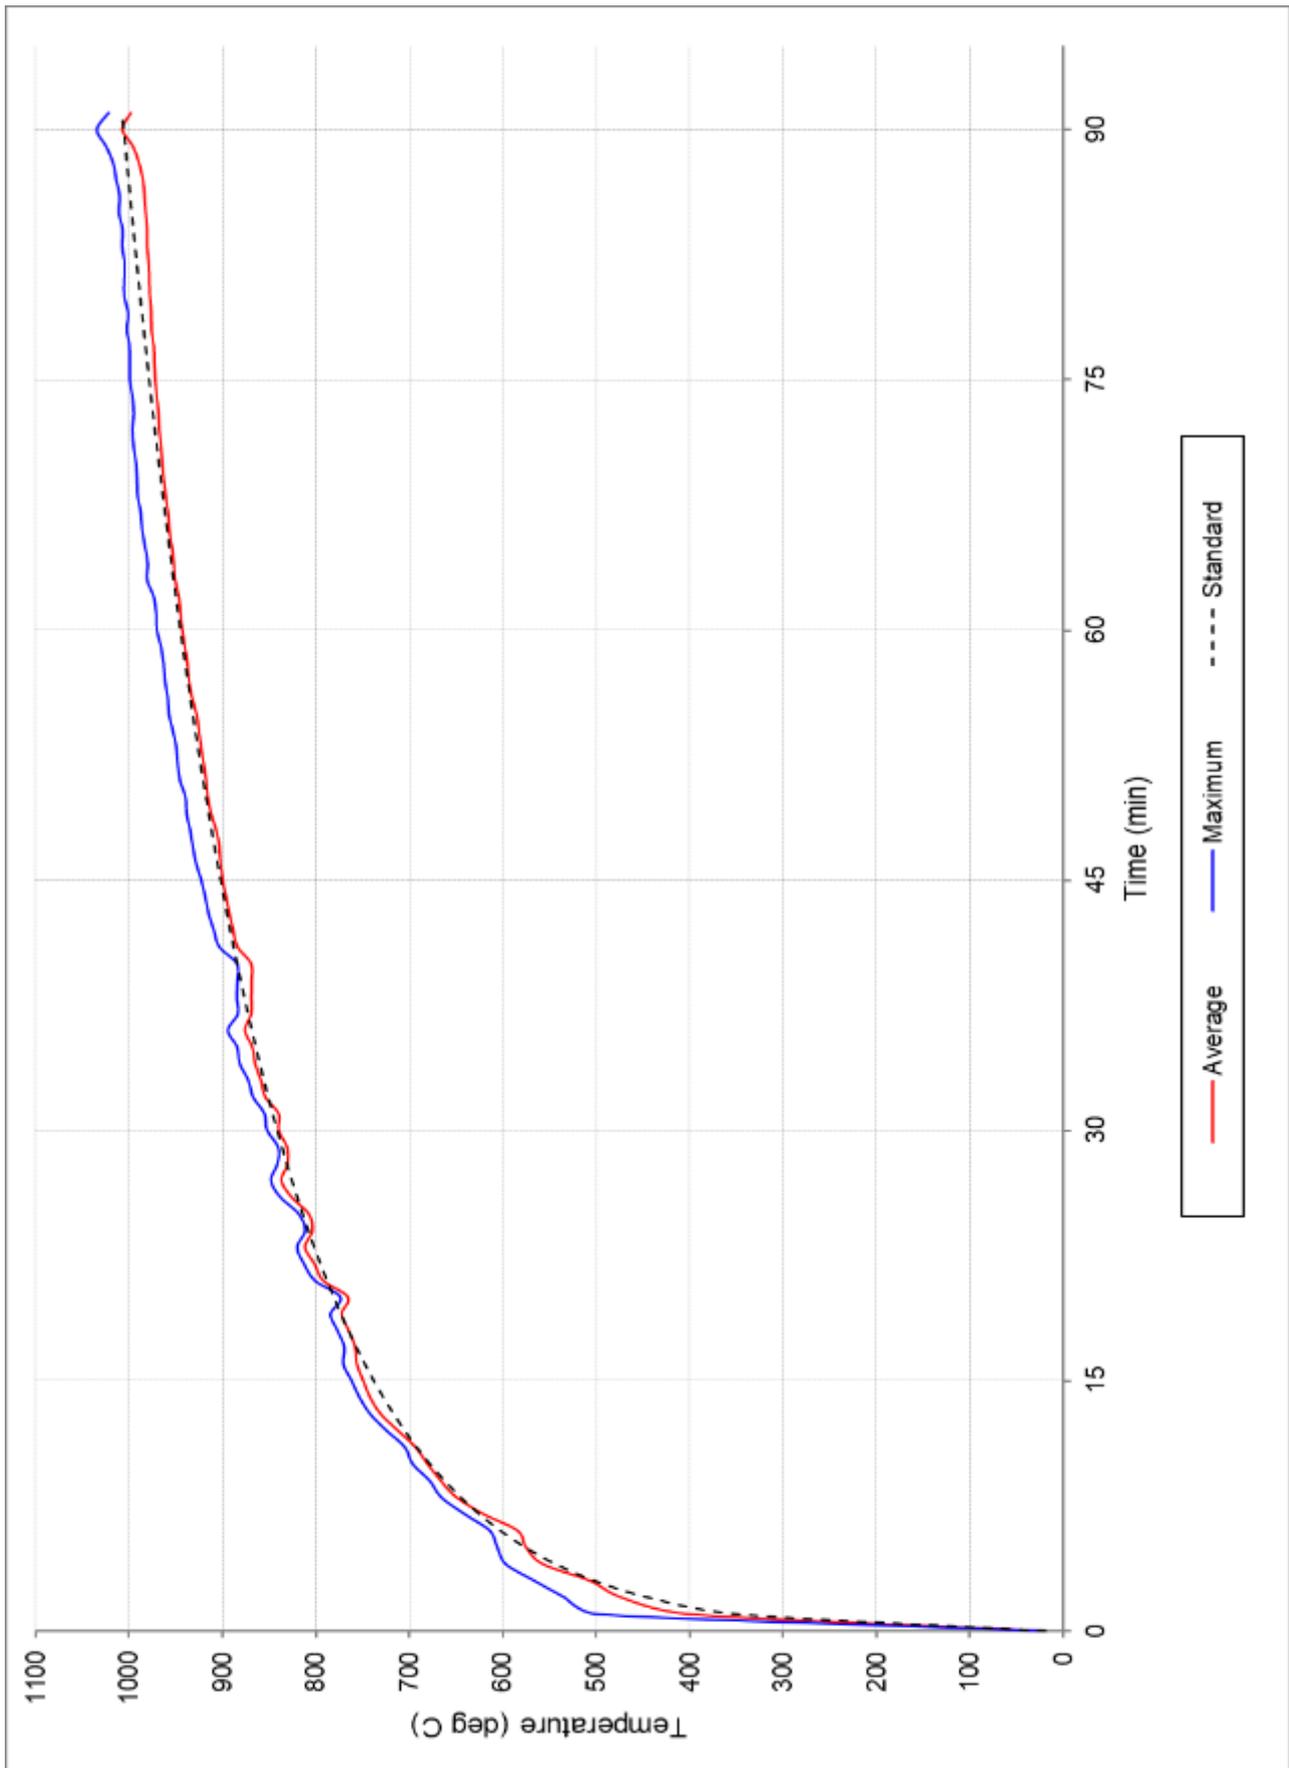
FIGURE 1 – FURNACE TEMPERATURE

The temperature in the furnace chamber was measured by four type K, 3-mm diameter, and 310 stainless steel Mineral Insulated Metal Sheathed (MIMS) thermocouples. Each thermocouple was housed in high-nickel steel tubes opened at the exposed end.

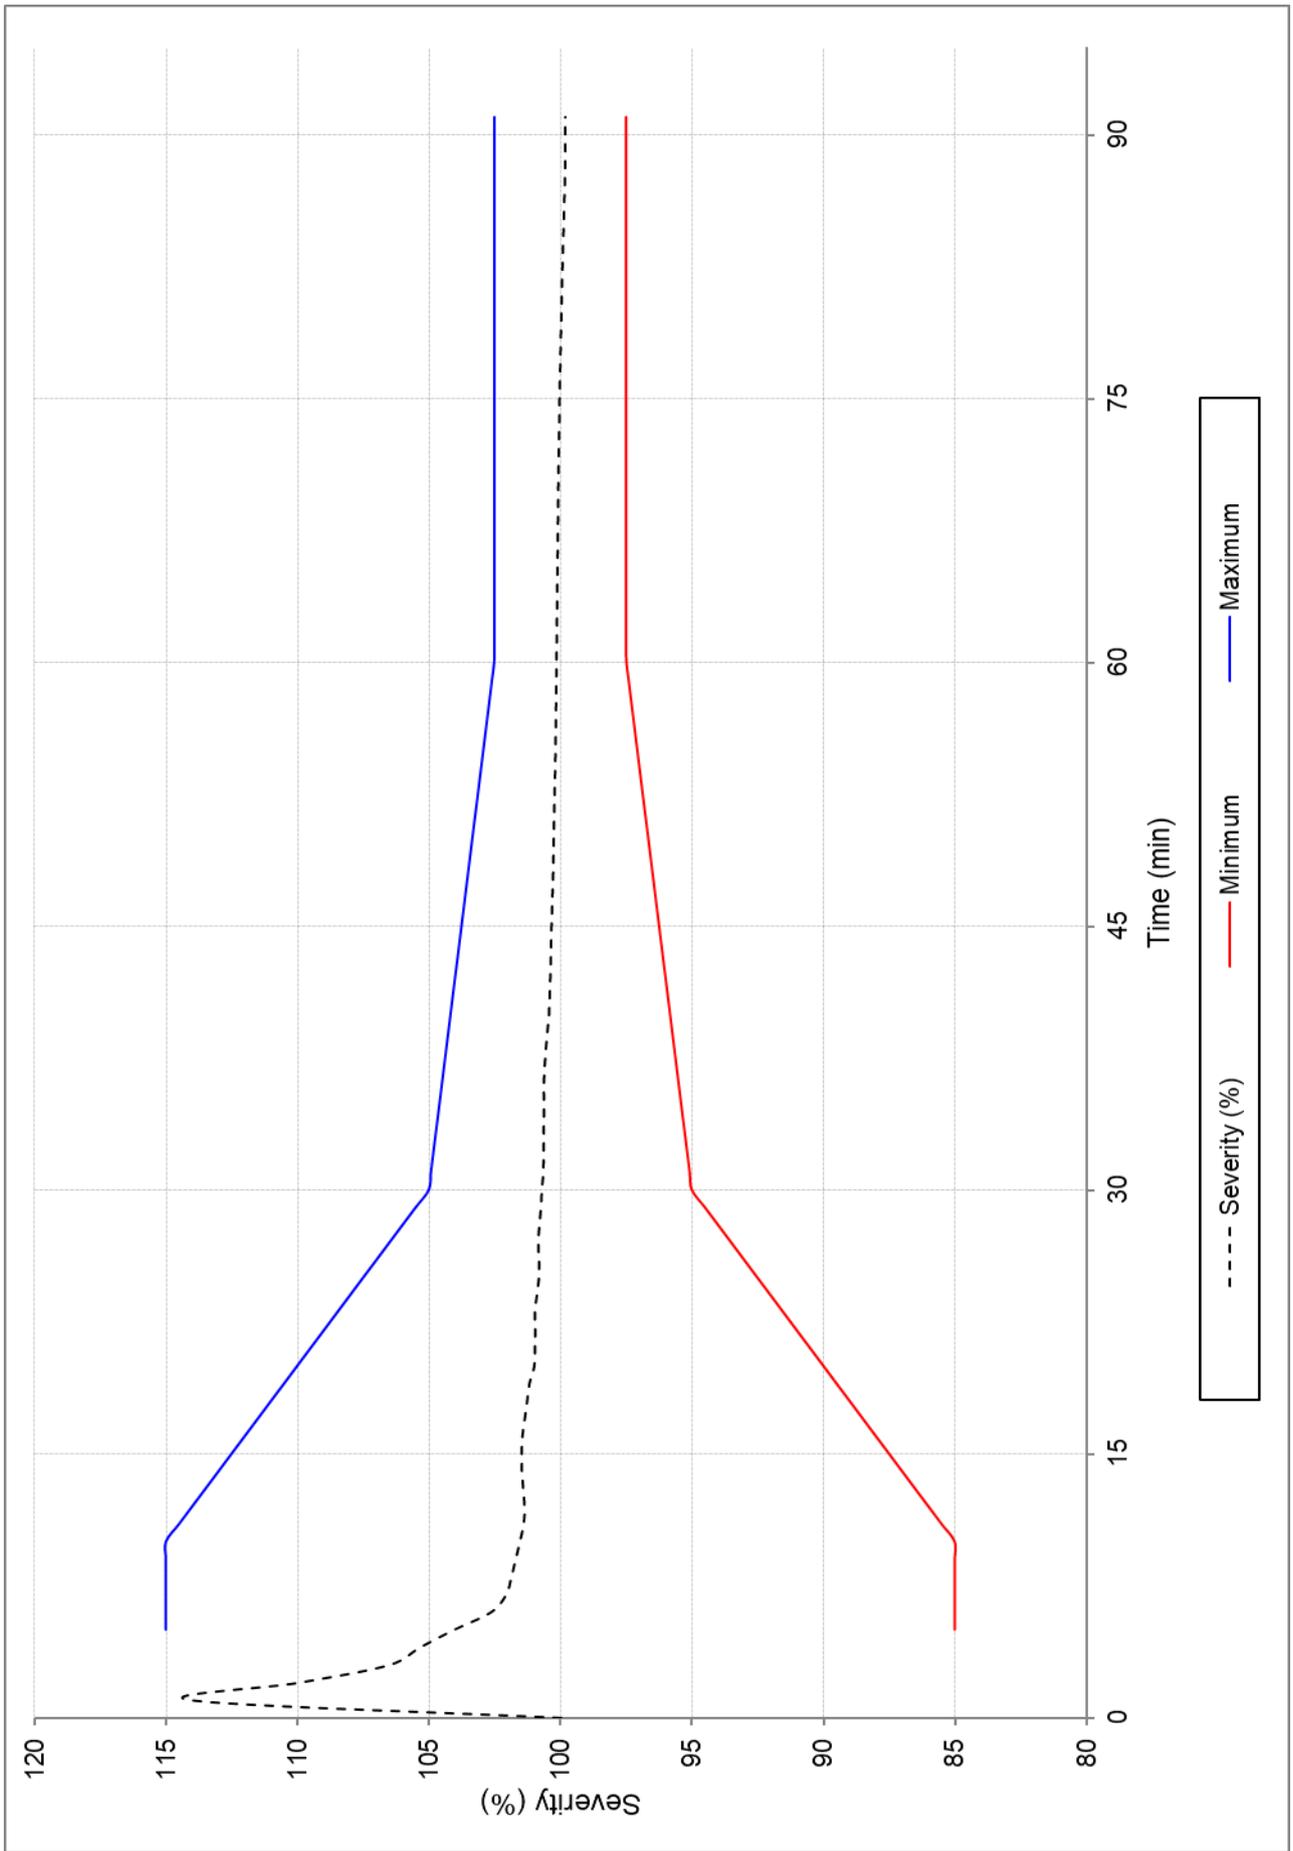
FIGURE 2 – FURNACE SEVERITY

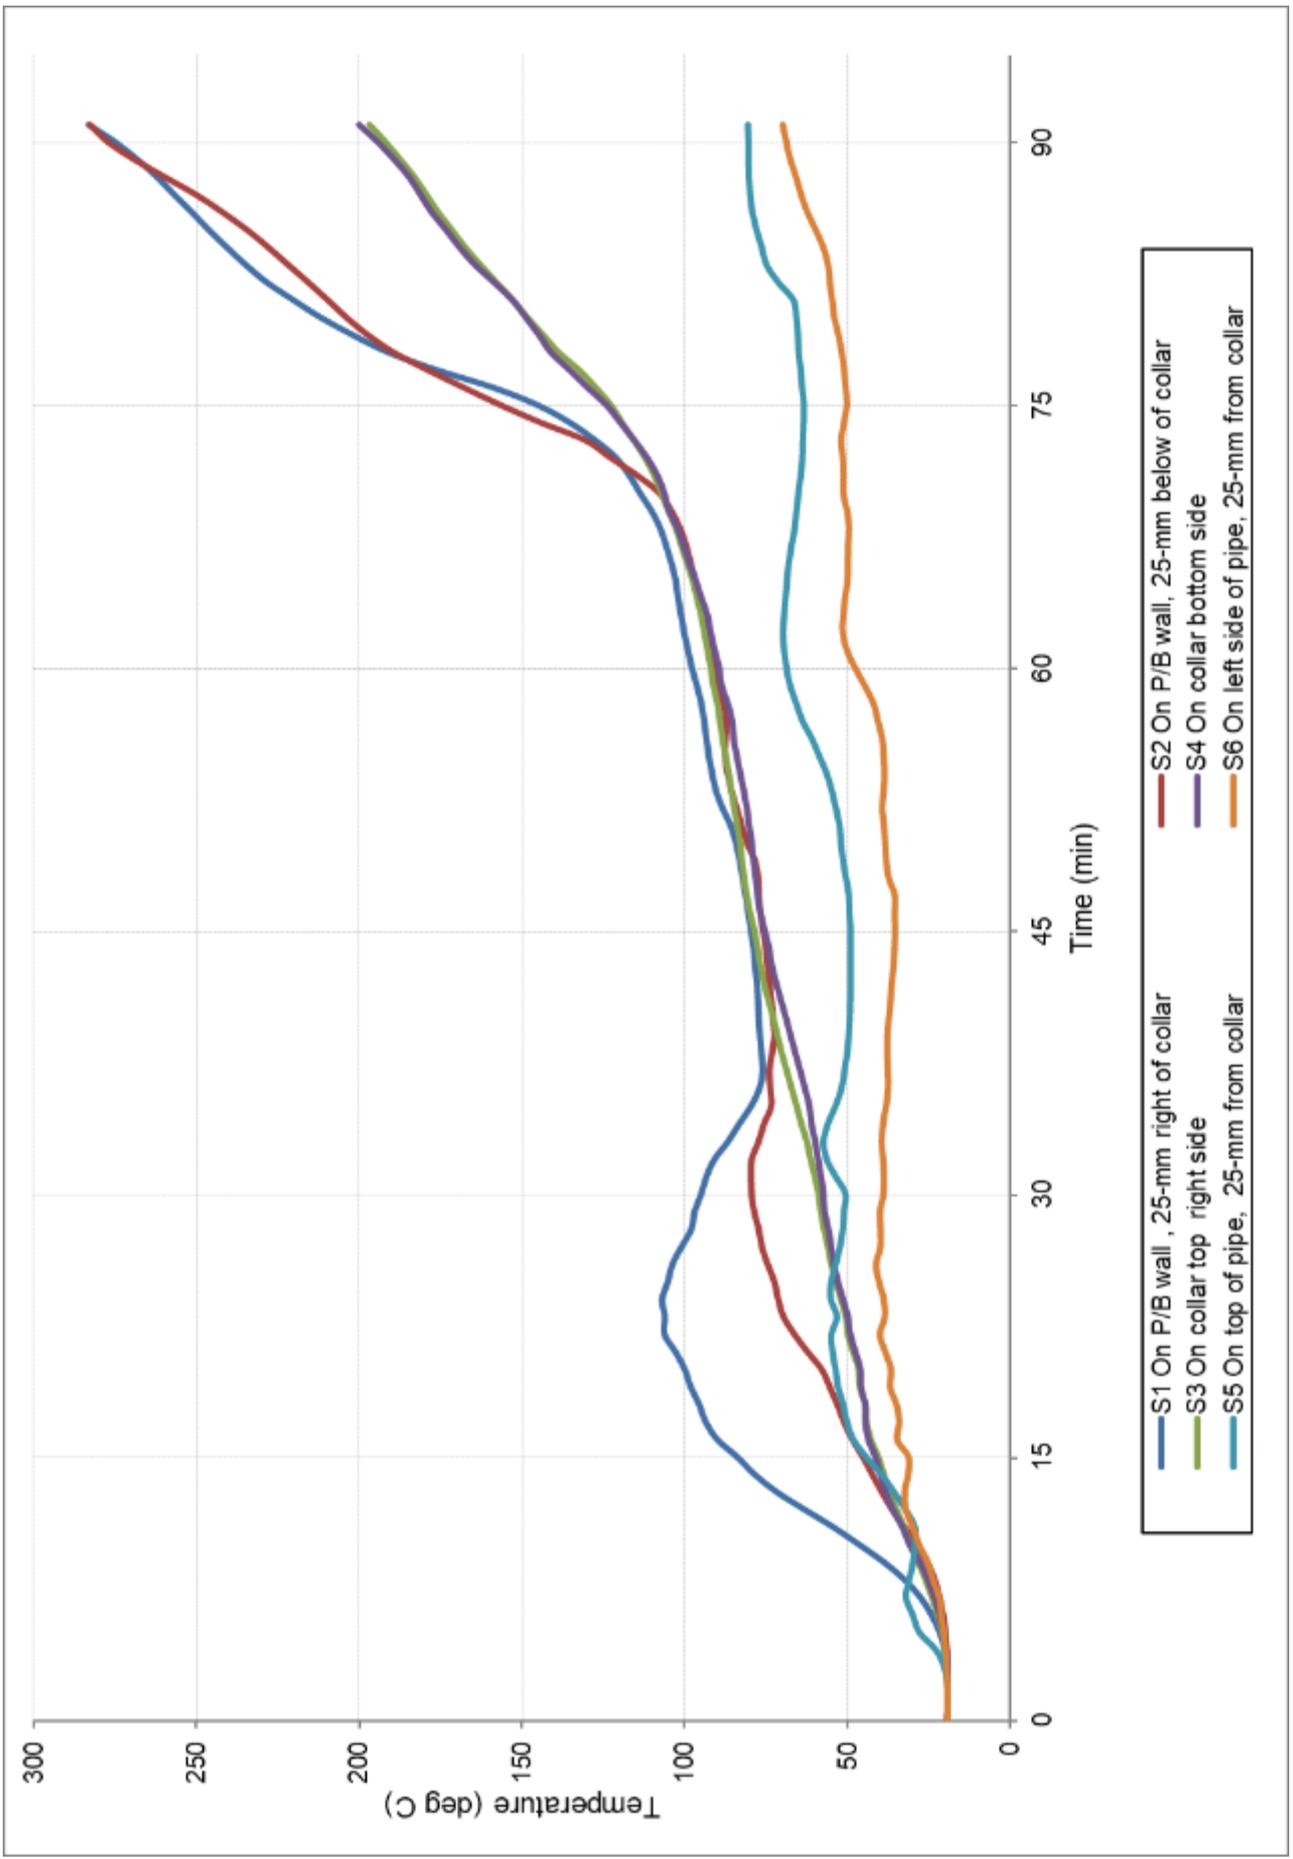
FIGURE 3 - TEMPERATURE VERSUS TIME ASSOCIATED WITH SPECIMEN #1

Specimen 1 - SNAP 32R Retrofit fire collars protecting a nominal 1-inch (33.4-mm OD) CPVC pipe penetrating a 35-mm diameter aperture.

The SNAP 32R Retrofit collar comprised a 0.75-mm steel casing with a 40-mm inner diameter and a 106-mm diameter base flange. The 32-mm high collar casing incorporated a closing mechanism which comprised two soft Intumesh intumescent strips lined within the internal circumference of the collar. The inner and outer strips were 4-mm thick x 26-mm wide x 135-mm long, and 4-mm thick x 26-mm wide x 154-mm long, respectively. Between the strips was a layer of 316 stainless steel mesh 135 mm long x 25-mm wide with wire mesh diameter of 0.15-mm, as shown in drawing titled “SNAP 32 Retro”, dated 5 October 2017, by Snap Fire Systems Pty Ltd. One collar was fixed to each side of the plasterboard wall in a back-to-back configuration using three M4 expandable steel hollow wall anchors with stainless steel washers.

The penetrating service comprised a Blazemaster CPVC 33.44-mm outside diameter pipe, with a wall thickness of 2.88-mm fitted through the collar's sleeve and penetrated the wall through a 35-mm diameter cut-out hole as shown in drawing titled 'Specimen #1, 1in C-PVC Stack & 32R', dated 26 February 2021, provided by Snap Fire Systems Pty Ltd. The pipe projected horizontally, 2000-mm away from the unexposed face of the wall and approximately 500-mm into the furnace chamber. The pipe was supported at nominally 500-mm and 1500-mm from the unexposed face of the plasterboard wall. The pipe was open at the unexposed end and plugged with ceramic fibre (Superwool) on the exposed end.
