Fire-resistance test on retrofit fire collars protecting a plasterboard wall penetrated by services

Test Report

Author: Peter Gordon
Report number: FSP 2188
Date: 27 April 2021
Client: IG6 Pty Ltd as trustee for the IG6 IP Trust

Sponsored Investigation No. FSP 2188

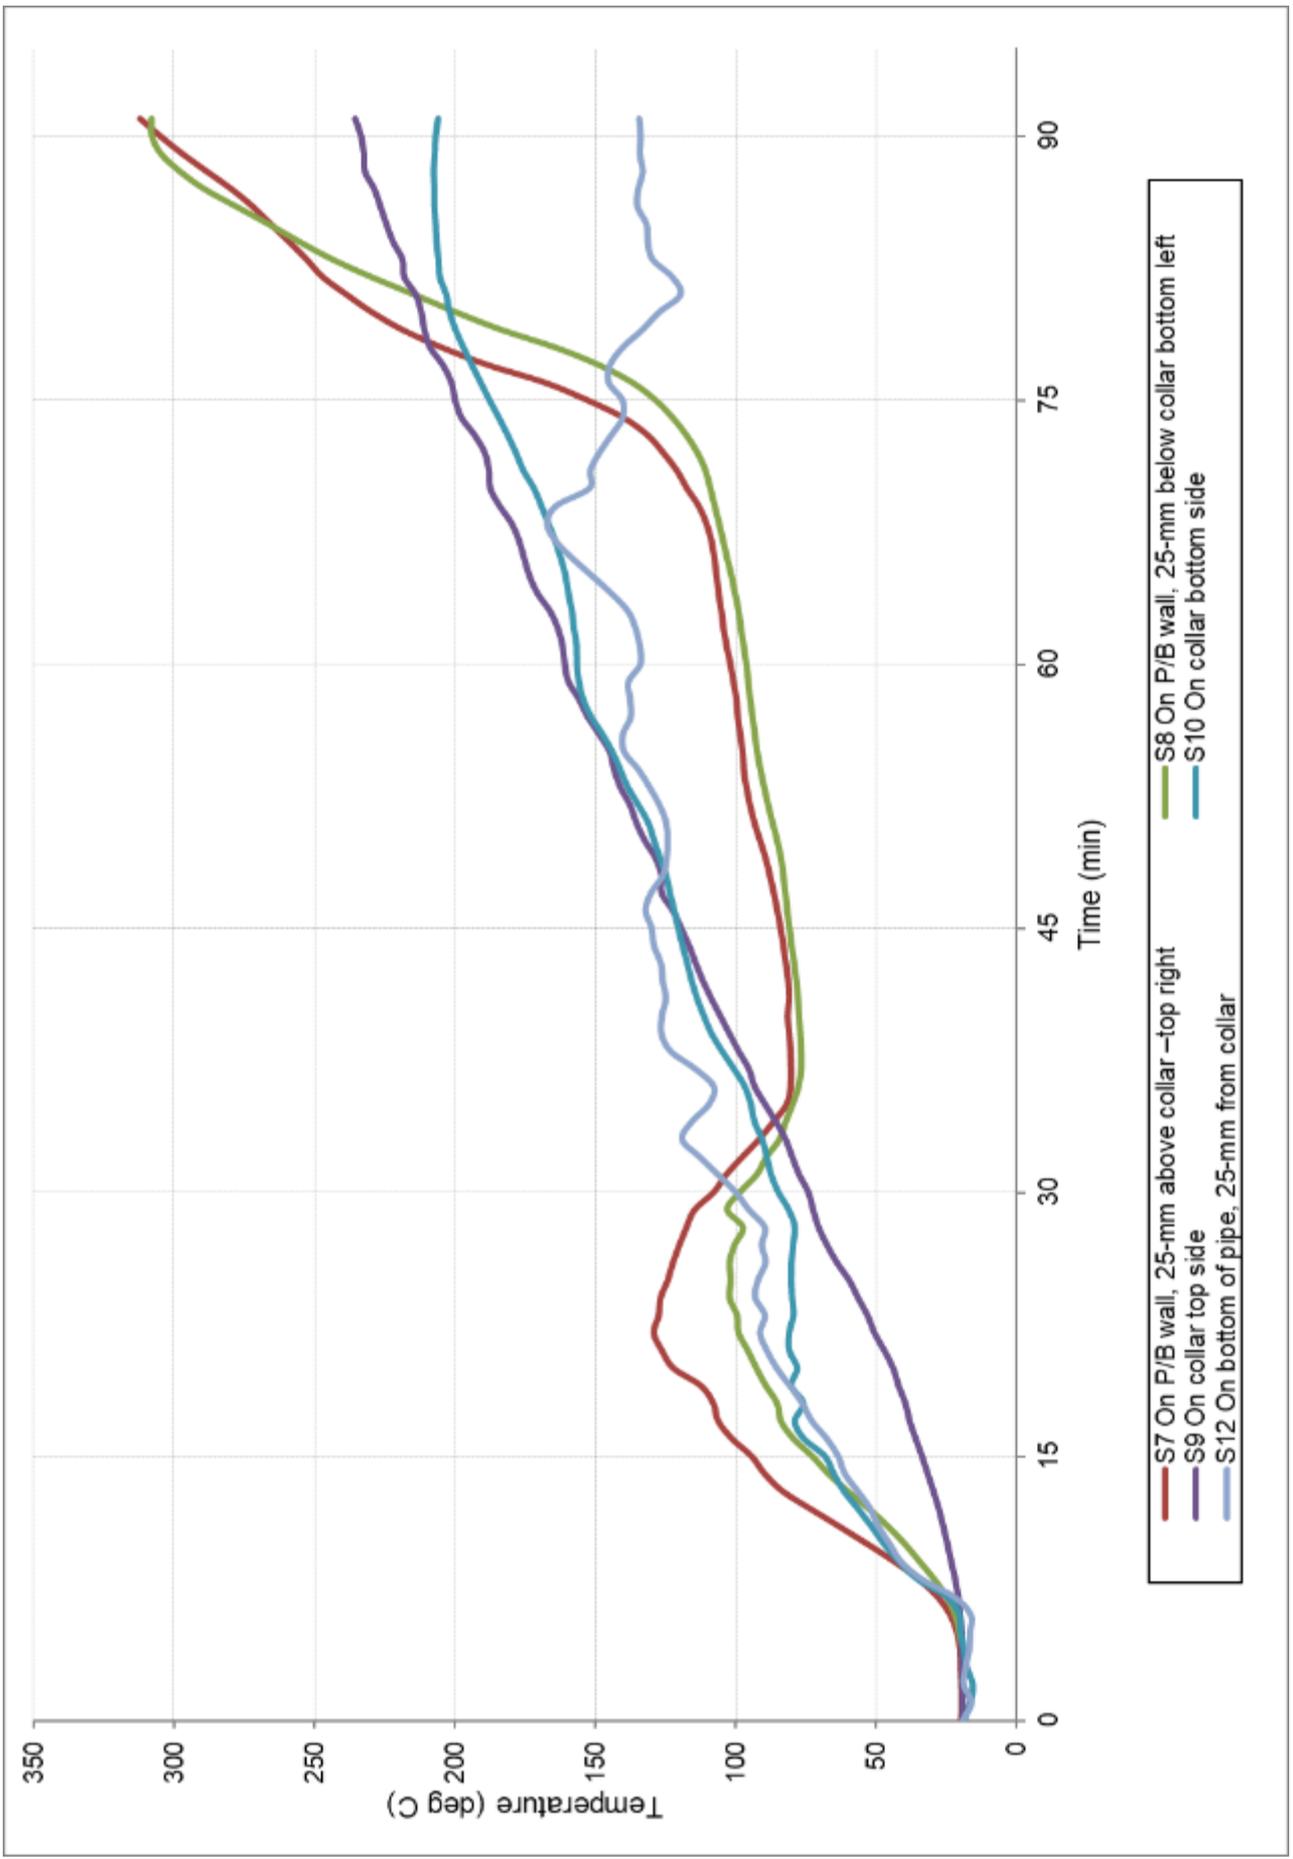
FIGURE 4 - TEMPERATURE VERSUS TIME ASSOCIATED WITH SPECIMEN #2

Specimen 2 - SNAP MS70R Multi Services Retrofit fire collars protecting a 1-inch copper pipe with 25-mm thick foil faced Sekisui lagging penetrating a 75-mm diameter aperture.

The SNAP MS70R Multi Service Retrofit fire collar comprised a 0.75-mm thick steel casing with a 69-mm inner diameter and a 0.95-mm thick steel base flange with a 162-mm diameter. The 95-mm high collar casing incorporated a 4-mm thick x 90-mm wide x 250-mm long soft Intumesh intumescent wrap lined within the internal circumference of the collar casing. The closing mechanism comprised three stainless steel springs, a nylon fuse link and a 258-mm long x 88-mm wide 316 stainless steel mesh located around the intumescent strip, as shown in drawing titled 'SNAP 70 Multi Service Retro', dated 23 September 2019, by Snap Fire Systems Pty Ltd. One collar was fixed to each side of the plasterboard wall in a back-to-back configuration using three M4 expandable steel hollow wall anchors with stainless steel washers.

The penetrating service comprised lagged 25-mm outside diameter copper pipe having a wall thickness of 1.34 mm, lagged with 25-mm thick foil faced Sekisui foam. The lagged pipe was fitted through the collar's sleeve and penetrated the wall through a 75-mm diameter cut-out hole as shown in drawing titled 'Specimen #2 1inch Copper Tube with 25mm Foil Faced Foam Lagging & MS70R Collar', dated 26 February 2021, by Snap Fire Systems Pty Ltd. The lagged pipe projected horizontally, 500-mm away from the unexposed face of the wall and approximately 500-mm into the furnace chamber. The lagged pipe was supported at nominally 500-mm from the unexposed face of the plasterboard wall. The copper pipe was open at the unexposed end and crimped closed on the exposed end.

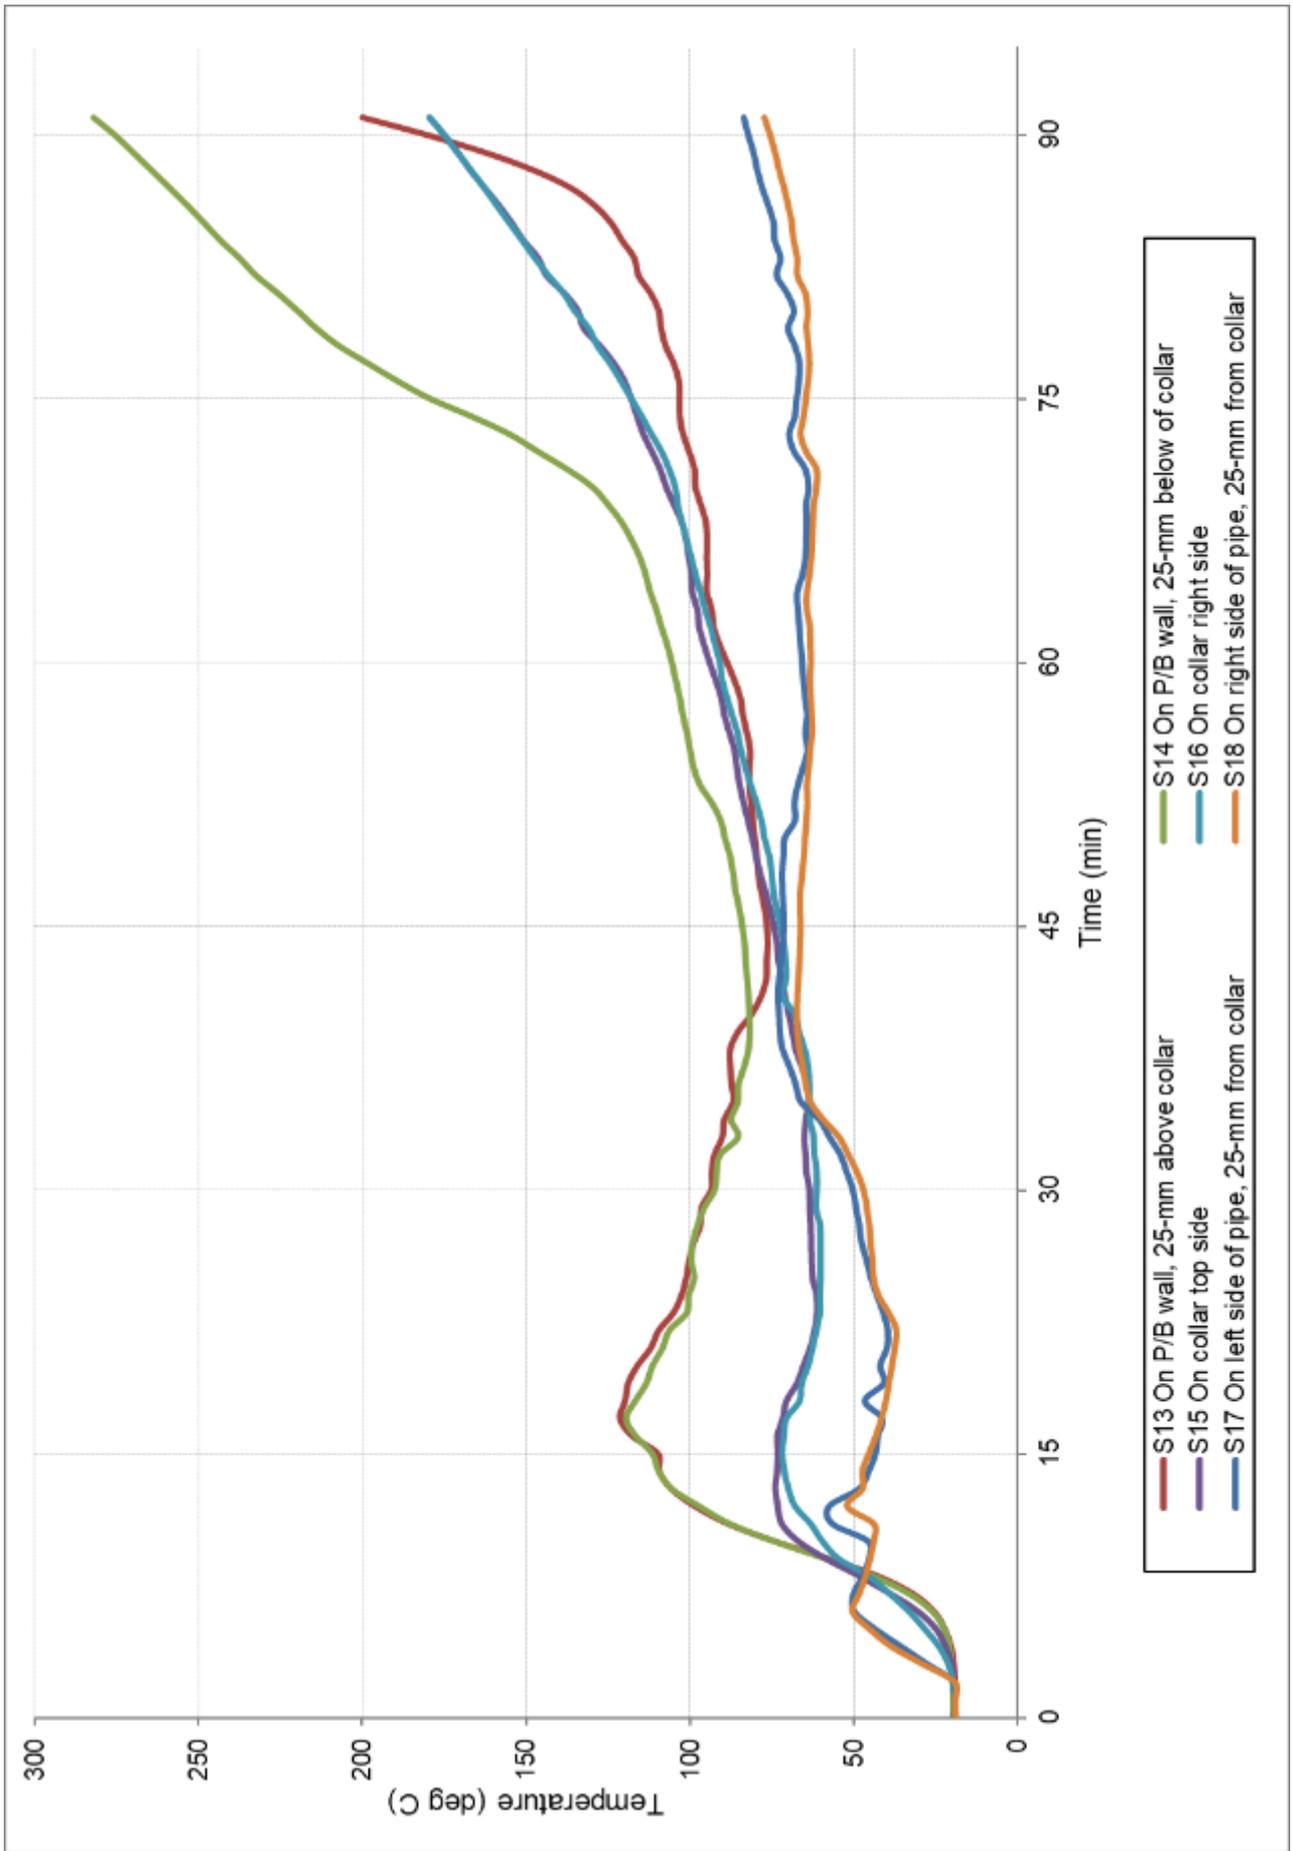
FIGURE 5 - TEMPERATURE VERSUS TIME ASSOCIATED WITH SPECIMEN #3

Specimen 3 - SNAP 32R Retrofit fire collars protecting a nominal 25-mm PE-Xa Rehau Rautitan pipe penetrating a 29-mm diameter aperture.

The SNAP 32R Retrofit collar comprised a 0.75-mm steel casing with a 40 mm inner diameter and a 106-mm diameter base flange. The 32-mm high collar casing incorporated a closing mechanism which comprised two soft Intumesh intumescent strips lined within the internal circumference of the collar. The inner and outer strips were 4-mm thick x 26-mm wide x 135-mm long, and 4-mm thick x 26-mm wide x 154-mm long, respectively. Between the strips was a layer of 316 stainless steel mesh 135 mm long x 25-mm wide with wire mesh diameter of 0.15-mm, as shown in drawing titled "SNAP 32 Retro", dated 5 October 2017, by Snap Fire Systems Pty Ltd. One collar was fixed to each side of the plasterboard wall in a back-to-back configuration using three M4 expandable steel hollow wall anchors with stainless steel washers.

The penetrating service comprised a Rehau Rautitan PE-Xa 25.2-mm outside diameter pipe, with a wall thickness of 3.95-mm fitted through the collar's sleeve and penetrated the wall through a 29-mm diameter cut-out hole as shown in drawing titled 'Specimen #3, 25 Pex-a Stack & 32R', dated 26 February 2021, provided by Snap Fire Systems Pty Ltd. The pipe projected horizontally, 2000-mm away from the unexposed face of the wall and approximately 500-mm into the furnace chamber. The pipe was supported at nominally 500-mm and 1500-mm from the unexposed face of the plasterboard wall. The pipe was open at the unexposed end and plugged with ceramic fibre (Superwool) on the exposed end.

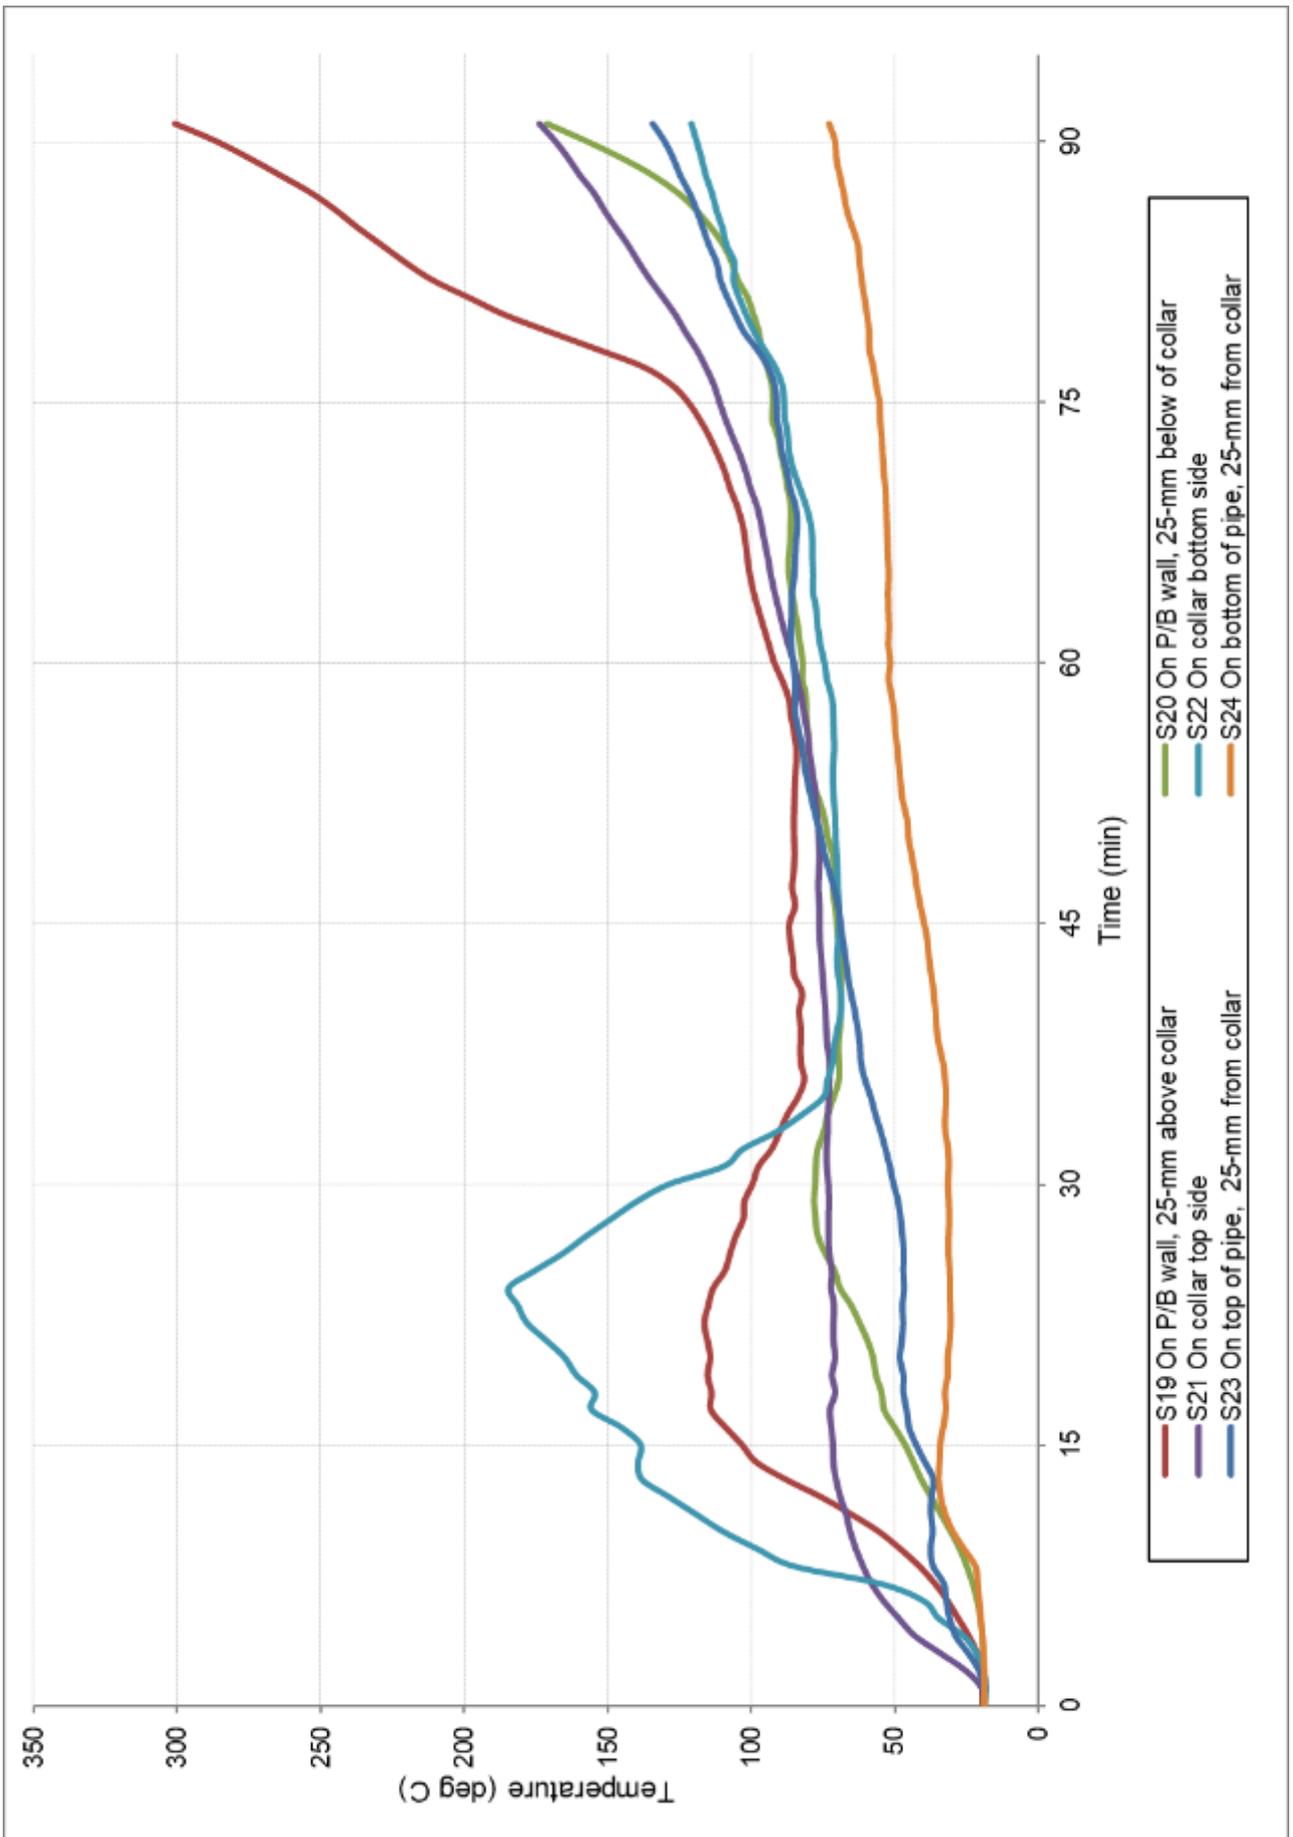
FIGURE 6 - TEMPERATURE VERSUS TIME ASSOCIATED WITH SPECIMEN #4

Specimen 4 - SNAP 50R Retrofit fire collars protecting a nominal 1 1/2-inch (48.2-mm OD) CPVC pipe penetrating a 51-mm diameter aperture.

The SNAP Retrofit 50R fire collar comprised a 0.75-mm steel casing with a 62-mm inner diameter and a 147-mm diameter base flange. The 47-mm high collar casing incorporated a closing mechanism which comprised two soft Intumesh intumescent wraps lined within the internal circumference of the collar. Intumescent A was 4-mm thick x 43-mm wide x 220-mm long, and Intumescent B was 4-mm thick x 43-mm wide x 200-mm long. Between the strips was a layer of 316 grade stainless steel mesh 210-mm long x 42-mm wide with a wire mesh diameter of 0.15-mm, as shown in drawing titled "SNAP 50 Retro", dated 18 January 2019, by Snap Fire Systems Pty Ltd. One collar was fixed to each side of the plasterboard wall in a back-to-back configuration using three M4 expandable steel hollow wall anchors with stainless steel washers.

The penetrating service comprised a Blazemaster CPVC 48.21-mm outside diameter pipe, with a wall thickness of 3.98-mm fitted through the collar's sleeve and penetrated the wall through a 51-mm diameter cut-out hole as shown in drawing titled 'Specimen #4, 1 1/2 in C-PVC Stack & 50R', dated 26 February 2021, provided by Snap Fire Systems Pty Ltd. The pipe projected horizontally, 2000-mm away from the unexposed face of the wall and approximately 500-mm into the furnace chamber. The pipe was supported at nominally 500-mm and 1500-mm from the unexposed face of the plasterboard wall. The pipe was open at the unexposed end and plugged with ceramic fibre (Superwool) on the exposed end.

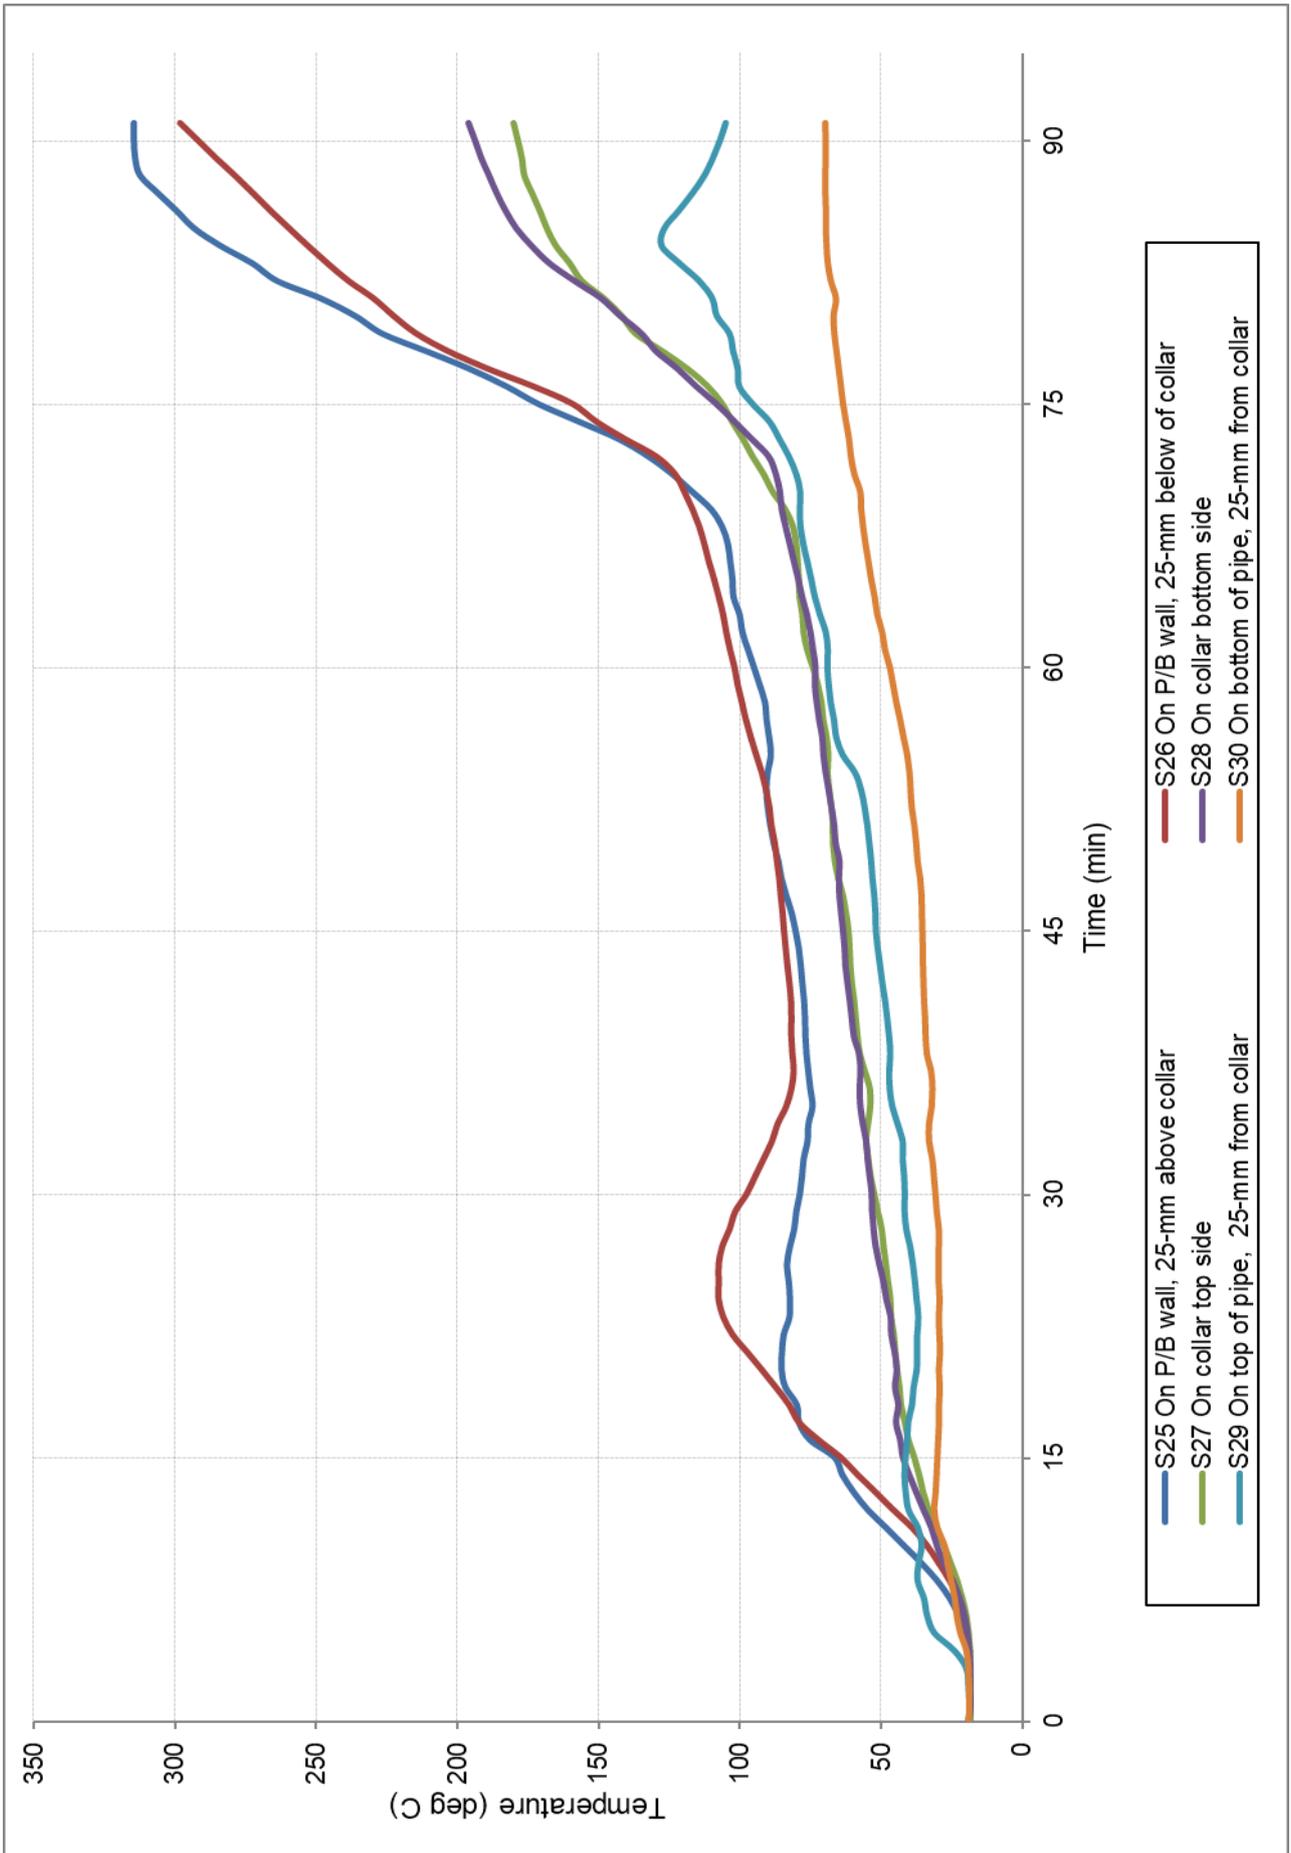
FIGURE 7 - TEMPERATURE VERSUS TIME ASSOCIATED WITH SPECIMEN #5

Specimen 5 - SNAP 50R Retrofit fire collars protecting a nominal 1 1/4 -inch (42.07-mm OD) CPVC pipe penetrating a 44-mm diameter aperture.

The SNAP Retrofit 50R fire collar comprised a 0.75-mm steel casing with a 62-mm inner diameter and a 147-mm diameter base flange. The 47-mm high collar casing incorporated a closing mechanism which comprised two soft Intumesh intumescent wraps lined within the internal circumference of the collar. Intumescent A was 4-mm thick x 43-mm wide x 220-mm long, and Intumescent B was 4-mm thick x 43-mm wide x 200-mm long. Between the strips was a layer of 316 grade stainless steel mesh 210-mm long x 42-mm wide with a wire mesh diameter of 0.15-mm, as shown in drawing titled "SNAP 50 Retro", dated 18 January 2019, by Snap Fire Systems Pty Ltd. One collar was fixed to each side of the plasterboard wall in a back-to-back configuration using three M4 expandable steel hollow wall anchors with stainless steel washers.

The penetrating service comprised a Blazemaster CPVC 42.07-mm outside diameter pipe, with a wall thickness of 3.59-mm fitted through the collar's sleeve and penetrated the wall through a 44-mm diameter cut-out hole as shown in drawing titled 'Specimen #5, 1 1/4 in C-PVC Stack & 50R', dated 26 February 2021, provided by Snap Fire Systems Pty Ltd. The pipe projected horizontally, 2000-mm away from the unexposed face of the wall and approximately 500-mm into the furnace chamber. The pipe was supported at nominally 500-mm and 1500-mm from the unexposed face of the plasterboard wall. The pipe was open at the unexposed end and plugged with ceramic fibre (Superwool) on the exposed end.

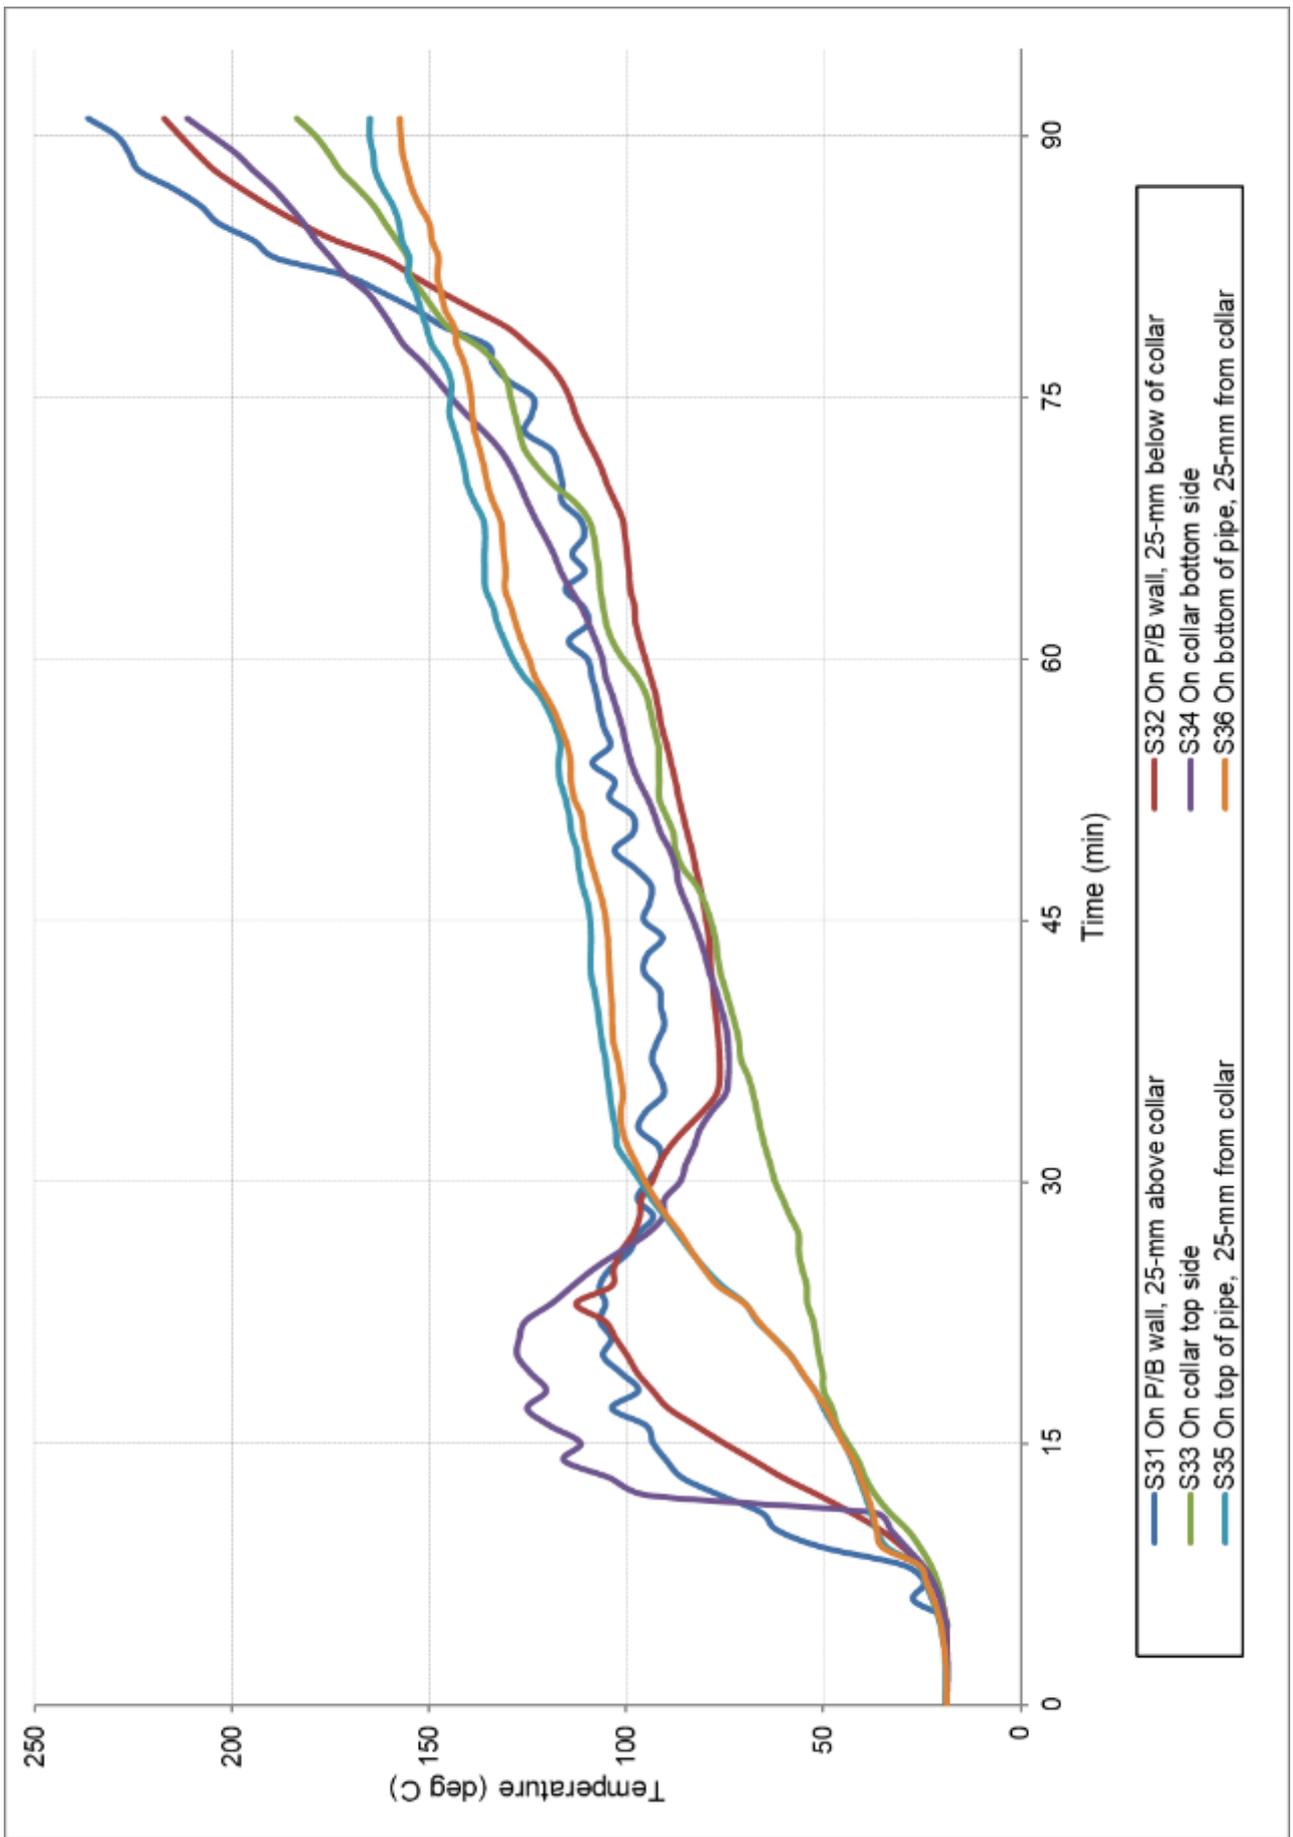
FIGURE 8 - TEMPERATURE VERSUS TIME ASSOCIATED WITH SPECIMEN #6

Specimen 6 - SNAP 32R Retrofit fire collars protecting a nominal 20-mm PE-Xa/Al/PE Rehau Rautitan pipe penetrating a 22-mm diameter aperture.

The SNAP 32R Retrofit collar comprised a 0.75-mm steel casing with a 40-mm inner diameter and a 106-mm diameter base flange. The 32-mm high collar casing incorporated a closing mechanism which comprised two soft Intumesh intumescent strips lined within the internal circumference of the collar. The inner and outer strips were 4-mm thick x 26-mm wide x 135-mm long, and 4-mm thick x 26-mm wide x 154-mm long, respectively. Between the strips was a layer of 316 stainless steel mesh 135 mm long x 25-mm wide with wire mesh diameter of 0.15-mm, as shown in drawing titled "SNAP 32 Retro", dated 5 October 2017, by Snap Fire Systems Pty Ltd. One collar was fixed to each side of the plasterboard wall in a back-to-back configuration using three M4 expandable steel hollow wall anchors with stainless steel washers.

The penetrating service comprised a Rehau Rautitan PE-Xa/Al/PE 19.95-mm outside diameter pipe, with a wall thickness of 3.43-mm fitted through the collar's sleeve and penetrated the wall through a 22-mm diameter cut-out hole as shown in drawing titled 'Specimen #6, 20 Pex-Al-PE Stack & 32R', dated 1 March 2021, provided by Snap Fire Systems Pty Ltd. The pipe projected horizontally, 2000-mm away from the unexposed face of the wall and approximately 500 mm into the furnace chamber. The pipe was supported at nominally 500-mm and 1500-mm from the unexposed face of the plasterboard wall. The pipe was open at the unexposed end and plugged with ceramic fibre (Superwool) on the exposed end.

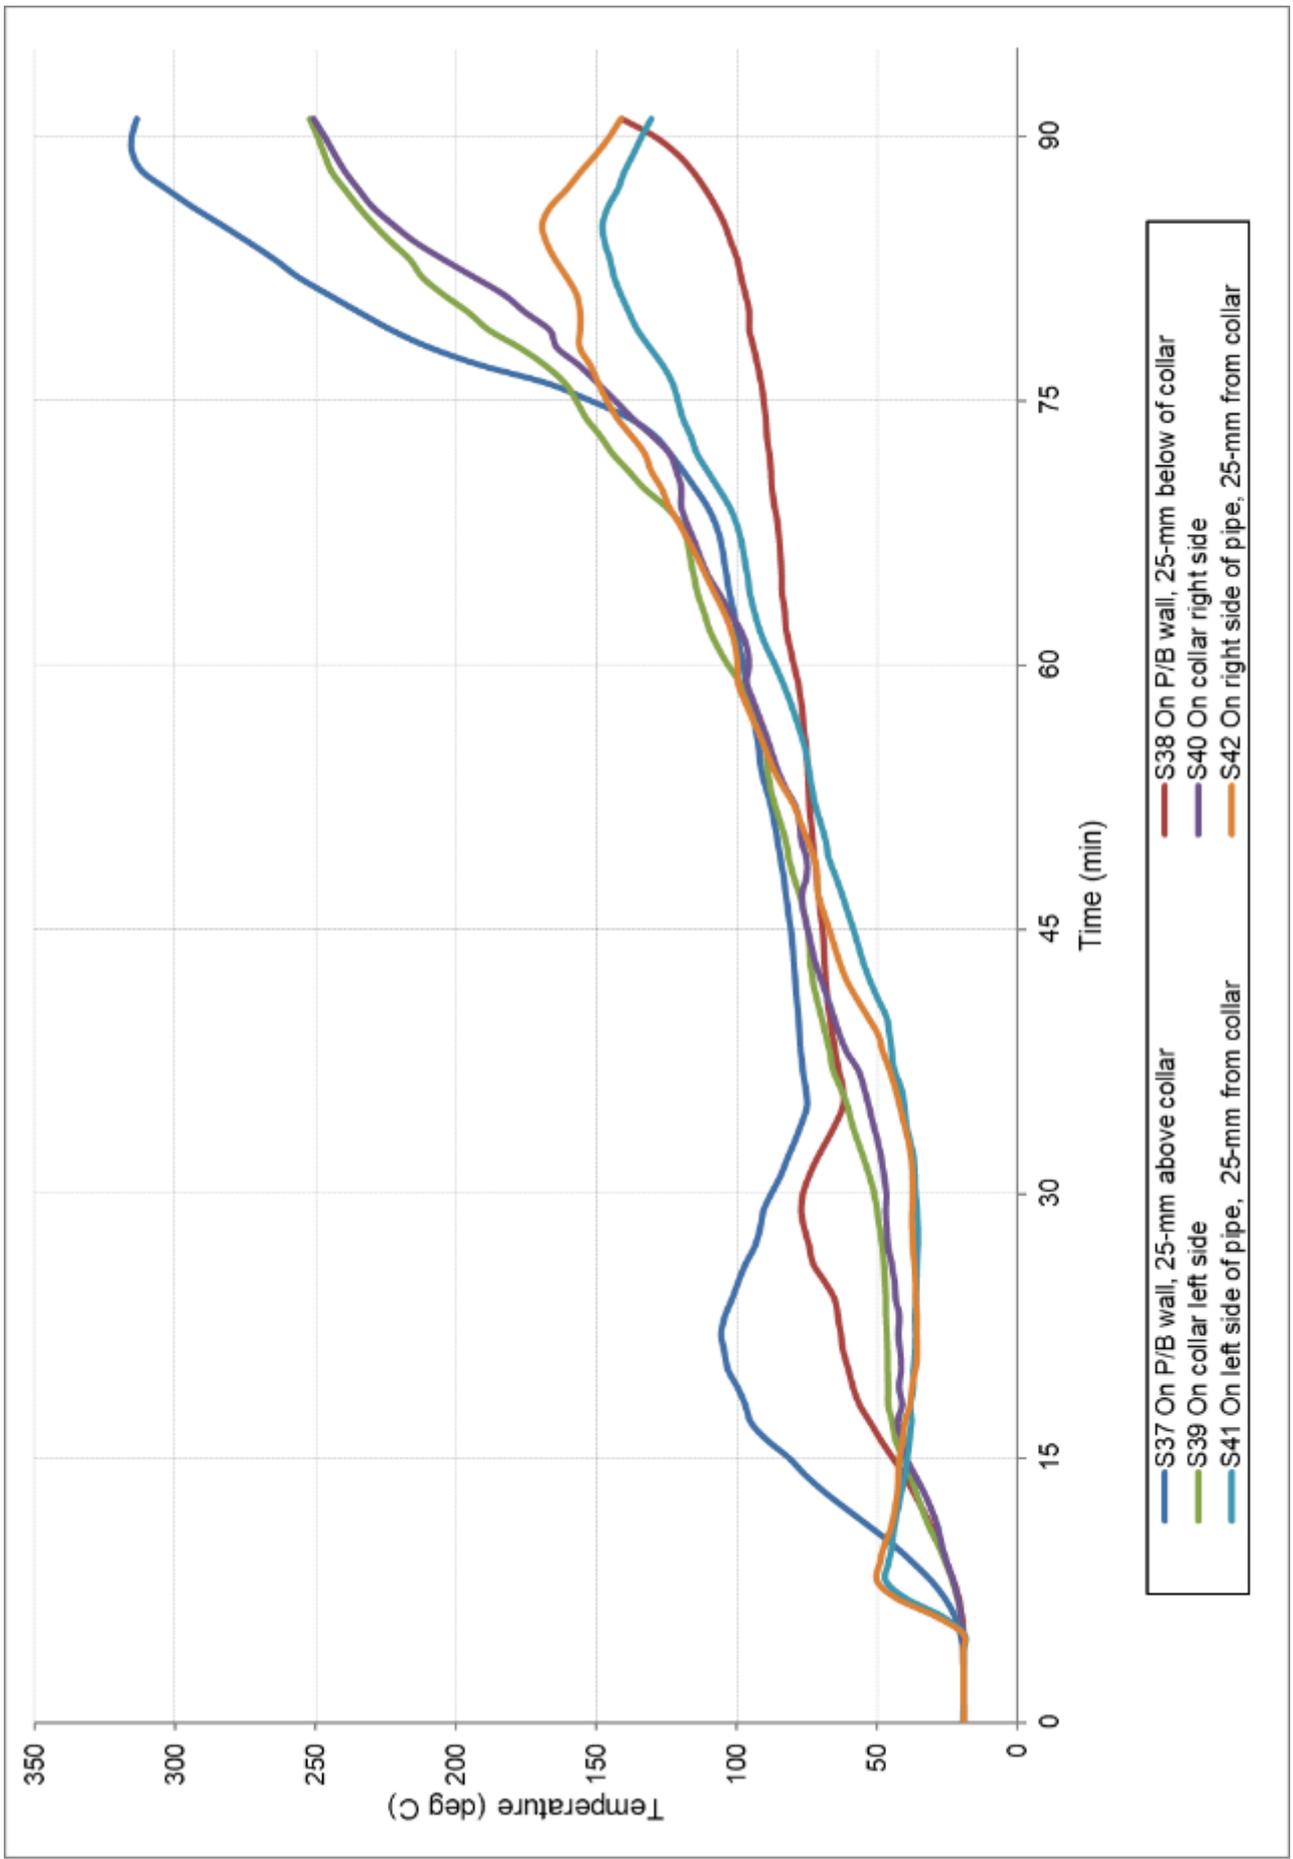
FIGURE 9 - TEMPERATURE VERSUS TIME ASSOCIATED WITH SPECIMEN #7

Specimen 7 - SNAP 32R Retrofit fire collars protecting a nominal 32-mm PE-Xa Rehau Rautitan pipe penetrating a 35-mm diameter aperture.

The SNAP 32R Retrofit collar comprised a 0.75-mm steel casing with a 40-mm inner diameter and a 106-mm diameter base flange. The 32-mm high collar casing incorporated a closing mechanism which comprised two soft Intumesh intumescent strips lined within the internal circumference of the collar. The inner and outer strips were 4-mm thick x 26-mm wide x 135-mm long, and 4-mm thick x 26-mm wide x 154-mm long, respectively. Between the strips was a layer of 316 stainless steel mesh 135 mm long x 25-mm wide with wire mesh diameter of 0.15-mm, as shown in drawing titled "SNAP 32 Retro", dated 5 October 2017, by Snap Fire Systems Pty Ltd. One collar was fixed to each side of the plasterboard wall in a back-to-back configuration using three M4 expandable steel hollow wall anchors with stainless steel washers.

The penetrating service comprised a Rehau Rautitan PE-Xa 32.06-mm outside diameter pipe, with a wall thickness of 4.67-mm fitted through the collar's sleeve and penetrated the wall through a 35-mm diameter cut-out hole as shown in drawing titled 'Specimen #7, 32 Pex-a Stack & 32R', dated 1 March 2021, provided by Snap Fire Systems Pty Ltd. The pipe projected horizontally, 2000-mm away from the unexposed face of the wall and approximately 500-mm into the furnace chamber. The pipe was supported at nominally 500-mm and 1500-mm from the unexposed face of the plasterboard wall. The pipe was open at the unexposed end and plugged with ceramic fibre (Superwool) on the exposed end.

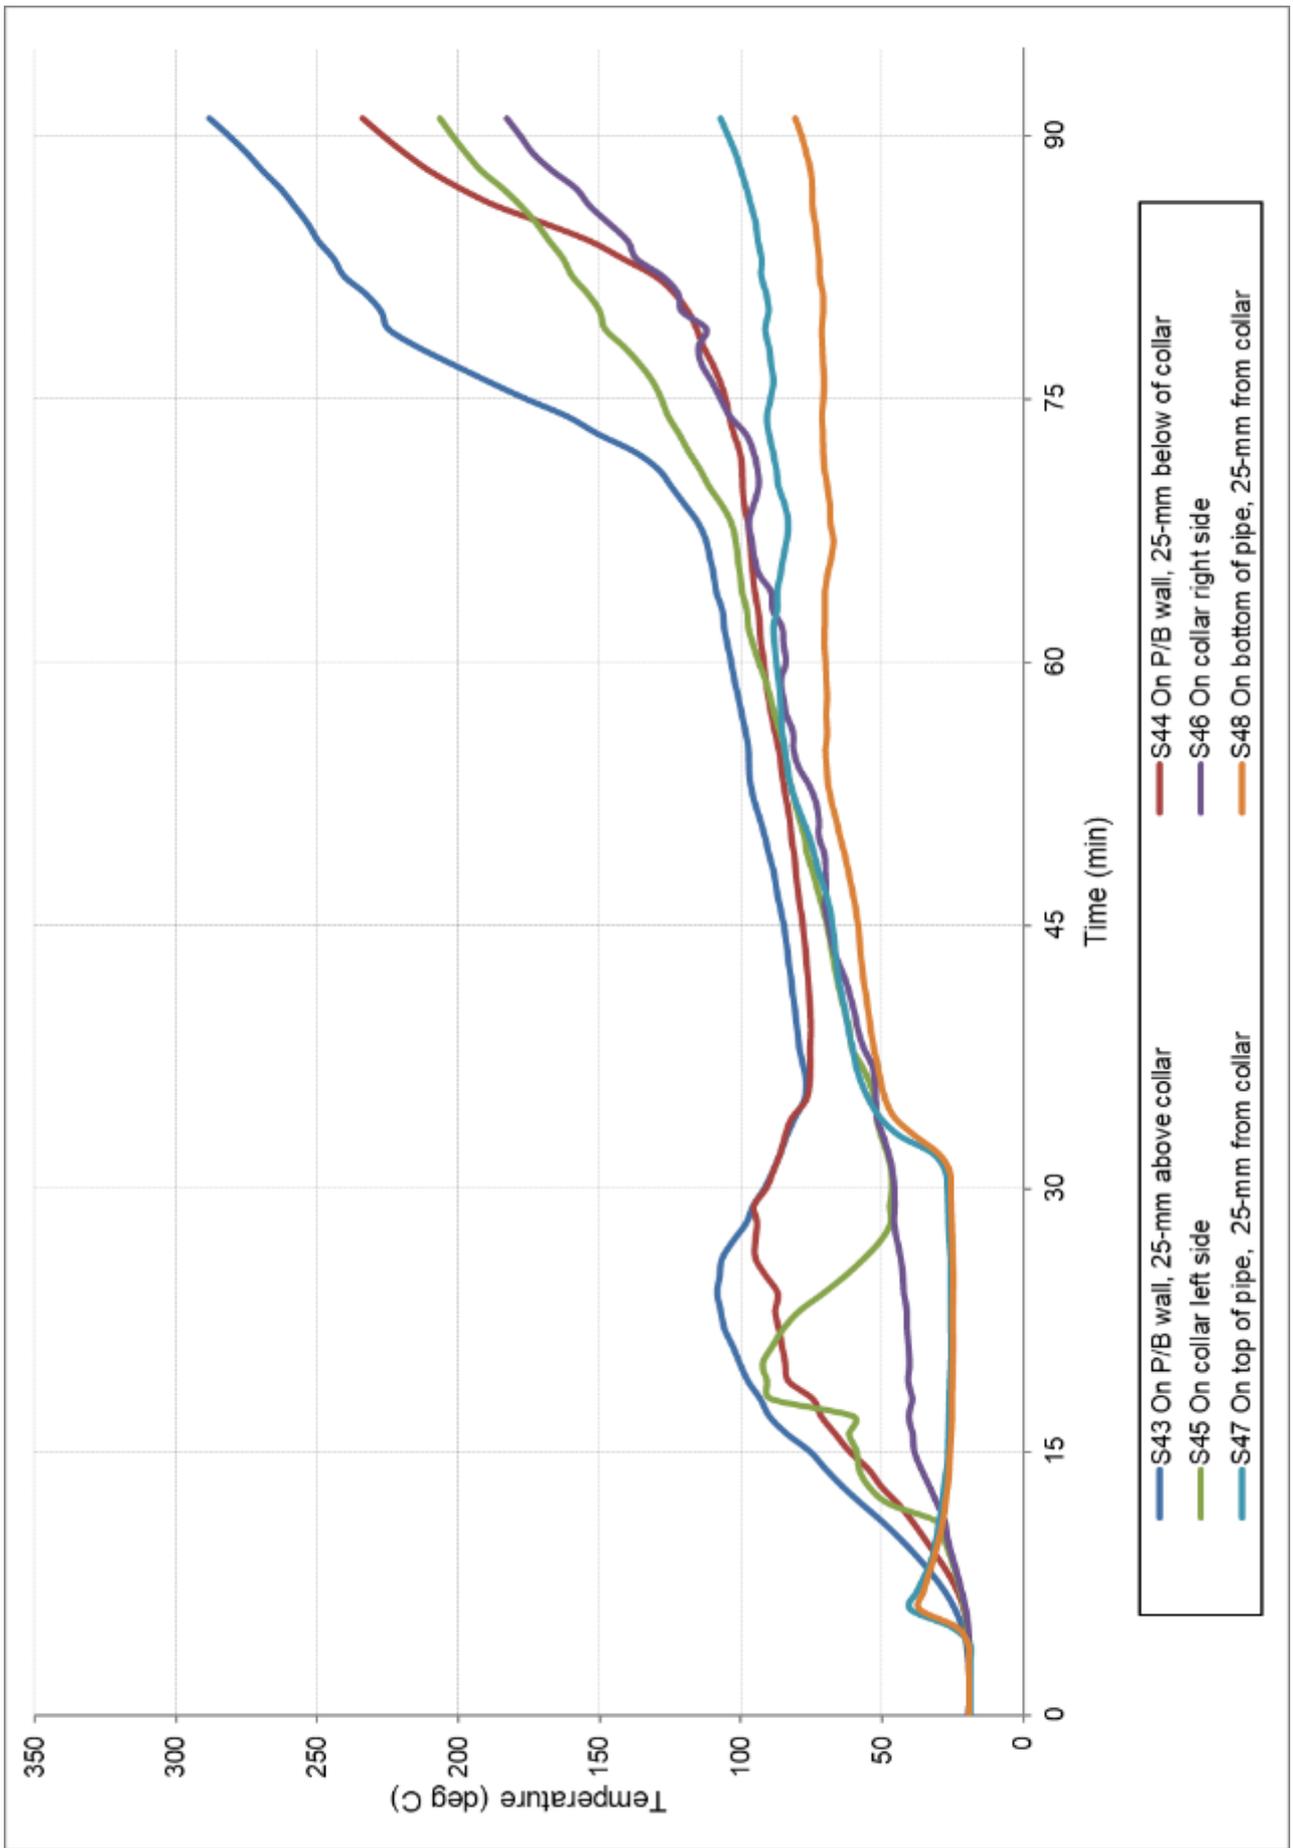
FIGURE 10 - TEMPERATURE VERSUS TIME ASSOCIATED WITH SPECIMEN #8

Specimen 8 - SNAP 32R Retrofit fire collars protecting a nominal 16-mm PE-Xa Rehau Rautitan pipe penetrating a 35-mm diameter aperture.

The SNAP 32R Retrofit collar comprised a 0.75-mm steel casing with a 40-mm inner diameter and a 106-mm diameter base flange. The 32-mm high collar casing incorporated a closing mechanism which comprised two soft Intumesh intumescent strips lined within the internal circumference of the collar. The inner and outer strips were 4-mm thick x 26-mm wide x 135-mm long, and 4-mm thick x 26-mm wide x 154-mm long, respectively. Between the strips was a layer of 316 stainless steel mesh 135 mm long x 25-mm wide with wire mesh diameter of 0.15-mm, as shown in drawing titled "SNAP 32 Retro", dated 5 October 2017, by Snap Fire Systems Pty Ltd. One collar was fixed to each side of the plasterboard wall in a back-to-back configuration using three M4 expandable steel hollow wall anchors with stainless steel washers.

The penetrating service comprised a Rehau Rautitan PE-Xa 16.2-mm outside diameter pipe, with a wall thickness of 2.54-mm fitted through the collar's sleeve and penetrated the wall through a 20-mm diameter cut-out hole as shown in drawing titled 'Specimen #8, 16 Pex-a Stack & 32R', dated 1 March 2021, provided by Snap Fire Systems Pty Ltd. The pipe projected horizontally, 2000-mm away from the unexposed face of the wall and approximately 500-mm into the furnace chamber. The pipe was supported at nominally 500-mm and 1500-mm from the unexposed face of the plasterboard wall. The pipe was open at the unexposed end and plugged with ceramic fibre (Superwool) on the exposed end.

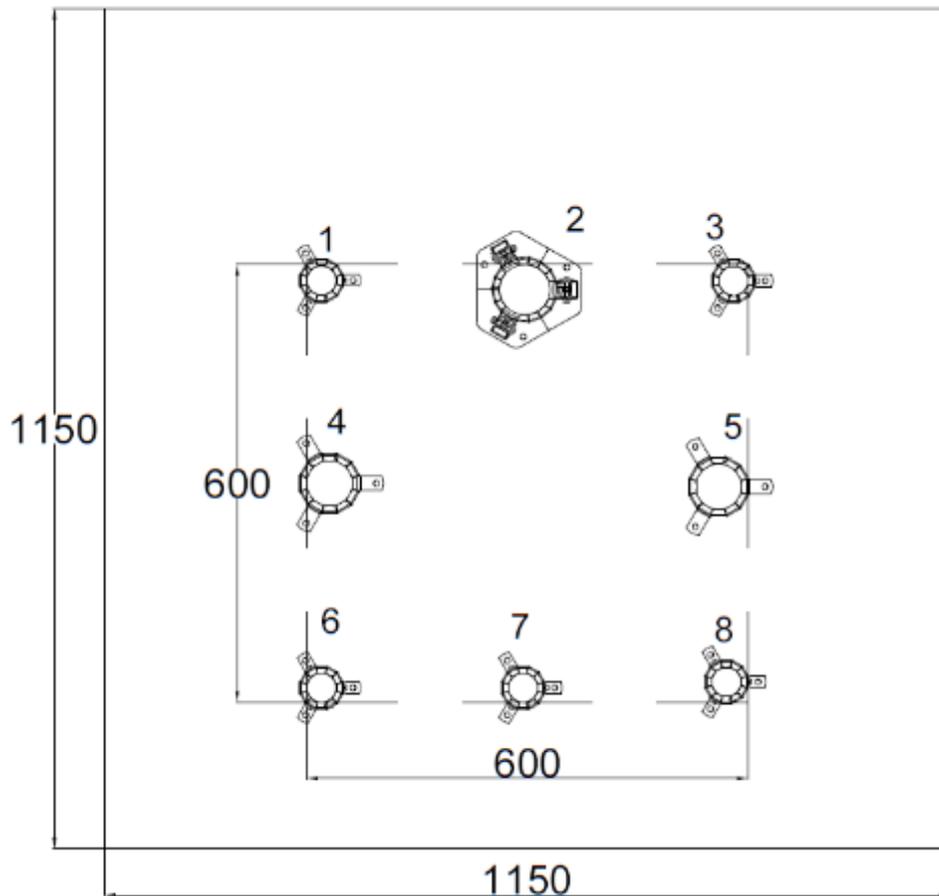
Test Wall W-21-H Layout

Penetration	Collar Code	Pipe Type	Pipe Diameter
1	32R	C-PVC	1 in
2	MS70R	Copper Tube, Foil Faced Lagging	1in (25mm Lagging)
3	32R	PEX-a	25
4	50R	C-PVC	1 ½ in
5	50R	C-PVC	1 ¼ in
6	32R	PEX-Al-PE	20
7	32R	PEX-a	32
8	32R	PEX-a	16

DRAWING TITLED 'TEST WALL W-21-H LAYOUT, DATED 1 MARCH 2021, BY SNAP FIRE SYSTEMS PTY LTD.

Drawing titled 'Test Wall W-21-H Layout', dated 1 March 2021, by Snap Fire Systems Pty Ltd.

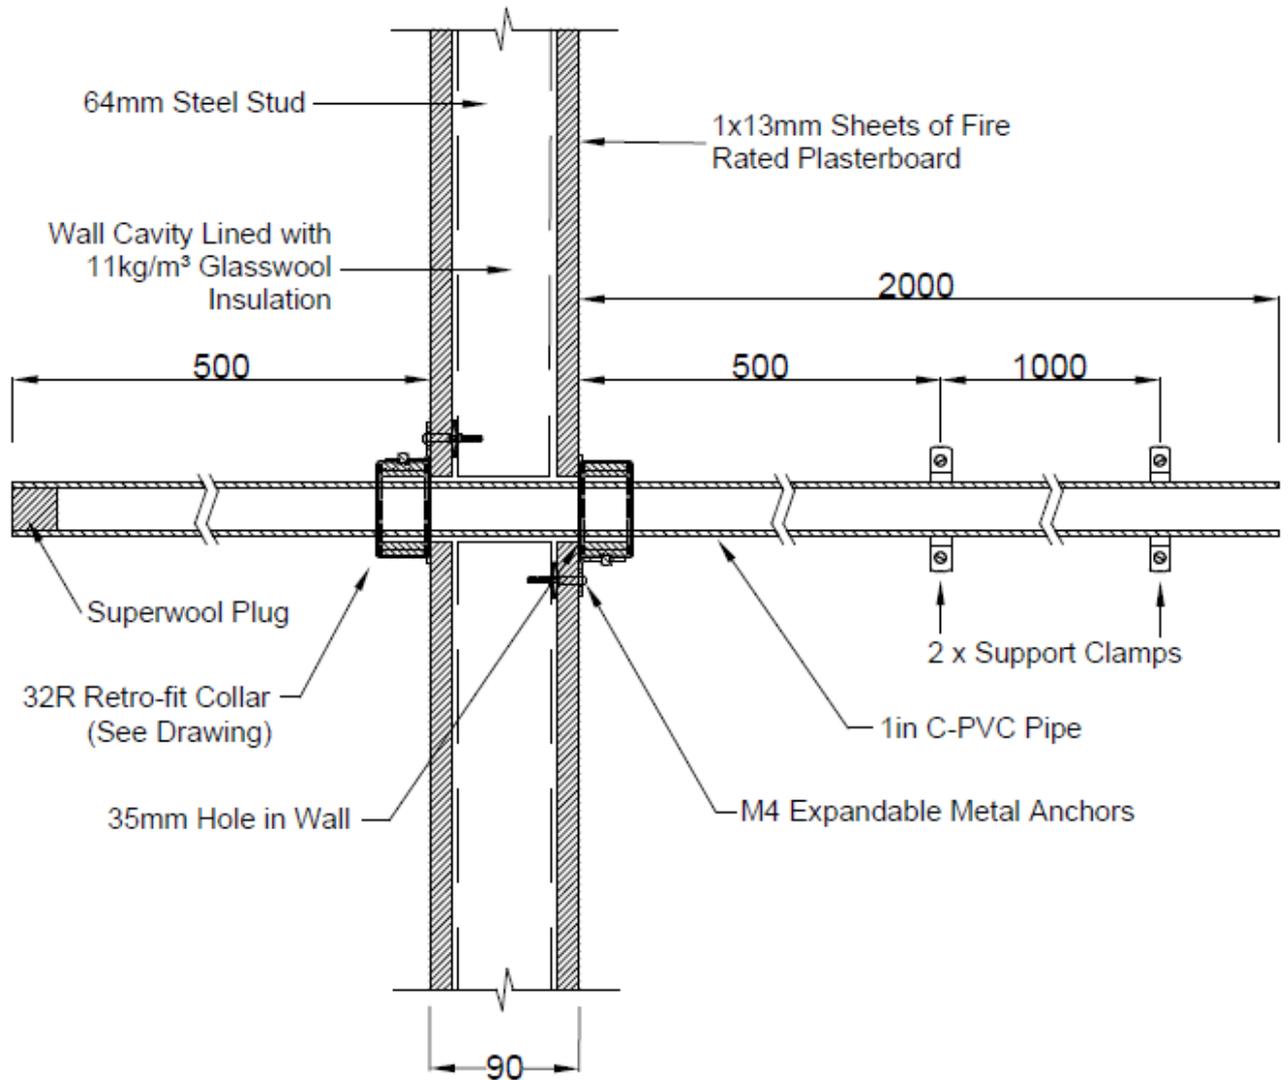
1in C-PVC Stack & 32R

DRAWING TITLED 'SPECIMEN # 1 1IN C-PVC STACK & 32R', DATED 26 FEBRUARY 2021, BY SNAP FIRE SYSTEMS PTY LTD

Specimen 1 - SNAP 32R Retrofit fire collars protecting a nominal 1-inch (33.4-mm OD) CPVC pipe penetrating a 35-mm diameter aperture.

The SNAP 32R Retrofit collar comprised a 0.75-mm steel casing with a 40-mm inner diameter and a 106-mm diameter base flange. The 32-mm high collar casing incorporated a closing mechanism which comprised two soft Intumesh intumescent strips lined within the internal circumference of the collar. The inner and outer strips were 4-mm thick x 26-mm wide x 135-mm long, and 4-mm thick x 26-mm wide x 154-mm long, respectively. Between the strips was a layer of 316 stainless steel mesh 135 mm long x 25-mm wide with wire mesh diameter of 0.15-mm, as shown in drawing titled “SNAP 32 Retro”, dated 5 October 2017, by Snap Fire Systems Pty Ltd. One collar was fixed to each side of the plasterboard wall in a back-to-back configuration using three M4 expandable steel hollow wall anchors with stainless steel washers.

The penetrating service comprised a Blazemaster CPVC 33.44-mm outside diameter pipe, with a wall thickness of 2.88-mm fitted through the collar's sleeve and penetrated the wall through a 35-mm diameter cut-out hole as shown in drawing titled 'Specimen #1, 1in C-PVC Stack & 32R', dated 26 February 2021, provided by Snap Fire Systems Pty Ltd. The pipe projected horizontally, 2000-mm away from the unexposed face of the wall and approximately 500-mm into the furnace chamber. The pipe was supported at nominally 500-mm and 1500-mm from the unexposed face of the plasterboard wall. The pipe was open at the unexposed end and plugged with ceramic fibre (Superwool) on the exposed end.
