Fire-resistance test on retrofit fire collars protecting a plasterboard wall penetrated by services

Test Report

Author: Peter Gordon
Report number: FSP 2188
Date: 27 April 2021
Client: IG6 Pty Ltd as trustee for the IG6 IP Trust

Sponsored Investigation No. FSP 2188

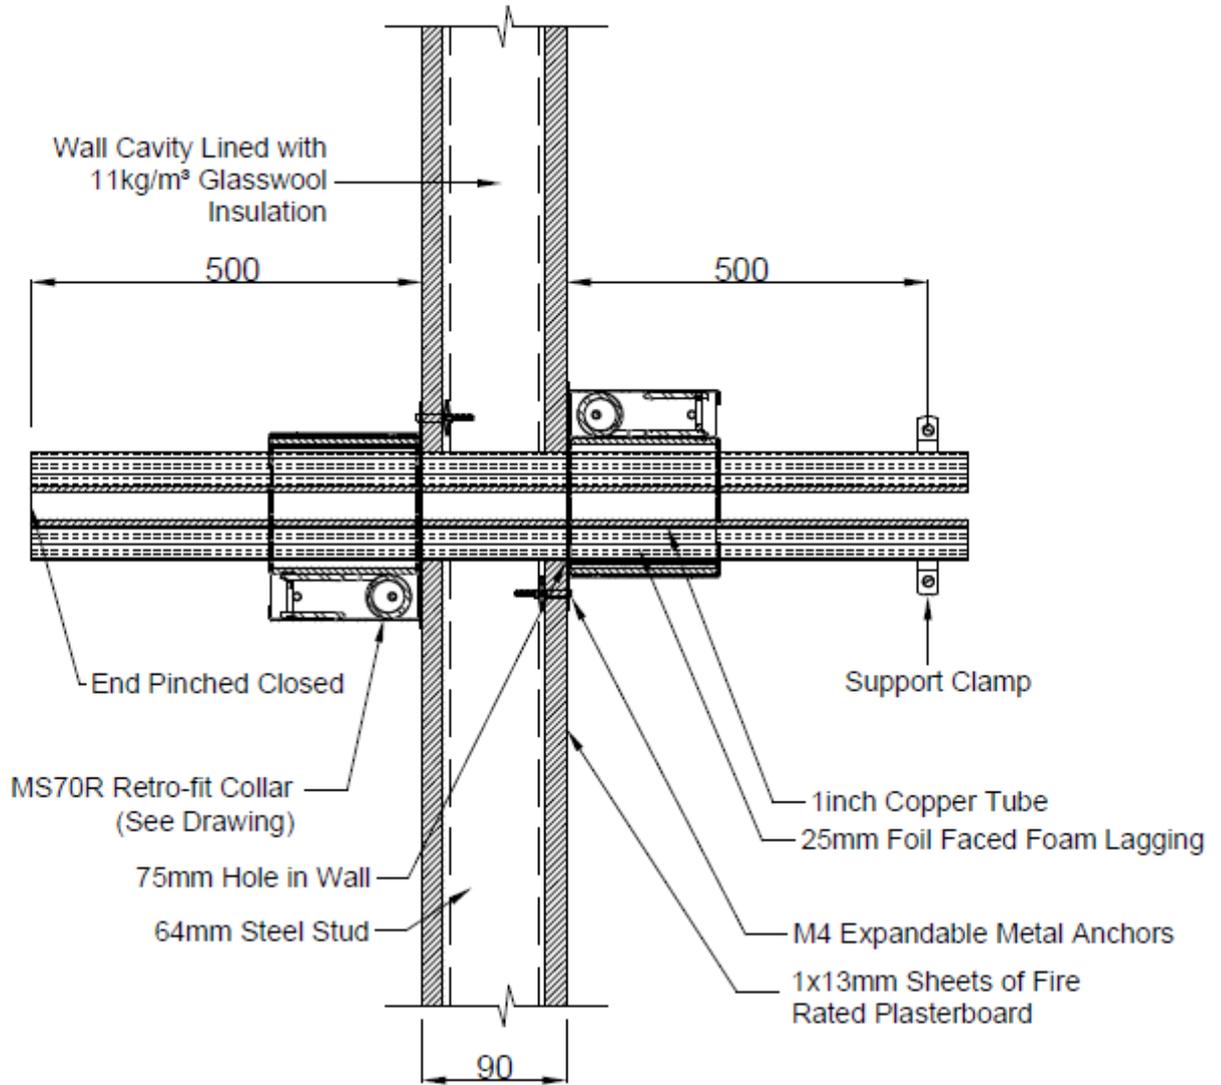
1inch Copper Tube with 25mm Foil Faced Foam Lagging & MS70R Collar

DRAWING TITLED 'SPECIMEN #2 1IN COPPER TUBE WITH 25MM FOILFACED FOAM LAGGING & MS70R COLLAR', DATED 26 FEBRUARY 2021, BY SNAP FIRE SYSTEMS PTY LTD

Specimen 2 - SNAP MS70R Multi Services Retrofit fire collars protecting a 1-inch copper pipe with 25-mm thick foil faced Sekisui lagging penetrating a 75-mm diameter aperture.

The SNAP MS70R Multi Service Retrofit fire collar comprised a 0.75-mm thick steel casing with a 69-mm inner diameter and a 0.95-mm thick steel base flange with a 162-mm diameter. The 95-mm high collar casing incorporated a 4-mm thick x 90-mm wide x 250-mm long soft Intumesh intumescent wrap lined within the internal circumference of the collar casing. The closing mechanism comprised three stainless steel springs, a nylon fuse link and a 258-mm long x 88-mm wide 316 stainless steel mesh located around the intumescent strip, as shown in drawing titled 'SNAP 70 Multi Service Retro', dated 23 September 2019, by Snap Fire Systems Pty Ltd. One collar was fixed to each side of the plasterboard wall in a back-to-back configuration using three M4 expandable steel hollow wall anchors with stainless steel washers.

The penetrating service comprised lagged 25-mm outside diameter copper pipe having a wall thickness of 1.34 mm, lagged with 25-mm thick foil faced Sekisui foam. The lagged pipe was fitted through the collar's sleeve and penetrated the wall through a 75-mm diameter cut-out hole as shown in drawing titled 'Specimen #2 1inch Copper Tube with 25mm Foil Faced Foam Lagging & MS70R Collar', dated 26 February 2021, by Snap Fire Systems Pty Ltd. The lagged pipe projected horizontally, 500-mm away from the unexposed face of the wall and approximately 500-mm into the furnace chamber. The lagged pipe was supported at nominally 500-mm from the unexposed face of the plasterboard wall. The copper pipe was open at the unexposed end and crimped closed on the exposed end.

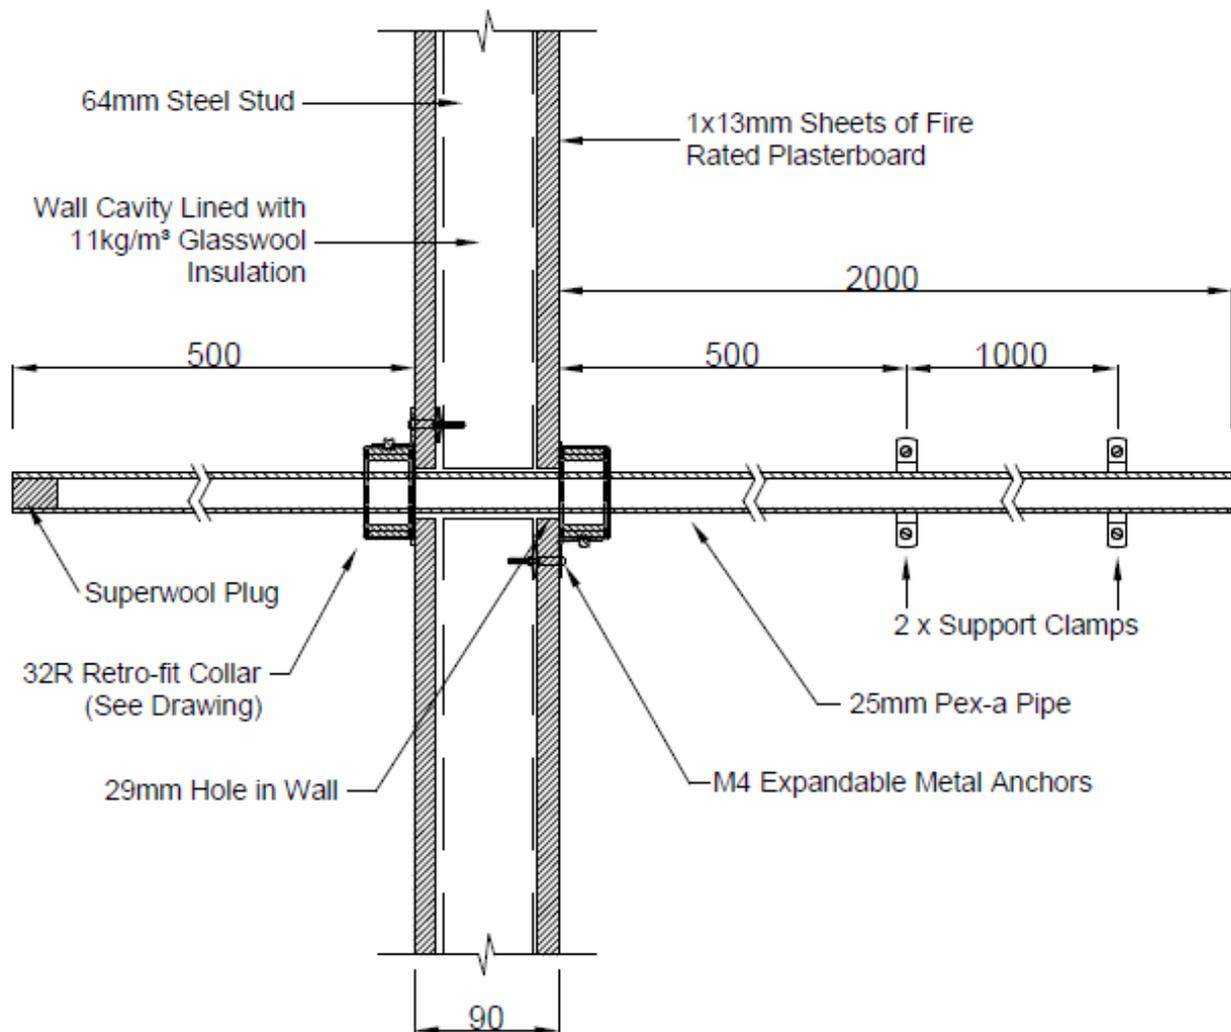
25 Pex-a Stack & 32R

DRAWING TITLED 'SPECIMEN #3 25 PEX-A STACK & 32R', DATED 26 FEBRUARY 2021, BY SNAP FIRE SNAP FIRE SYSTEMS PTY LTD

Specimen 3 - SNAP 32R Retrofit fire collars protecting a nominal 25-mm PE-Xa Rehau Rautitan pipe penetrating a 29-mm diameter aperture.

The SNAP 32R Retrofit collar comprised a 0.75-mm steel casing with a 40 mm inner diameter and a 106-mm diameter base flange. The 32-mm high collar casing incorporated a closing mechanism which comprised two soft Intumesh intumescent strips lined within the internal circumference of the collar. The inner and outer strips were 4-mm thick x 26-mm wide x 135-mm long, and 4-mm thick x 26-mm wide x 154-mm long, respectively. Between the strips was a layer of 316 stainless steel mesh 135 mm long x 25-mm wide with wire mesh diameter of 0.15-mm, as shown in drawing titled "SNAP 32 Retro", dated 5 October 2017, by Snap Fire Systems Pty Ltd. One collar was fixed to each side of the plasterboard wall in a back-to-back configuration using three M4 expandable steel hollow wall anchors with stainless steel washers.

The penetrating service comprised a Rehau Rautitan PE-Xa 25.2-mm outside diameter pipe, with a wall thickness of 3.95-mm fitted through the collar's sleeve and penetrated the wall through a 29-mm diameter cut-out hole as shown in drawing titled 'Specimen #3, 25 Pex-a Stack & 32R', dated 26 February 2021, provided by Snap Fire Systems Pty Ltd. The pipe projected horizontally, 2000-mm away from the unexposed face of the wall and approximately 500-mm into the furnace chamber. The pipe was supported at nominally 500-mm and 1500-mm from the unexposed face of the plasterboard wall. The pipe was open at the unexposed end and plugged with ceramic fibre (Superwool) on the exposed end.

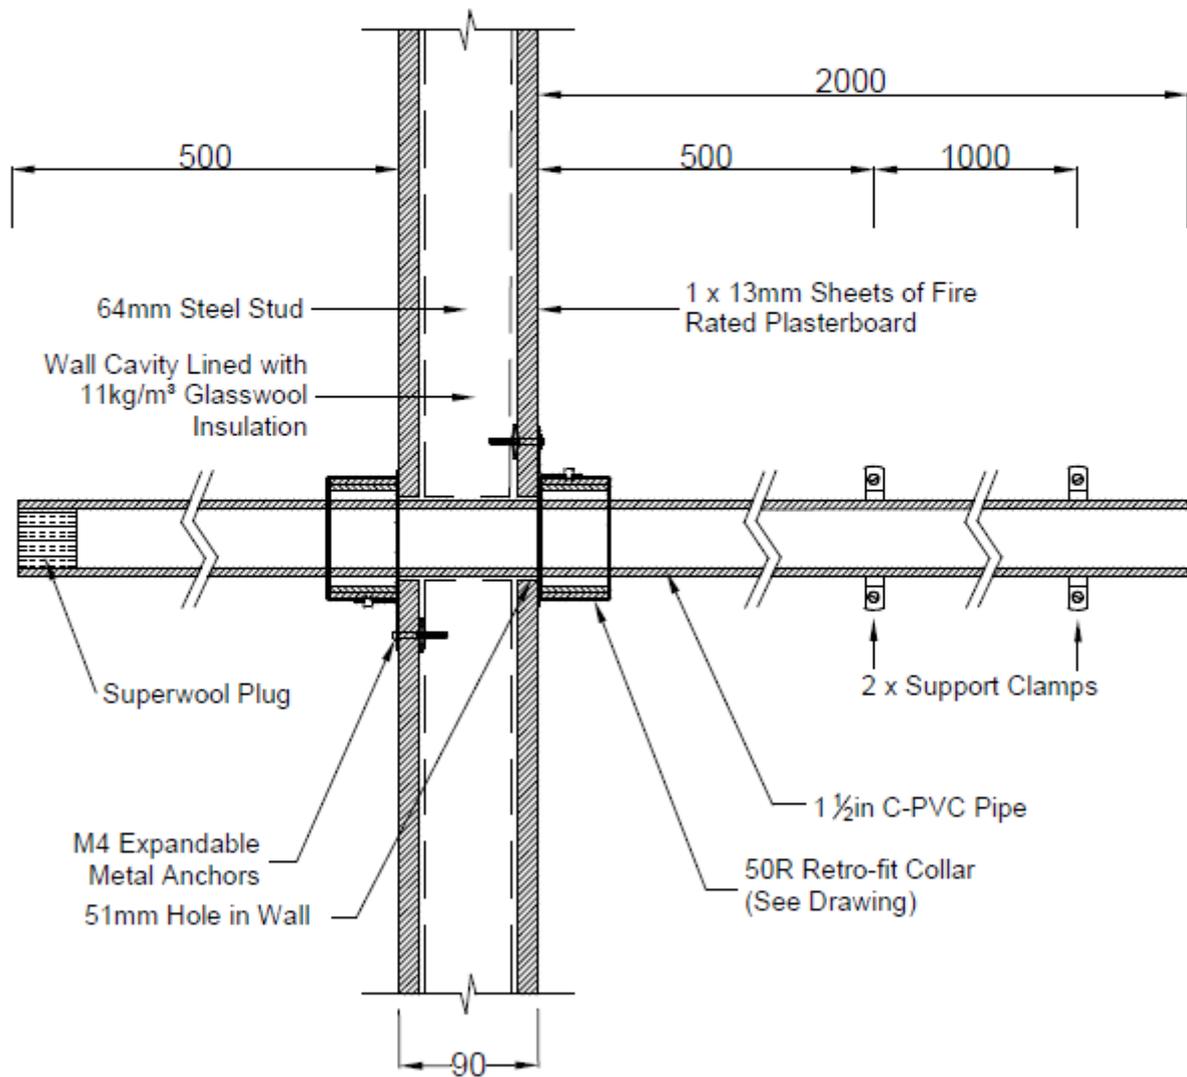
1 1/2in C-PVC Stack & 50R

DRAWING TITLED 'SPECIMEN #4 1 1/2 IN C-PVC STACK & 50R', DATED 26 FEBRUARY 2021, BY SNAP FIRE SYSTEMS PTY LTD

Specimen 4 - SNAP 50R Retrofit fire collars protecting a nominal 1 1/2-inch (48.2-mm OD) CPVC pipe penetrating a 51-mm diameter aperture.

The SNAP Retrofit 50R fire collar comprised a 0.75-mm steel casing with a 62-mm inner diameter and a 147-mm diameter base flange. The 47-mm high collar casing incorporated a closing mechanism which comprised two soft Intumesh intumescent wraps lined within the internal circumference of the collar. Intumescent A was 4-mm thick x 43-mm wide x 220-mm long, and Intumescent B was 4-mm thick x 43-mm wide x 200-mm long. Between the strips was a layer of 316 grade stainless steel mesh 210-mm long x 42-mm wide with a wire mesh diameter of 0.15-mm, as shown in drawing titled "SNAP 50 Retro", dated 18 January 2019, by Snap Fire Systems Pty Ltd. One collar was fixed to each side of the plasterboard wall in a back-to-back configuration using three M4 expandable steel hollow wall anchors with stainless steel washers.

The penetrating service comprised a Blazemaster CPVC 48.21-mm outside diameter pipe, with a wall thickness of 3.98-mm fitted through the collar's sleeve and penetrated the wall through a 51-mm diameter cut-out hole as shown in drawing titled 'Specimen #4, 1 1/2 in C-PVC Stack & 50R', dated 26 February 2021, provided by Snap Fire Systems Pty Ltd. The pipe projected horizontally, 2000-mm away from the unexposed face of the wall and approximately 500-mm into the furnace chamber. The pipe was supported at nominally 500-mm and 1500-mm from the unexposed face of the plasterboard wall. The pipe was open at the unexposed end and plugged with ceramic fibre (Superwool) on the exposed end.

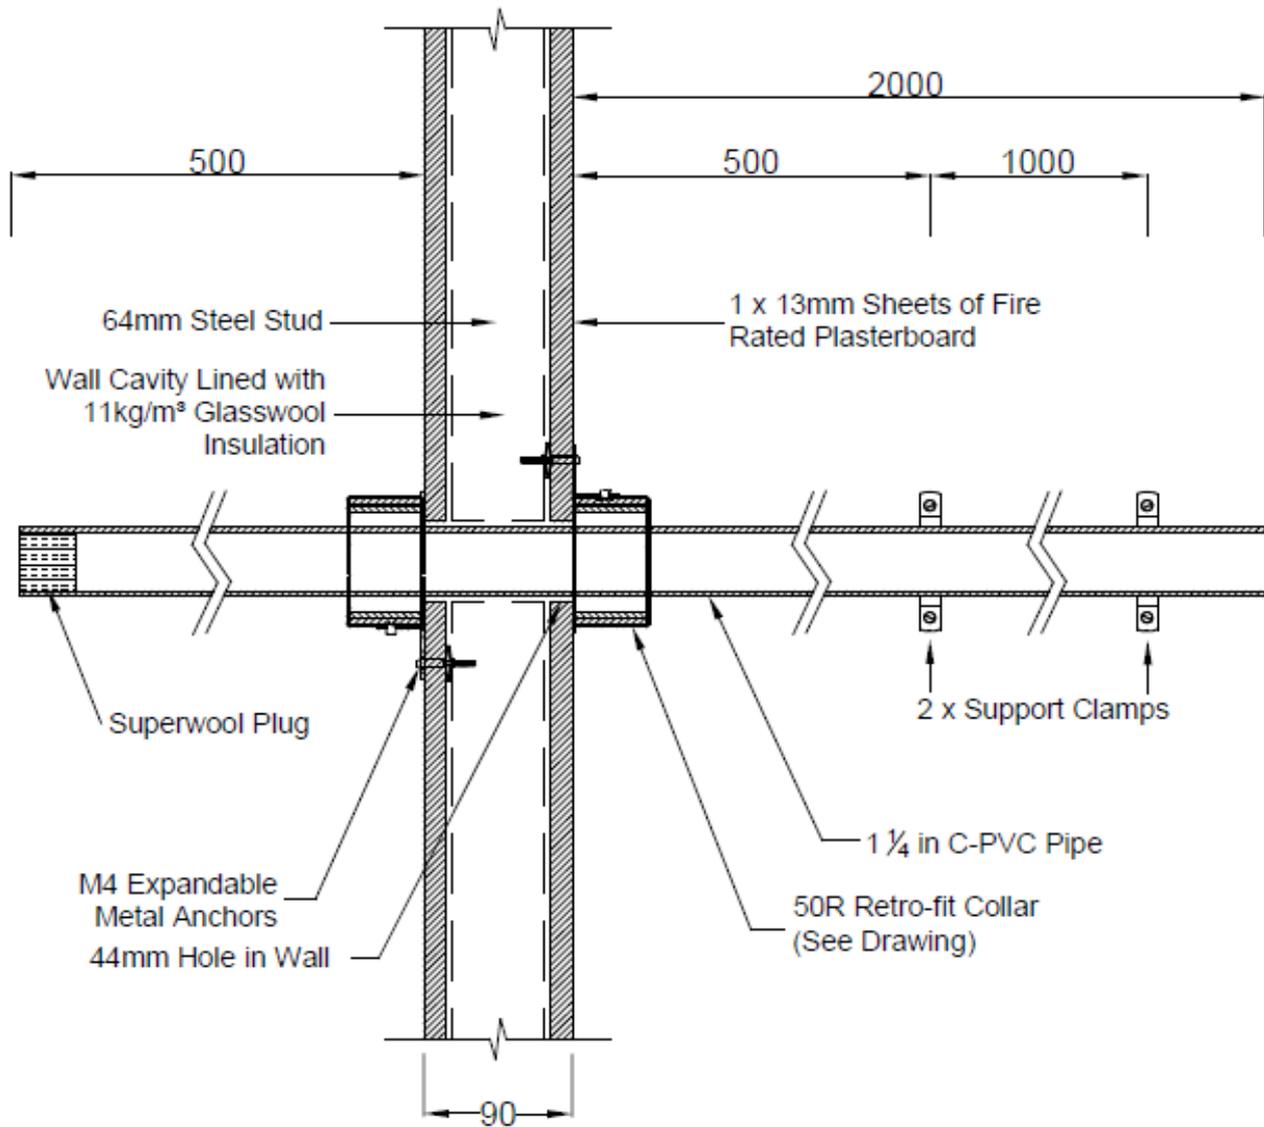
1 ¼in C-PVC & 50R

DRAWING TITLED 'SPECIMEN #5 1 ¼ IN C-PVC & 50R', DATED 26 FEBRUARY 2021, BY SNAP FIRE SYSTEMS PTY LTD

Specimen 5 - SNAP 50R Retrofit fire collars protecting a nominal 1 1/4 -inch (42.07-mm OD) CPVC pipe penetrating a 44-mm diameter aperture.

The SNAP Retrofit 50R fire collar comprised a 0.75-mm steel casing with a 62-mm inner diameter and a 147-mm diameter base flange. The 47-mm high collar casing incorporated a closing mechanism which comprised two soft Intumesh intumescent wraps lined within the internal circumference of the collar. Intumescent A was 4-mm thick x 43-mm wide x 220-mm long, and Intumescent B was 4-mm thick x 43-mm wide x 200-mm long. Between the strips was a layer of 316 grade stainless steel mesh 210-mm long x 42-mm wide with a wire mesh diameter of 0.15-mm, as shown in drawing titled "SNAP 50 Retro", dated 18 January 2019, by Snap Fire Systems Pty Ltd. One collar was fixed to each side of the plasterboard wall in a back-to-back configuration using three M4 expandable steel hollow wall anchors with stainless steel washers.

The penetrating service comprised a Blazemaster CPVC 42.07-mm outside diameter pipe, with a wall thickness of 3.59-mm fitted through the collar's sleeve and penetrated the wall through a 44-mm diameter cut-out hole as shown in drawing titled 'Specimen #5, 1 1/4 in C-PVC Stack & 50R', dated 26 February 2021, provided by Snap Fire Systems Pty Ltd. The pipe projected horizontally, 2000-mm away from the unexposed face of the wall and approximately 500-mm into the furnace chamber. The pipe was supported at nominally 500-mm and 1500-mm from the unexposed face of the plasterboard wall. The pipe was open at the unexposed end and plugged with ceramic fibre (Superwool) on the exposed end.

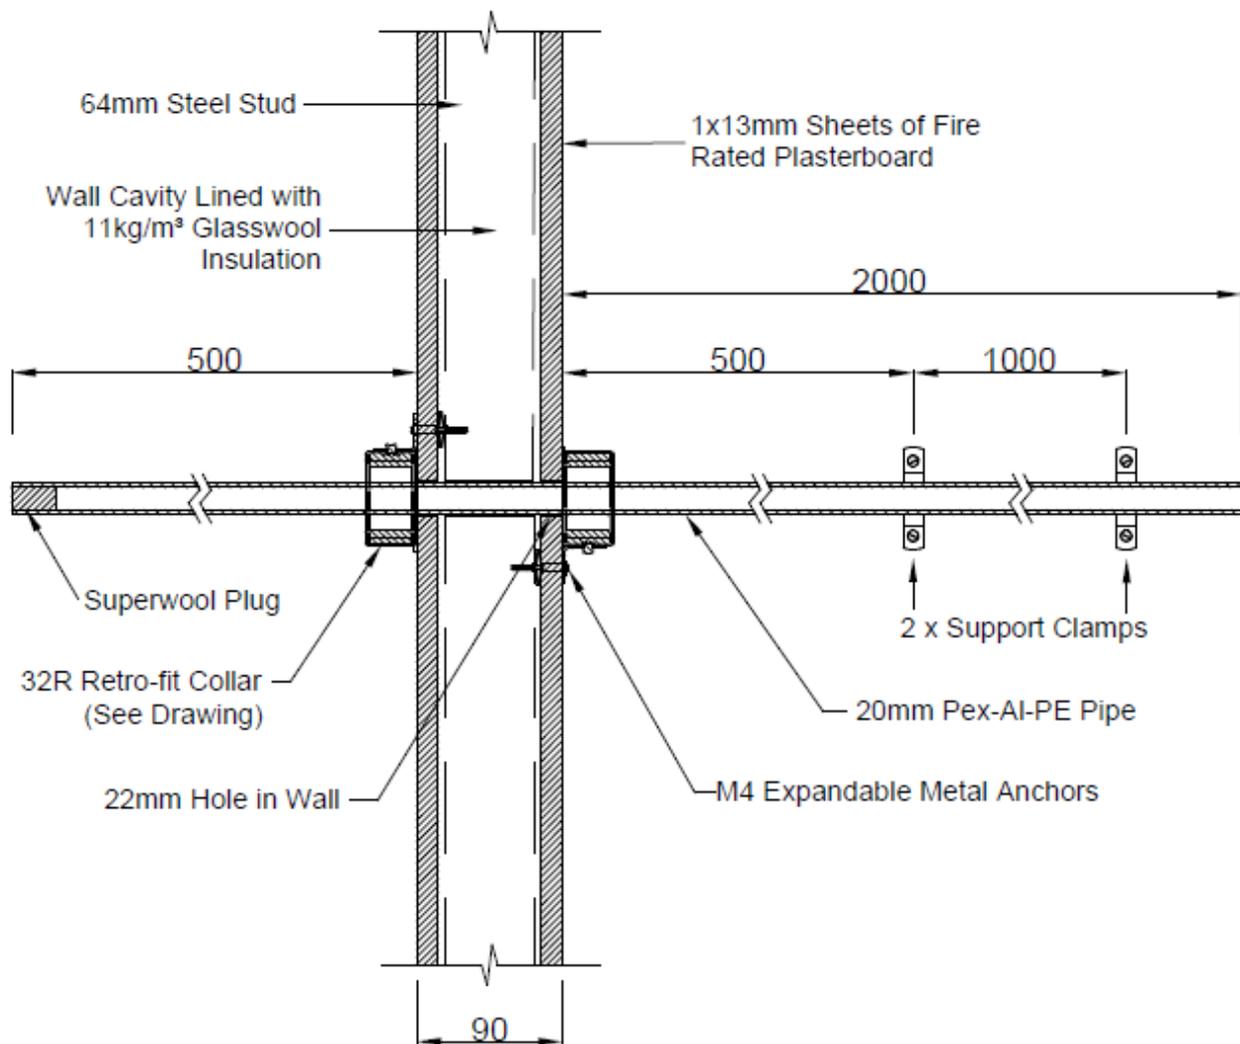
20 Pex-Al-PE Stack & 32R

DRAWING TITLED 'SPECIMEN #6 20 PEX-AL-PE STACK & 32R', DATED 1 MARCH 2021, BY SNAP FIRE SNAP FIRE SYSTEMS PTY LTD

Specimen 6 - SNAP 32R Retrofit fire collars protecting a nominal 20-mm PE-Xa/Al/PE Rehau Rautitan pipe penetrating a 22-mm diameter aperture.

The SNAP 32R Retrofit collar comprised a 0.75-mm steel casing with a 40-mm inner diameter and a 106-mm diameter base flange. The 32-mm high collar casing incorporated a closing mechanism which comprised two soft Intumesh intumescent strips lined within the internal circumference of the collar. The inner and outer strips were 4-mm thick x 26-mm wide x 135-mm long, and 4-mm thick x 26-mm wide x 154-mm long, respectively. Between the strips was a layer of 316 stainless steel mesh 135 mm long x 25-mm wide with wire mesh diameter of 0.15-mm, as shown in drawing titled "SNAP 32 Retro", dated 5 October 2017, by Snap Fire Systems Pty Ltd. One collar was fixed to each side of the plasterboard wall in a back-to-back configuration using three M4 expandable steel hollow wall anchors with stainless steel washers.

The penetrating service comprised a Rehau Rautitan PE-Xa/Al/PE 19.95-mm outside diameter pipe, with a wall thickness of 3.43-mm fitted through the collar's sleeve and penetrated the wall through a 22-mm diameter cut-out hole as shown in drawing titled 'Specimen #6, 20 Pex-Al-PE Stack & 32R', dated 1 March 2021, provided by Snap Fire Systems Pty Ltd. The pipe projected horizontally, 2000-mm away from the unexposed face of the wall and approximately 500 mm into the furnace chamber. The pipe was supported at nominally 500-mm and 1500-mm from the unexposed face of the plasterboard wall. The pipe was open at the unexposed end and plugged with ceramic fibre (Superwool) on the exposed end.

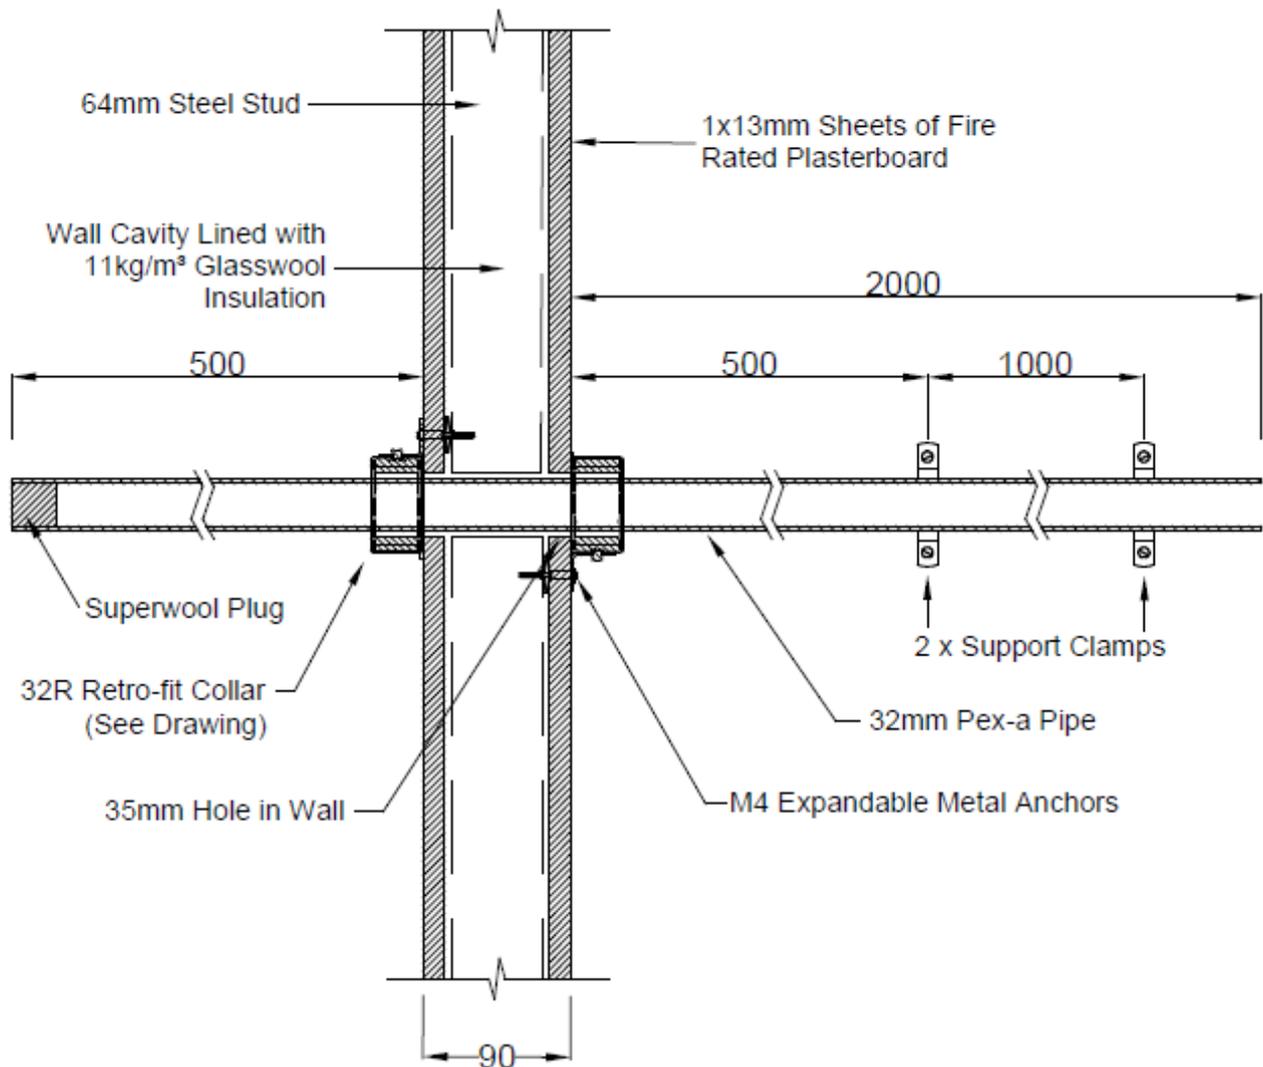
32 Pex-a Stack & 32R

DRAWING TITLED 'SPECIMEN #7 32 PEX-A STACK & 32R', DATED 1 MARCH 2021, BY SNAP FIRE SNAP FIRE SYSTEMS PTY LTD

Specimen 7 - SNAP 32R Retrofit fire collars protecting a nominal 32-mm PE-Xa Rehau Rautitan pipe penetrating a 35-mm diameter aperture.

The SNAP 32R Retrofit collar comprised a 0.75-mm steel casing with a 40-mm inner diameter and a 106-mm diameter base flange. The 32-mm high collar casing incorporated a closing mechanism which comprised two soft Intumesh intumescent strips lined within the internal circumference of the collar. The inner and outer strips were 4-mm thick x 26-mm wide x 135-mm long, and 4-mm thick x 26-mm wide x 154-mm long, respectively. Between the strips was a layer of 316 stainless steel mesh 135 mm long x 25-mm wide with wire mesh diameter of 0.15-mm, as shown in drawing titled "SNAP 32 Retro", dated 5 October 2017, by Snap Fire Systems Pty Ltd. One collar was fixed to each side of the plasterboard wall in a back-to-back configuration using three M4 expandable steel hollow wall anchors with stainless steel washers.

The penetrating service comprised a Rehau Rautitan PE-Xa 32.06-mm outside diameter pipe, with a wall thickness of 4.67-mm fitted through the collar's sleeve and penetrated the wall through a 35-mm diameter cut-out hole as shown in drawing titled 'Specimen #7, 32 Pex-a Stack & 32R', dated 1 March 2021, provided by Snap Fire Systems Pty Ltd. The pipe projected horizontally, 2000-mm away from the unexposed face of the wall and approximately 500-mm into the furnace chamber. The pipe was supported at nominally 500-mm and 1500-mm from the unexposed face of the plasterboard wall. The pipe was open at the unexposed end and plugged with ceramic fibre (Superwool) on the exposed end.

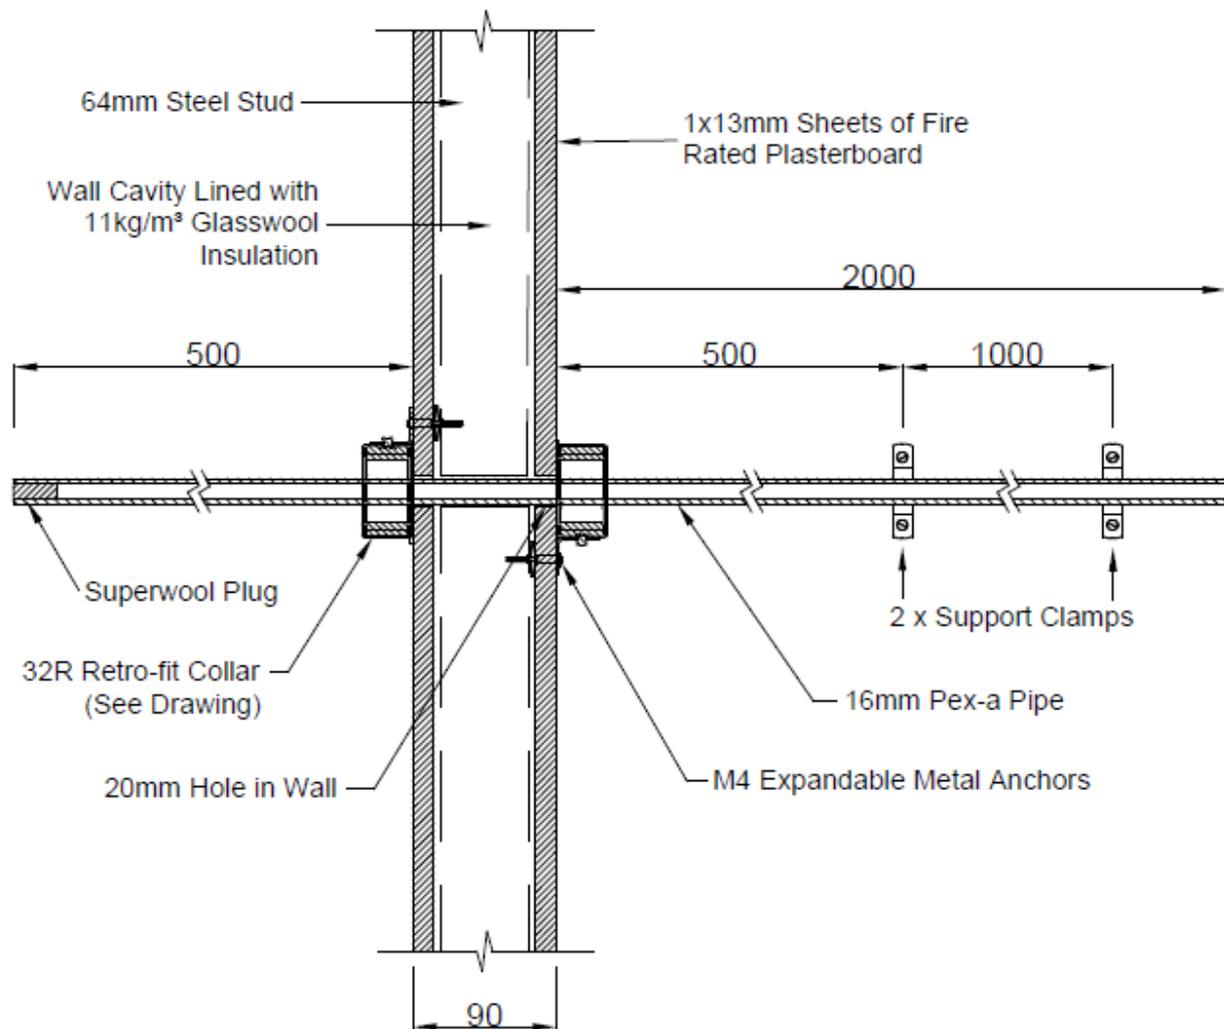
16 Pex-a Stack & 32R

DRAWING TITLED 'SPECIMEN #8 16 PEX-A STACK & 32R', DATED 1 MARCH 2021, BY SNAP FIRE SNAP FIRE SYSTEMS PTY LTD

Specimen 8 - SNAP 32R Retrofit fire collars protecting a nominal 16-mm PE-Xa Rehau Rautitan pipe penetrating a 35-mm diameter aperture.

The SNAP 32R Retrofit collar comprised a 0.75-mm steel casing with a 40-mm inner diameter and a 106-mm diameter base flange. The 32-mm high collar casing incorporated a closing mechanism which comprised two soft Intumesh intumescent strips lined within the internal circumference of the collar. The inner and outer strips were 4-mm thick x 26-mm wide x 135-mm long, and 4-mm thick x 26-mm wide x 154-mm long, respectively. Between the strips was a layer of 316 stainless steel mesh 135 mm long x 25-mm wide with wire mesh diameter of 0.15-mm, as shown in drawing titled "SNAP 32 Retro", dated 5 October 2017, by Snap Fire Systems Pty Ltd. One collar was fixed to each side of the plasterboard wall in a back-to-back configuration using three M4 expandable steel hollow wall anchors with stainless steel washers.

The penetrating service comprised a Rehau Rautitan PE-Xa 16.2-mm outside diameter pipe, with a wall thickness of 2.54-mm fitted through the collar's sleeve and penetrated the wall through a 20-mm diameter cut-out hole as shown in drawing titled 'Specimen #8, 16 Pex-a Stack & 32R', dated 1 March 2021, provided by Snap Fire Systems Pty Ltd. The pipe projected horizontally, 2000-mm away from the unexposed face of the wall and approximately 500-mm into the furnace chamber. The pipe was supported at nominally 500-mm and 1500-mm from the unexposed face of the plasterboard wall. The pipe was open at the unexposed end and plugged with ceramic fibre (Superwool) on the exposed end.

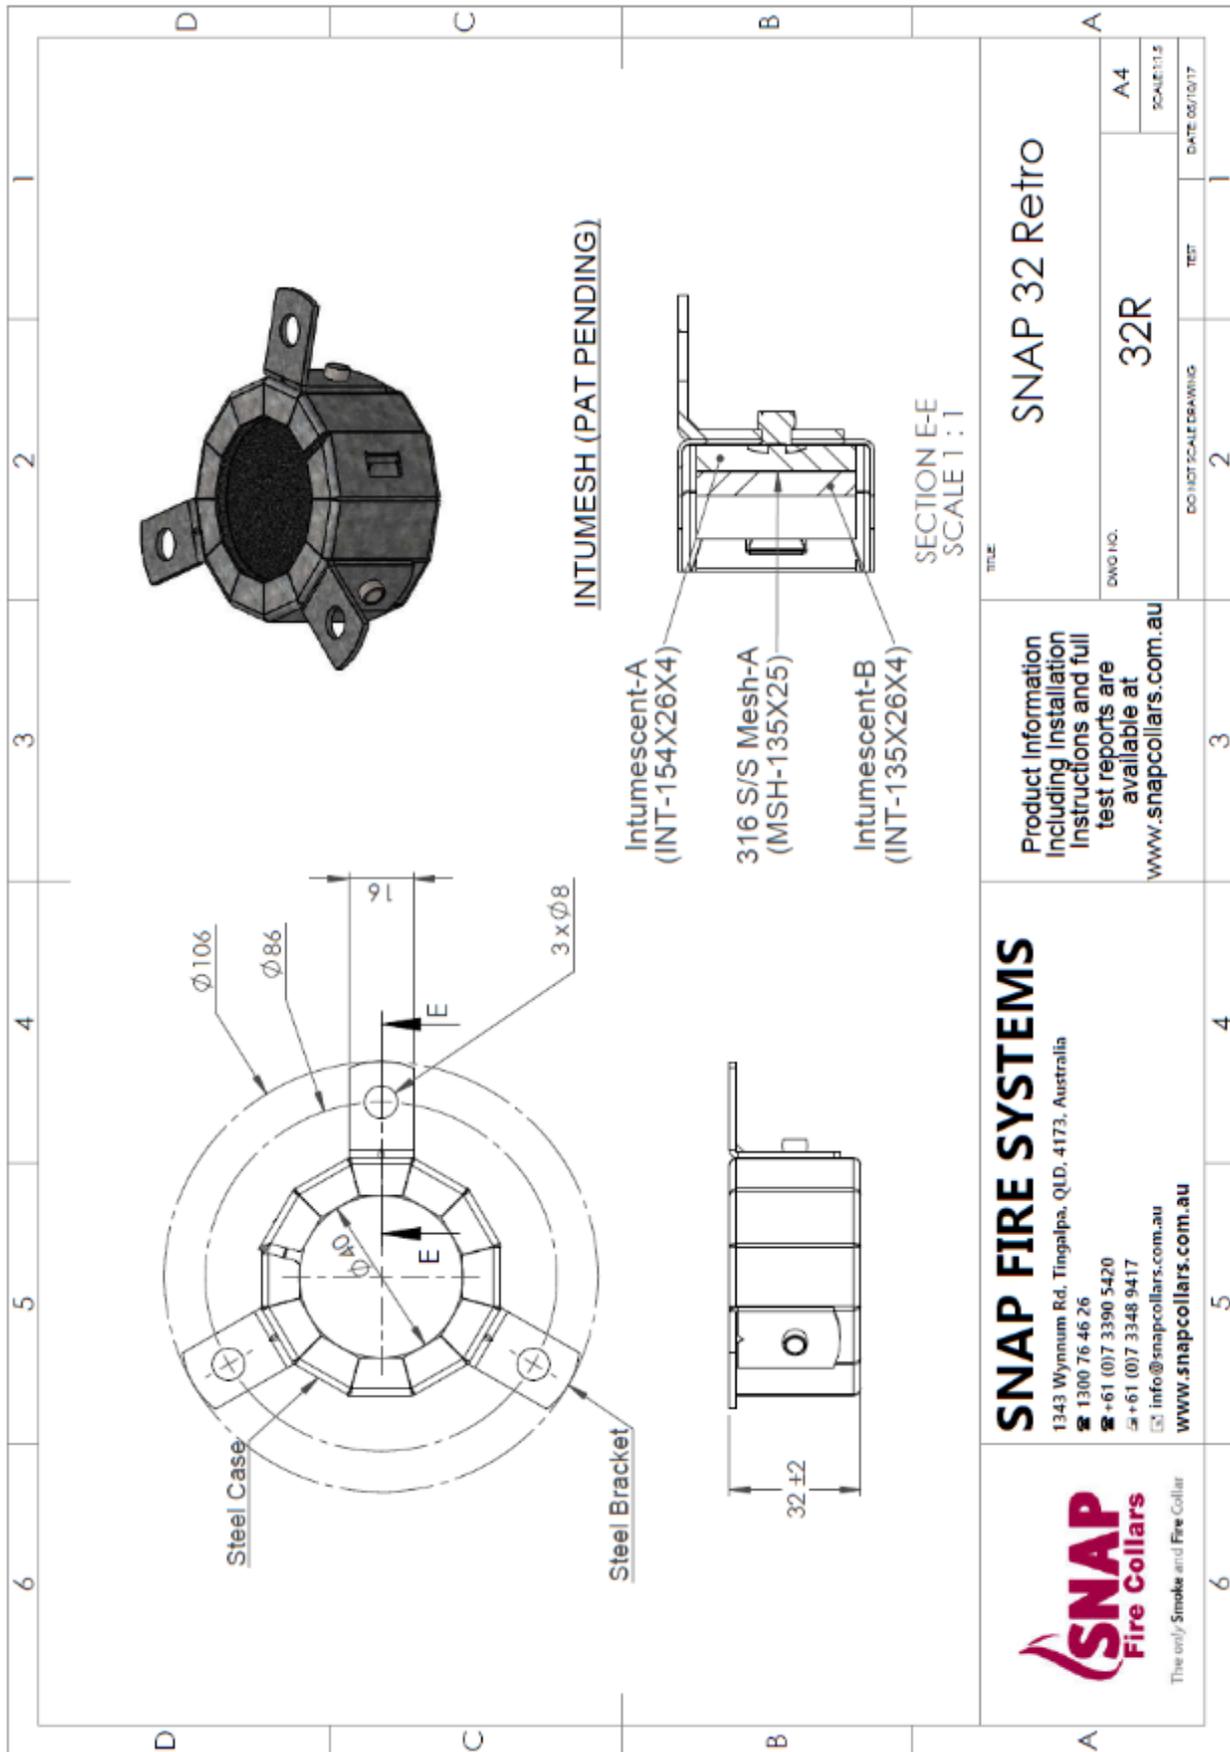
DRAWING TITLED 'SNAP 32 RETRO', DATED 5 OCTOBER 2017, BY SNAP FIRE SYSTEMS.

The SNAP 32R Retrofit collar comprised a 0.75-mm steel casing with a 40-mm inner diameter and a 106-mm diameter base flange. The 32-mm high collar casing incorporated a closing mechanism which comprised two soft Intumesh intumescent strips lined within the internal circumference of the collar. The inner and outer strips were 4-mm thick x 26-mm wide x 135-mm long, and 4-mm thick x 26-mm wide x 154-mm long, respectively. Between the strips was a layer of 316 stainless steel mesh 135 mm long x 25-mm wide with wire mesh diameter of 0.15-mm, as shown in drawing titled “SNAP 32 Retro”, dated 5 October 2017, by Snap Fire Systems Pty Ltd. One collar was fixed to each side of the plasterboard wall in a back-to-back configuration using three M4 expandable steel hollow wall anchors with stainless steel washers.

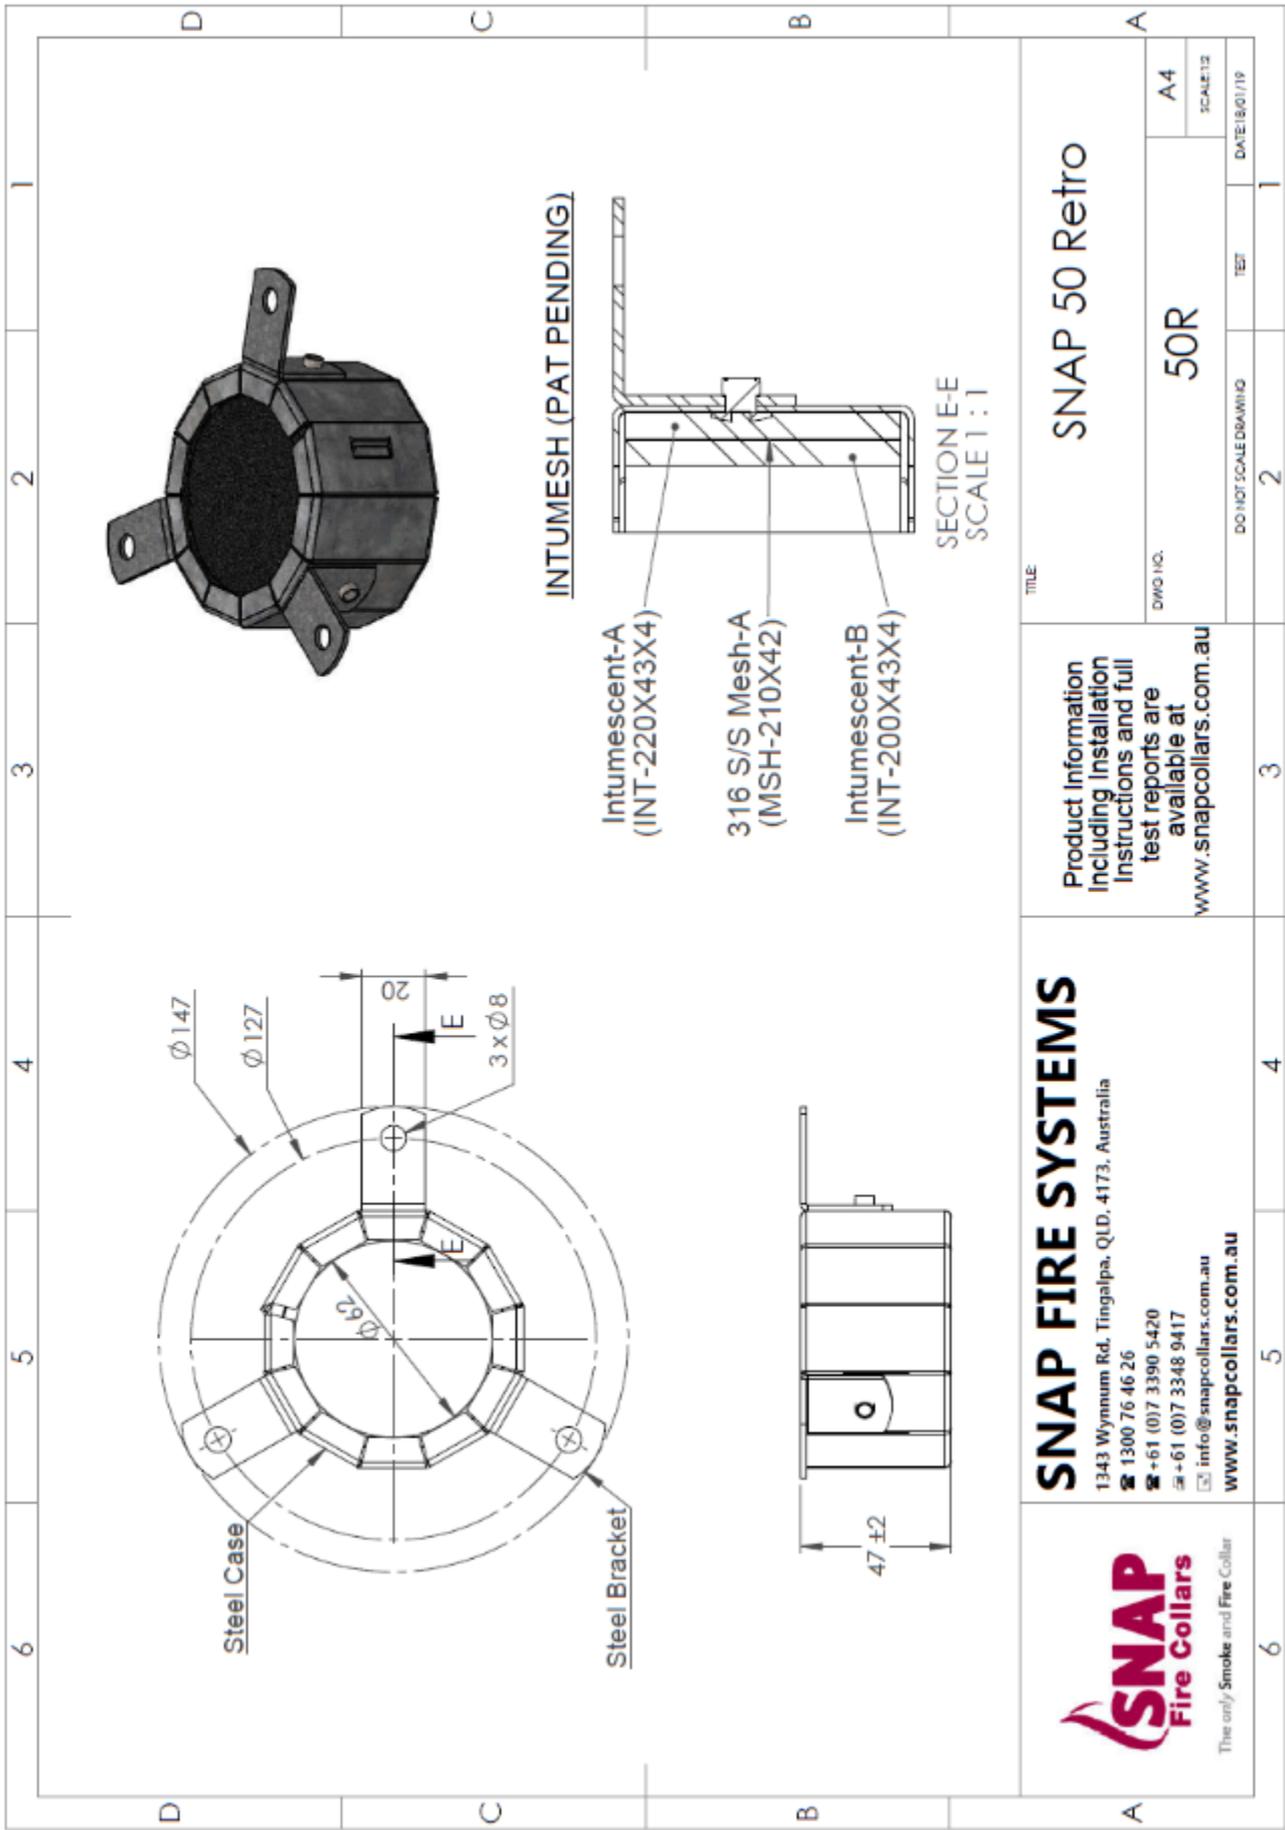
TITLE		SNAP 50 Retro	
DWG NO.	50R	SCALE	A4
DATE	18/01/19	TEST	
DO NOT SCALE DRAWING
