Fire-resistance test on retrofit fire collars protecting a plasterboard wall penetrated by services

Test Report

Author: Peter Gordon
Report number: FSP 2216
Date: 6 October 2021
Client: IG6 Pty Ltd as trustee for the IG6 IP Trust

Sponsored Investigation No. FSP 2216

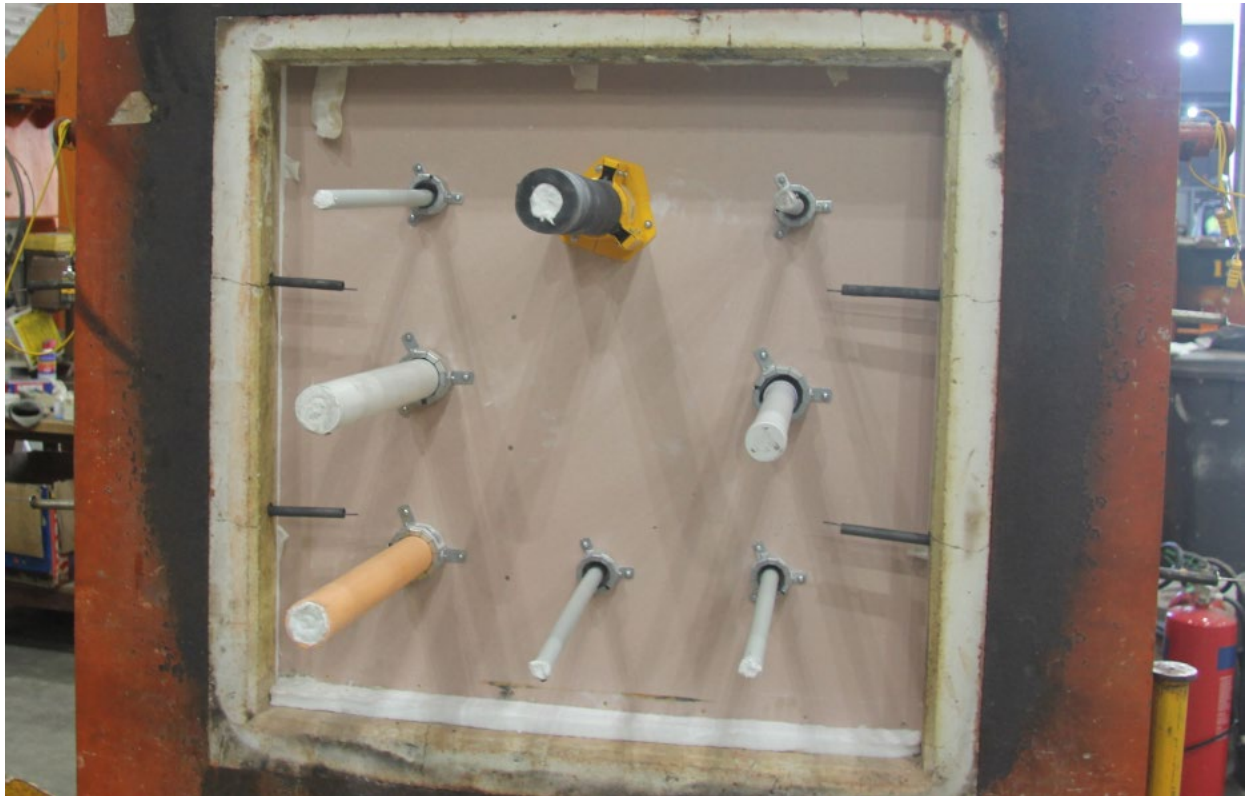
PHOTOGRAPH 1 – EXPOSED FACE OF SPECIMENS PRIOR TO TESTING

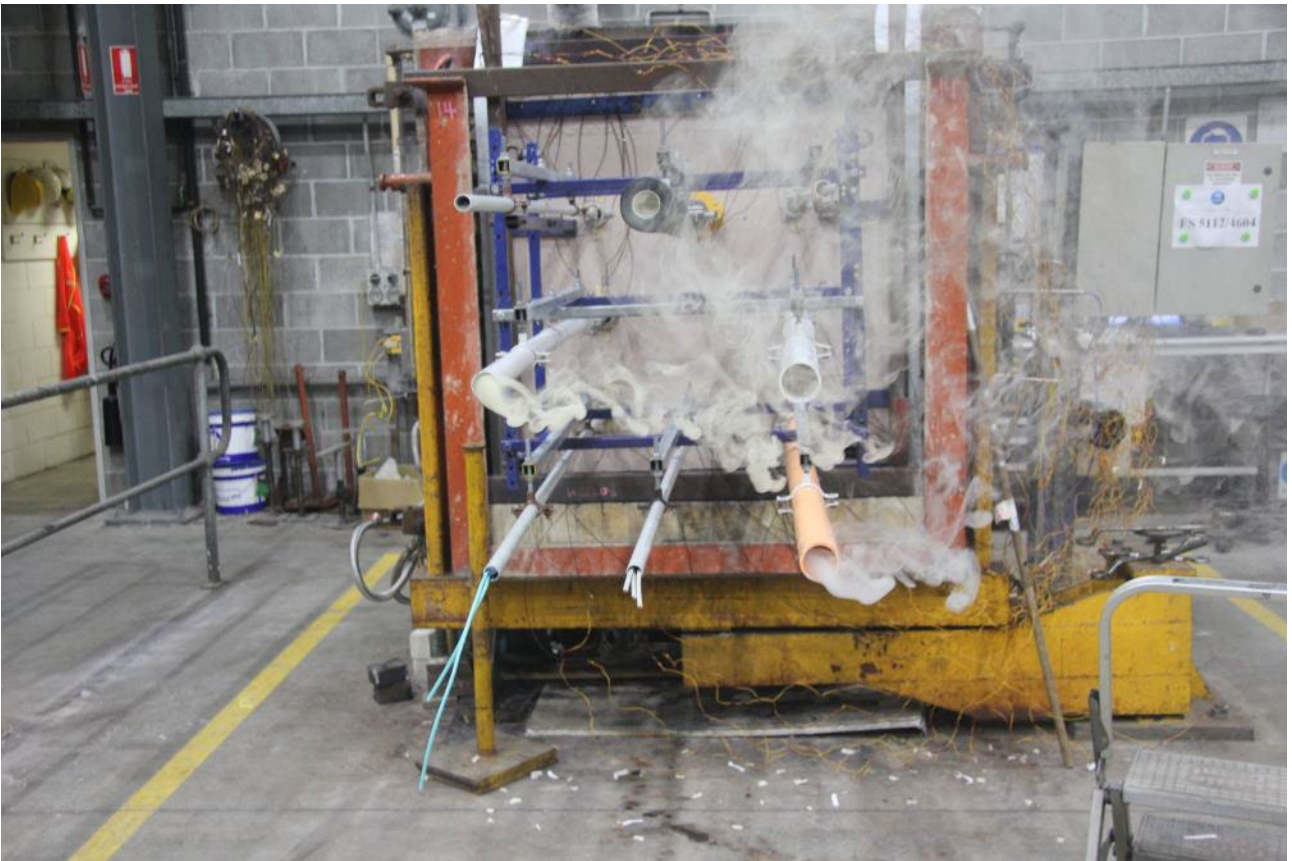
PHOTOGRAPH 3 – SPECIMENS AFTER 7 MINUTES OF TESTING

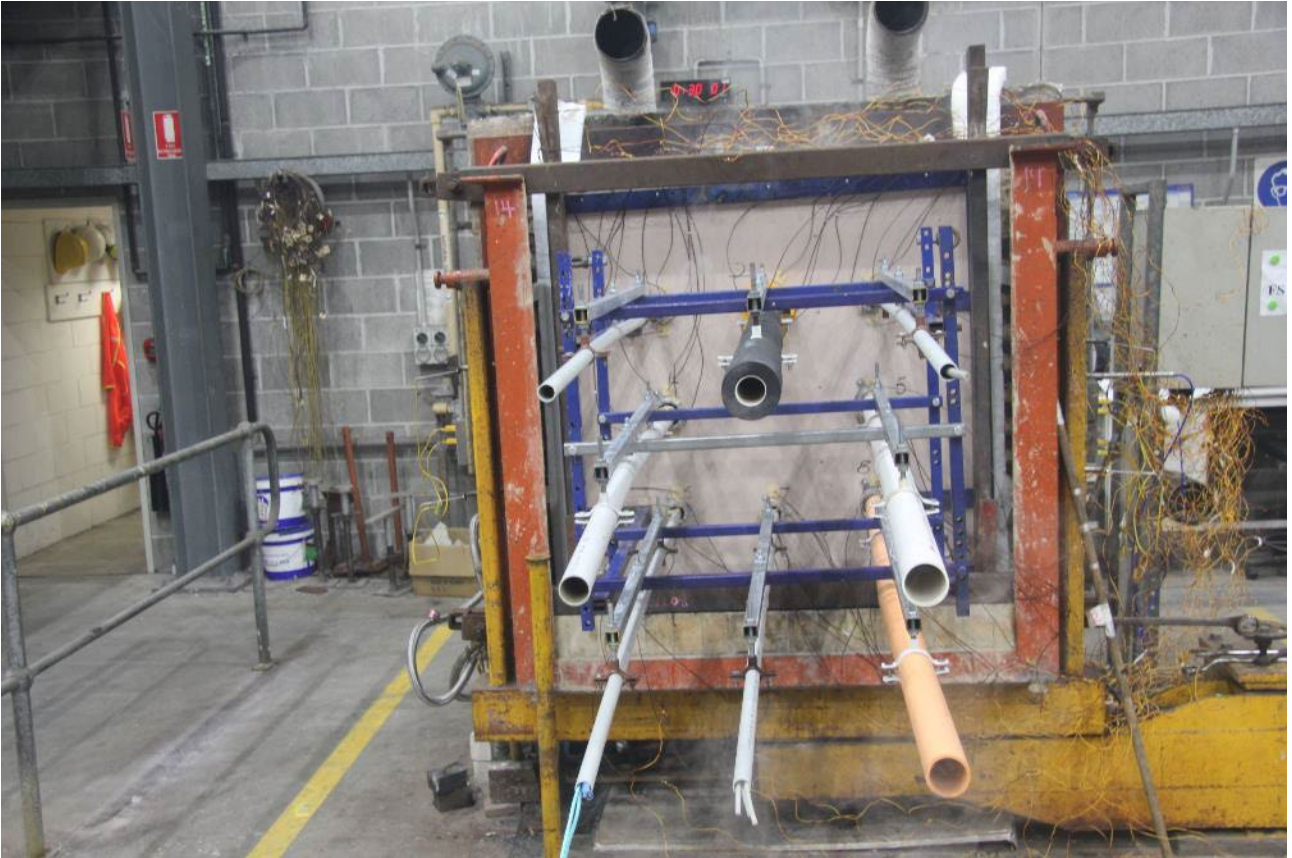
PHOTOGRAPH 4 – SPECIMENS AFTER 30 MINUTES OF TESTING

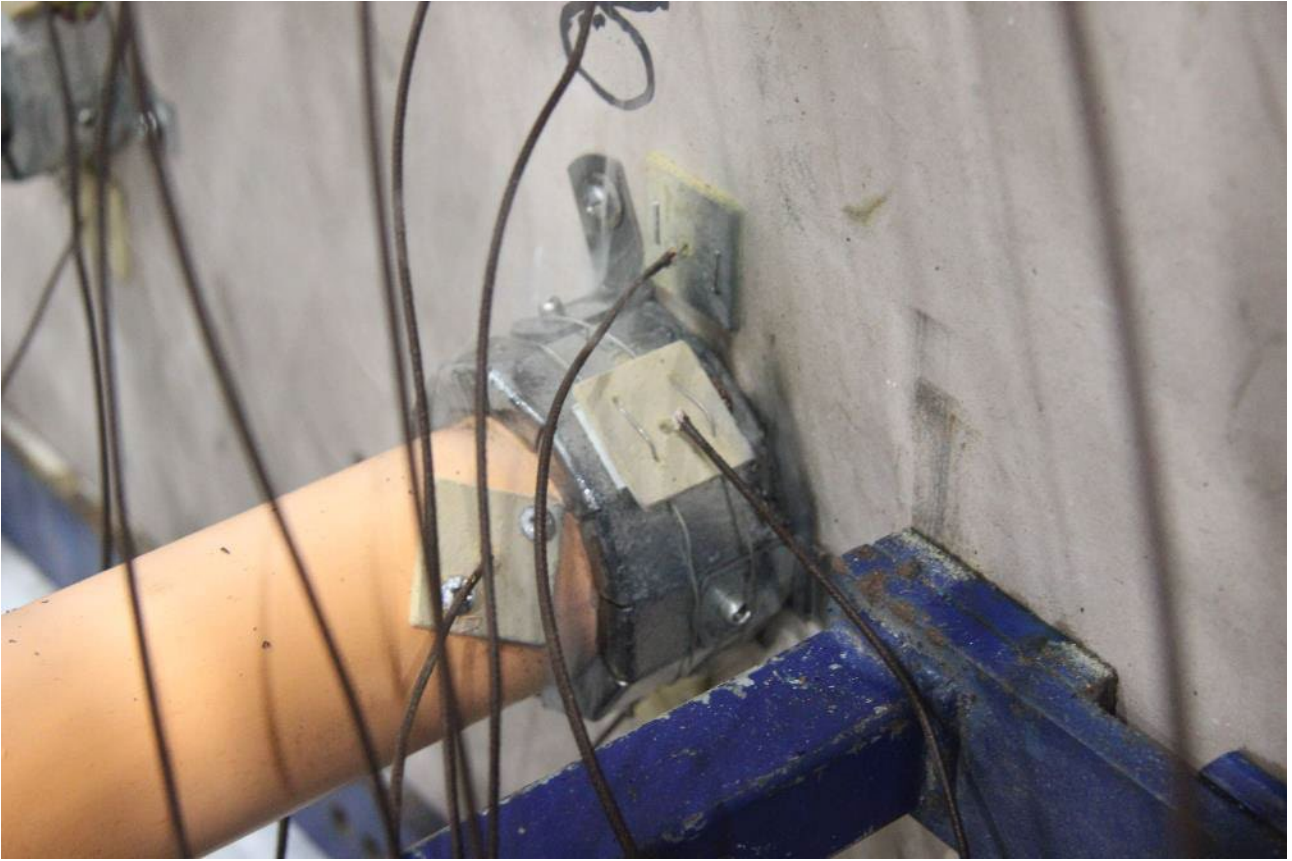
PHOTOGRAPH 5 – SPECIMEN 8 AFTER 40 MINUTES OF TESTING

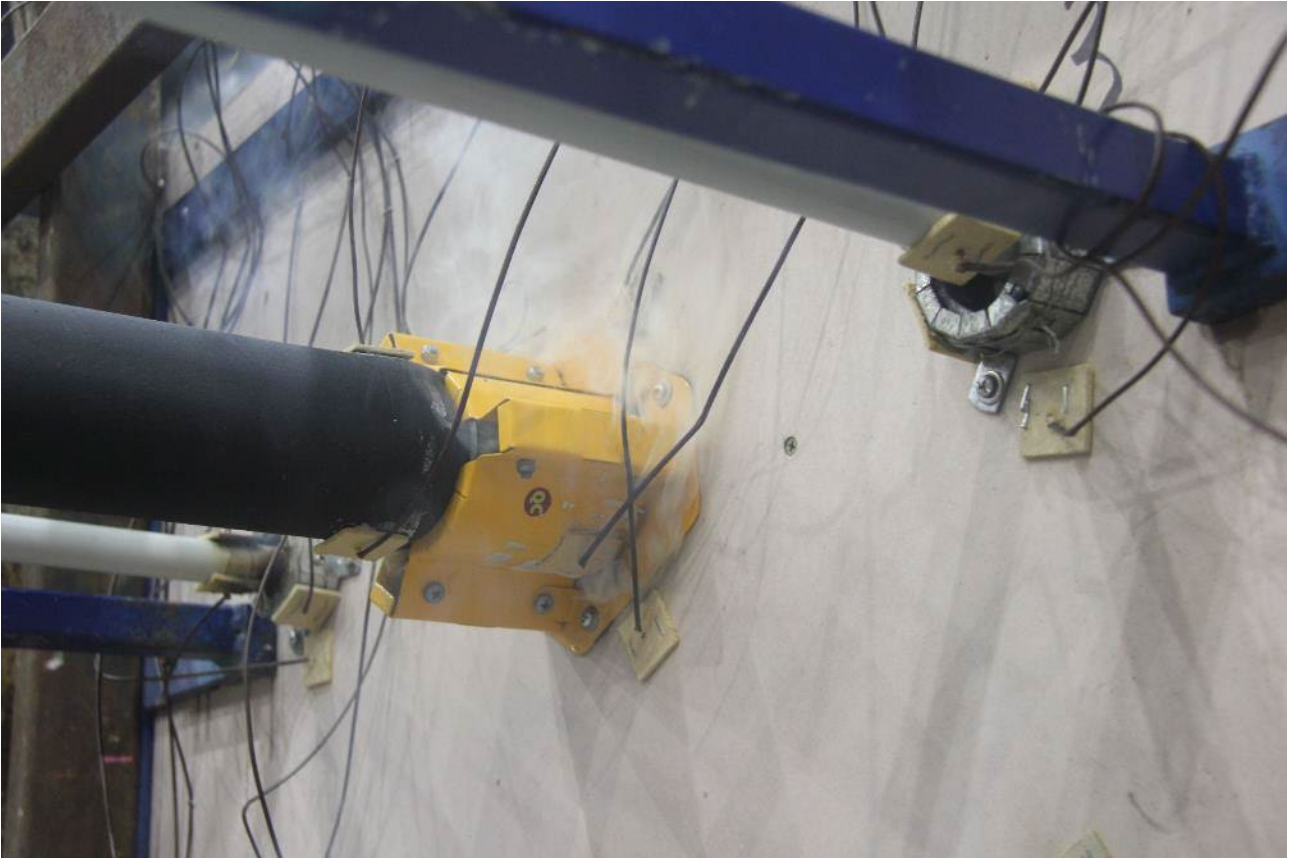
PHOTOGRAPH 6 – SPECIMEN 2 AFTER 55 MINUTES OF TESTING

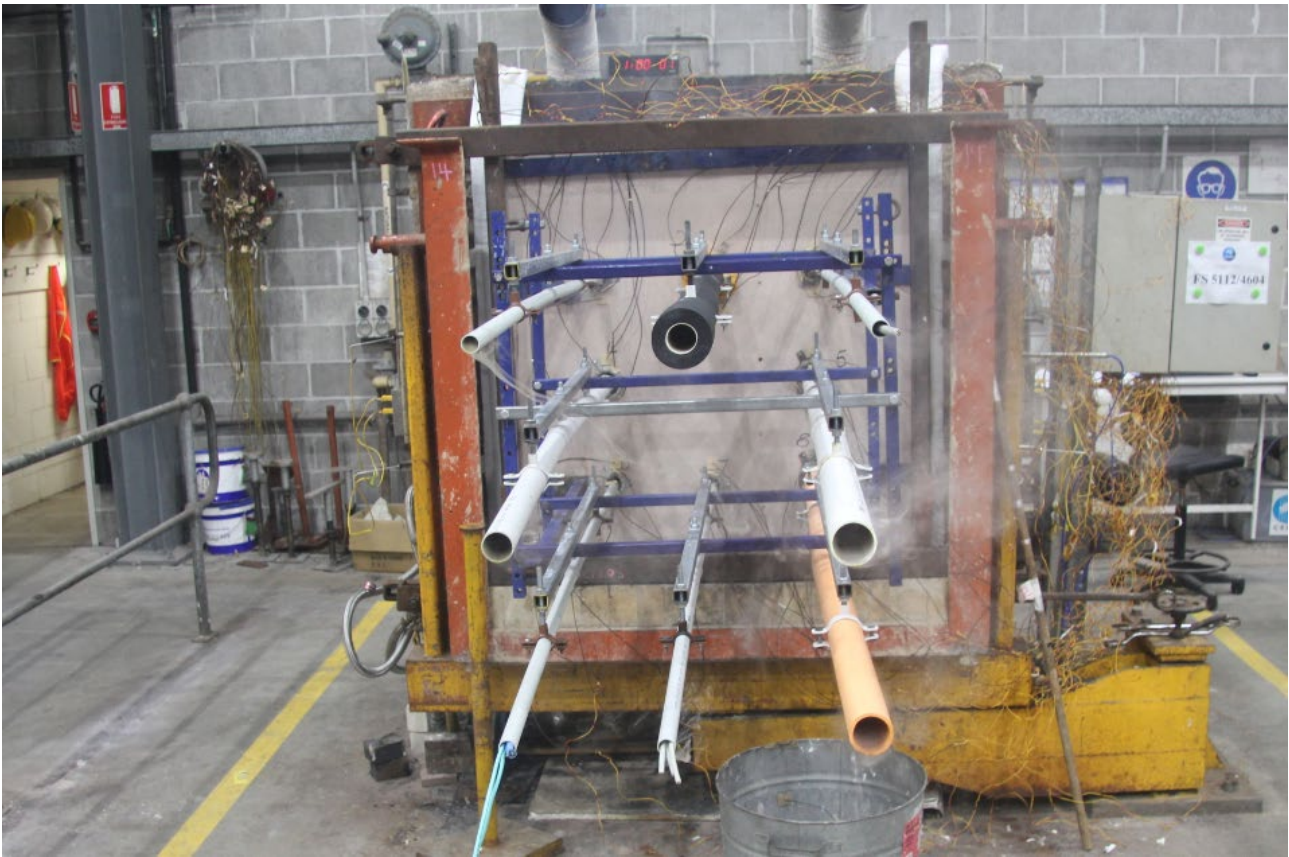
PHOTOGRAPH 7 – SPECIMENS AFTER 60 MINUTES OF TESTING

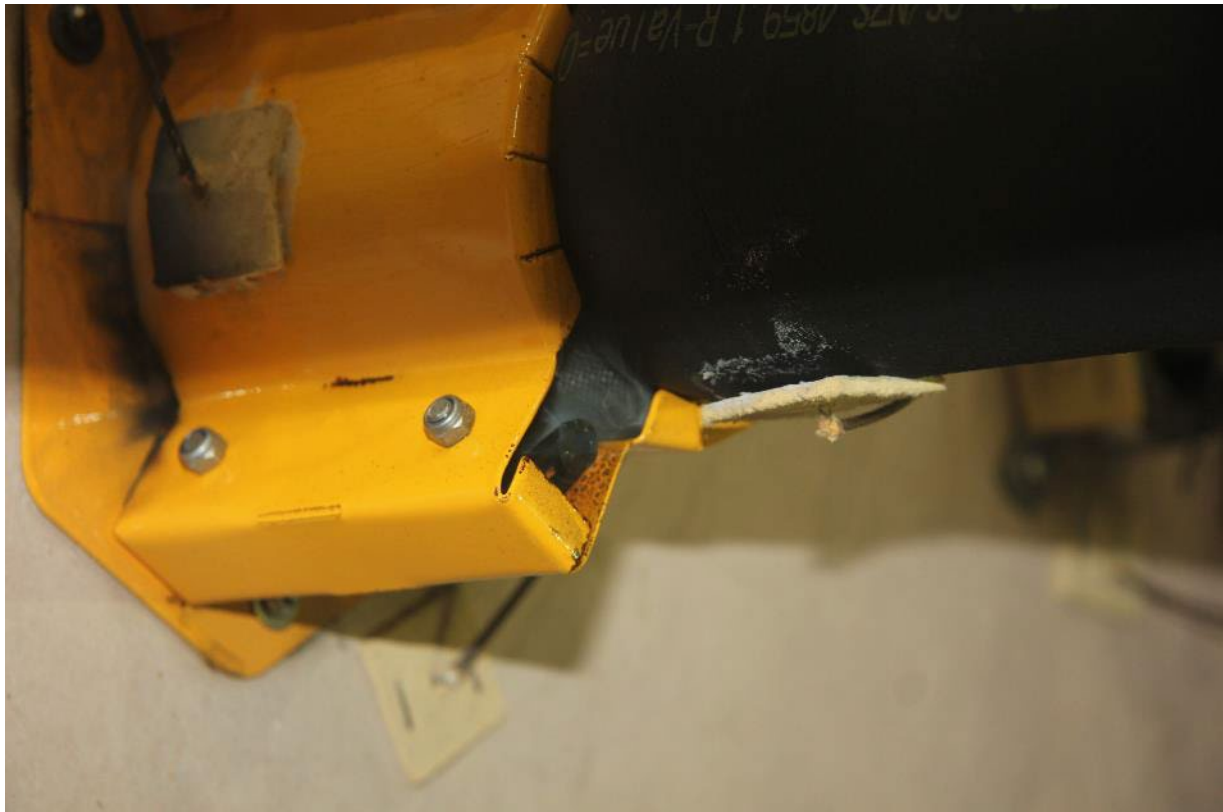
PHOTOGRAPH 8 – SPECIMEN 2 AFTER 62 MINUTES OF TESTING

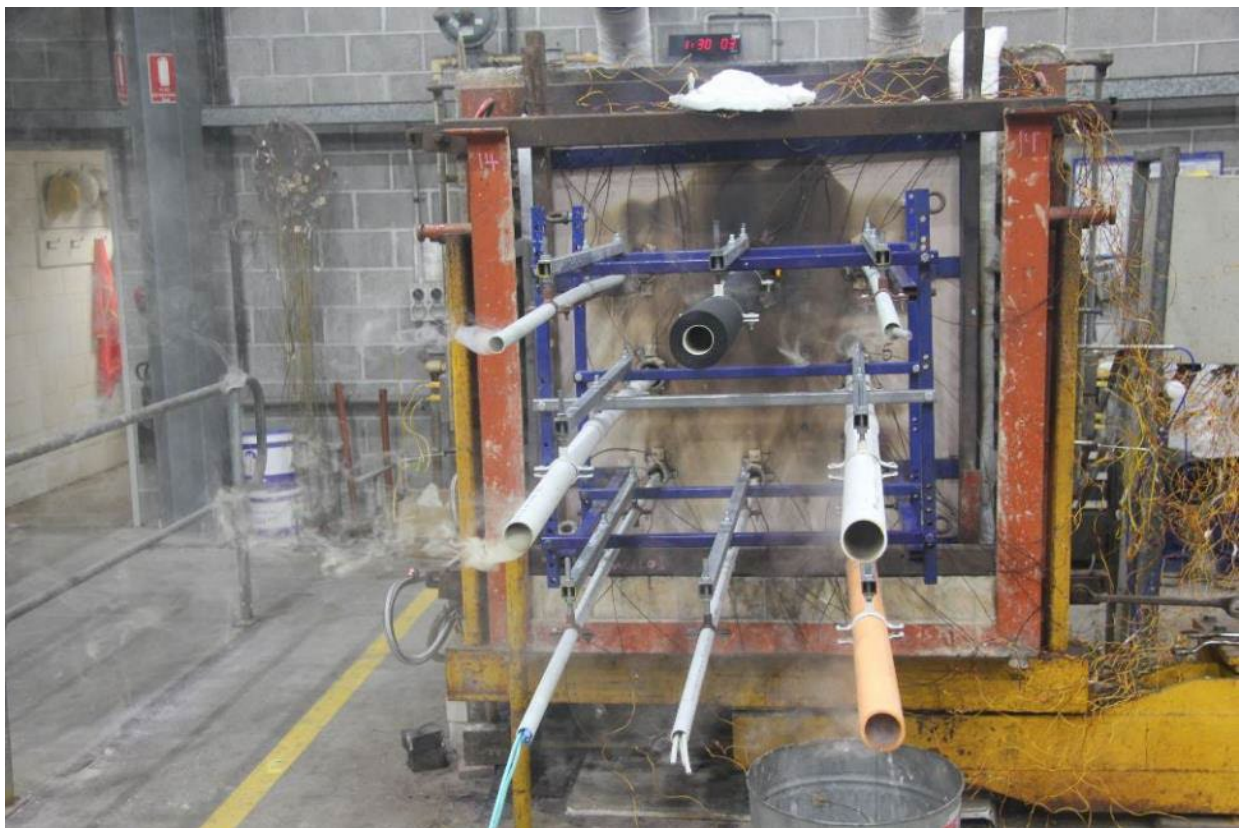
PHOTOGRAPH 10 – SPECIMENS AFTER 90 MINUTES OF TESTING

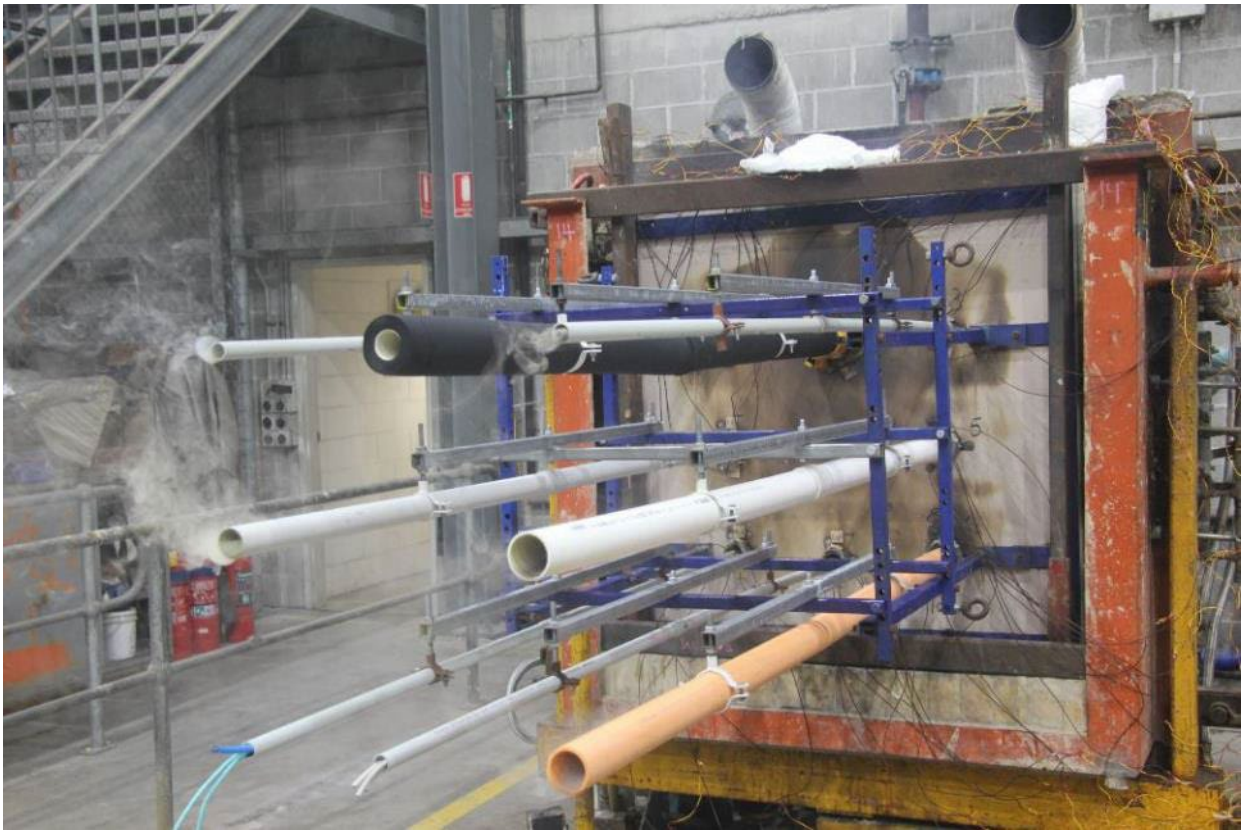
PHOTOGRAPH 11 – SPECIMENS AT CONCLUSION OF TESTING

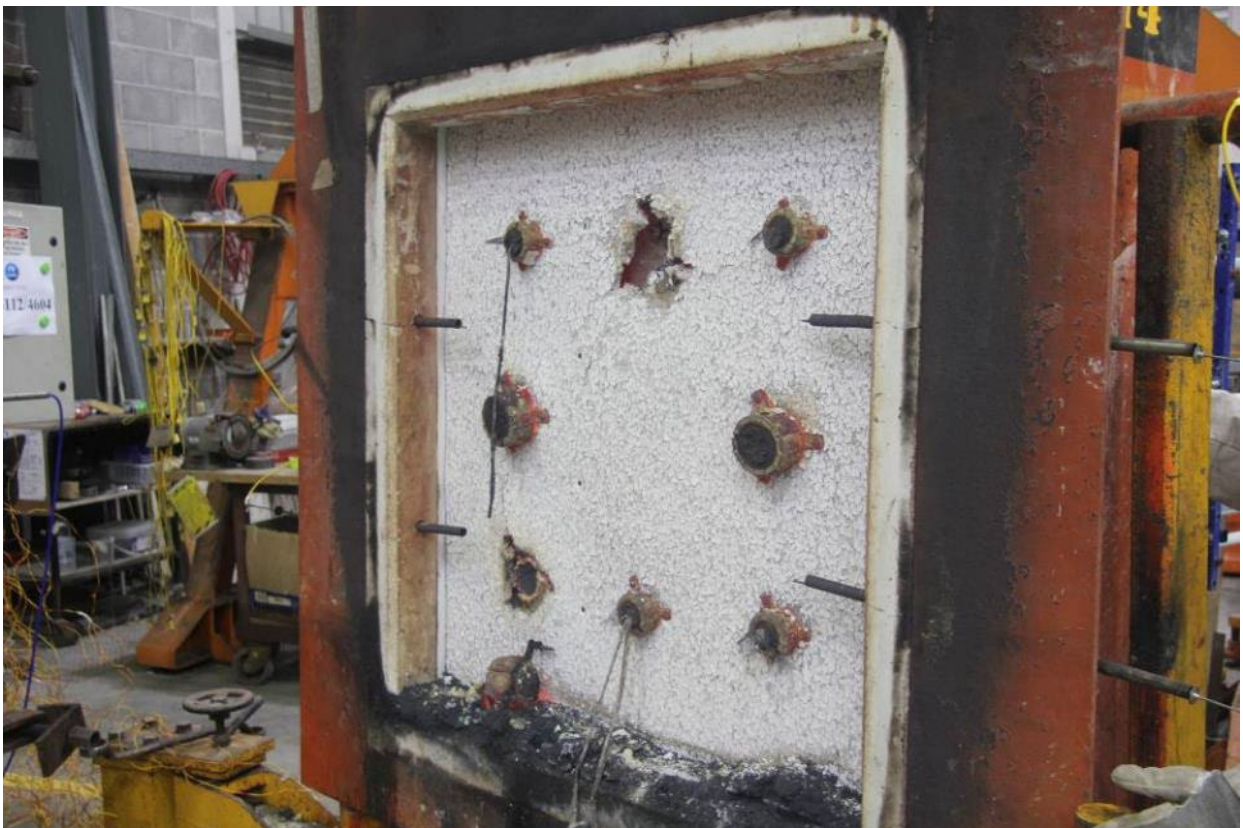
PHOTOGRAPH 12 – EXPOSED FACE OF SPECIMENS AT CONCLUSION OF TESTING

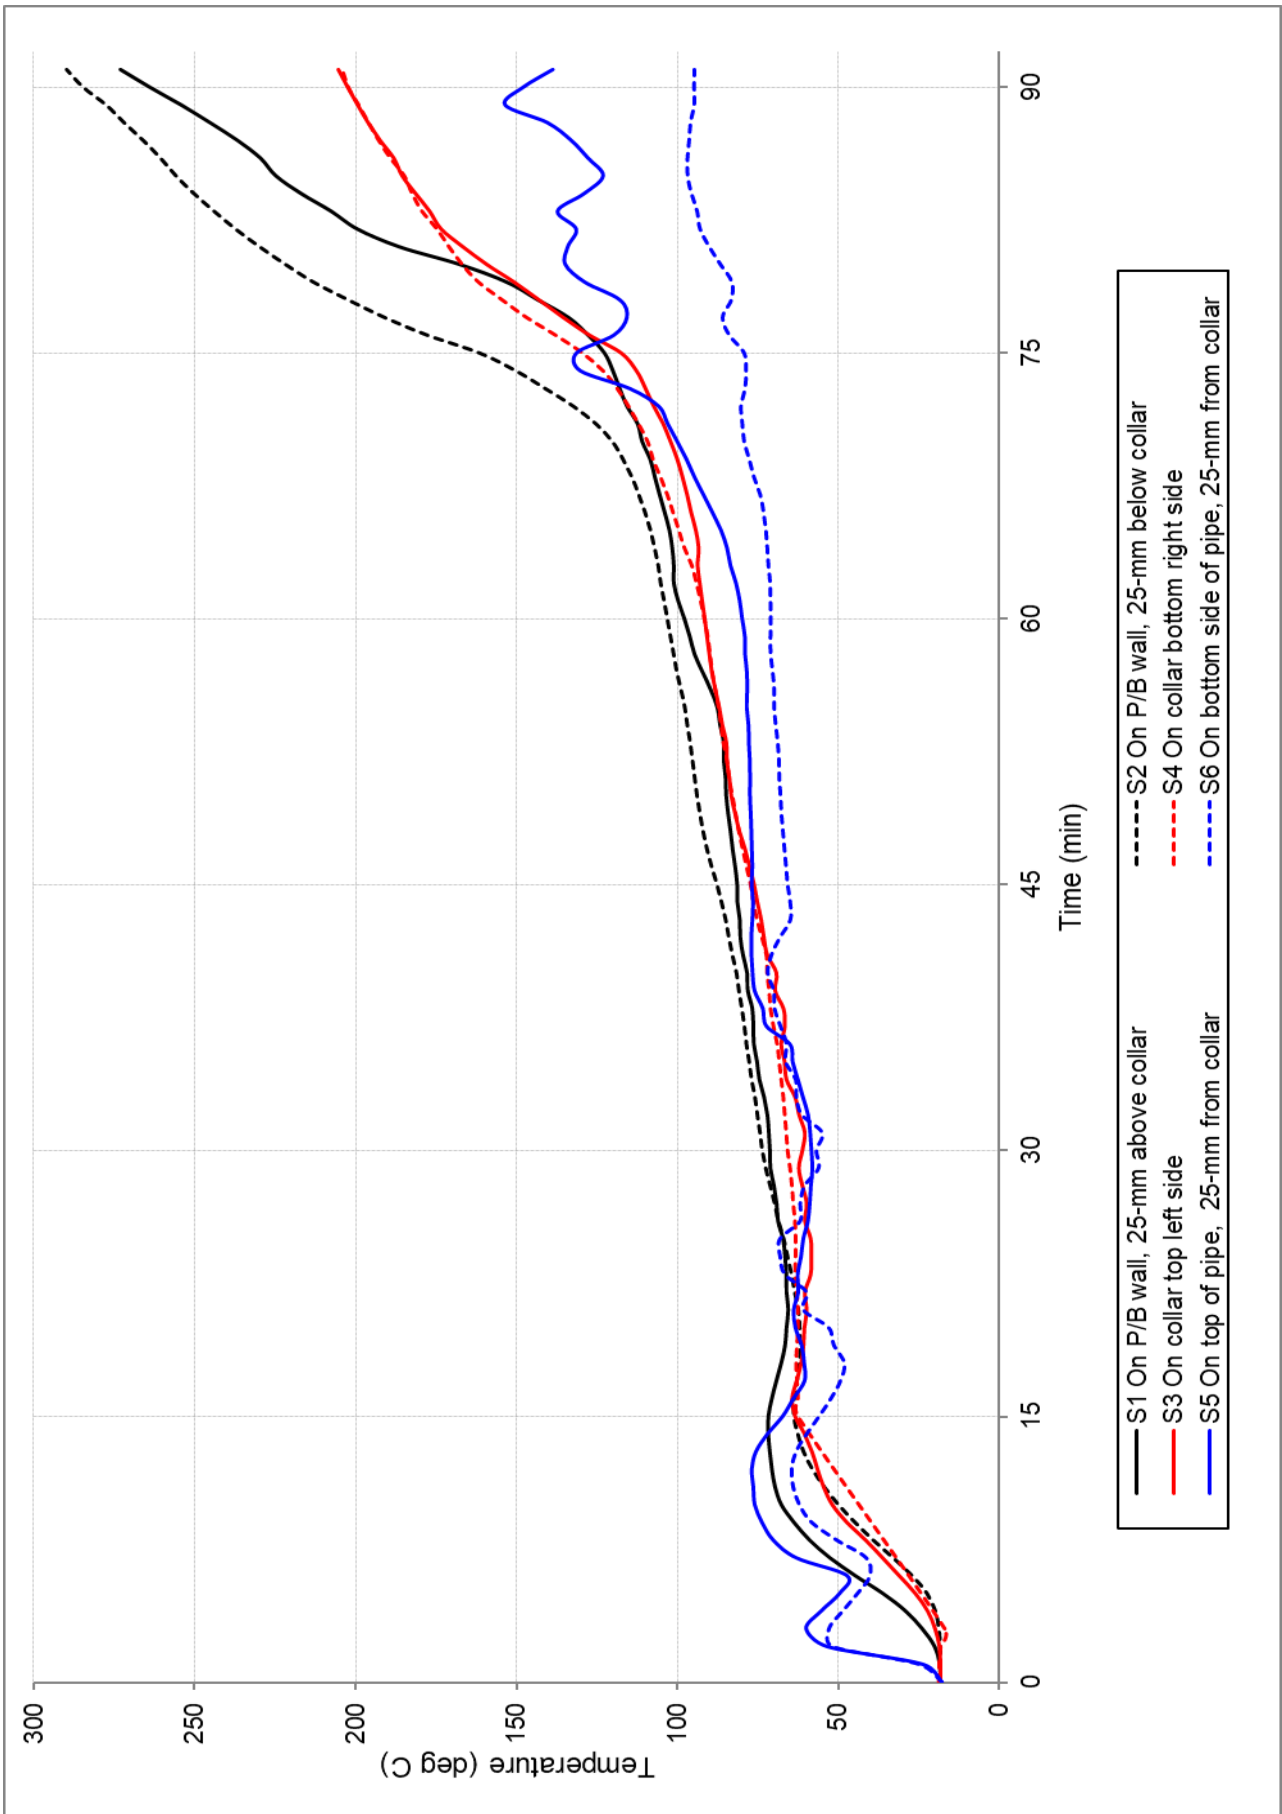
FIGURE 3 - TEMPERATURE VERSUS TIME ASSOCIATED WITH SPECIMEN #1

Structural adequacy	-	not applicable
Integrity	-	no failure at 91 minutes
Insulation	-	78 minutes
