Fire-resistance test on fire collars protecting a concrete slab penetrated by services and a blank penetration seal

Test Report

Author: Peter Gordon
Report number: FSP 2271
Date: 13 October 2022

Sponsored Investigation No. FSP 2271

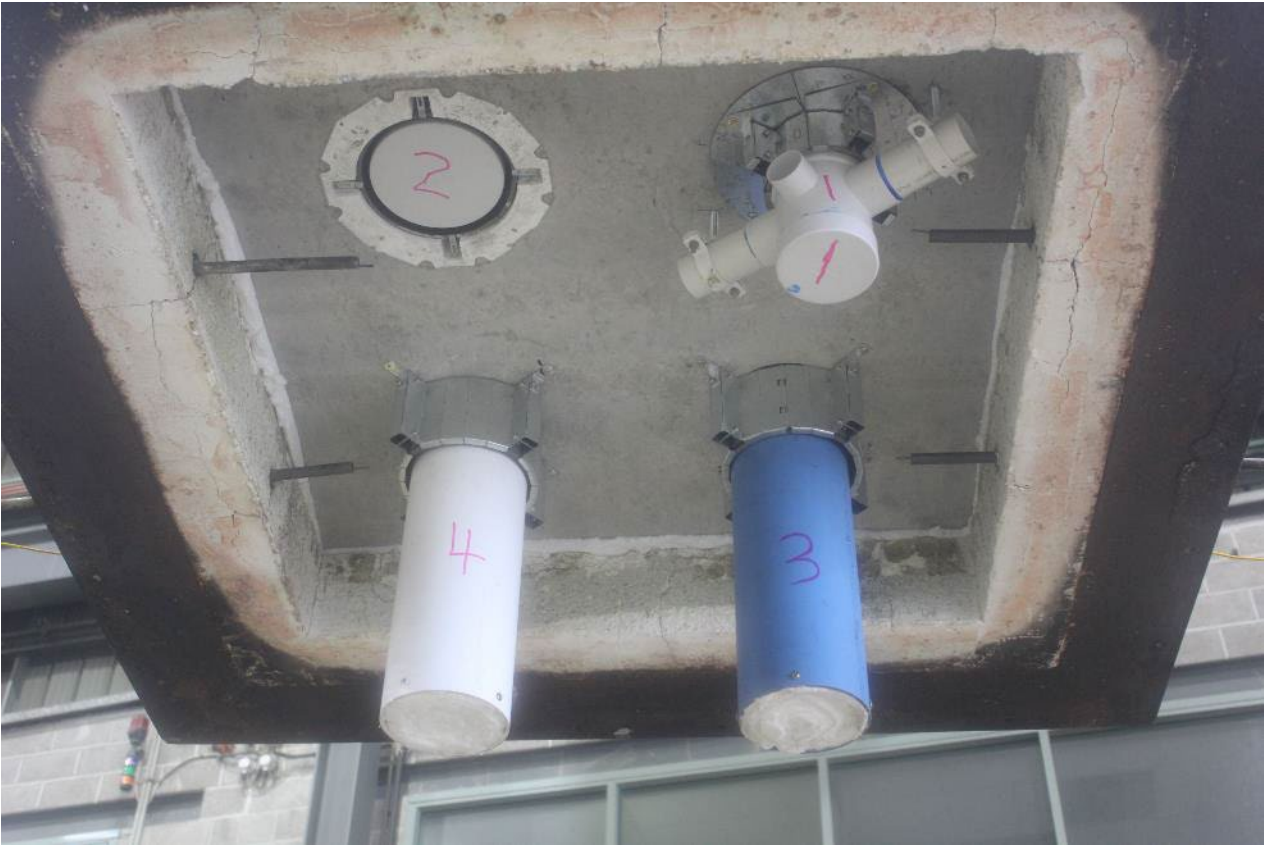
PHOTOGRAPH 1 – EXPOSED FACE OF SPECIMENS PRIOR TO TESTING

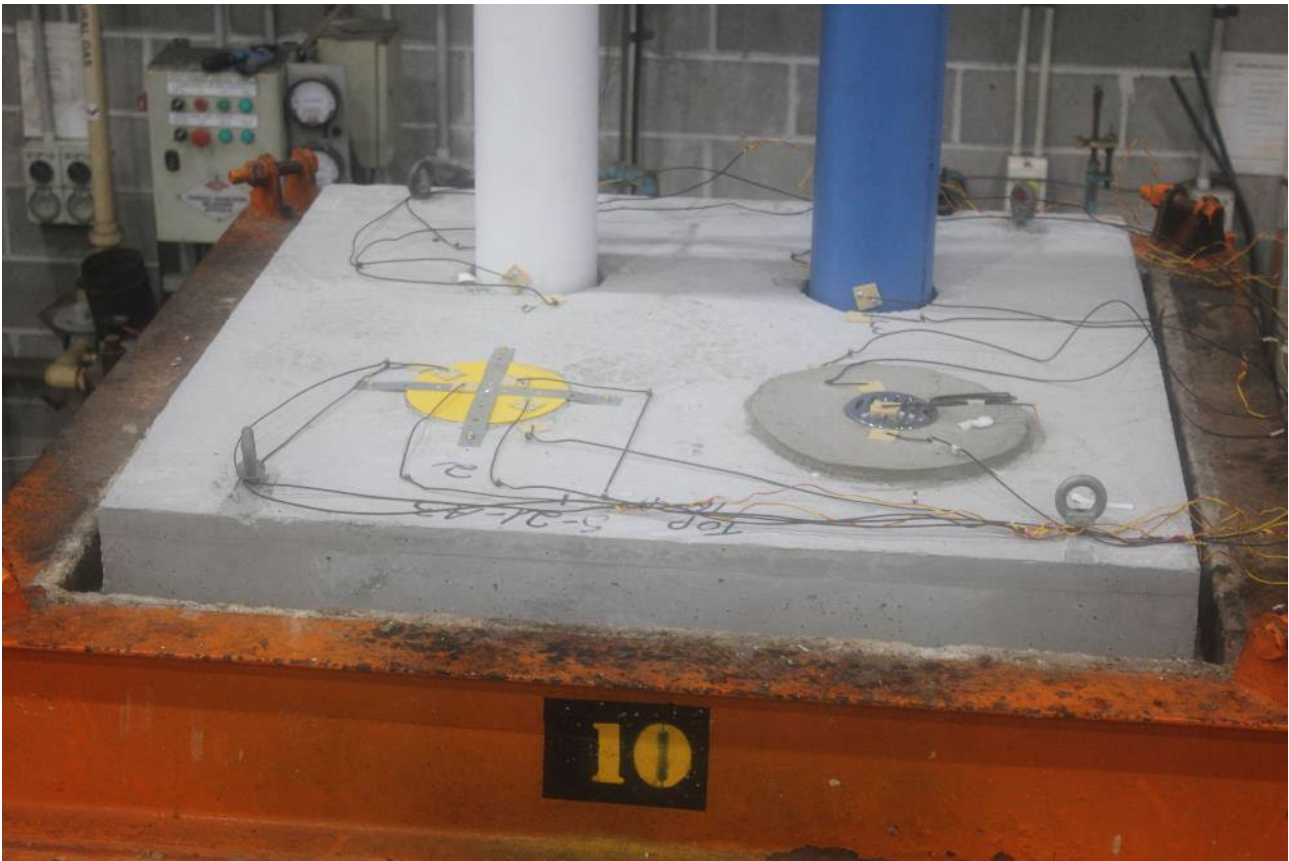
PHOTOGRAPH 3 – UNEXPOSED FACE OF SPECIMENS PRIOR TO TESTING

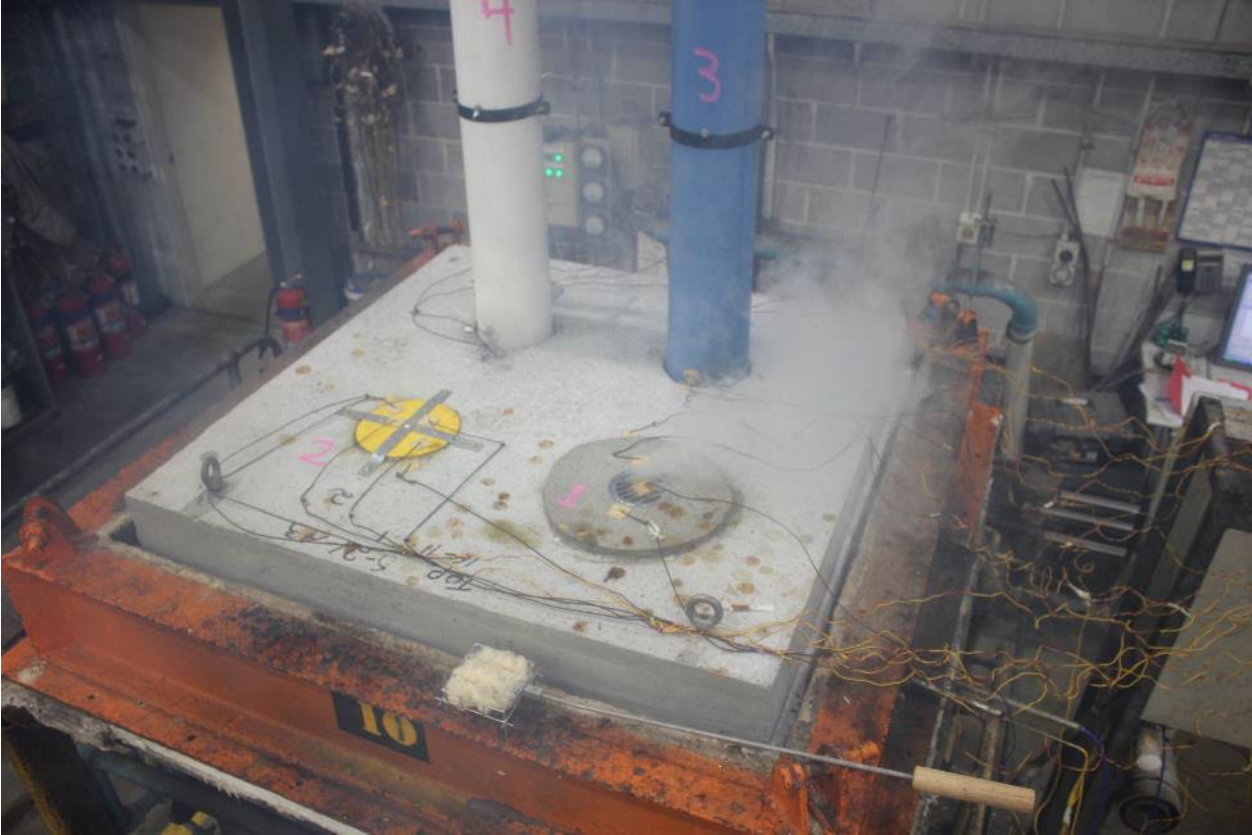
PHOTOGRAPH 4 – SPECIMENS AT 8 MINUTES INTO THE TEST

Time	Observation
1 minute -	Smoke is being emitted between the concrete slab and the pipes of Specimens 3 and 4.
3 minutes -	Smoke is fluing from the end of the pipes of Specimens 3 and 4.
4 minutes -	Smoke has begun fluing from the floor waste grate of Specimen 1.
6 minutes -	Smoke fluing from end of the pipes of Specimens 3 and 4 has reduced.
9 minutes -	Smoke has ceased fluing from the end of the pipe of Specimen 4.
14 minutes -	Light discolouration (smoke staining) is visible on the base of the pipes of Specimens 3 and 4.

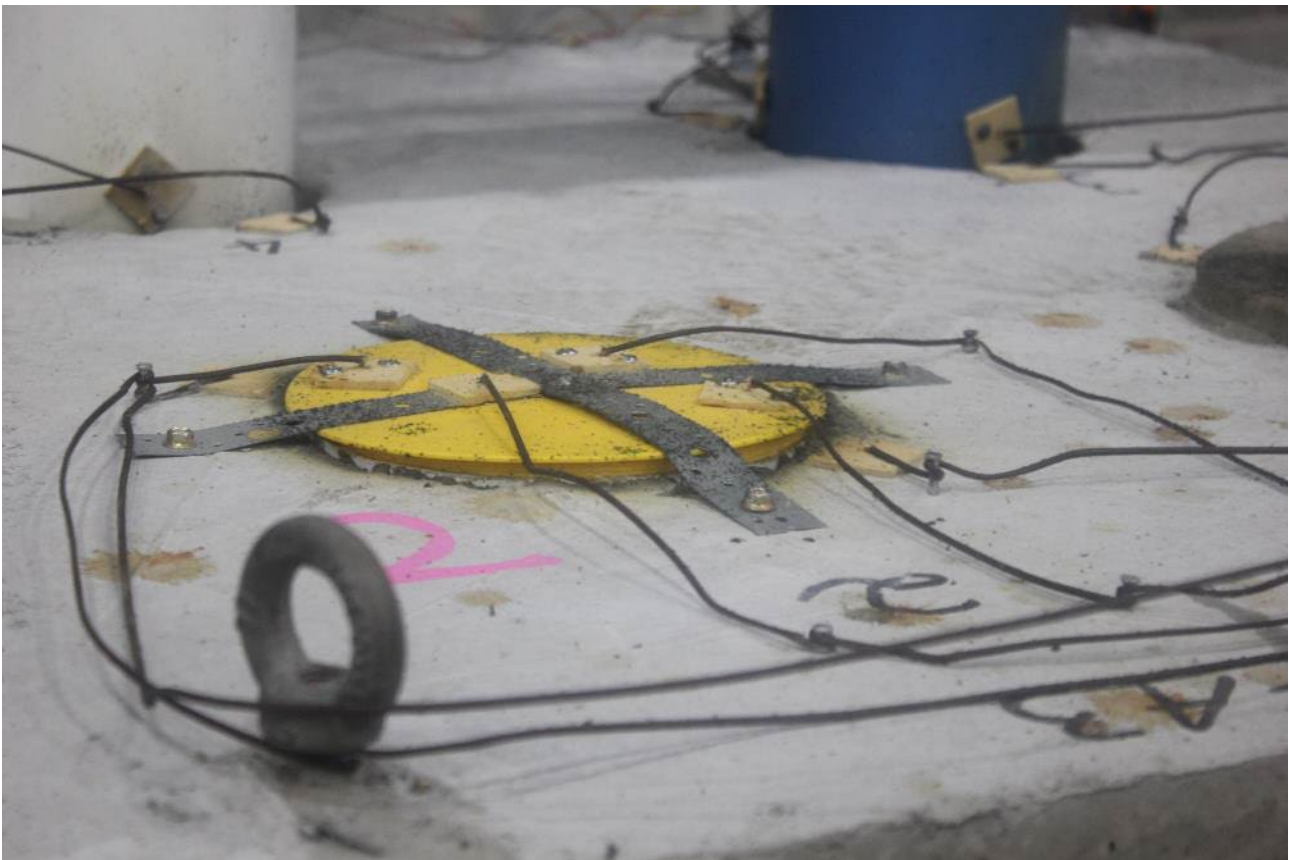
PHOTOGRAPH 6 – SPECIMEN 2 AT 39 MINUTES INTO THE TEST

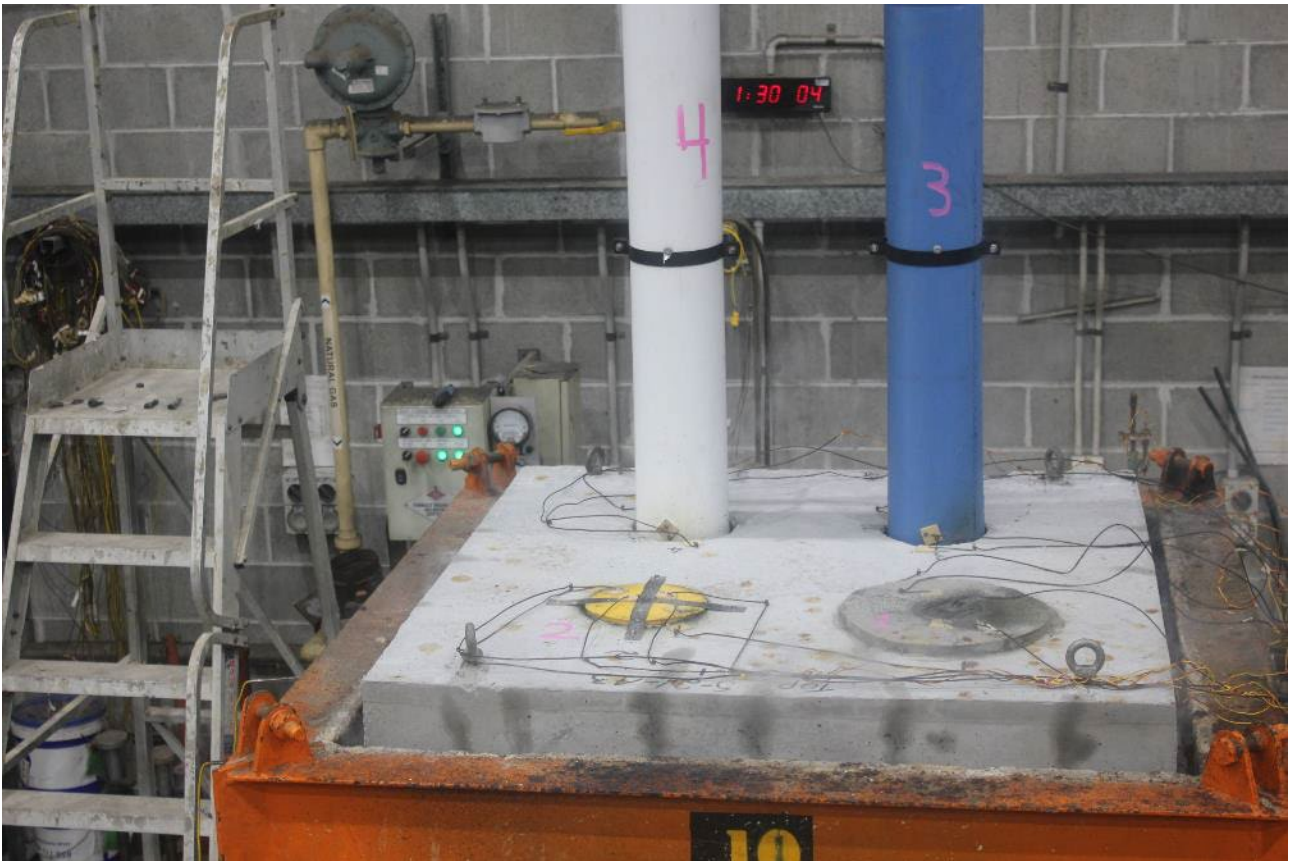
PHOTOGRAPH 8 – SPECIMENS AT 90 MINUTES INTO THE TEST

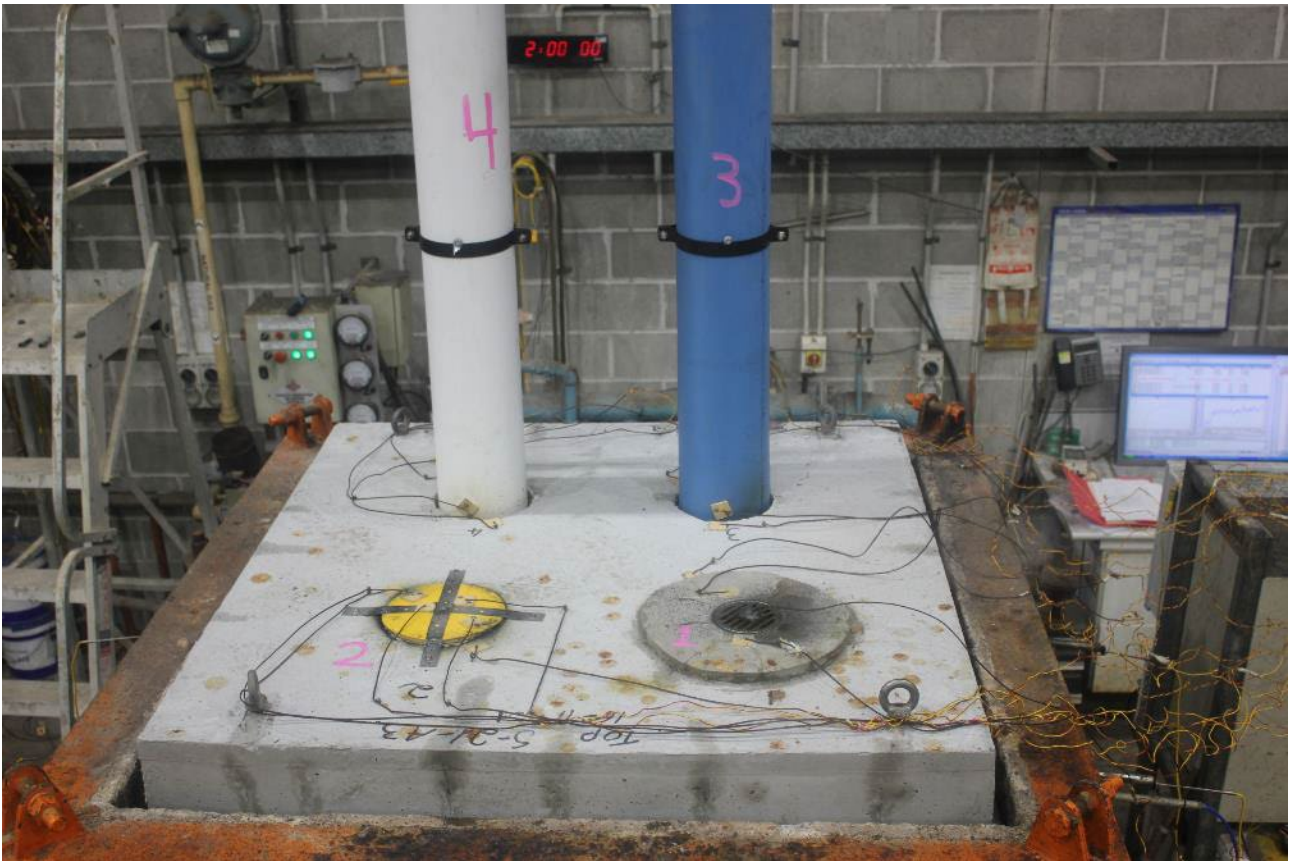
PHOTOGRAPH 9 – SPECIMENS AT 120 MINUTES INTO THE TEST

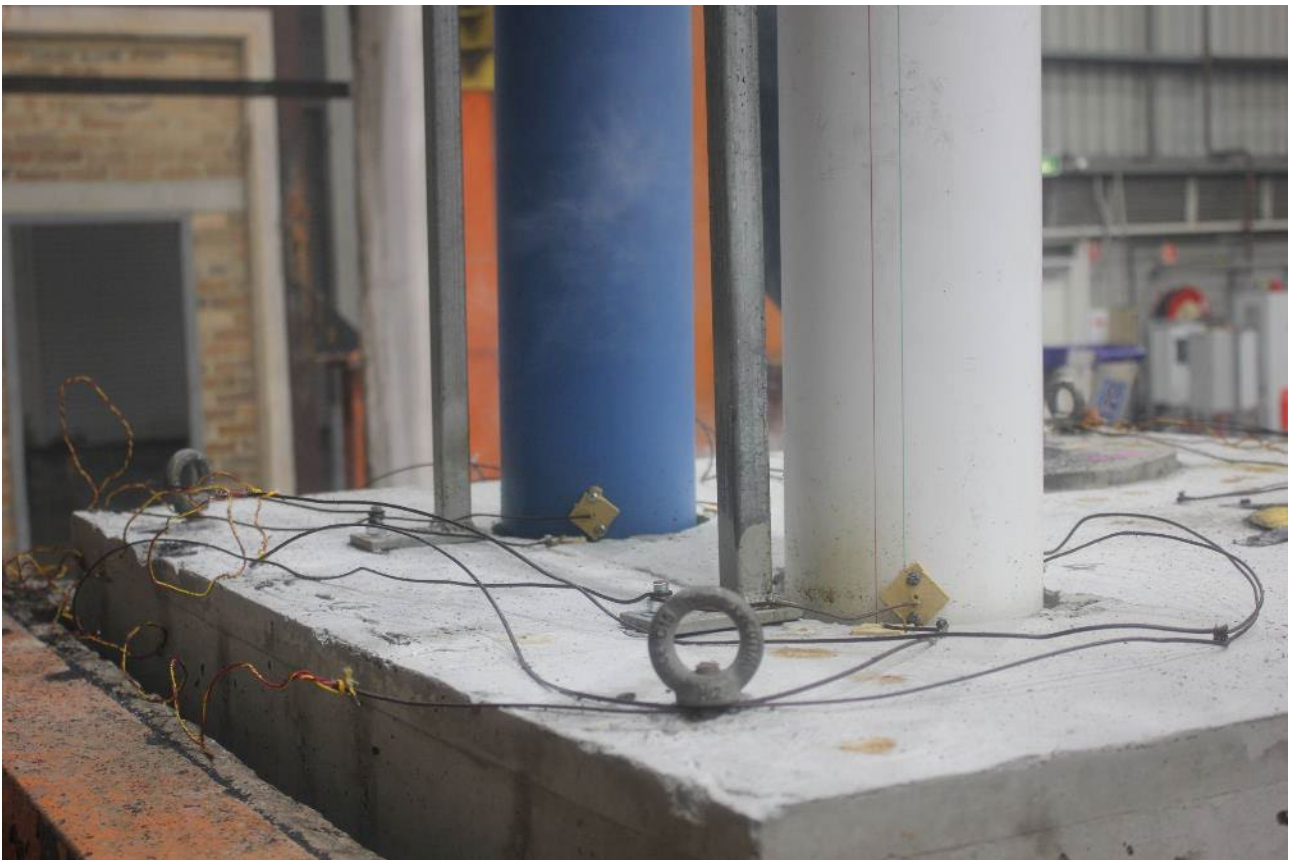
PHOTOGRAPH 10 – SPECIMENS 3 AND 4 AT 133 MINUTES INTO THE TEST

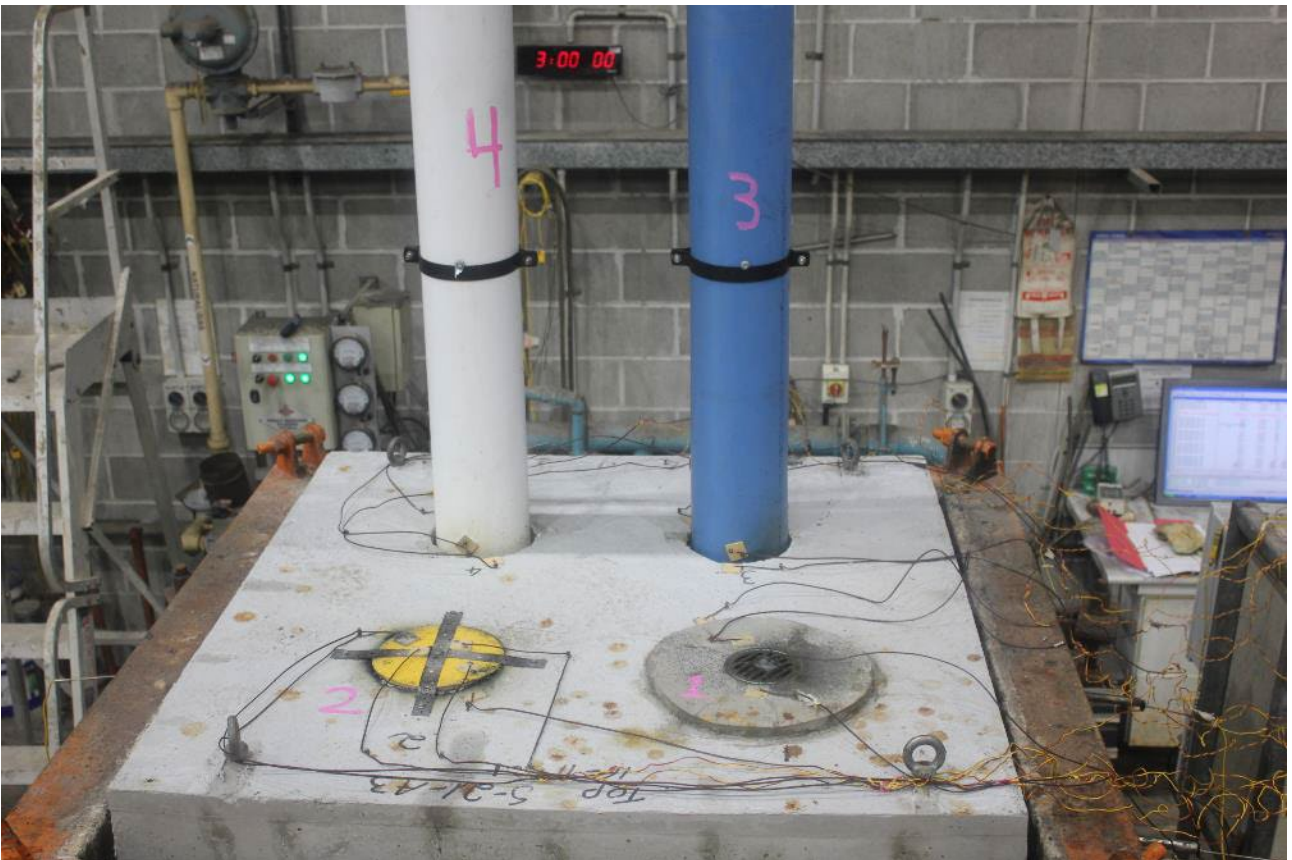
PHOTOGRAPH 12 – SPECIMENS AT 180 MINUTES INTO THE TEST

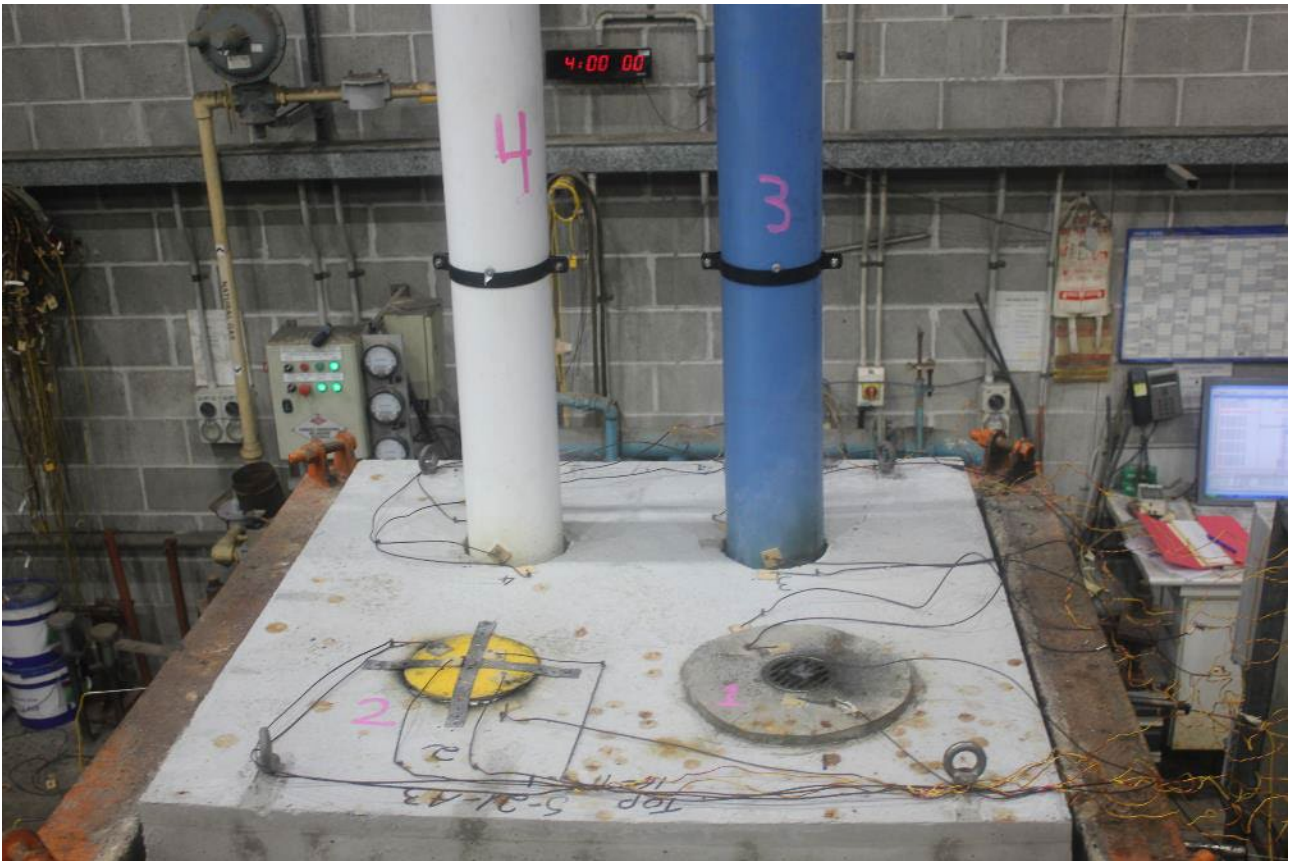
PHOTOGRAPH 13 – SPECIMENS AT 240 MINUTES INTO THE TEST.

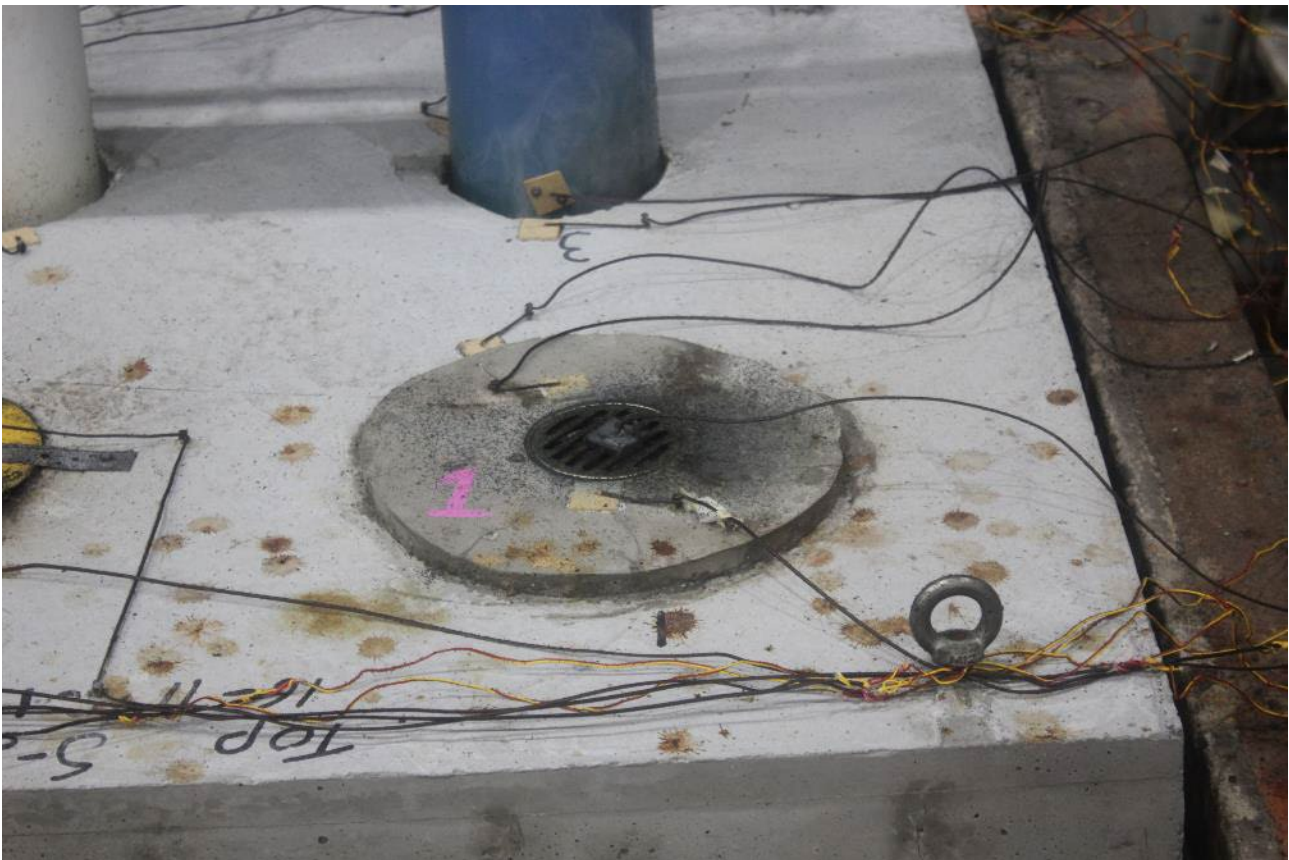
PHOTOGRAPH 14 – SPECIMENS AT THE CONCLUSION OF TESTING

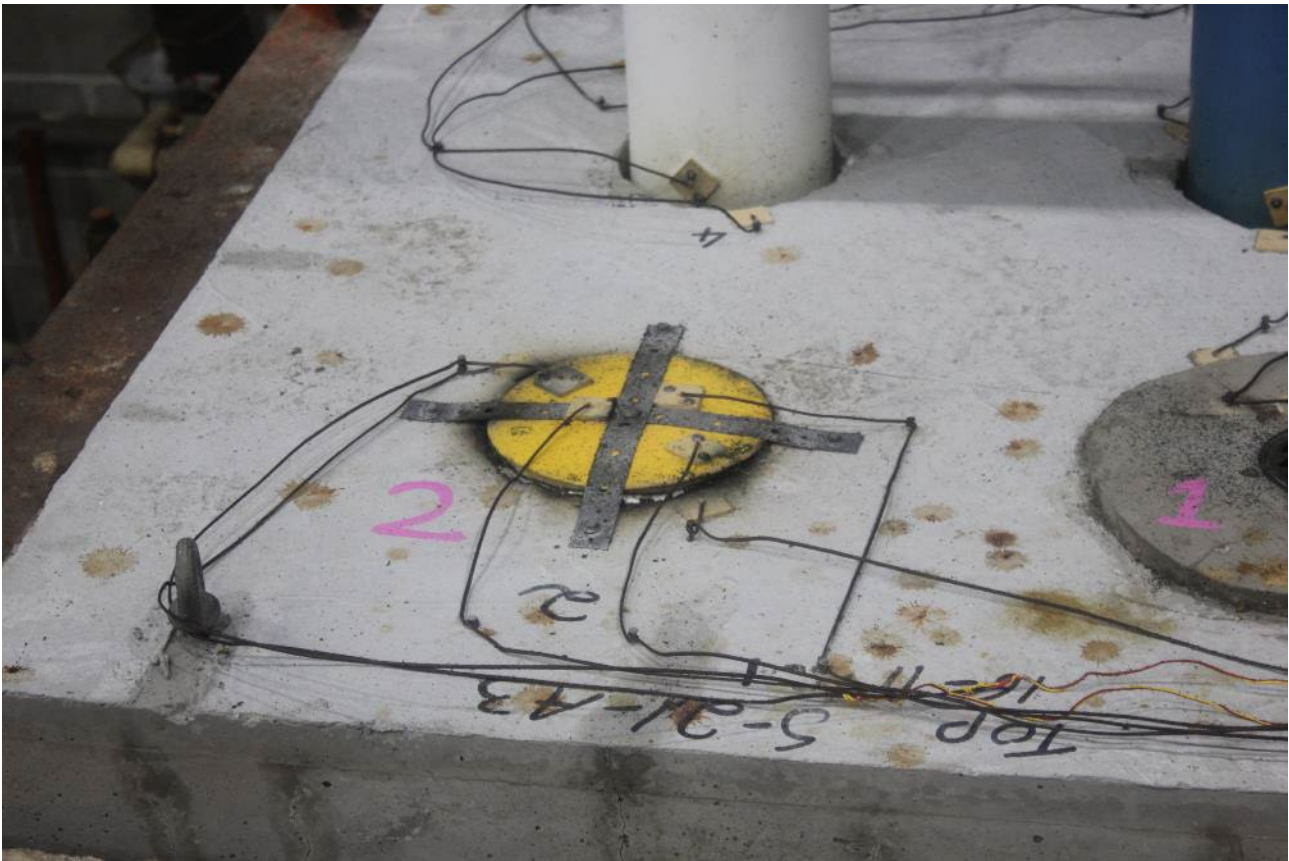
PHOTOGRAPH 15 – SPECIMENS AT THE CONCLUSION OF TESTING

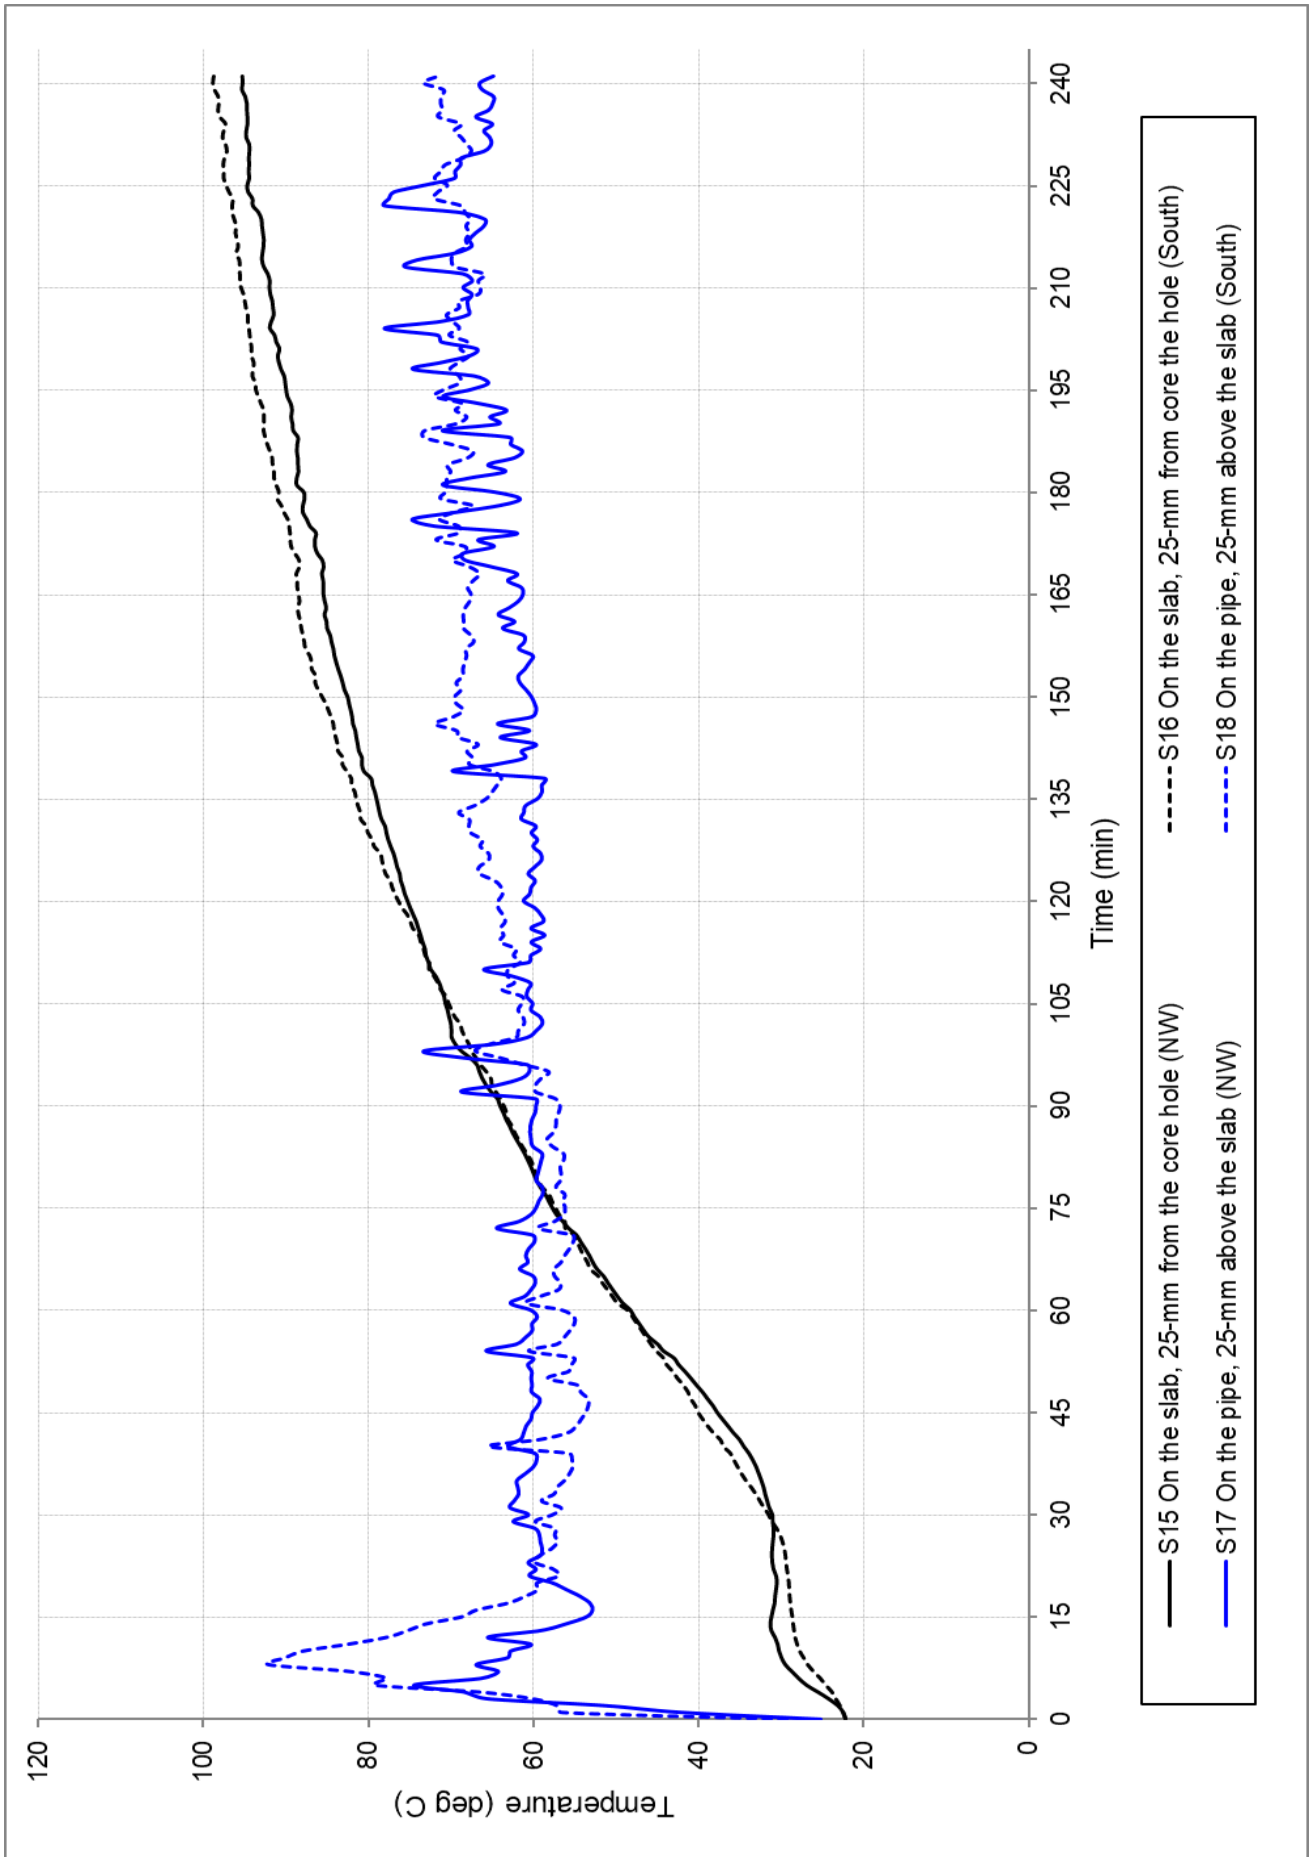
FIGURE 7 – SPECIMEN TEMPERATURE – ASSOCIATED WITH SPECIMEN 4

Structural adequacy	-	not applicable
Integrity	-	no failure at 241 minutes
Insulation	-	no failure at 241 minutes

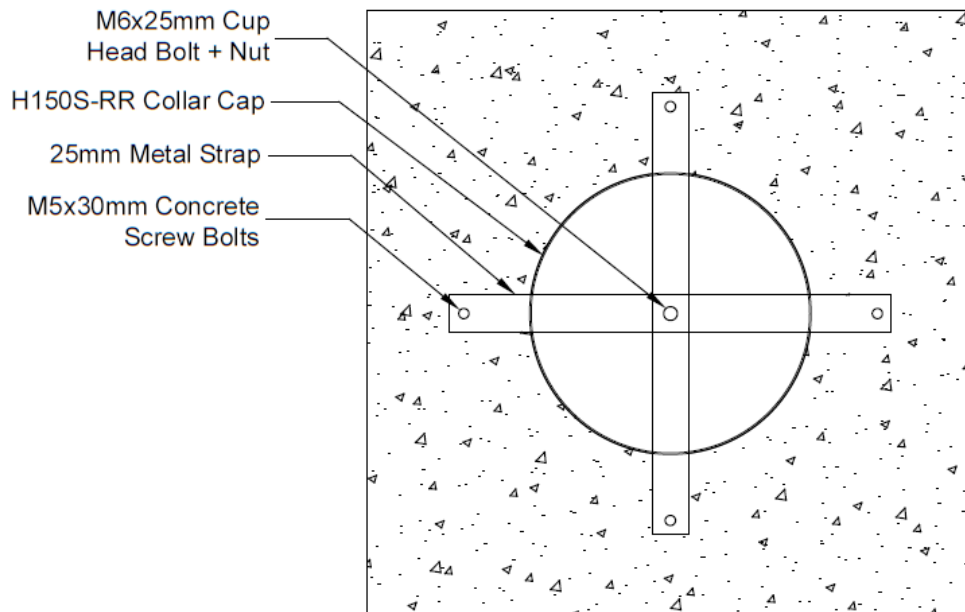
150 PVC(SC) Plug & H150S-RR

DRAWING TITLED 'SPECIMEN #2 50 TRIPLUS FLOOR WASTE & H50FWS-RR', DATED 15 FEBRUARY 2022 BY SNAP FIRE SYSTEMS PTY LTD

The H150S-RR fire collar was cast into a 150-mm thick concrete slab with the collar casing cut down to 150-mm high to finish flush with the unexposed face of the concrete slab.

The opening inside the sleeve of the SNAP H150S-RR Cast-in fire collar was protected with a blank penetration seal. The blank penetration seal comprised a SNAP H150S-RR collar cap incorporating a small section of uPVC pipe located inside the collar's sleeve. The Iplex DWV uPVC (sandwich construction) pipe was approximately 140-mm long, had a 160-mm outside diameter and a nominal wall thickness of 4.68-mm and incorporated PVC endcaps glued to both ends using PVC adhesive. The top PVC end cap was centrally fixed to the underside of the H150S-RR collar cap and with a M6 x 25-mm cup head bolt, nut and a 17-mm washer. The blank penetration seal was friction fitted into the sleeve of the SNAP H150S-RR fire collar from the unexposed face and fixed in place using two 25-mm wide x 230-mm long metal straps that were attached through the central bolt and screw fixed to the concrete slab with four M5 x 30-mm concrete screws as shown in drawing titled "Specimen #2, 150 PVC(SC) Plug and H150S-RR", dated 24 February 2022, by Snap Fire Systems Pty Ltd.

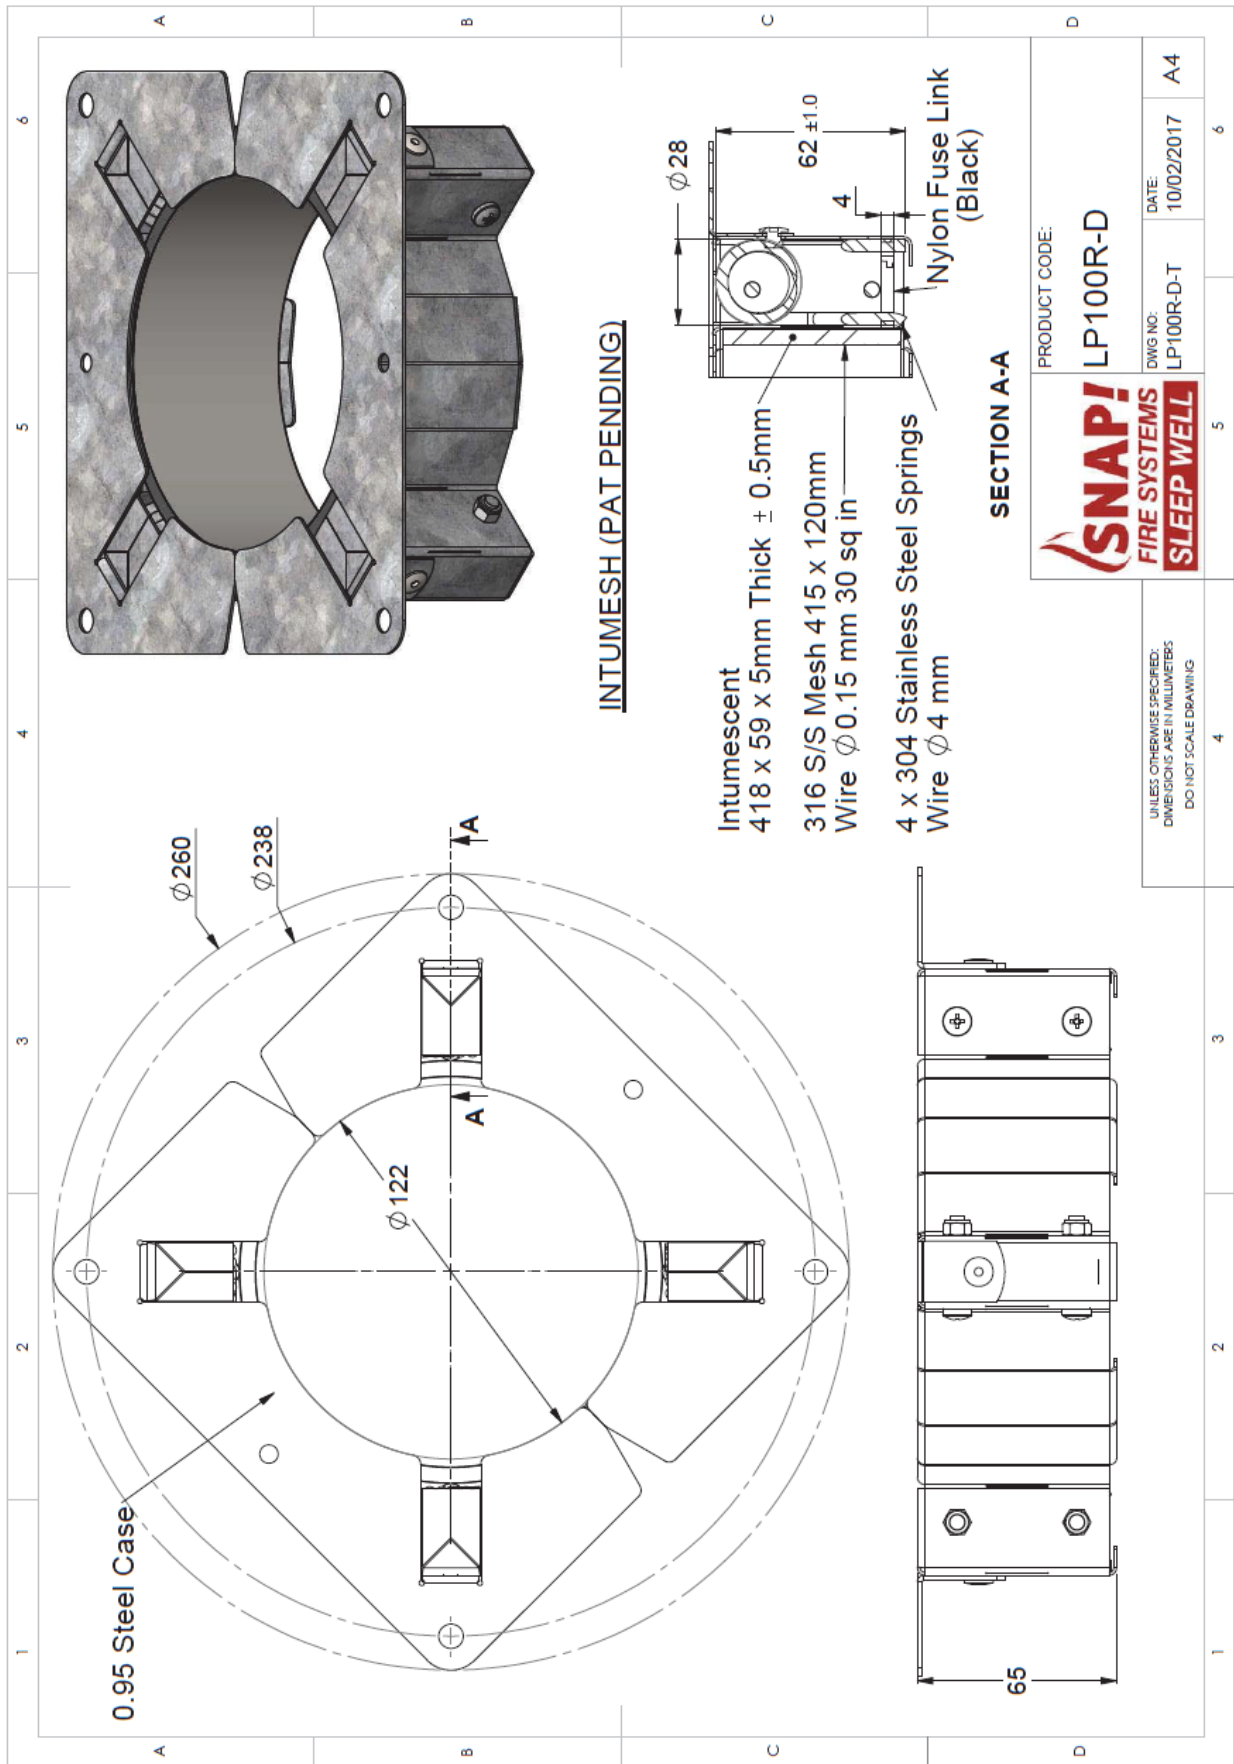
DRAWING NUMBERED LP100R-D-T, DATED 10 FEBRUARY 2017, BY SNAP FIRE SYSTEMS PTY LTD

The SNAP LP100R-D Low Profile Retrofit fire collar comprised a 0.95-mm steel casing with a 122-mm inner diameter and a 260-mm diameter base flange. The 65-mm high collar casing incorporated a closing mechanism which comprised a 5-mm thick x 59-mm wide x 418-mm long Intumesh intumescent wrap lined within the internal circumference of the collar casing. The closing mechanism comprised four 4-mm diameter 304 stainless steel springs with black nylon fuse links and a 415-mm long x 120-mm wide mesh with a wire diameter of 0.15-mm as shown in drawing numbered LP100R-D-T dated 10 February 2017, by Snap Fire Systems Pty Ltd.
