Fire-resistance test on fire collars protecting a concrete slab penetrated by services

Test Report

Author: Peter Gordon
Report number: FSP 2298
Date: 6 October 2022

Sponsored Investigation No. FSP 2298

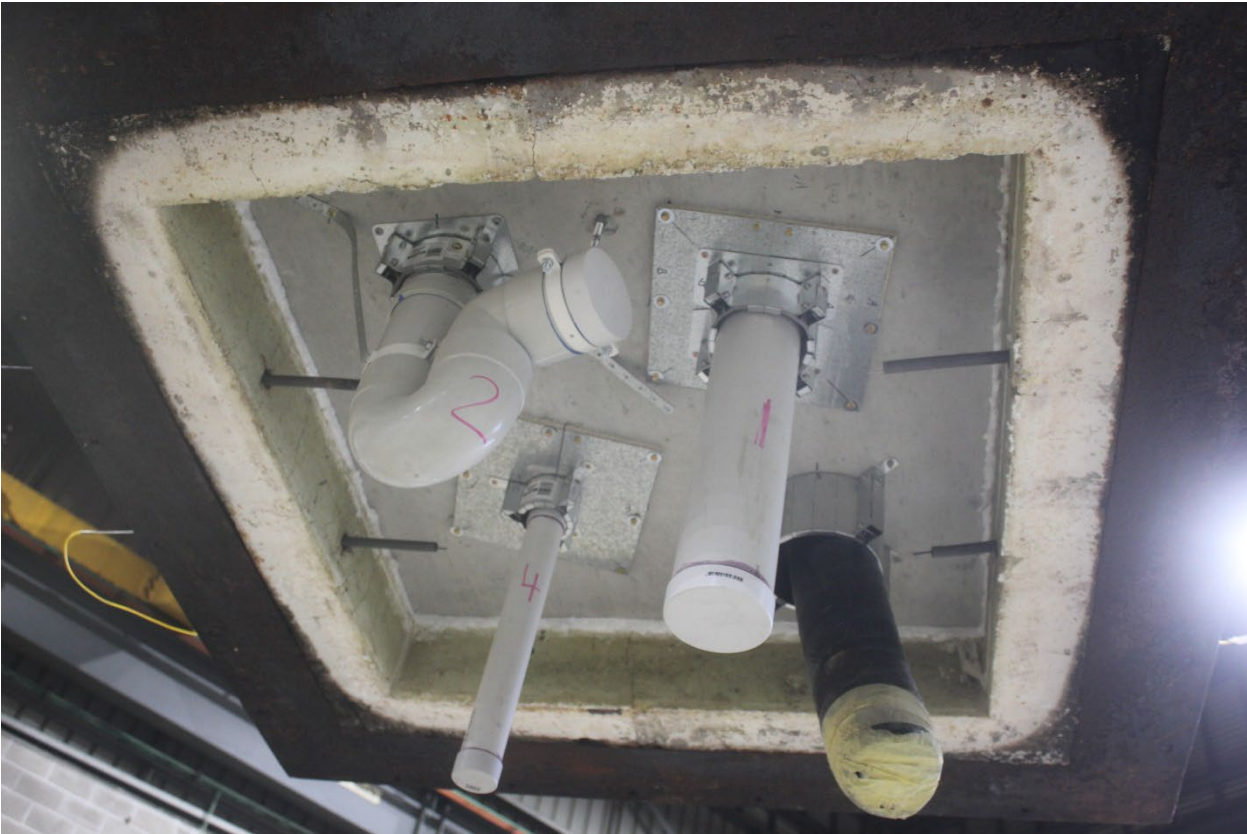
PHOTOGRAPH 1 – EXPOSED FACE OF SPECIMENS PRIOR TO TESTING

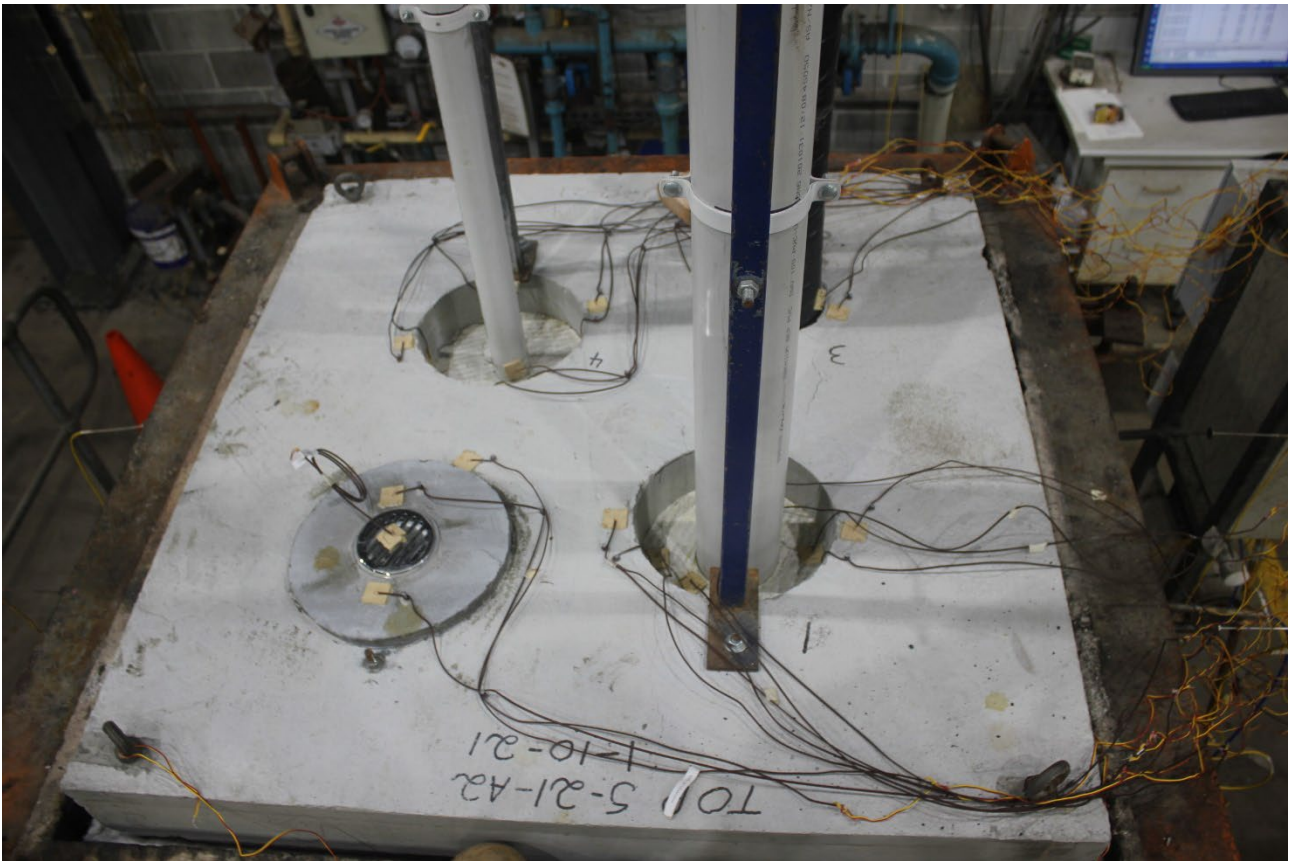
PHOTOGRAPH 3 – UNEXPOSED FACE OF SPECIMENS PRIOR TO TESTING

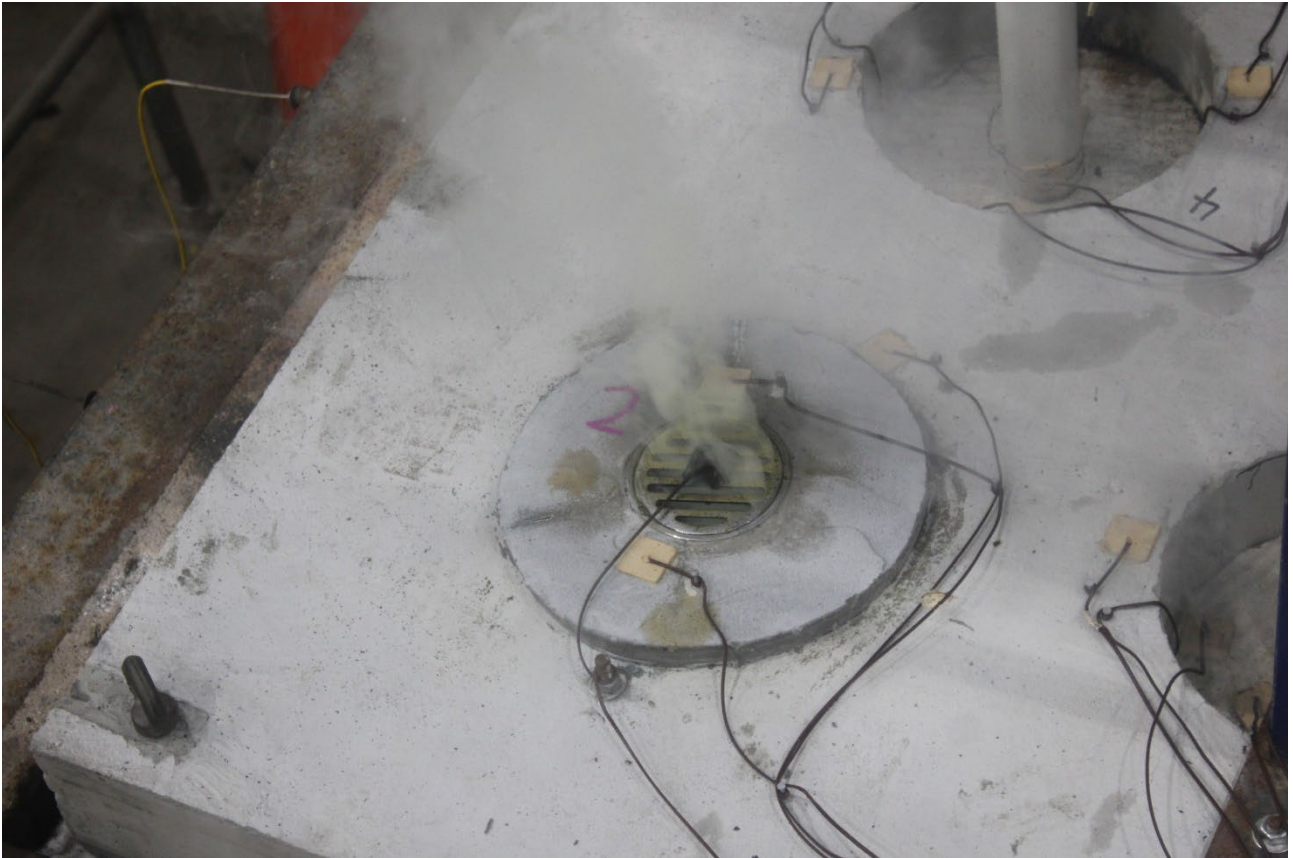
PHOTOGRAPH 8 – SPECIMEN 2 AT 80 MINUTES INTO THE TEST

- 78 minutes - The light grey smoke is fluing from the floor waste grate of specimen 2 and has now changed to a greenish colour.
- 102 minutes - Insulation failure of specimen 4 - maximum temperature rise of 180K is exceeded on the slab inside the core hole, 25-mm above the batt (west side) at the base of the specimen.

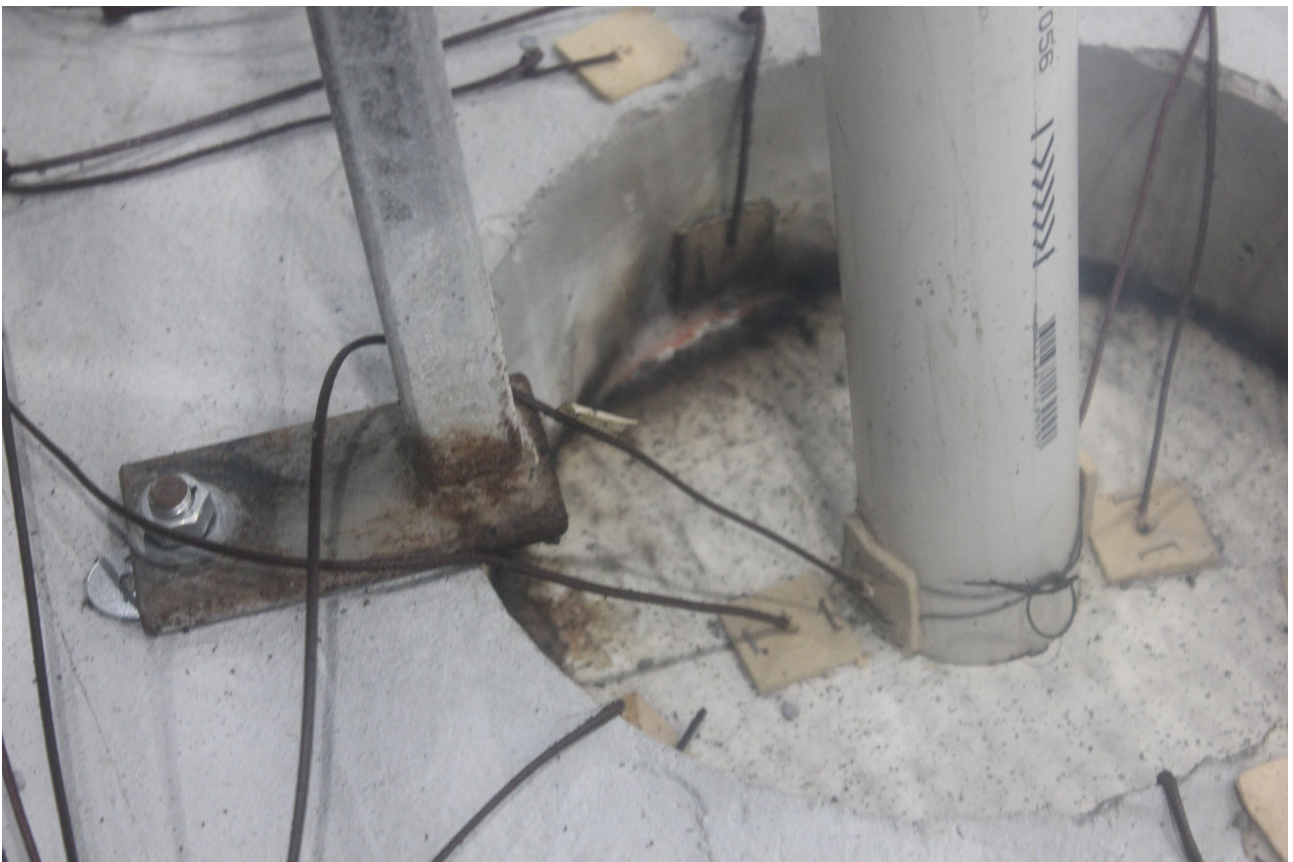
PHOTOGRAPH 10 – SPECIMEN 4 AT 104 MINUTES INTO THE TEST

- 104 minutes - A red glow is visible between the batt and the core hole (east side) at the base of specimen 4 (photograph 10). Cotton pad test was applied at the base of Specimen 4 – no ignition noted at this time.

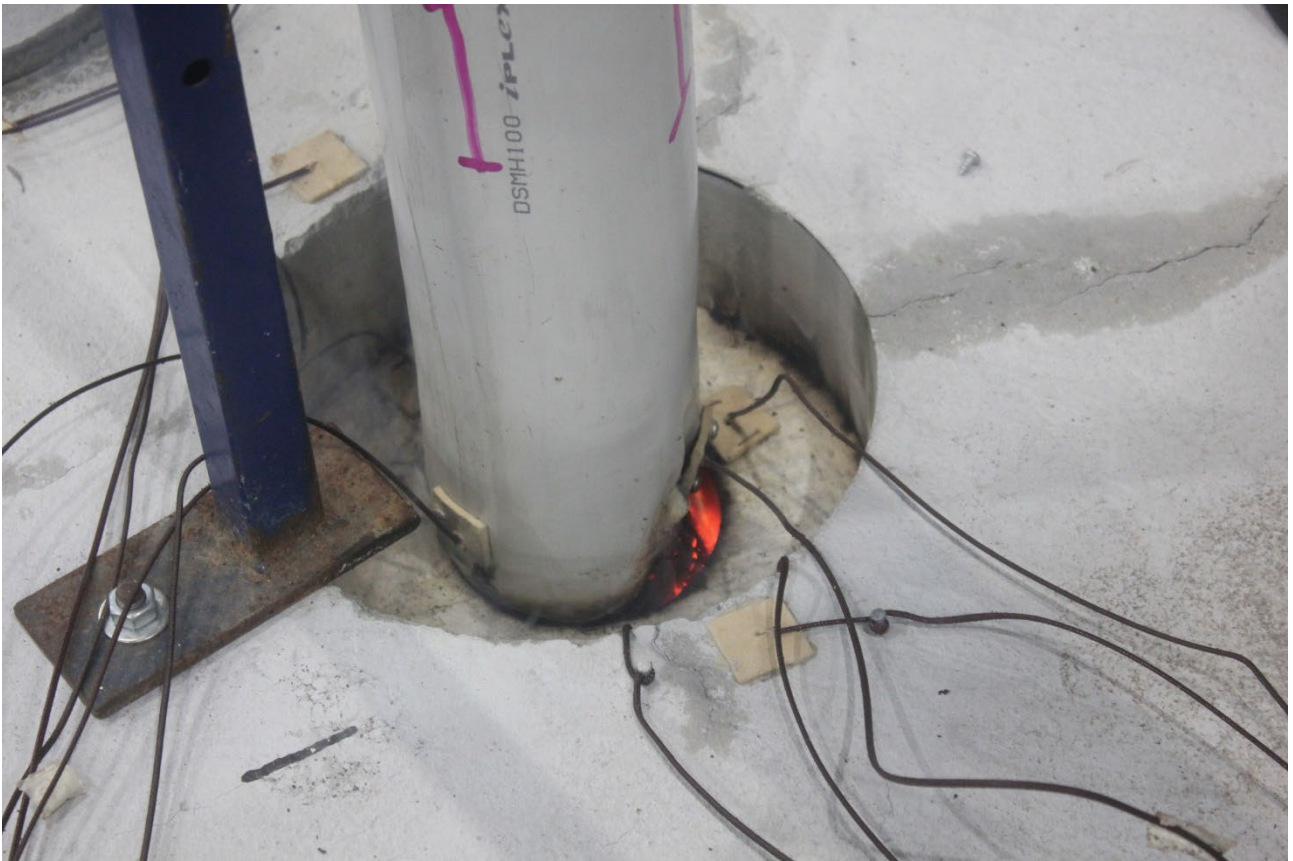
PHOTOGRAPH 13 – SPECIMEN 1 AT 154 MINUTES INTO THE TEST

- 156 minutes - Insulation failure of specimen 1 - maximum temperature rise of 180K is exceeded on the batt, 25-mm from the slab (east side) at the base of the specimen.
The pipe at the base of specimen 1 has melted leaving a void and a red glow into the furnace visible. Cotton pad test was applied over the void – no ignition noted at this time.

- 158 minutes - Integrity failure of specimen 1 - Cotton pad test applied over the void where a red glow is visible at the base of specimen 1, ignition of cotton pad noted at this time.

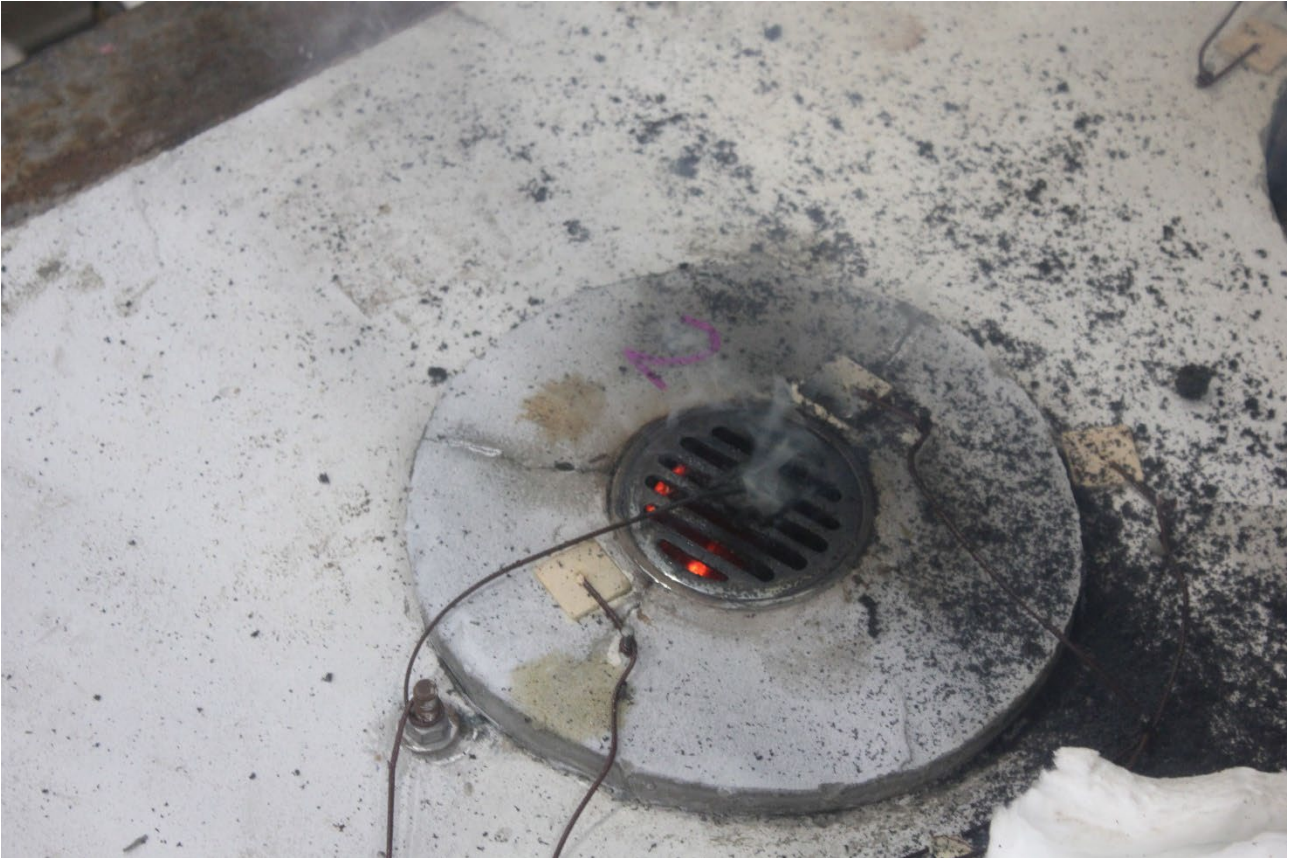
PHOTOGRAPH 15 – SPECIMEN 2 AT 185 MINUTES INTO THE TEST.

- 188 minutes - A bright orange glow of the furnace chamber is visible through the floor waste grate of specimen 2.
Integrity failure of specimen 2 - Cotton pad test applied over the floor waste grate of specimen 2, ignition of cotton pad noted at this time.

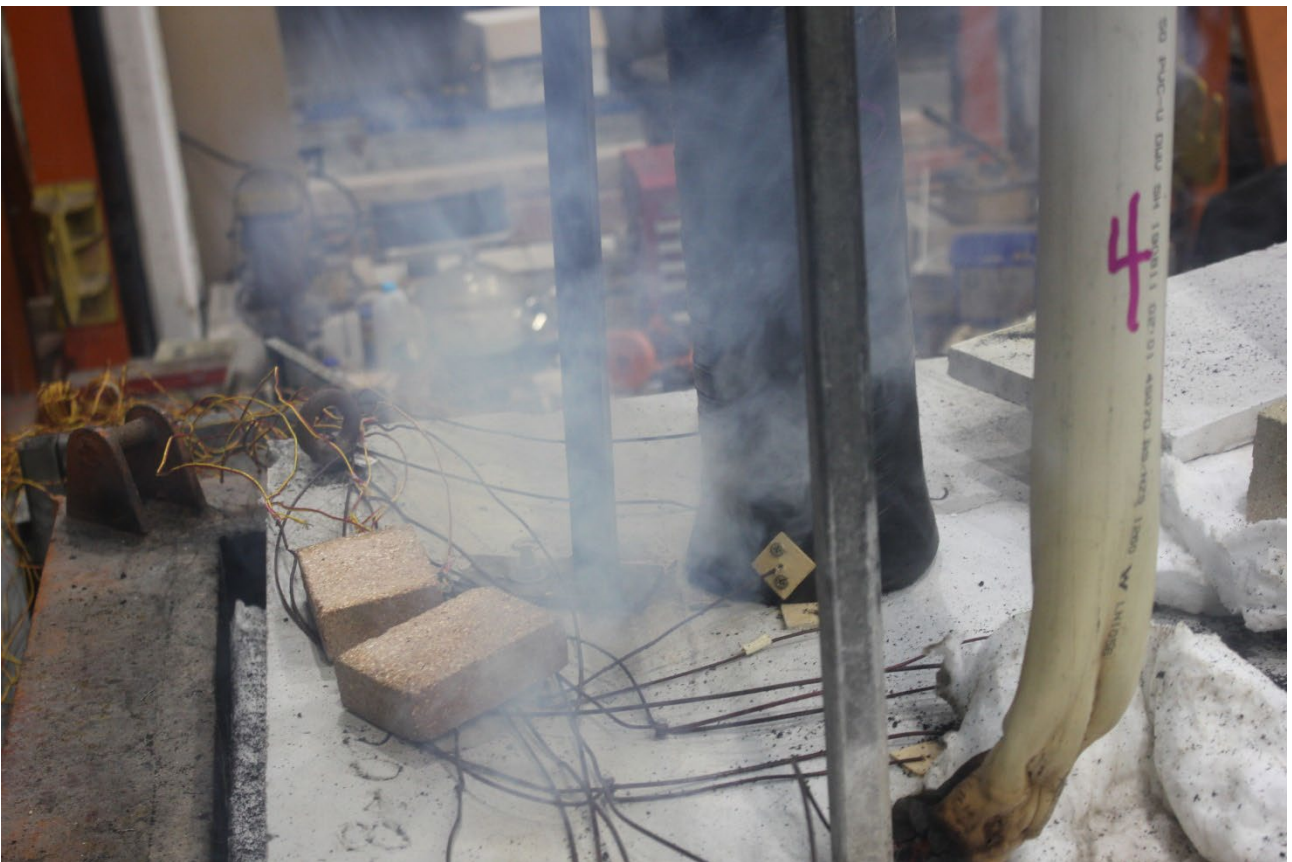
PHOTOGRAPH 18 – SPECIMEN 3 AT 215 MINUTES INTO THE TEST

- 218 minutes - Insulation and Integrity failure of specimen 3 - Cotton pad test applied over the split in the Python pipe at the base of specimen 3, ignition of cotton pad noted at this time.
Sustained flaming at the base of specimen 3 noted at this time, test terminated.

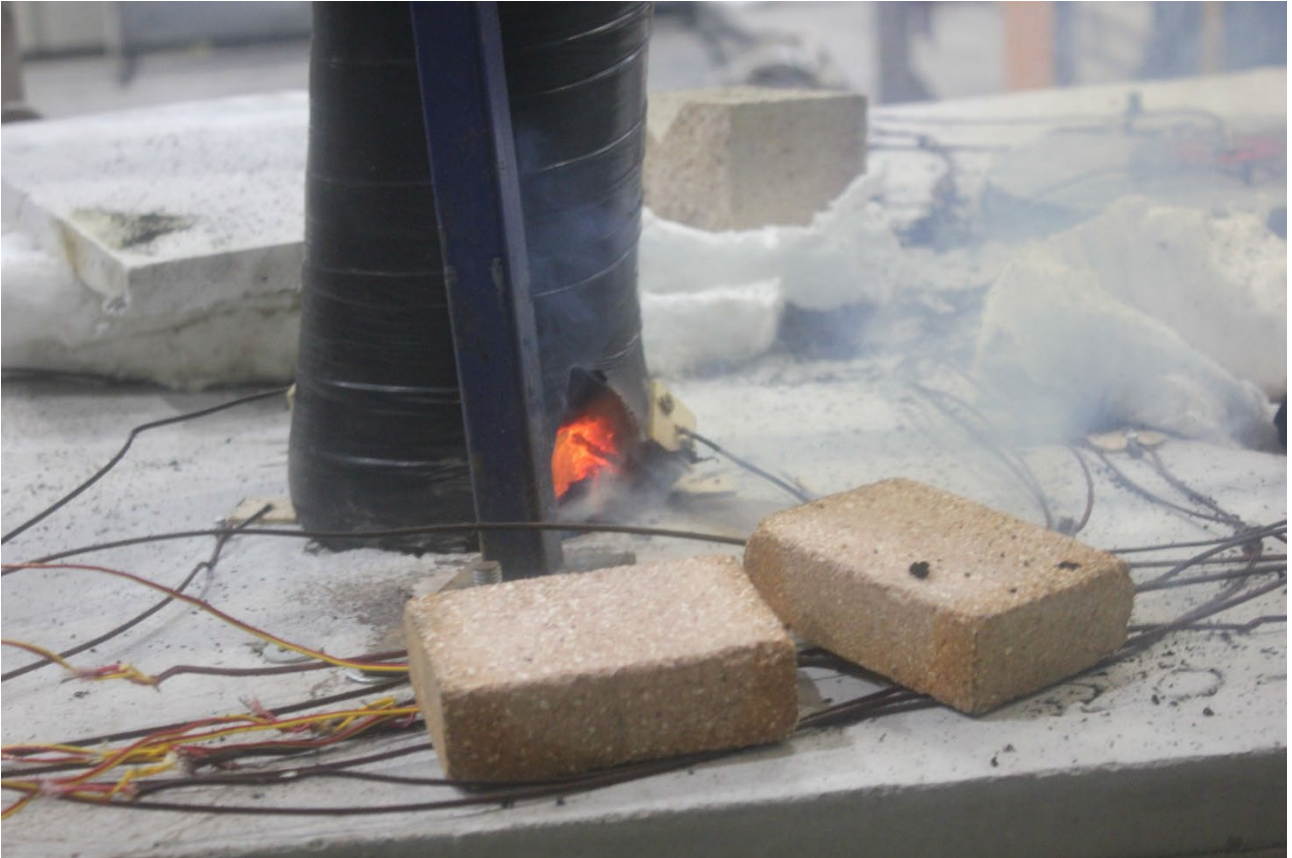
PHOTOGRAPH 19 – SPECIMEN3 AT 216 MINUTES INTO THE TEST
