Fire-resistance test on fire collars protecting a concrete slab penetrated by services

Test Report

Author: Peter Gordon
Report number: FSP 2315
Date: 22 November 2022

Sponsored Investigation No. FSP 2315

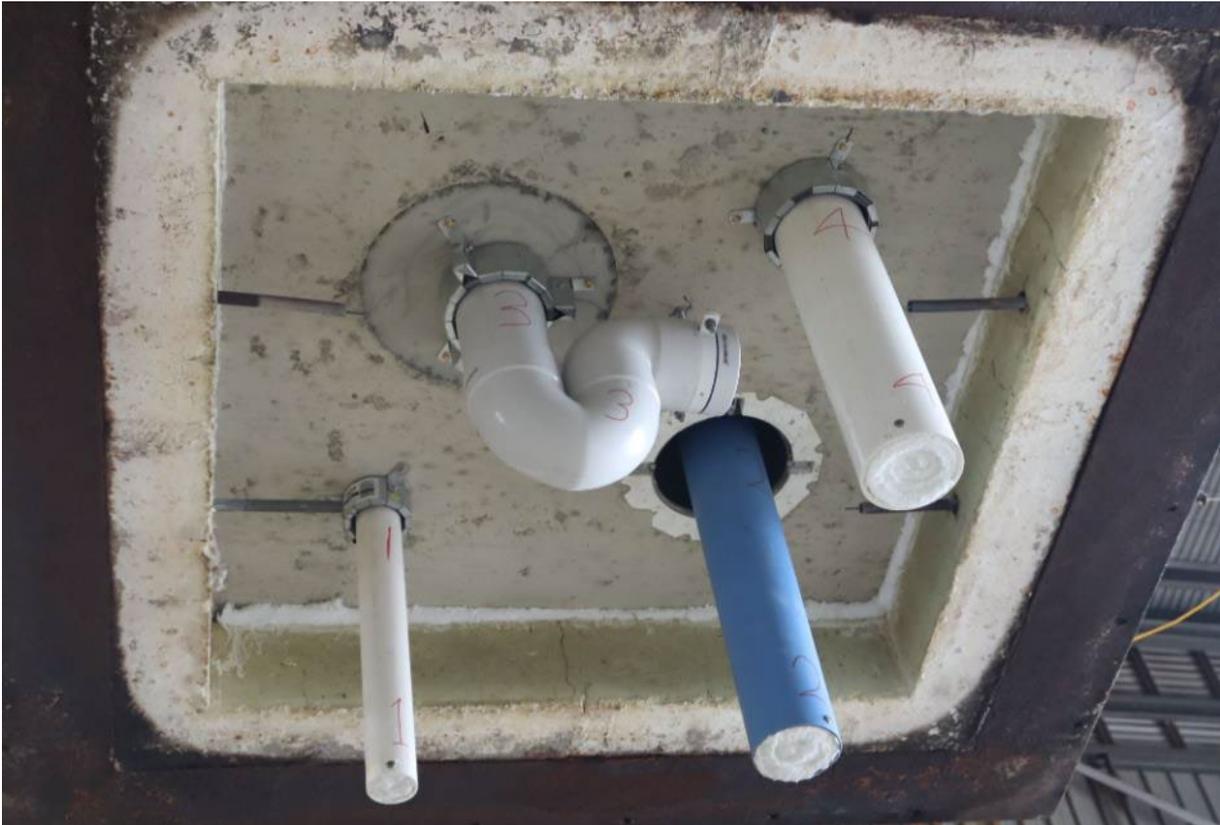
PHOTOGRAPH 1 – EXPOSED FACE OF SPECIMENS PRIOR TO TESTING

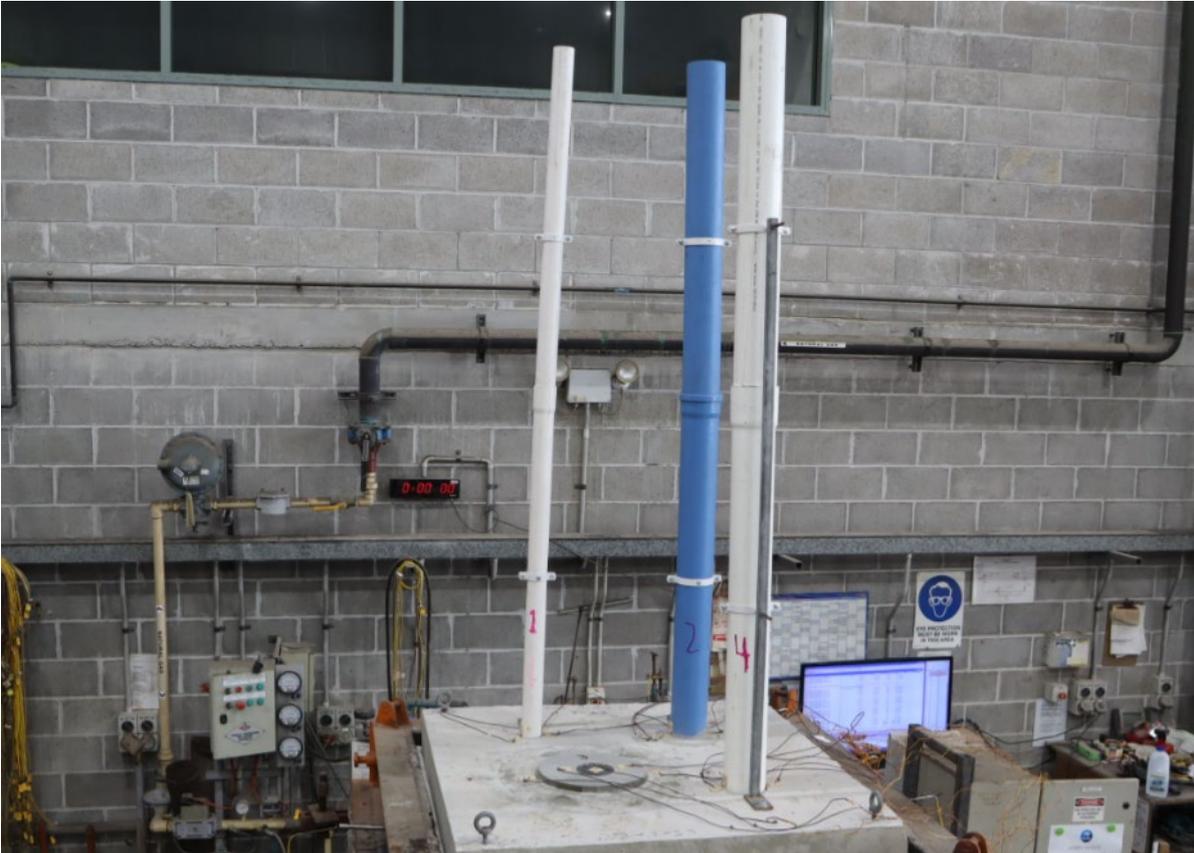
PHOTOGRAPH 2 – UNEXPOSED FACE OF SPECIMENS PRIOR TO TESTING

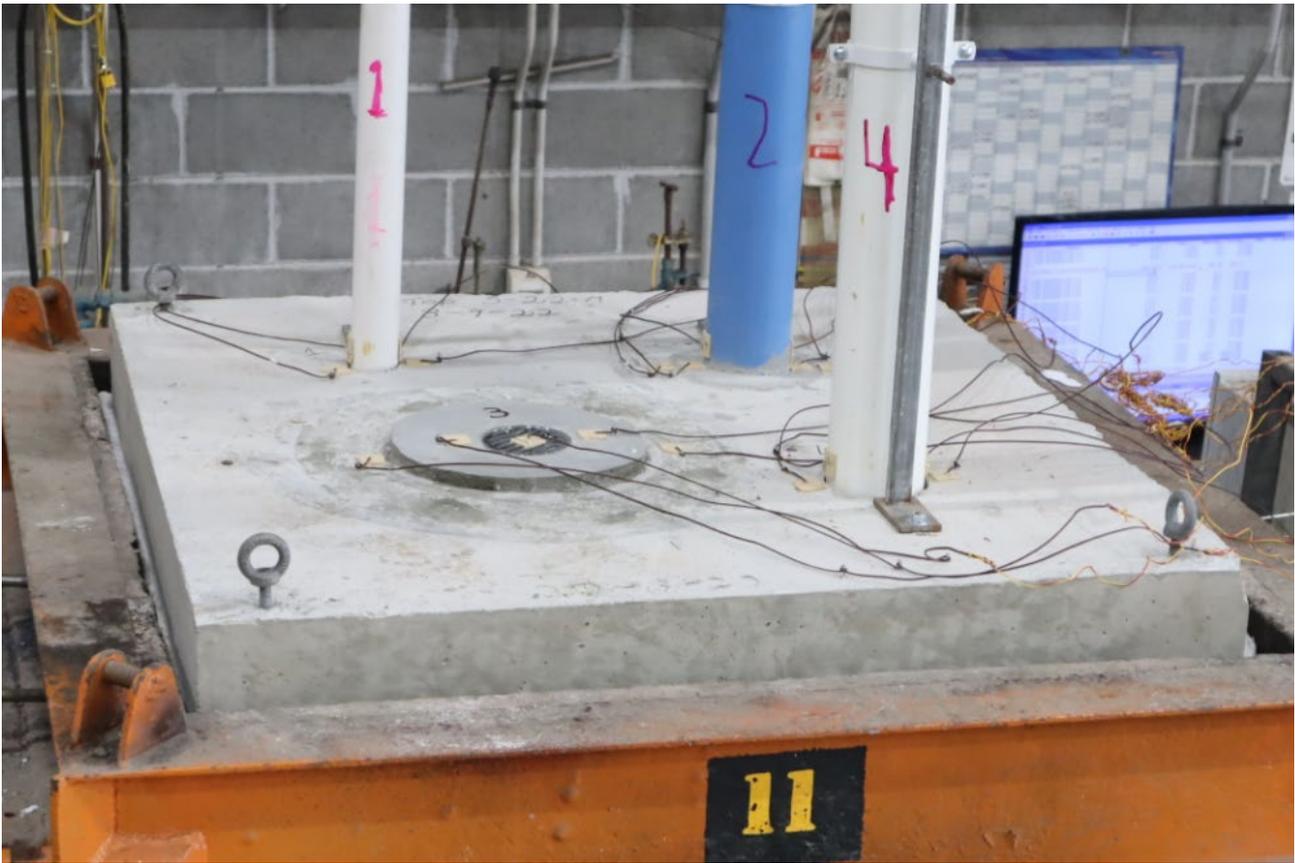
PHOTOGRAPH 3 – UNEXPOSED FACE OF SPECIMENS PRIOR TO TESTING

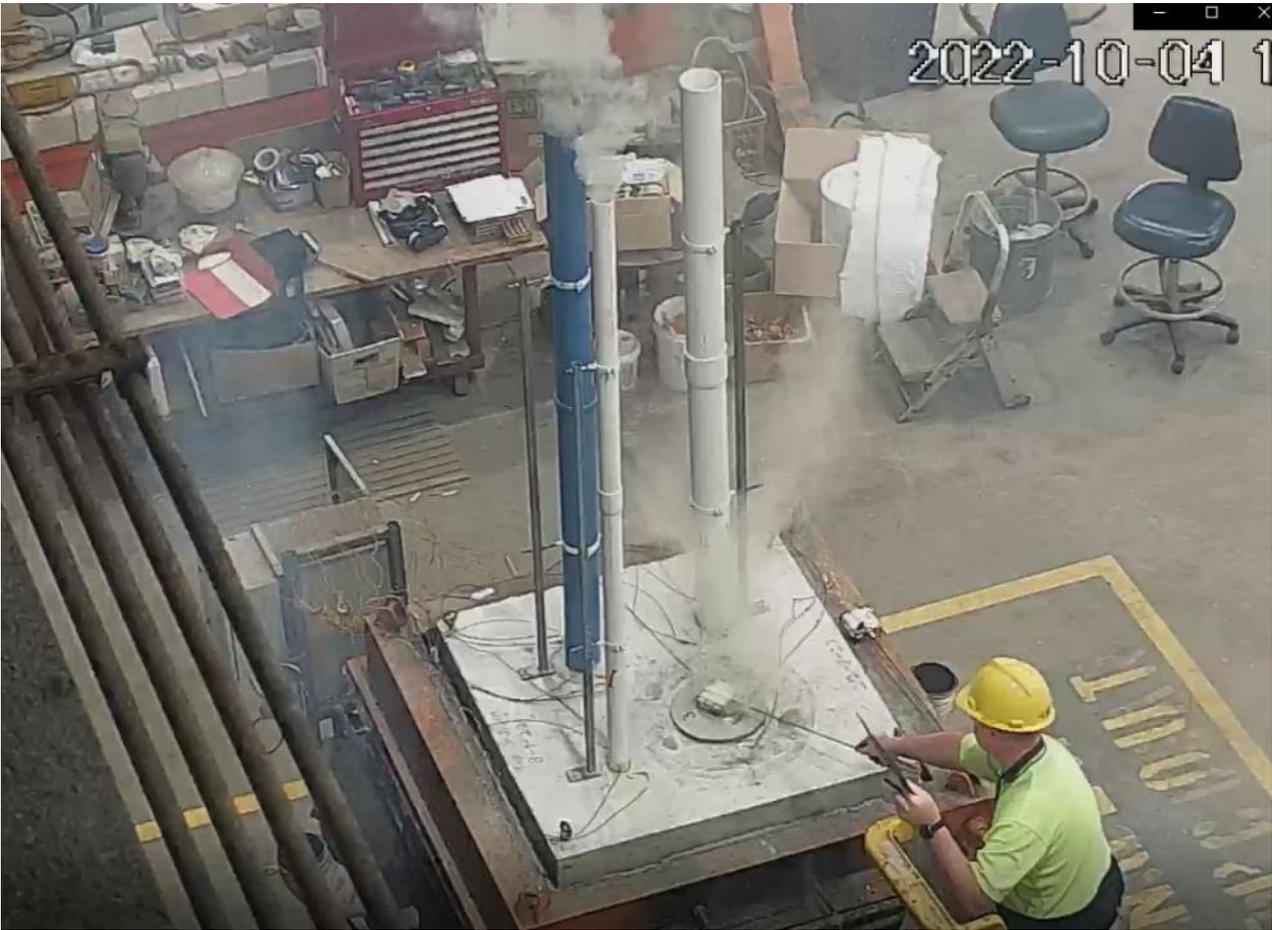
PHOTOGRAPH 4 – SPECIMENS AT 3 MINUTES INTO THE TEST

2:30 minutes -	Light smoke has begun fluing from the end of the pipe of specimen 2 for 5 seconds then ceased.
3:40 minutes -	Cotton pad test was applied above the grate of Specimen 3 – no ignition noted at this time (photograph 4). Smoke has begun fluing from the ends of the pipes of specimens 1 and 2.
4 minutes -	Smoke has begun fluing from the end of the pipe of specimen 4. Smoke has ceased fluing from the end of the pipe of specimen 1 and the floor waste grate of specimen 2.
5 minutes -	Smoke has ceased fluing from the pipe end of specimen 2.
8 minutes -	Smoke has ceased fluing from the pipe end of specimen 4.
9 minutes -	Smoke has ceased emitting between the slab and the pipe at the base of specimen 1.
11 minutes -	Smoke staining on the pipe at the base of specimen 4 is now visible.
14 minutes -	Smoke has ceased emitting between the slab and pipe at the base of specimen 4.
17 minutes -	Moisture is visible on the screed of specimen 3.

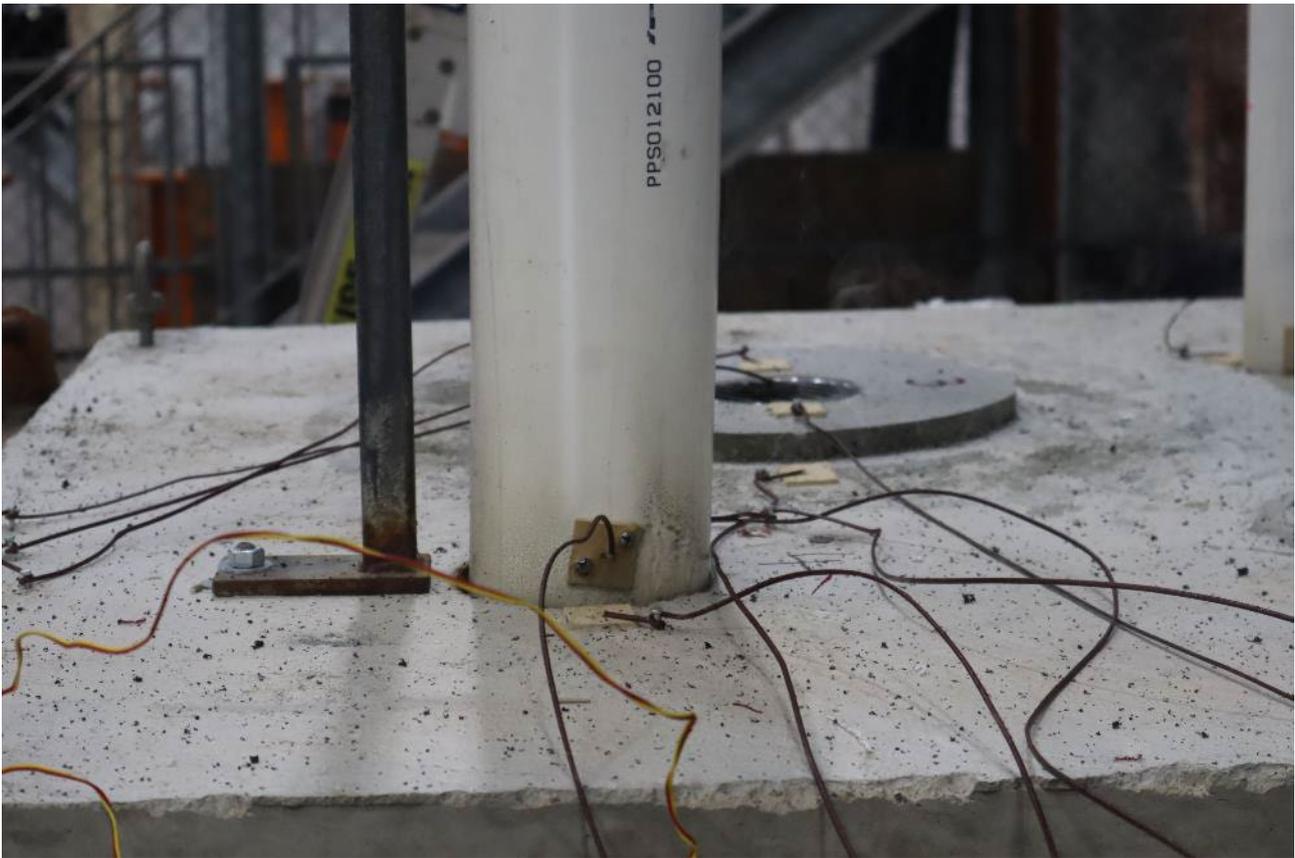
PHOTOGRAPH 5 – SPECIMEN 4 AT 11 MINUTES INTO THE TEST

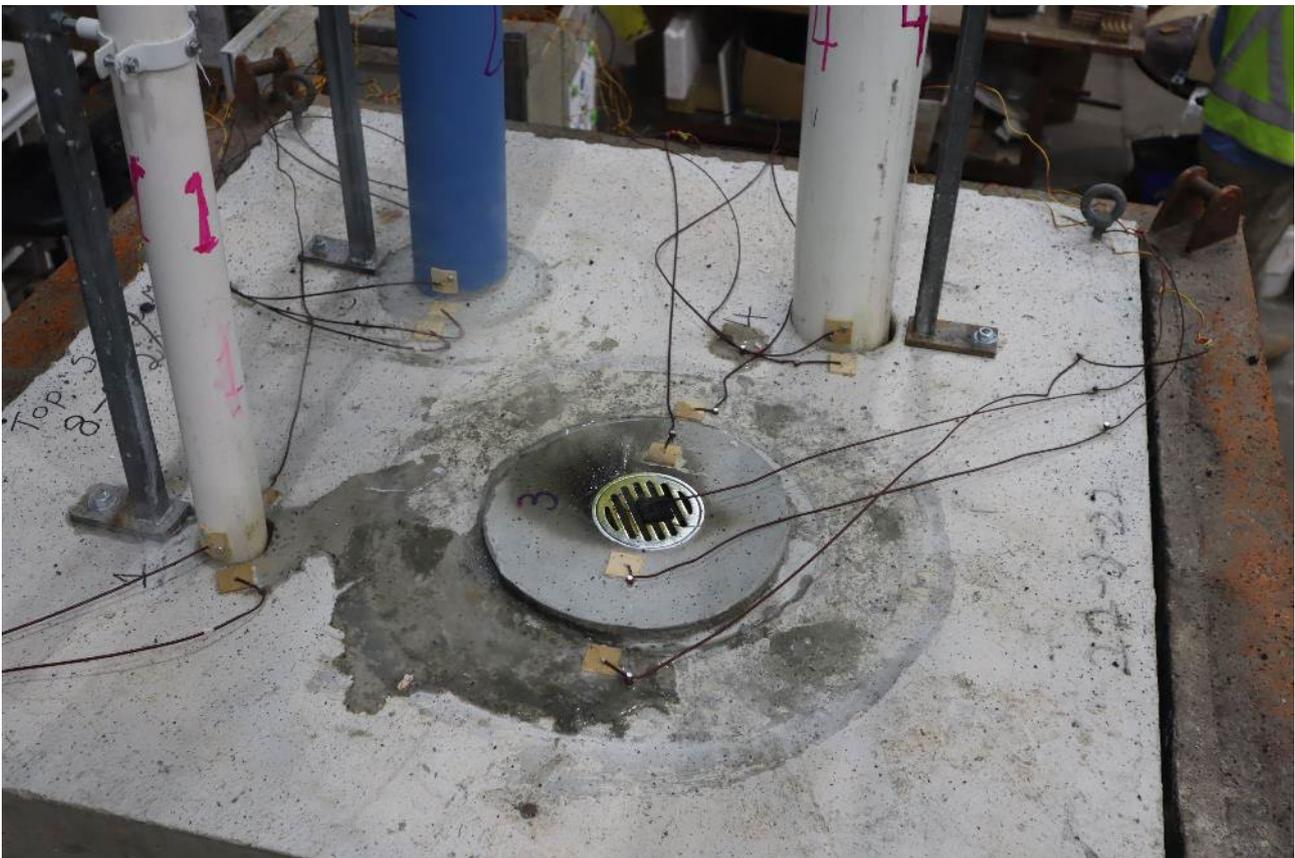
PHOTOGRAPH 6 – SPECIMENS AT 27 MINUTES INTO THE TEST

27 minutes -	Moisture has begun pooling on the slab and the screed around the base of specimen 3 floor waste.
33 minutes -	Light smoke has resumed fluing from the ends of the pipes of specimens 1 and 4.
75 minutes -	Thermocouple #10 on the pipe of specimen 2 was replaced.
67 minutes -	Light smoke continues to flue from the end of the pipe of specimen 4.
116 minutes -	The moisture on the slab around the base of specimen 3 has dried up.
143 minutes -	The pipe at the base of specimens 1 and 4 continue to discolour.
229 minutes -	Cotton pad test applied above the grate of specimen 3 – no ignition noted at this time.
231 minutes -	The level of smoke venting at the base of specimen 4 has intensified. Cotton pad test at the base of specimen 4 – no ignition noted at this time.
241 minutes -	Test terminated.

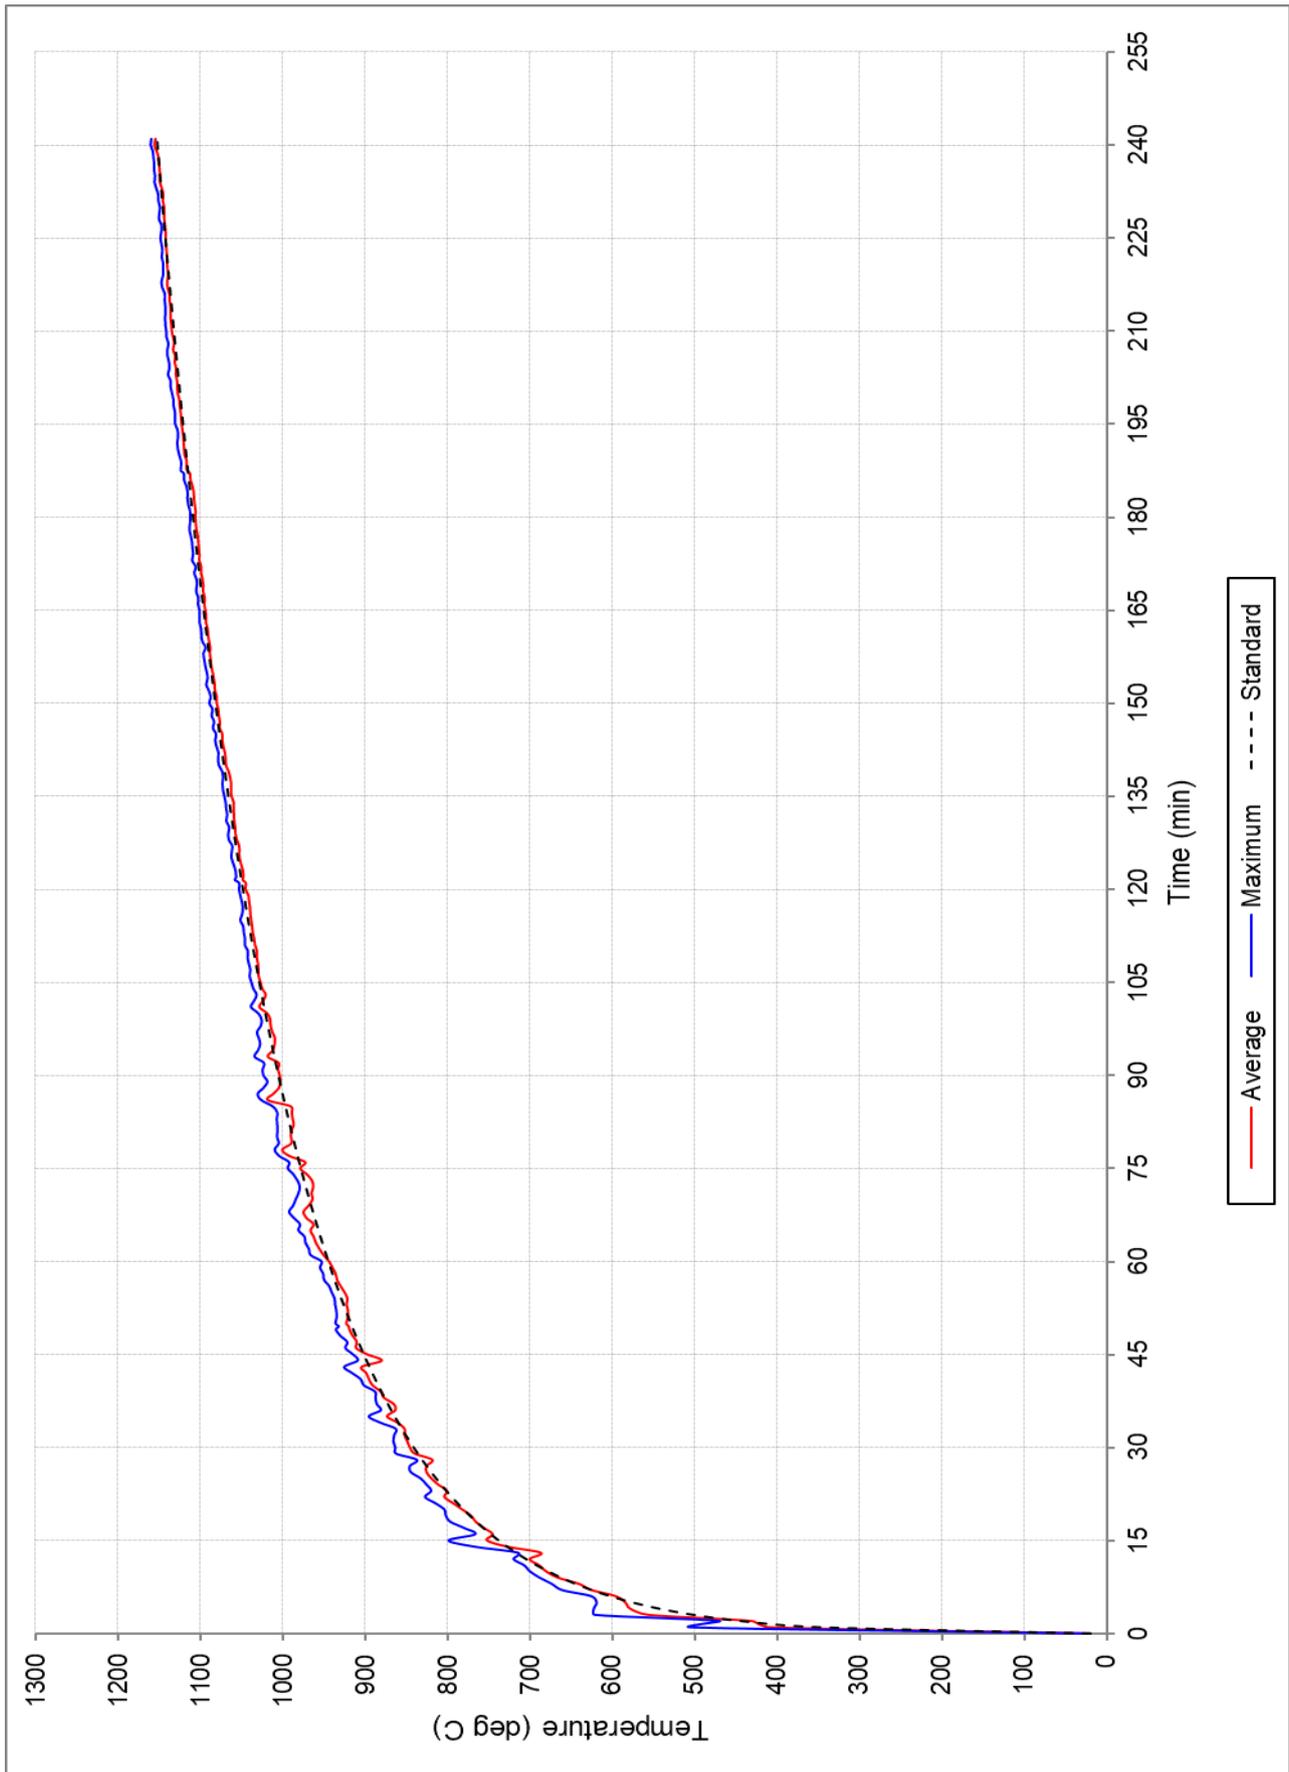
FIGURE 1 – FURNACE TEMPERATURE

Figure 1 shows the standard curves of temperature versus time for heating the furnace chamber and the actual curves of average and maximum temperature versus time recorded during the heating period.

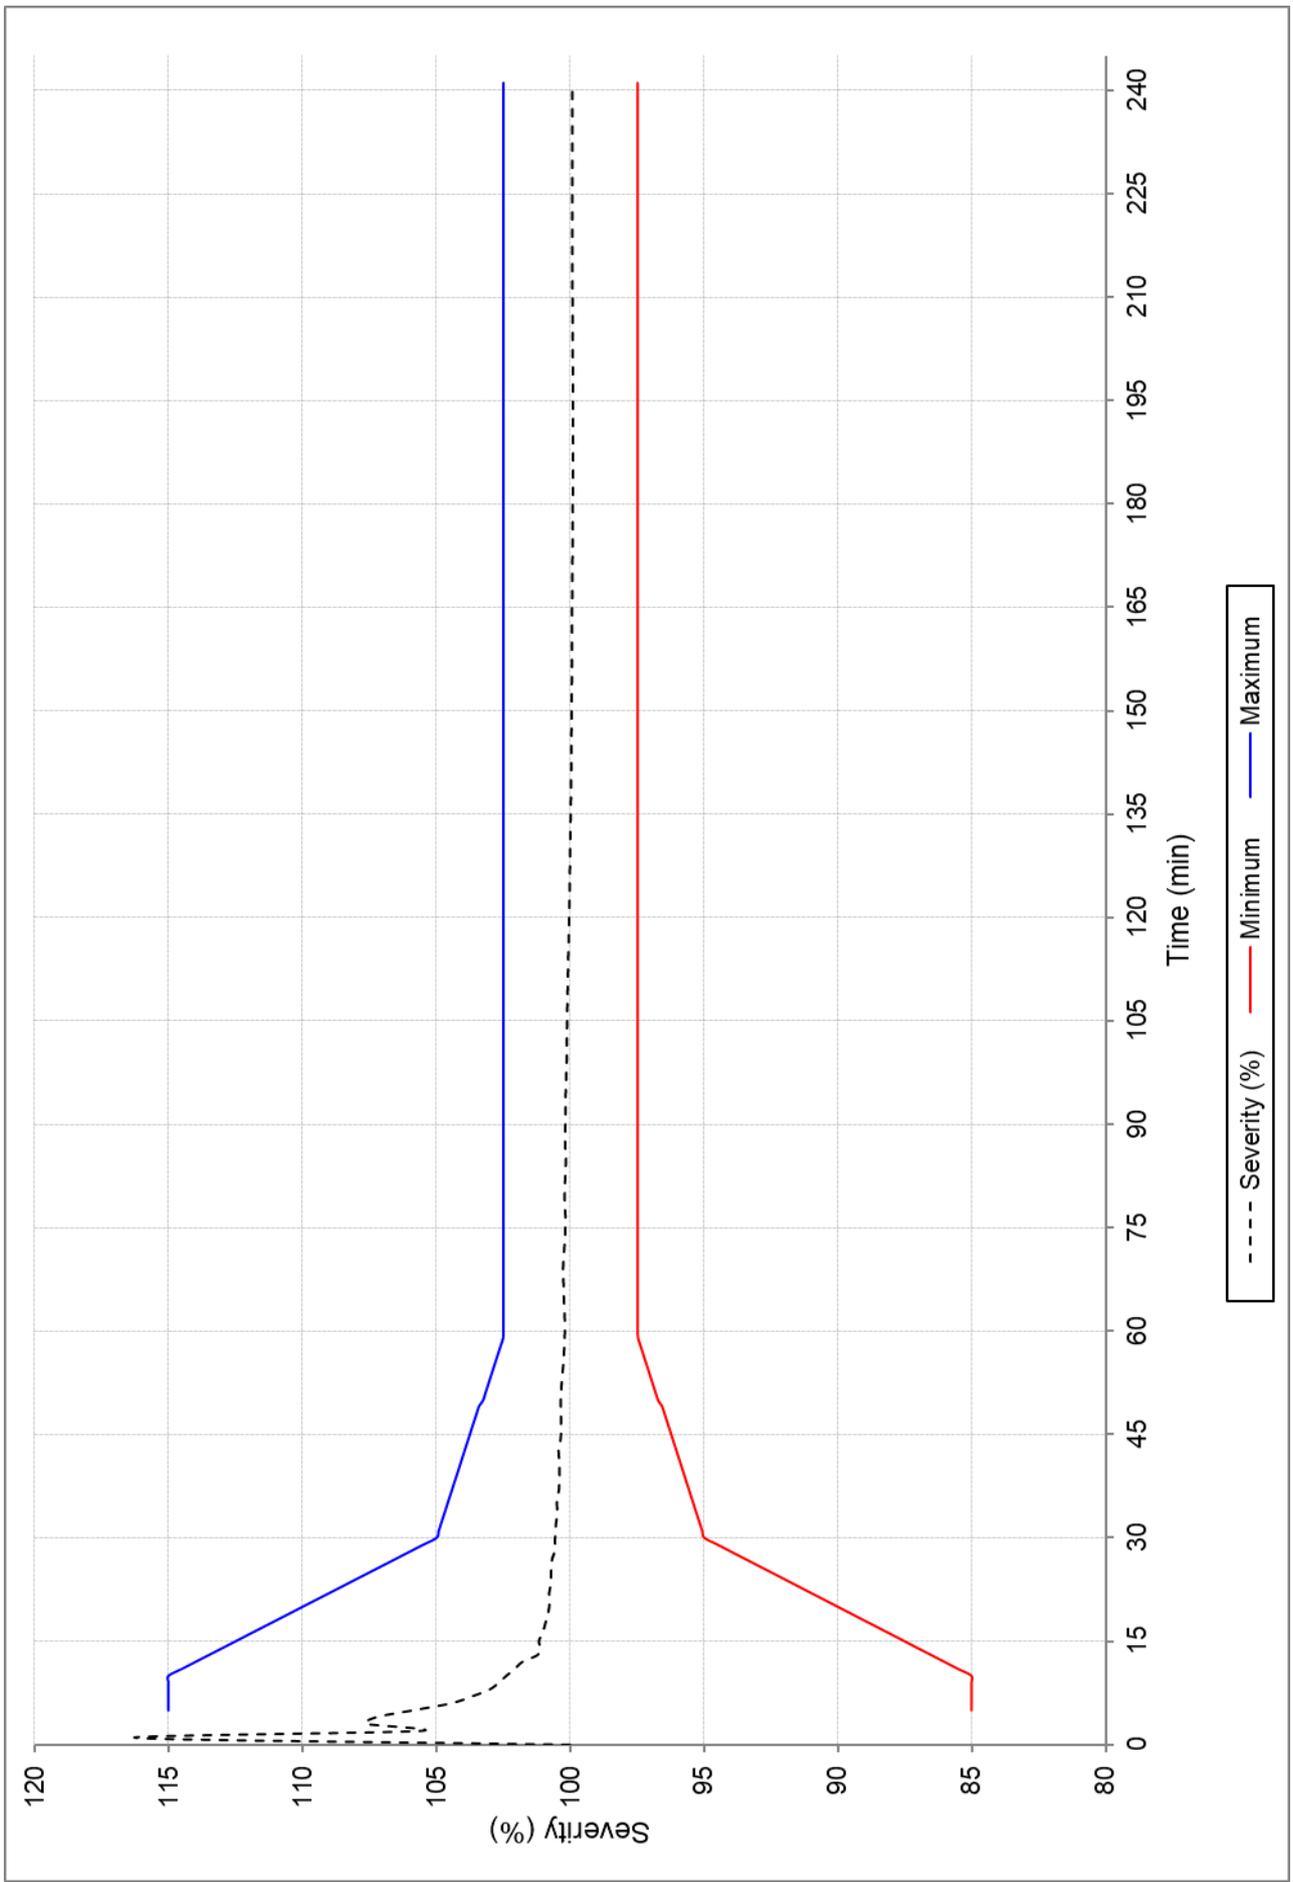
FIGURE 2 – FURNACE SEVERITY

Figure 2 shows the curve of furnace severity versus time during the heating period.

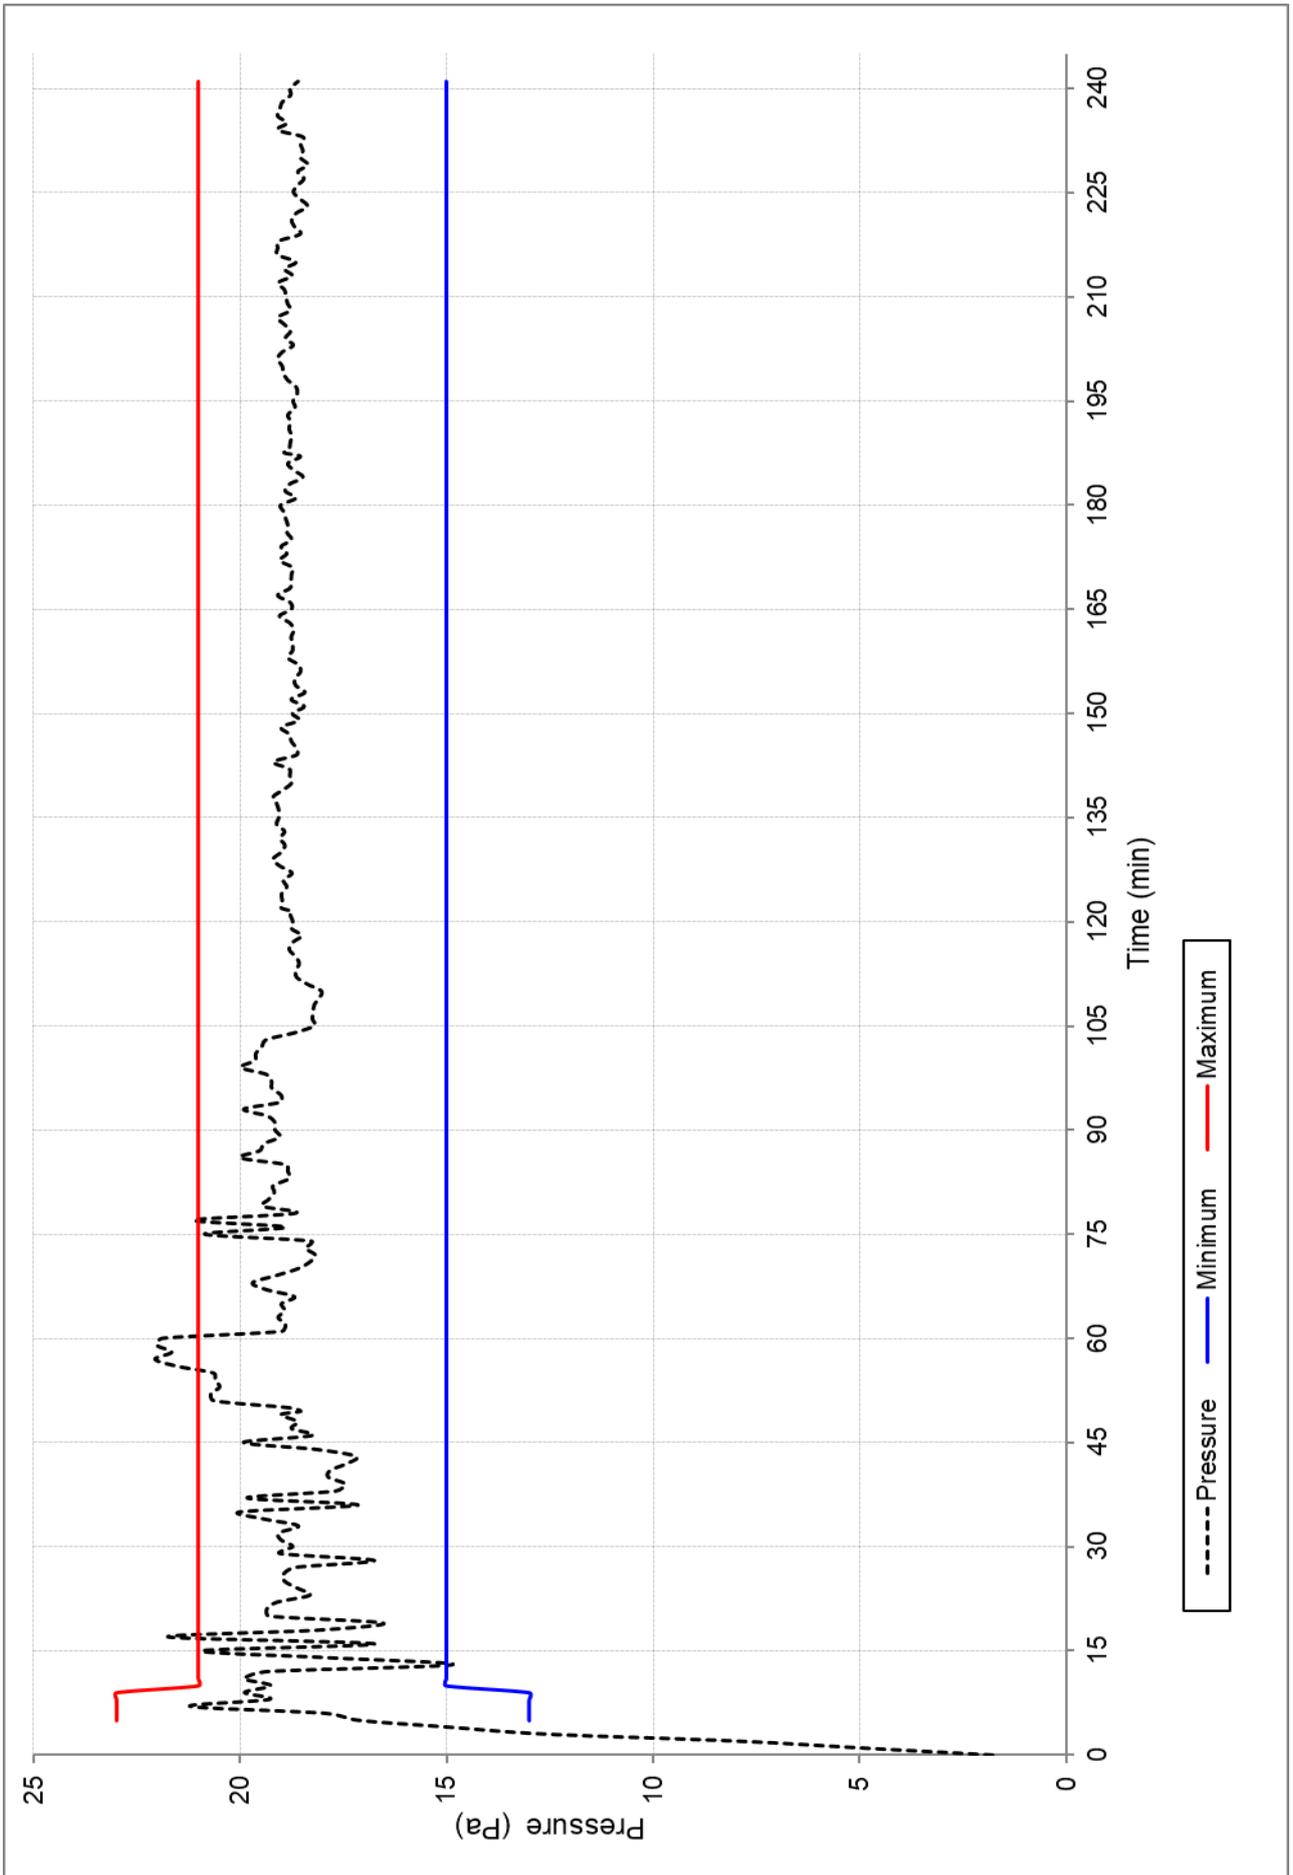
FIGURE 3 – FURNACE PRESSURE

The furnace pressure was in excess of the tolerances of the requirements of AS 1530.4-2014 for the short periods of time as shown in Figure 3. The test laboratory confirms that this minor departure in furnace pressure would not have significantly affected the results of this test.

Figure 3 shows the curve of average pressure versus time inside the furnace chamber recorded during the heating period.

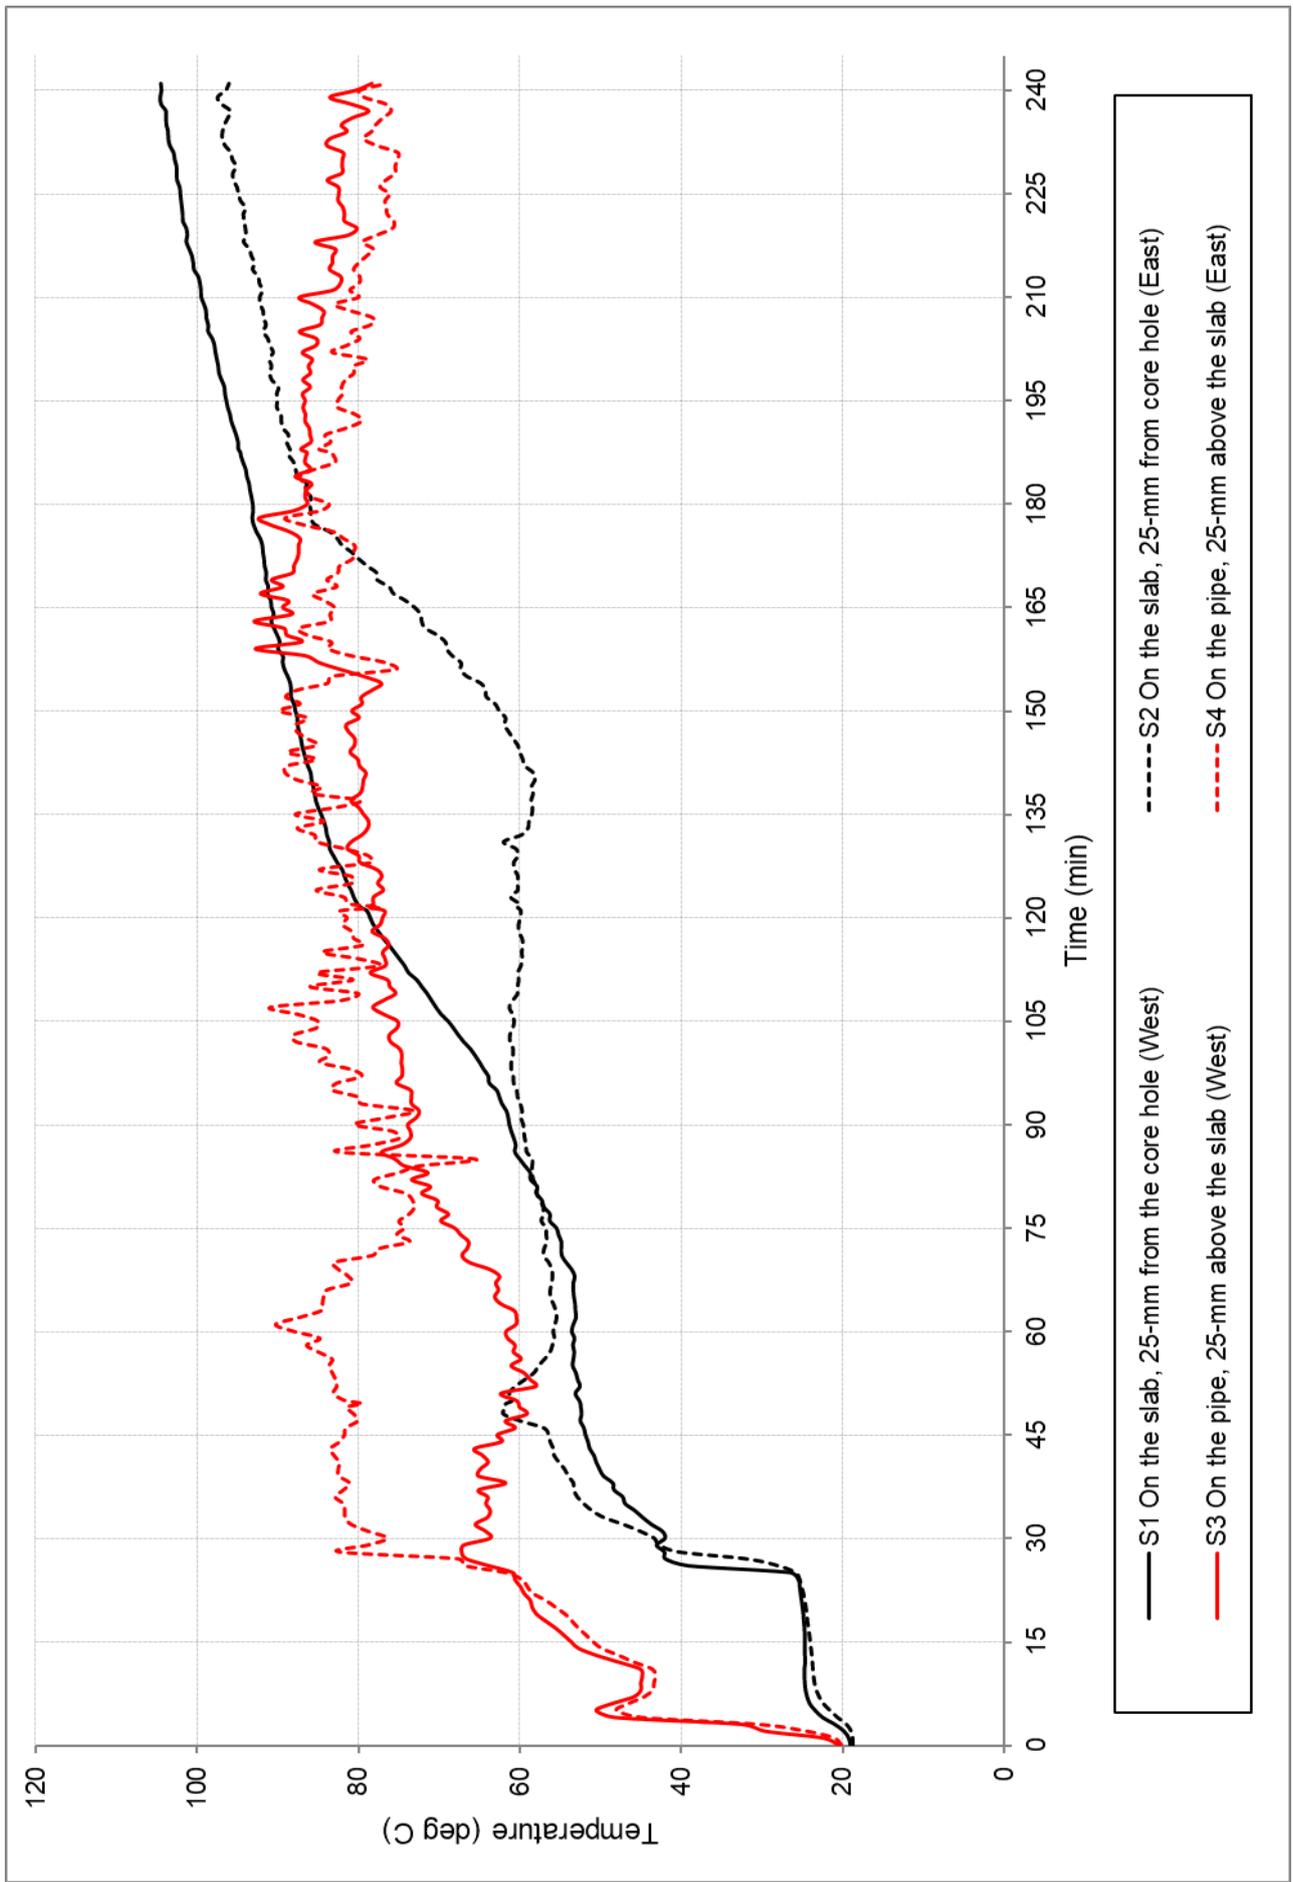
FIGURE 4 – SPECIMEN TEMPERATURE – ASSOCIATED WITH SPECIMEN 1

Figure 4 shows the curve of temperature versus time associated with specimen 1.

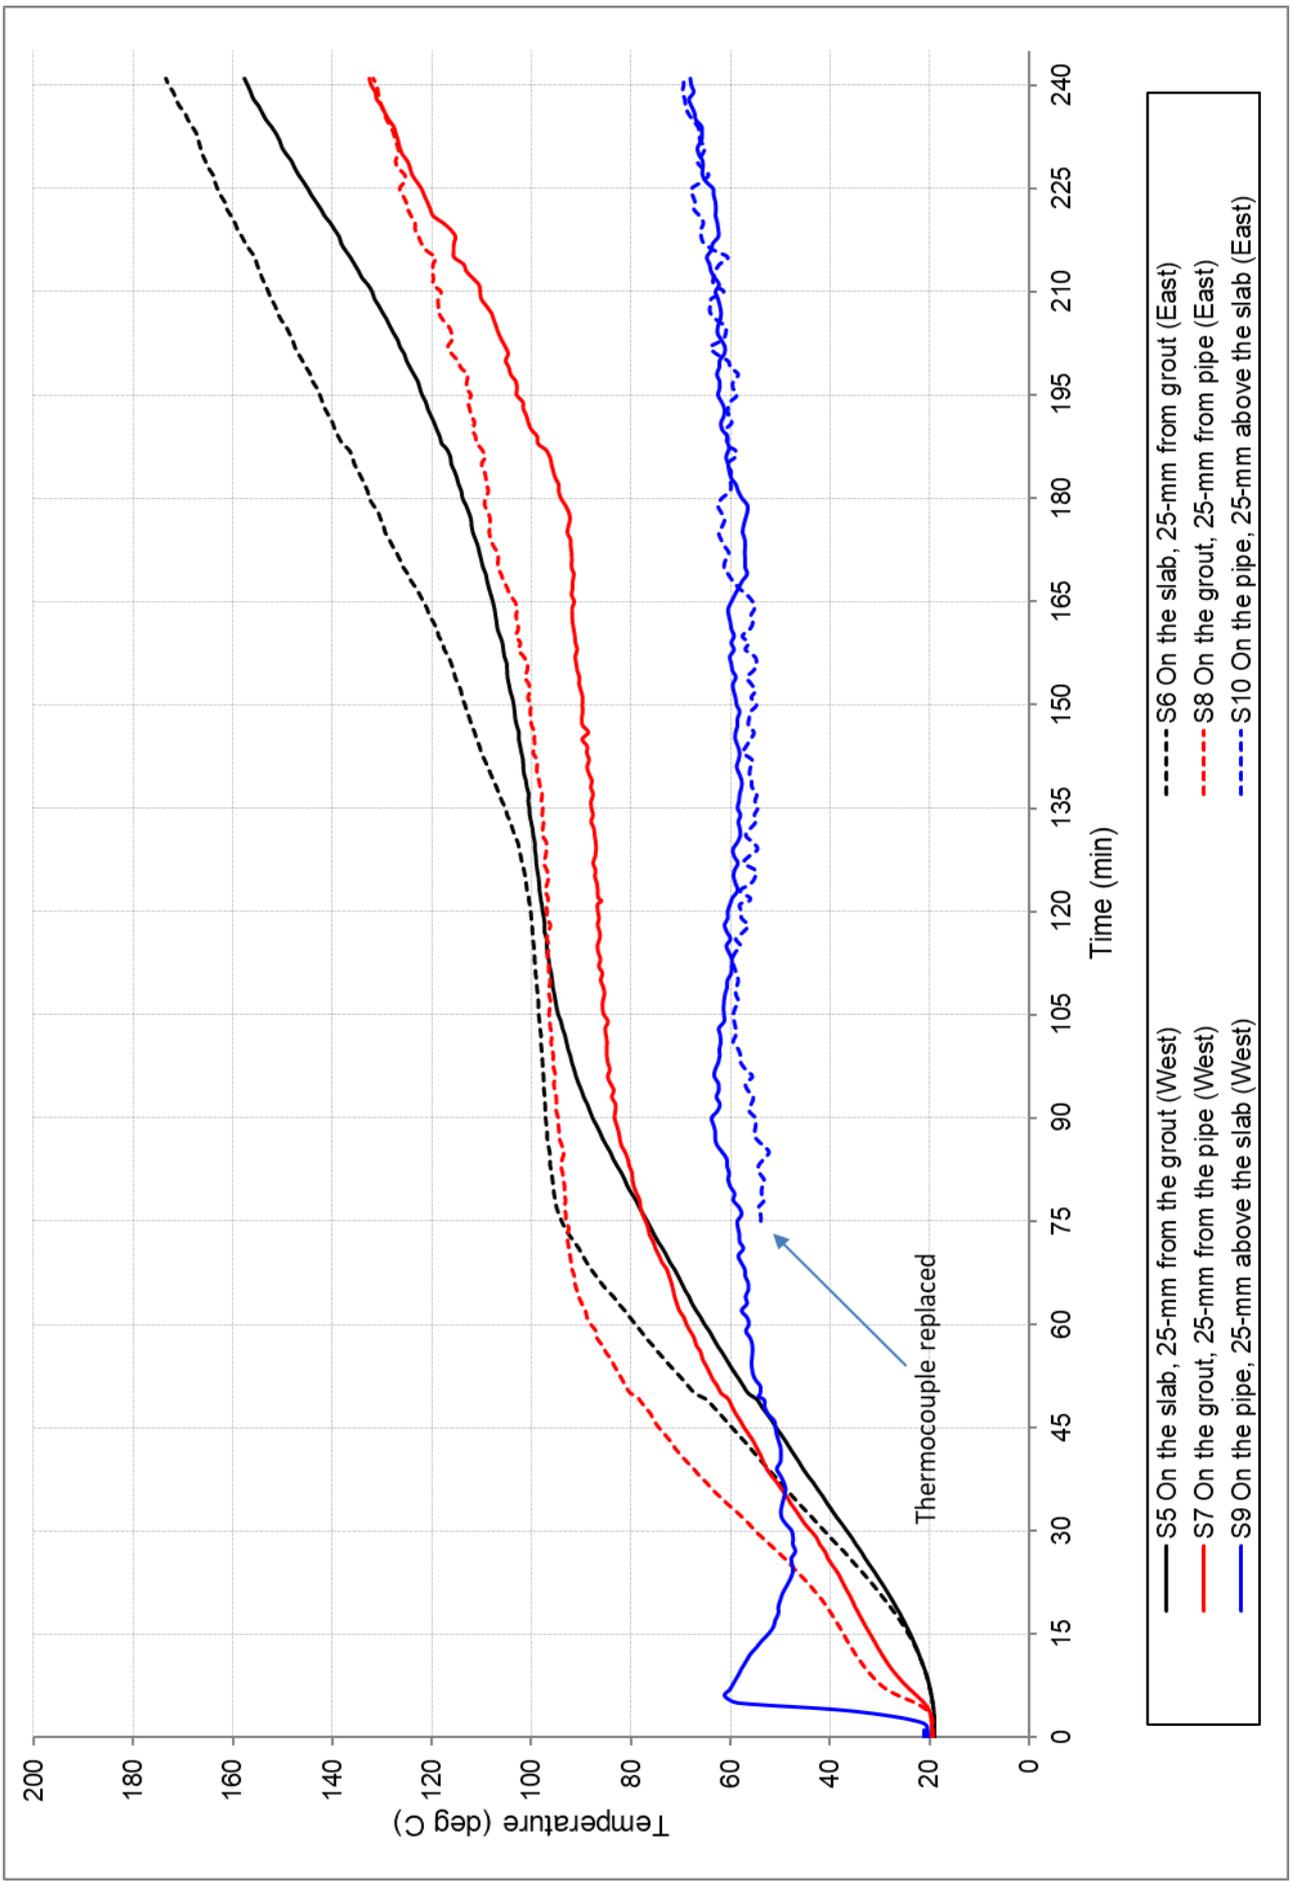
FIGURE 5 – SPECIMEN TEMPERATURE – ASSOCIATED WITH SPECIMEN 2

Figure 5 shows the curve of temperature versus time associated with specimen 2.

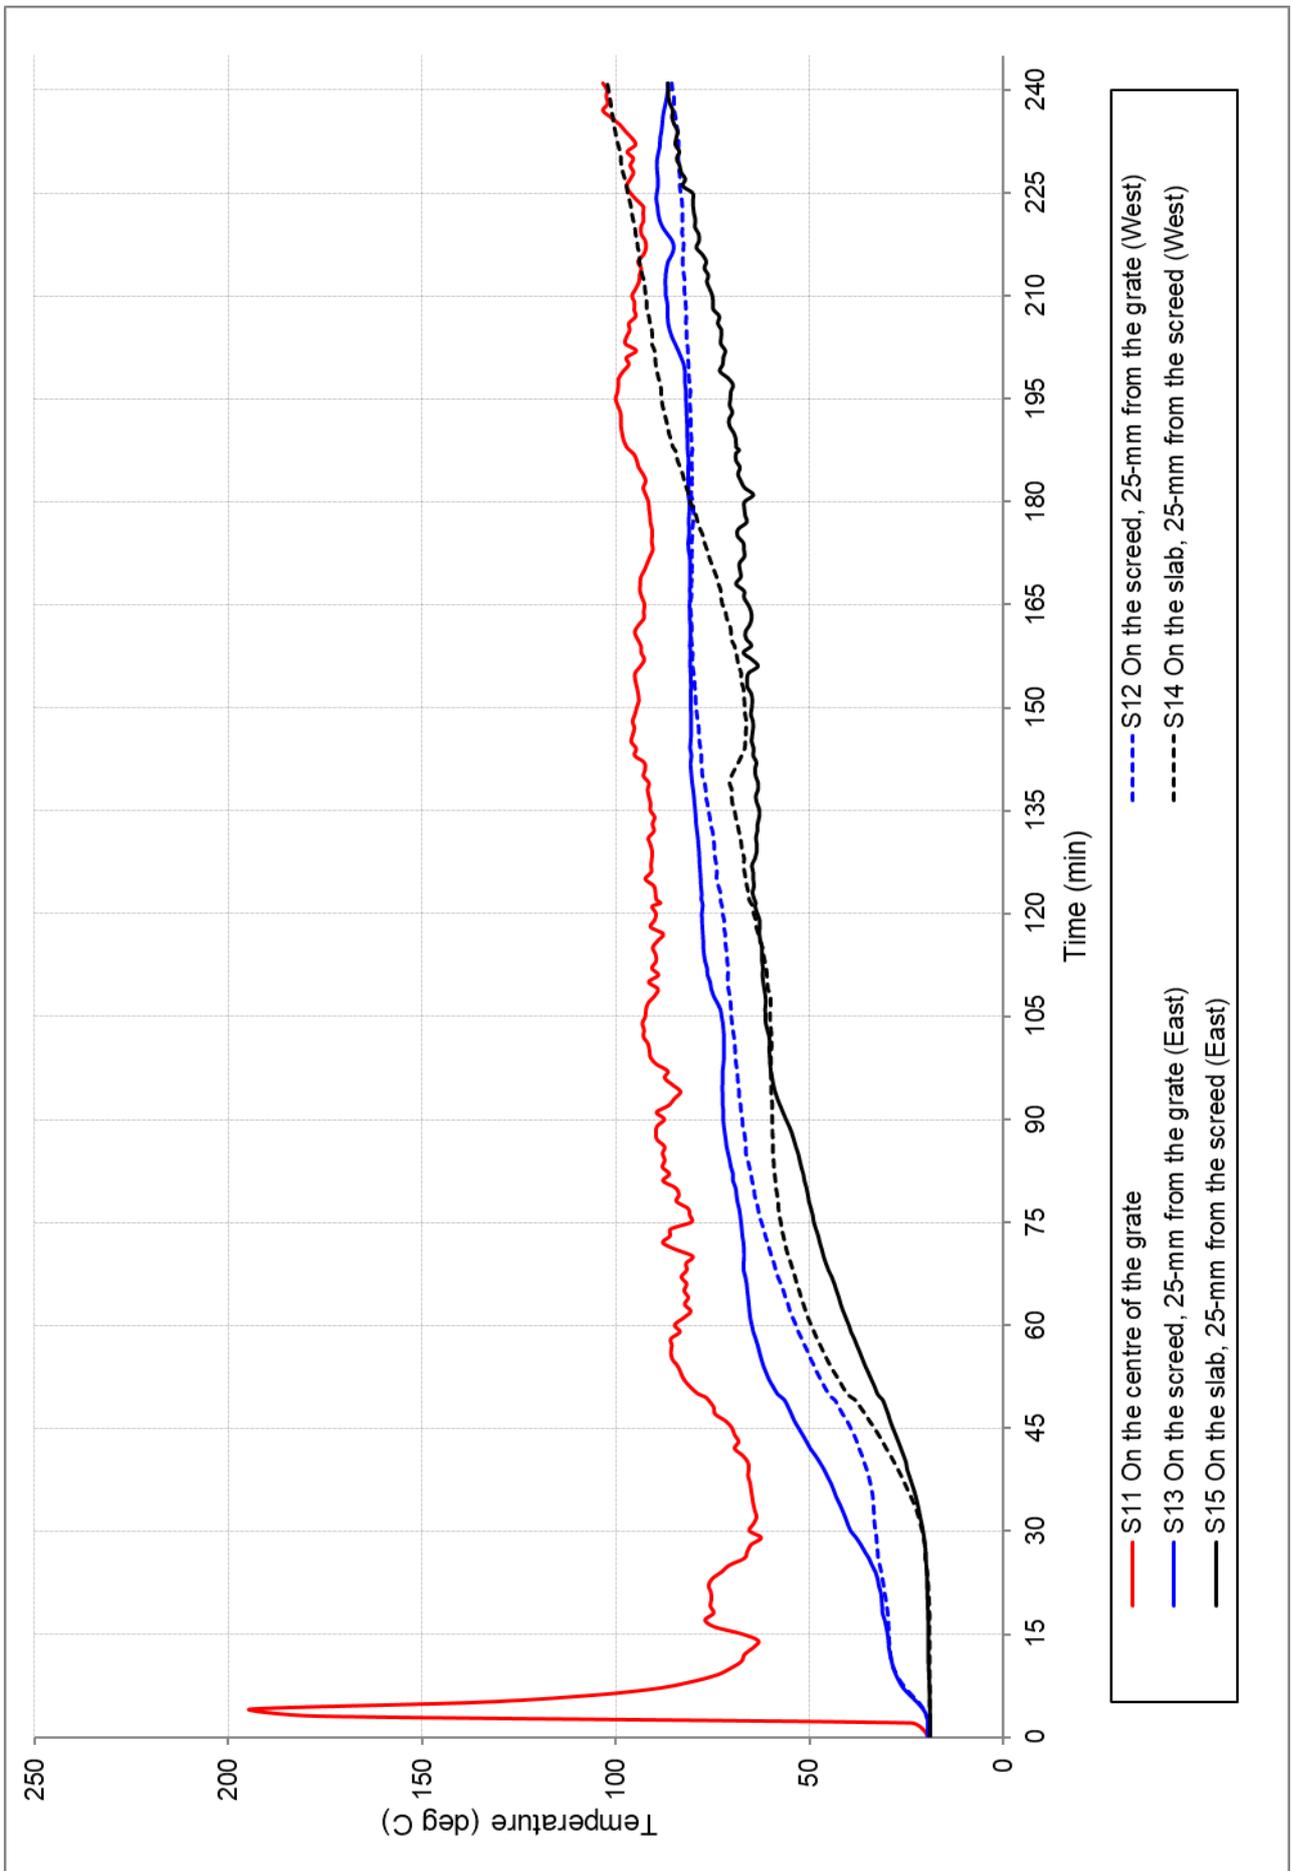
FIGURE 6 – SPECIMEN TEMPERATURE – ASSOCIATED WITH SPECIMEN 3

Figure 6 shows the curve of temperature versus time associated with specimen 3.
