Fire-resistance test on fire collars protecting a concrete slab penetrated by services

Test Report

Author: Peter Gordon
Report number: FSP 2315
Date: 22 November 2022

Sponsored Investigation No. FSP 2315

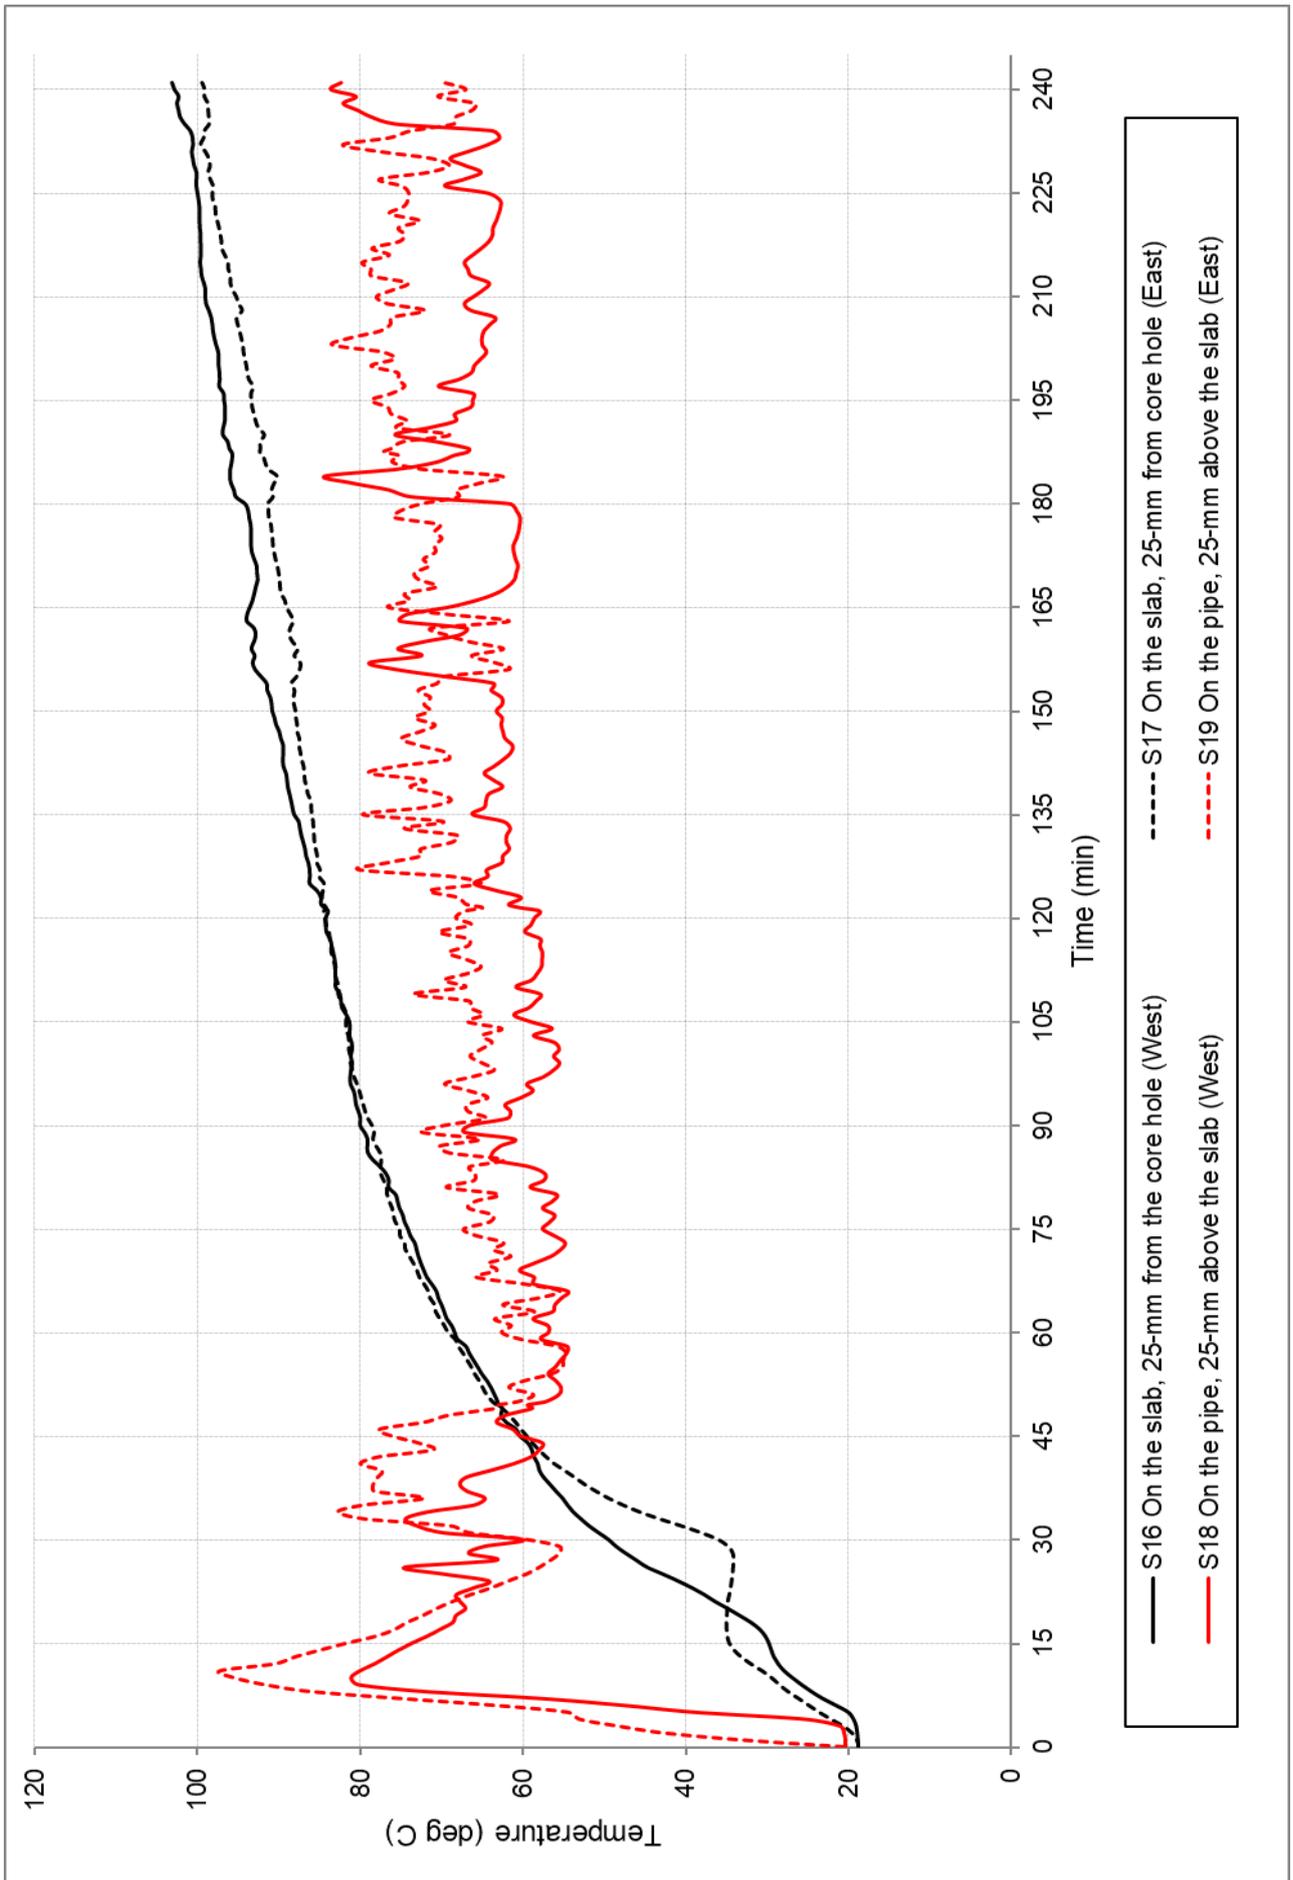
FIGURE 7 – SPECIMEN TEMPERATURE – ASSOCIATED WITH SPECIMEN 4

Figure 7 shows the curve of temperature versus time associated with specimen 4.

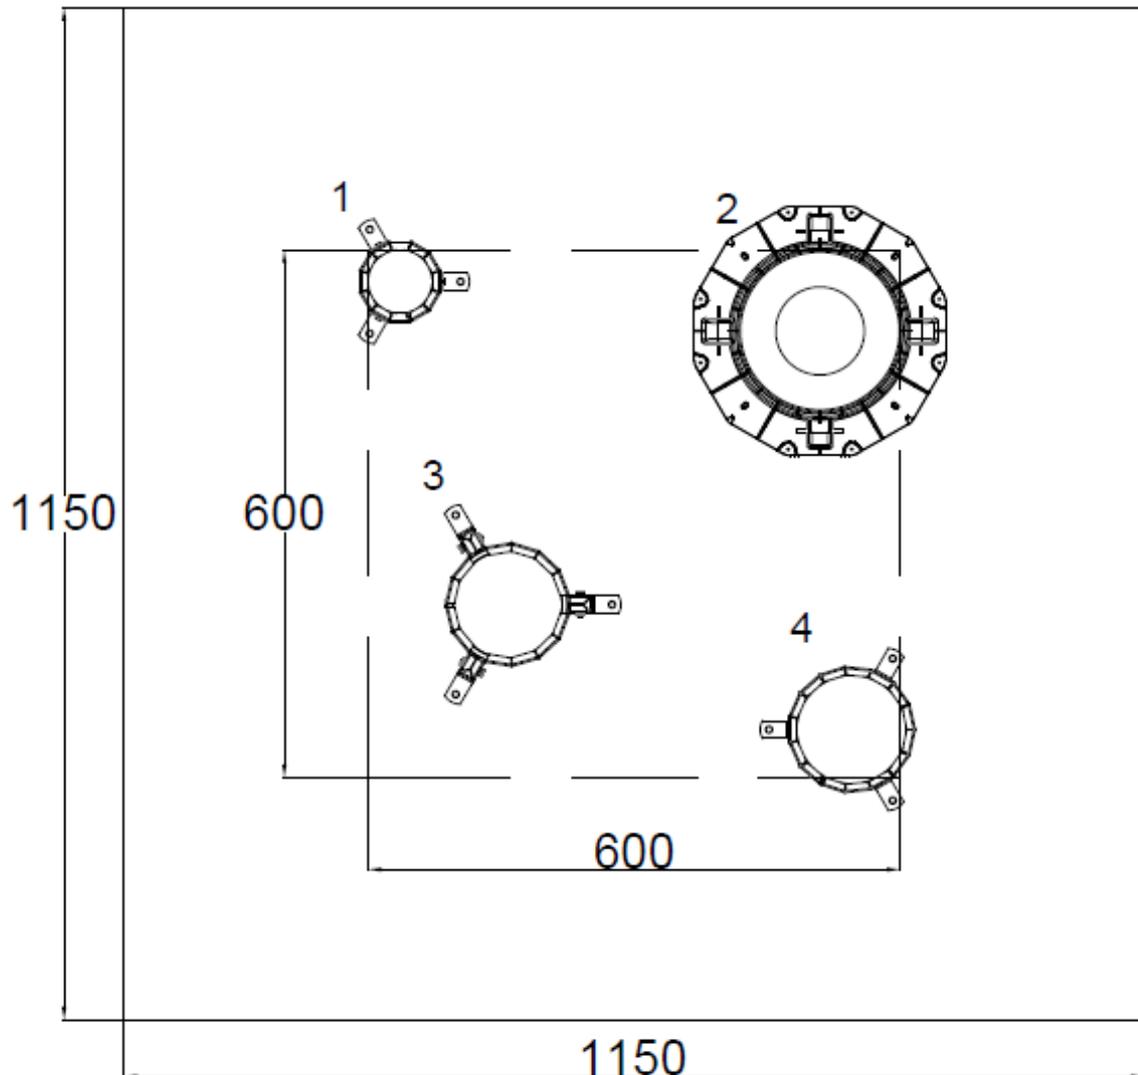
DRAWING TITLED 'TEST SLAB S-22-M LAYOUT', DATED 9 SEPTEMBER 2022, BY SNAP FIRE SYSTEMS PTY LTD

Penetration	Collar Code	Pipe Type	Pipe Diameter
1	63R	PN12 PVC	50
2	H150S-RR	Triplus	110
3	LP100R	PVC(SC)	100
4	110R	PN12 PVC	110

The specimen comprised a 1150-mm x 1150-mm x 150-mm thick concrete slab which was penetrated by multiple services protected by three retrofit fire collars and once cast in fire collar.

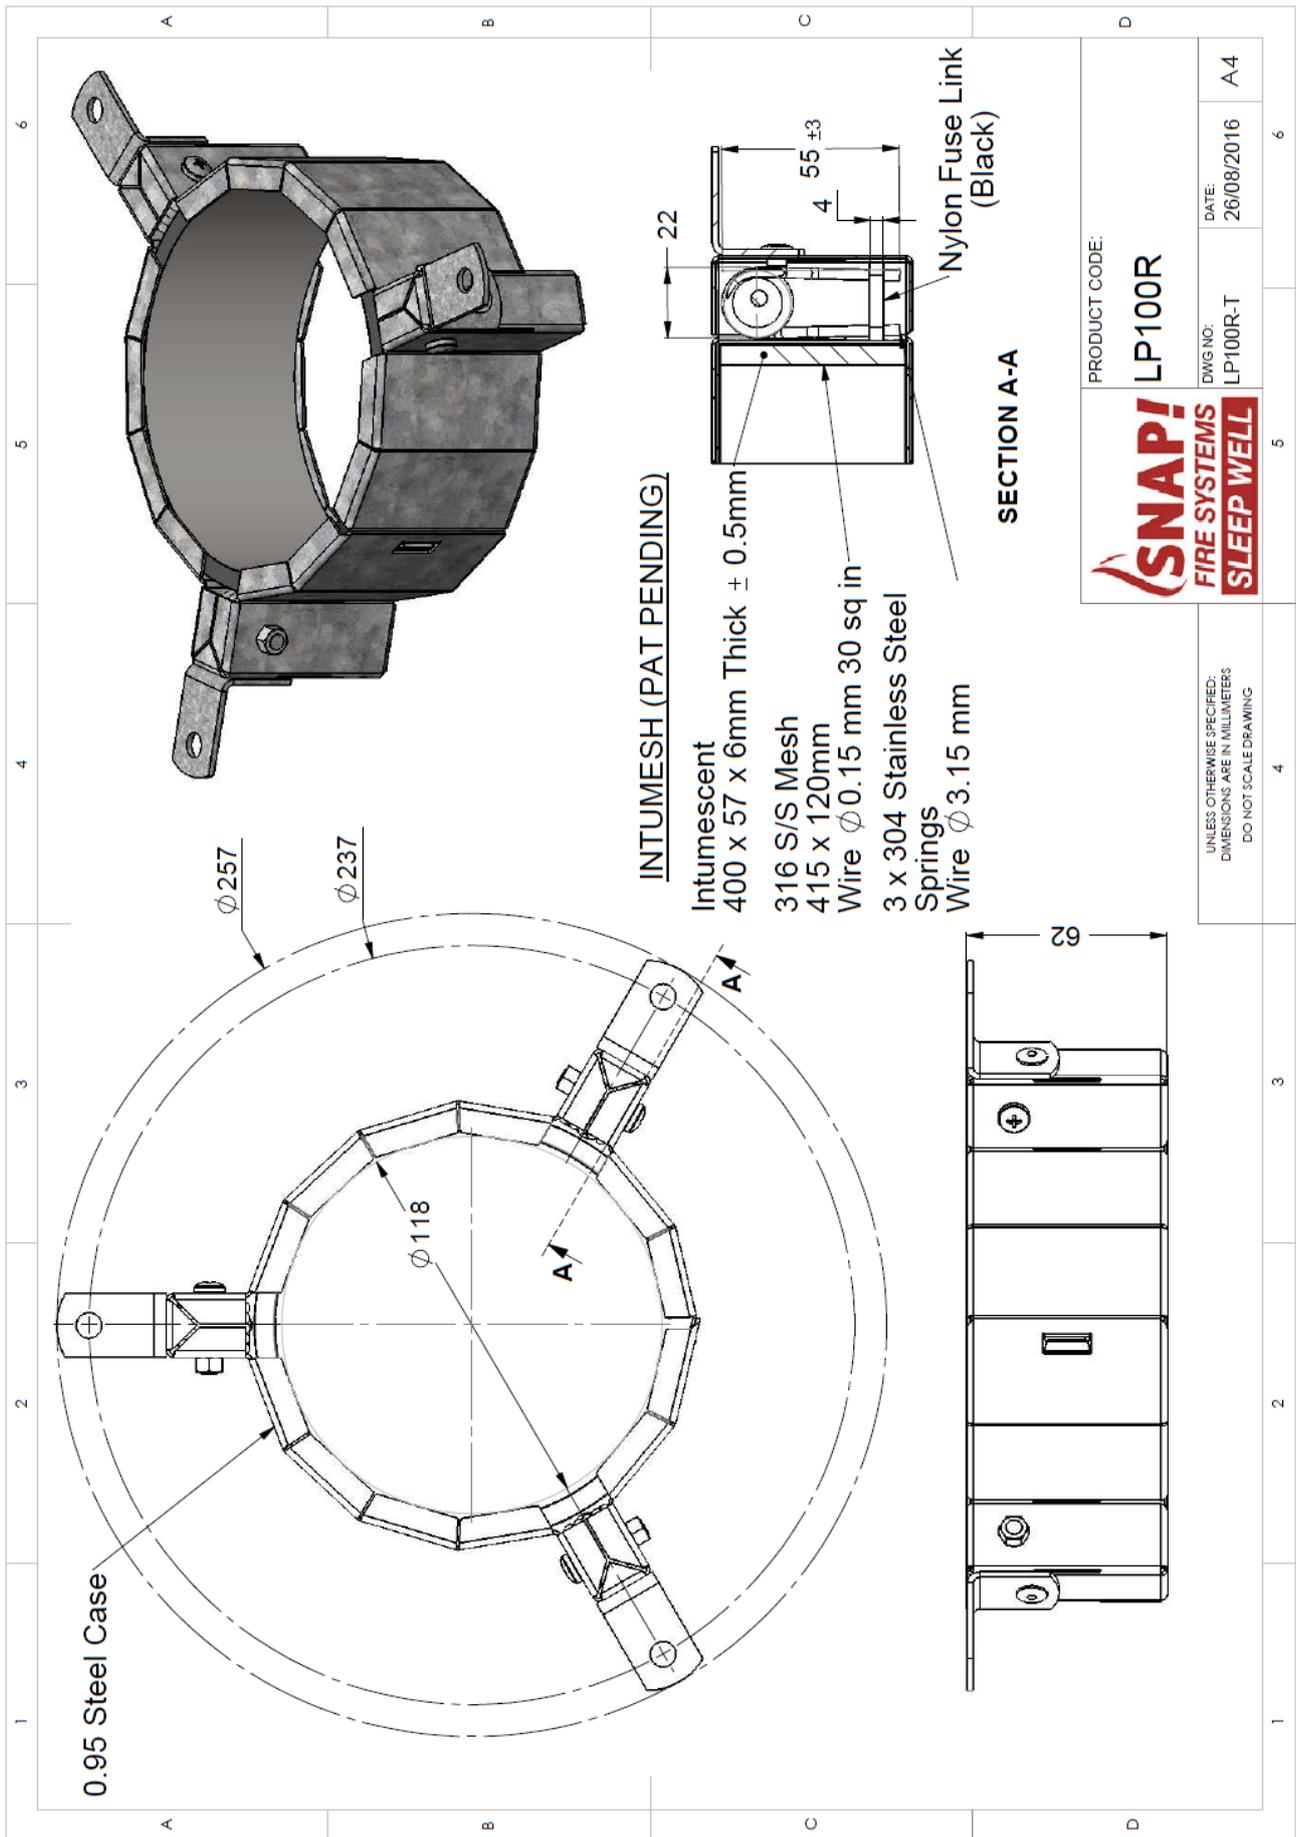
DWG NO: LP100R-T DATE: 26/08/2016 A4

INTUMESH (PAT PENDING)

- Intumescent
400 x 57 x 6mm Thick ± 0.5mm
- 316 S/S Mesh
415 x 120mm
- Wire 0.15 mm 30 sq in
- 3 x 304 Stainless Steel
Springs
Wire 3.15 mm

The SNAP LP100R Low Profile Retrofit fire collar comprised a 0.95-mm steel casing with a 118-mm inner diameter and a 257-mm diameter base flange. The 62-mm high fire collar casing incorporated a closing mechanism which comprised a 6-mm thick x 57-mm wide x 400-mm long Intumesh intumescent wrap lined within the internal circumference of the fire collar casing. The closing mechanism comprised three 3.15-mm diameter 304 stainless steel springs with black nylon fuse links and a 415-mm long x 120-mm wide stainless steel wire mesh with a diameter of 0.15-mm as shown in drawing number 'LP100R', dated 26 August 2016, by Snap Fire Systems Pty Ltd.
