Fire-resistance test on fire collars protecting a concrete slab penetrated by services

Test Report

Author: Peter Gordon
Report number: FSP 2274
Date: 20 December 2023

Sponsored Investigation No. FSP 2274

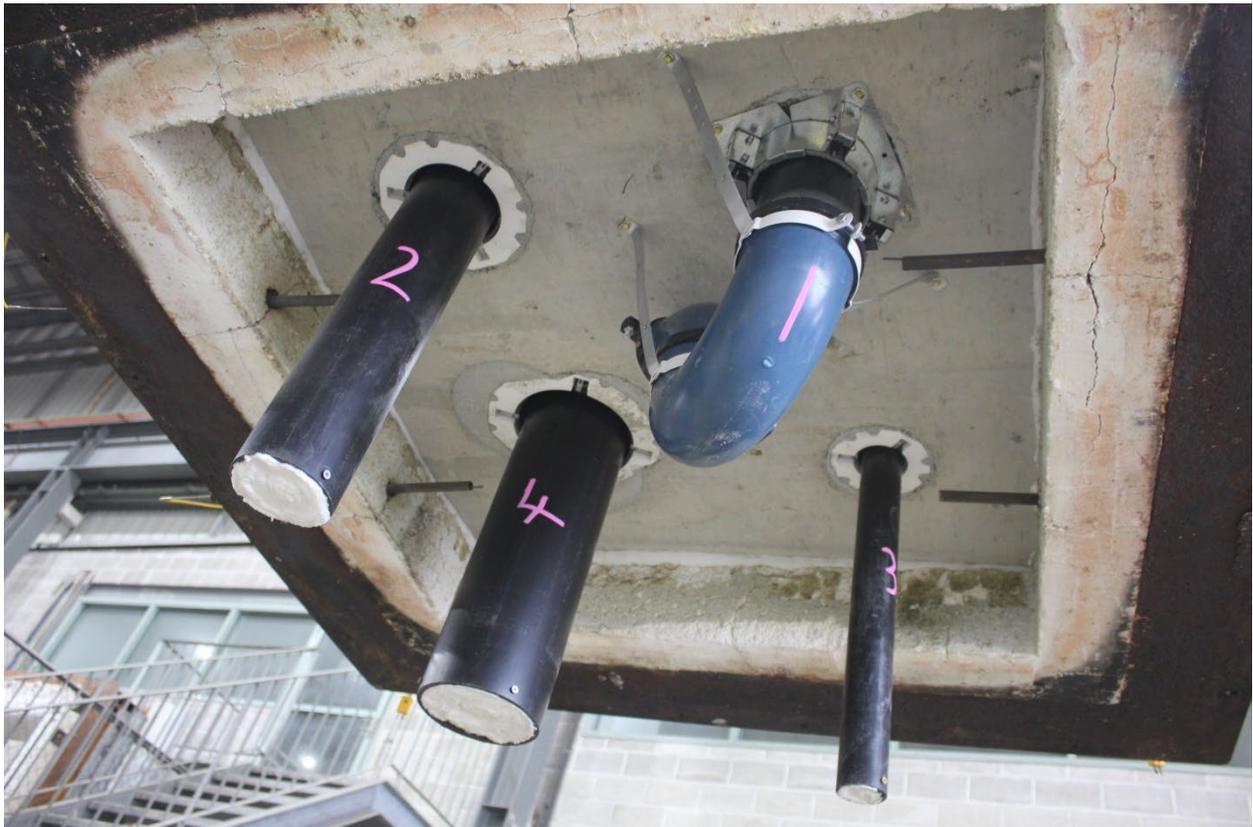
PHOTOGRAPH 1 – EXPOSED FACE OF SPECIMENS PRIOR TO TESTING

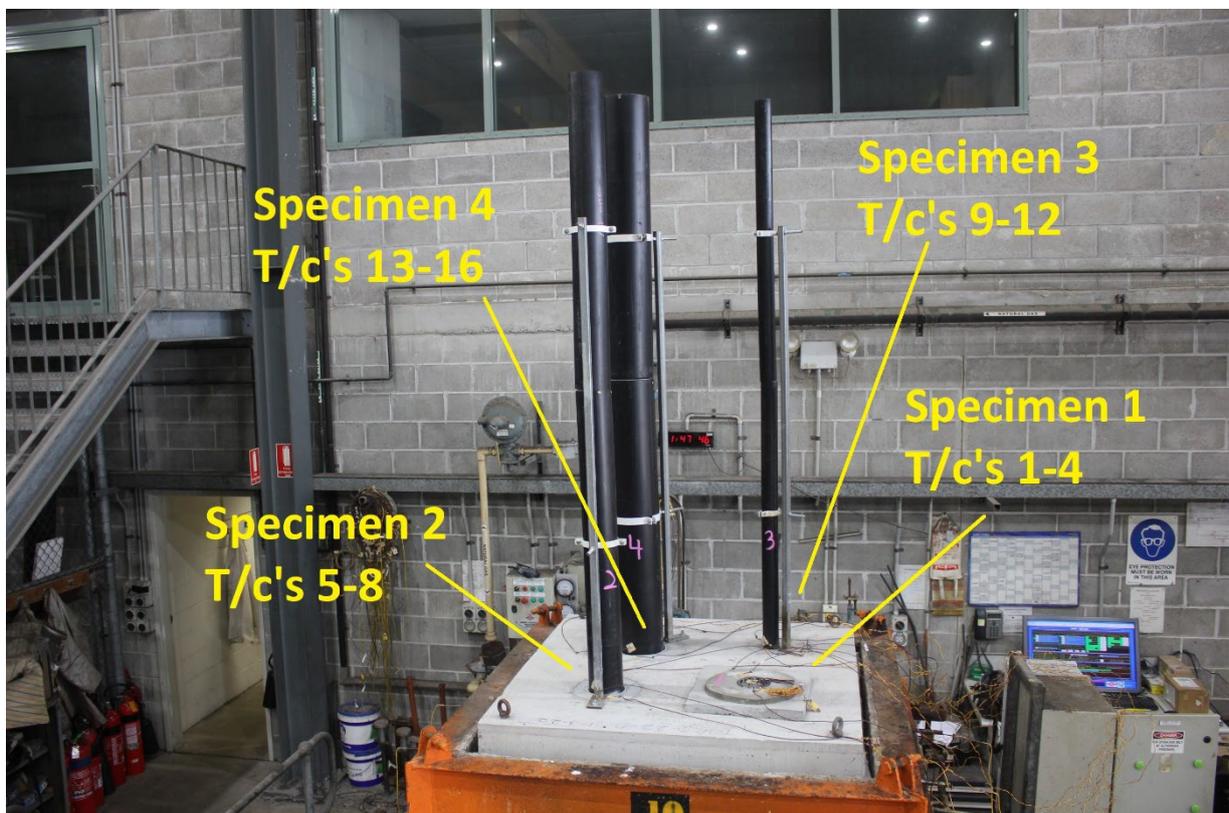
PHOTOGRAPH 2 – UNEXPOSED FACE OF SPECIMENS PRIOR TO TESTING

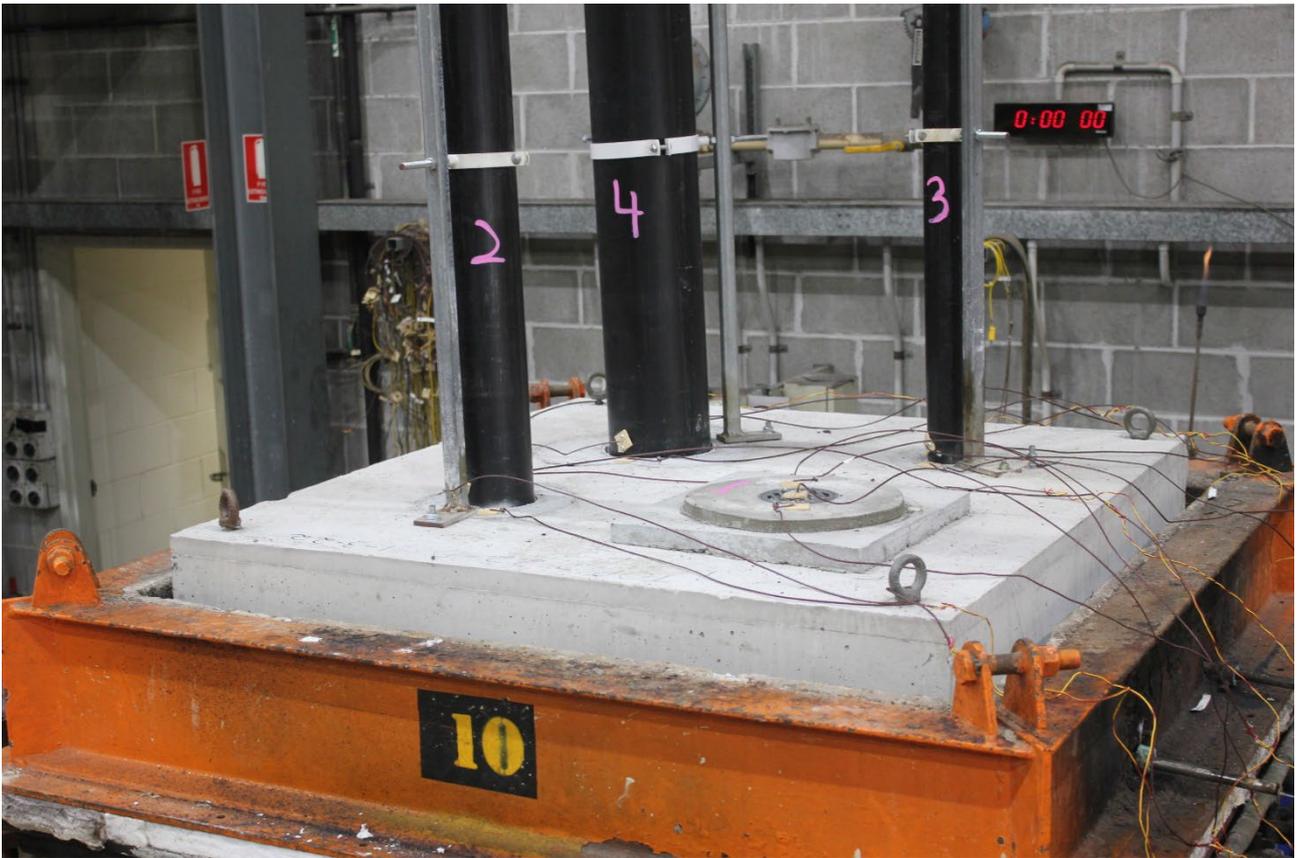
PHOTOGRAPH 3 – UNEXPOSED FACE OF SPECIMENS PRIOR TO TESTING

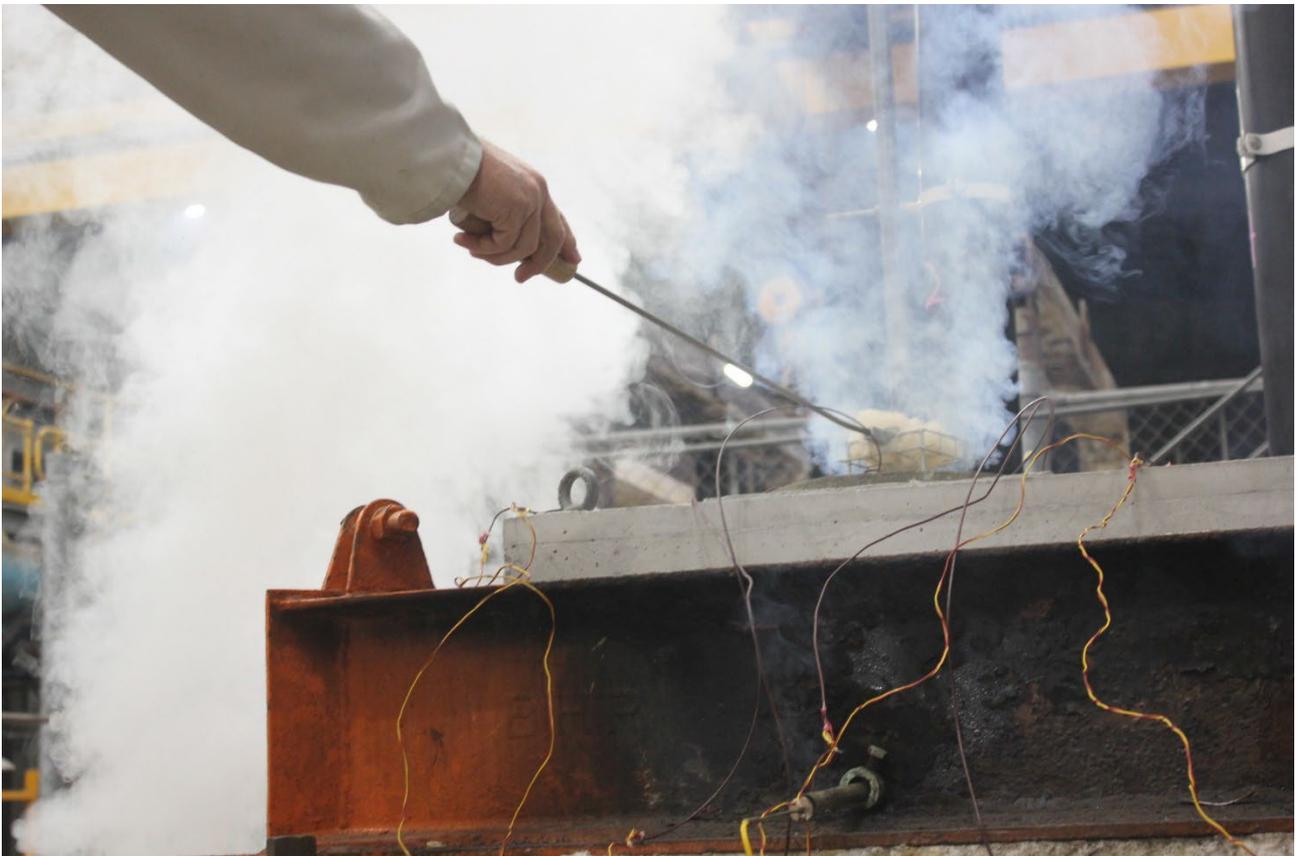
PHOTOGRAPH 4 – SPECIMENS AT 9 MINUTES INTO THE TEST

Time	Observation
4 minutes	- Smoke is fluing from the end of the pipe of specimen 2.
5 minutes	- Smoke is fluing from end of the pipes of specimens 3 and 4.
6 minutes	- The level of smoke fluing from the end of the pipe of specimens 2 and 3 has reduced.
7 minutes	- Smoke has begun fluing from the floor waste grate of specimen 1. Cotton pad test was applied above the floor waste grate of specimen 1 – no ignition was noted at this time.
8 minutes	- Smoke has ceased fluing from the floor waste grate of specimen 1.
9 minutes	- Smoke has ceased fluing from the pipes of specimens 2 and 3.
12 minutes	- The level of smoke fluing from end of the pipe of specimen 4 has reduced.
14 minutes	- The pipe of specimen 4 has begun to distort
16 minutes	- Light smoke has resumed fluing from the end of the pipes of specimens 2 and 3.
34 minutes	- Light smoke has resumed fluing from the floor waste grate of specimen 1.

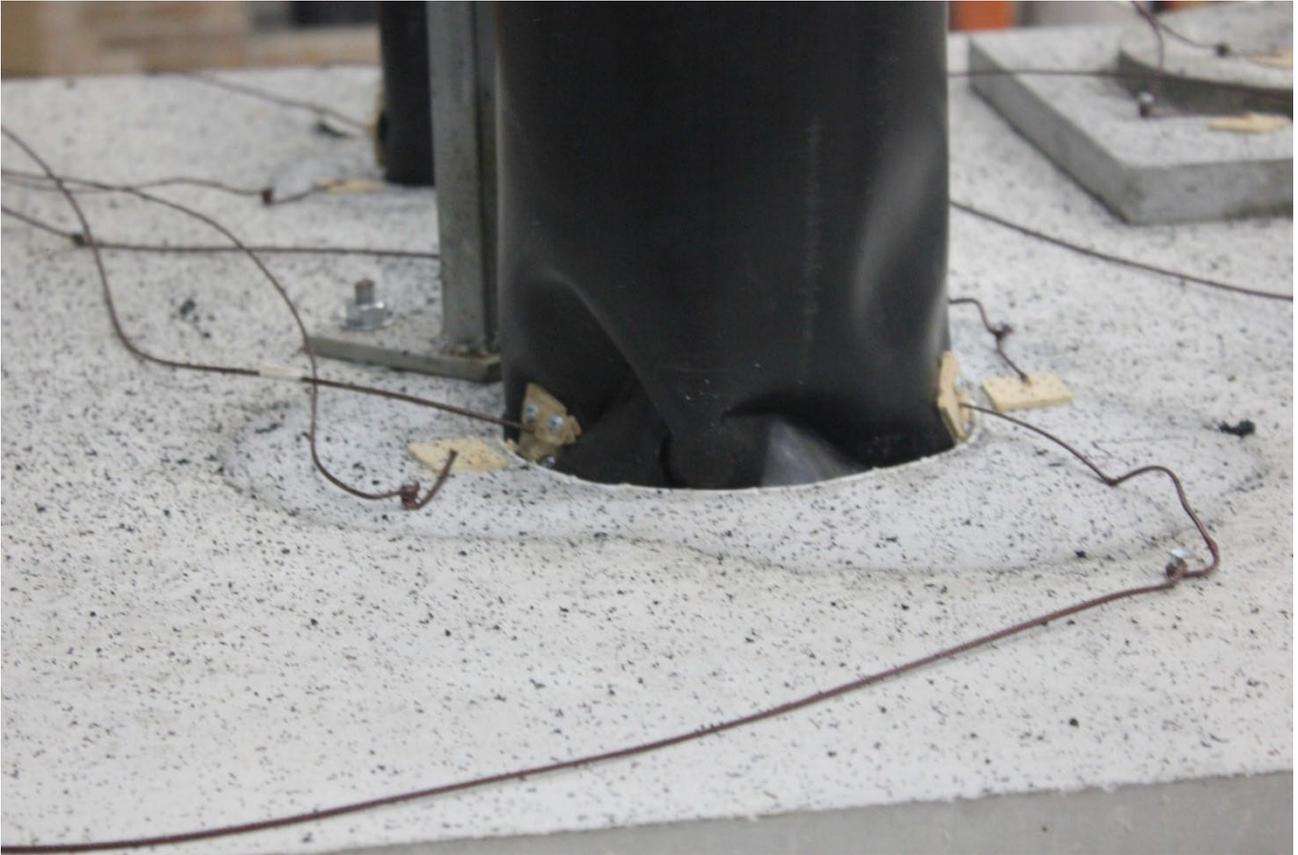
PHOTOGRAPH 5 – SPECIMEN 4 AT 14 MINUTES INTO THE TEST

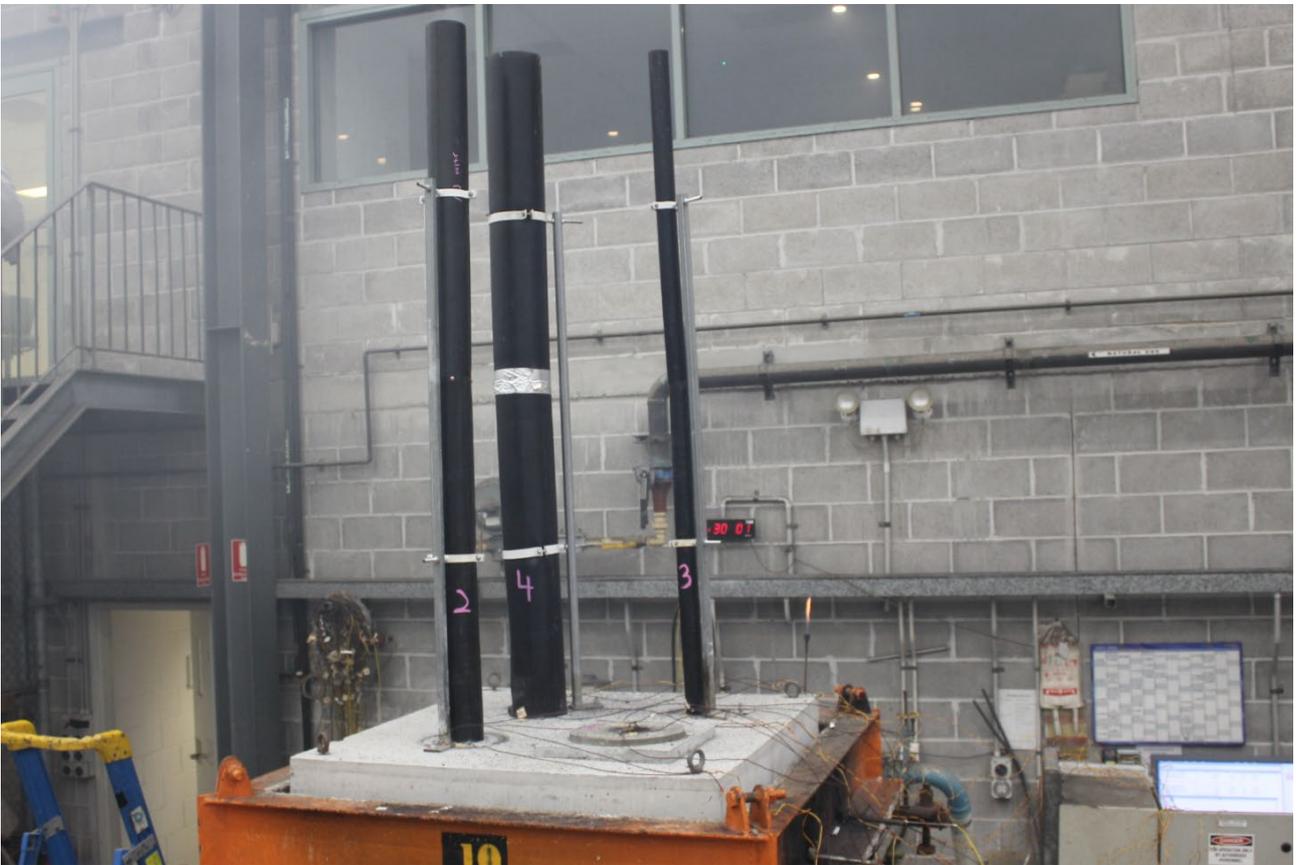
PHOTOGRAPH 6 –SPECIMENS AT 30 MINUTES INTO THE TEST

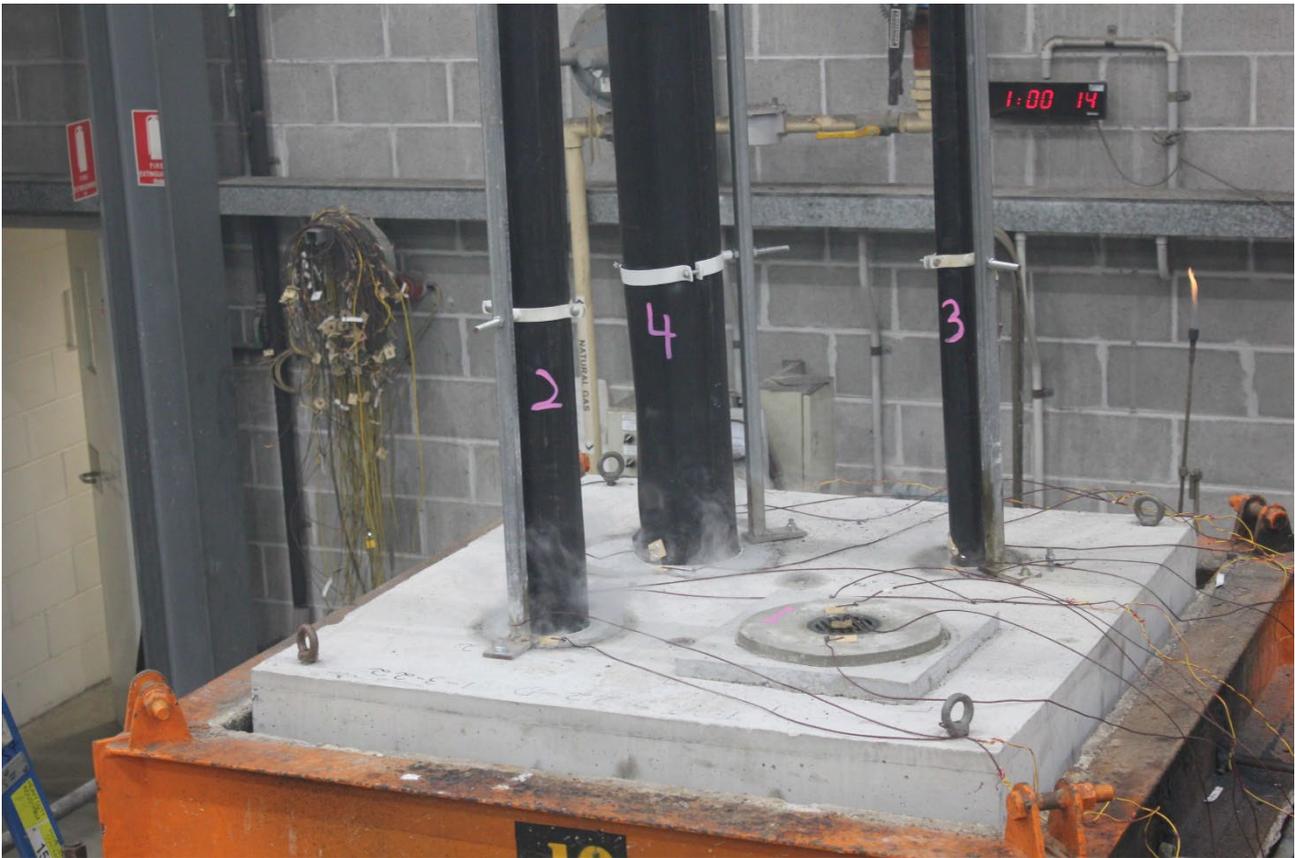
PHOTOGRAPH 7 – SPECIMENS AT 60 MINUTES INTO THE TEST

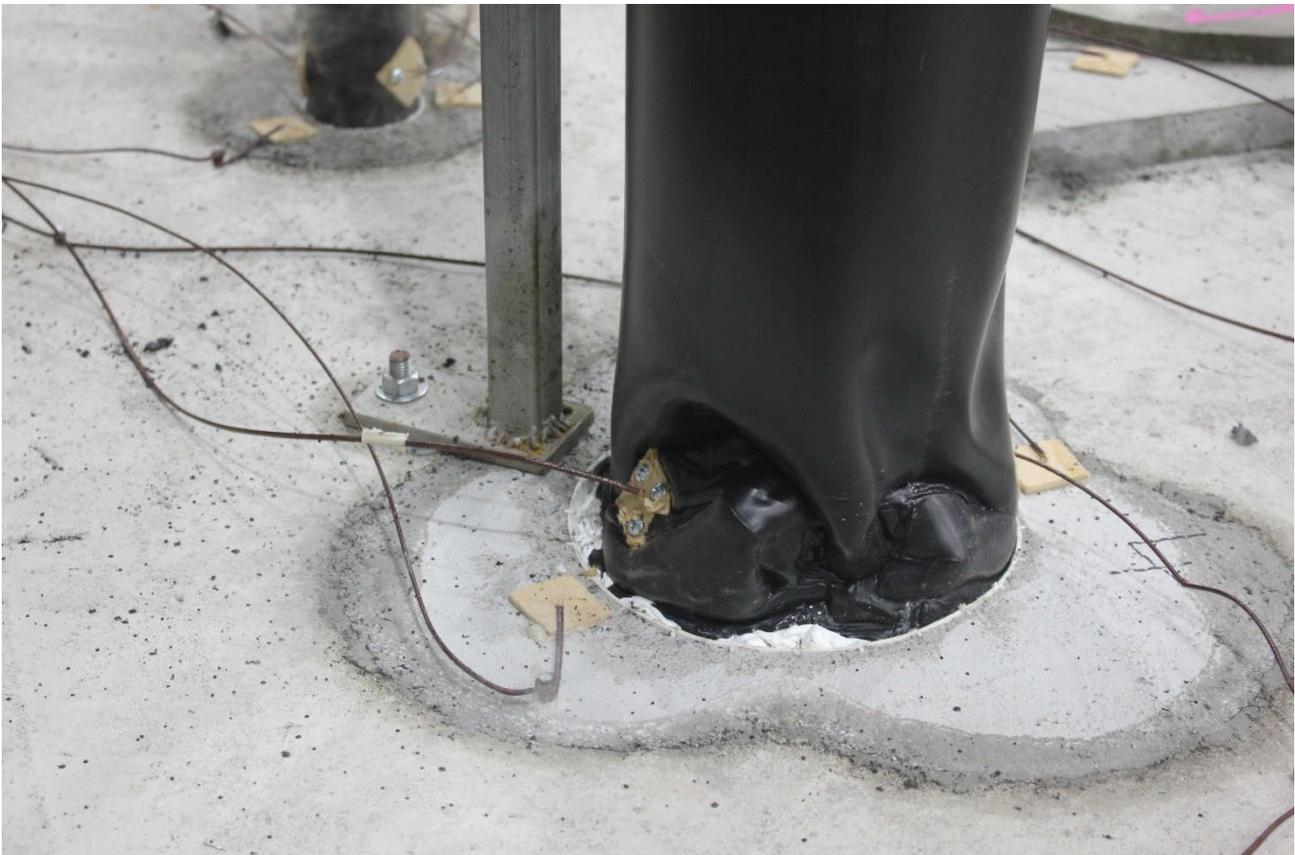
PHOTOGRAPH 8 – SPECIMEN 4 AT 88 MINUTES INTO THE TEST

45 minutes	- Smoke has ceased fluing from the pipe of specimen 3.
69 minutes	- Smoke has ceased fluing from the pipe of specimens 2 and 4.
83 minutes	- The white-collar casing at the base of specimen 4 has begun to melt, the pipe at the base of the specimen continues to deform.
124 minutes	- The white-collar casing at the base of specimen 4 has continues to melt, the pipe at the base specimen continues to deform.
151 minutes	- <u>Insulation failure of specimen 4</u> - maximum temperature rise of 180K is exceeded on the slab 25-mm from the collar case at the base (north side).
204 minutes	- The thermocouple (#13) pad at the base of specimen 4 has been covered with molten white plastic from the collar.
230 minutes	- The white-collar casing at the base of specimen 2 has been pushed up above the slab with some sections melted.
235 minutes	- The white-collar casing and black pipe at the base of specimen 4 have melted.

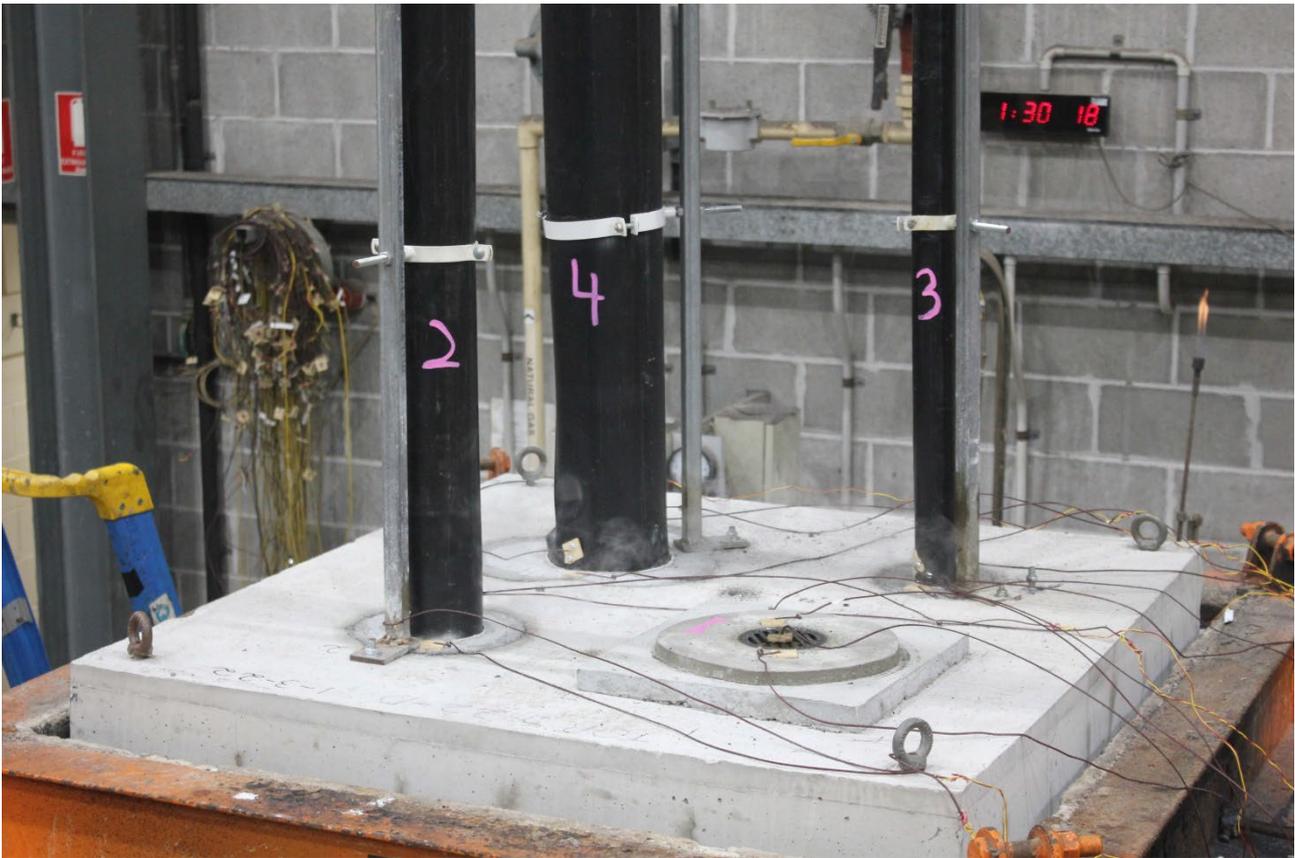
PHOTOGRAPH 9 – SPECIMENS AT 90 MINUTES INTO THE TEST

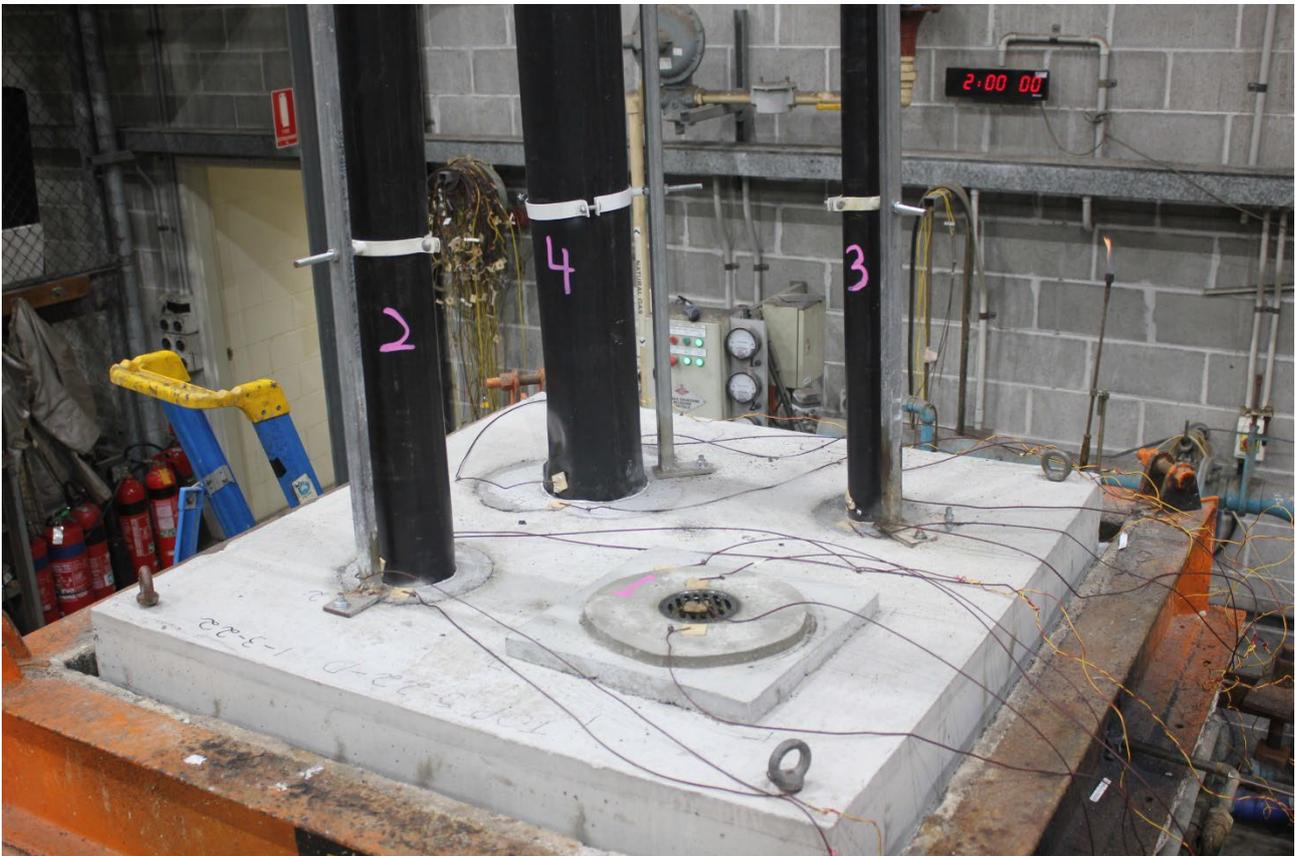
PHOTOGRAPH 10 – SPECIMEN 1 AT 120 MINUTES INTO THE TEST

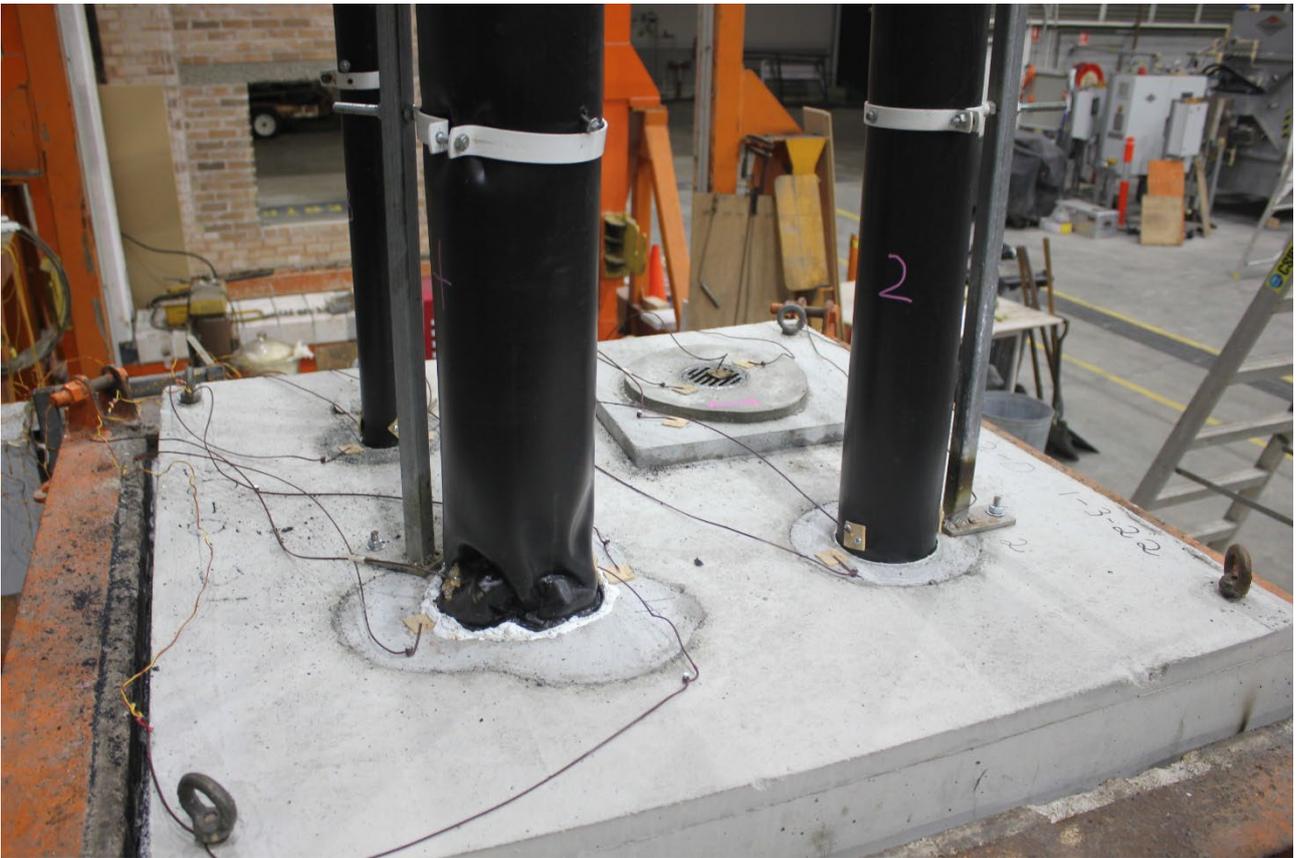
PHOTOGRAPH 11 – SPECIMENS AT 150 MINUTES INTO THE TEST

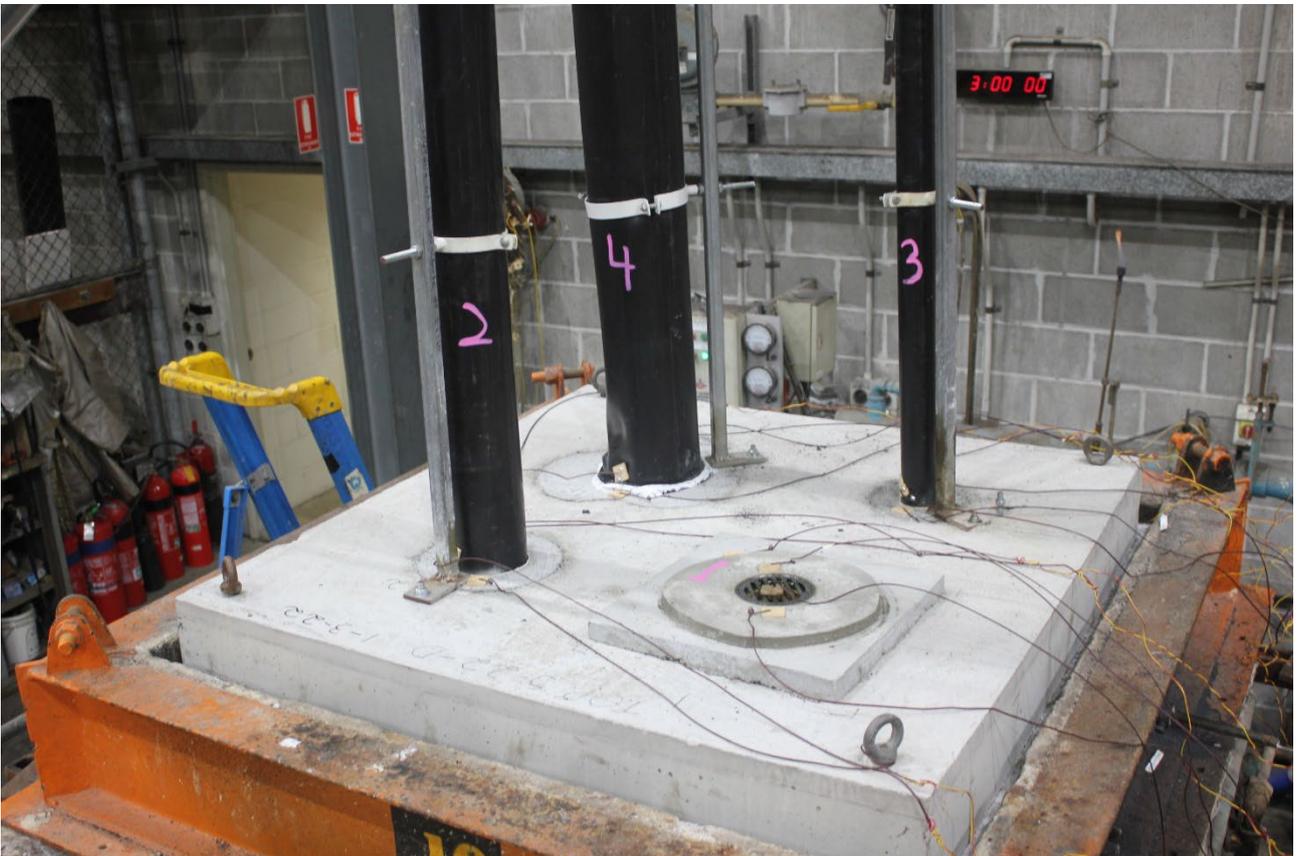
PHOTOGRAPH 12 – SPECIMENS AT 180 MINUTES INTO THE TEST

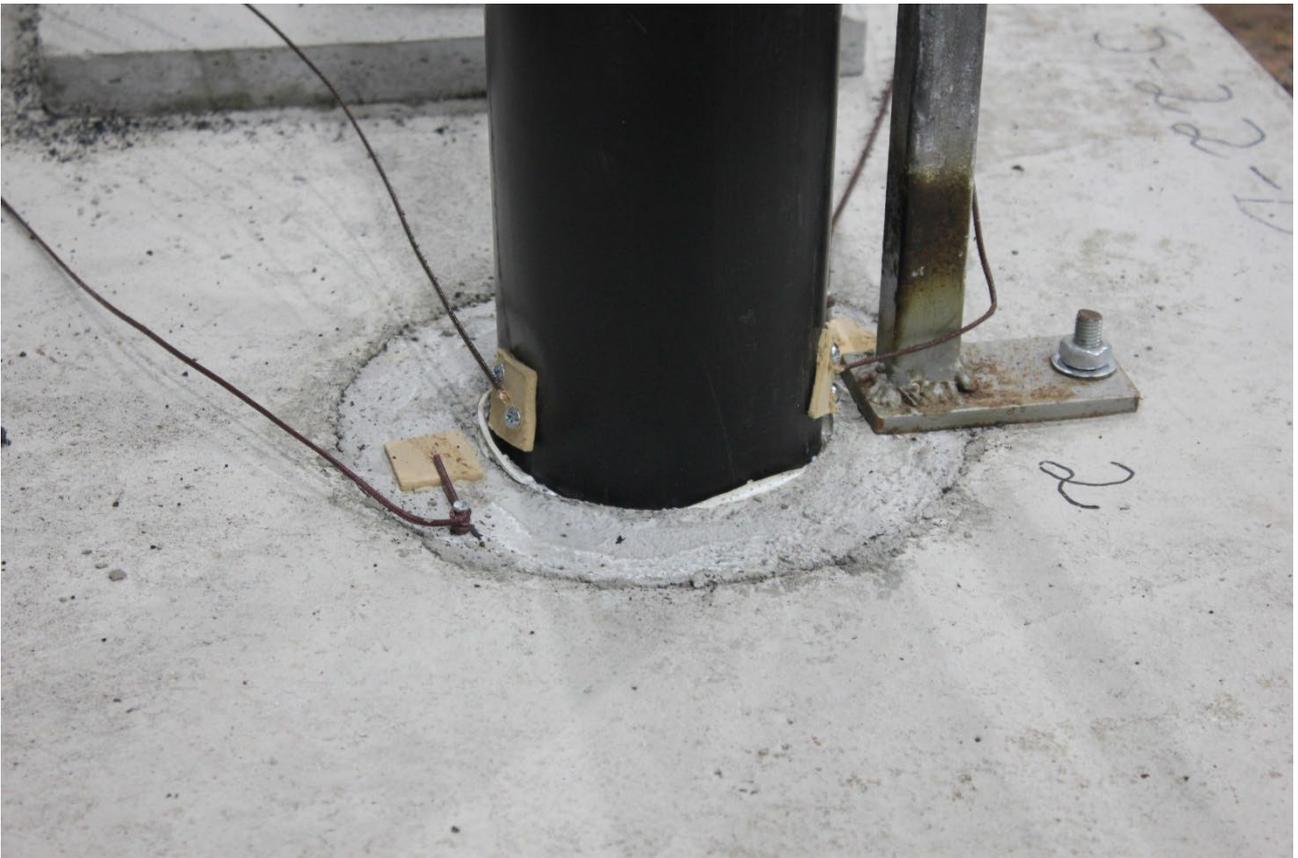
PHOTOGRAPH 13 – THE BASE OF SPECIMEN 2 AT 230 MINUTES INTO THE TEST

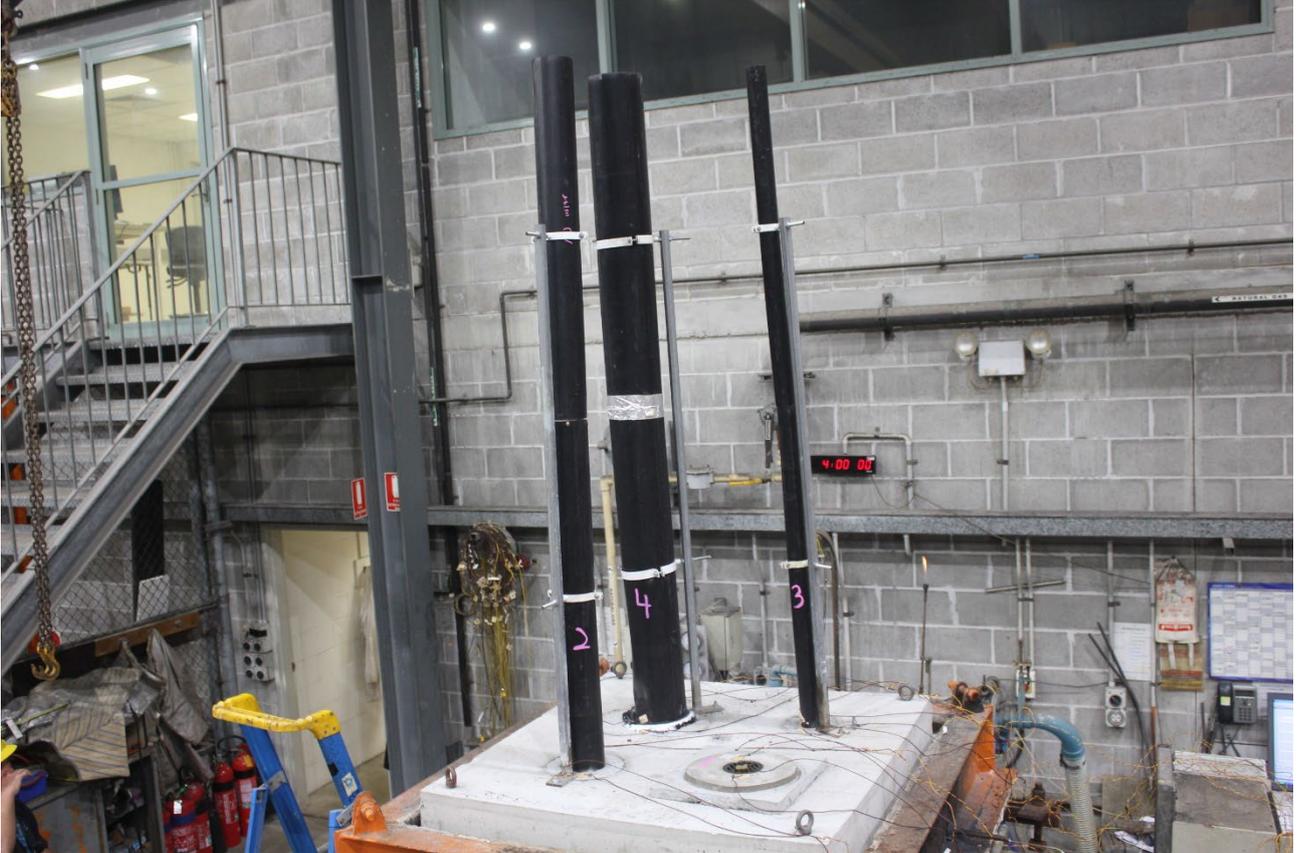
PHOTOGRAPH 14 – SPECIMENS AT 240 MINUTES INTO THE TEST.

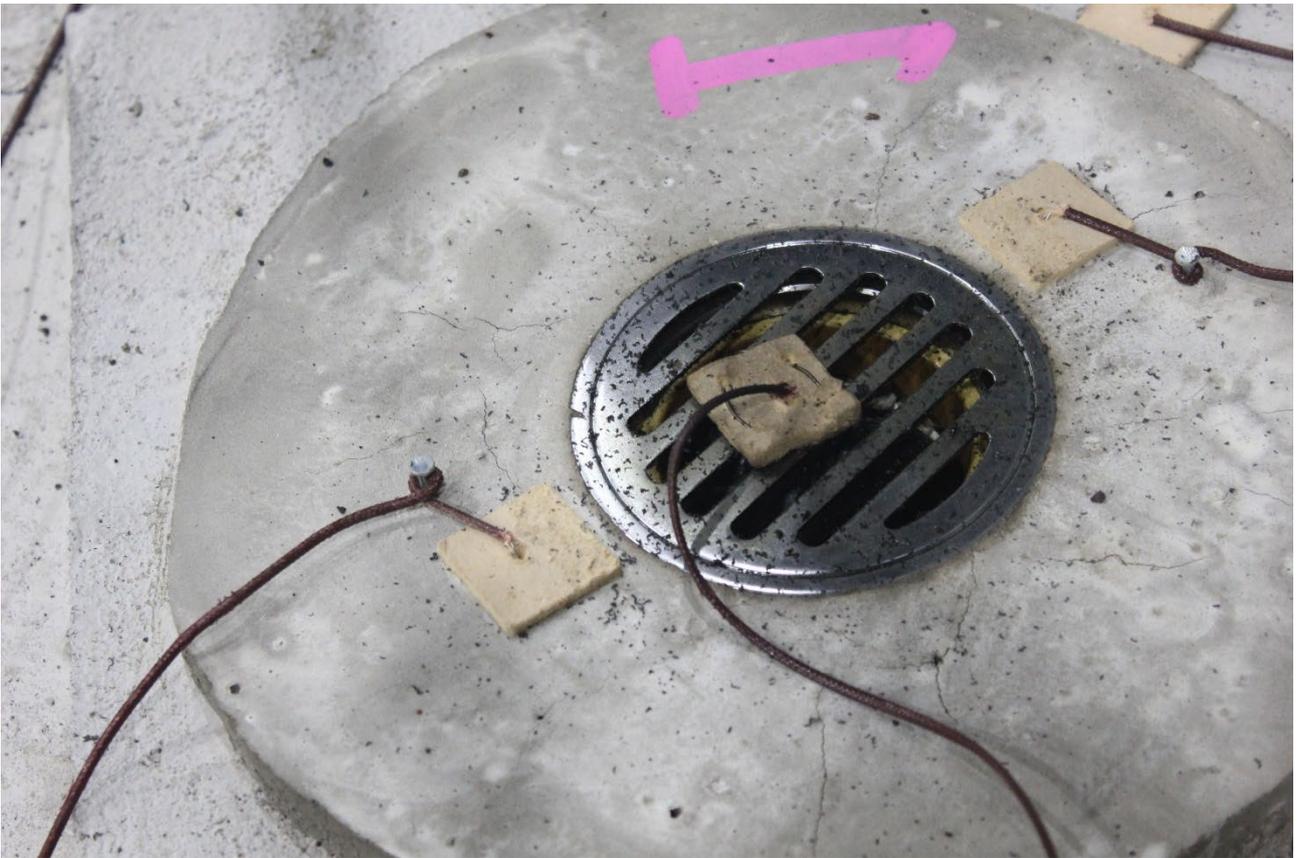
PHOTOGRAPH 15 – SPECIMEN 1 AT 240 MINUTES INTO THE TEST

236 minutes	- Intumescent material is visible through the metal grate inside the pipe of the floor waste of specimen 1.
237 minutes	- <u>Insulation failure of specimen 2</u> - maximum temperature rise of 180K is exceeded on the northern side of the slab, 25-mm from the collar.
242 minutes	- Test terminated.

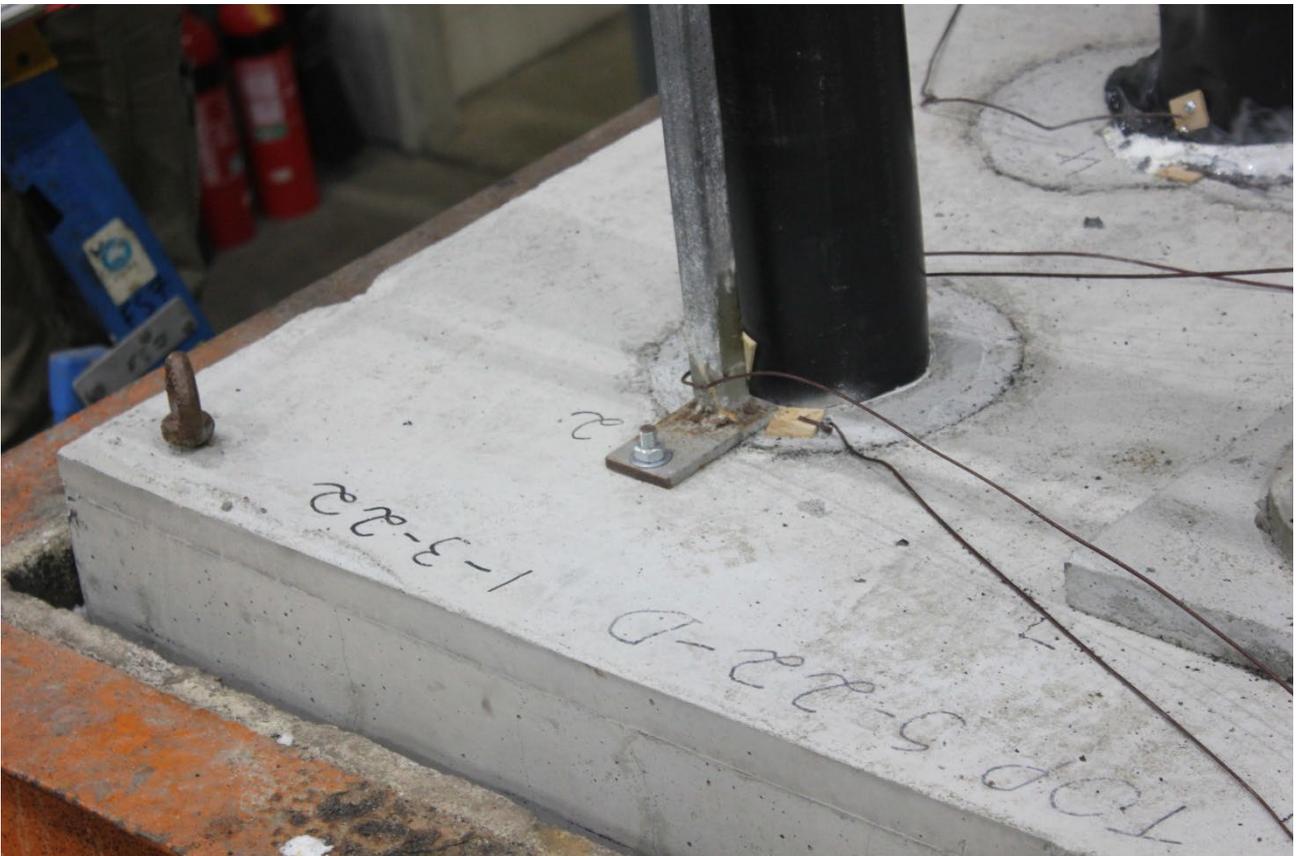
PHOTOGRAPH 16 – SPECIMEN 2 AT 240 MINUTES INTO THE TEST

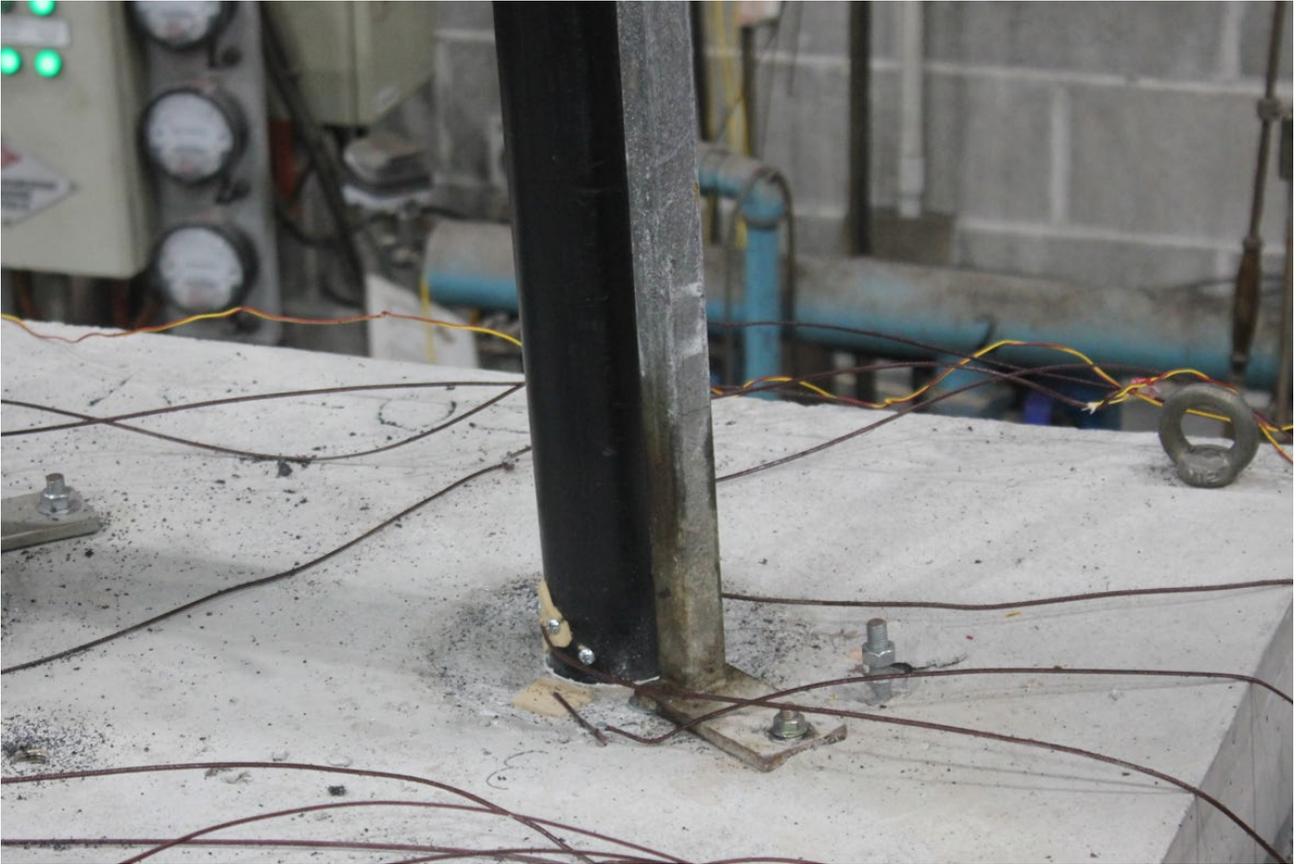
PHOTOGRAPH 17 – SPECIMEN 3 AT 240 MINUTES INTO THE TEST

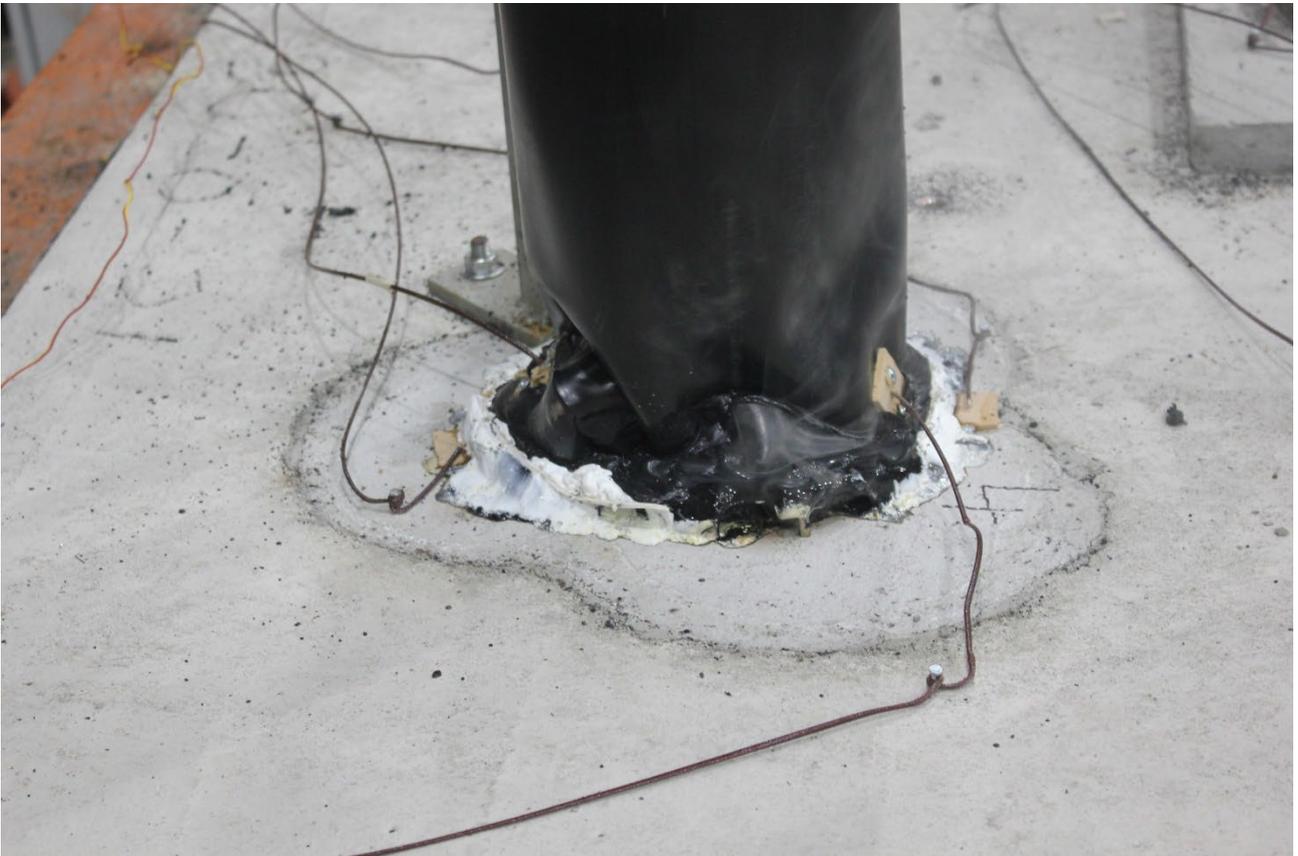
PHOTOGRAPH 18 – SPECIMEN 4 AT 240 MINUTES INTO THE TEST

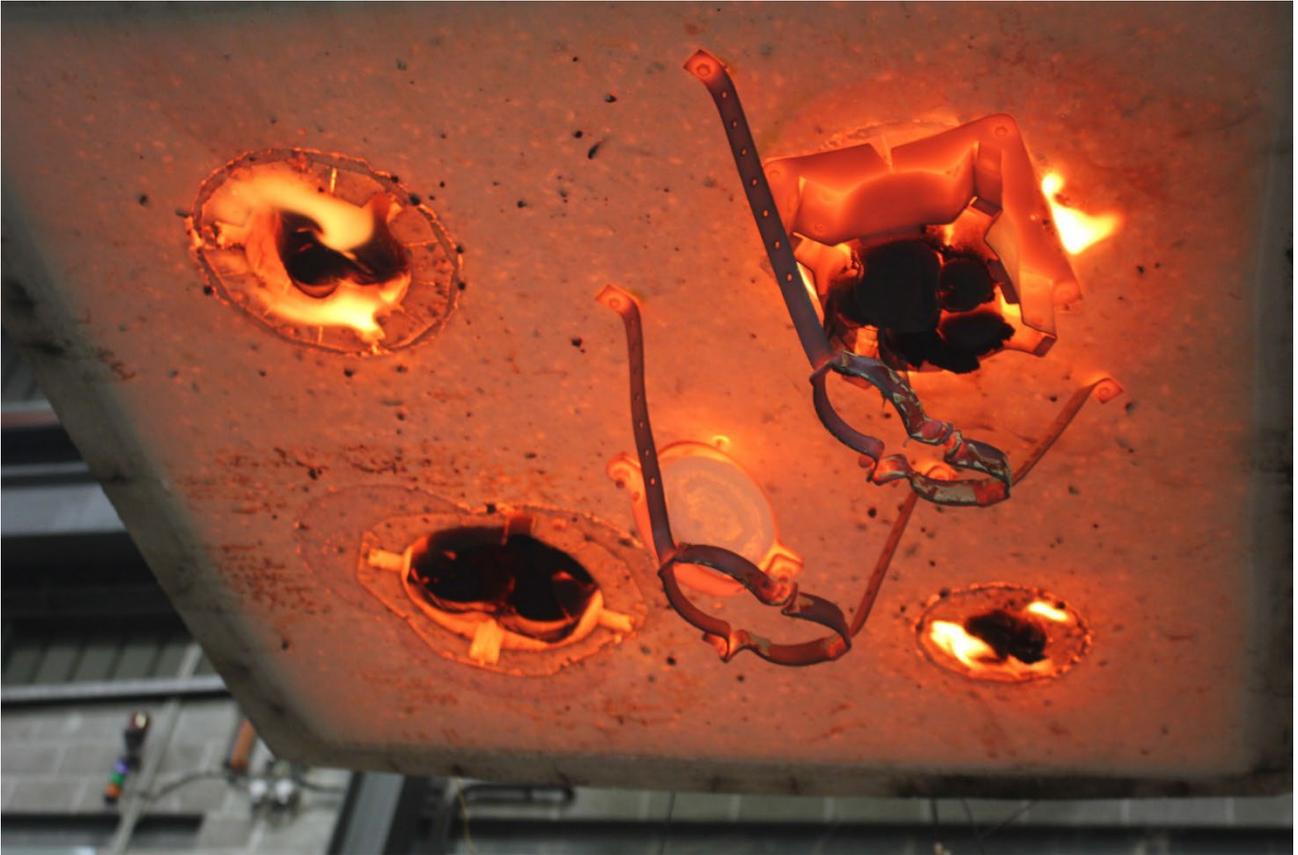
PHOTOGRAPH 19 – EXPOSED FACE OF SPECIMENS AT THE CONCLUSION OF TESTING
