Fire-resistance test on fire collars protecting a concrete slab penetrated by services

Test Report

Author: Peter Gordon
Report number: FSP 2274
Date: 20 December 2023

Sponsored Investigation No. FSP 2274

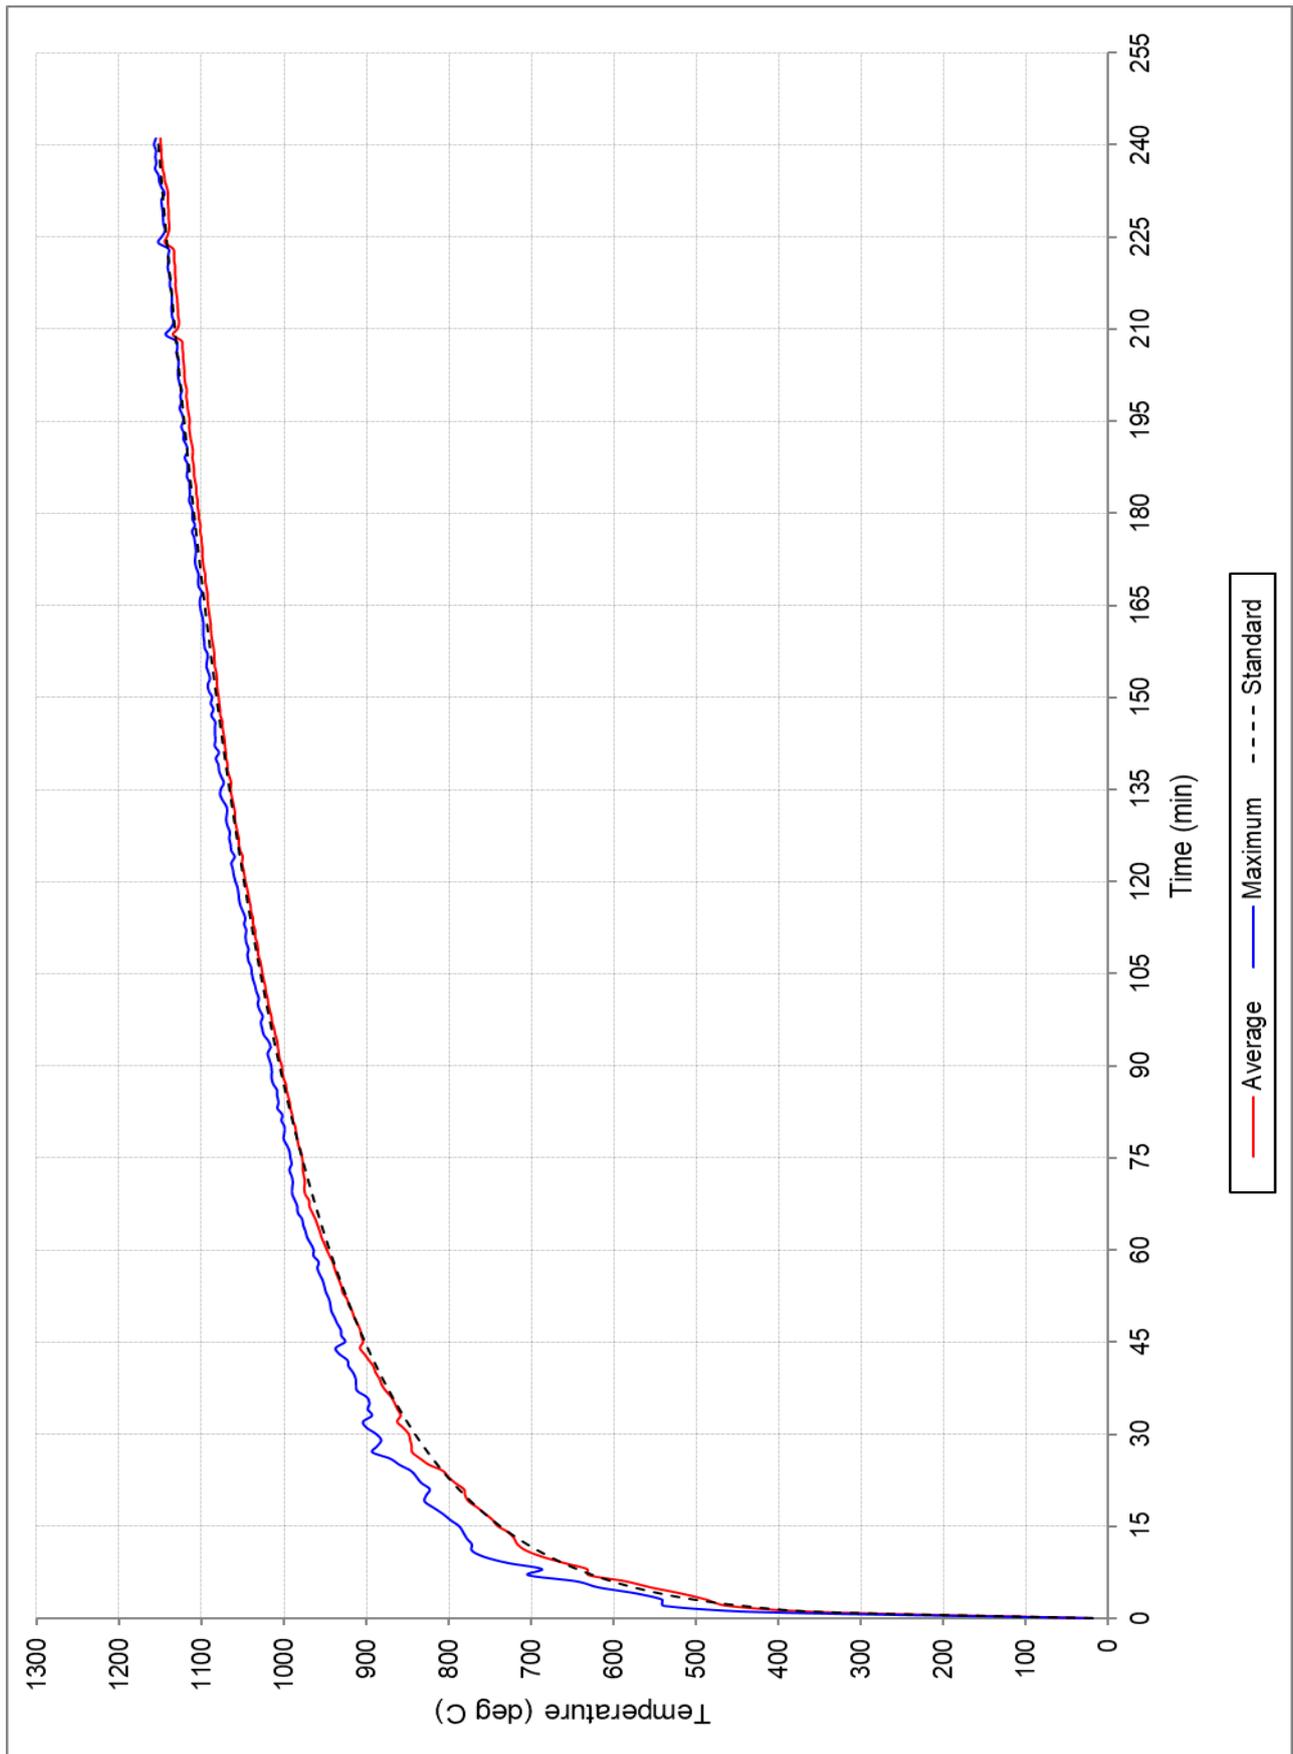
FIGURE 1 – FURNACE TEMPERATURE

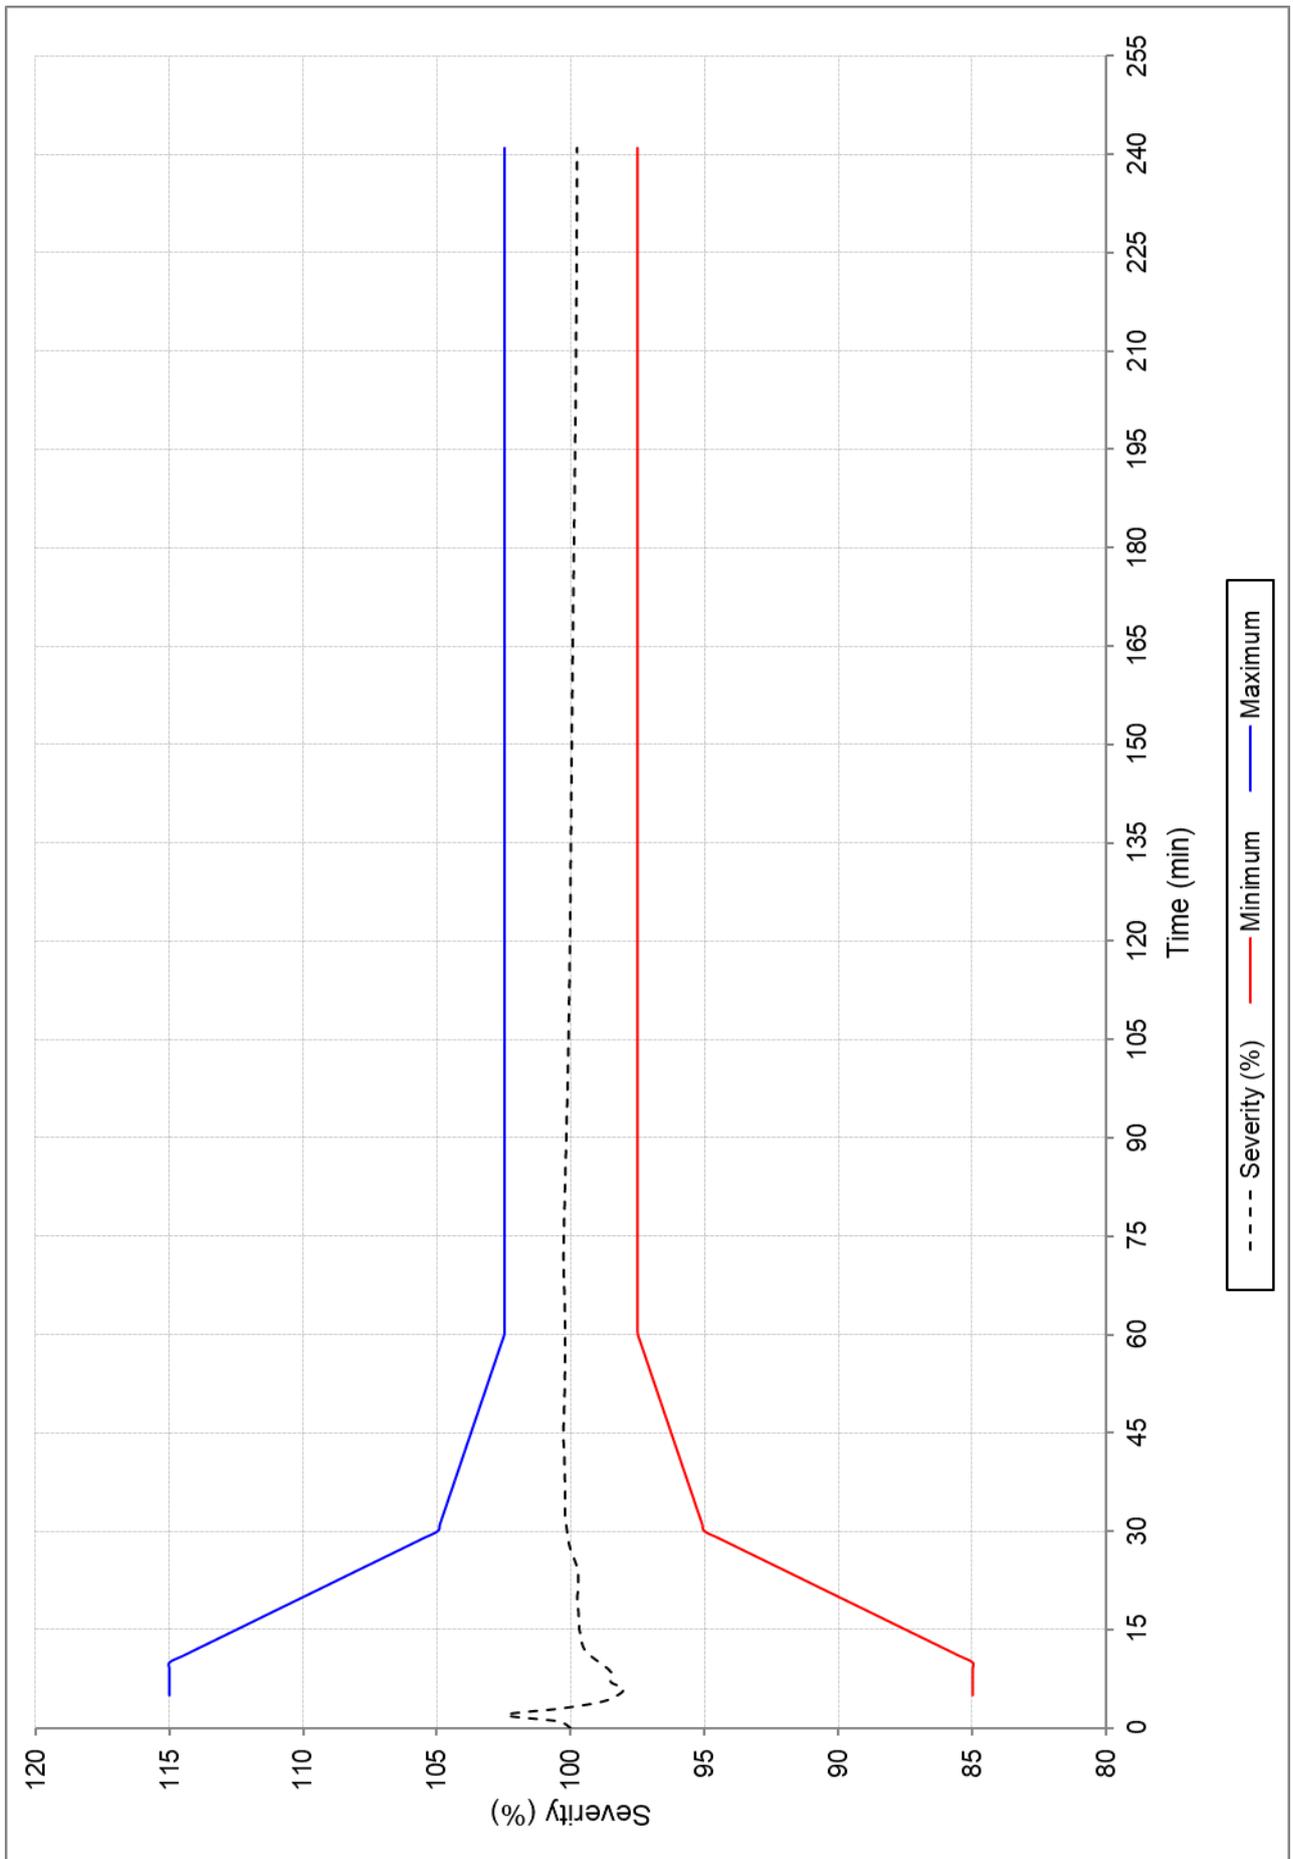
FIGURE 2 – FURNACE SEVERITY

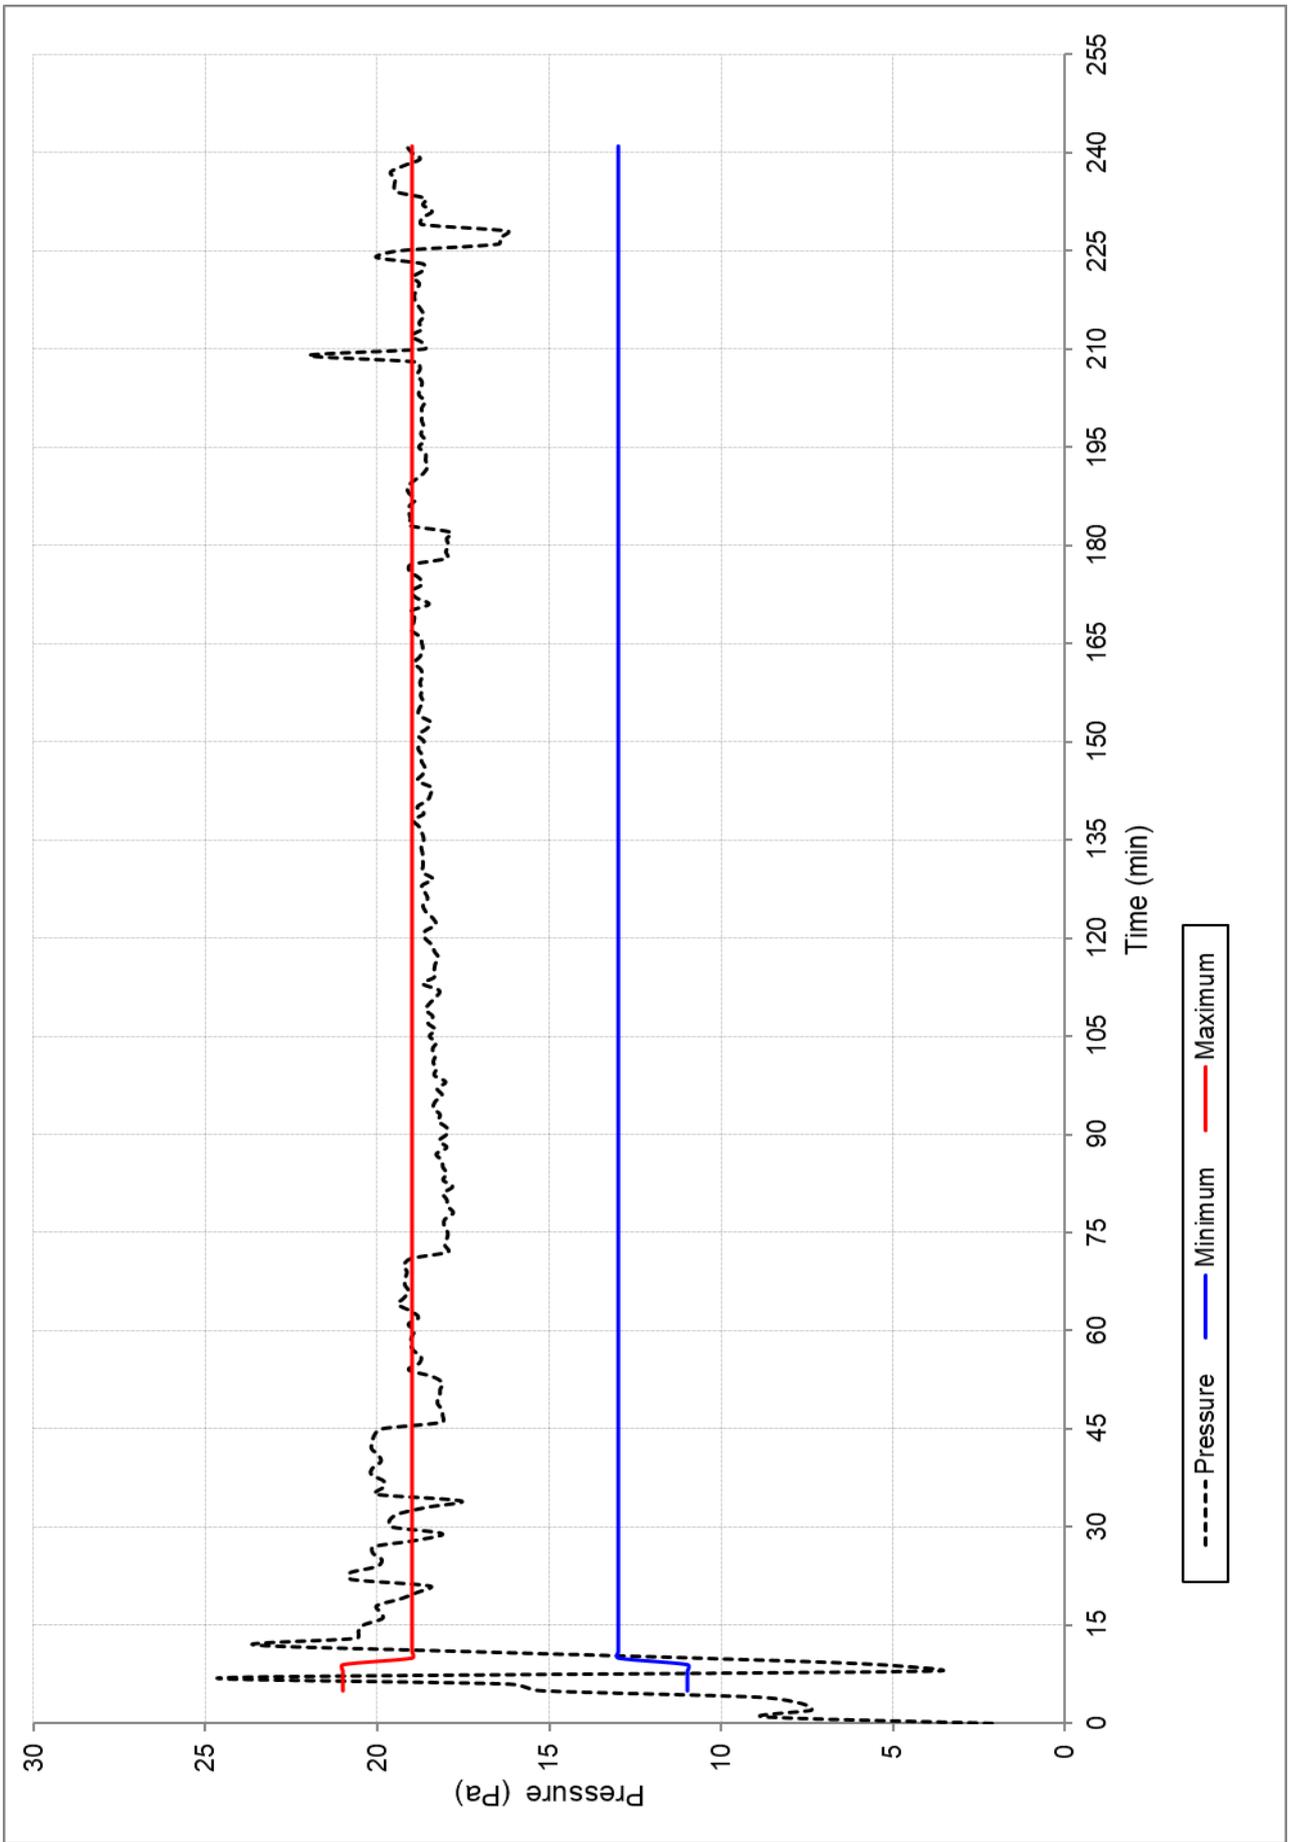
FIGURE 3 – FURNACE PRESSURE

The furnace pressure was measured by a differential low-pressure transducer with a range of ± 50 Pa.

The pressure probe was located approximately 350-mm below the concrete slab supporting construction.

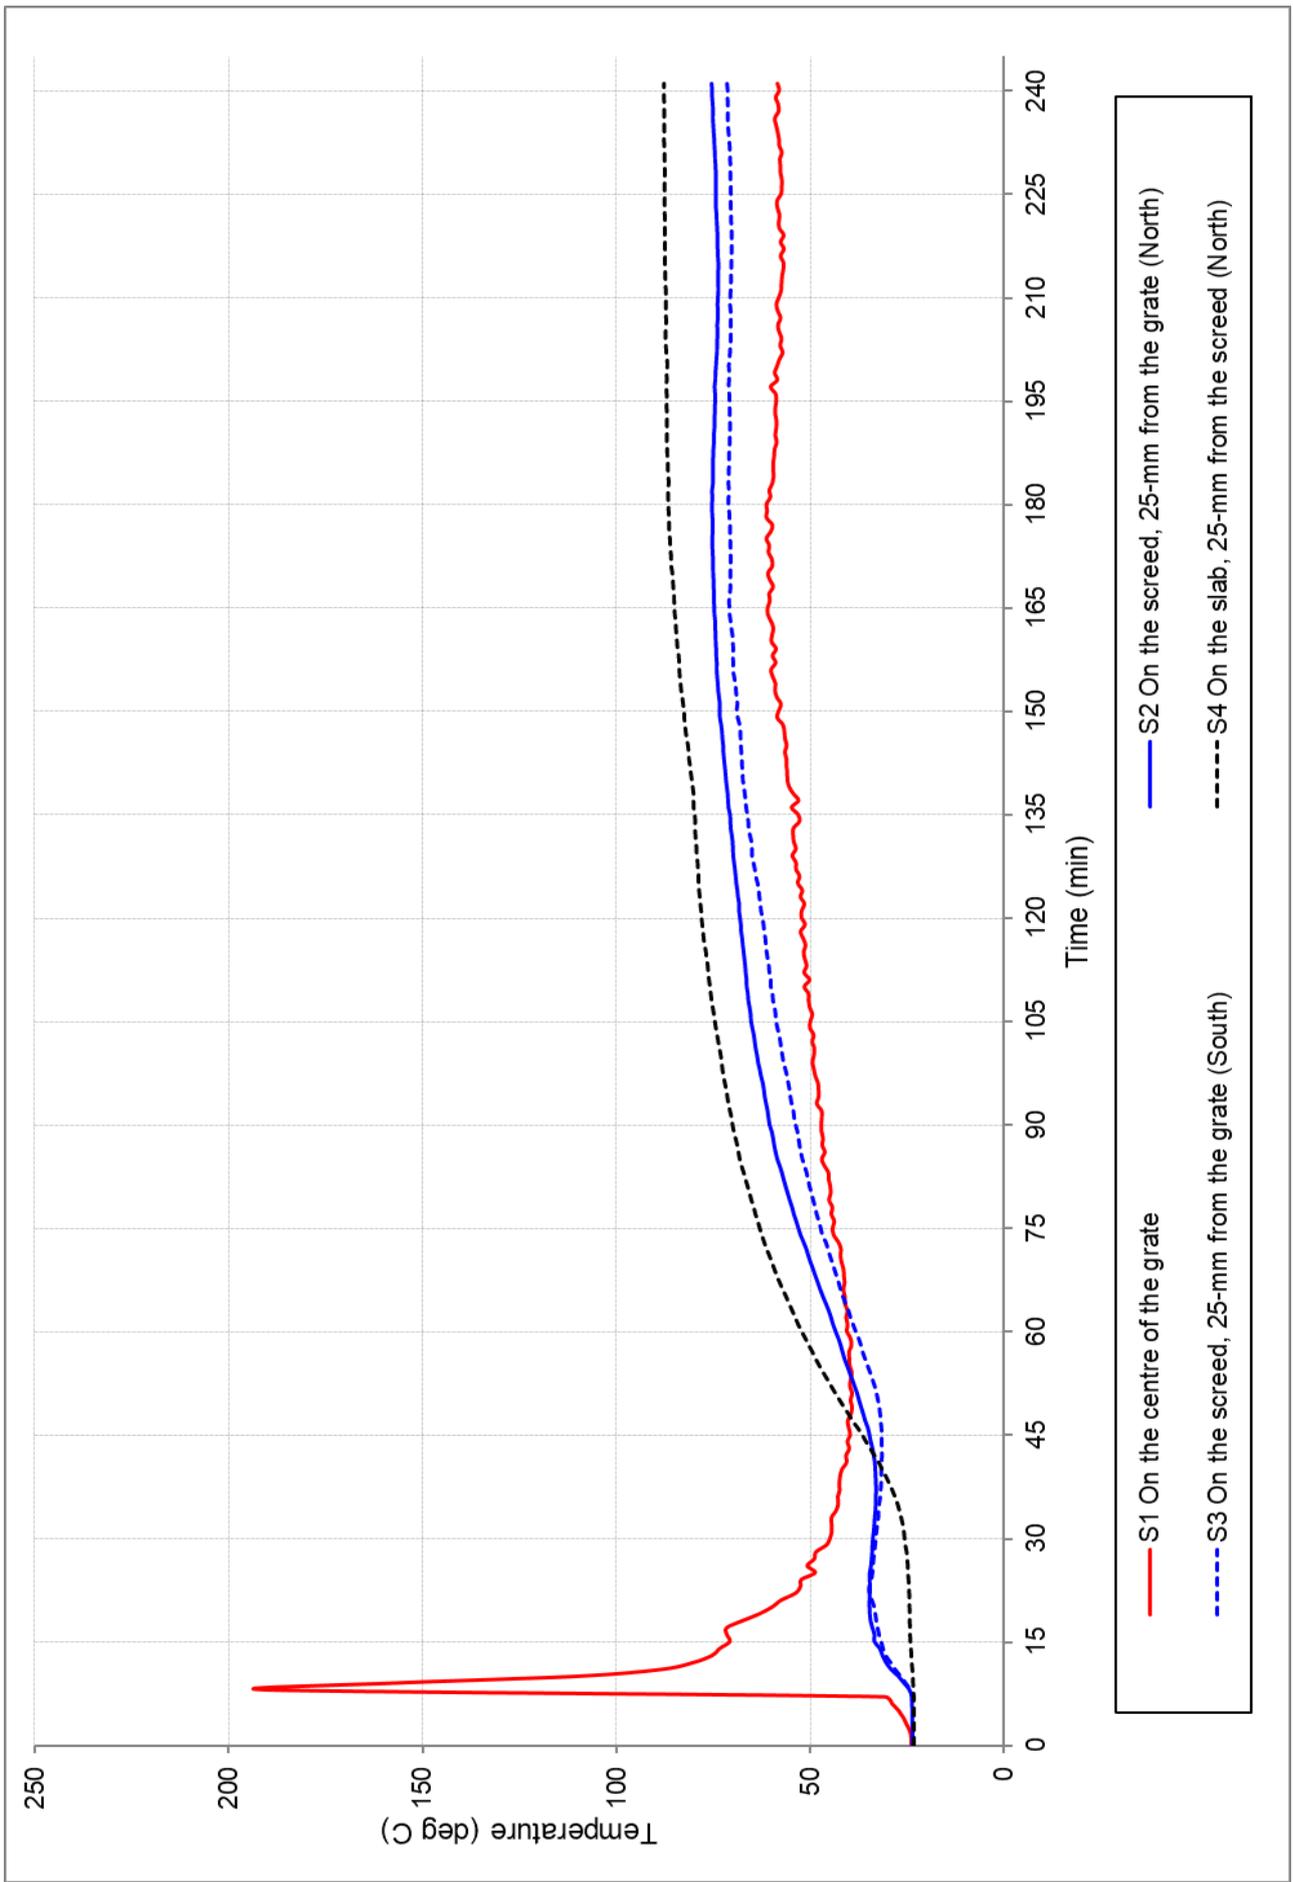
FIGURE 4 – SPECIMEN TEMPERATURE – ASSOCIATED WITH SPECIMEN 1

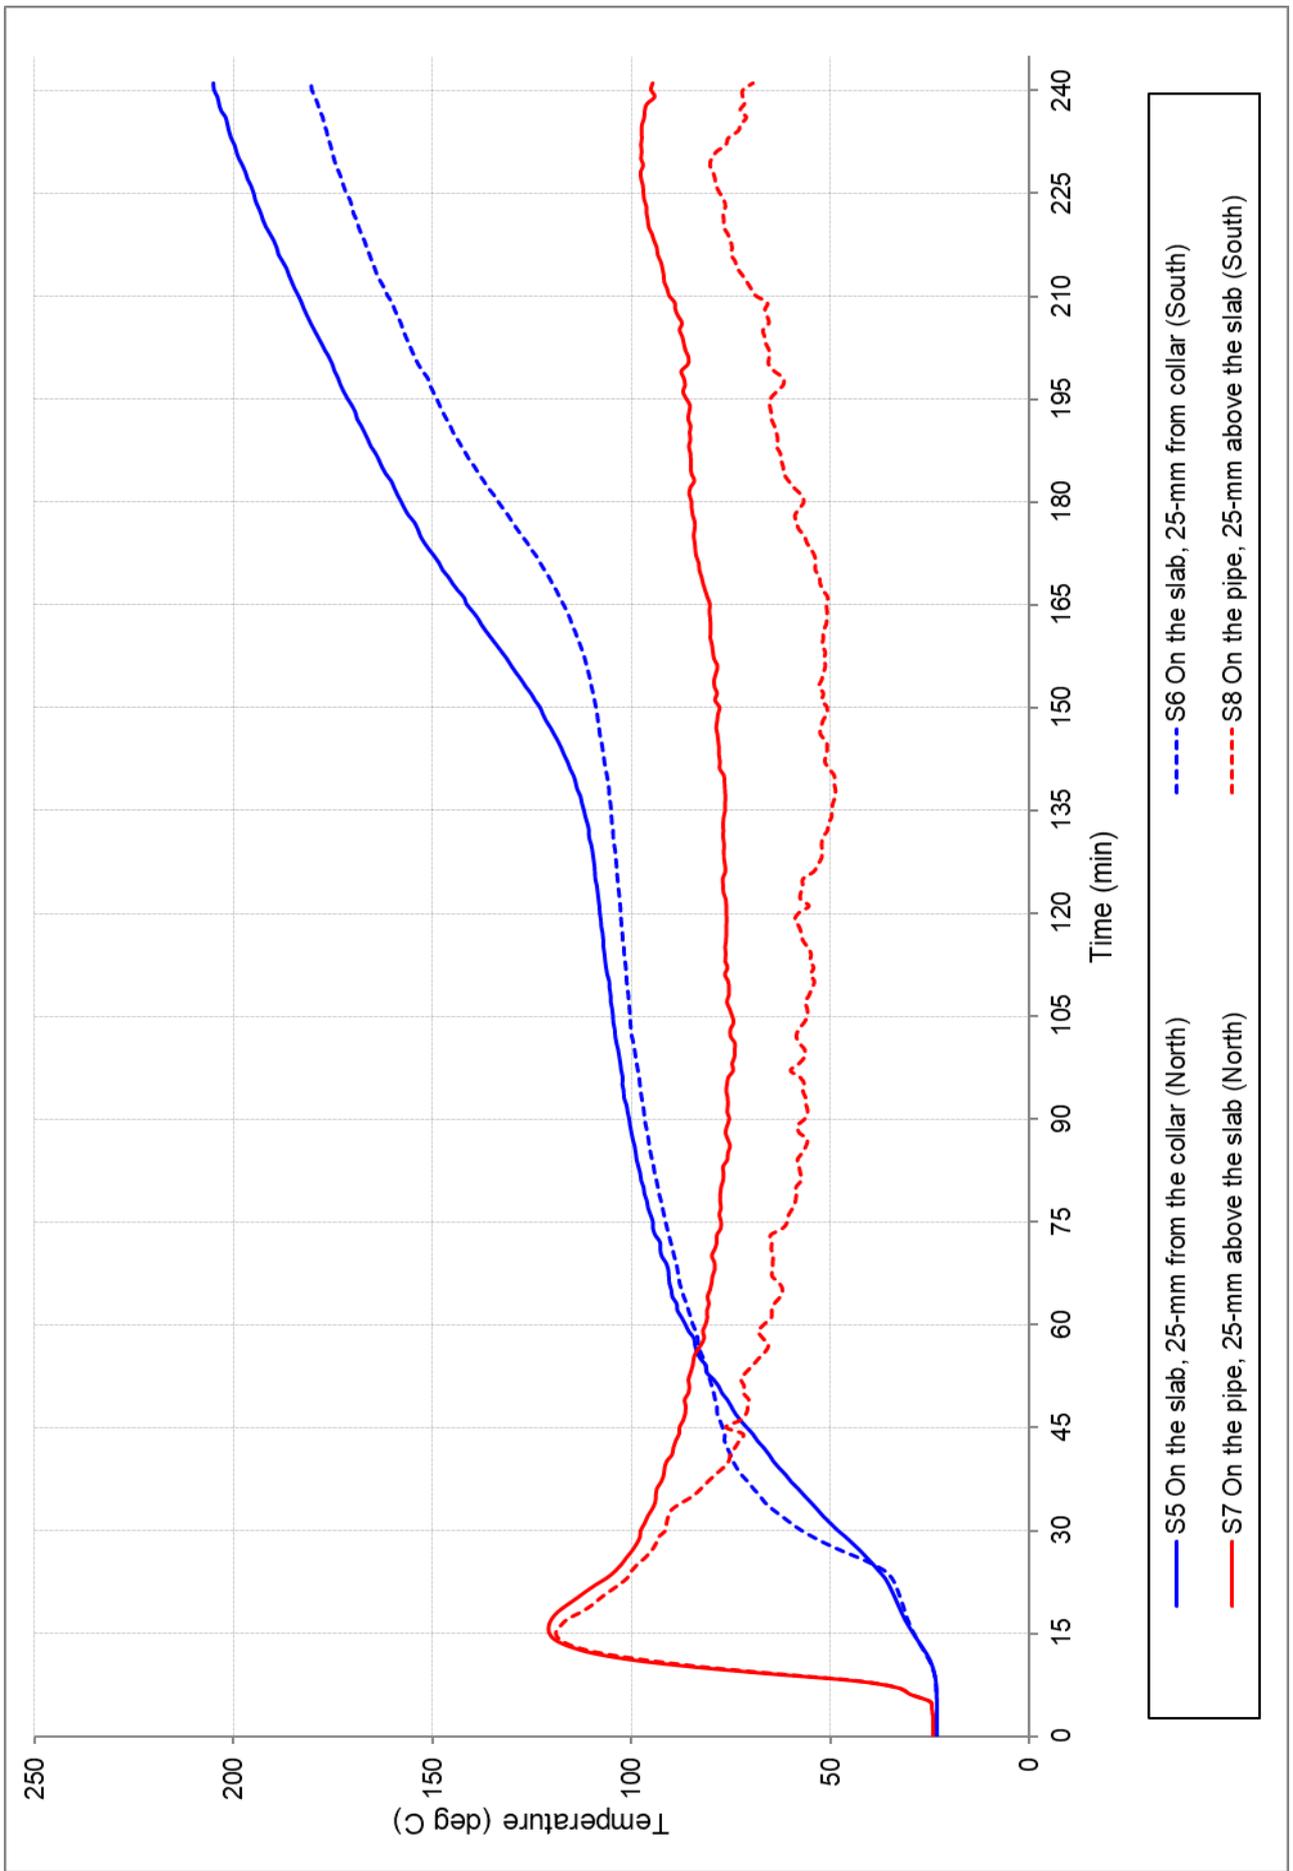
FIGURE 5 – SPECIMEN TEMPERATURE – ASSOCIATED WITH SPECIMEN 2

236 minutes	- Intumescent material is visible through the metal grate inside the pipe of the floor waste of specimen 1.
237 minutes	- <u>Insulation failure of specimen 2</u> - maximum temperature rise of 180K is exceeded on the northern side of the slab, 25-mm from the collar.
242 minutes	- Test terminated.

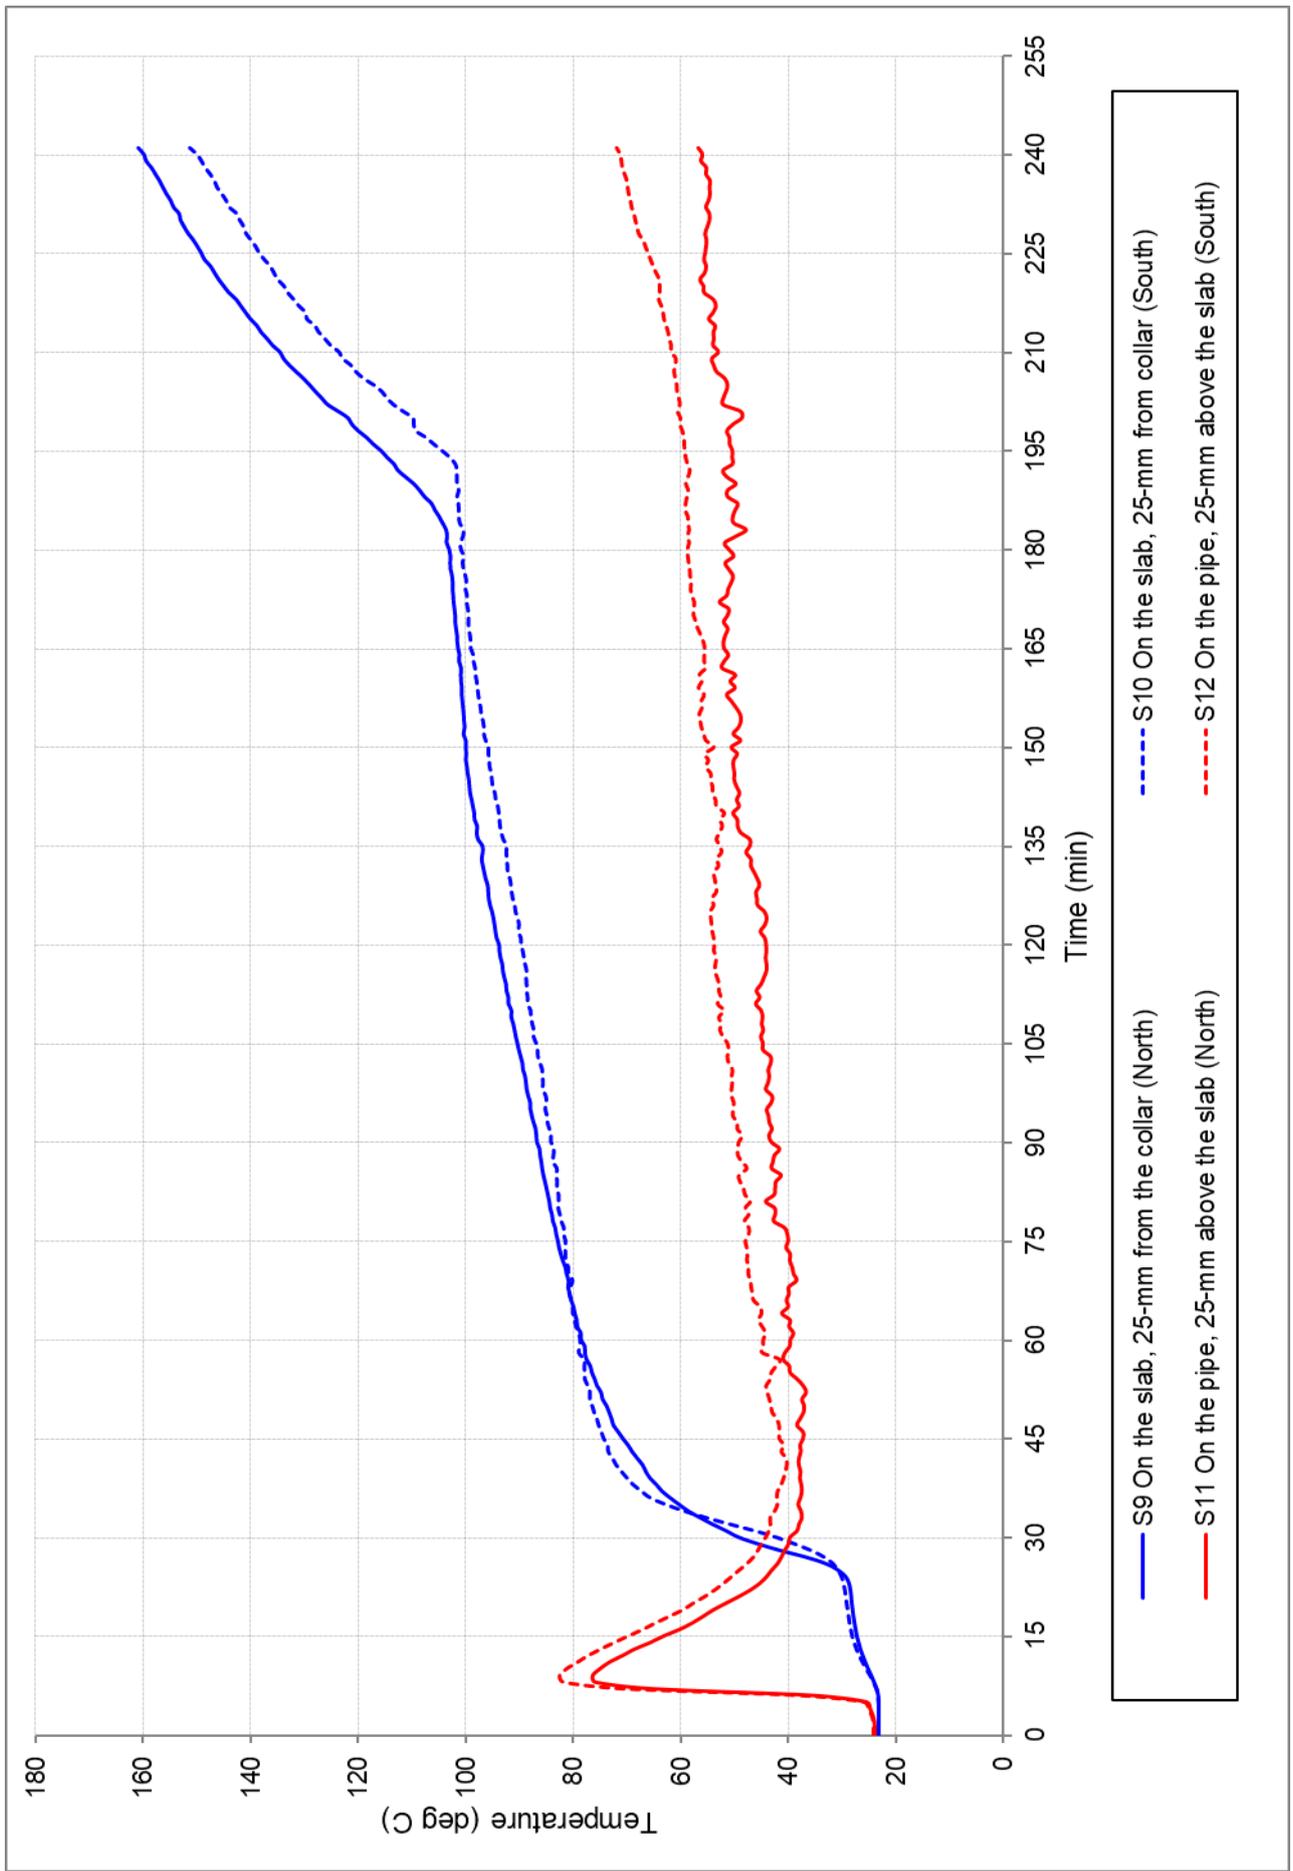
FIGURE 6 – SPECIMEN TEMPERATURE – ASSOCIATED WITH SPECIMEN 3

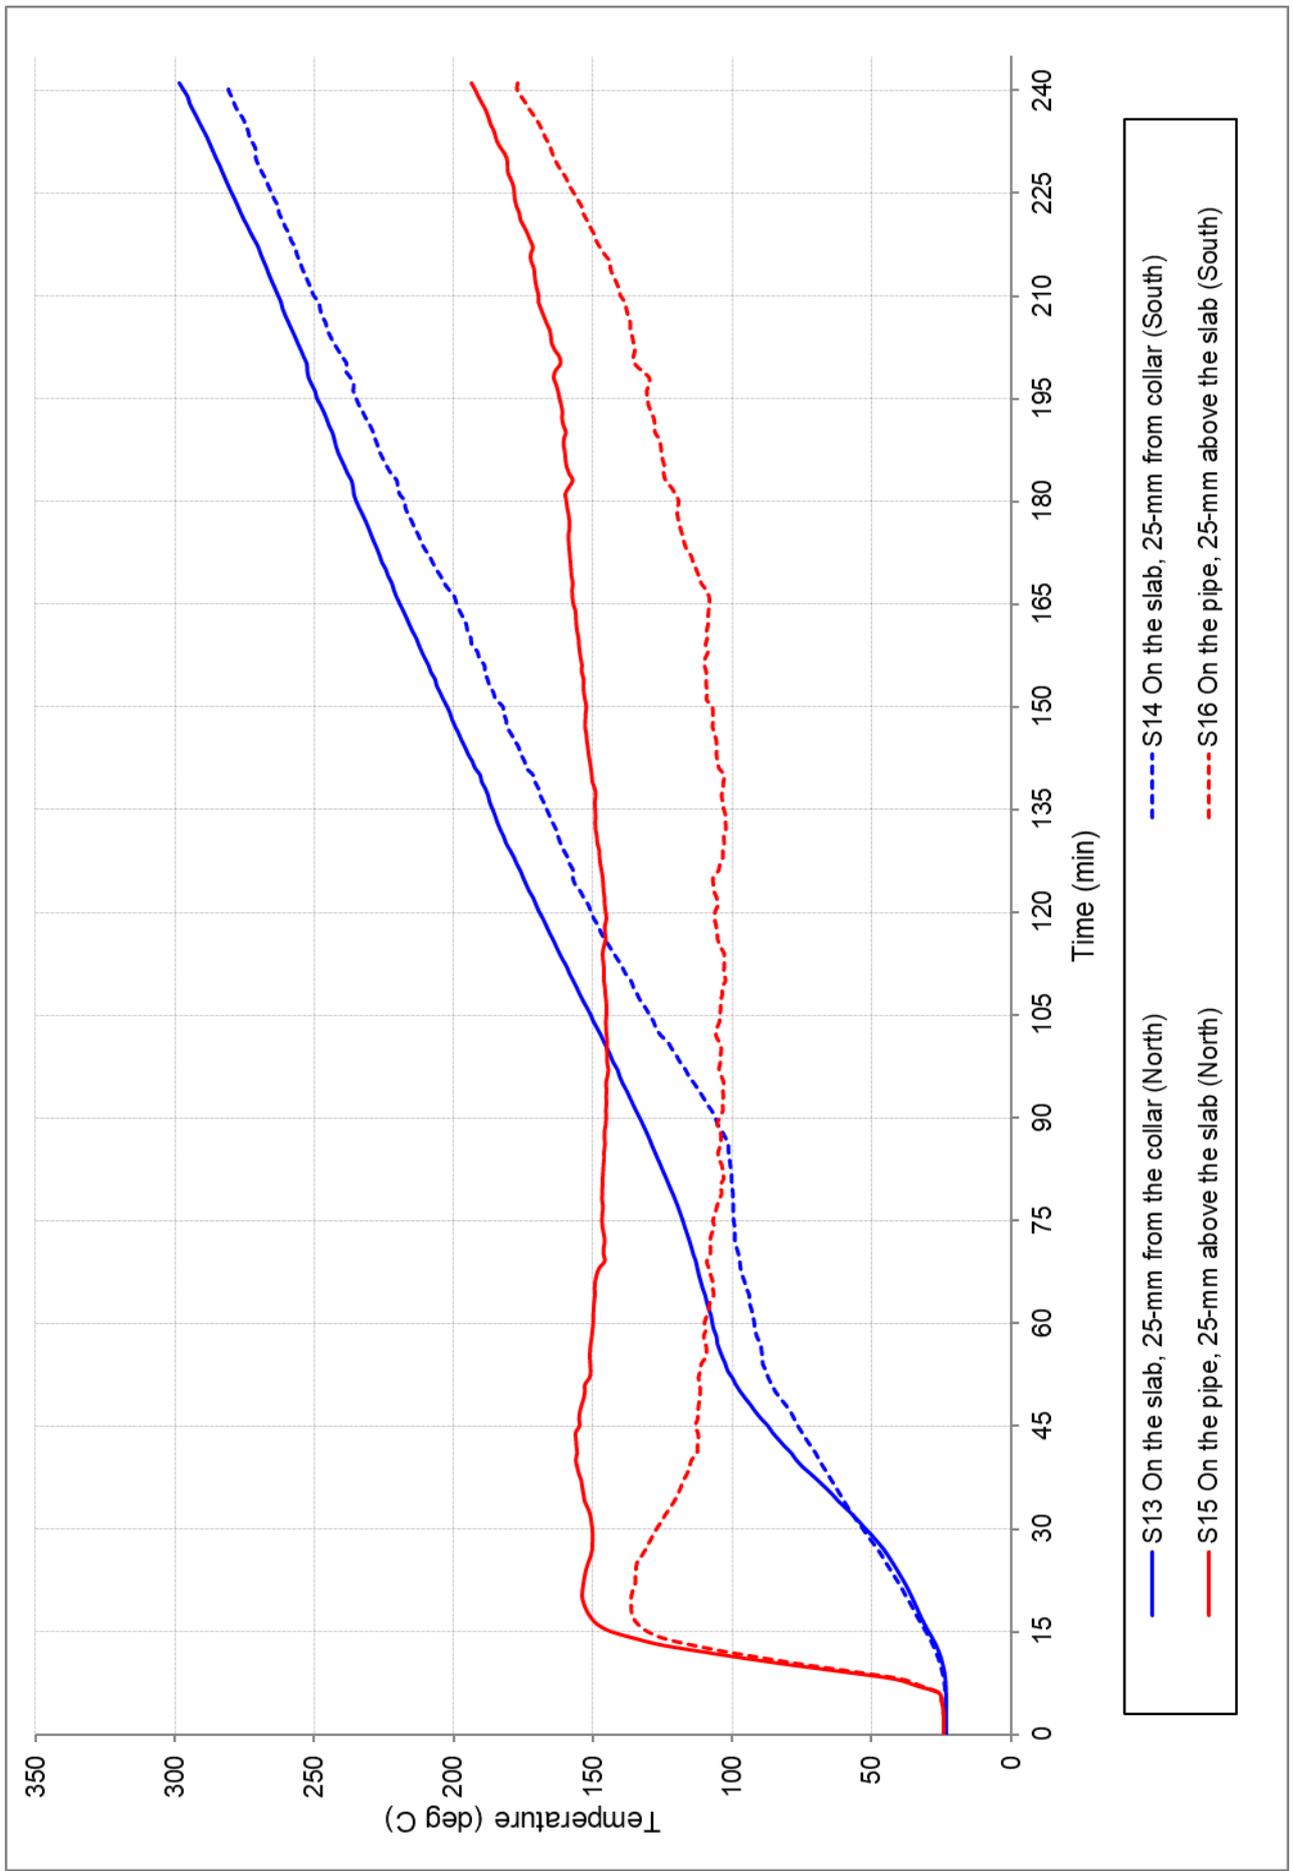
FIGURE 7 – SPECIMEN TEMPERATURE – ASSOCIATED WITH SPECIMEN 4

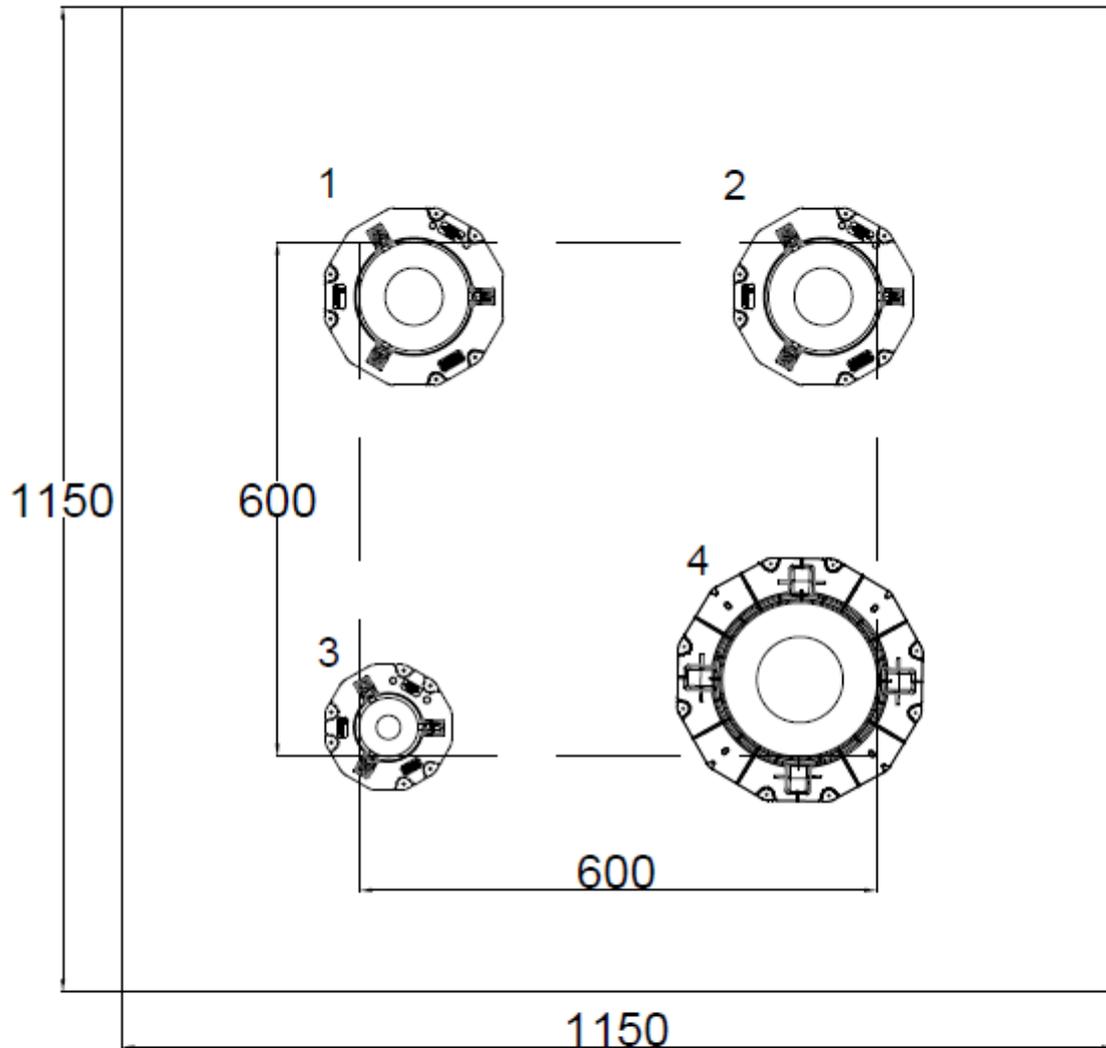
Test Slab S-22-D Layout

Penetration	Collar Code	Pipe Type	Pipe Diameter
1	H100FWS-RR & LP100R-D	Fuseal	110
2	H100S-RR	Fuseal	110
3	H50S-RR	Fuseal	50
4	H150S-RR	Fuseal	160

DRAWING TITLED "TEST SLAB S-22-D LAYOUT", DATED 18 JANUARY 2022, BY SNAP FIRE SYSTEMS PTY LTD

The specimen comprised an 1150-mm x 1150-mm x 150mm/180-mm concrete slab which was penetrated by a total of four (4) polypropylene pipes protected with SNAP retrofit and cast-in fire collars.

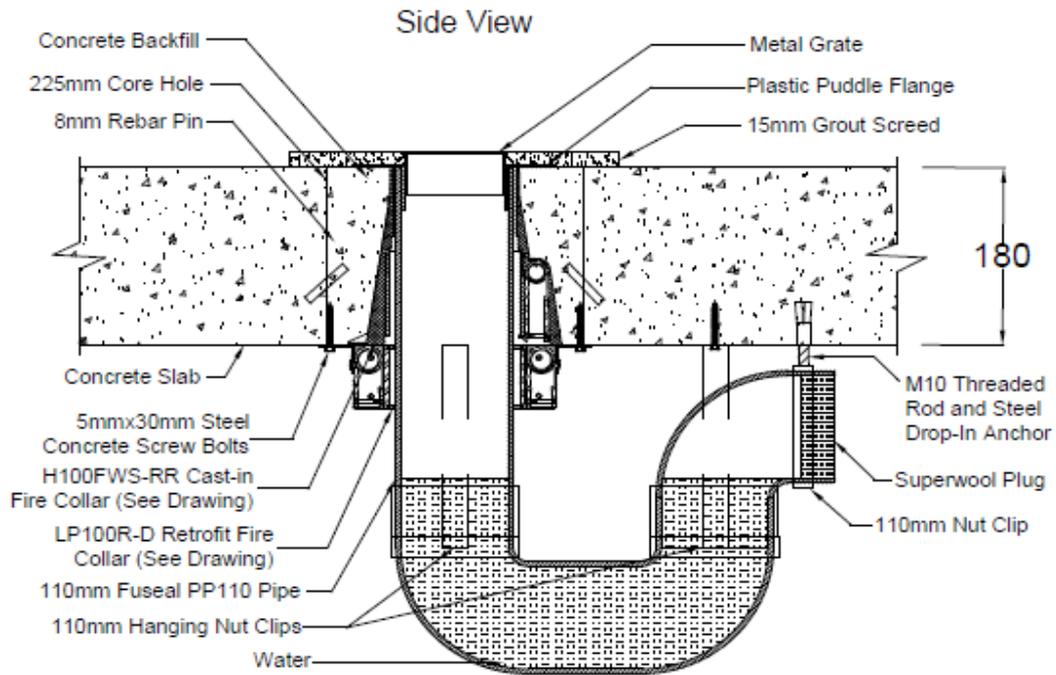
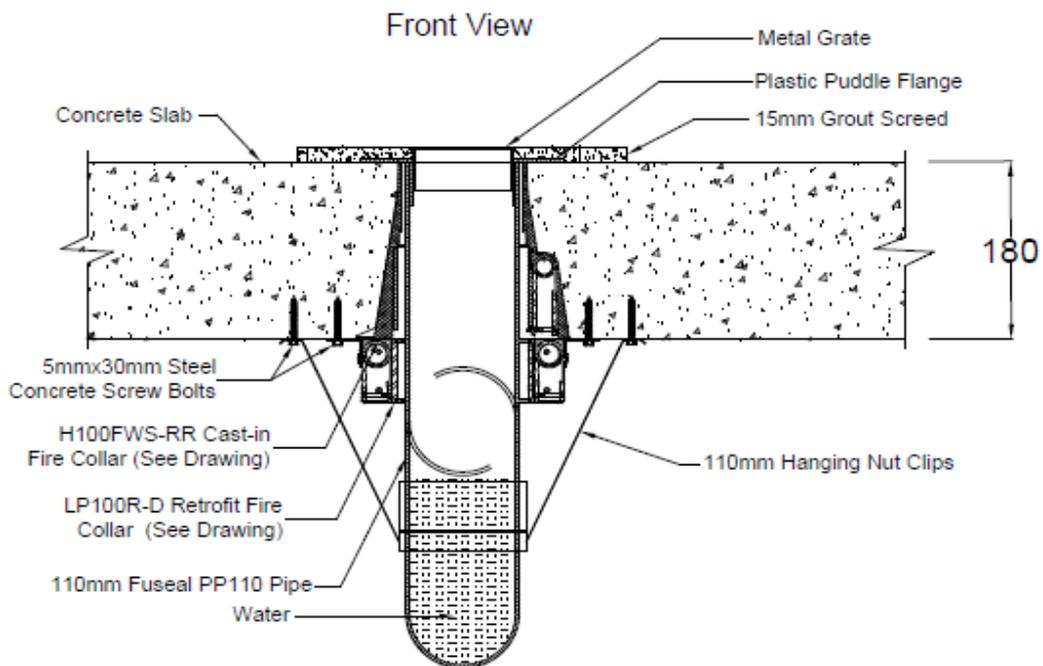
110 Fuseal PP110 Floor Waste & LP100R-D over H100FWS-RR

DRAWING TITLED 'SPECIMEN #1 '110 FUSEAL PP110 FLOORWASTE & LP100R-D OVER H100FWS-RR', DATED 24 FEB 2022, BY SNAP FIRE SYSTEMS PTY LTD

The SNAP LP100R-D fire collar was centrally located over the SNAP H100FWS-RR cast-in collar on the exposed face of the concrete slab and fixed in place through the four mounting brackets using 5-mm x 30-mm long concrete screw bolts.

The penetrating service comprised a polypropylene pipe with a floor waste system incorporating a P-Trap. The penetrating George Fischer Fuseal PP110 polypropylene pipe had a 114.3-mm outside diameter pipe with a wall thickness of 6.7 mm and was fitted through a sleeve on both fire collars. The top of the propylene pipe incorporated a floor waste comprising a chrome plated brass grate and a plastic puddle flange. A 15-mm thick grout screed was laid on top of the concrete slab and finished flush with the floor grate.

On the exposed side of the slab a Fuseal P-Trap was coupled below the SNAP LP100R-D fire collar. The end of the P-Trap was closed with a ceramic fibre (Superwool) plug. The P-Trap was supported from the centre coupling using double hanging side nut clips fixed to the slab with 5-mm x 30-mm long steel concrete screw bolts and from the end of the P-Trap, with a nut clip and M10 threaded rod that was fixed to the concrete slab with a steel drop-in anchor.

The P-trap was charged with water to the level shown in drawing titled 'Specimen #1 110 Fuseal PP110 Floor Waste & LP100R-D over H100FWS-RR', dated 9 March 2022, by Snap Fire Systems Pty Ltd.

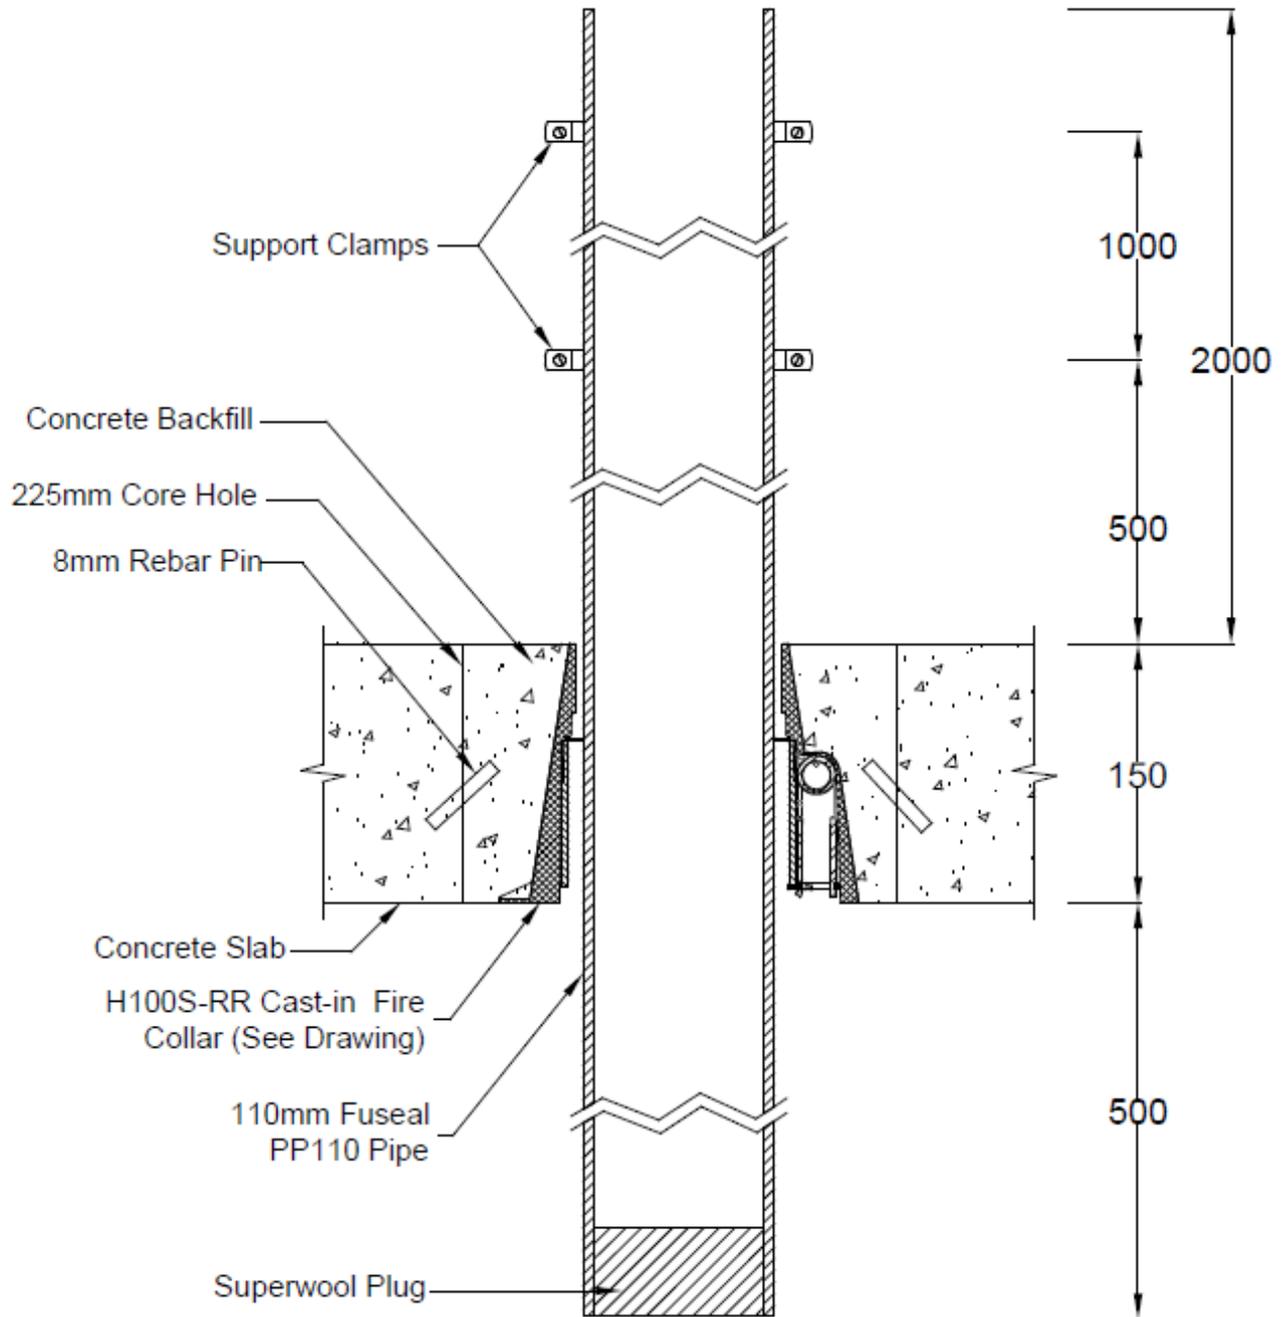
110 Fuseal PP110 Stack & H100S-RR

DRAWING TITLED 'SPECIMEN #2, 110 FUSEAL PP110 STACK & H100S-RR', DATED 9 MARCH 2022 BY SNAP FIRE SYSTEMS PTY LTD

The SNAP H100S-RR High-Top Stack fire collar was cast into a 150-mm thick concrete slab with the collar's casing cut down to 150-mm high finishing flush with the unexposed face of the concrete slab.

The penetrating service comprised a George Fischer Fuseal PP110 polypropylene pipe with a 114.3-mm outside diameter pipe and a wall thickness of 6.7-mm fitted through the collars sleeve. The pipe projected vertically 2000-mm above the unexposed face of the concrete slab and 500-mm below into the furnace chamber. The pipe was supported at nominally 500-mm and 1500-mm from the unexposed face of the slab, left open at the unexposed end and capped with a ceramic fibre (Superwool) plug on the exposed end.

On the unexposed face the annular gap between the pipe and the collars sleeve was left unprotected as shown in drawing titled 'Specimen #2, 110 Fuseal PP110 Stack & H100S-RR', dated 9 March 2022 by Snap Fire Systems Pty Ltd.
