Fire-resistance test on fire collars protecting a concrete slab penetrated by services

Test Report

Author: Peter Gordon
Report number: FSP 2274
Date: 20 December 2023

Sponsored Investigation No. FSP 2274

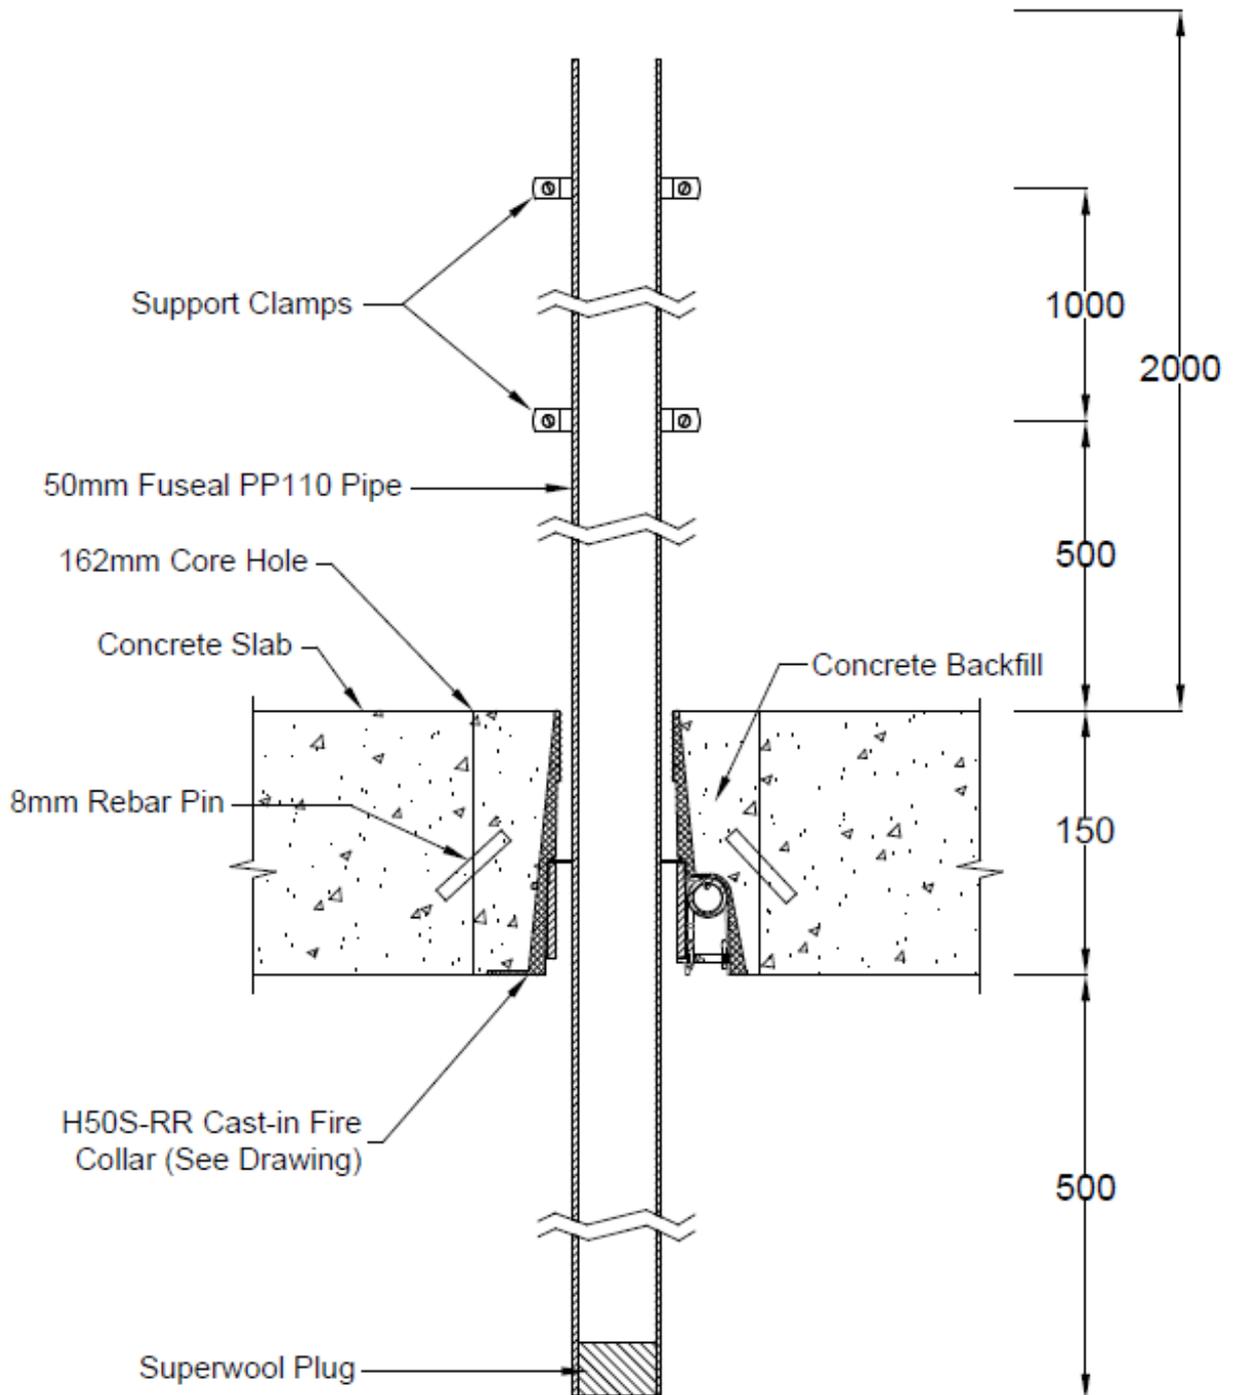
50 Fuseal PP110 Stack & H50S-RR

DRAWING TITLED 'SPECIMEN #3 50 FUSEAL PP110 STACK & H50S-RR', DATED 9 MARCH 2022 BY SNAP FIRE SYSTEMS PTY LTD

The SNAP H50S-RR High-Top Stack fire collar was cast into a 150-mm thick concrete slab with the collar casing cut down to 150-mm high finishing flush with the unexposed face of the concrete slab.

The penetrating service comprised a George Fischer Fuseal PP110 polypropylene pipe with a 61.2-mm outside diameter pipe and a wall thickness of 4.5-mm fitted through the collars sleeve. The pipe projected vertically 2000-mm above the unexposed face of the concrete slab and 500-mm below into the furnace chamber. The pipe was supported at nominally 500-mm and 1500-mm from the unexposed face of the slab, left open at the unexposed end and capped with a ceramic fibre (Superwool) plug on the exposed end.

On the unexposed face the annular gap between the pipe and the collars sleeve was left unprotected as shown in drawing titled 'Specimen #3, 50 Fuseal PP110 Stack & H50S-RR', dated 9 March 2022 by Snap Fire Systems Pty Ltd.

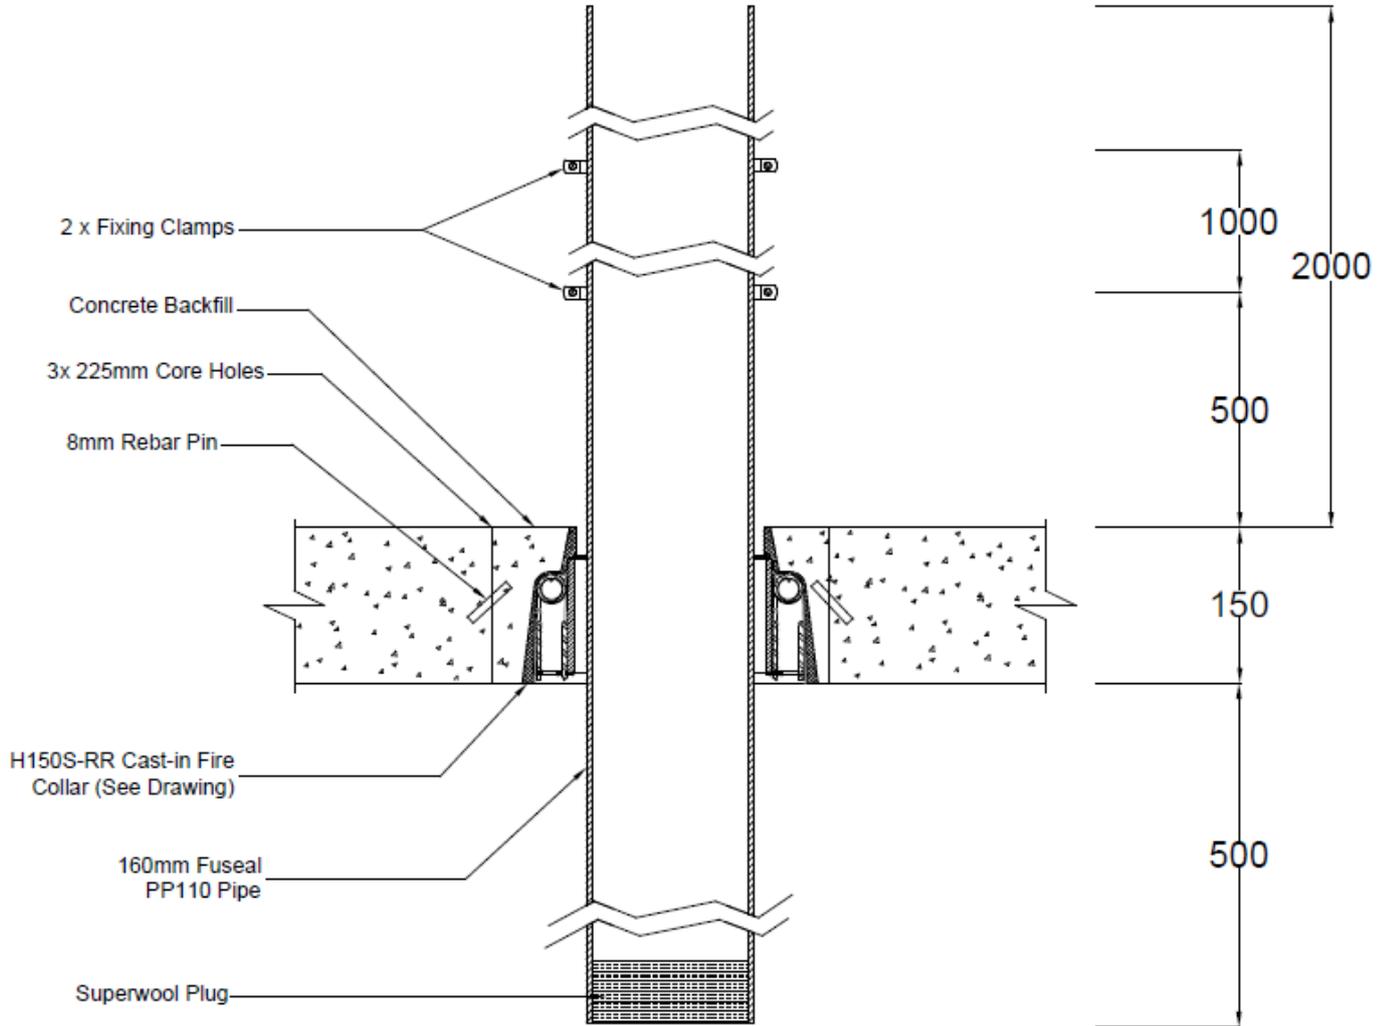
160 Fuseal PP110 Stack & H150S-RR

DRAWING TITLED 'SPECIMEN #4 160 FUSEAL PP110 STACK & H150S-RR', DATED 9 MARCH 2022 BY SNAP FIRE SYSTEMS PTY LTD

The SNAP H150S-RR High Top Stack fire collar comprised a white 2-mm thick polypropylene casing with a 180 mm inner diameter sleeve and a 292-mm diameter base flange. The 250-mm high collar casing incorporated a 600-mm wide x 110-mm wide x 6-mm thick intumescent material and a rubber ring seal. The closing mechanism comprised four x 4-mm diameter galvanised steel springs, four nylon fuse links and a 640 mm x 109-mm 316 stainless steel mesh as shown in drawing titled 'SNAP 150 High-Top Stack', dated 29 September 2017, by SNAP Fire Systems. The H150S-RR collar was cast into a 150-mm thick concrete slab with the collar casing cut down to 150-mm high finishing flush with the unexposed face of the concrete slab.

The penetrating service comprised a George Fischer Fuseal PP110 polypropylene pipe with a 168.2-mm outside diameter pipe and a wall thickness of 7.58-mm fitted through the collars sleeve. The pipe projected vertically 2000-mm above the unexposed face of the concrete slab and 500-mm below into the furnace chamber. The pipe was supported at nominally 500-mm and 1500-mm from the unexposed face of the slab, left open at the unexposed end and capped with a ceramic fibre (Superwool) plug on the exposed end.

On the unexposed face the annular gap between the pipe and the collars sleeve was left unprotected as shown in drawing titled 'Specimen #4, 160 Fuseal PP110 Stack & H150S-RR', dated 9 March 2022 by Snap Fire Systems Pty Ltd.

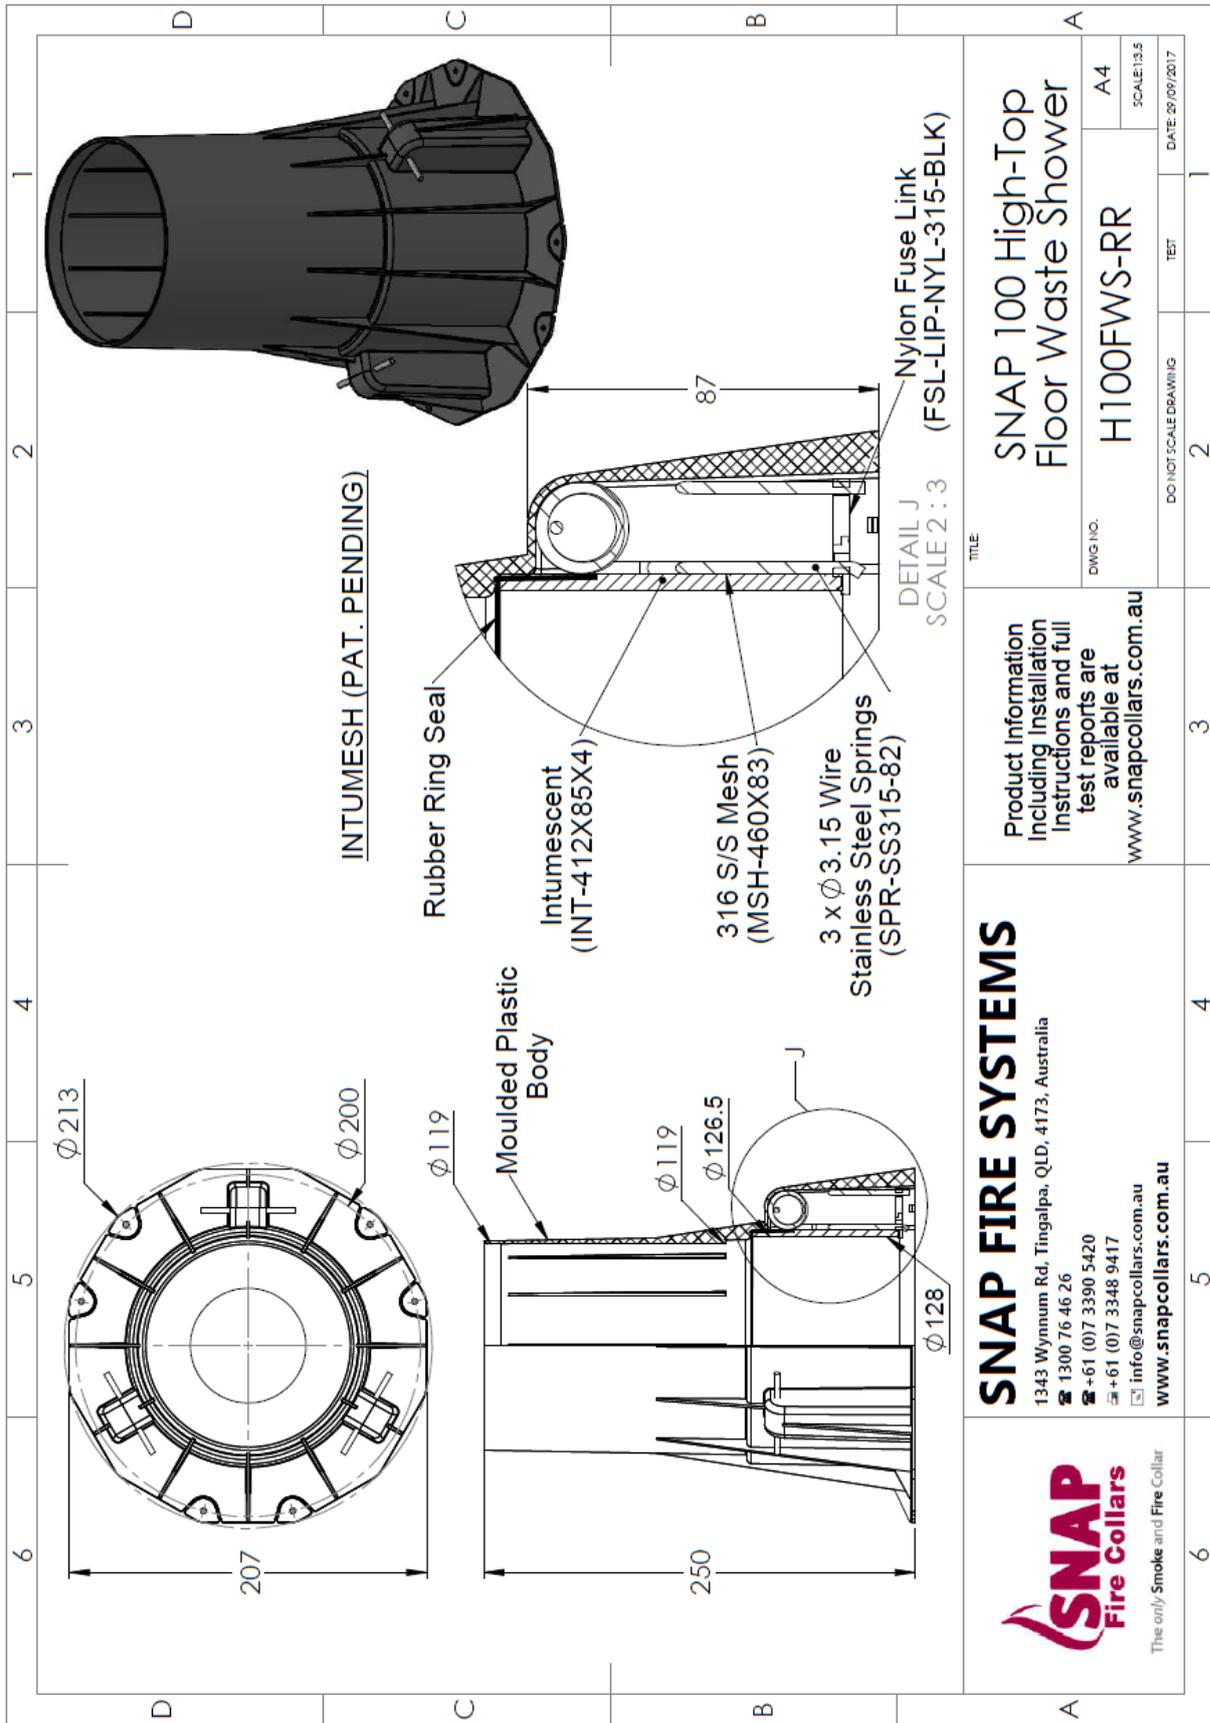
DRAWING TITLED 'SNAP 100 HIGH-TOP FLOOR WASTE SHOWER' DATED 29 SEPTEMBER 2017, BY SNAP FIRE SYSTEMS PTY LTD.

The SNAP H100FWS-RR High-Top Floor Waste Shower Cast-in fire collar comprised a 1.6-mm thick polypropylene casing with a 119-mm inner diameter and a 213-mm base flange. The 250-mm high collar casing incorporated a layer of 412-mm x 85-mm x 4-mm thick Intumescent material and a rubber ring seal. The closing mechanism comprised three equally spaced steel springs held with nylon fuse links. The springs were fabricated using 304 grade stainless steel wire with a diameter of 3.15-mm, with the springs acting against a layer of 316 grade stainless steel mesh measuring 460 x 83-mm as shown in drawing titled 'SNAP 100 High-Top Floor Waste Shower', dated 29 September 2017, by Snap Fire Systems Pty Ltd.

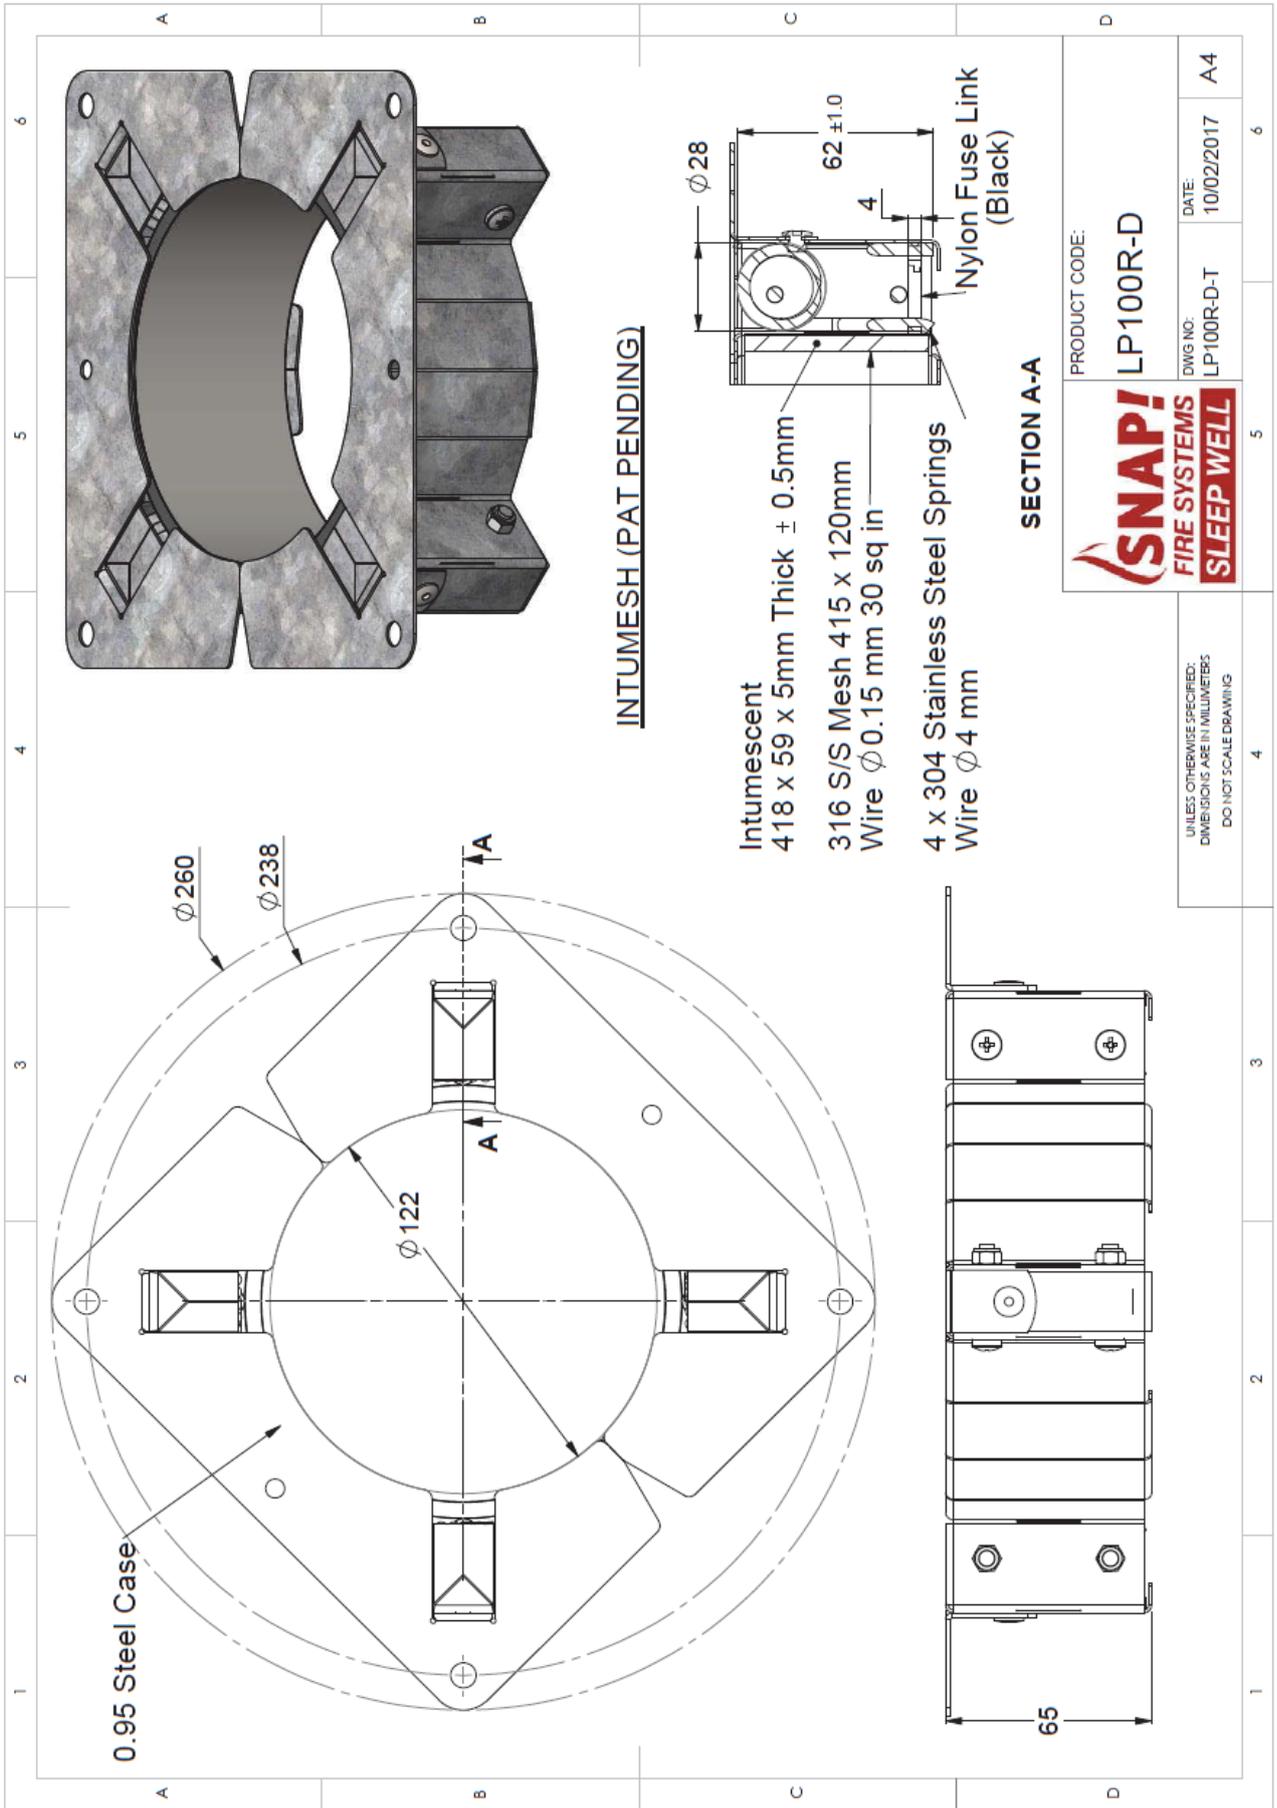
DRAWING NUMBERED LP100R-D-T, DATED 10 FEBRUARY 2017, BY SNAP FIRE SYSTEMS PTY LTD

The SNAP LP100R-D Low Profile Retrofit fire collar comprised a 0.95-mm steel casing with a 122-mm inner diameter and a 260-mm diameter base flange. The 65-mm high collar casing incorporated a closing mechanism which comprised a 5-mm thick x 59-mm wide x 418-mm long Intumesh intumescent wrap lined within the internal circumference of the collar casing. The closing mechanism comprised four 4-mm diameter 304 stainless steel springs with black nylon fuse links and a 415-mm long x 120-mm wide mesh with a wire diameter of 0.15 mm as shown in drawing numbered LP100R-D-T dated 10 February 2017, by Snap Fire Systems Pty Ltd.

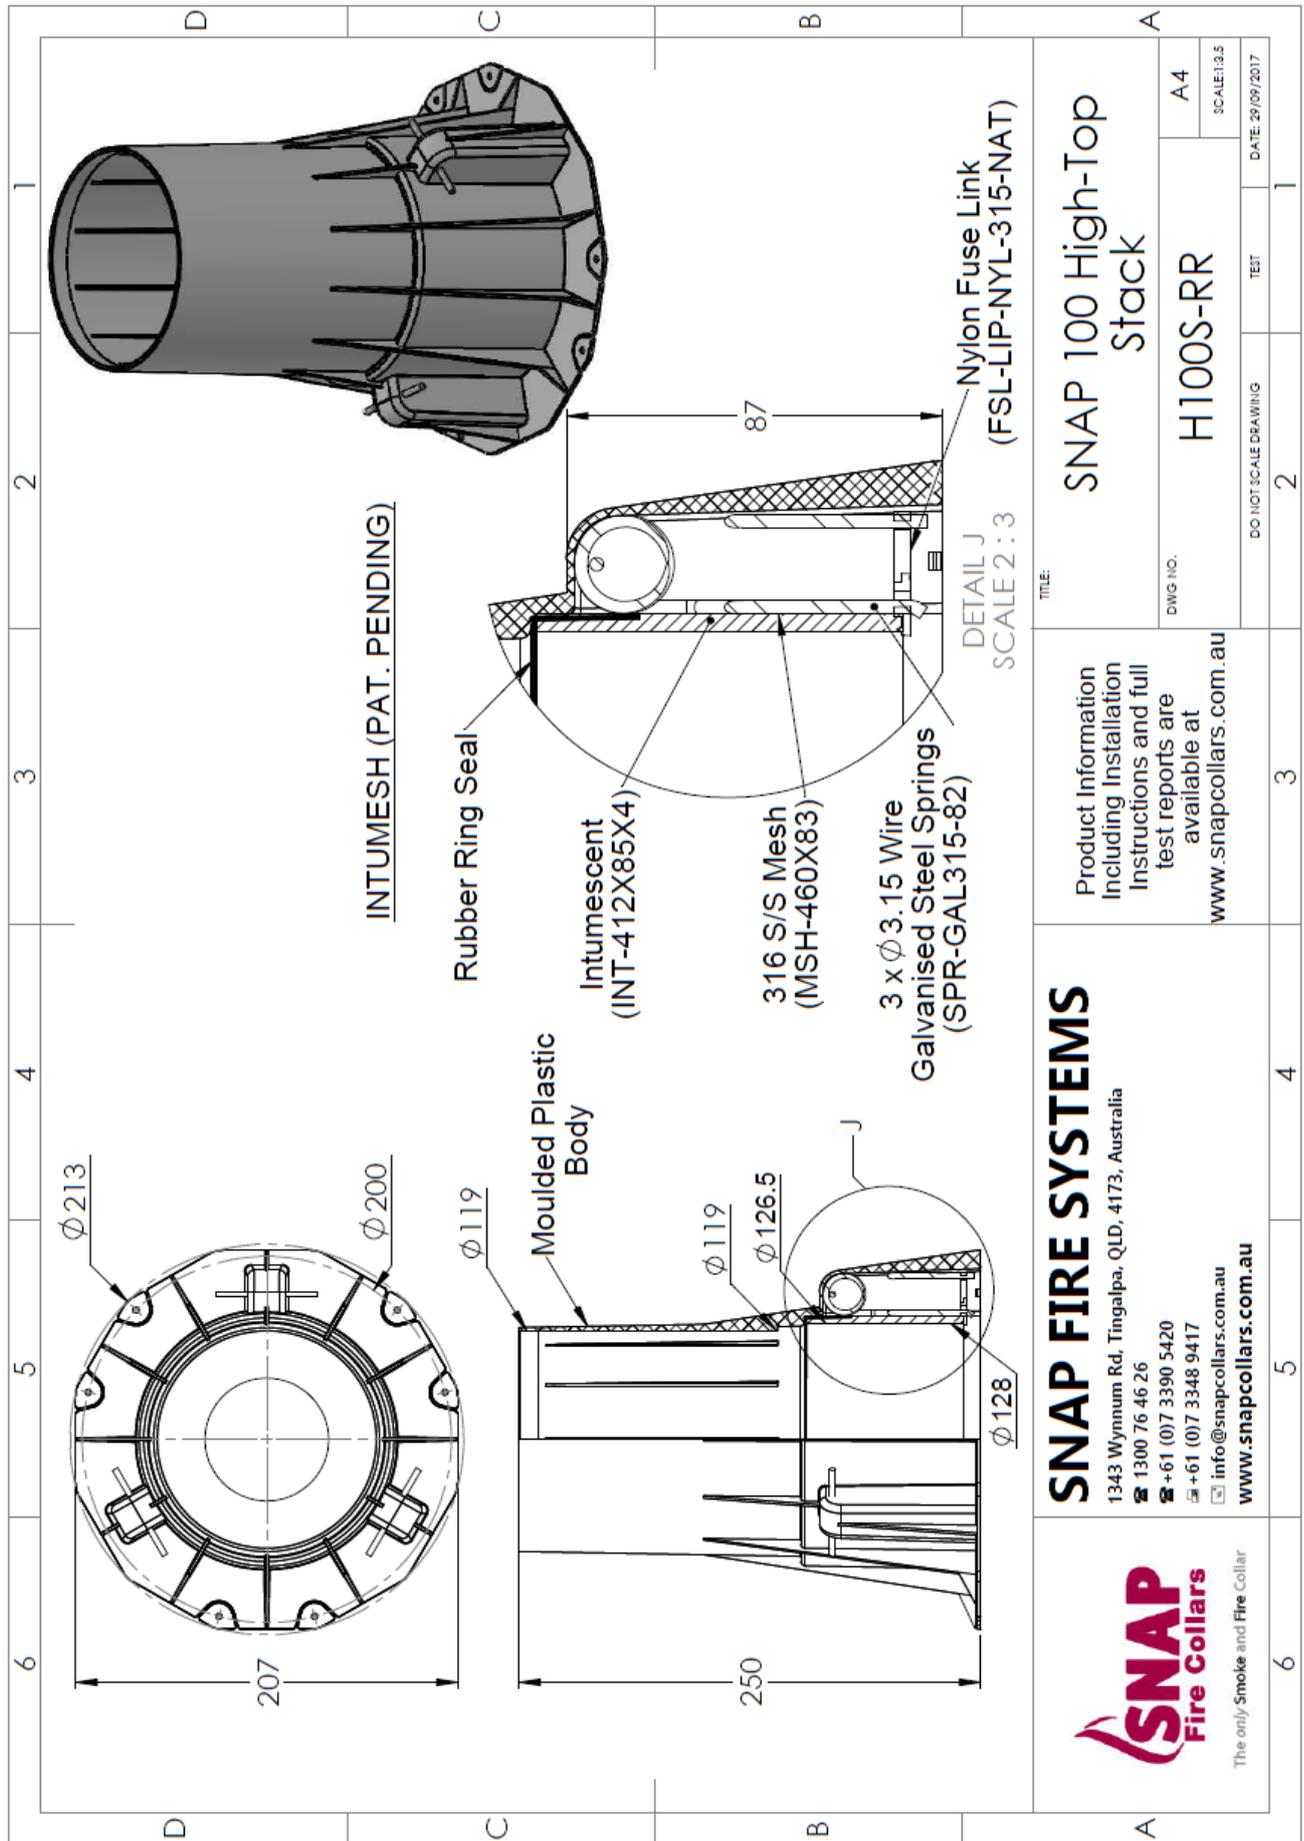
TITLE: SNAP 100 High-Top Stack		DWG NO. H100S-RR	SCALE: 1:3.5	DATE: 29/09/2017
DO NOT SCALE DRAWING		TEST	2

DRAWING TITLED "SNAP 100 HIGH-TOP STACK", DATED 29 SEPTEMBER 2017, BY SNAP FIRE SYSTEMS PTY LTD

The SNAP H100-S-RR High-Top Stack cast-in fire collar comprised a 1.6-mm thick polypropylene casing with a 119-mm inner diameter and a 213-mm diameter base flange. The 250-mm high collar casing incorporated a 412-mm x 85-mm x 4-mm thick Intumesh intumescent material and a rubber ring seal. The closing mechanism comprised three equally spaced 3.15-mm diameter galvanised steel springs bound with nylon fuse links acting against a 460-mm x 83-mm 316 stainless steel mesh as shown in drawing titled "SNAP 100 High-Top Stack", dated 29 September 2017, by Snap Fire Systems Pty Ltd

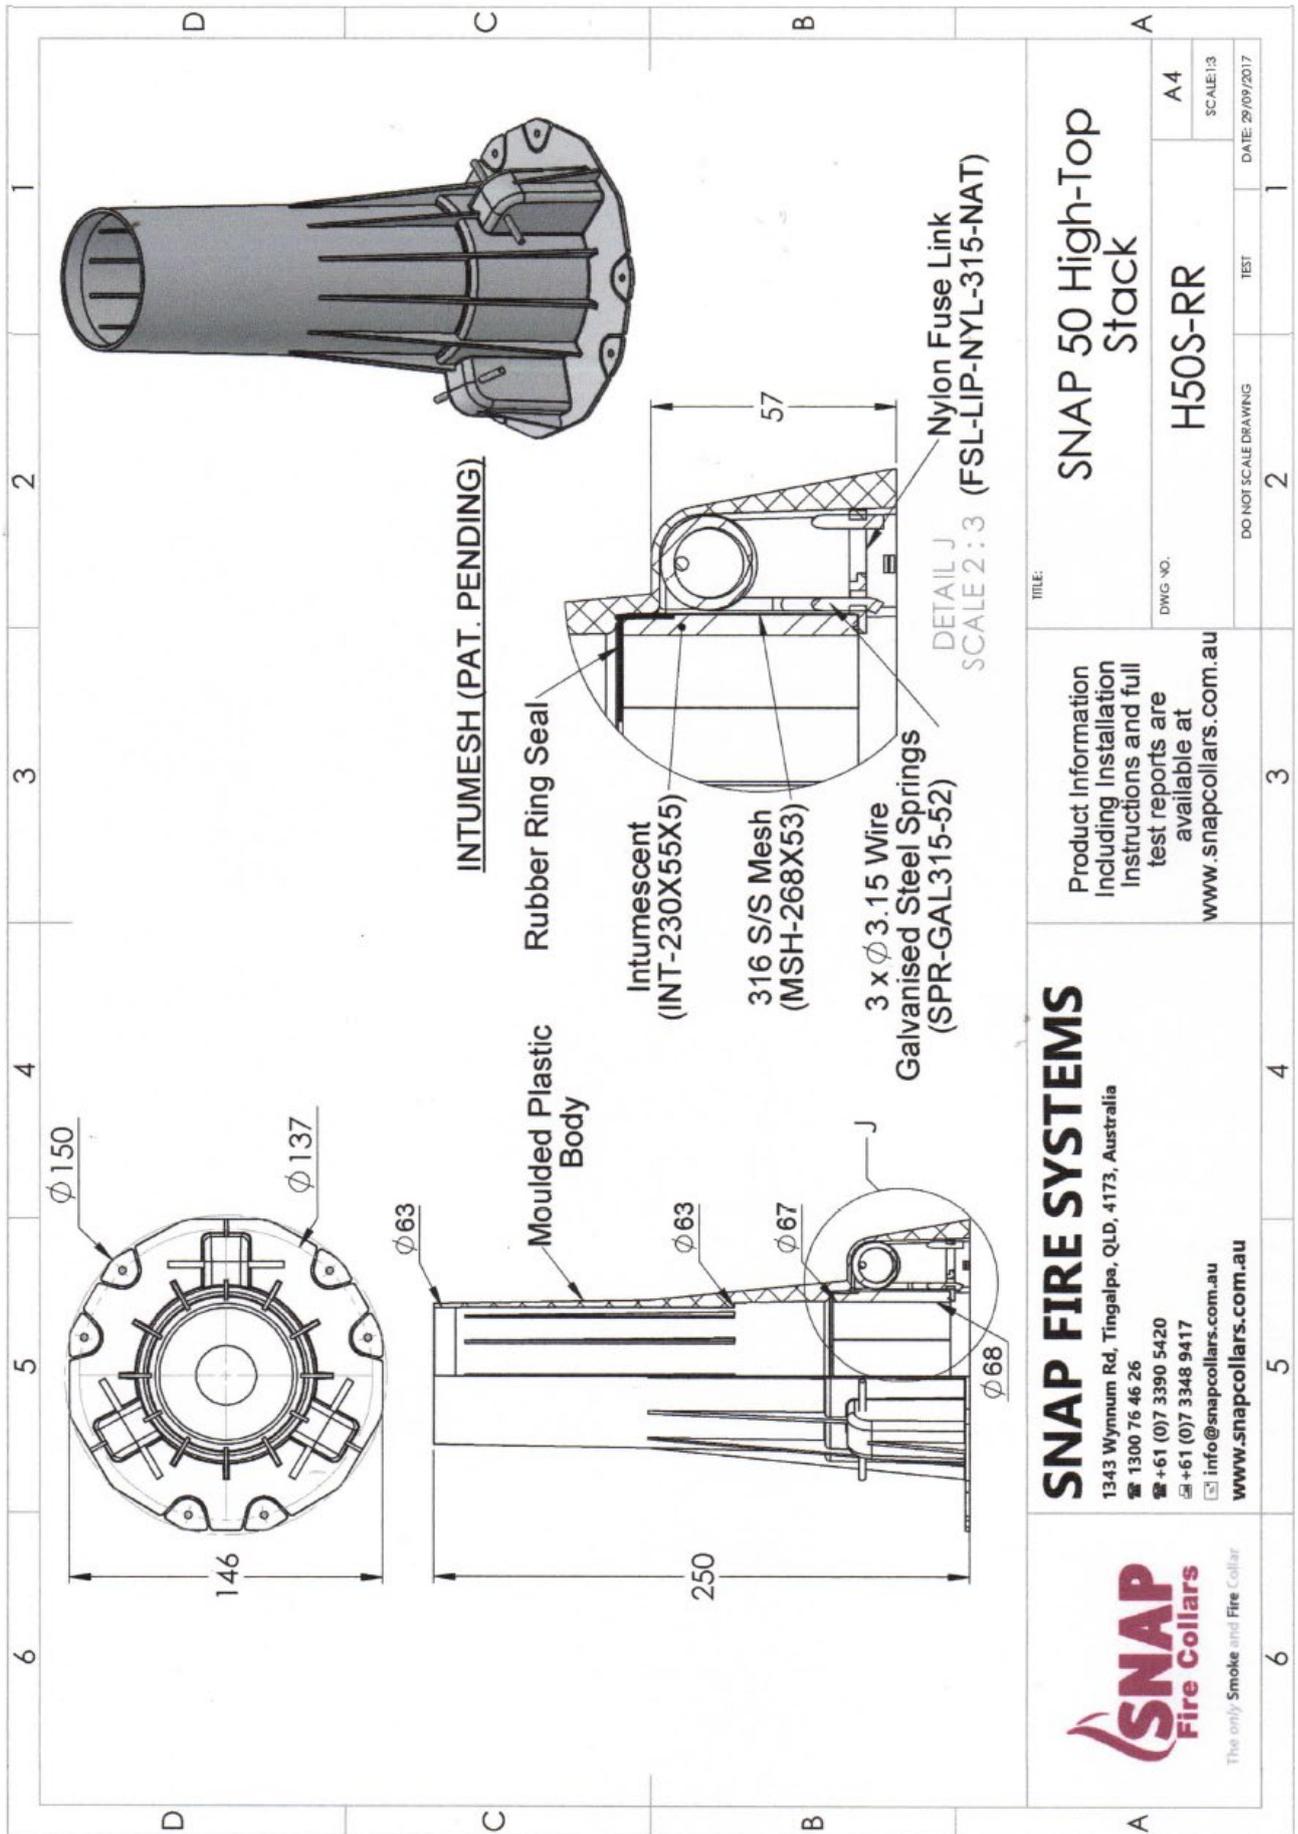
DRAWING TITLED "SNAP 50 HIGH-TOP STACK", DATED 29 SEPTEMBER 2017, BY SNAP FIRE SYSTEMS PTY LTD

The SNAP H50S-RR High-Top Stack cast-in fire collar comprised a 1.6-mm thick polypropylene casing with a 63 mm inner diameter and a 150-mm diameter base flange. The 250 mm high collar casing incorporated a 230-mm x 55-mm x 5-mm thick Intumesh intumescent material and a rubber ring seal. The closing mechanism comprised three galvanised steel springs bound with nylon fuse links and a 268-mm x 53-mm 316 stainless steel mesh as shown in drawing titled 'SNAP 50 High-Top Stack', dated 29 September 2017, by Snap Fire Systems Pty Ltd.
