Fire-resistance test on service penetrations in a panel wall system

Test Report

Author: Chris Wojcik **Report number:** FSV 1731

Client: H.B. Fuller Company Australia Pty Ltd

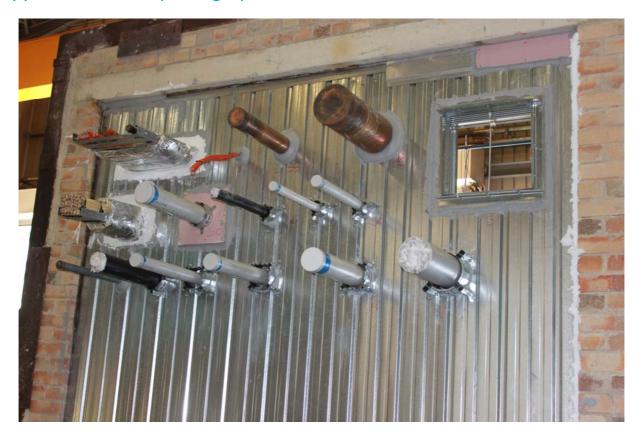
PHOTOGRAPH 1 – EXPOSED FACE OF THE SPECIMEN PRIOR TO TEST

Sealant - water based acrylic sealant		
Application	Fire collars were fitted around the pipe on both sides of the wall and fixed to the wall through the collar's three mounting tabs using 14-10 x 65-mm long hex head screws. Annular gaps around the pipe and the base of the collars were sealed on both sides of the wall with a bead of Firesound sealant.		
Photograph	1.P 5.0.2.

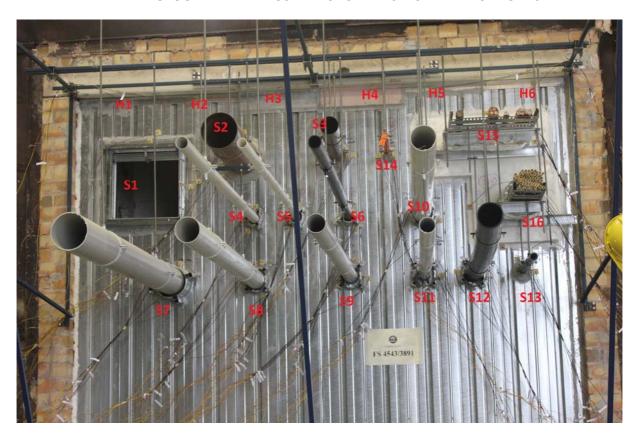
PHOTOGRAPH 2 – UNEXPOSED FACE OF THE SPECIMEN PRIOR TO TESTING

In addition to the above, six different wall deflection detail variations were installed, which were documented and instrumented for the purpose of a separate assessment report, as shown in photograph 2 (referenced H1 to H6).

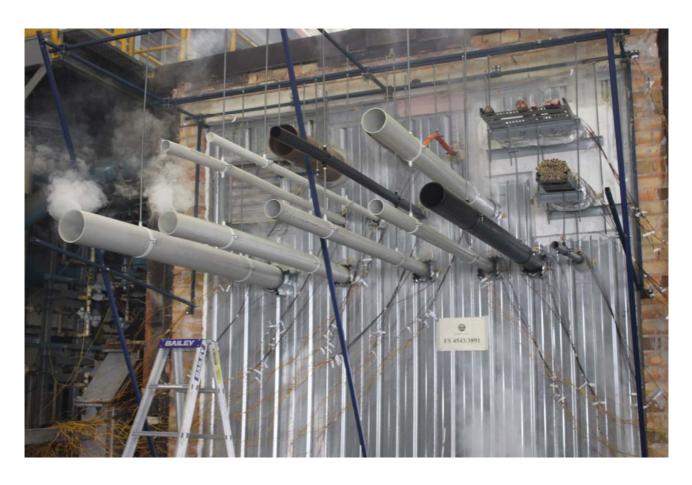
PHOTOGRAPH 3 – SPECIMENS AT 31 MINUTES INTO THE TEST

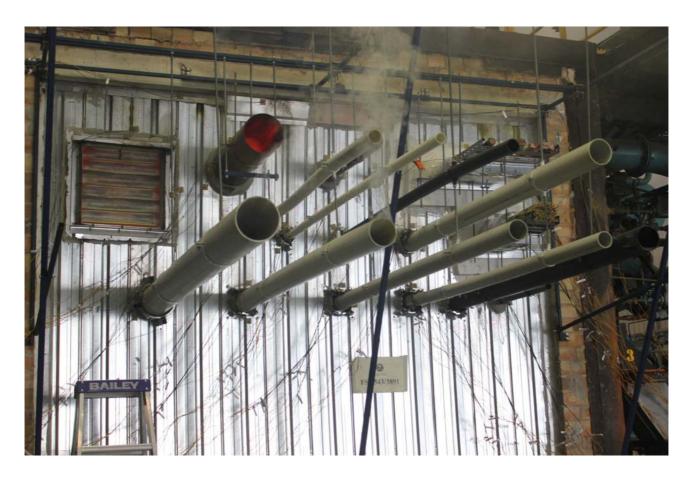
PHOTOGRAPH 5 - SPECIMENS AT 60 MINUTES INTO THE TEST

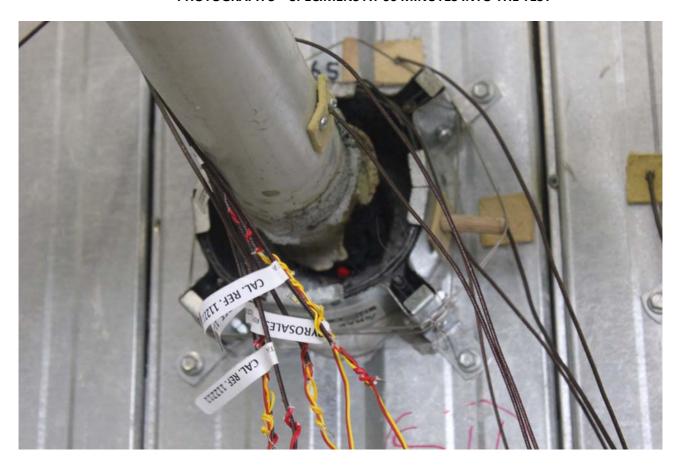
PHOTOGRAPH 6 - SPECIMEN 11 AT 61 MINUTES INTO THE TEST

Specimens 9 & 11 are starting to deform at the fire collar (photograph 6).

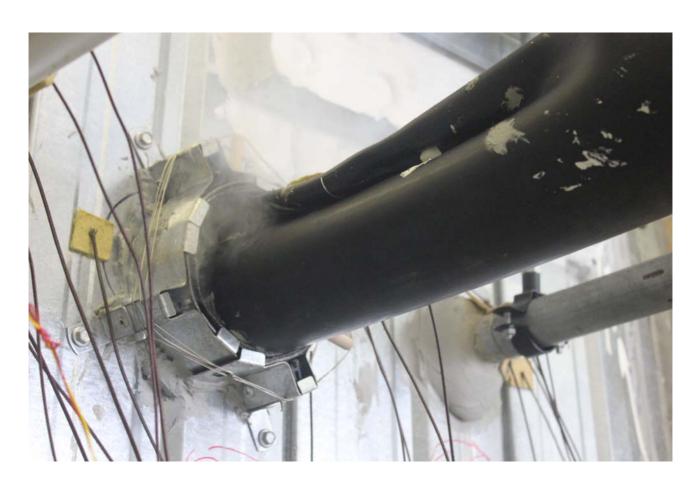
PHOTOGRAPH 7 – SPECIMEN 12 AT 71 MINUTES INTO THE TEST

69 minutes - Specimens 8 & 12 are starting to deform at the fire collar (photographs 7 & 8).

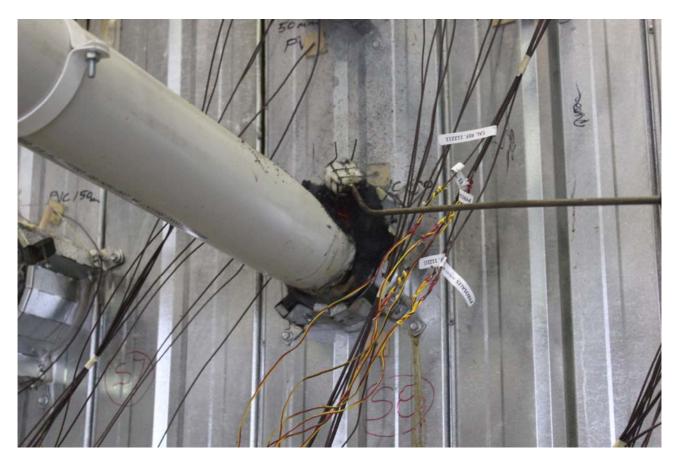
PHOTOGRAPH 8 – SPECIMEN 8 AT 72 MINUTES INTO THE TEST

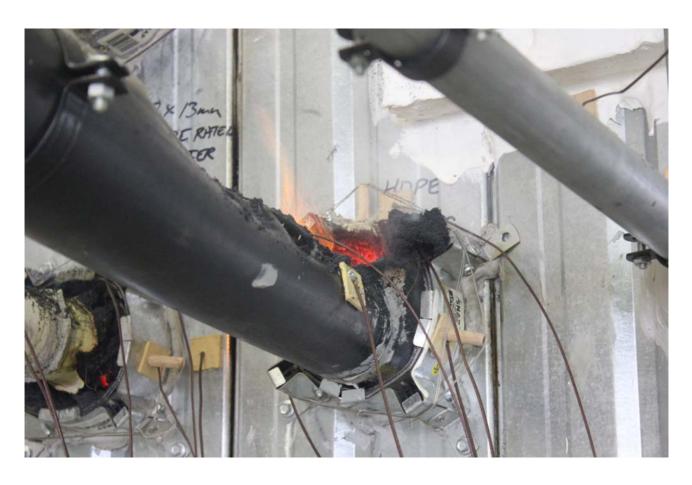
PHOTOGRAPH 9 - SPECIMEN 12 AT 80 MINUTES INTO THE TEST

77 minutes - Integrity Failure of Specimen 12 - cotton wool pad test applied over the glow near the fire collar – ignition of cotton noted (photograph 9).

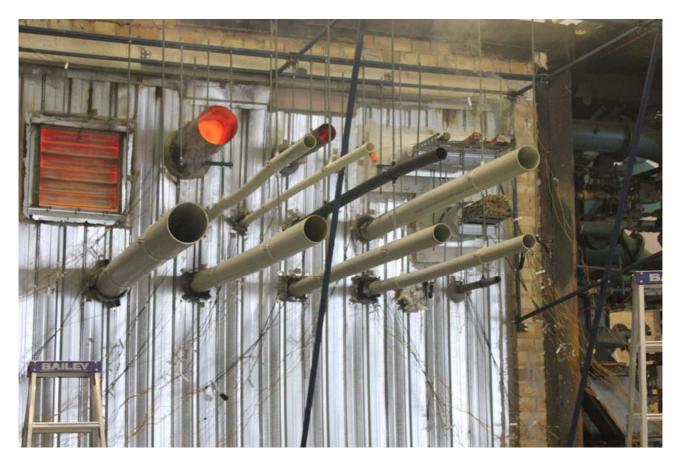
PHOTOGRAPH 10 – SPECIMENS AT 90 MINUTES INTO THE TEST

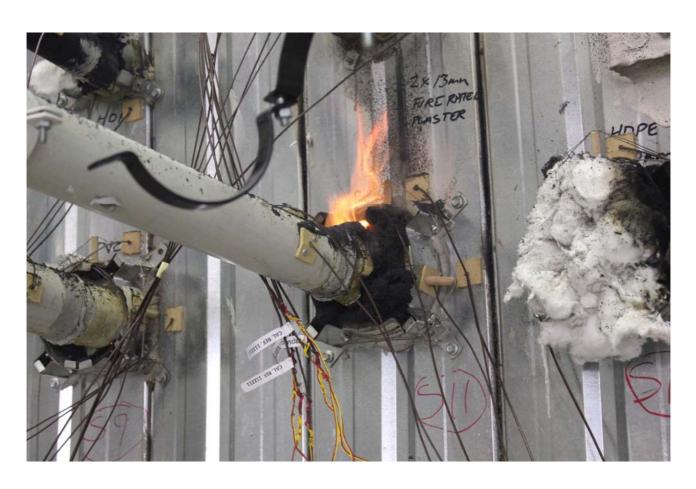
PHOTOGRAPH 11 – SPECIMEN 11 AT 110 MINUTES INTO THE TEST

110 minutes - <u>Integrity Failure of Specimen 11</u> - cotton wool pad test applied over the glow near the fire collar – ignition of cotton noted (photograph 11).

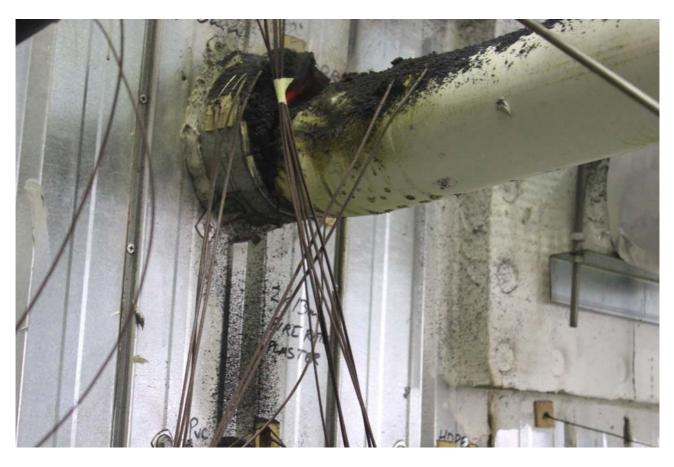
PHOTOGRAPH 12 - SPECIMEN 10 AT 113 MINUTES INTO THE TEST

114 minutes - Cotton wool pad test applied over the glow near the fire collar of Specimen 10 – no ignition of cotton noted.

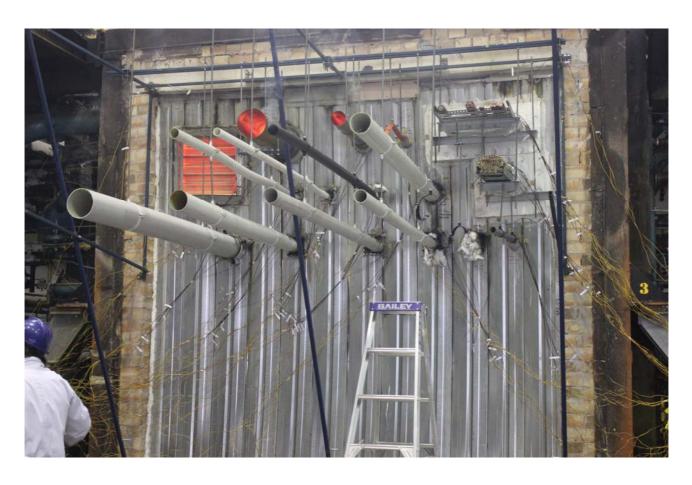
PHOTOGRAPH 13 - SPECIMENS AT THE CONCLUSION OF TESTING

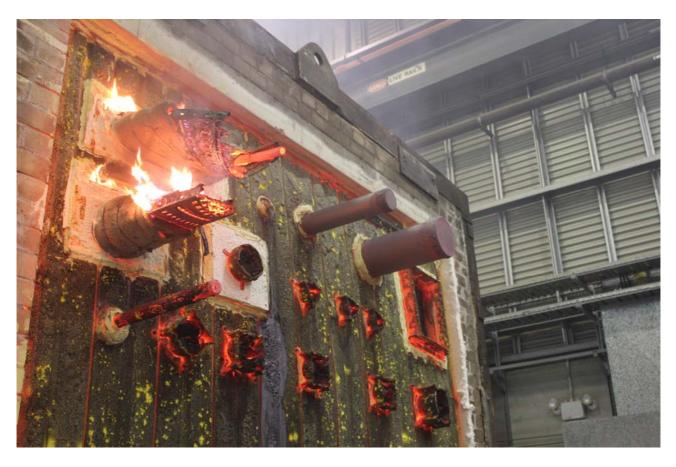
PHOTOGRAPH 14 – EXPOSED FACE OF THE SPECIMEN AFTER THE CONCLUSION OF TESTING

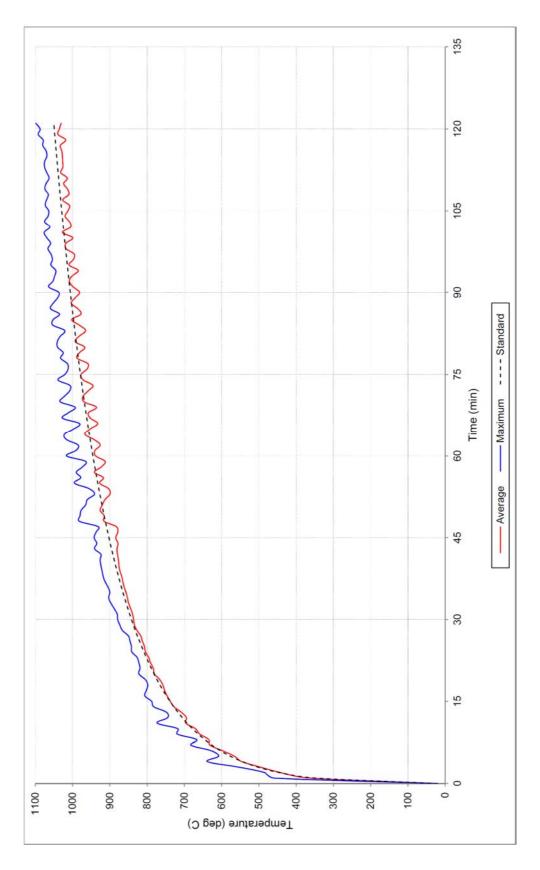
FIGURE 1 – FURNACE TEMPERATURE

Figure 1 shows the standard curves of temperature versus time for heating the furnace chamber and the actual curves of average and maximum temperature versus time recorded during the heating period.

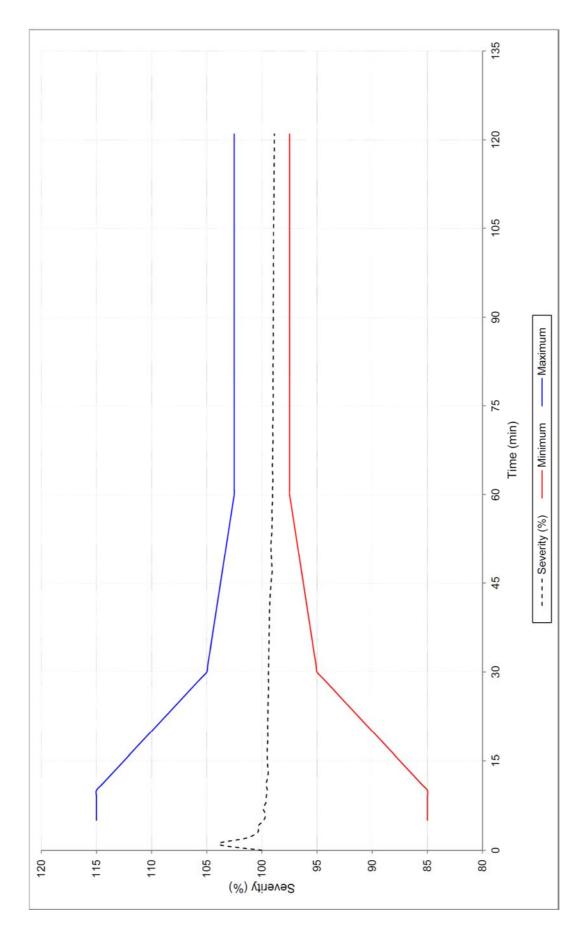
FIGURE 2 – FURNACE SEVERITY

Figure 2 shows the curve of furnace severity versus time during the heating period.

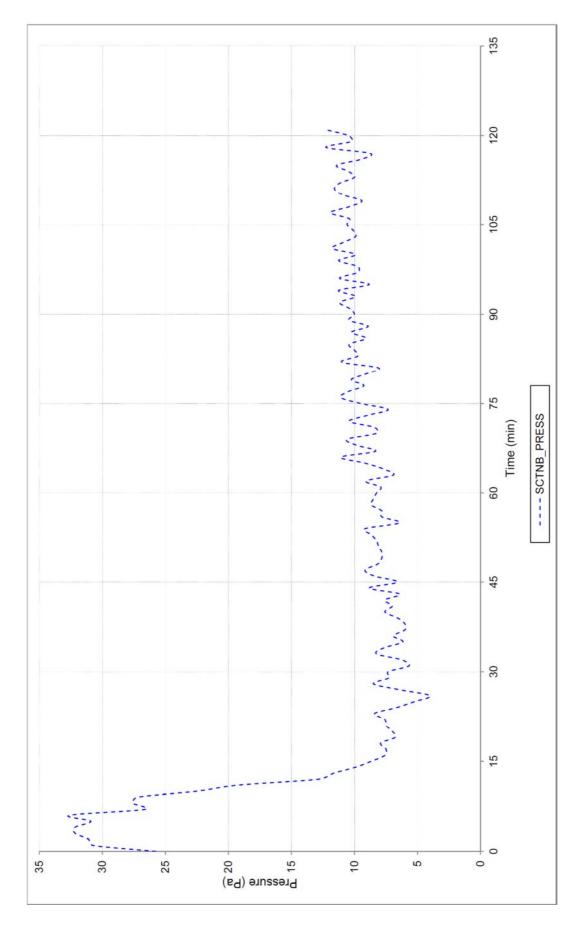
FIGURE 3 – FURNACE PRESSURE

Figure 3 shows the curve of average pressure versus time inside the furnace chamber recorded during the heating period.

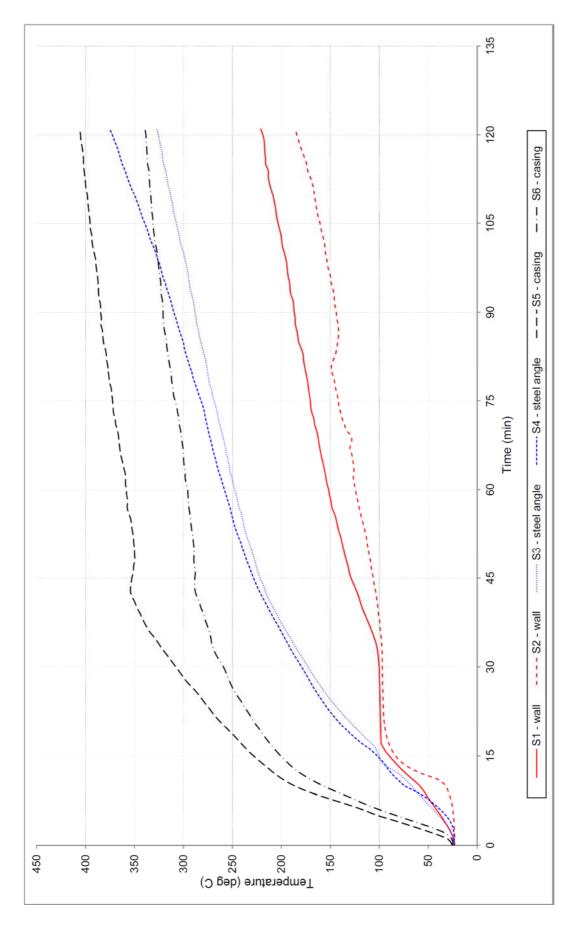
FIGURE 4 – SPECIMEN TEMPERATURE – UNEXPOSED FACE OF THE SPECIMEN 1

Figures 4 to 13 show curves of temperature versus time recorded on the unexposed face of specimens 1 to 16.

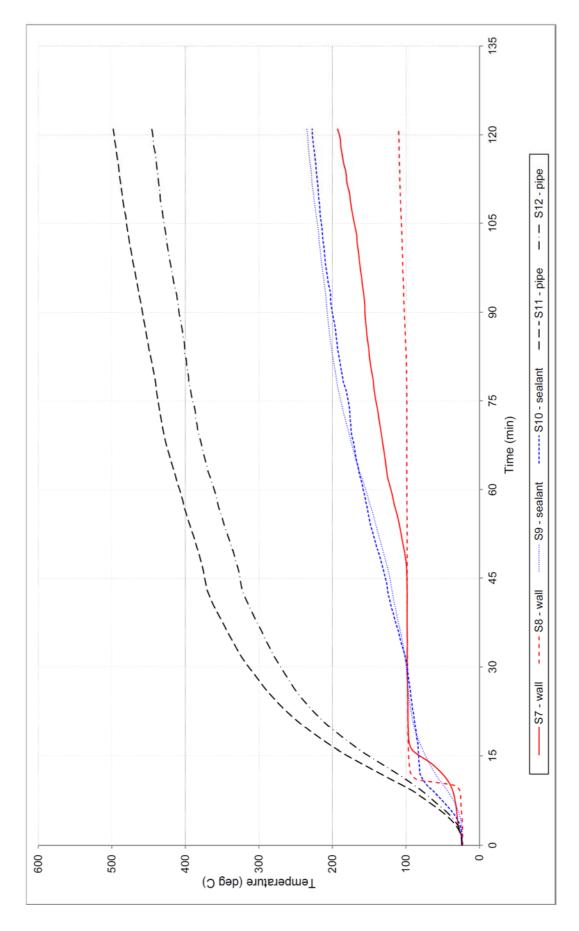
FIGURE 5 – SPECIMEN TEMPERATURE – UNEXPOSED FACE OF THE SPECIMEN 2

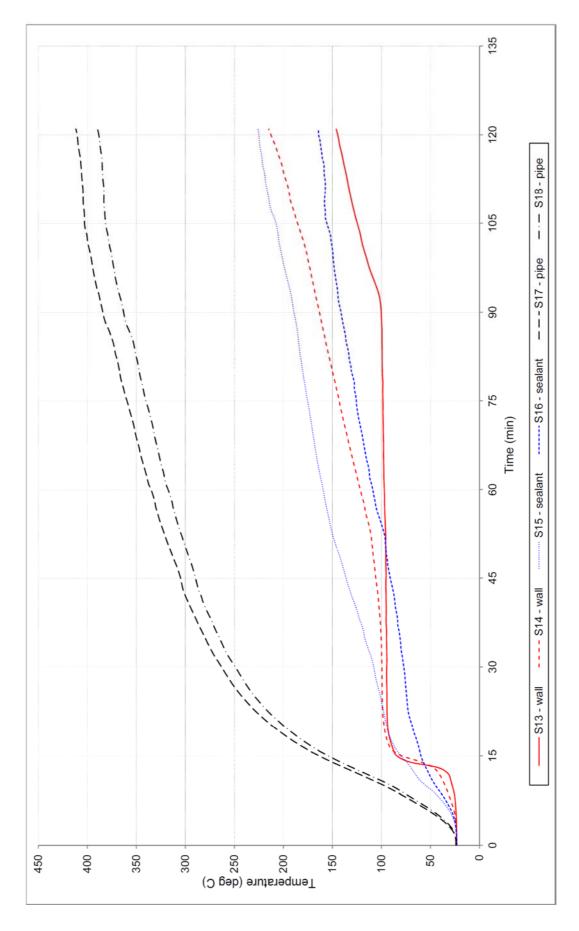
FIGURE 6 – SPECIMEN TEMPERATURE – UNEXPOSED FACE OF THE SPECIMEN 3

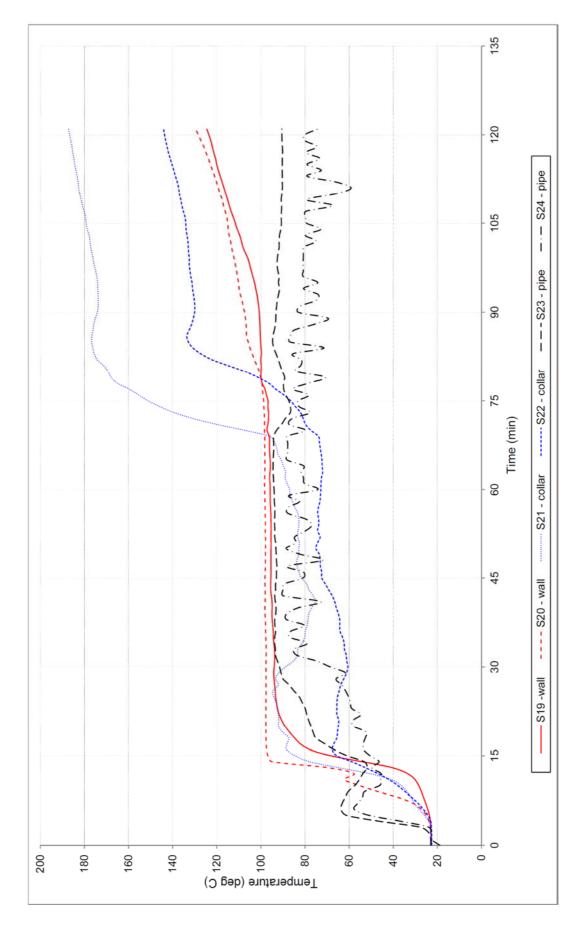
FIGURE 7 – SPECIMEN TEMPERATURE – UNEXPOSED FACE OF THE SPECIMEN 4

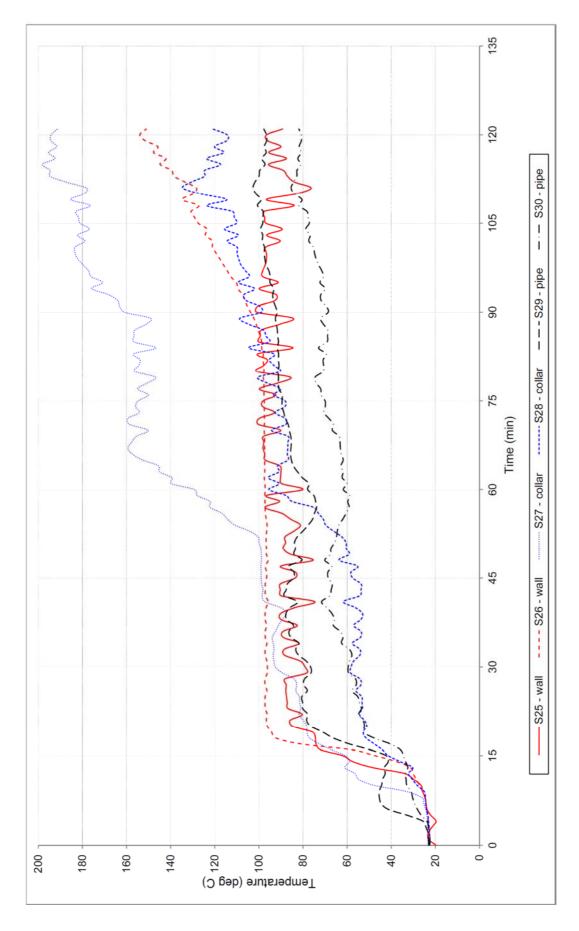
FIGURE 8 – SPECIMEN TEMPERATURE – UNEXPOSED FACE OF THE SPECIMEN 5

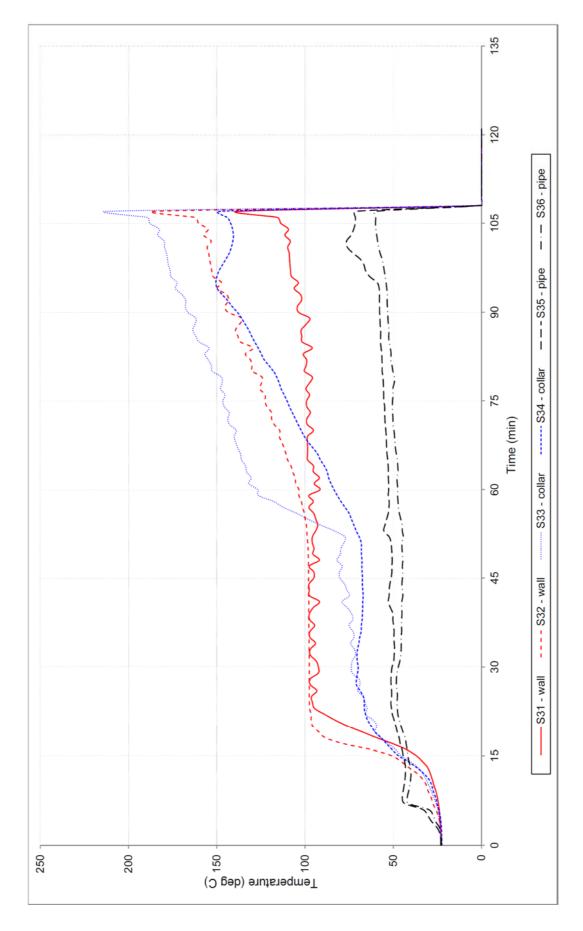
FIGURE 9 – SPECIMEN TEMPERATURE – UNEXPOSED FACE OF THE SPECIMEN 6

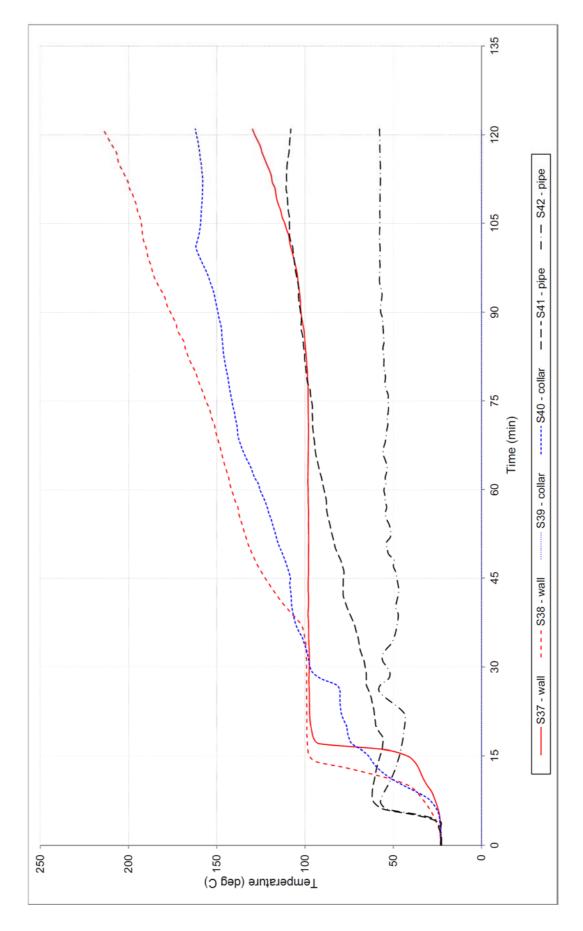
FIGURE 10 – SPECIMEN TEMPERATURE – UNEXPOSED FACE OF THE SPECIMEN 7

115 minutes - <u>Insulation Failure of Specimen 7</u> – maximum temperature rise of 180 degrees Celsius is exceeded on the wall, 25-mm above the sealant.

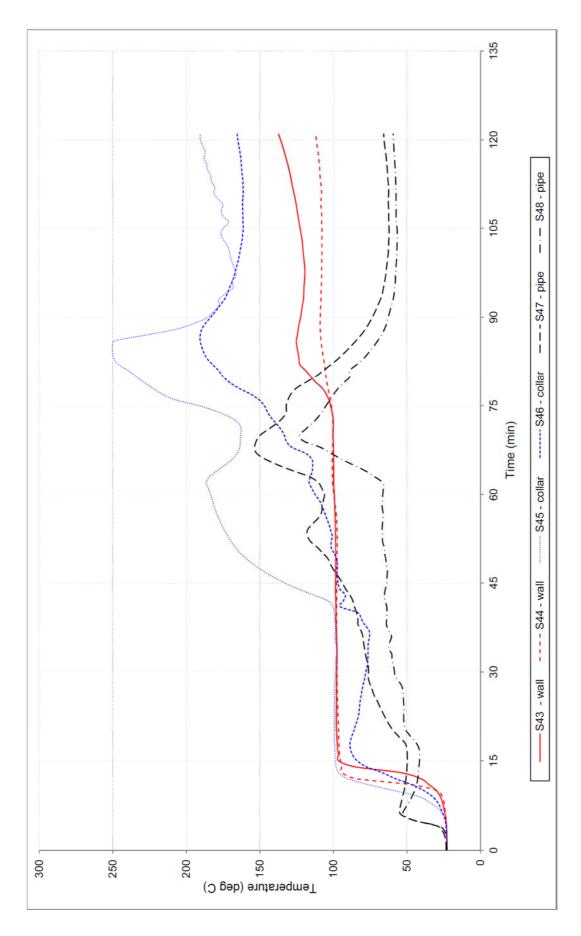
FIGURE 11 – SPECIMEN TEMPERATURE – UNEXPOSED FACE OF THE SPECIMEN 8

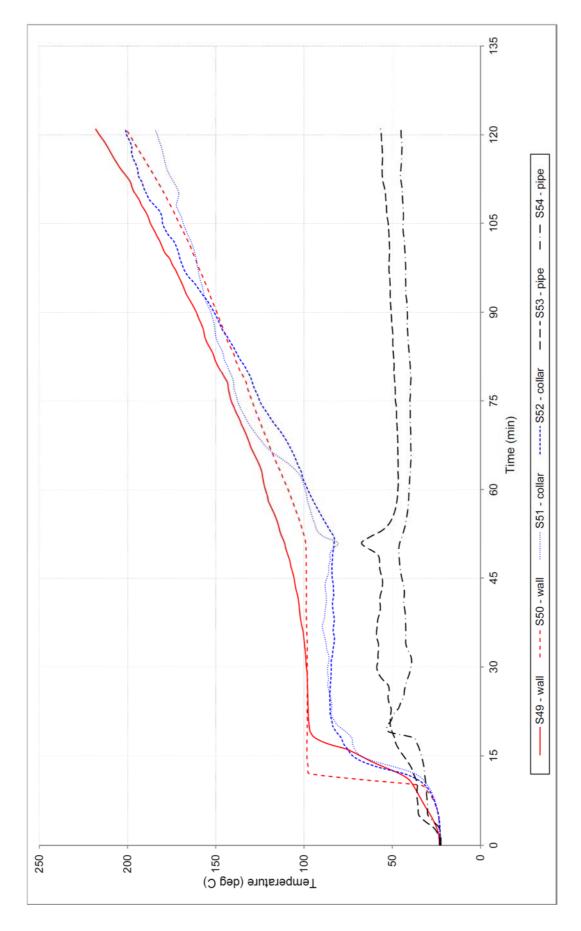
FIGURE 12 – SPECIMEN TEMPERATURE – UNEXPOSED FACE OF THE SPECIMEN 9

<u>Insulation Failure of Specimen 9</u> – maximum temperature rise of 180 degrees Celsius is exceeded on the wall, 25-mm above the sealant.

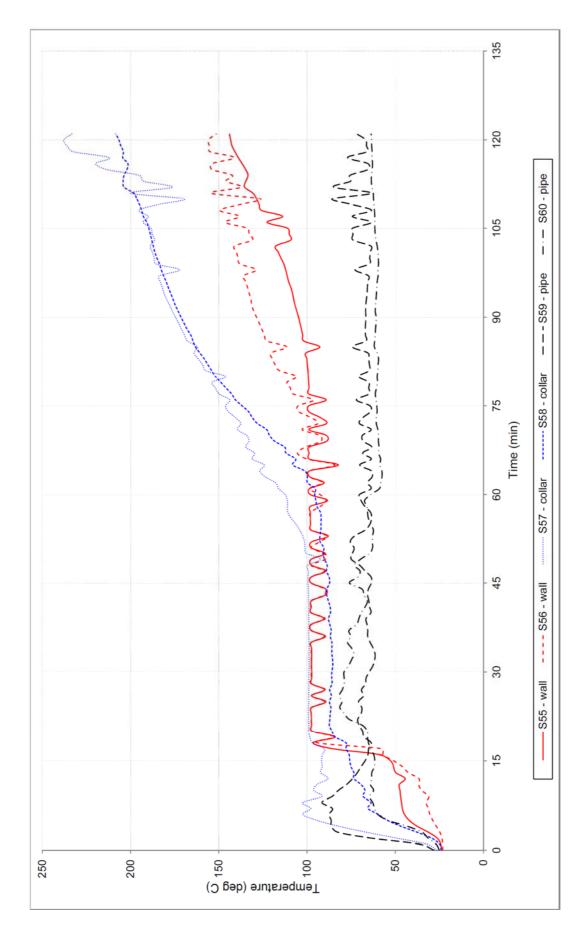
FIGURE 13 – SPECIMEN TEMPERATURE – UNEXPOSED FACE OF THE SPECIMEN 10

<u>Insulation Failure of Specimen 10</u> – maximum temperature rise of 180 degrees Celsius is exceeded on top of the collar.

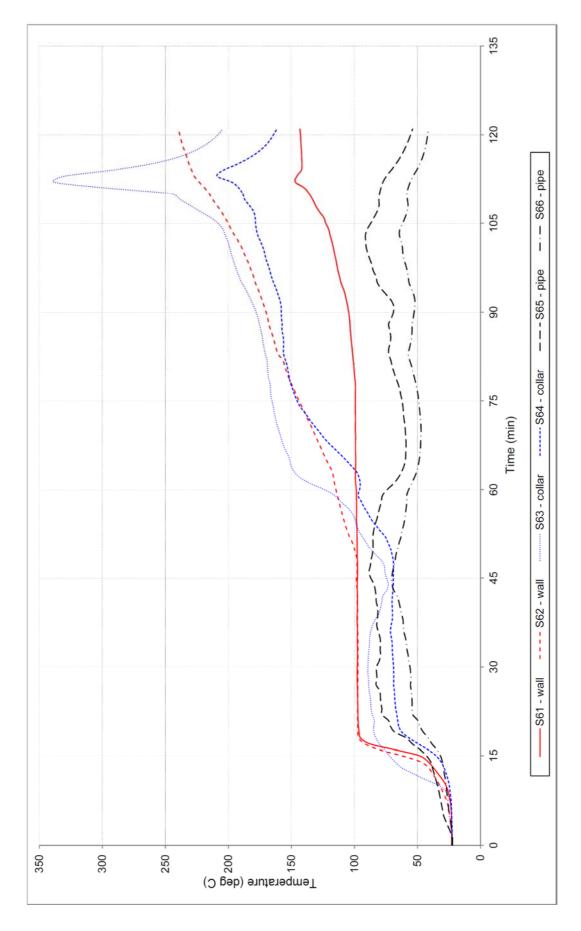
FIGURE 14 – SPECIMEN TEMPERATURE – UNEXPOSED FACE OF THE SPECIMEN 11

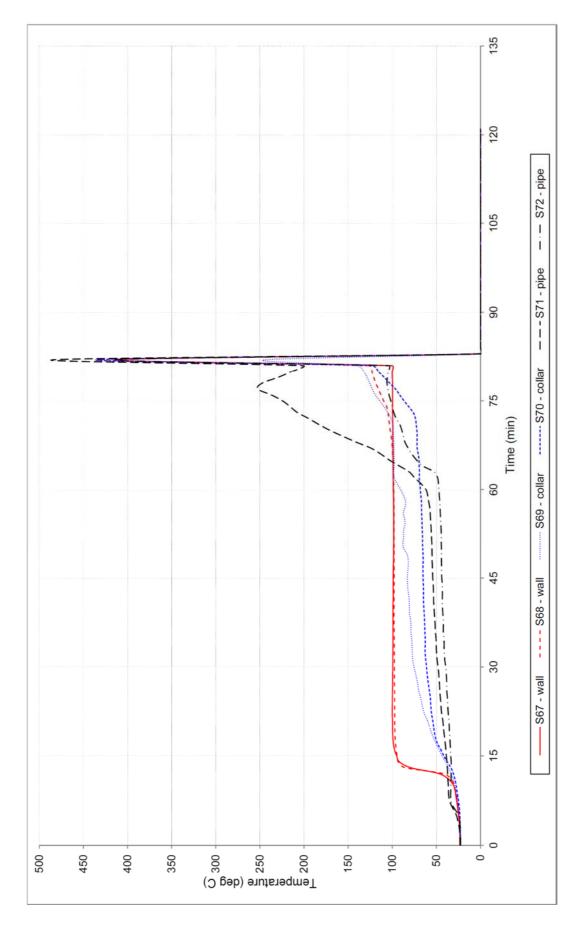
FIGURE 15 – SPECIMEN TEMPERATURE – UNEXPOSED FACE OF THE SPECIMEN 12

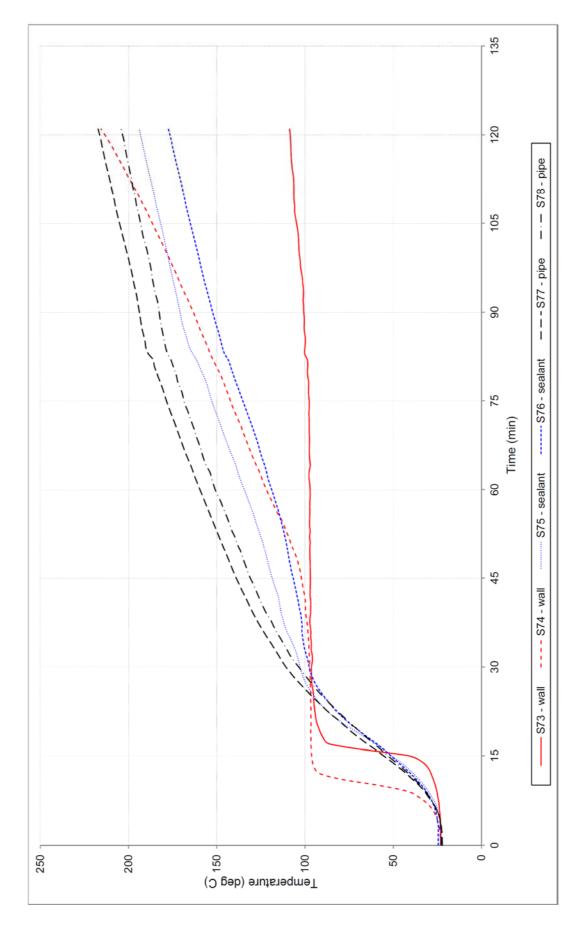
FIGURE 16 – SPECIMEN TEMPERATURE – UNEXPOSED FACE OF THE SPECIMEN 13

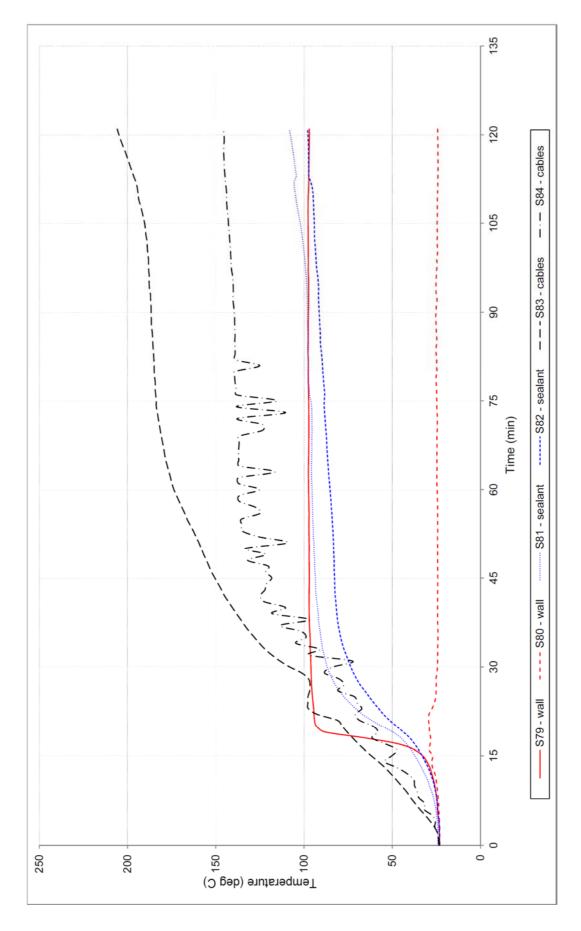
FIGURE 17 – SPECIMEN TEMPERATURE – UNEXPOSED FACE OF THE SPECIMEN 14

120 minutes - <u>Insulation Failure of Specimen 14</u> — maximum temperature rise of 180 degrees Celsius is exceeded on top of the cables.

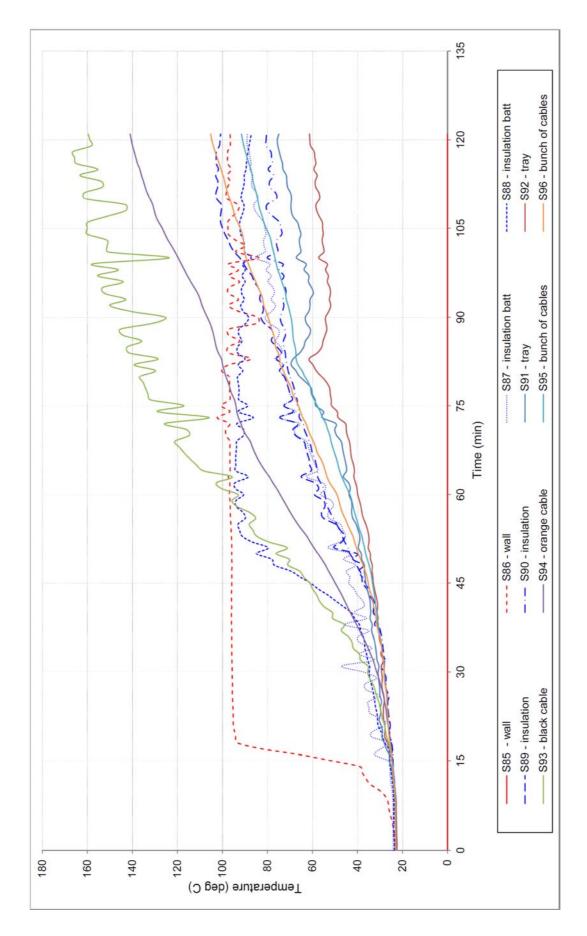
FIGURE 18 – SPECIMEN TEMPERATURE – UNEXPOSED FACE OF THE SPECIMEN 15

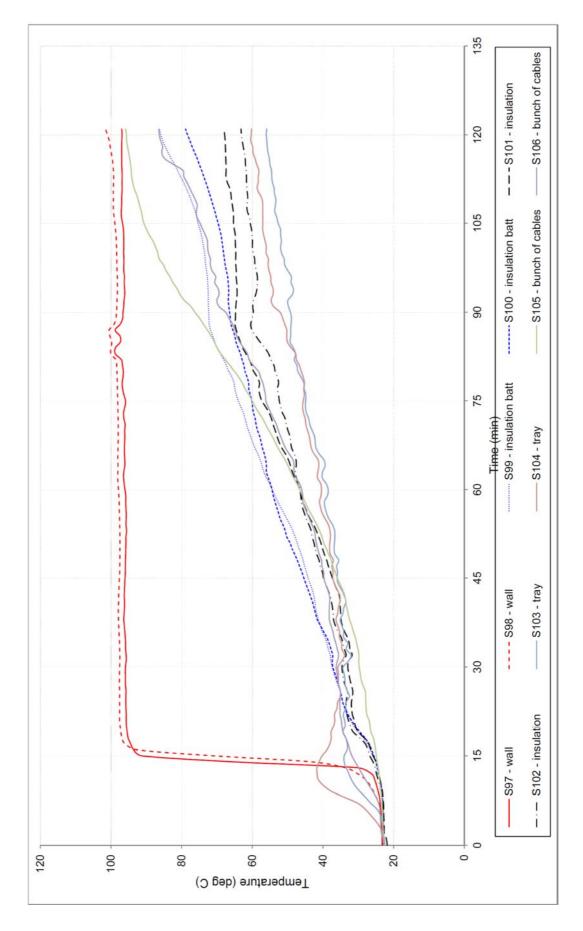
FIGURE 19 - SPECIMEN TEMPERATURE - UNEXPOSED FACE OF THE SPECIMEN 16

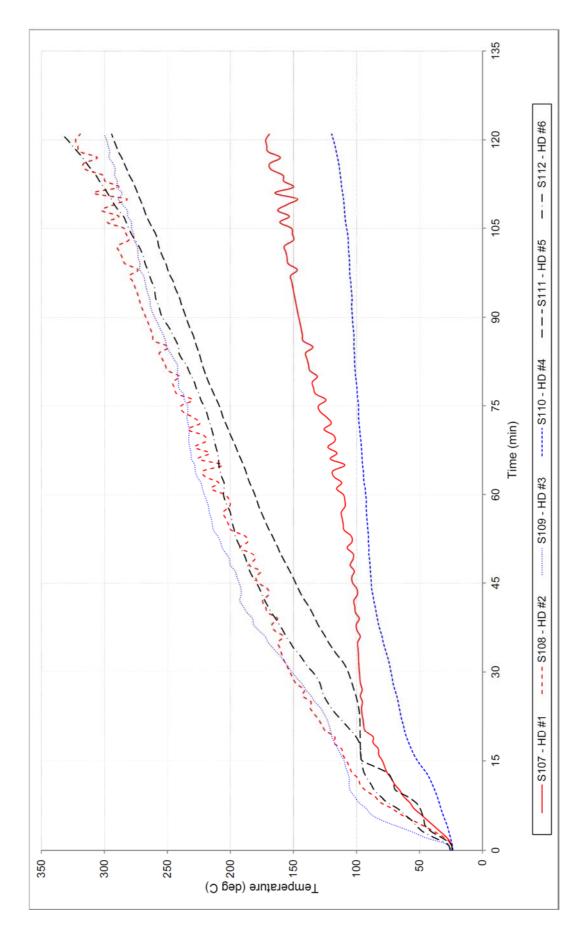
FIGURE 20 – SPECIMEN TEMPERATURE – HEAD DETAIL VARIATIONS

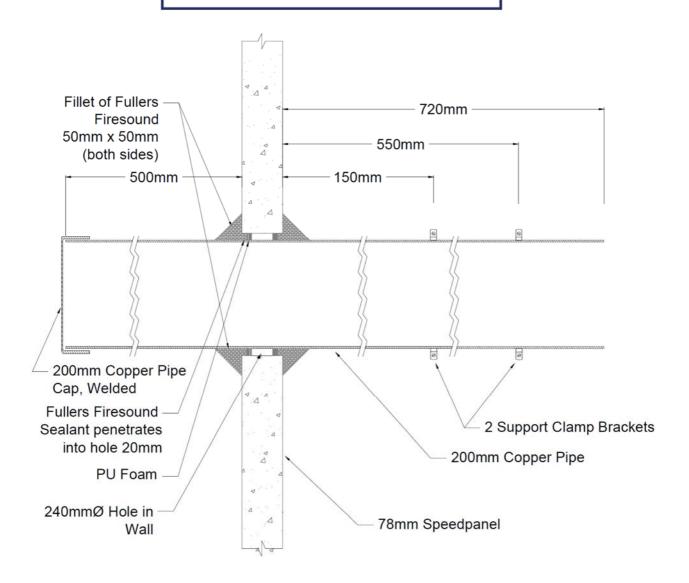
DRAWING NUMBERED 3, DATED 15 FEBRUARY 2016, BY SNAP FIRE SYSTEMS

Drawing #3 Speedpanel Test Wall: Penetration # 2 200mm Copper Pipe – Firesound Filleting 15 FEB 2016

PENETRATING SERVICE
Description	200-mm nominal copper pipe
Size	202-mm OD x 2-mm wall thickness extending 700-mm away from the wall and 500-mm into the furnace chamber
End conditions	Capped on the exposed end using a copper cap, and left open on the unexposed end
Supports	Approximately 100-mm and 500-mm away from the wall
	FIRE STOPPING SYSTEM
Application	20-mm annular gap around the pipe sealed on both sides of the wall with Firesound sealant to a nominal depth of 20-mm controlled by open cell polyurethane backing rod, and finished with a 50-mm fillet.
Drawing	Drawing numbered 3, dated 15 February 2016.

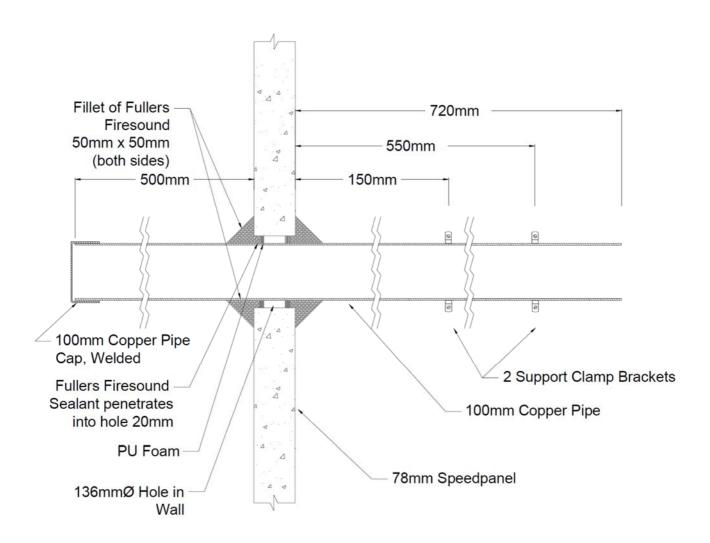
DRAWING NUMBERED 4, DATED 15 FEBRUARY 2016, BY SNAP FIRE SYSTEMS

Drawing #4
Speedpanel Test Wall Penetration # 3
100mm Copper Pipe – Firesound Filleting
15 FEB 2016

PENETRATING SERVICE
Description	100-mm nominal copper pipe
Size	102-mm OD x 3-mm wall thickness extending 720-mm away from the wall and 500-mm into the furnace chamber
End conditions	Capped on the exposed end using a copper cap, and left open on the unexposed end
Supports	Approximately 100-mm and 500-mm away from the wall
	FIRE STOPPING SYSTEM
Application	17-mm annular gap around the pipe sealed on both sides of the wall with Firesound sealant to a nominal depth of 20-mm controlled by open cell polyurethane backing rod, and finished with a 50-mm fillet.
Drawing	Drawing numbered 4, dated 15 February 2016.

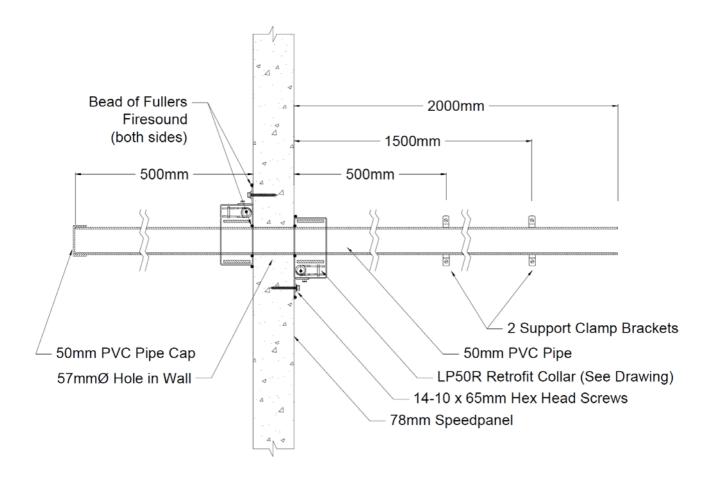
DRAWING NUMBERED 5, DATED 15 FEBRUARY 2016, BY SNAP FIRE SYSTEMS

Drawing #5
Speedpanel Test Wall Penetration # 4
50mm PVC Pipe – LP50R Retrofit Collar
15 FEB 2016

PENETRATING SERVICE
Description	50-mm nominal uPVC pipe
Size	57-mm OD x 2.5-mm wall thickness extending 2000-mm away from the wall and 500-mm into the furnace chamber
End conditions	Capped on the exposed end using a uPVC cap, and left open on the unexposed end
Supports	Approximately 500-mm and 1500-mm away from the wall
	FIRE STOPPING SYSTEM
Application	Fire collars were fitted around the pipe on both sides of the wall and fixed to the wall through the collar's three mounting tabs using 14-10 x 65-mm long hex head screws. Annular gaps around the pipe and the base of the collars were sealed on both sides of the wall with a bead of Firesound sealant.
Drawing	Drawing # LP 50 R-T, dated 14/09/14, by Snap Fire Systems. Drawing # 5, dated 15/02/16

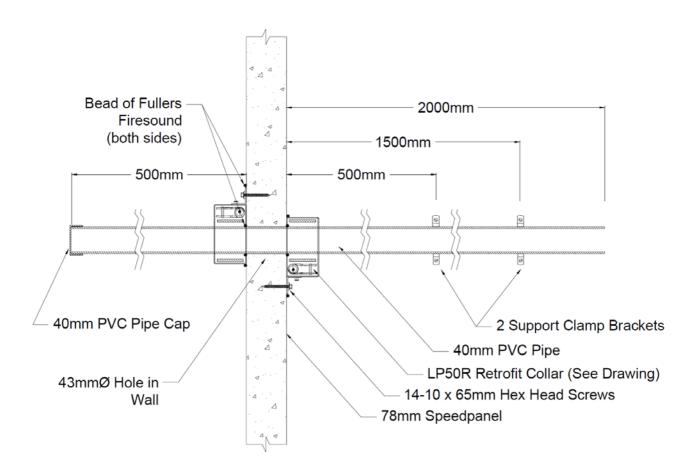
DRAWING NUMBERED 6, DATED 15 FEBRUARY 2016, BY SNAP FIRE SYSTEMS

Drawing #6
Speedpanel Test Wall Penetration # 5
40mm PVC Pipe – LP50R Retrofit Collar
15 FEB 2016

PENETRATING SERVICE
Description	40-mm nominal uPVC pipe
Size	43-mm OD x 2-mm wall thickness extending 2000-mm away from the wall and 500-mm into the furnace chamber
End conditions	Capped on the exposed end using a uPVC cap, and left open on the unexposed end
Supports	Approximately 500-mm and 1500-mm away from the wall
	FIRE STOPPING SYSTEM
Application	Fire collars were fitted around the pipe on both sides of the wall and fixed to the wall through the collar's three mounting tabs using 14-10 x 65-mm long hex head screws. Annular gaps around the pipe and the base of the collars were sealed on both sides of the wall with a bead of Firesound sealant.
Drawing	Drawing # LP 50 R-T, dated 14/09/14, by Snap Fire Systems. Drawing # 6, dated 15/02/16

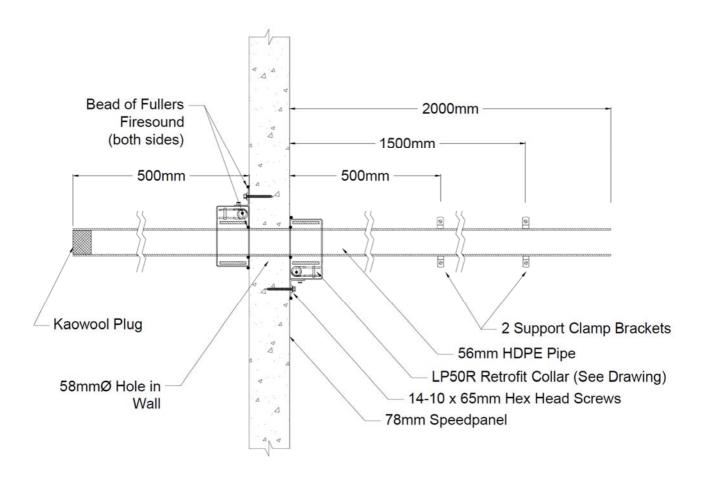
DRAWING NUMBERED 7, DATED 15 FEBRUARY 2016, BY SNAP FIRE SYSTEMS

Drawing #7
Speedpanel Test Wall Penetration # 6
56mm HDPE Pipe – LP50R Retrofit Collar
15 FEB 2016

PENETRATING SERVICE
Description	50-mm nominal HDPE pipe
Size	57-mm OD x 3.5-mm wall thickness extending 2000-mm away from the wall and 500-mm into the furnace chamber
End conditions	Capped on the exposed end using a ceramic fibre plug, and left open on unexposed end
Supports	Approximately 500-mm and 1500-mm away from the wall
	FIRE STOPPING SYSTEM
Application	Fire collars were fitted around the pipe on both sides of the wall and fixed to the wall through the collar's three mounting tabs using 14-10 x 65-mm long hex head screws. Annular gaps around the pipe and the base of the collars were sealed on both sides of the wall with a bead of Firesound sealant.
Drawing	Drawing # LP 50 R, dated 14/09/14, by Snap Fire Systems. Drawing # 7, dated 15/02/16.

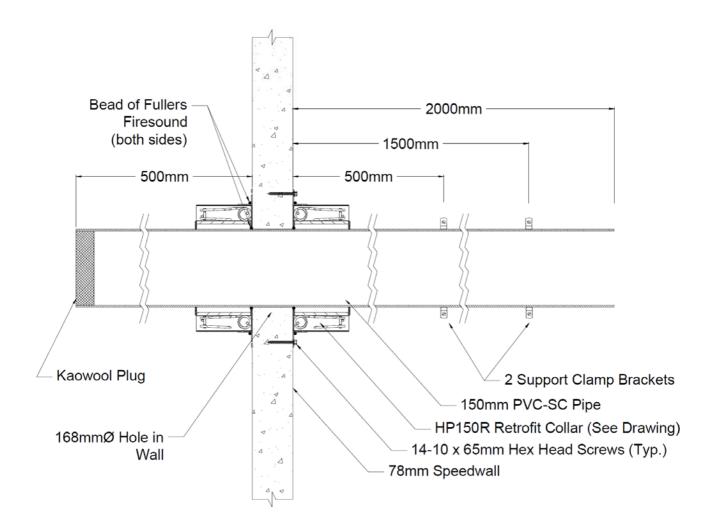
DRAWING NUMBERED 8, DATED 15 FEBRUARY 2016, BY SNAP FIRE SYSTEMS

Speedwall Test Wall Penetration # 7 150mm PVC-SC Pipe – HP150R Retrofit Collar 15 FEB 2016

PENETRATING SERVICE
Description	168-mm ID opening
Size	157-mm OD x 4.5-mm wall thickness extending 2000-mm away from the wall and 500-mm into the furnace chamber
End conditions	Capped on the exposed end using a ceramic fibre plug, and left open on unexposed end
Supports	Approximately 500-mm and 1500-mm away from the wall
· · · · · · · · · · · · · · · · · · ·	FIRE STOPPING SYSTEM
Application	Fire collars were fitted around the pipe on both sides of the wall and fixed to the wall through the collar's three mounting tabs using 14-10 x 65-mm long hex head screws. Annular gaps around the pipe and the base of the collars were sealed on both sides of the wall with a bead of Firesound sealant.
Drawing	Drawing # HP 150 R-T, dated 2/10/15, by Snap Fire Systems. Drawing # 8, dated 15/02/16

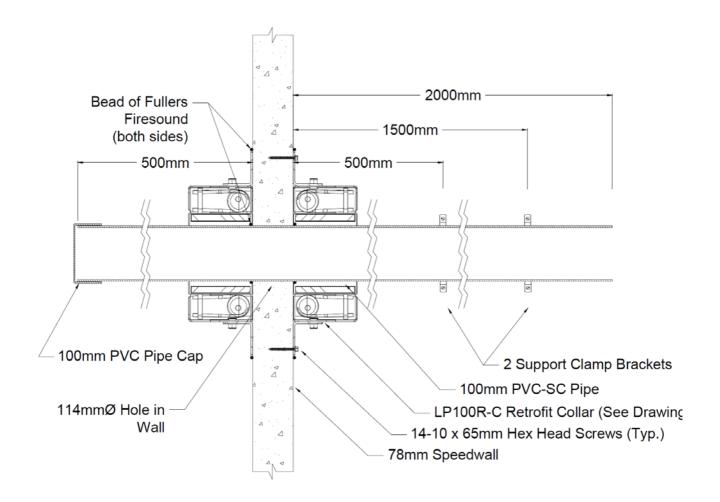
DRAWING NUMBERED 9, DATED 15 FEBRUARY 2016, BY SNAP FIRE SYSTEMS

Speedwall Test Wall Penetration # 8 100mm PVC-SC Pipe – LP100R-C Retrofit Collar 15 FEB 2016

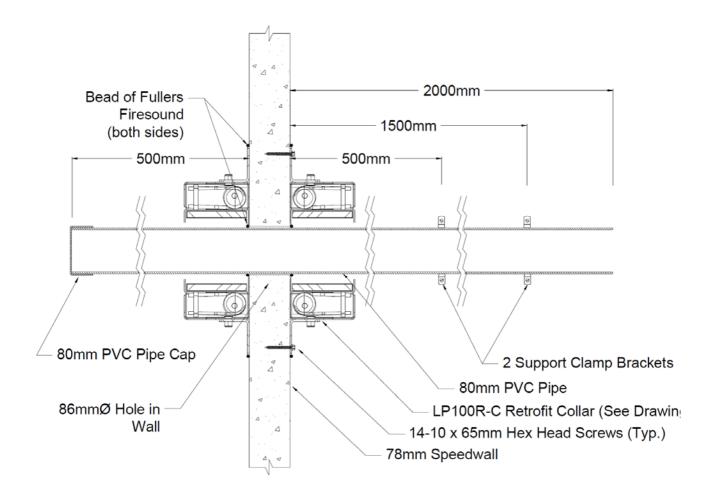
DRAWING NUMBERED 10, DATED 15 FEBRUARY 2016, BY SNAP FIRE SYSTEMS

Speedwall Test Wall Penetration # 9 80mm PVC Pipe – LP100R-C Retrofit Collar 15 FEB 2016

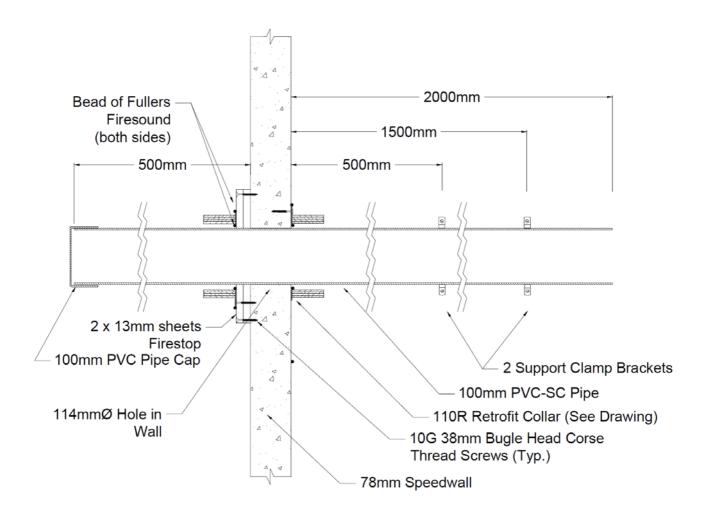
DRAWING NUMBERED 11, DATED 15 FEBRUARY 2016, BY SNAP FIRE SYSTEMS

Speedwall Test Wall Penetration # 10 100mm PVC-SC Pipe – 110R Retrofit Collar 15 FEB 2016

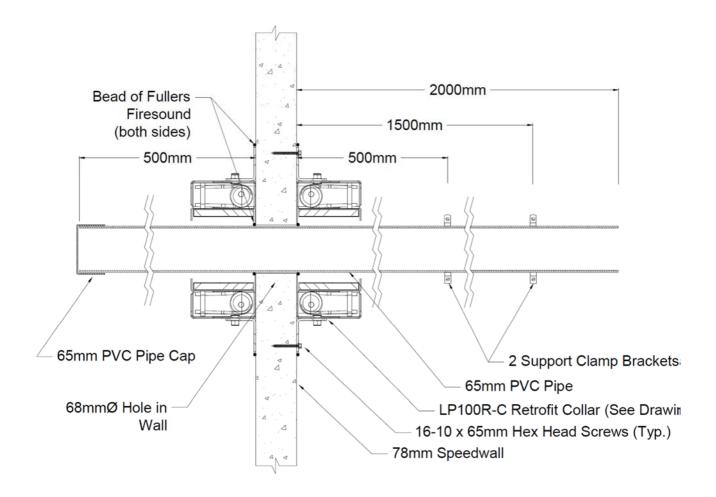
DRAWING NUMBERED 12, DATED 15 FEBRUARY 2016, BY SNAP FIRE SYSTEMS

Speedwall Test Wall Penetration # 11 65mm PVC Pipe – LP100R-C Retrofit Collar 15 FEB 2016

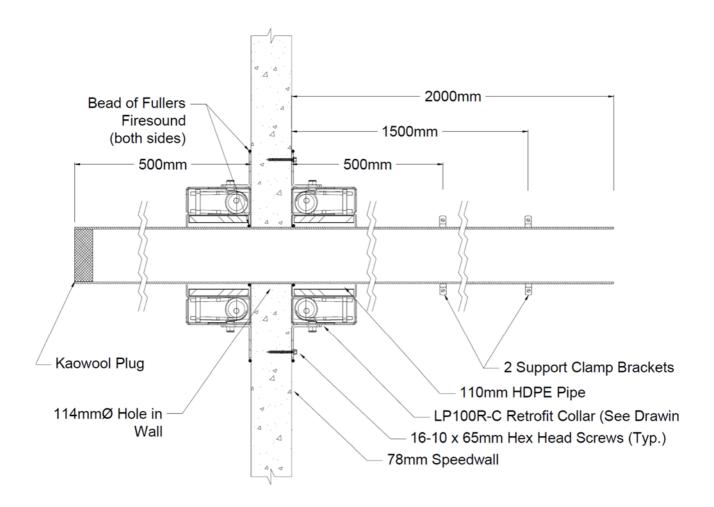
DRAWING NUMBERED 13, DATED 15 FEBRUARY 2016, BY SNAP FIRE SYSTEMS

Speedwall Test Wall Penetration # 12 110mm HDPE Pipe – LP100R-C Retrofit Collar 15 FEB 2016
