## FIRE-RESISTANCE TEST ON FIRE COLLARS PROTECTING A CONCRETE SLAB PENETRATED BY SERVICES

Report number FSP 1577 CSIRO job number SP3627 Date of issue 29 MARCH 2013

Client SNAP FIRE SYSTEMS PTY LTD.

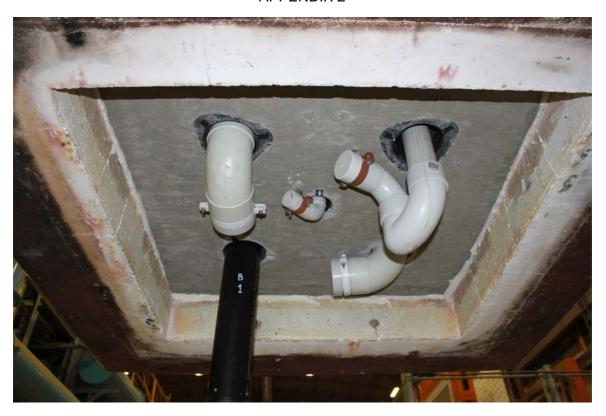
Photograph 1 – Exposed face of the specimen prior to testing

The penetrating service comprised a 65-mm OD PVC pipe, with a wall thickness of 2.7-mm fitted through the H 100 FWS-RR cast-in Snap fire collar. The floor waste system was capped on the unexposed face with chromed brass floor waste grate, a 35-mm thick cement screed was laid on top of the concrete slab and finished flush with the floor grate. On the exposed side of the slab a 80-mm OD PVC gully trap was connected to the penetrating pipe, supported by M10 HKD clamps fixed to the concrete slab as shown in photograph #1. On the exposed face, the floor waste gully was sealed using a PVC end cap.

The penetrating service comprised a 110-mm OD PVC pipe (Sandwich Construction), with a wall thickness of 3.5-mm fitted through the H 100 FWS-RR cast-in Snap fire collar. The floor waste system was capped on the unexposed face with chromed brass floor waste grate, a 35-mm thick cement screed was laid on top of the concrete slab and finished flush with the floor grate. On the exposed side of the slab a PVC 90° elbow was connected to the penetrating pipe within the fire collar and supported by a steel support M10 HKD clamp as shown in photograph #1. The pipe was capped on the exposed end using a PVC cap.

The penetrating service comprised a 42-mm OD PVC pipe, with a wall thickness of 2-mm fitted through the collar's sleeve. The pipe projected vertically, 2000-mm above the concrete slab. The pipe was supported at 1000-mm from the unexposed face of the concrete slab. On the exposed side of the slab a PVC 90° elbow was connected to the penetrating pipe within the fire collar and supported by a steel support M10 HKD clamp as shown in photograph #1. The pipe was open at the unexposed end and capped on the exposed end using a PVC cap.

The penetrating service comprised a 110-mm OD PVC pipe (Sandwich Construction), with a wall thickness of 3.5-mm fitted through the collar's sleeve. The pipe projected vertically, 2000-mm above the concrete slab. The pipe was supported at 1000-mm from the unexposed face of the concrete slab. On the exposed side of the slab a PVC 90° elbow was connected to the penetrating pipe within the fire collar and supported by a steel support M10 HKD clamp, as shown in photograph #1. The pipe was open at the unexposed end and capped on the exposed end using a PVC cap

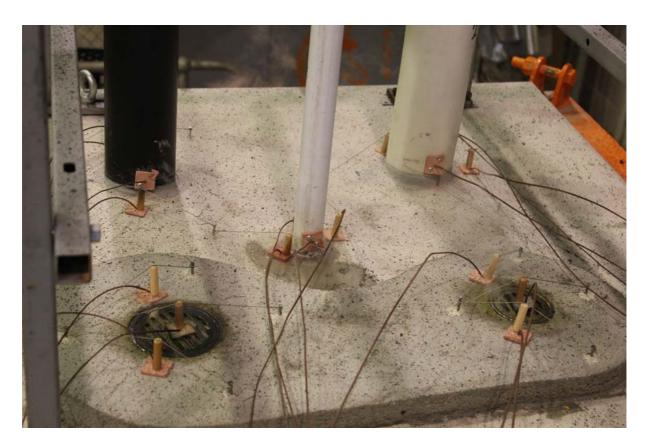
Photograph 3 – Specimens after 60 minutes of testing

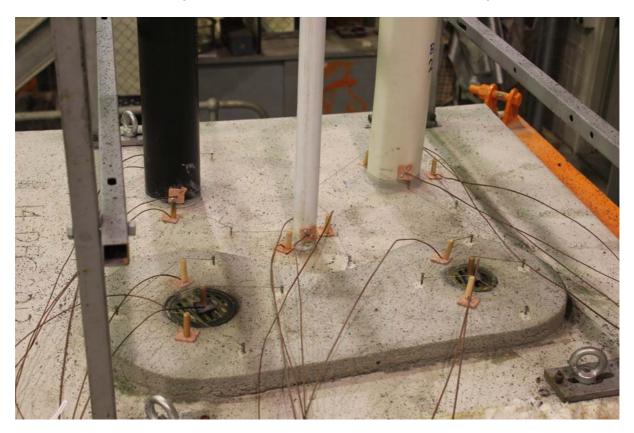
Photograph 4 – Specimens after 120 minutes of testing

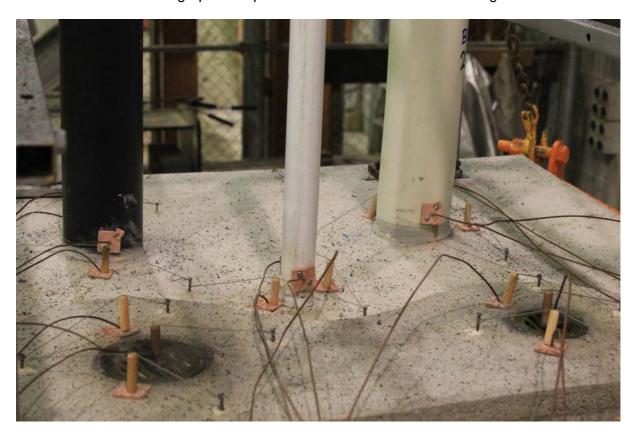
Photograph 6 – Specimens after 240 minutes of testing
