Fire-resistance test on fire collars protecting a floor/ceiling system penetrated by services

Test Report

Report number: FSP 2097

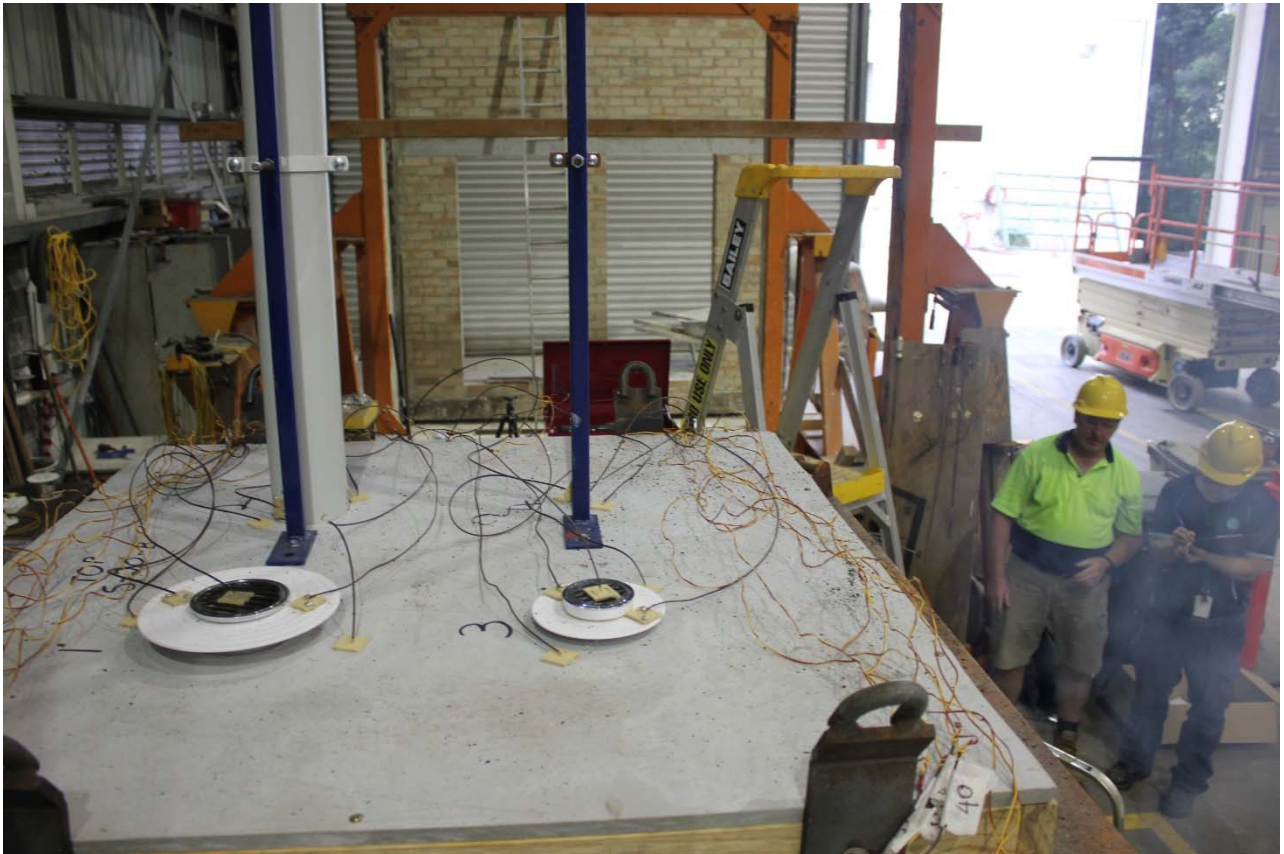
PHOTOGRAPH 3 – SPECIMENS AFTER 6 MINUTES OF TESTING

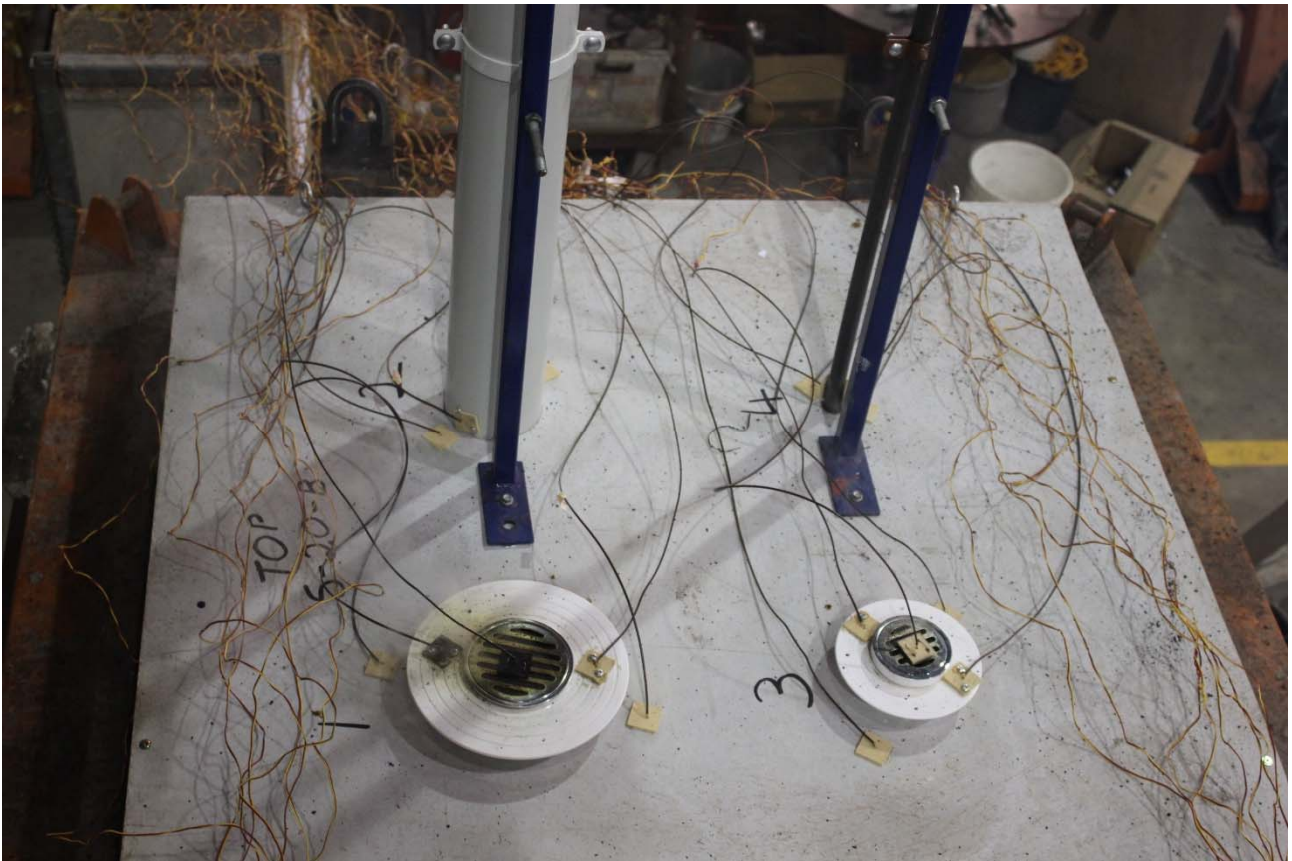
PHOTOGRAPH 5 – SPECIMENS AFTER 30 MINUTES OF TESTING

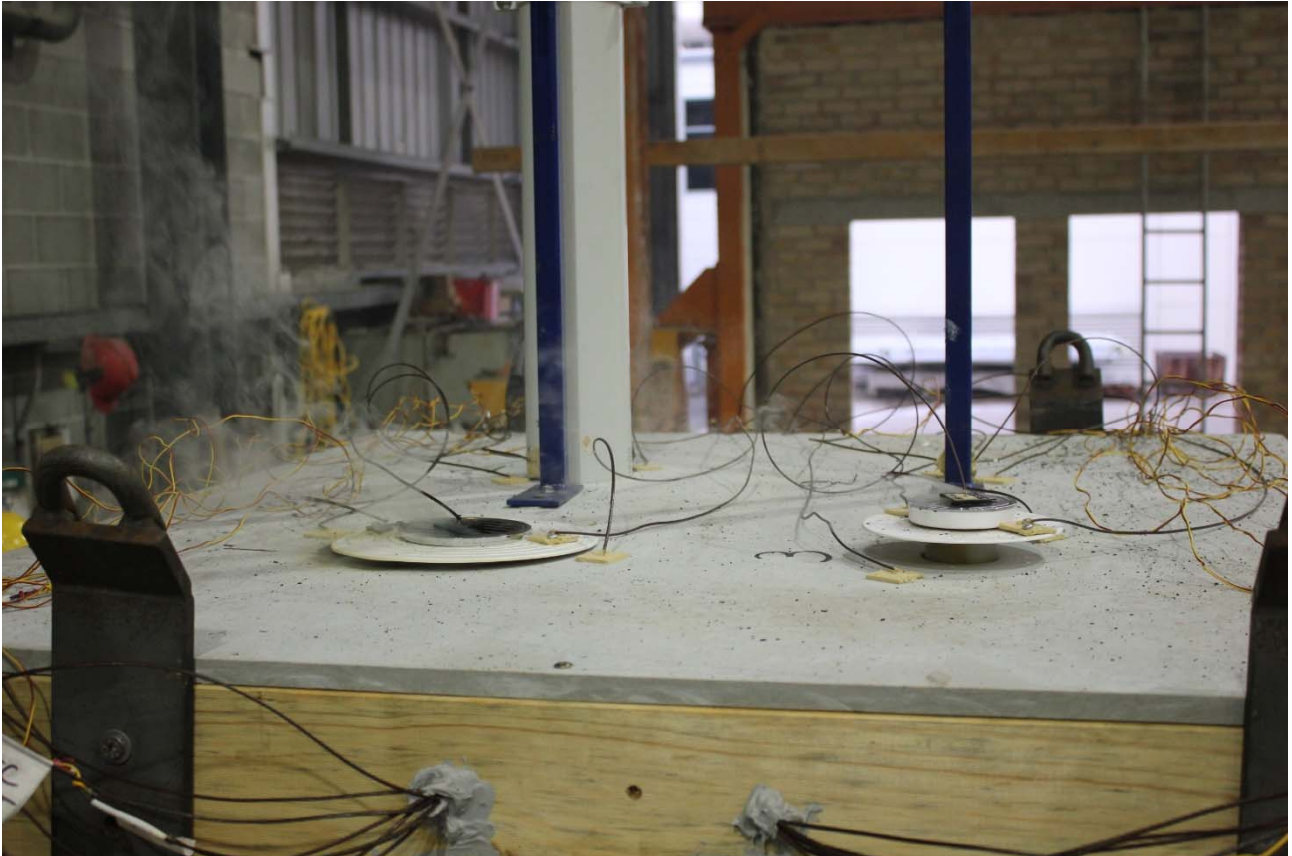
PHOTOGRAPH 6 – SPECIMENS AFTER 52 MINUTES OF TESTING
