Fire-resistance test on retrofit fire collars protecting a plasterboard wall penetrated by services

Test Report

Author: Peter Gordon
Report number: FSP 2120
Date: 7 September 2020
Client: IG6 Pty Ltd as trustee for the IG6 IP Trust

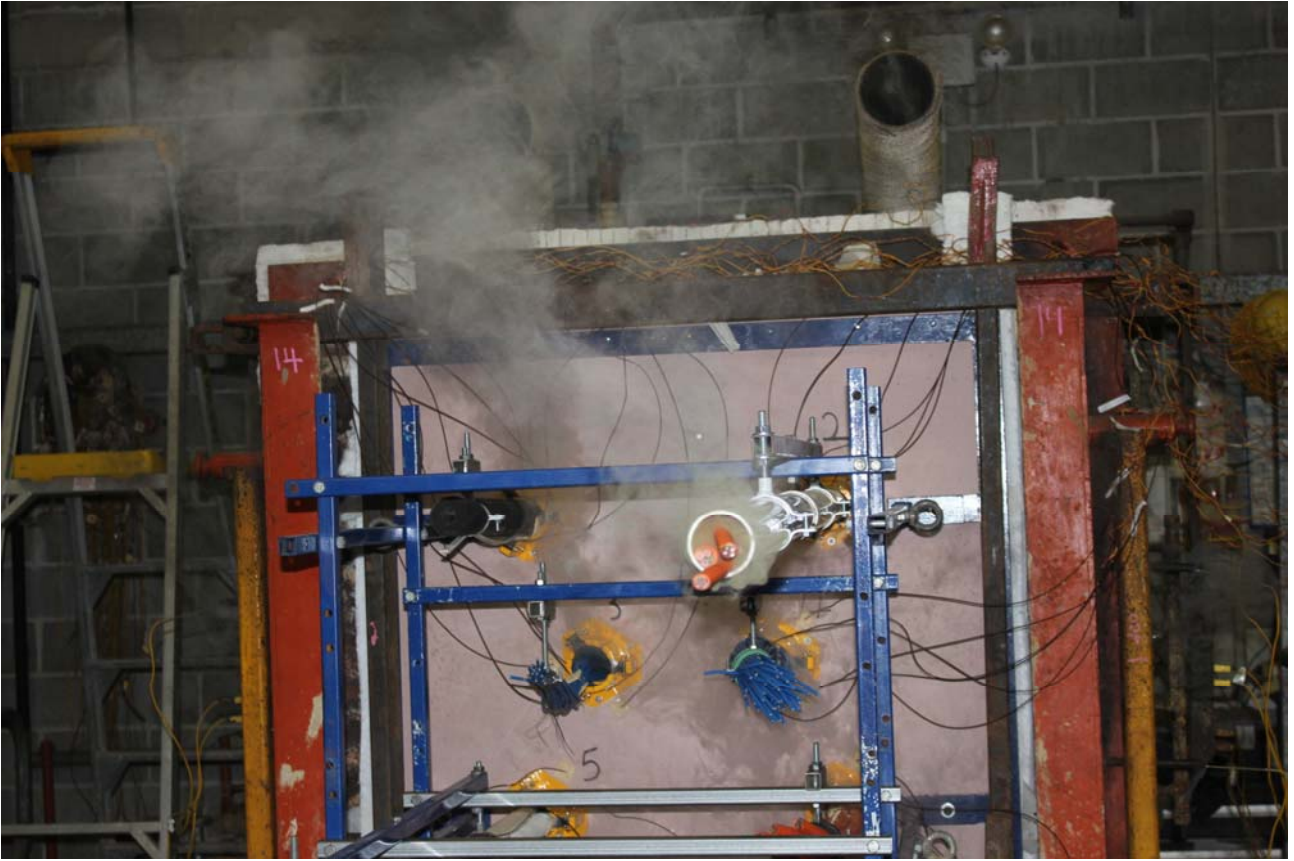
PHOTOGRAPH 3 – SPECIMENS AFTER 2 MINUTES OF TESTING

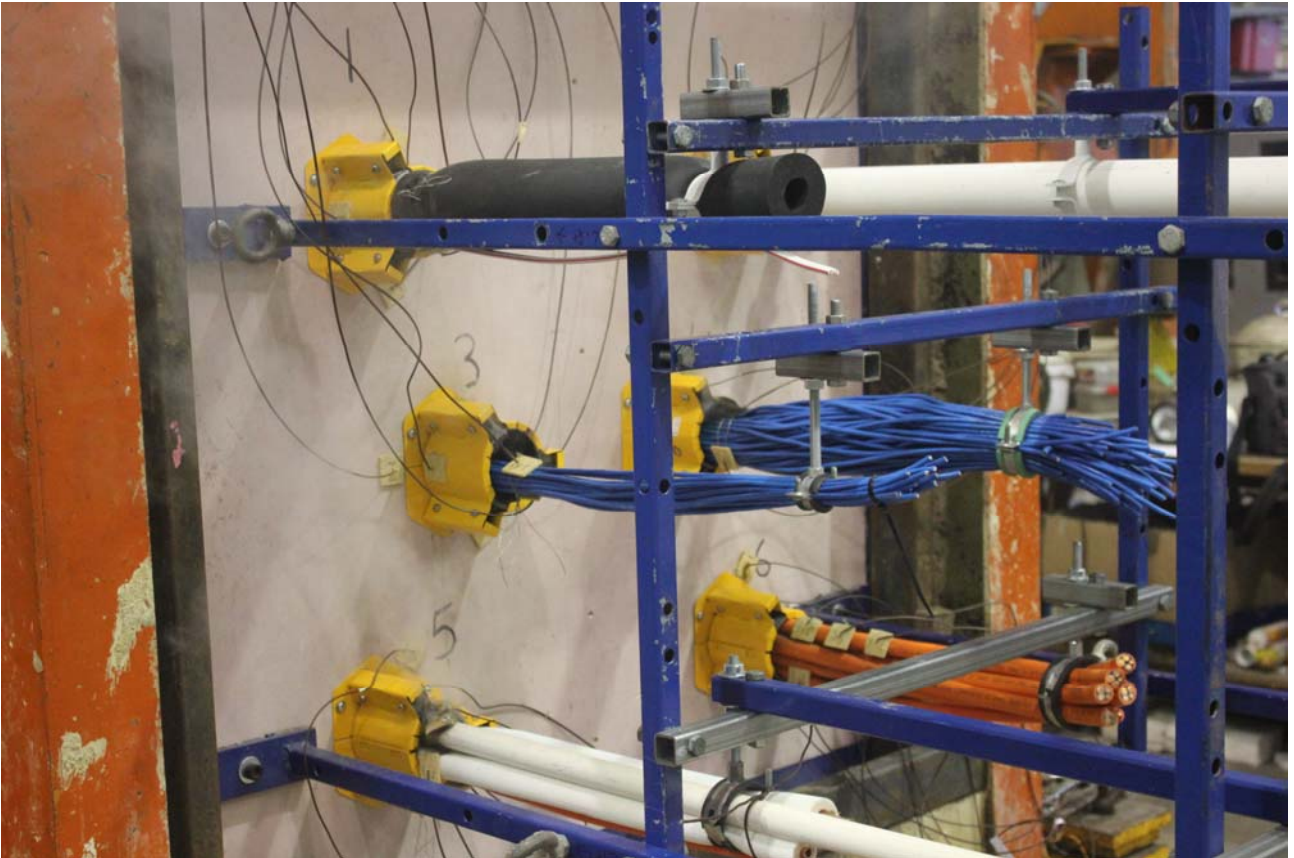
PHOTOGRAPH 6 – SPECIMENS AFTER 30 MINUTES OF TESTING

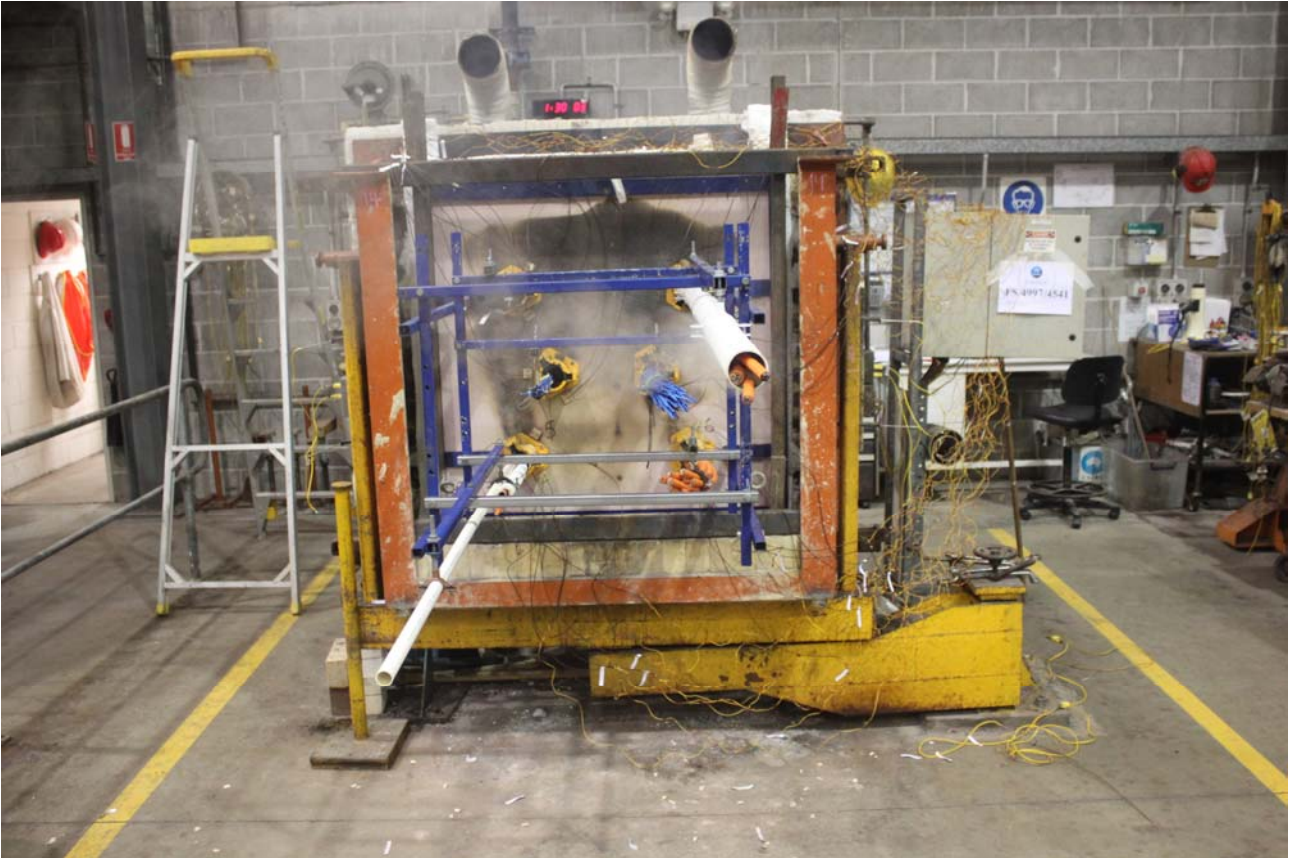
PHOTOGRAPH 11 – SPECIMENS AFTER 90 MINUTES OF TESTING

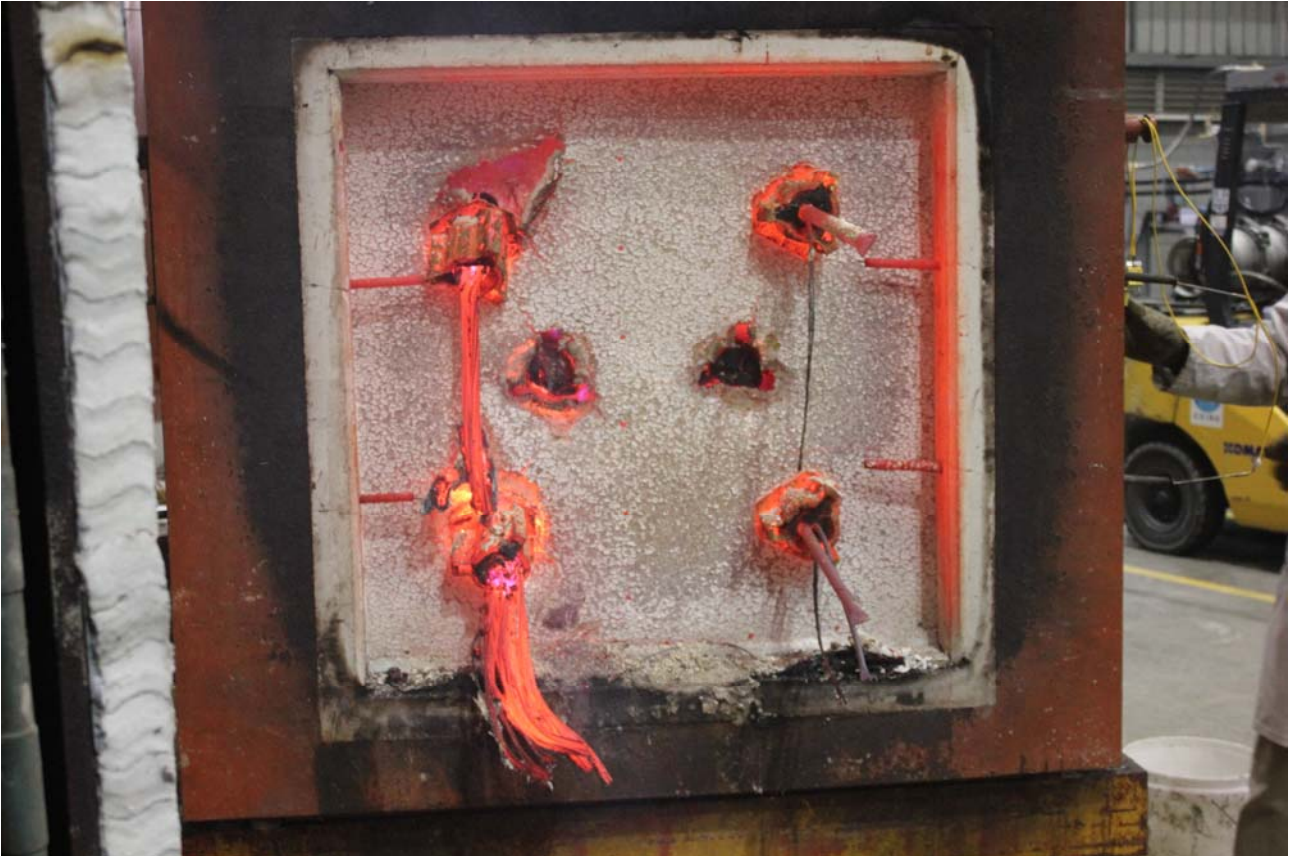
PHOTOGRAPH 12 – EXPOSED FACE OF SPECIMENS AT CONCLUSION OF TESTING
