# Fire-resistance test on retrofit fire collars protecting a plasterboard wall penetrated by services

## Test Report

**Author:** Peter Gordon  
**Report number:** FSP 2120 (Revision C)  
**Date:** 30 June 2022  
**Client:** IG6 Pty Ltd as trustee for the IG6 IP Trust

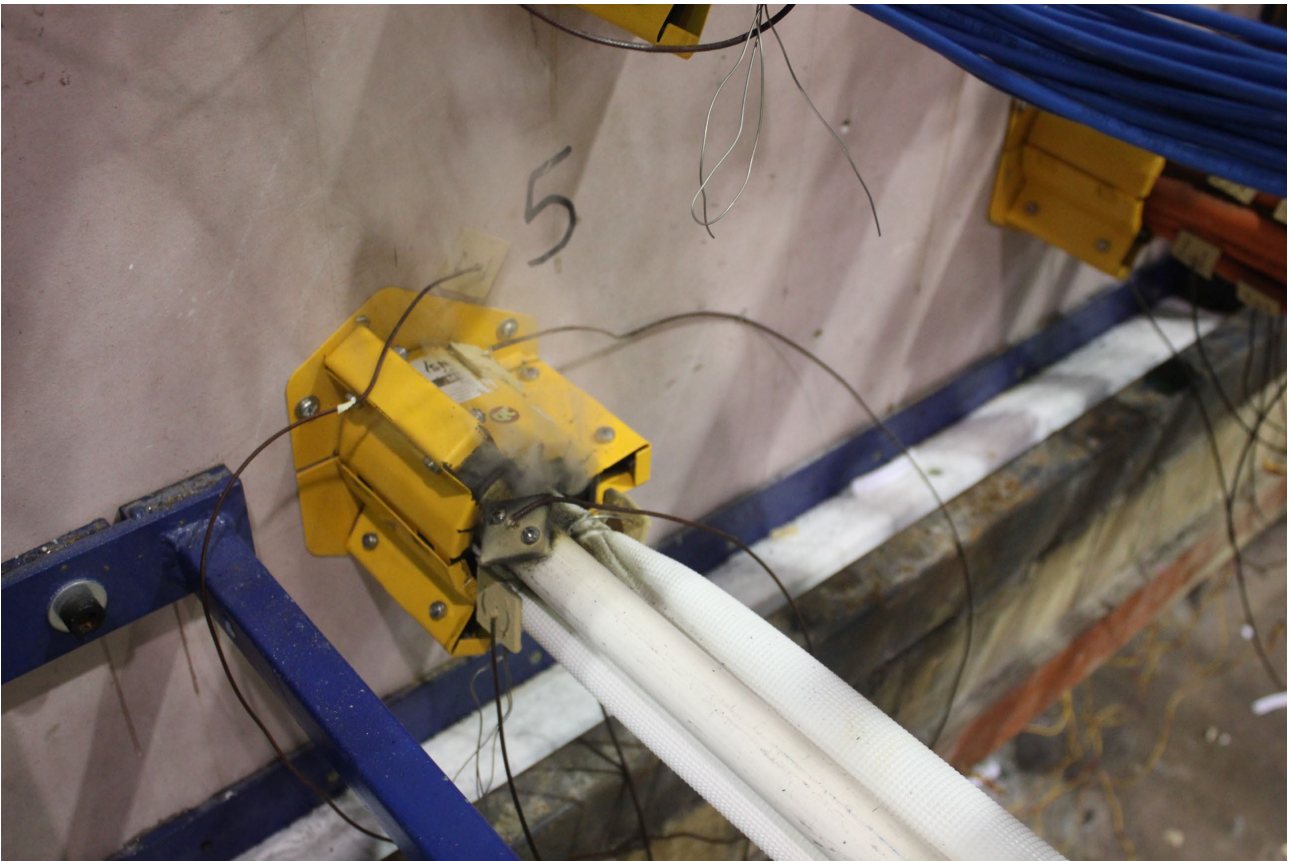
**PHOTOGRAPH 7 – SPECIMENS 5 AND 4 AFTER 45 MINUTES OF TESTING**

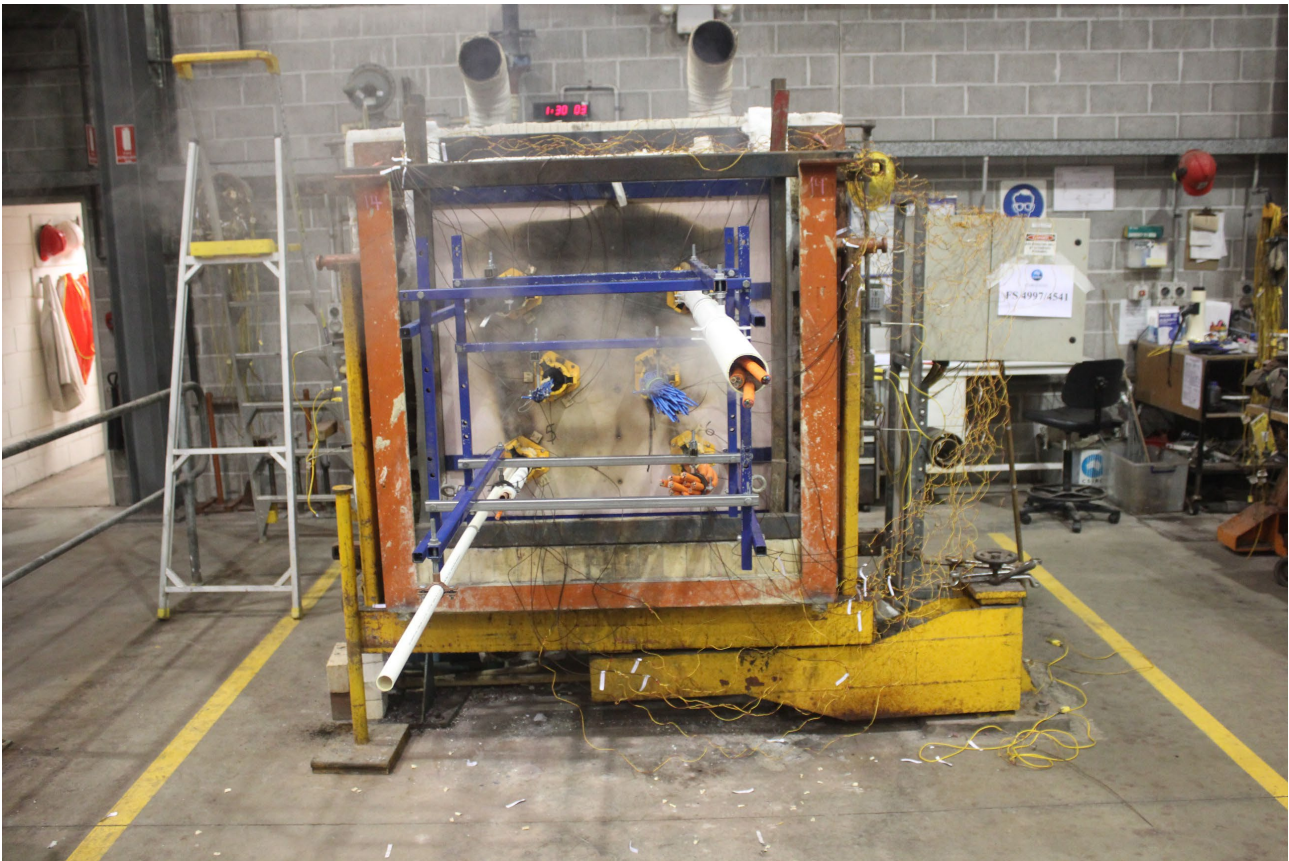
**PHOTOGRAPH 11 – SPECIMENS AFTER 90 MINUTES OF TESTING**

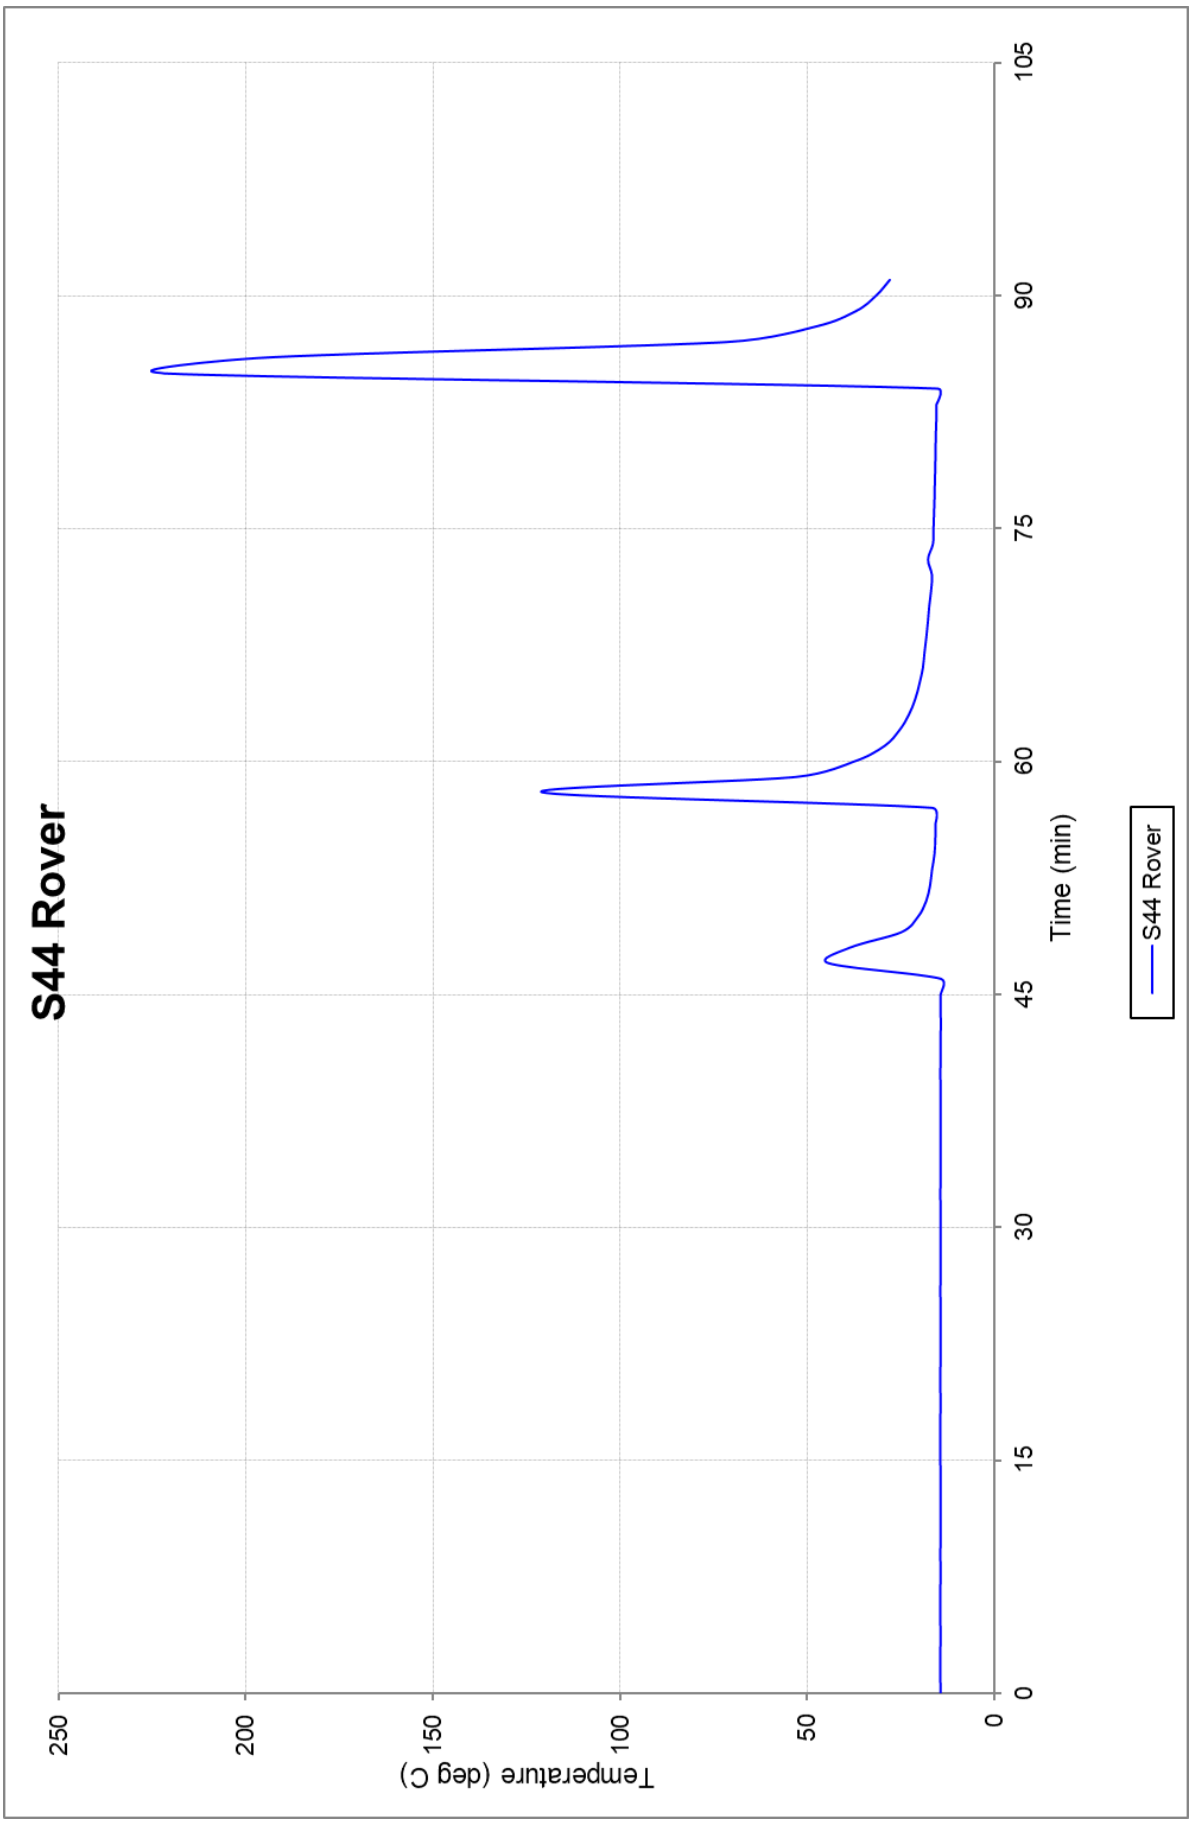
FIGURE 9 TEMPERATURE VERSUS TIME ASSOCIATED WITH ROVING THERMOCOUPLE

Figure 9 shows the curve of temperature versus time associated with the roving thermocouple.

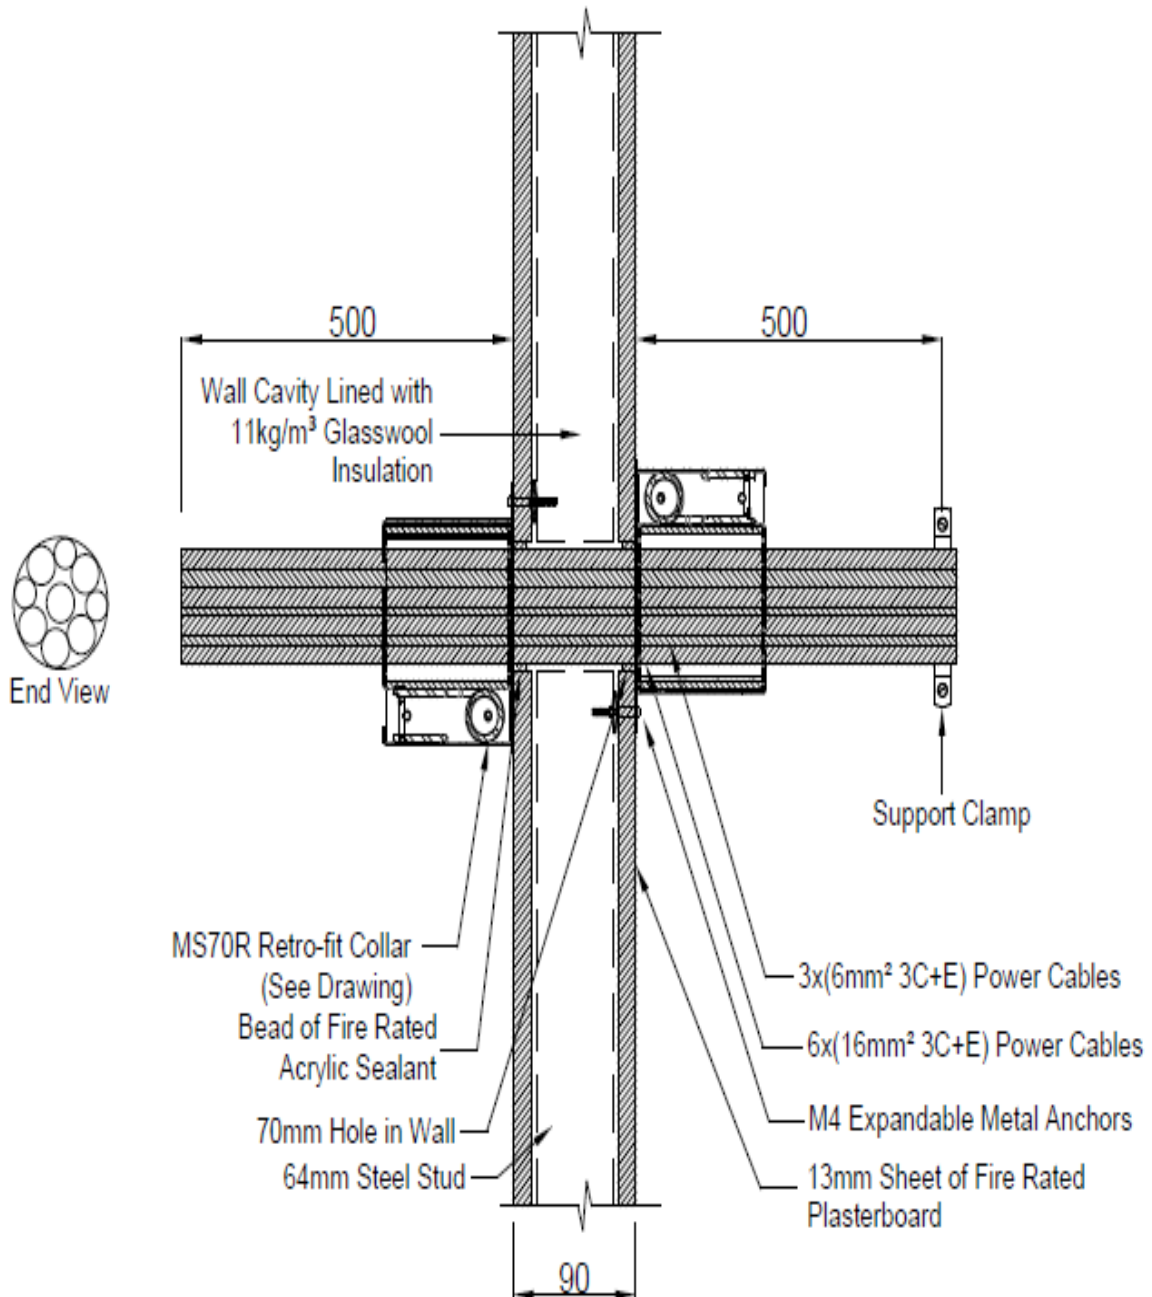
16mm<sup>2</sup> 3C+E & 6mm<sup>2</sup> 3C+E Power Cables & MS70R Collar

**DRAWING TITLED "SPECIMEN #6 16MM<sup>2</sup> 3C+E & 6MM<sup>2</sup> 3C+E POWER CABLES & MS70R COLLAR", DATED 10 JUNE 2020, PROVIDED BY SNAP FIRE SYSTEMS PTY LTD**
