# Fire-resistance test on retrofit fire collars protecting a plasterboard wall penetrated by services

## Test Report

**Author:** Peter Gordon  
**Report number:** FSP 2126 Revision C  
**Date:** 20 July 2022  
**Client:** IG6 Pty Ltd as trustee for the IG6 IP Trust

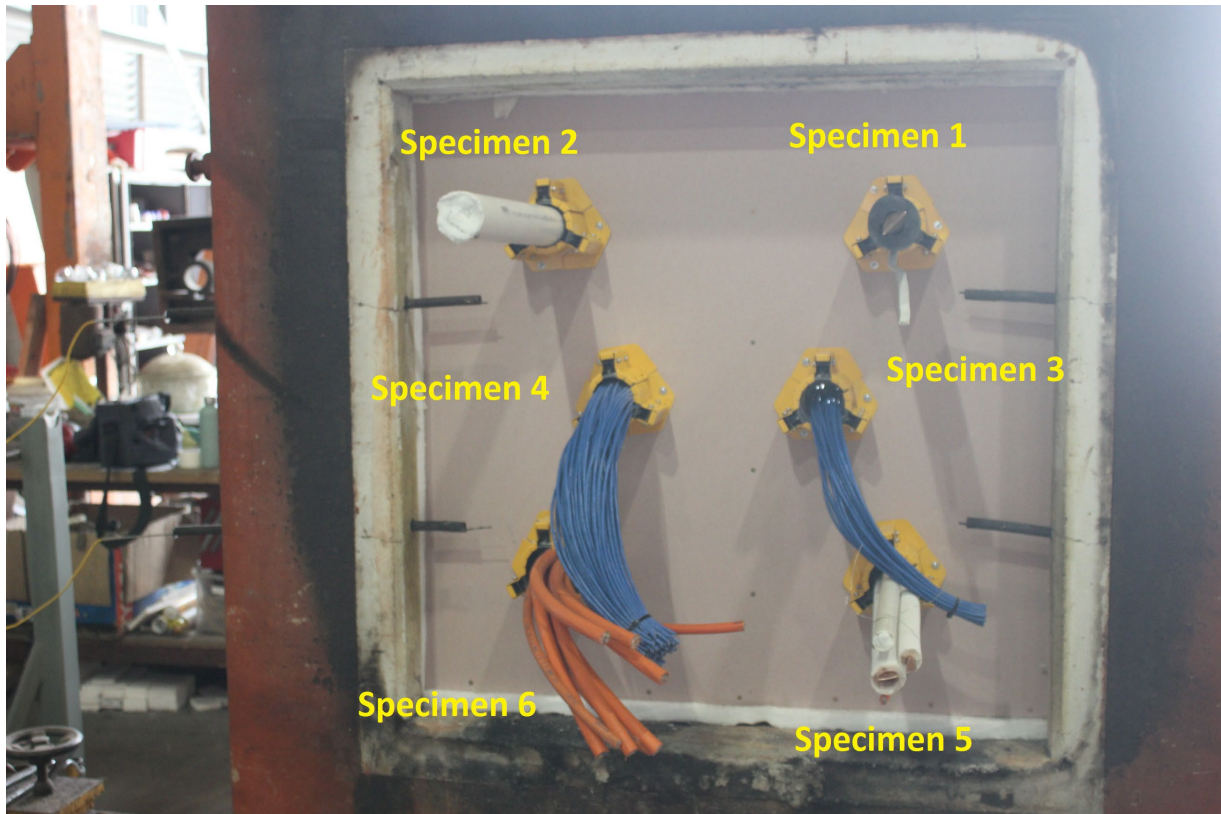
**PHOTOGRAPH 1 – EXPOSED FACE OF SPECIMENS PRIOR TO TESTING**

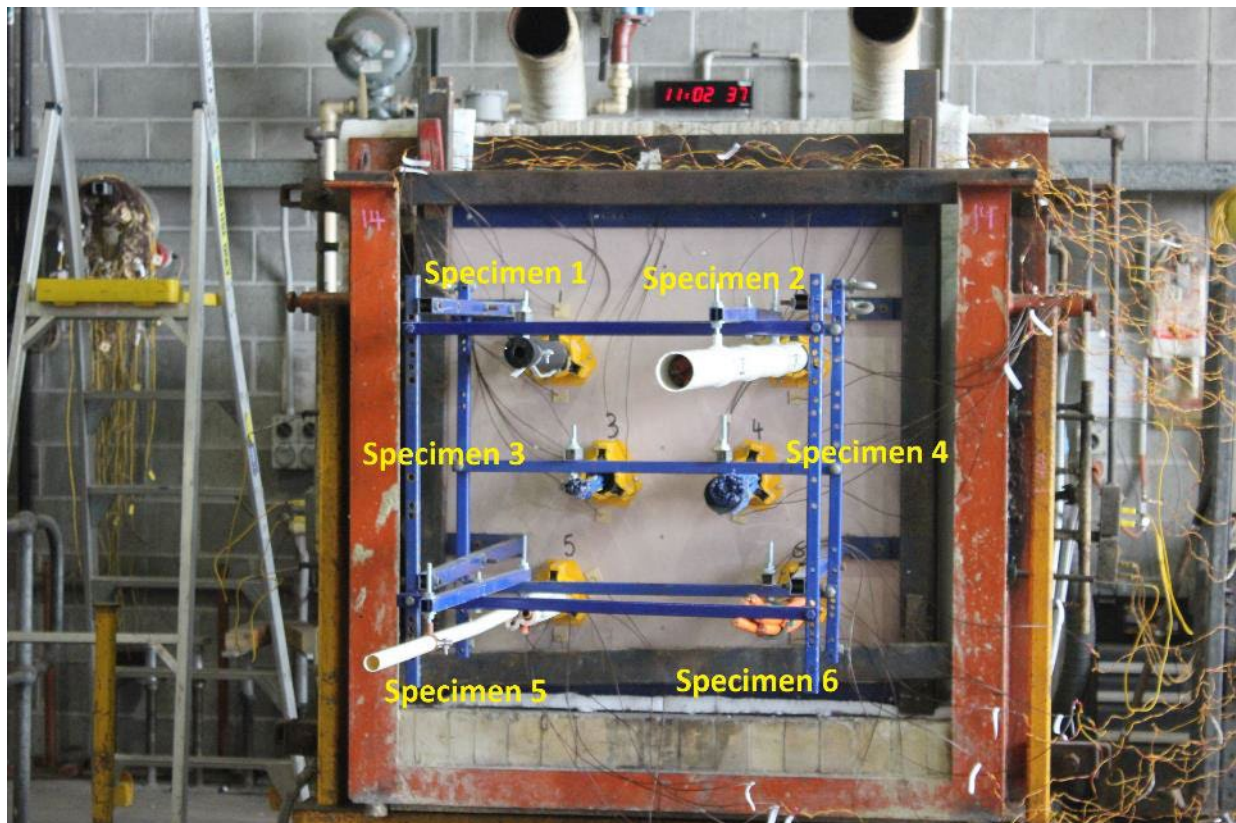
**PHOTOGRAPH 2 – UNEXPOSED FACE OF SPECIMENS PRIOR TO TESTING**

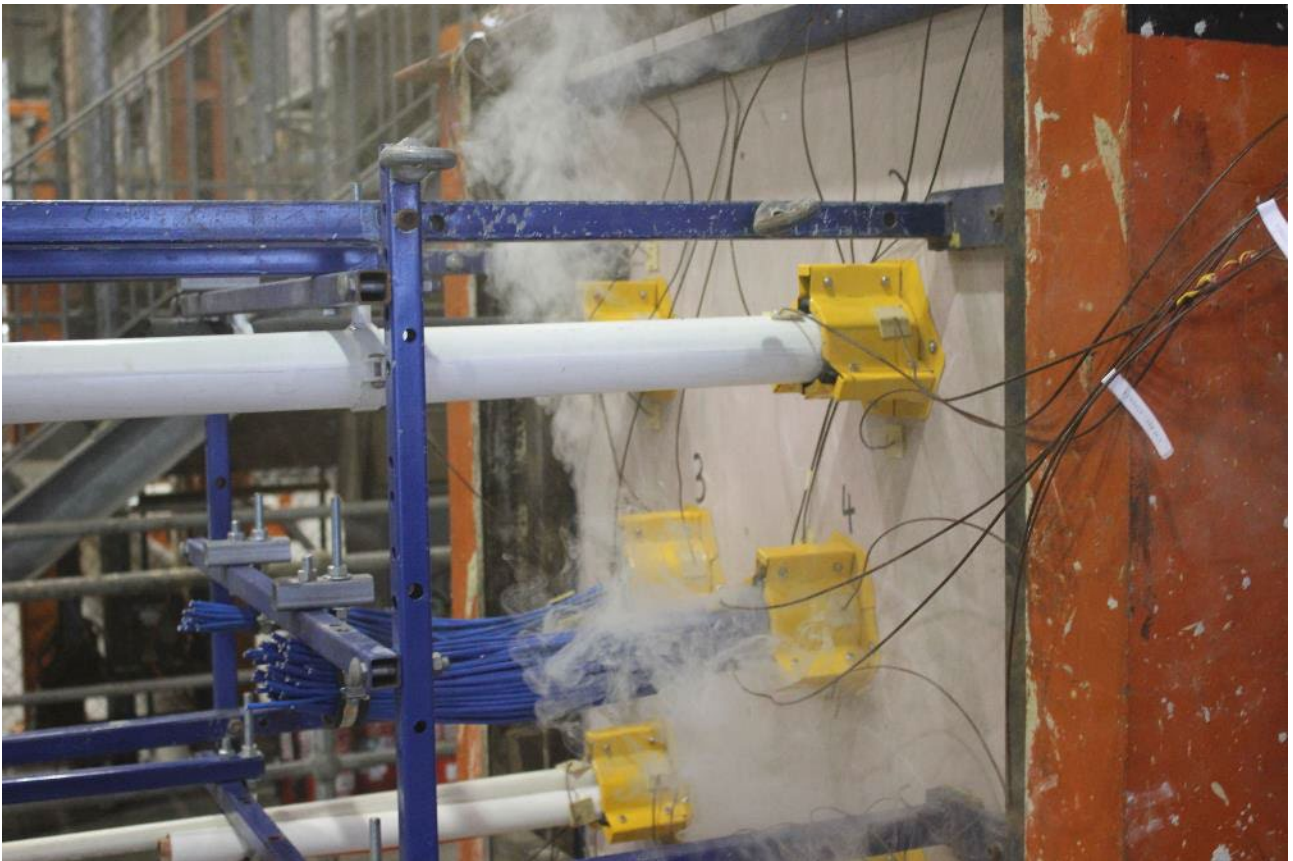
**PHOTOGRAPH 3 – SPECIMENS AFTER 2 MINUTES OF TESTING**

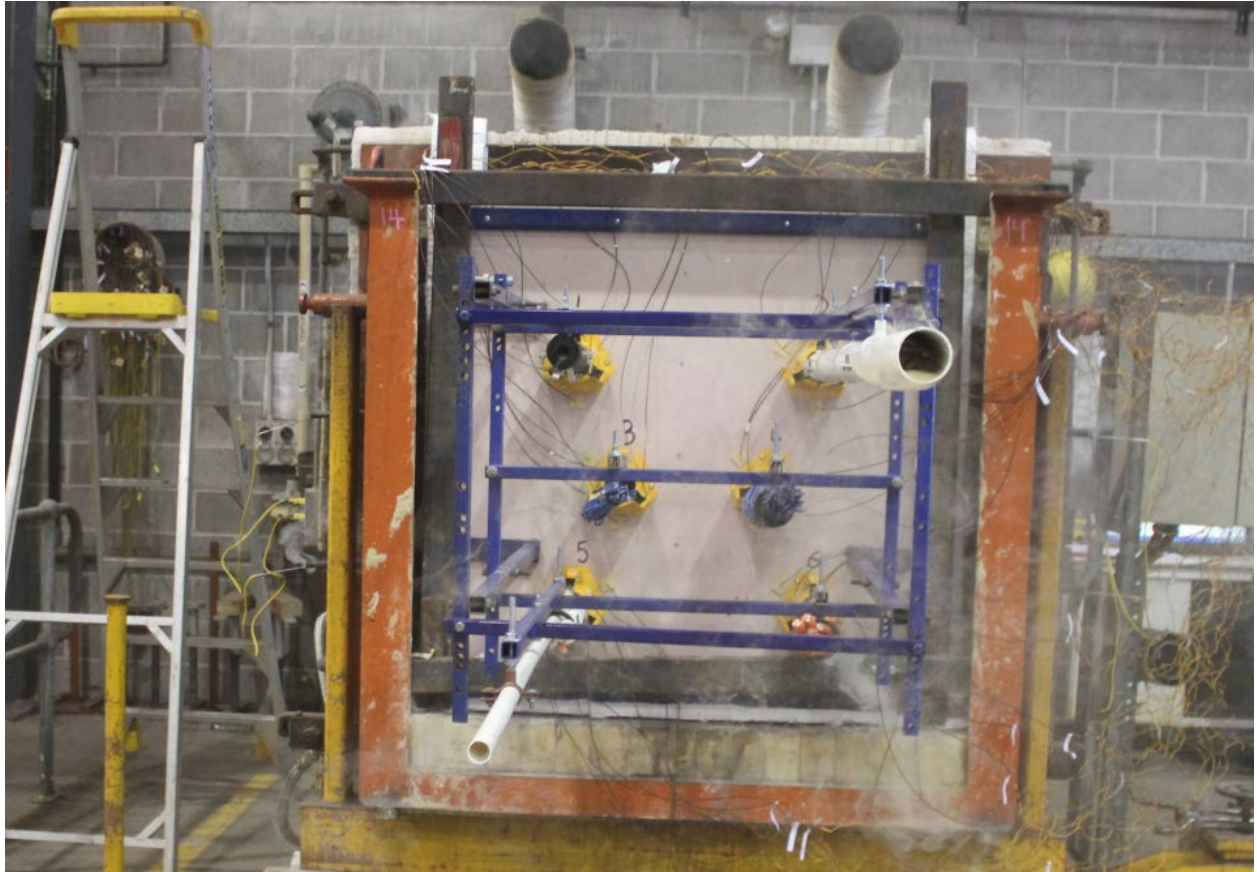
**PHOTOGRAPH 4 – SPECIMENS AFTER 4 MINUTES OF TESTING**

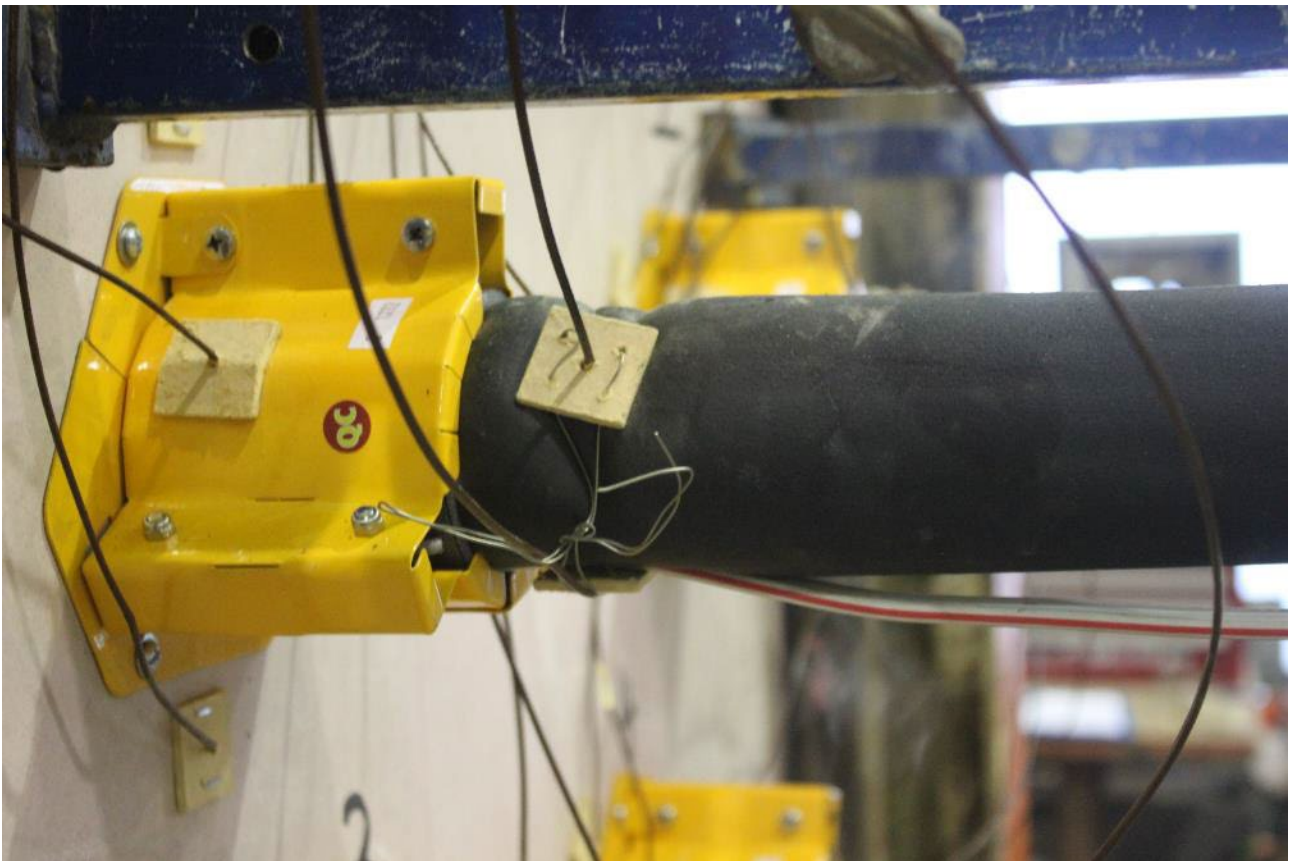
**PHOTOGRAPH 5 – SPECIMEN 1 AFTER 18 MINUTES OF TESTING**

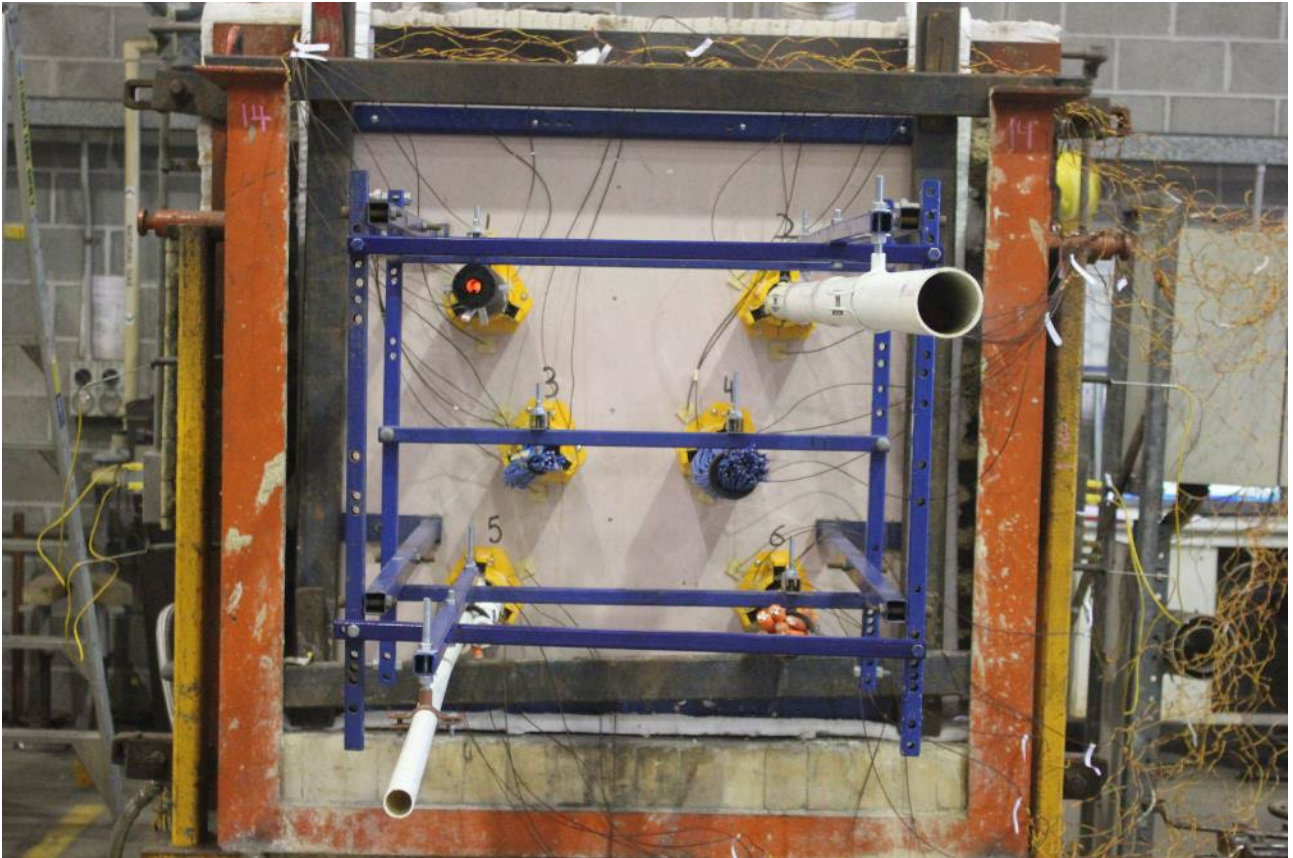
**PHOTOGRAPH 6 – SPECIMENS AFTER 30 MINUTES OF TESTING**

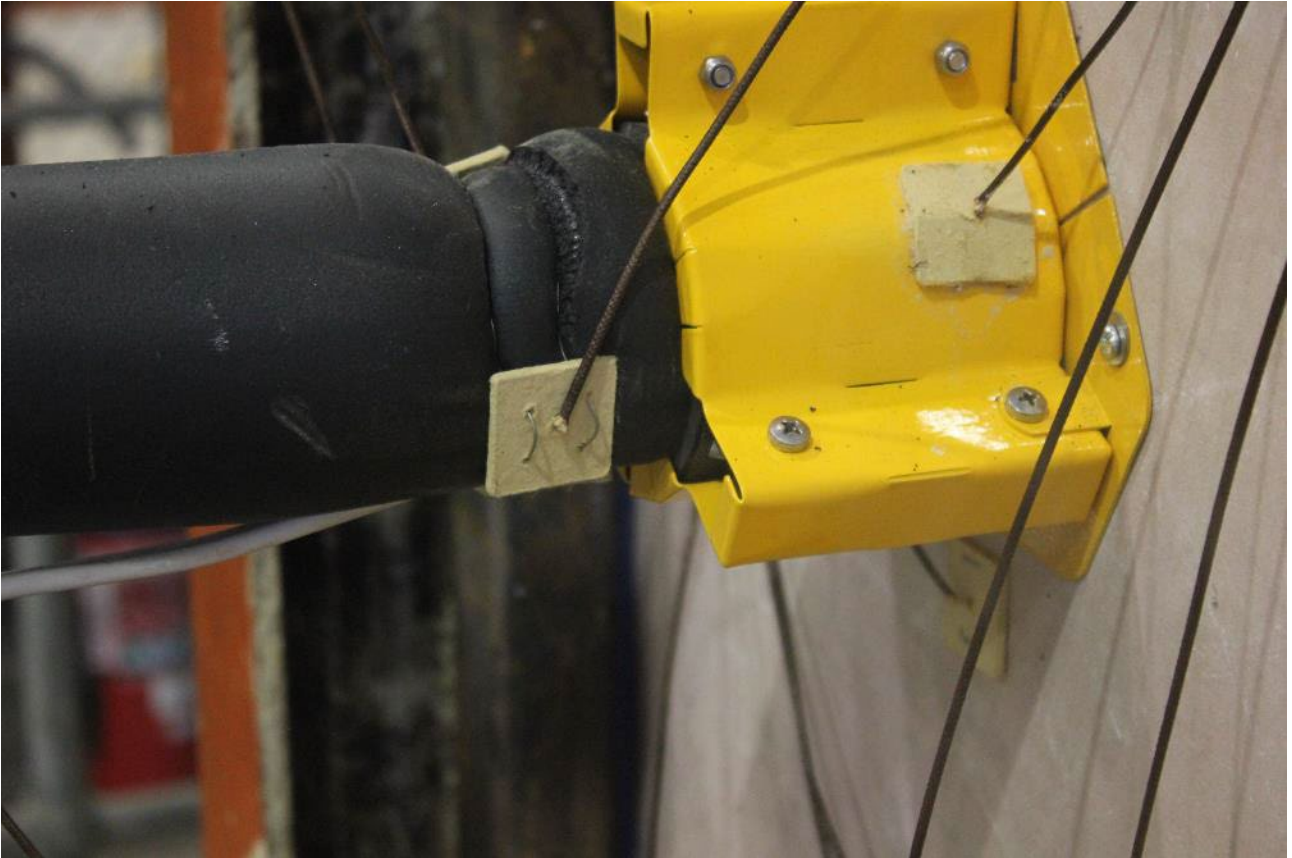
**PHOTOGRAPH 7 – SPECIMEN 1 AFTER 32 MINUTES OF TESTING**

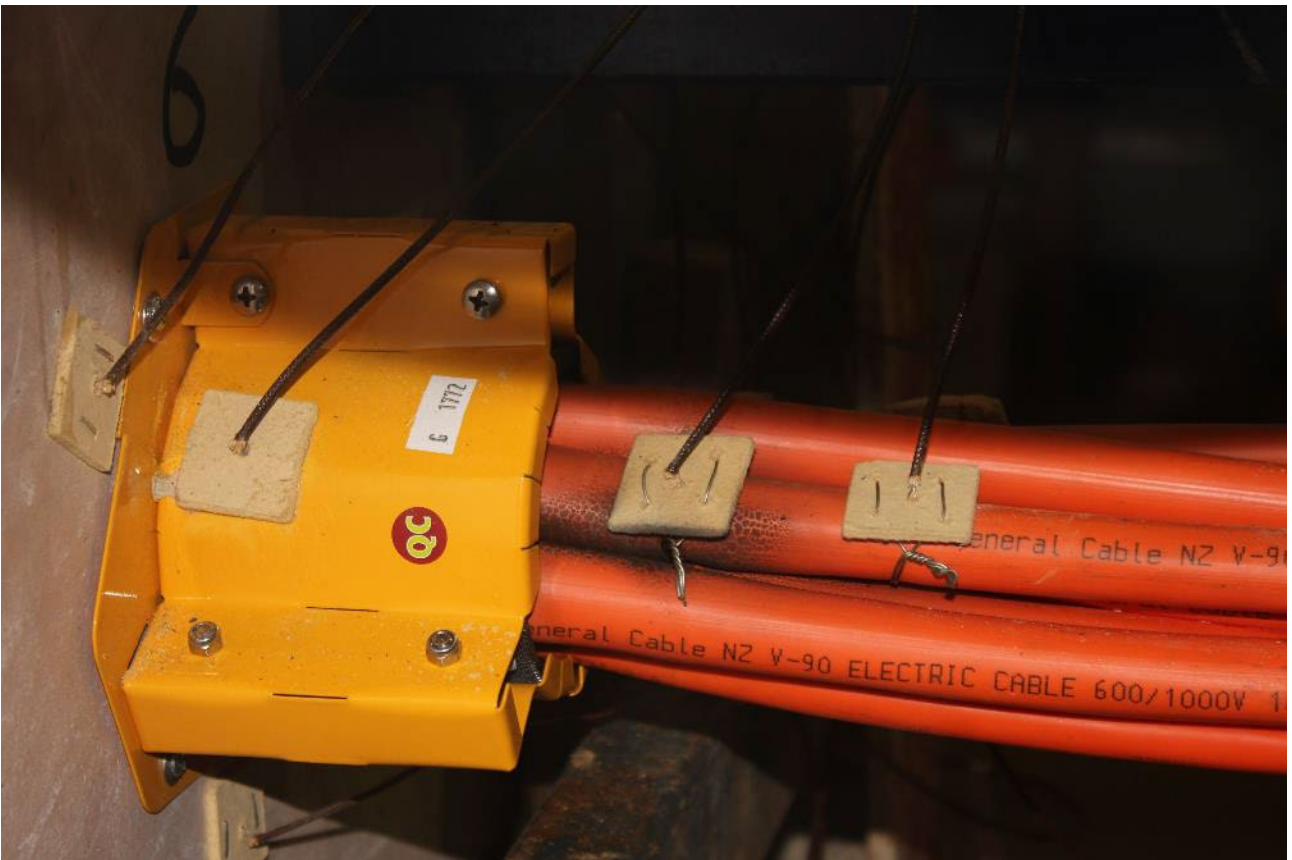
**PHOTOGRAPH 8 – SPECIMEN 6 AFTER 40 MINUTES OF TESTING**

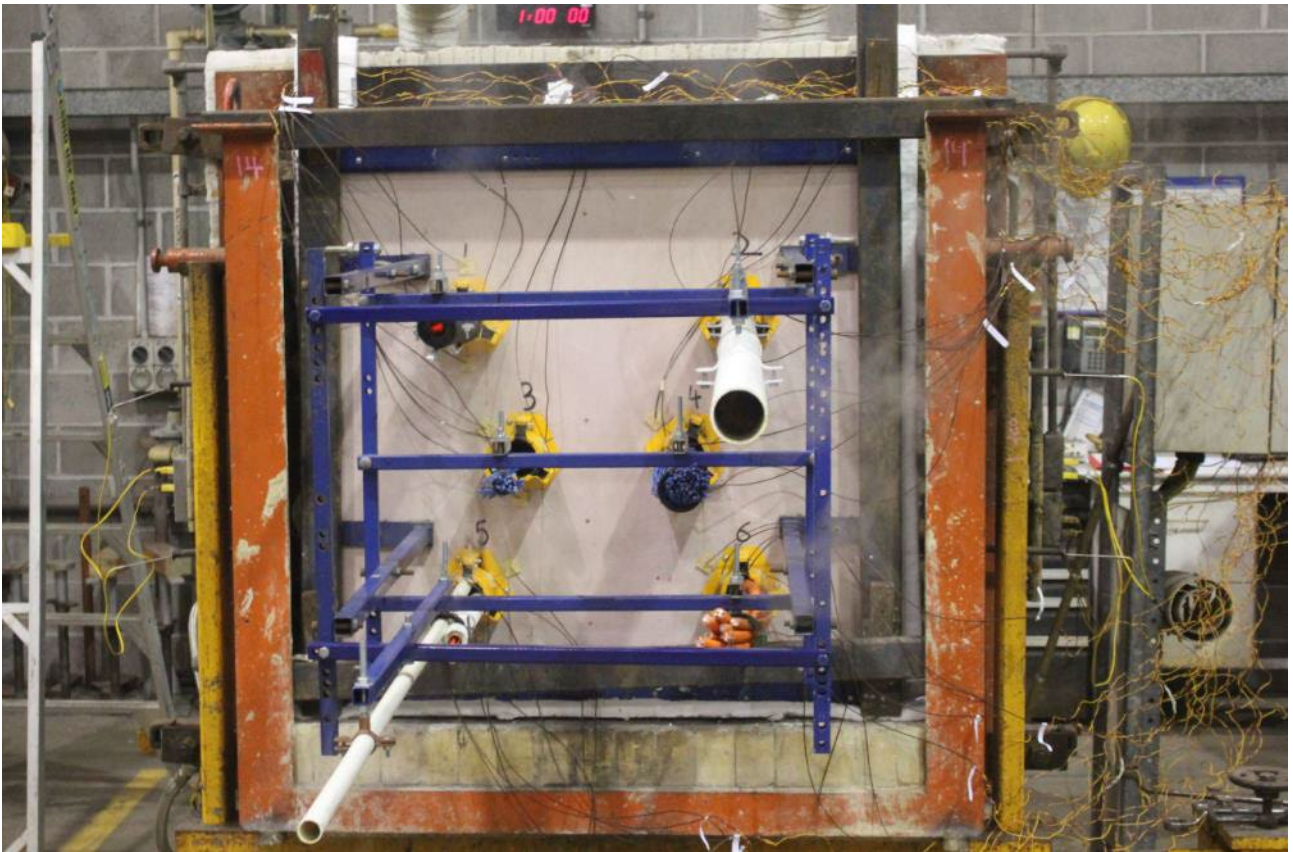
**PHOTOGRAPH 9 – SPECIMENS AFTER 60 MINUTES OF TESTING**

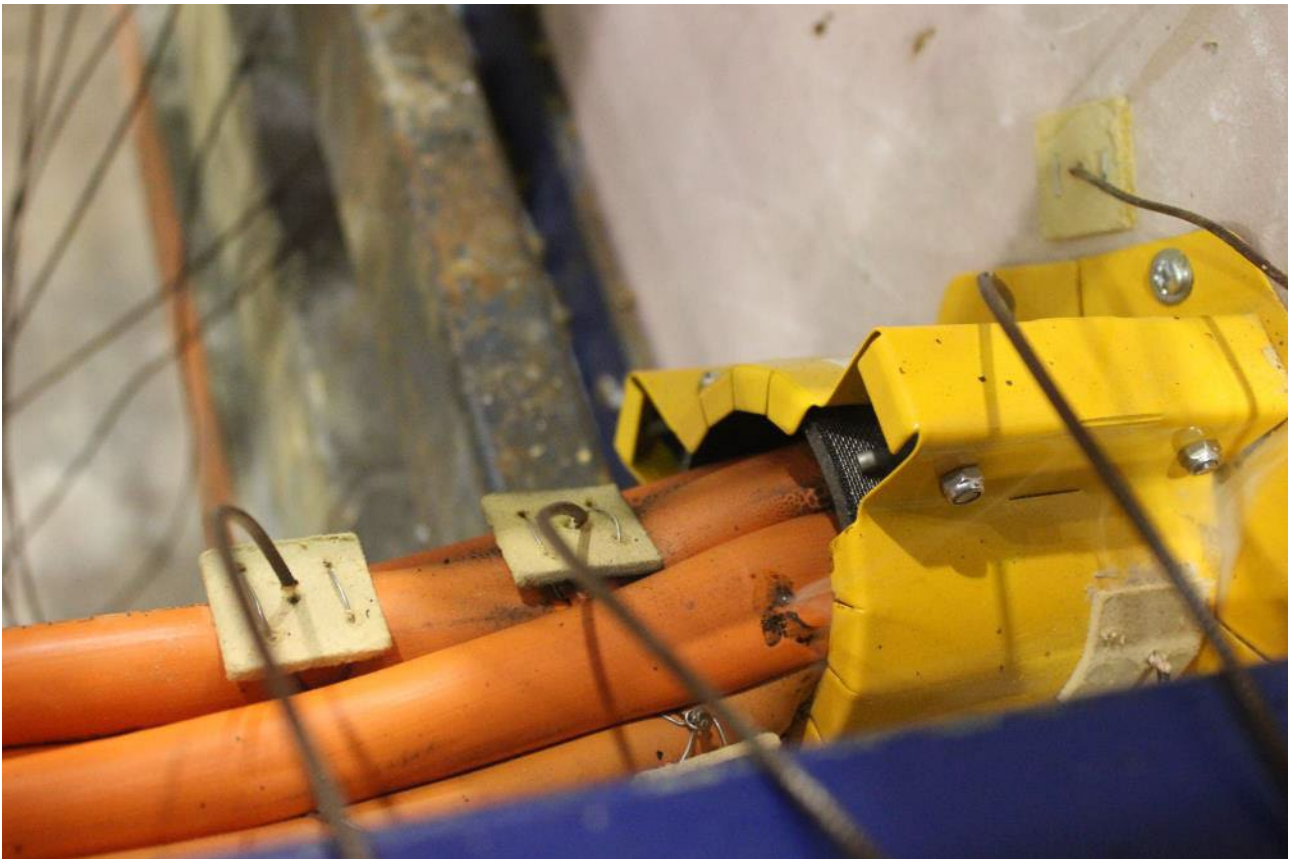
**PHOTOGRAPH 10 – SPECIMEN 6 AFTER 62 MINUTES OF TESTING**

- 62 minutes - The orange sheath on the 16-mm<sup>2</sup> cable – top right of Specimen 6 adjacent to the collar has begun to split (Photograph 10).
- 66 minutes - The blue sheath at the top of cable bundles and of Specimens 3 and 4 have started to discolour, with the adjacent collars having smoke stains.

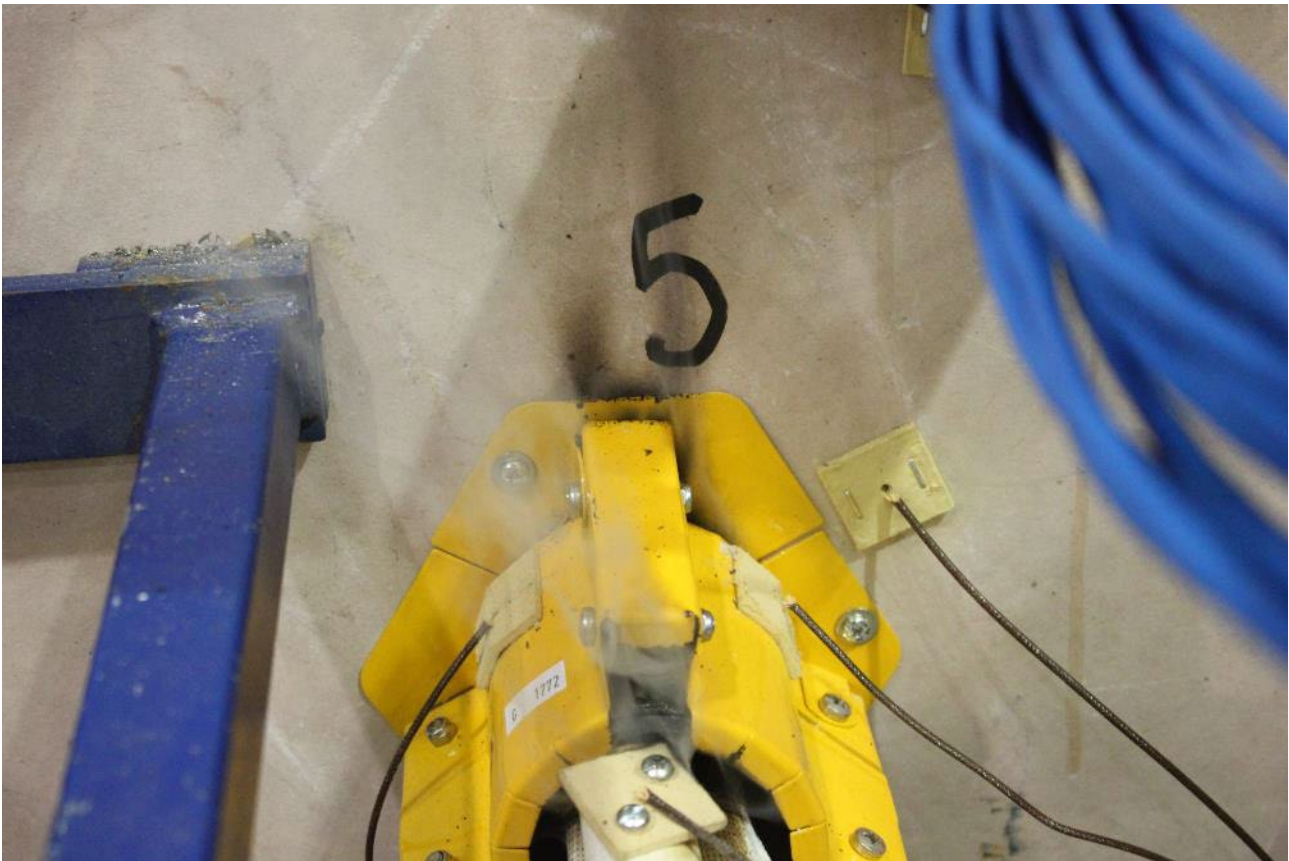
**PHOTOGRAPH 11 – SPECIMEN 5 AFTER 75 MINUTES OF TESTING**

- 75 minutes - Smoke staining is visible on the plasterboard wall above Specimen 5 (Photograph 11). The E-Flex insulation around the pipe of Specimen 1 continues to swell with a split in the lagging, thermocouples #6 and #7 appear detached from the lagging.

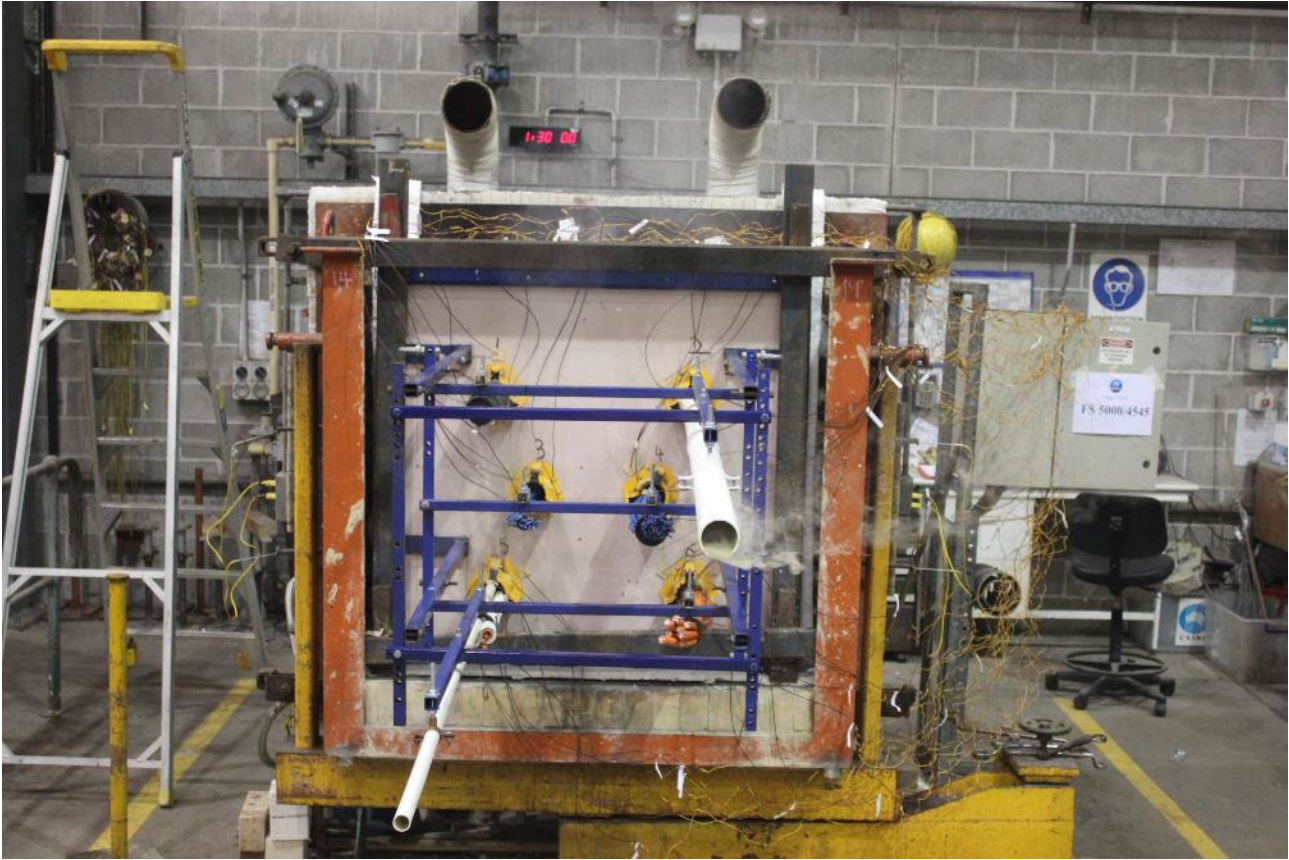
**PHOTOGRAPH 12 – SPECIMENS AFTER 90 MINUTES OF TESTING**

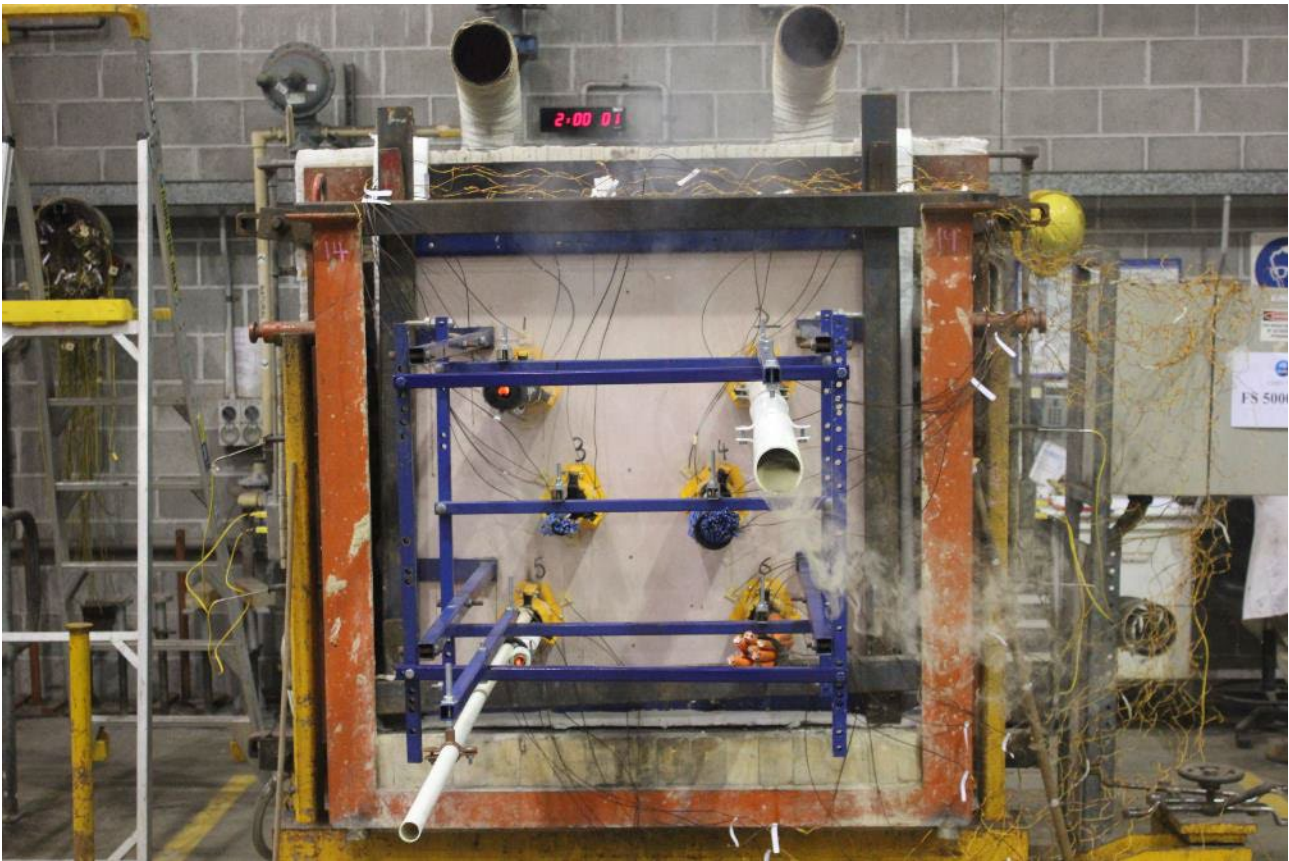
**PHOTOGRAPH 13 – SPECIMENS AFTER 120 MINUTES OF TESTING**

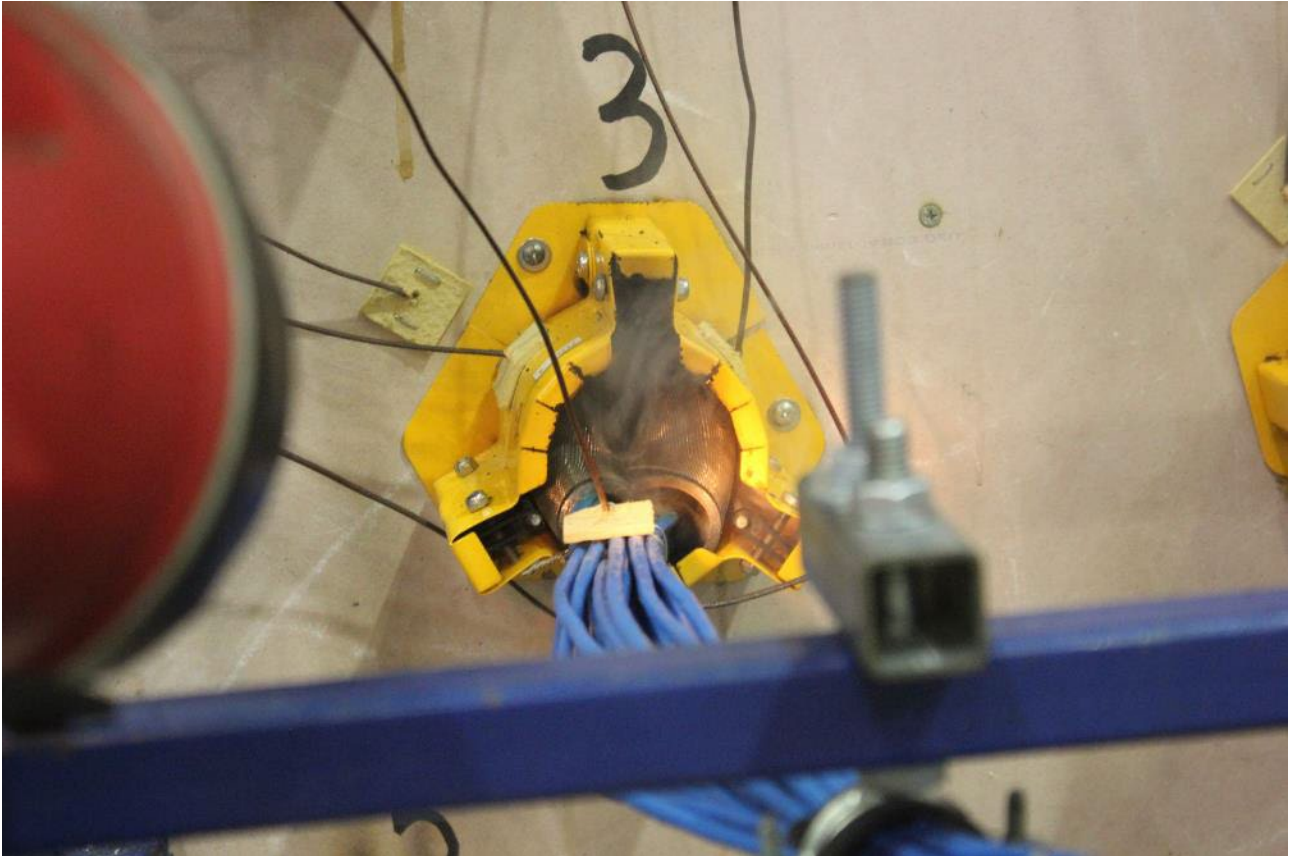
**PHOTOGRAPH 14 – SPECIMEN 3 AFTER 138 MINUTES OF TESTING**

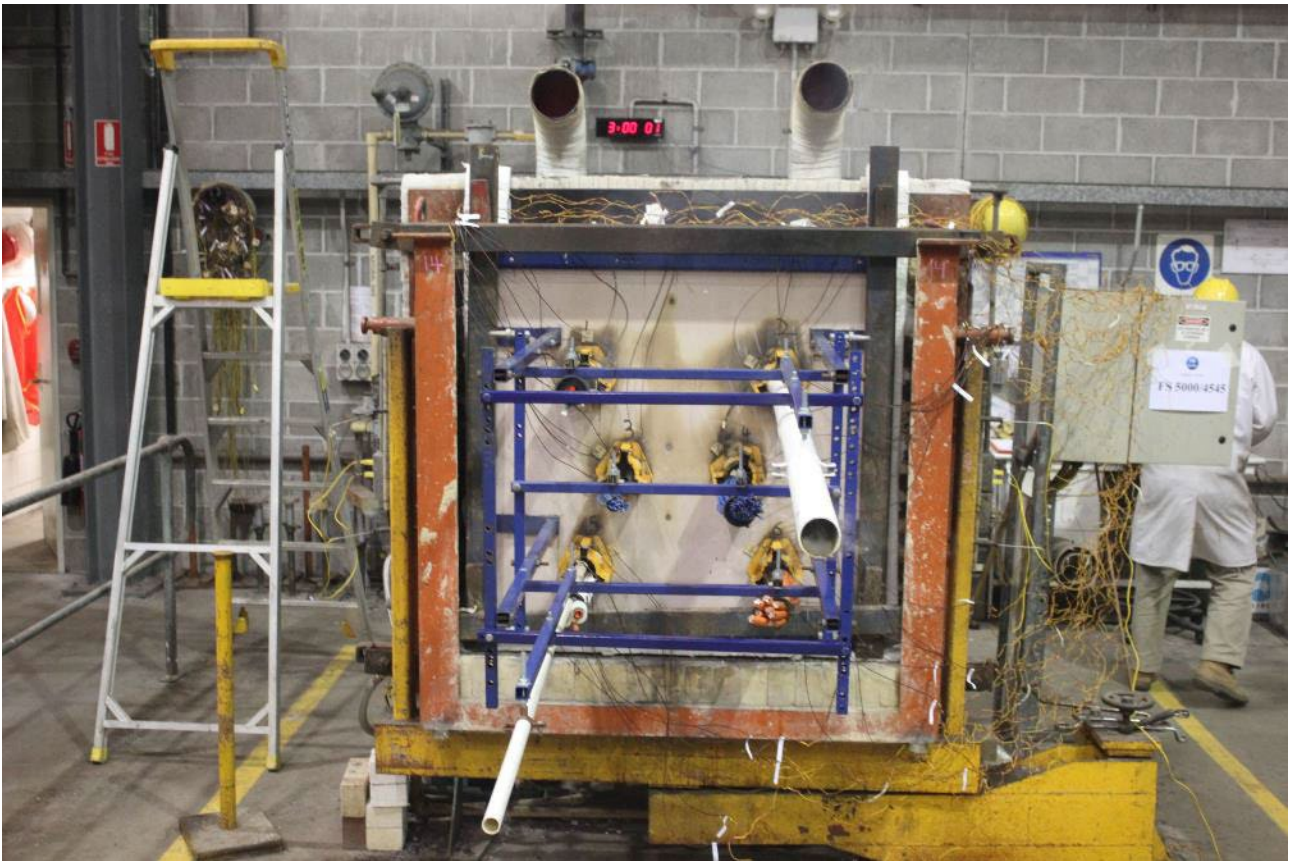
**PHOTOGRAPH 15 – SPECIMENS AFTER 180 MINUTES OF TESTING**

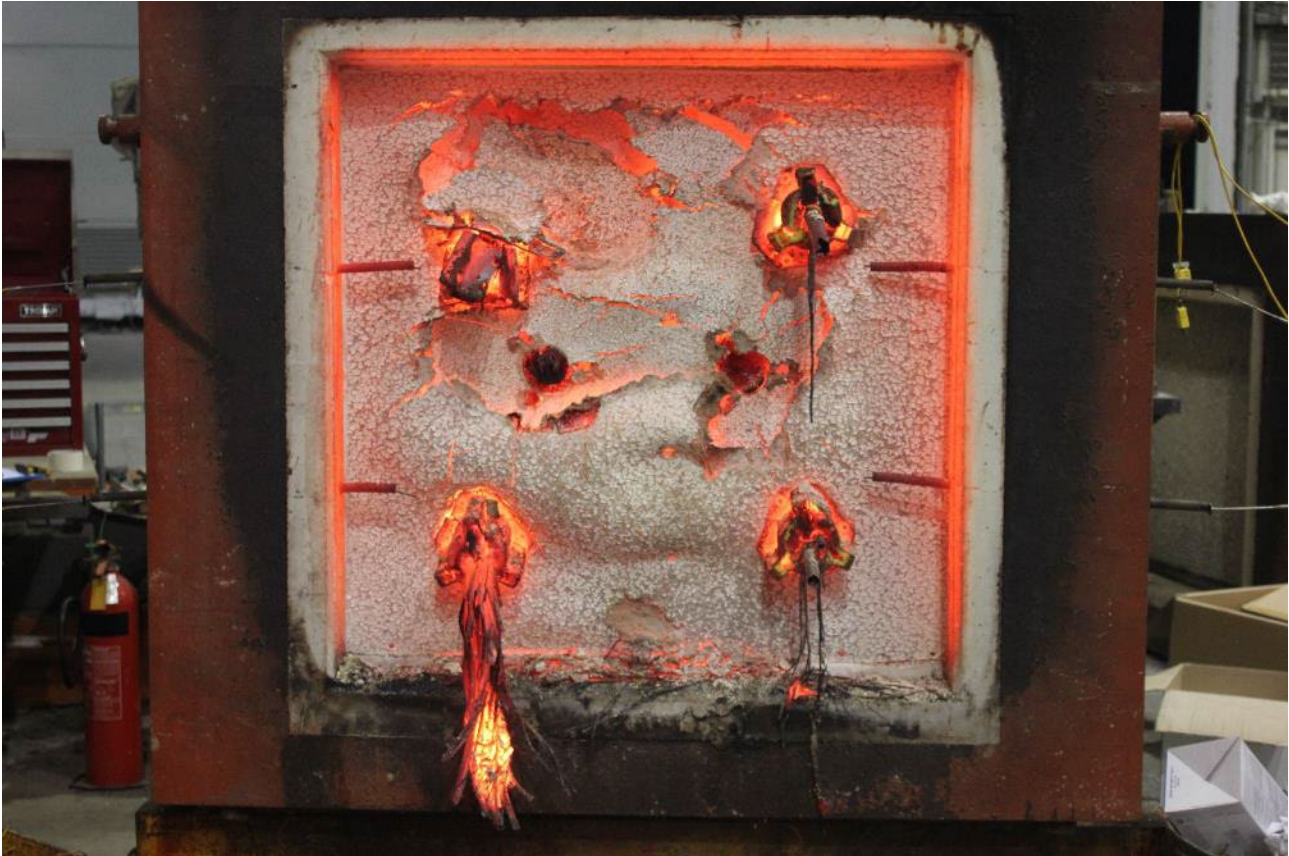
**PHOTOGRAPH 16 – EXPOSED FACE OF SPECIMENS AT CONCLUSION OF TESTING**

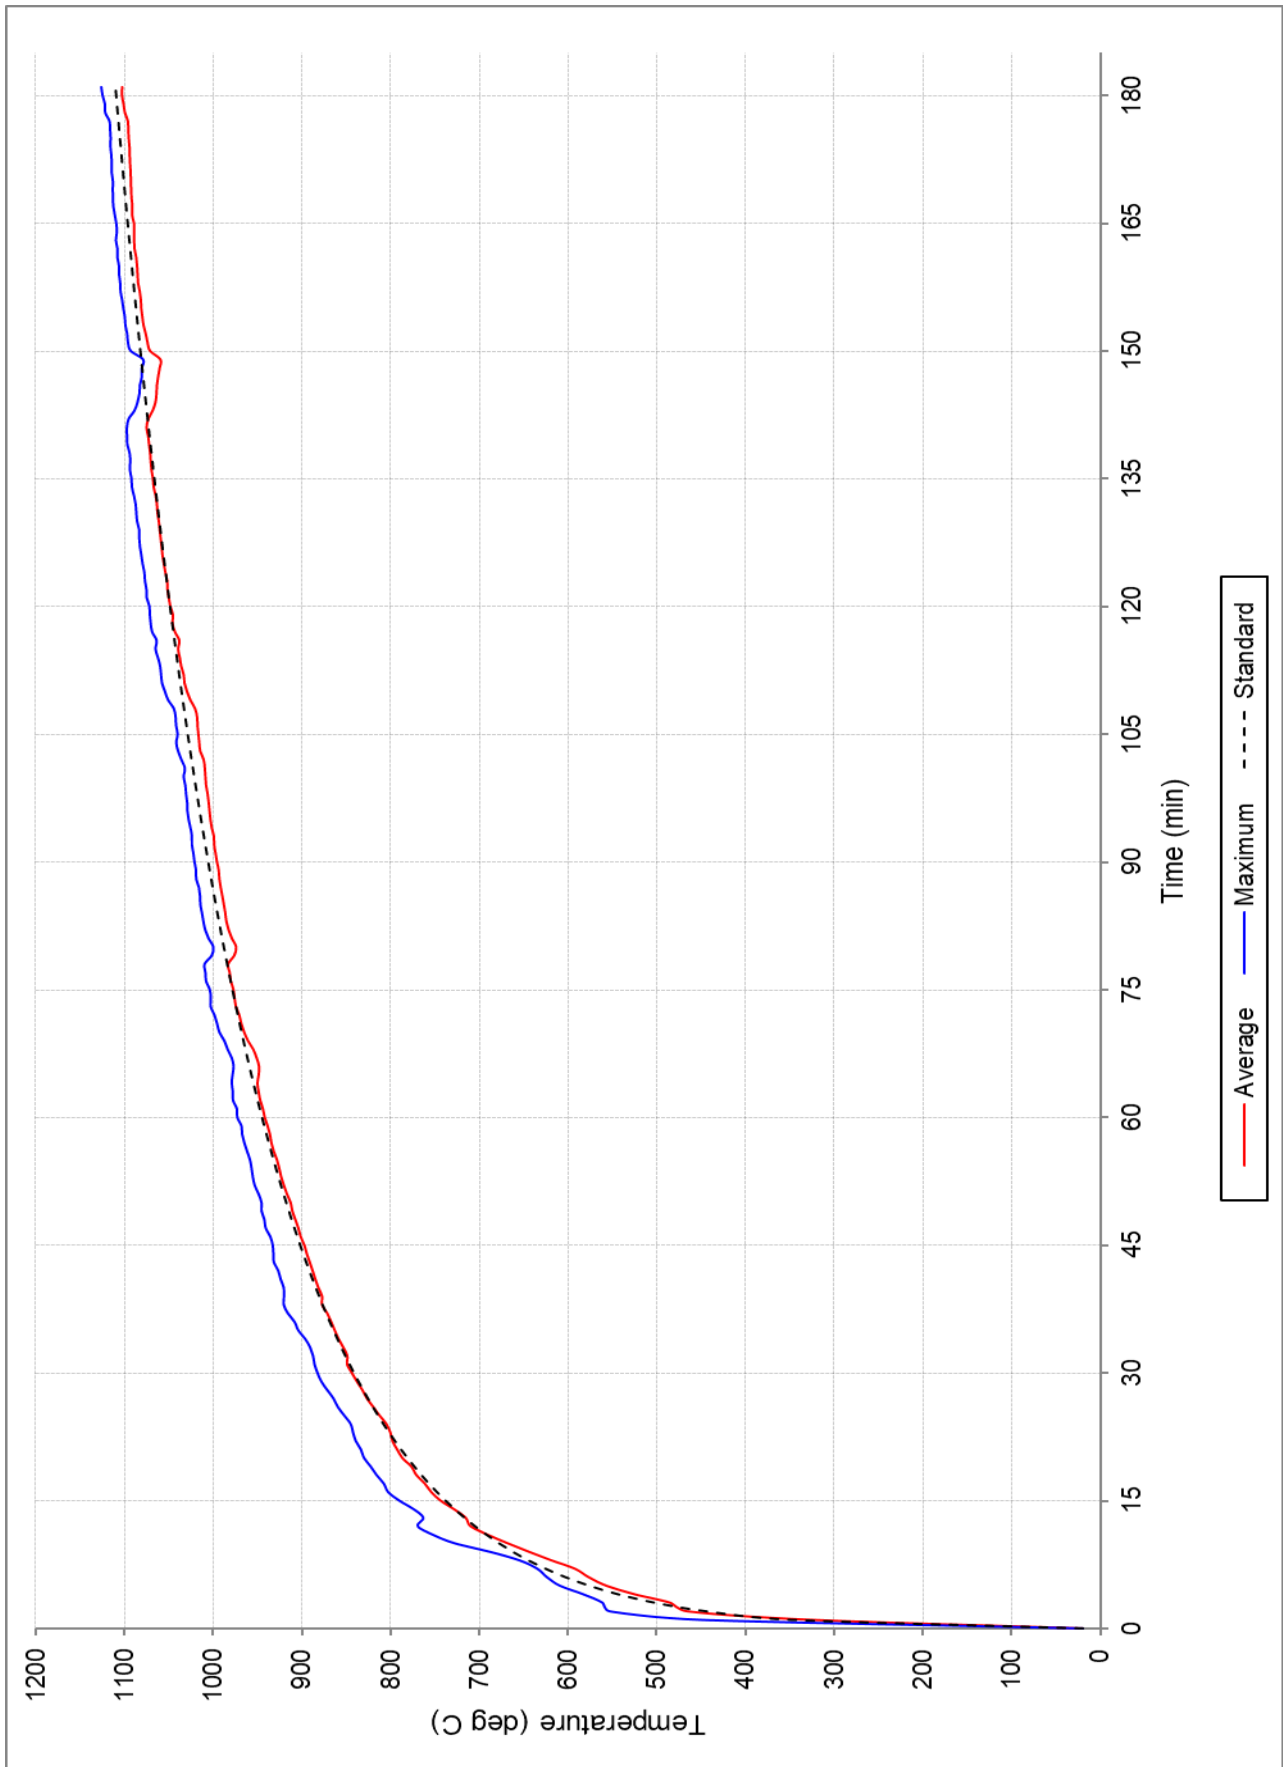
**FIGURE 1 – FURNACE TEMPERATURE**

Figure 1 shows the standard curves of temperature versus time for heating the furnace chamber and the actual curves of average and maximum temperature versus time recorded during the heating period.

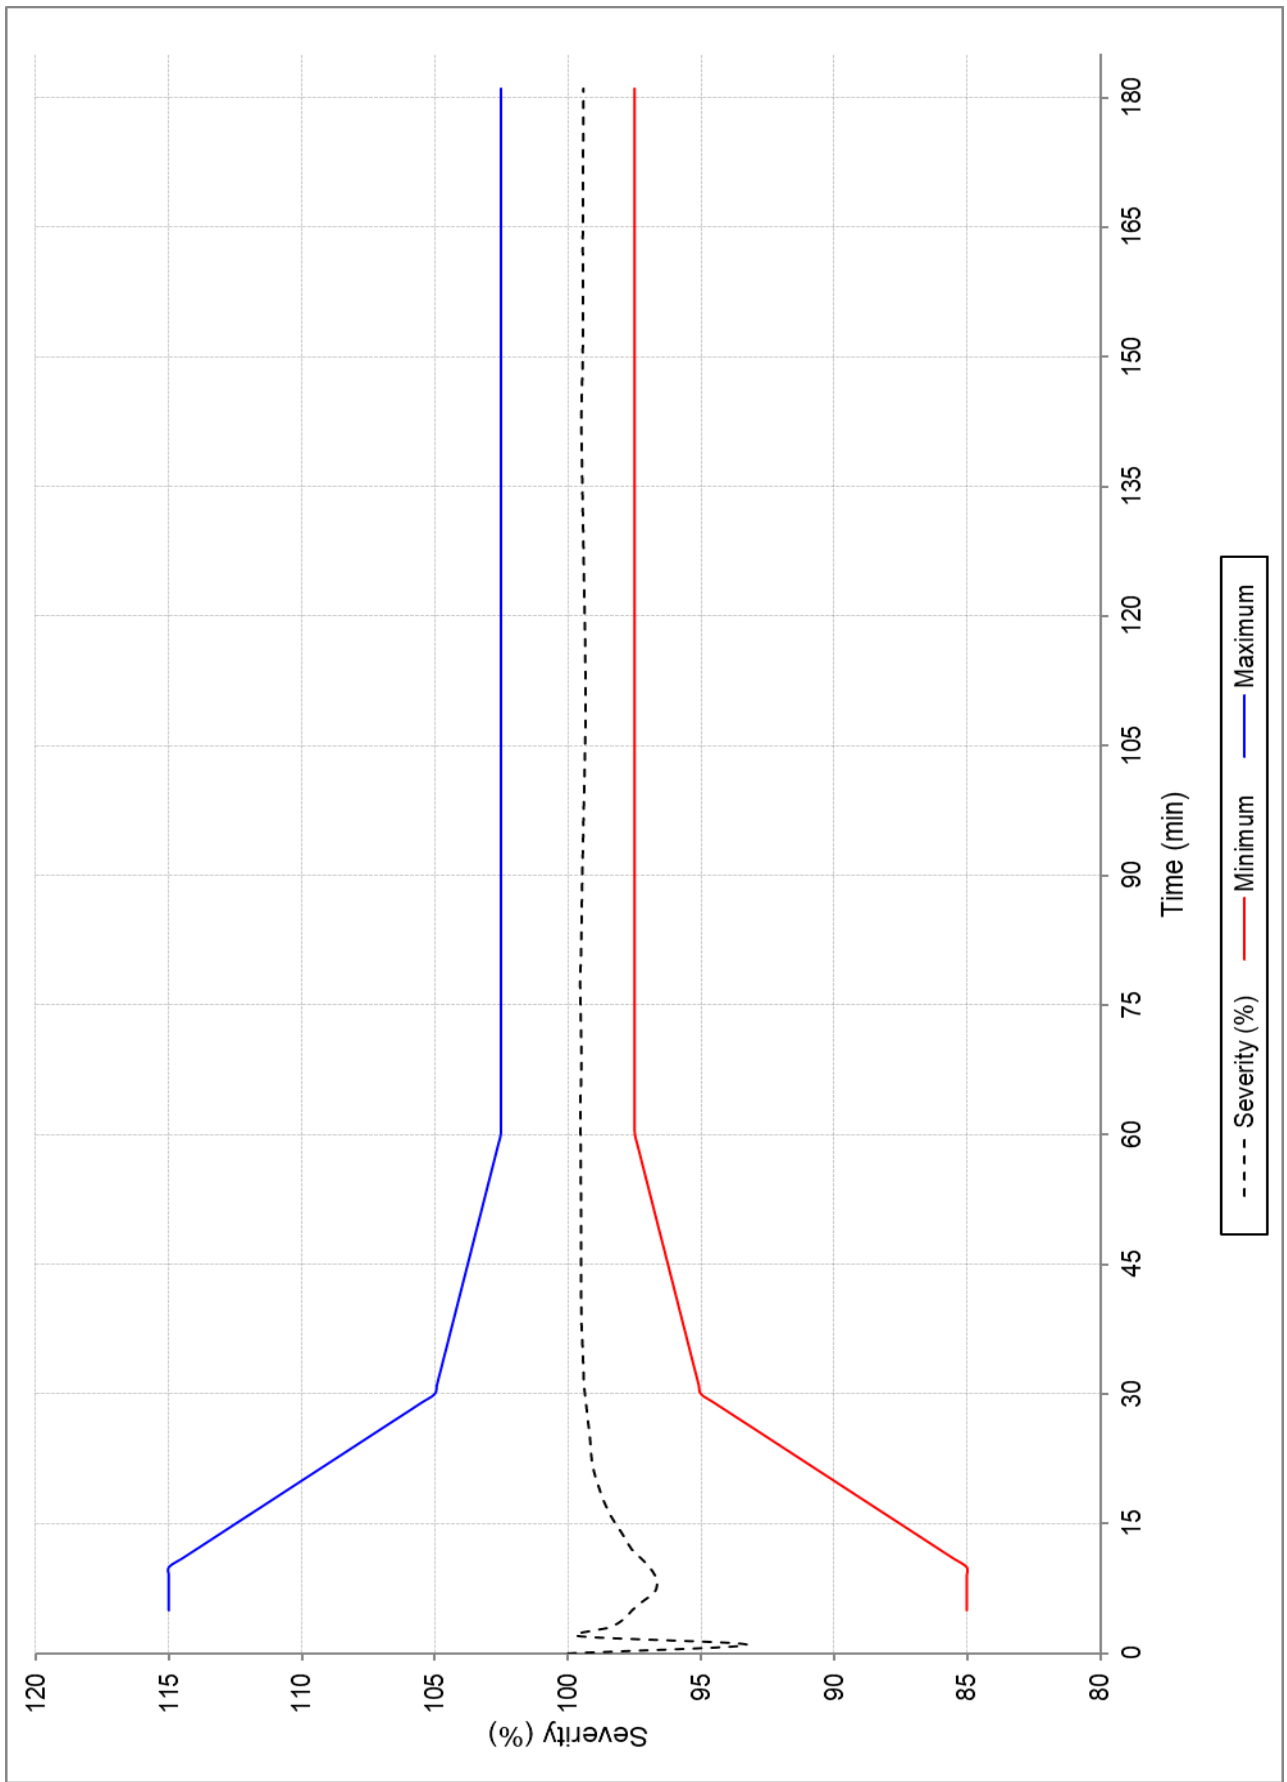
FIGURE 2 – FURNACE SEVERITY

Figure 2 shows the curve of furnace severity versus time during the heating period.
