# Fire-resistance test on retrofit fire collars protecting a plasterboard wall penetrated by services

## Test Report

**Author:** Peter Gordon  
**Report number:** FSP 2126 Revision C  
**Date:** 20 July 2022  
**Client:** IG6 Pty Ltd as trustee for the IG6 IP Trust

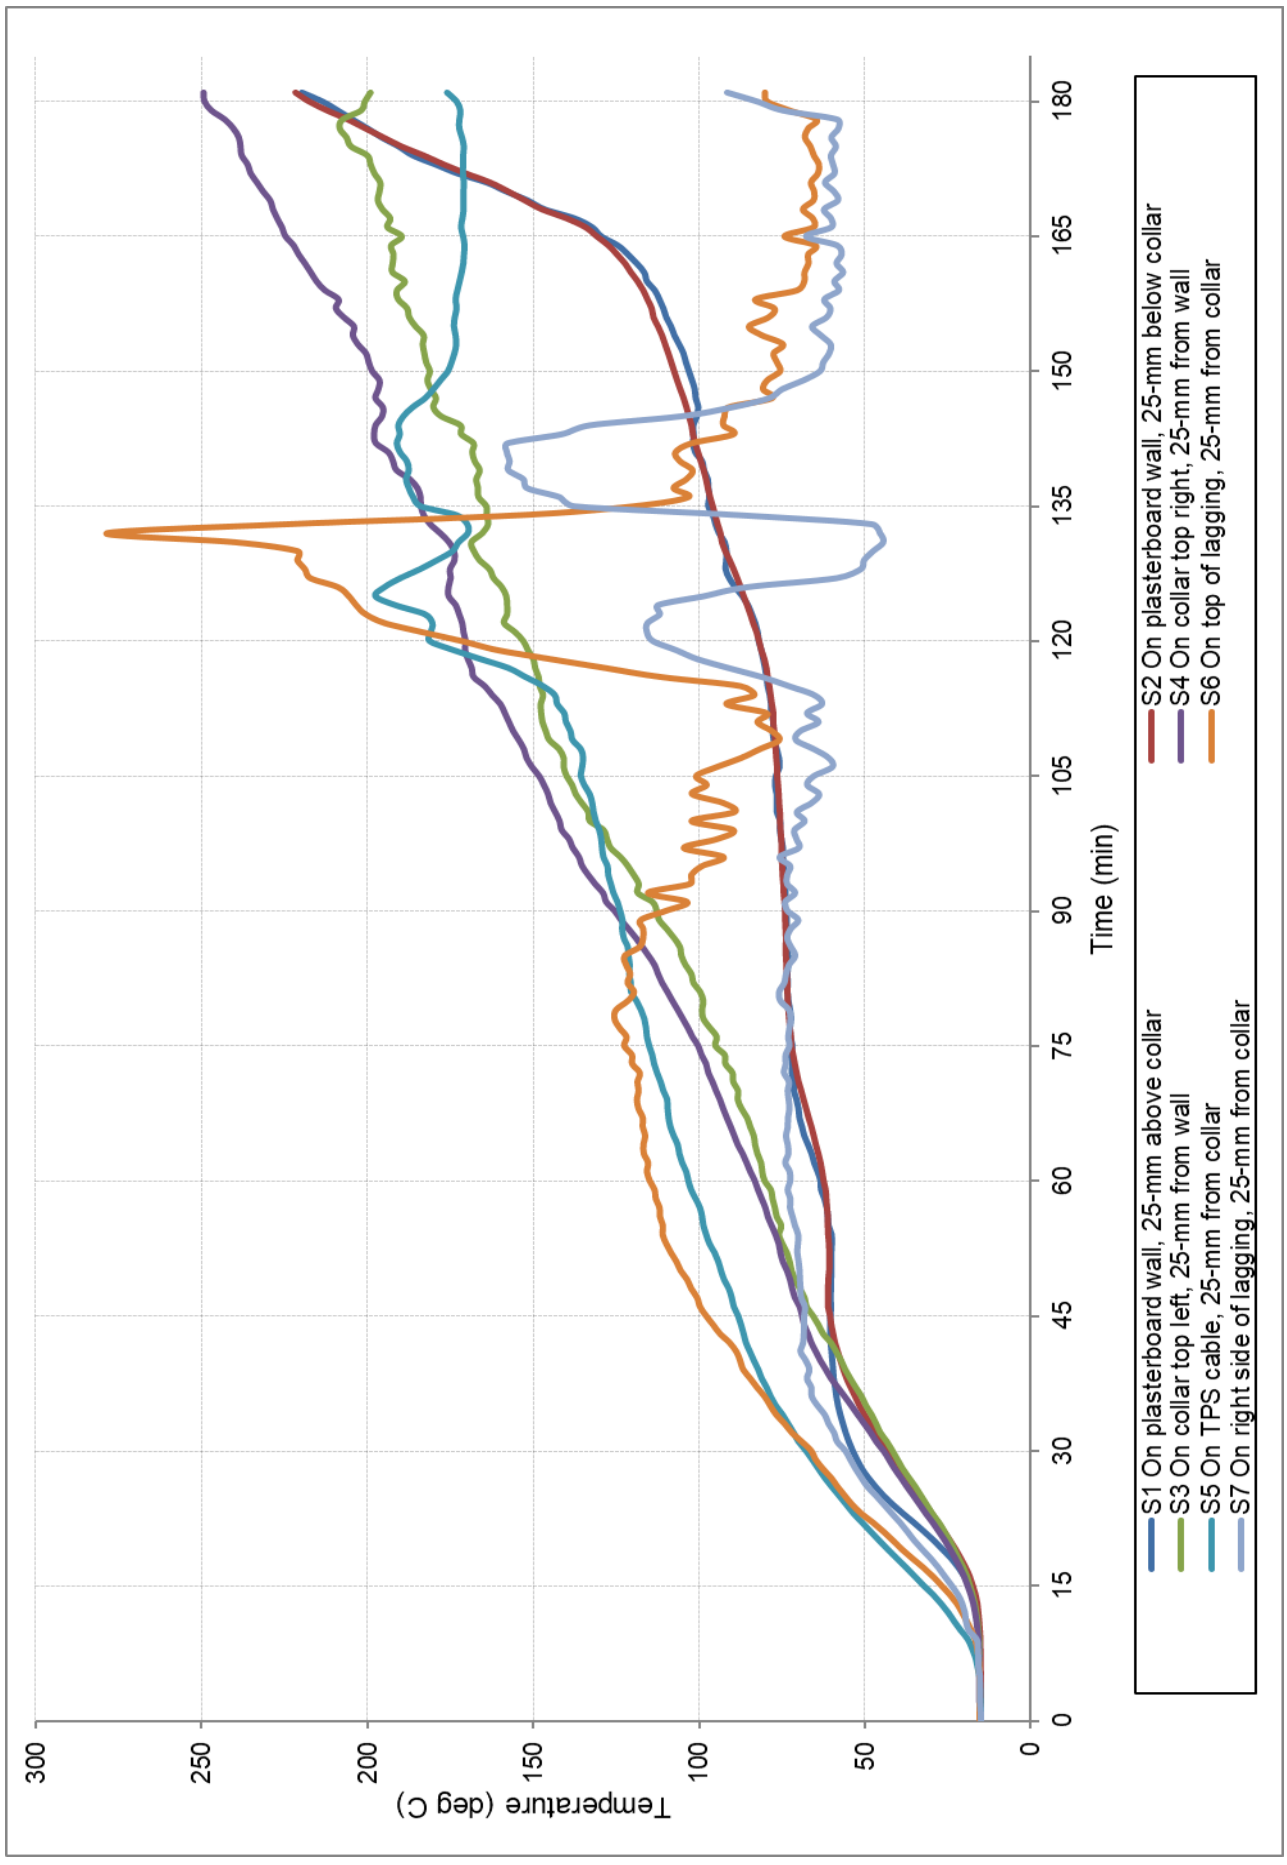
FIGURE 3 - TEMPERATURE VERSUS TIME ASSOCIATED WITH SPECIMEN #1

Figure 3 shows the curve of temperature versus time associated with Specimen 1.

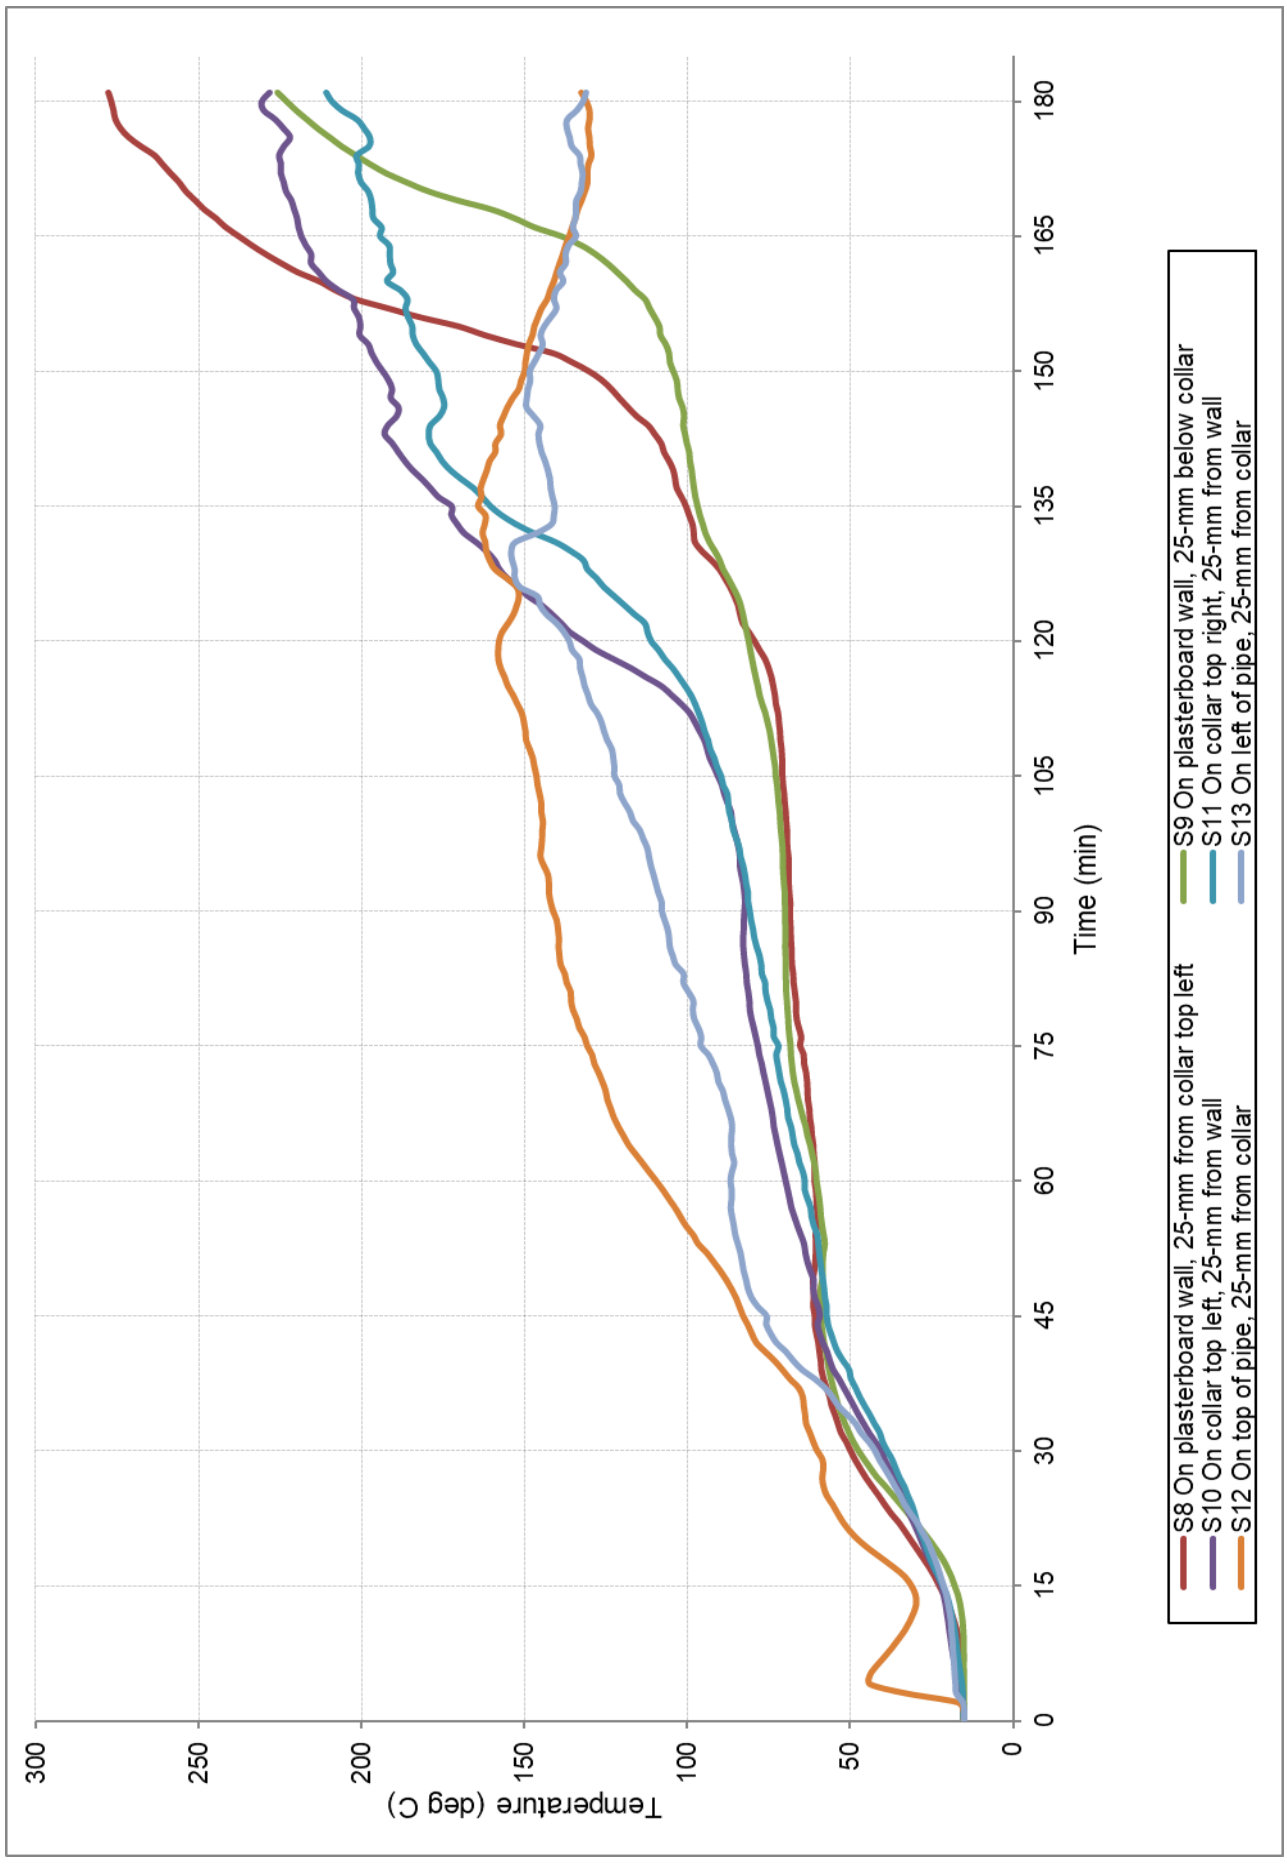
**FIGURE 4 - TEMPERATURE VERSUS TIME ASSOCIATED WITH SPECIMEN #2**

Figure 4 shows the curve of temperature versus time associated with Specimen 2.

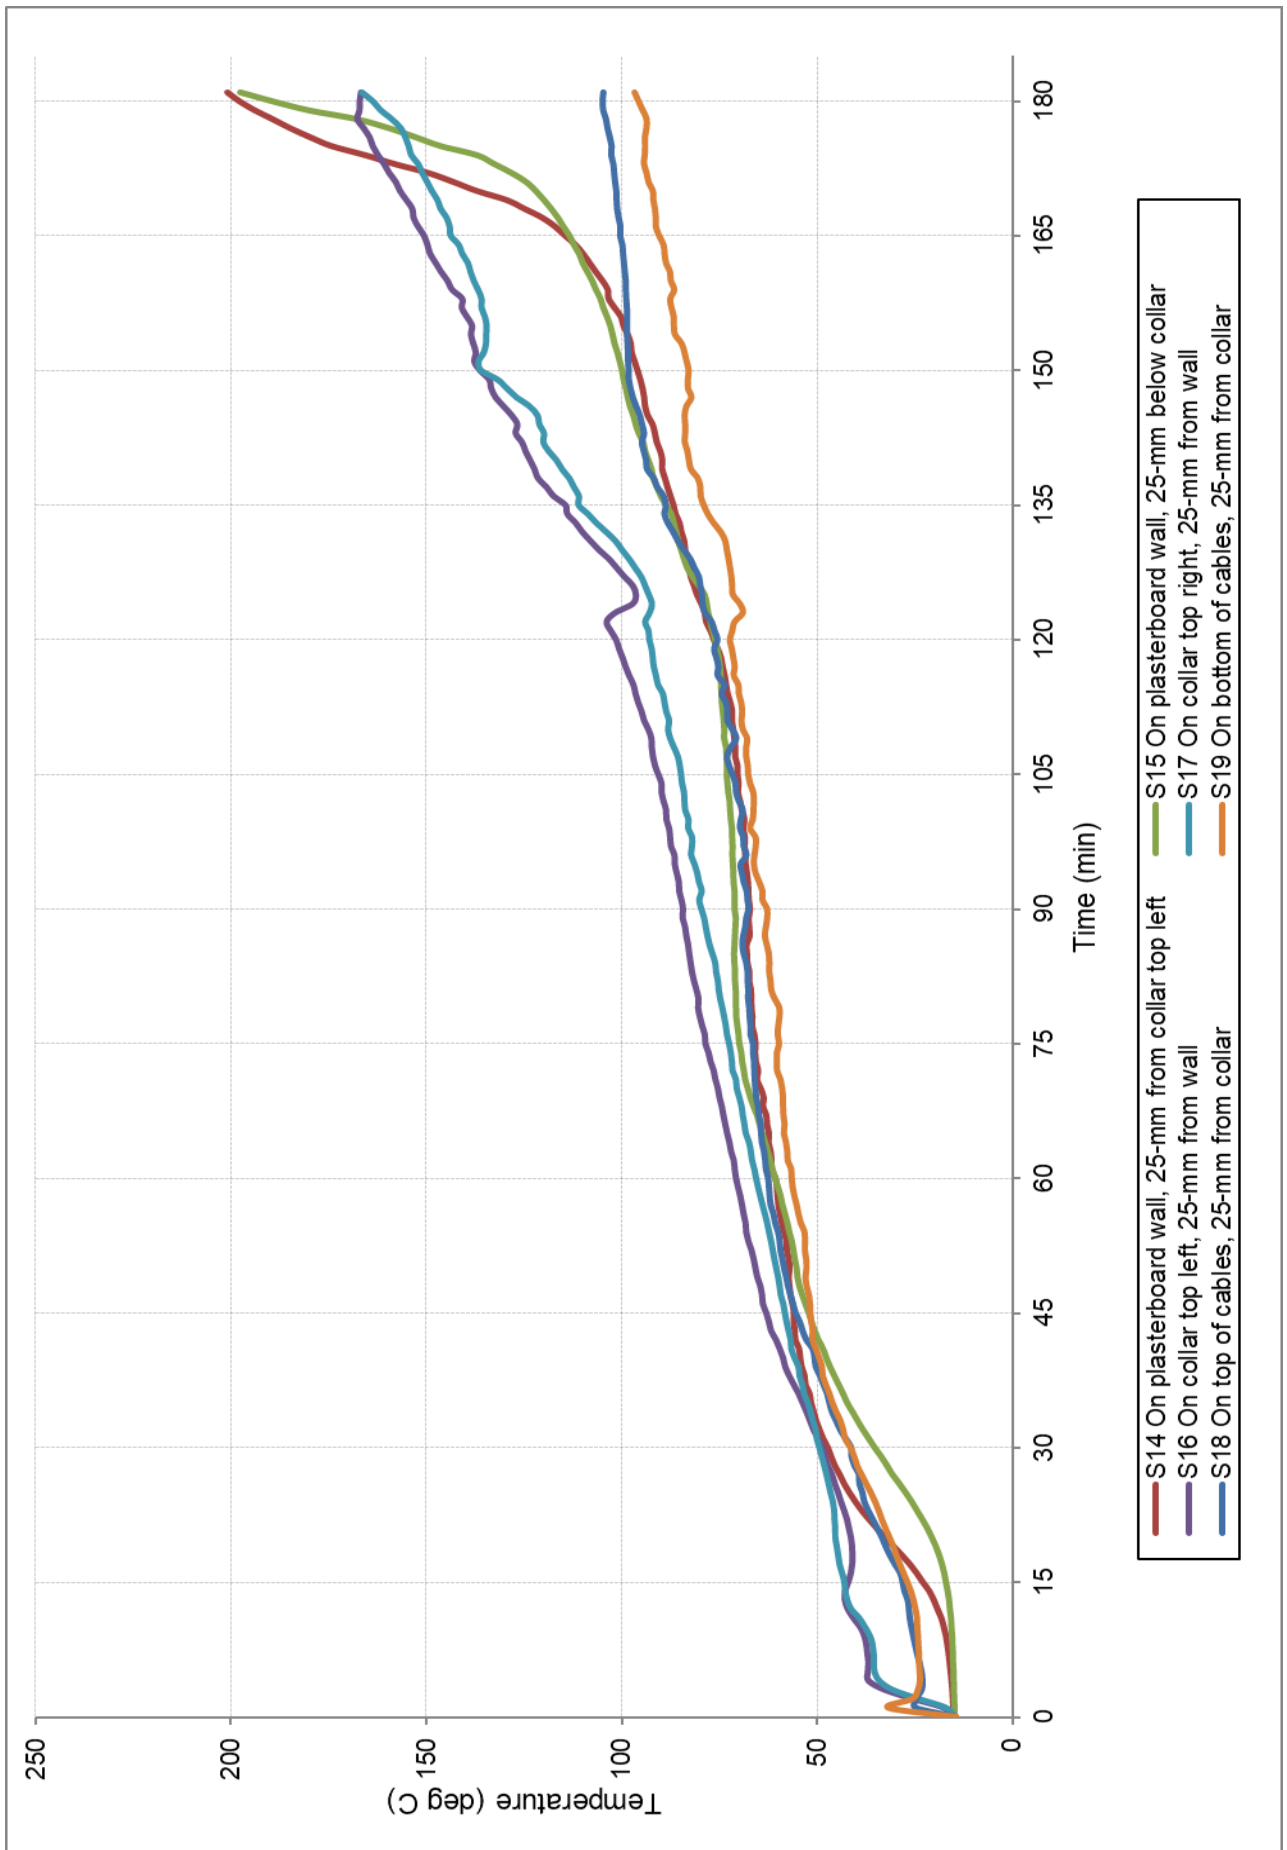
**FIGURE 5 - TEMPERATURE VERSUS TIME ASSOCIATED WITH SPECIMEN #3**

Figure 5 shows the curve of temperature versus time associated with Specimen 3.

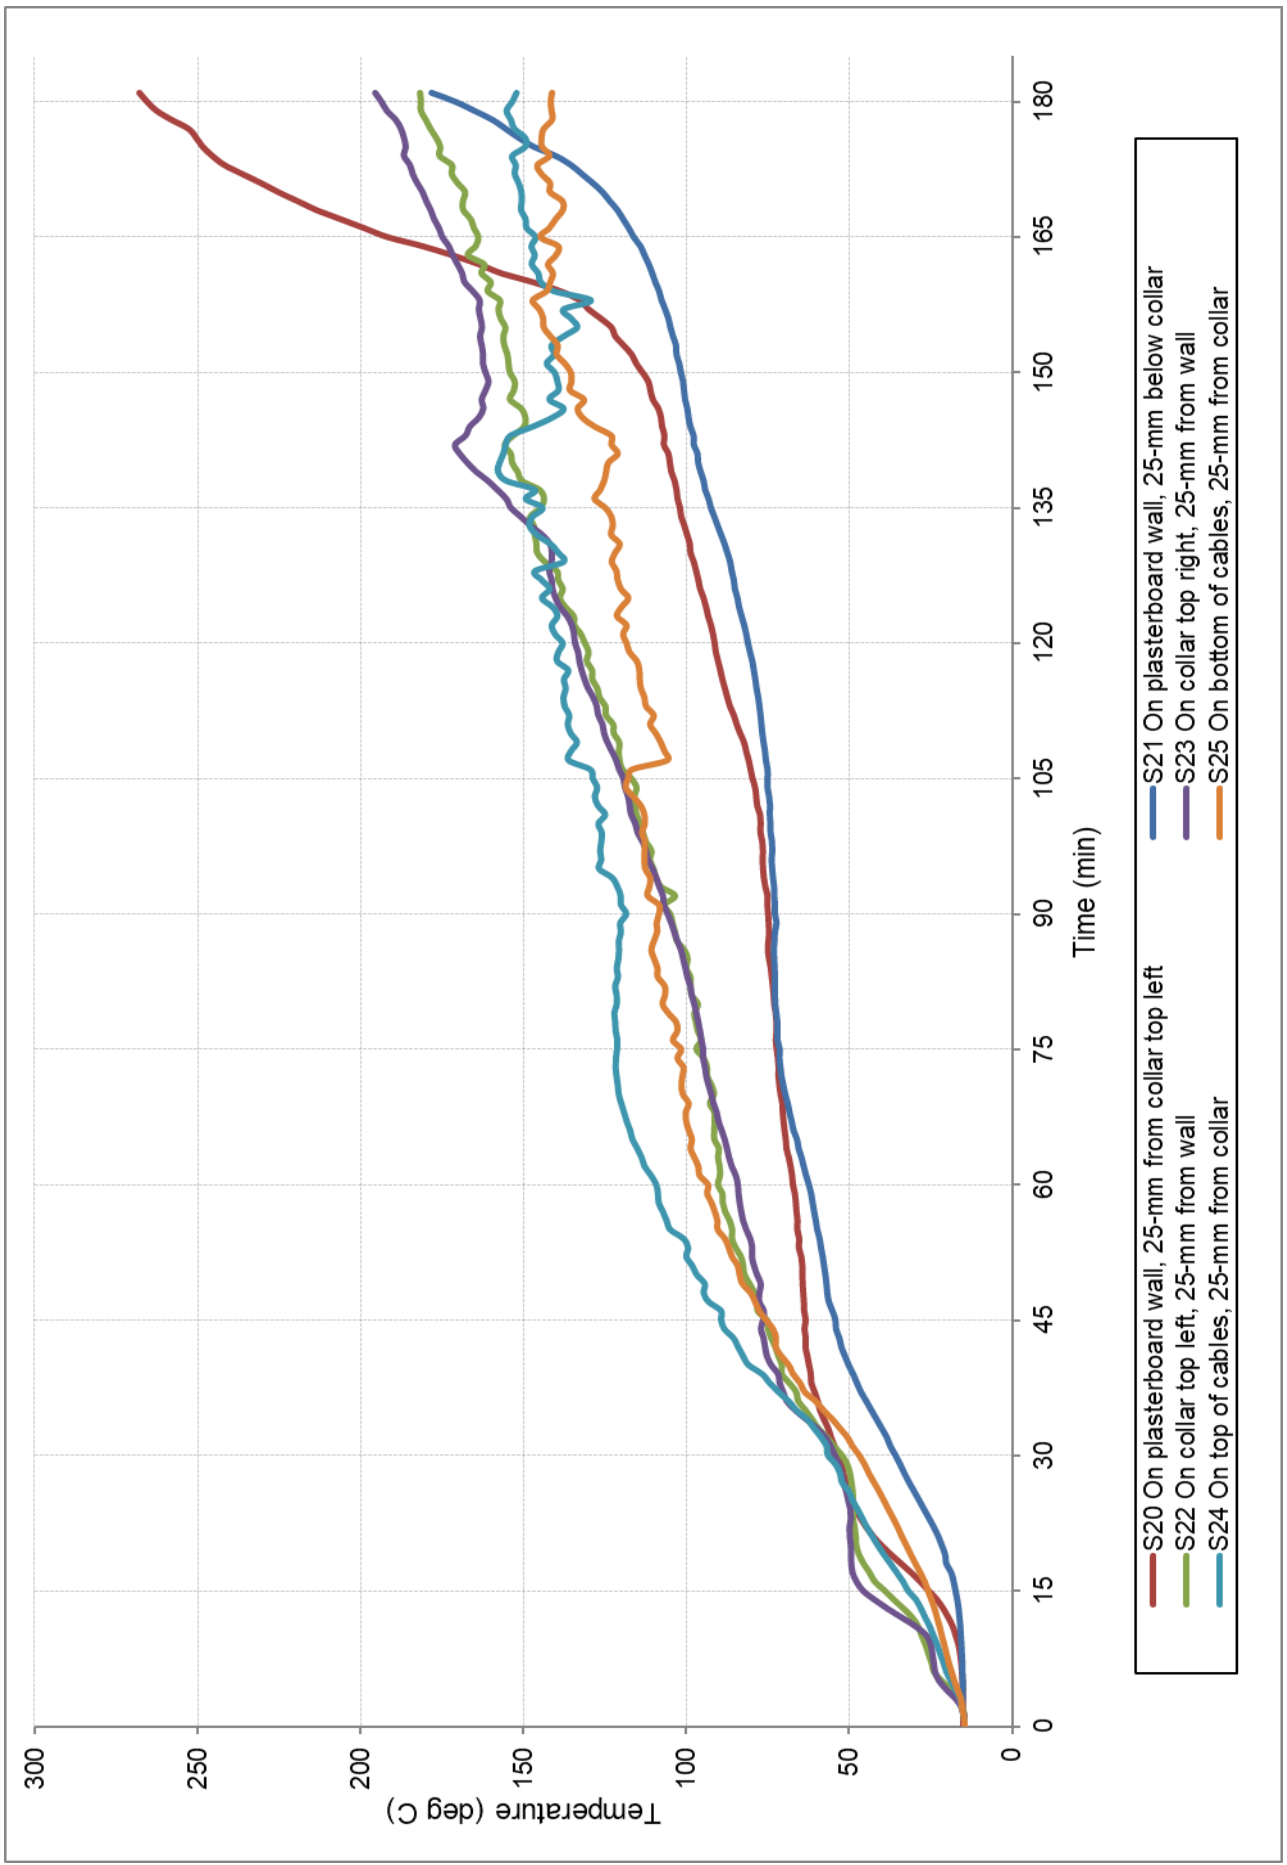
FIGURE 6 - TEMPERATURE VERSUS TIME ASSOCIATED WITH SPECIMEN #4

Figure 6 shows the curve of temperature versus time associated with Specimen 4.

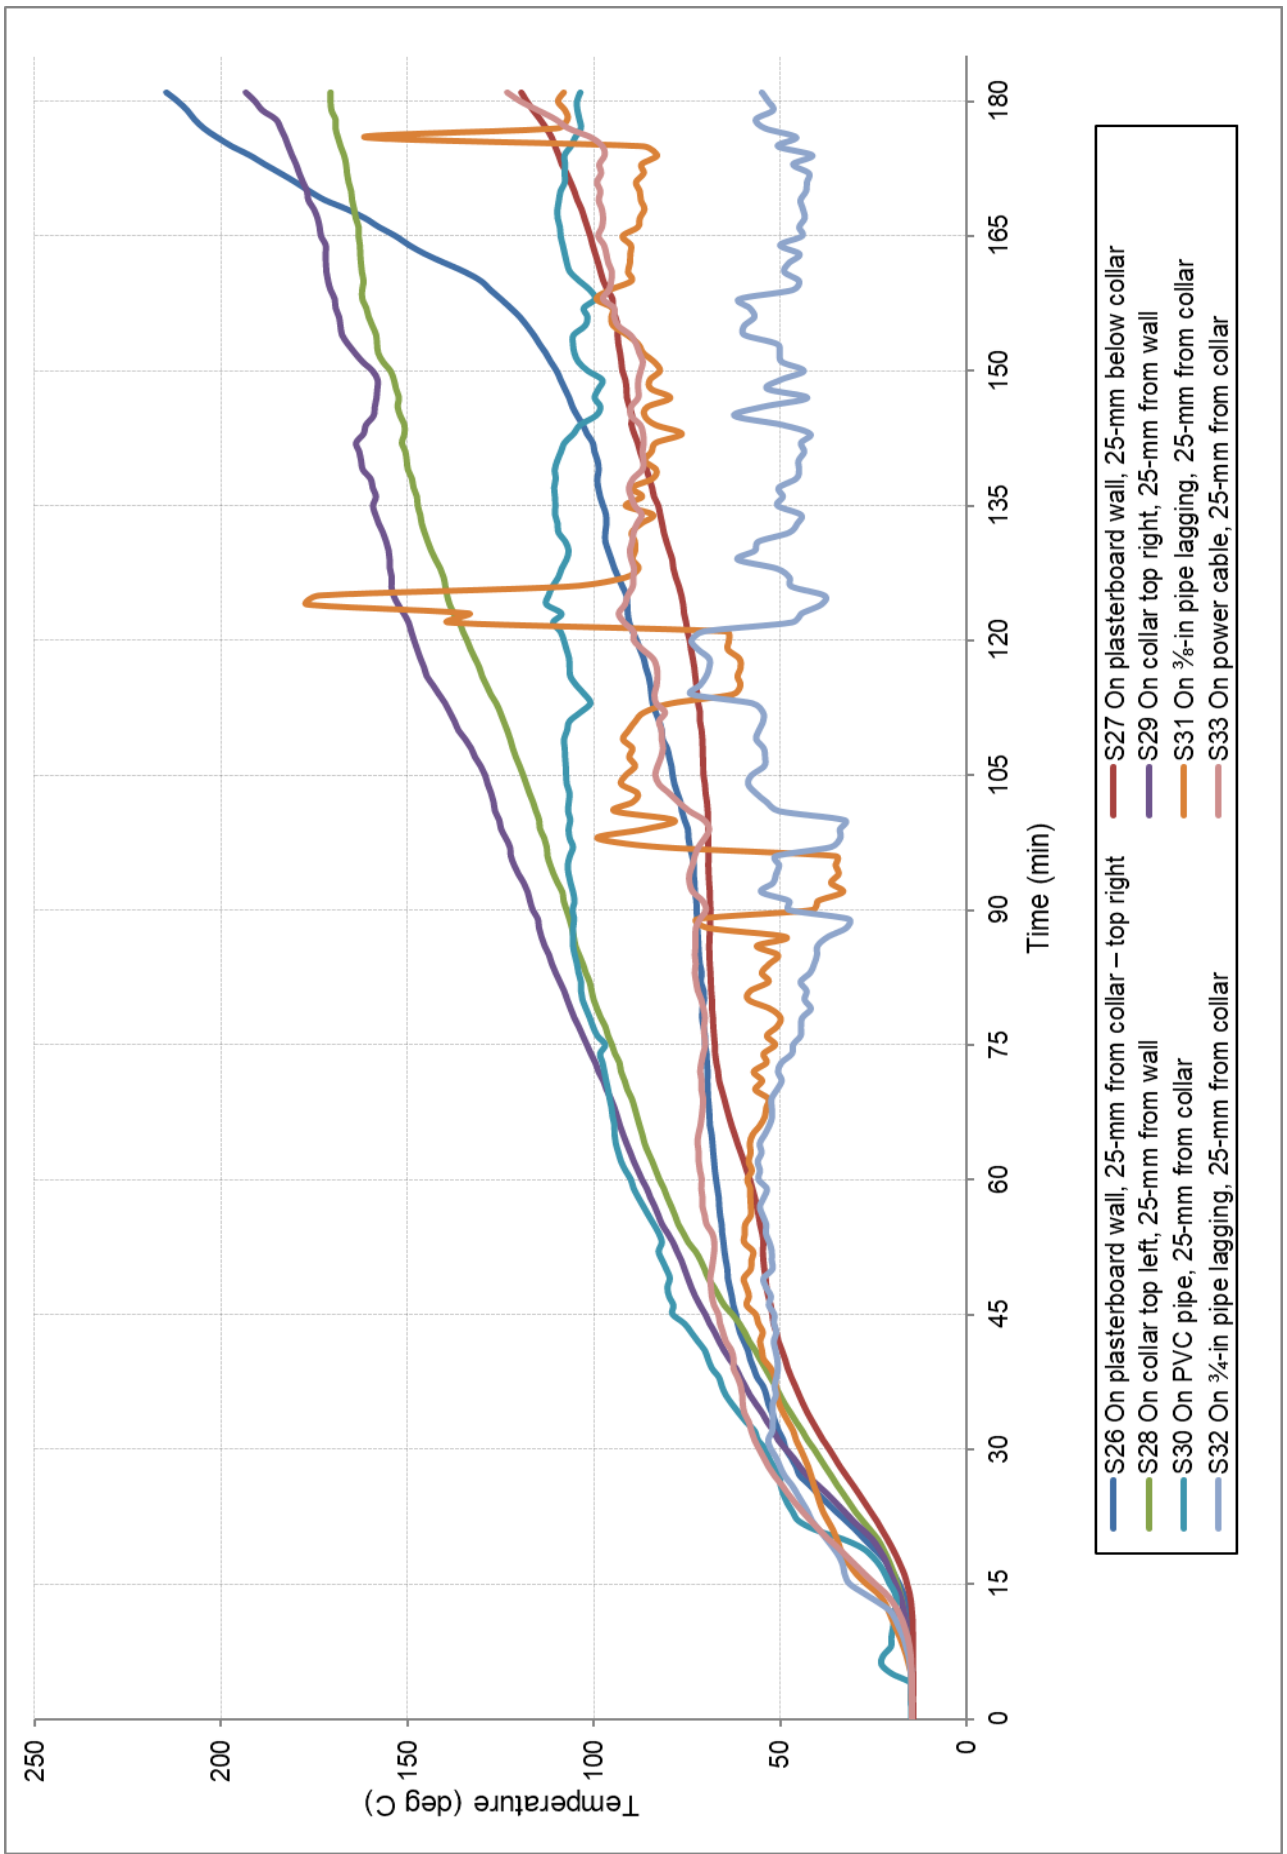
FIGURE 7 - TEMPERATURE VERSUS TIME ASSOCIATED WITH SPECIMEN #5

Figure 7 shows the curve of temperature versus time associated with Specimen 5.

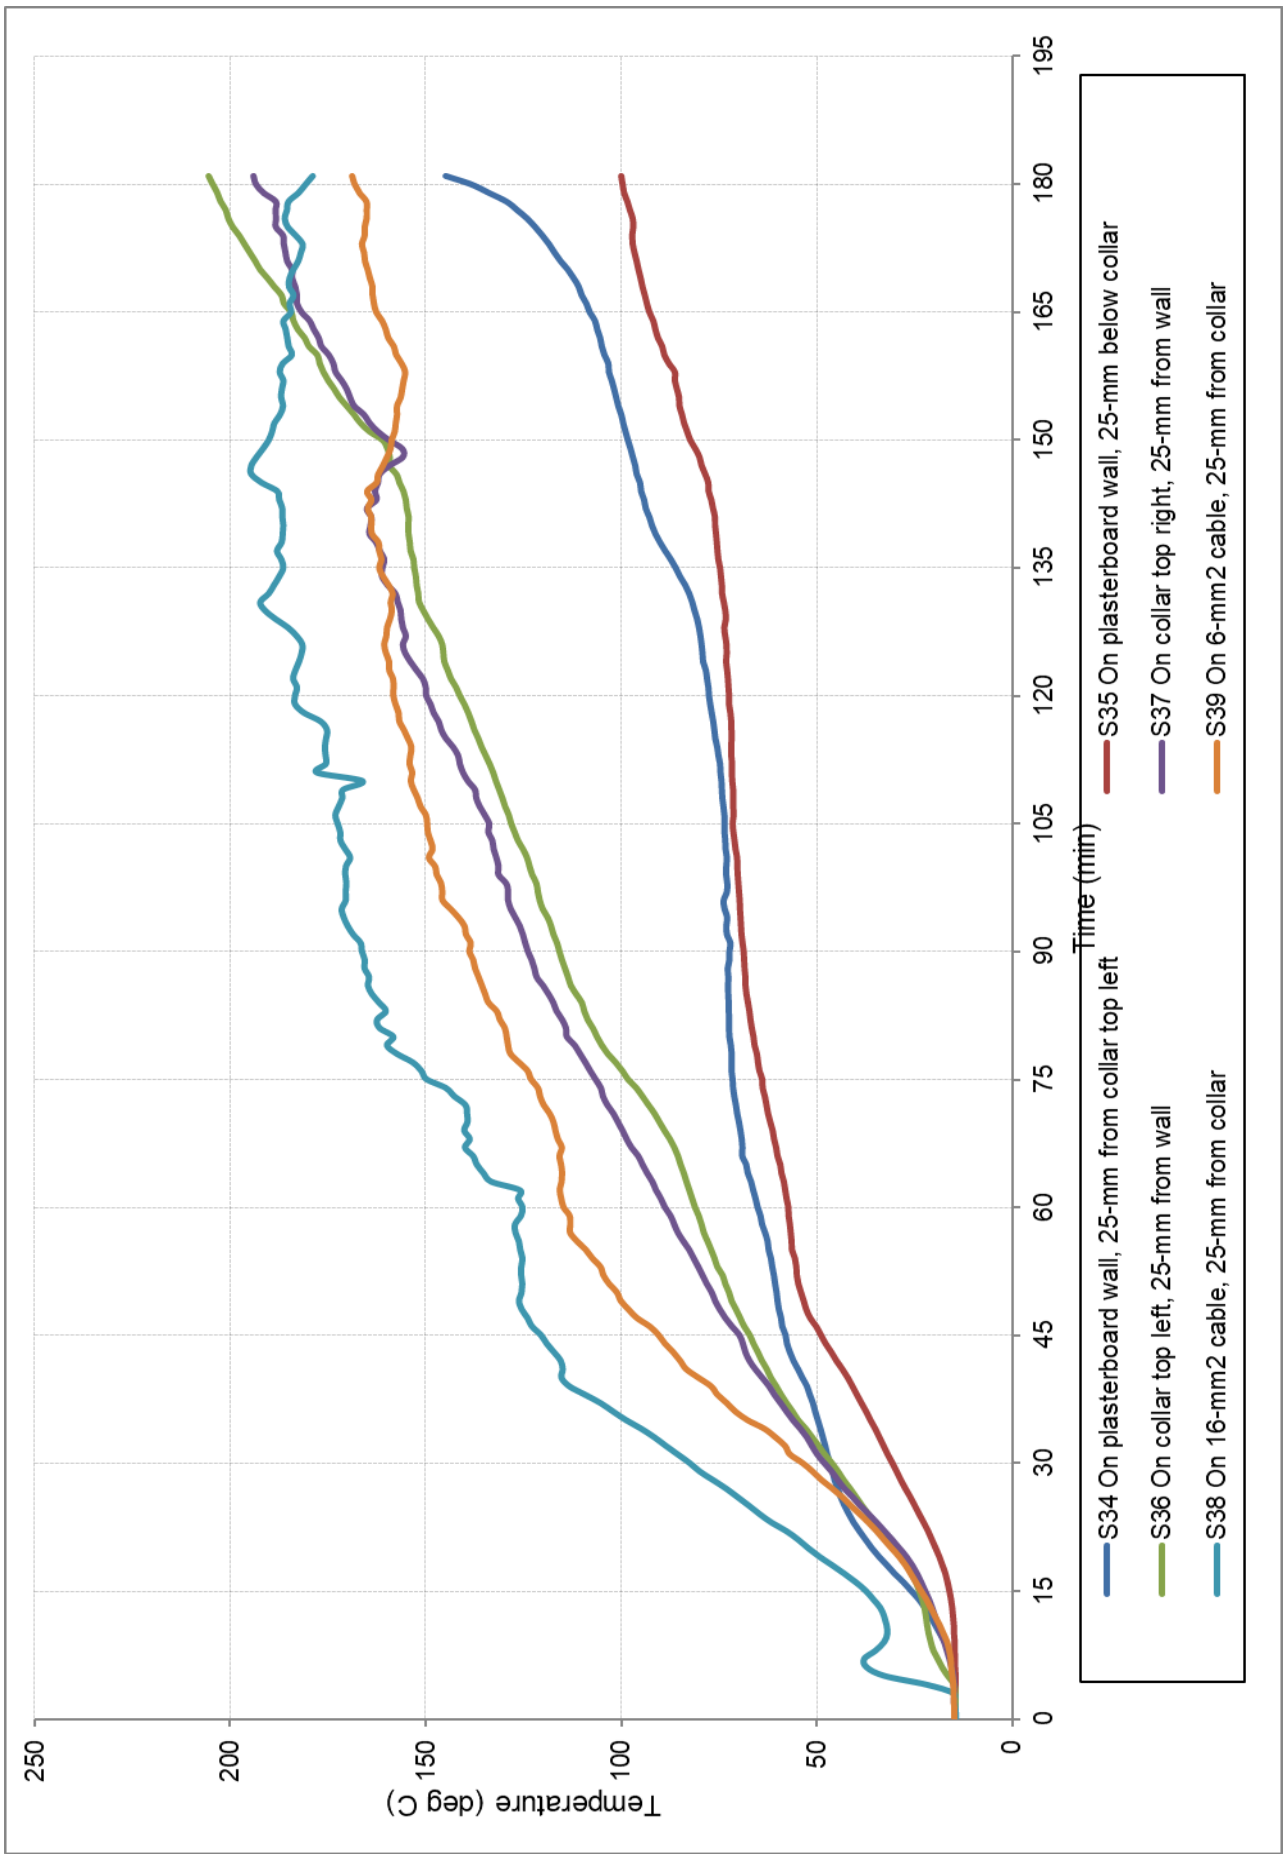
**FIGURE 8 - TEMPERATURE VERSUS TIME ASSOCIATED WITH SPECIMEN #6**

Figure 8 shows the curve of temperature versus time associated with Specimen 6.

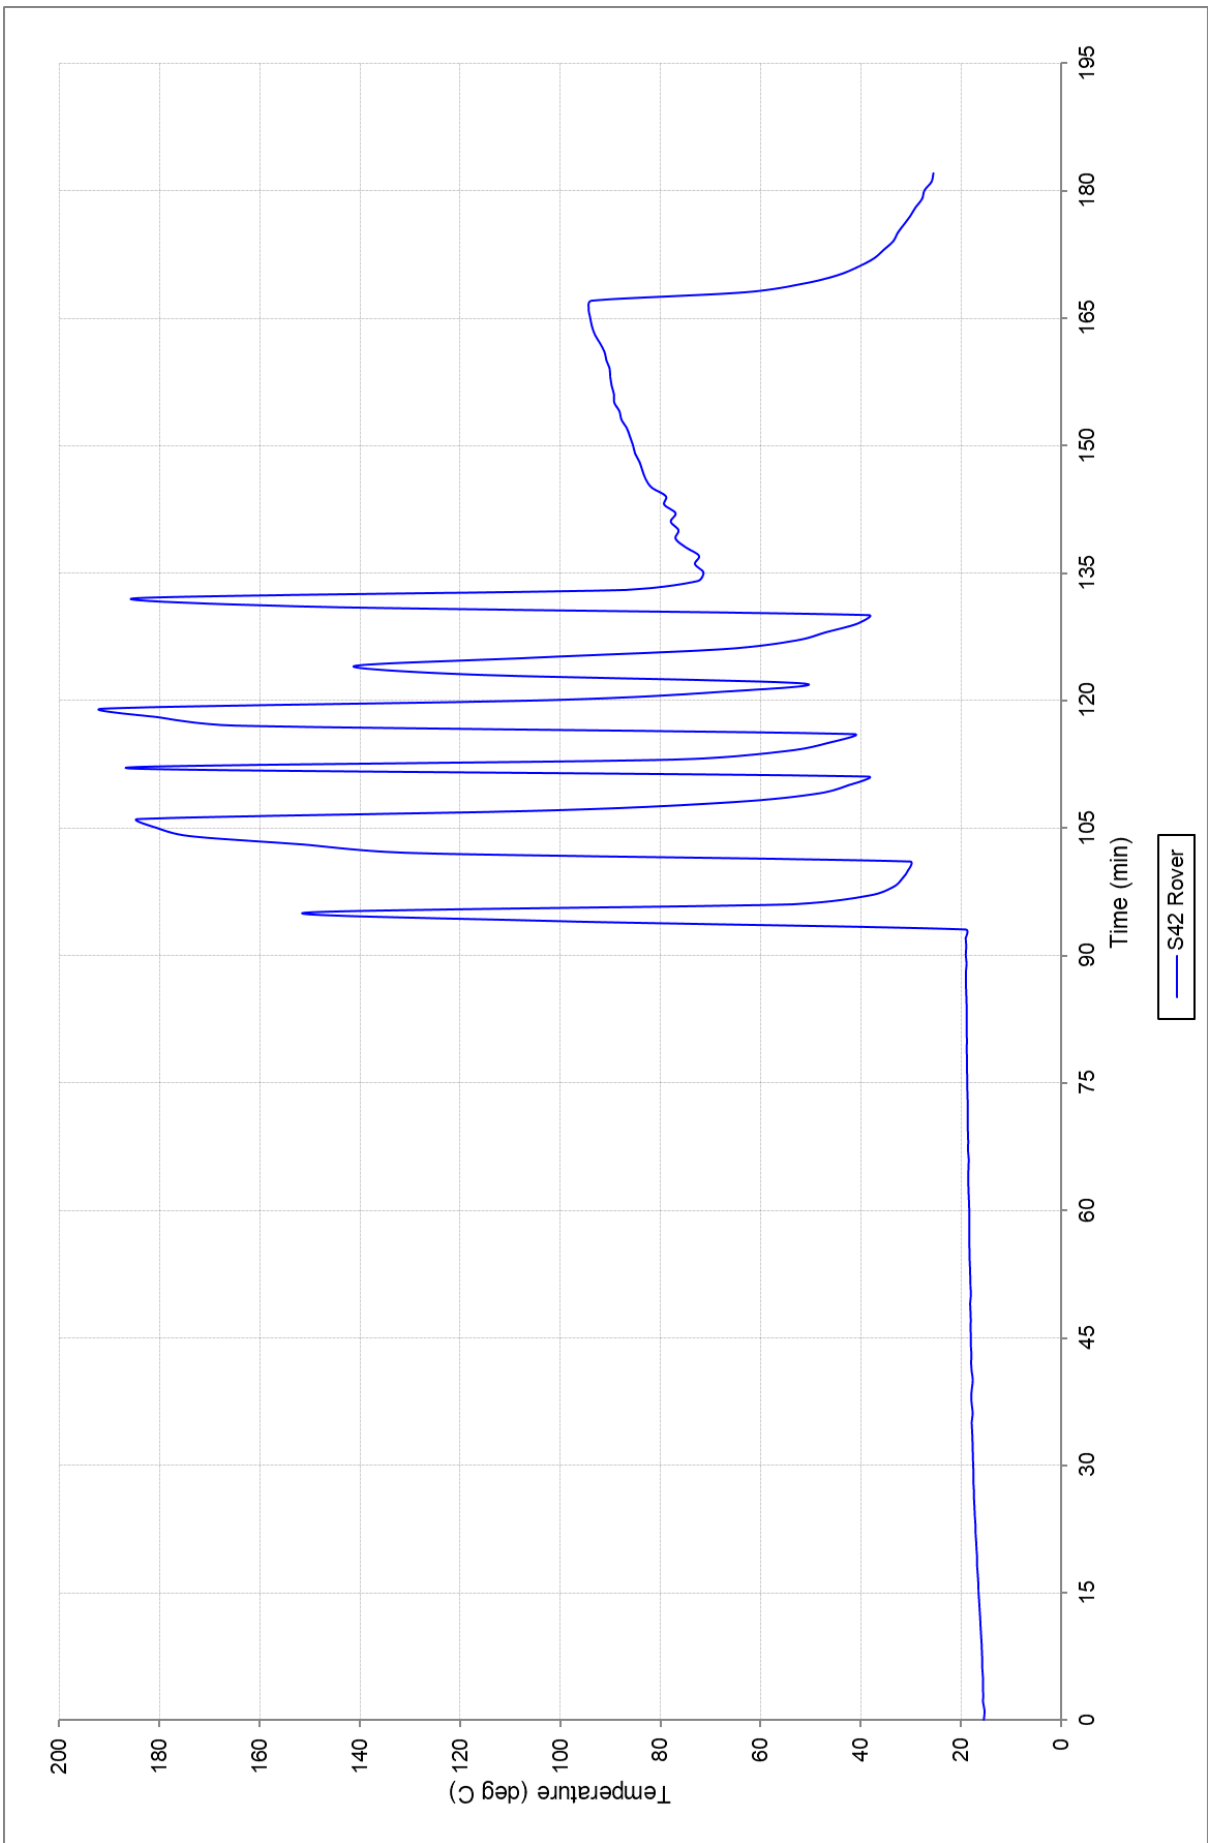
**FIGURE 9 - TEMPERATURE VERSUS TIME ASSOCIATED WITH THE ROVING THERMOCOUPLE**

Figure 9 shows the curve of temperature versus time associated with the roving thermocouple.

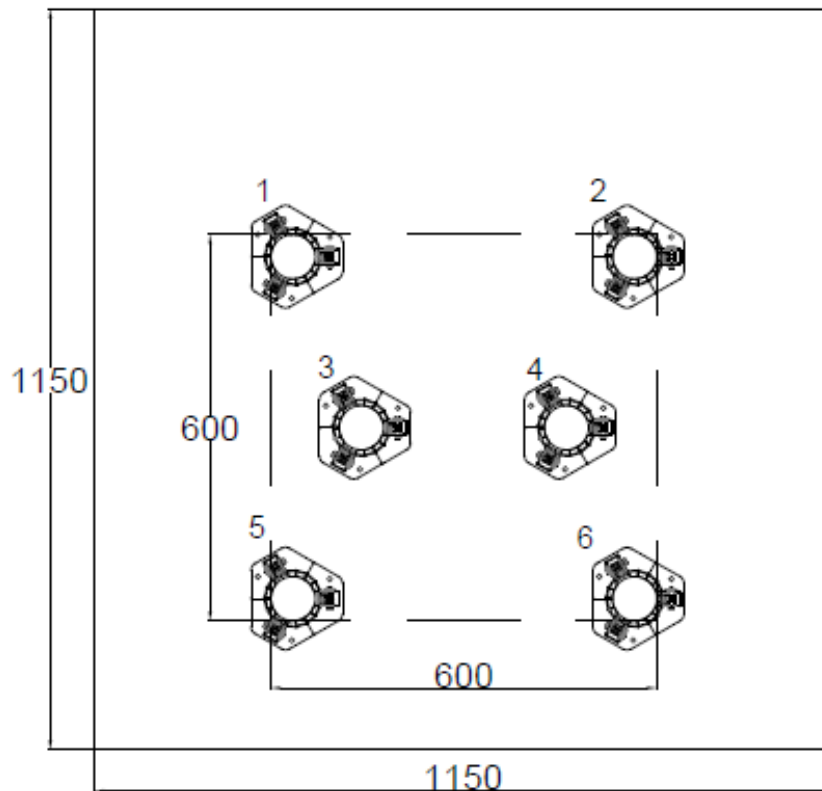
Test Wall W-20-G Layout

Penetration	Collar Code	Pipe Type	Pipe Diameter
1	MS70R	Copper Tube with F/R lagging and TPS cable	1in(19mm Lagging) & 2.5mm <sup>2</sup> 3C
2	MS70R	Medium Duty PVC Conduit with Orange Power Cables	50, 2x(16mm <sup>2</sup> 3C+E) & 2x(6mm <sup>2</sup> 3C+E)
3	MS70R	20xCat5e Cables	
4	MS70R	100xCat5e Cables	
5	MS70R	Copper pair coil lagged in non-F/R lagging, 3 core+E round power cable and pressure PVC	3/8 & 3/4 in (9mm Lagging), 2.5mm <sup>2</sup> 3C+E, 25mm
6	MS70R	Orange Power Cables	3x(6mm <sup>2</sup> 3C+E) & 6x(16mm <sup>2</sup> 3C+E)

**DRAWING TITLED "TEST WALL W-20-G LAYOUT, DATED 10 JUNE 2020, PROVIDED BY SNAP FIRE SYSTEMS PTY LTD.**

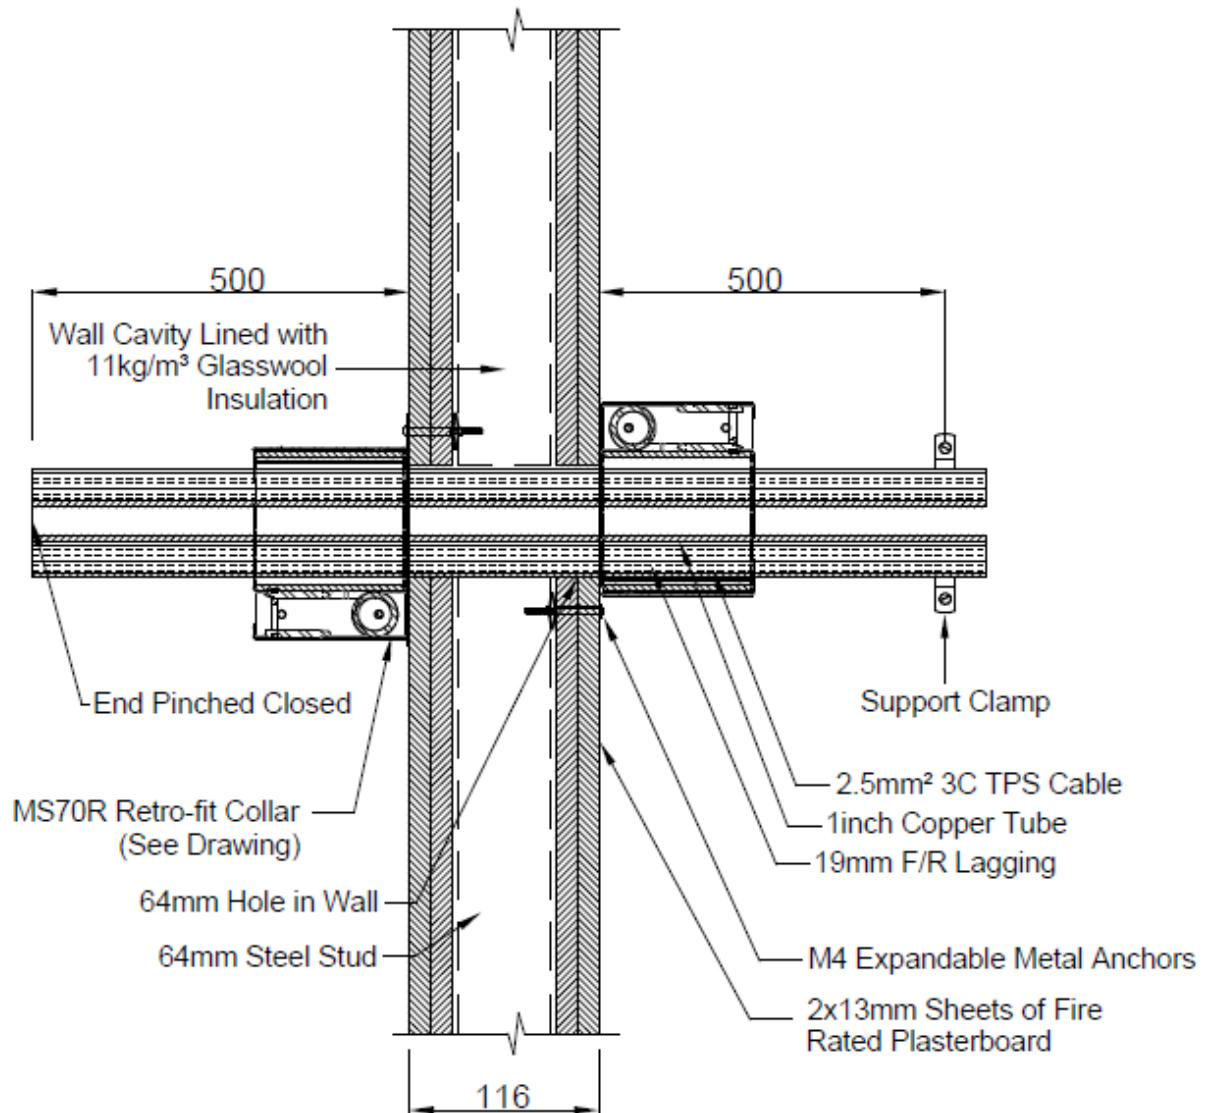
1inch Copper Tube with 19mm F/R Lagging,  
2.5mm<sup>2</sup> 3C TPS Cable & MS70R Collar

**DRAWING TITLED "SPECIMEN # 1 1INCH COPPER TUBE WITH 19MM F/R LAGGING, 3C TPS CABLE & MS70R COLLAR", DATED 11 JUNE 2020, PROVIDED BY SNAP FIRE SYSTEMS PTY LTD**

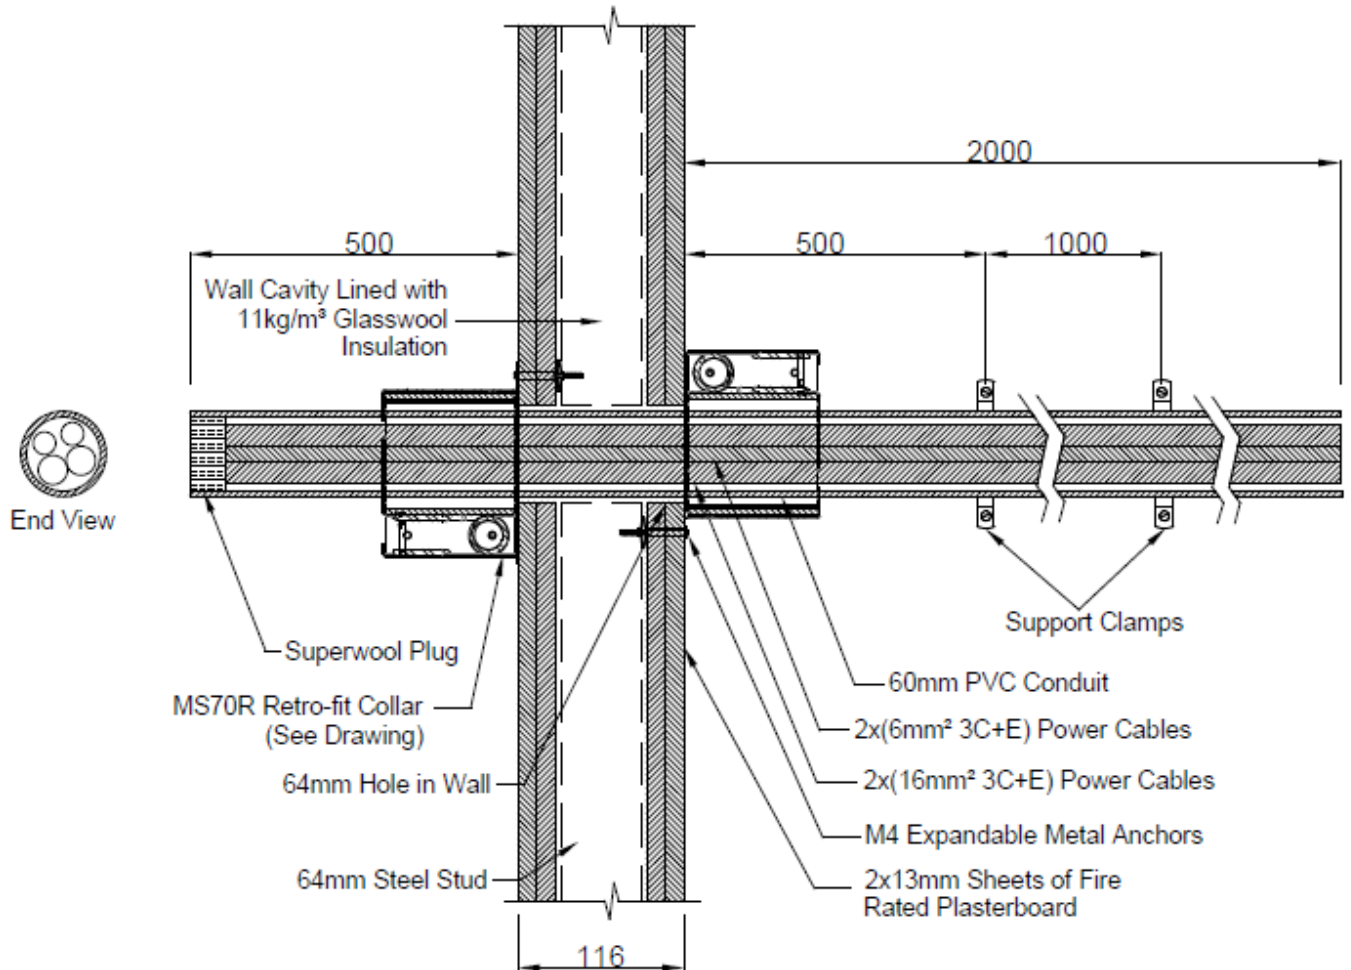
50 PVC Conduit with 16mm<sup>2</sup> 3C+E &  
6mm<sup>2</sup> 3C+E Power Cables & MS70R Collar

**DRAWING TITLED "SPECIMEN #2 50 PVC CONDUIT WITH 16MM<sup>2</sup> 3C+E & 6MM<sup>2</sup> 3C+E POWER CABLES & MS70R COLLAR", DATED 11 JUNE 2020, PROVIDED BY SNAP FIRE SYSTEMS PTY LTD**

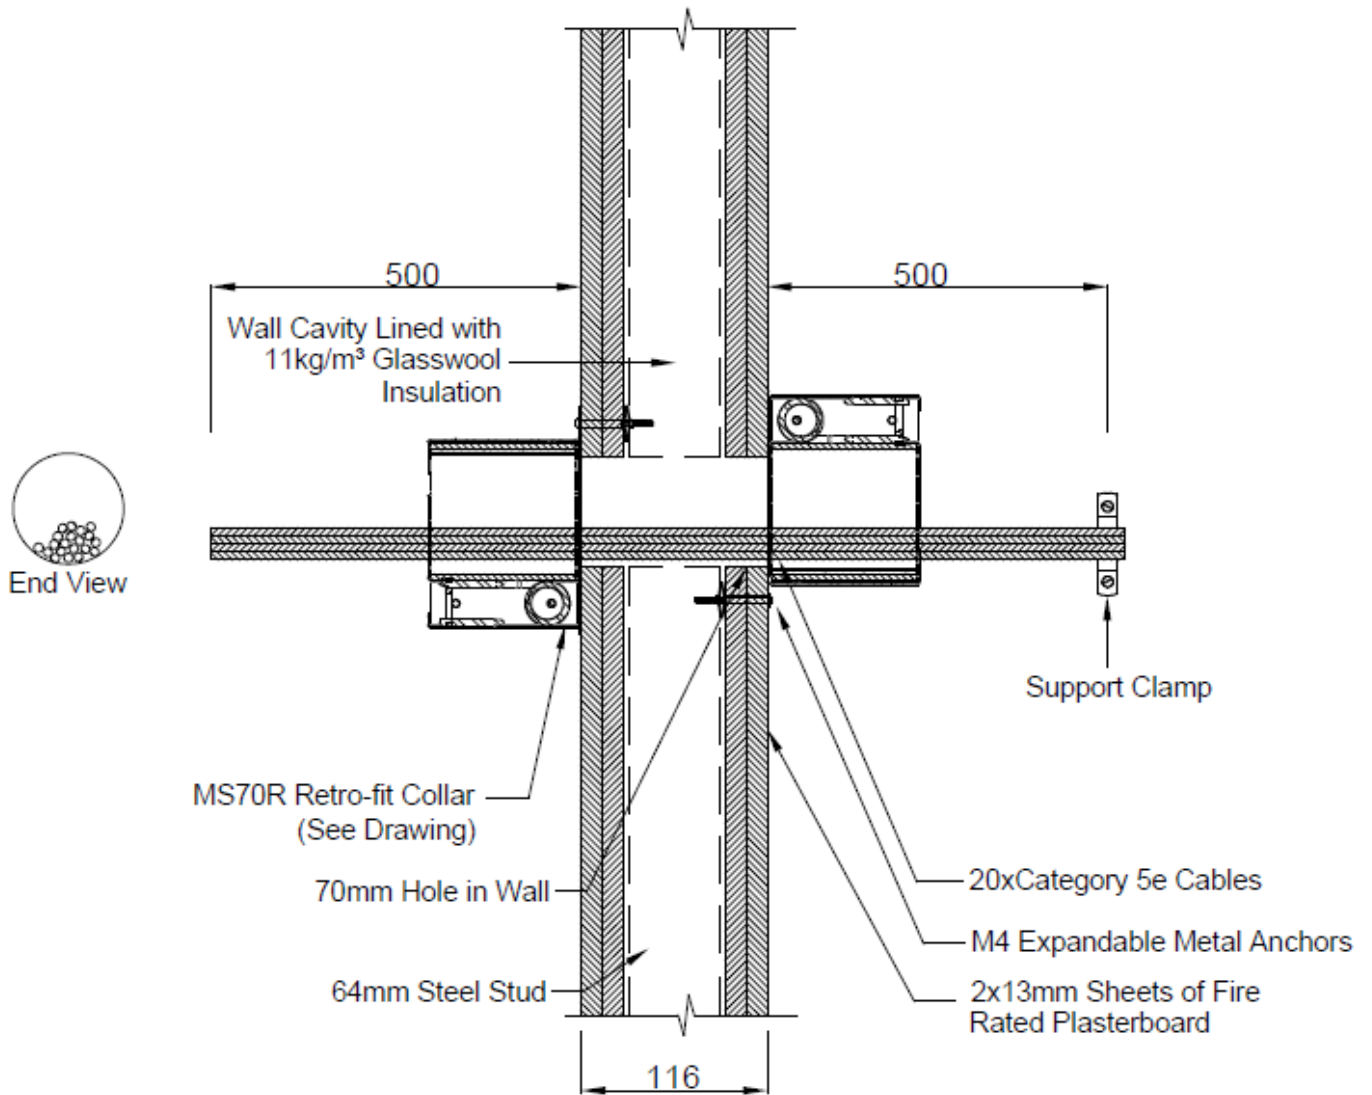
20% Full of Cat5e Cables & MS70R Collar

**DRAWING TITLED "SPECIMEN #3 20% FULL OF CAT5E CABLES & MS70R COLLAR", DATED 11 JUNE 2020, PROVIDED BY SNAP FIRE SYSTEMS PTY LTD, PROVIDED BY SNAP FIRE SYSTEMS PTY LTD**
