# Fire-resistance test on retrofit fire collars protecting a plasterboard wall penetrated by services

## Test Report

**Author:** Peter Gordon  
**Report number:** FSP 2126 Revision C  
**Date:** 20 July 2022  
**Client:** IG6 Pty Ltd as trustee for the IG6 IP Trust

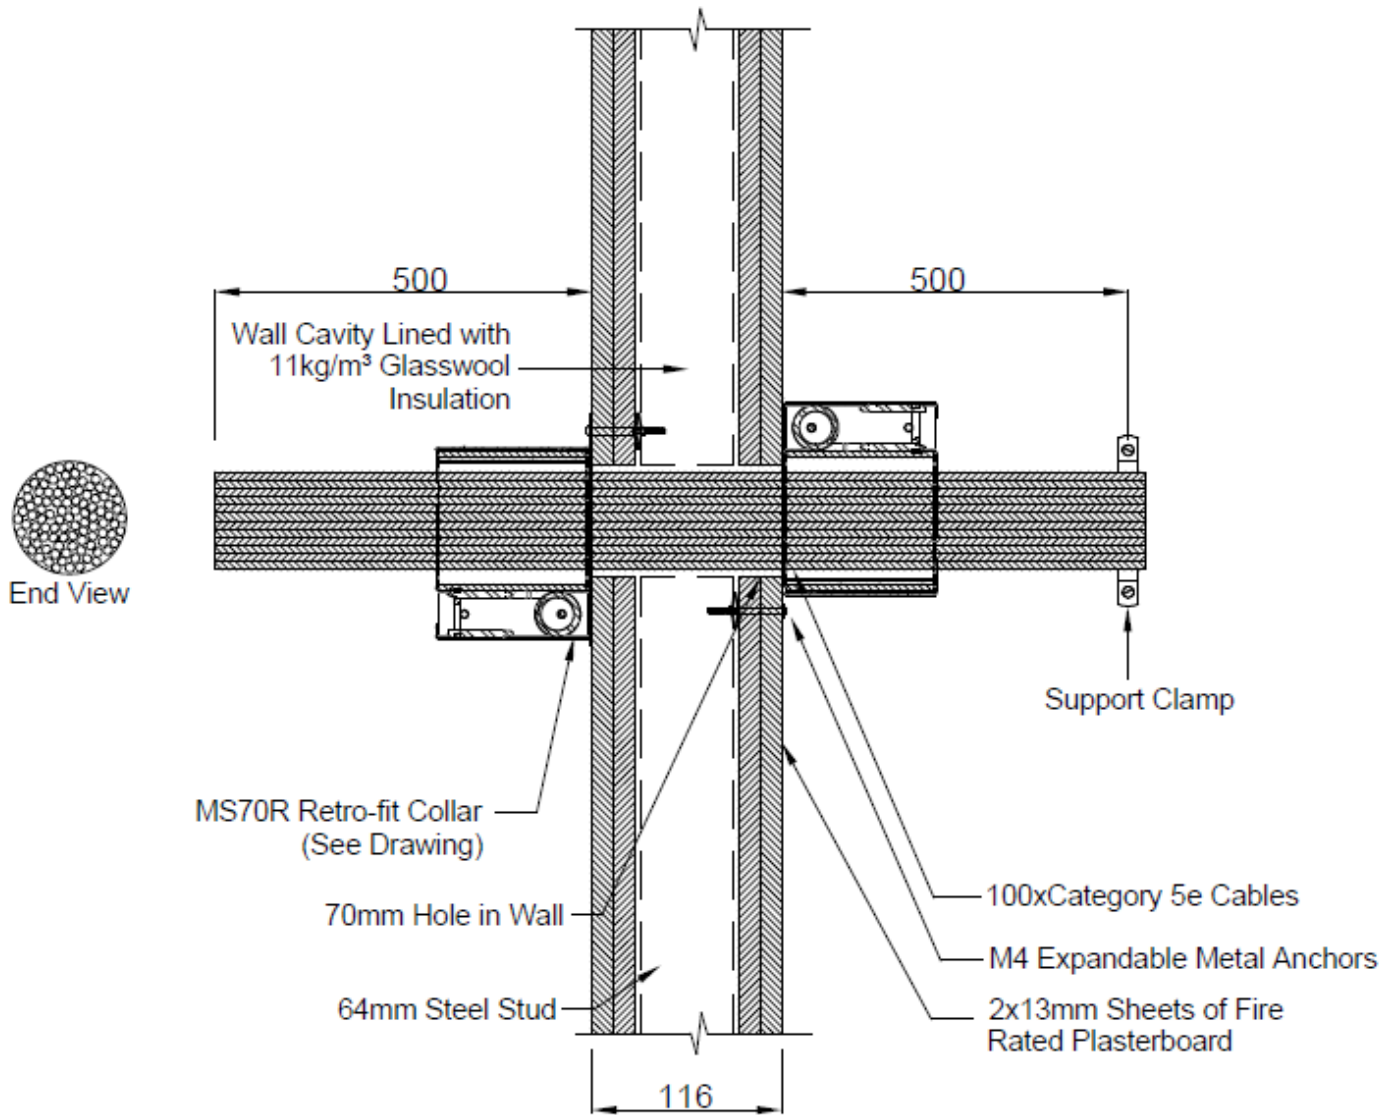
100% Full of Cat5e Cables & MS70R Collar

**DRAWING TITLED "SPECIMEN #4 100% FULL OF CAT5E CABLES & MS70R COLLAR", DATED 11 JUNE 2020, PROVIDED BY SNAP FIRE SYSTEMS PTY LTD, PROVIDED BY SNAP FIRE SYSTEMS PTY LTD**

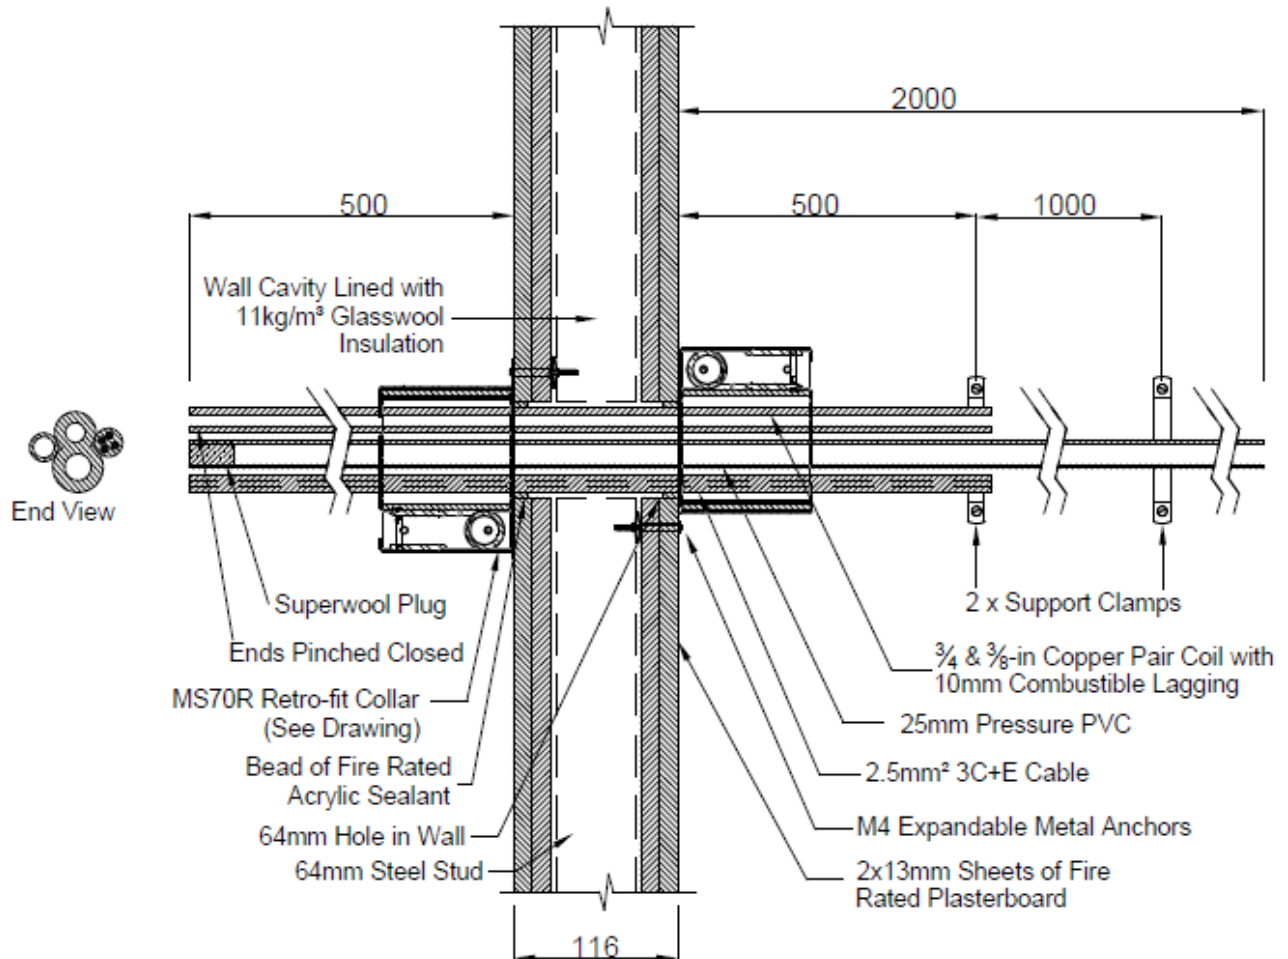
$\frac{3}{4}$ -in &  $\frac{3}{8}$ -in Insulated Copper Pair Coil, 25mm Pressure PVC,  
2.5mm<sup>2</sup> 3C+E Cable & MS70R

**DRAWING TITLED "SPECIMEN #5  $\frac{3}{4}$ -IN &  $\frac{3}{8}$ -IN INSULATED COPPER PAIR COIL, 25-MM PRESSURE PVC, 2.5MM<sup>2</sup> 3C+E CABLE & MS70R", DATED 11 JUNE 2020, PROVIDED BY SNAP FIRE SYSTEMS PTY LTD**

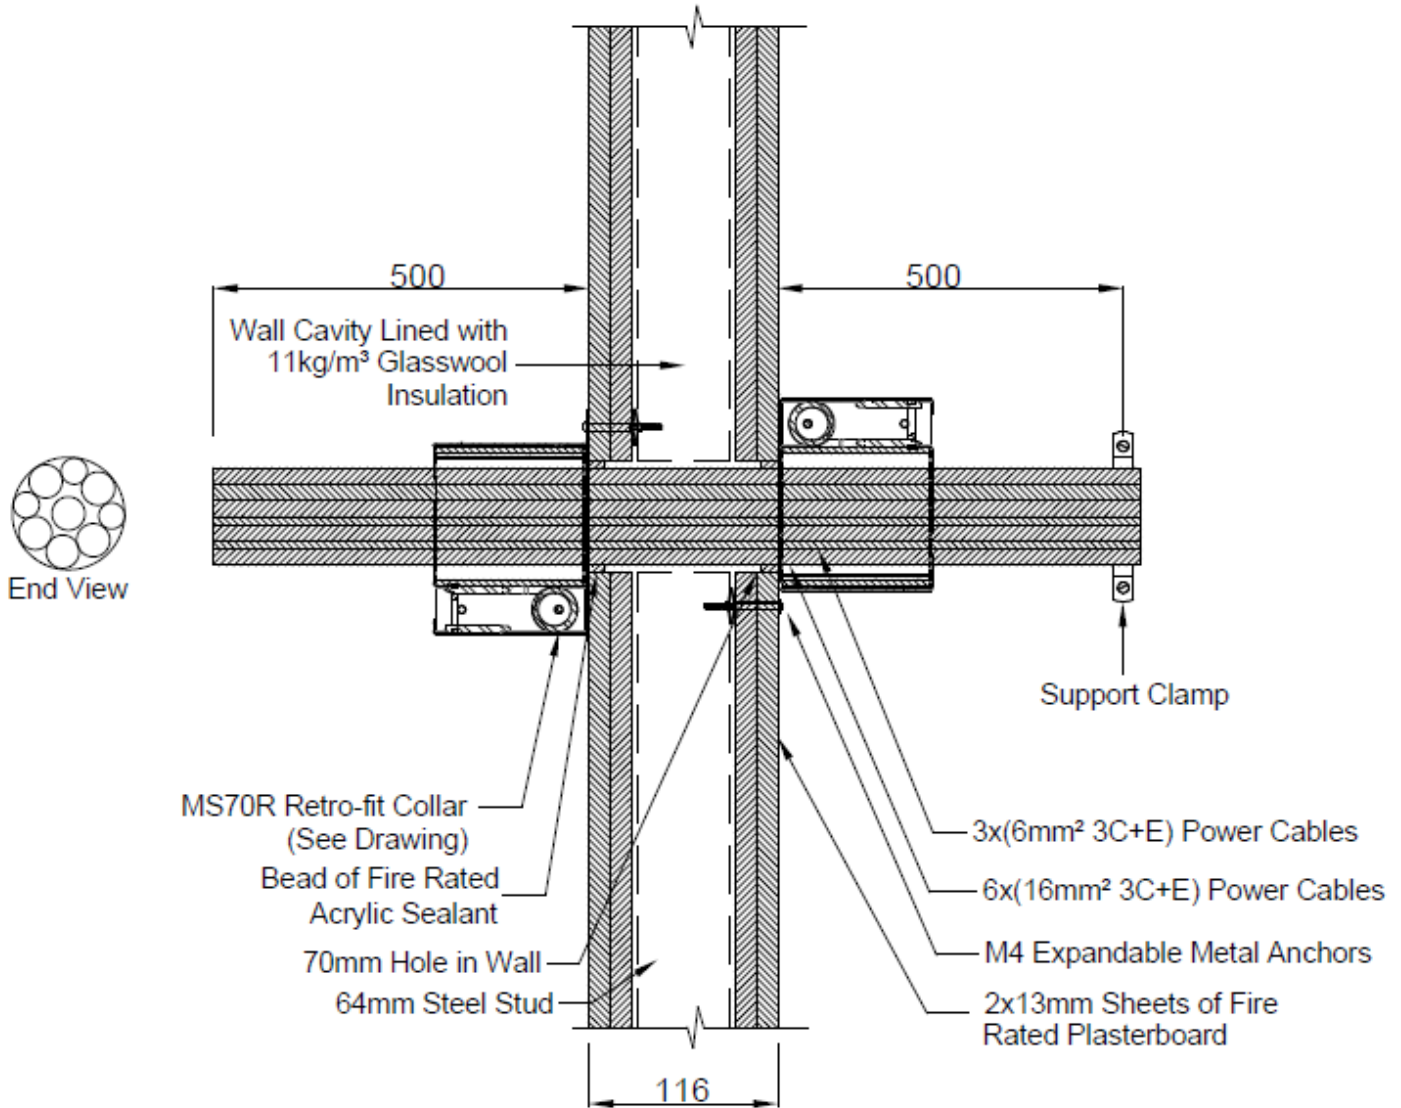
16mm<sup>2</sup> 3C+E & 6mm<sup>2</sup> 3C+E Power Cables | & MS70R Collar

**DRAWING TITLED "SPECIMEN #6 16MM<sup>2</sup> 3C+E & 6MM<sup>2</sup> 3C+E POWER CABLES & MS70R COLLAR", DATED 11 JUNE 2020, PROVIDED BY SNAP FIRE SYSTEMS PTY LTD**

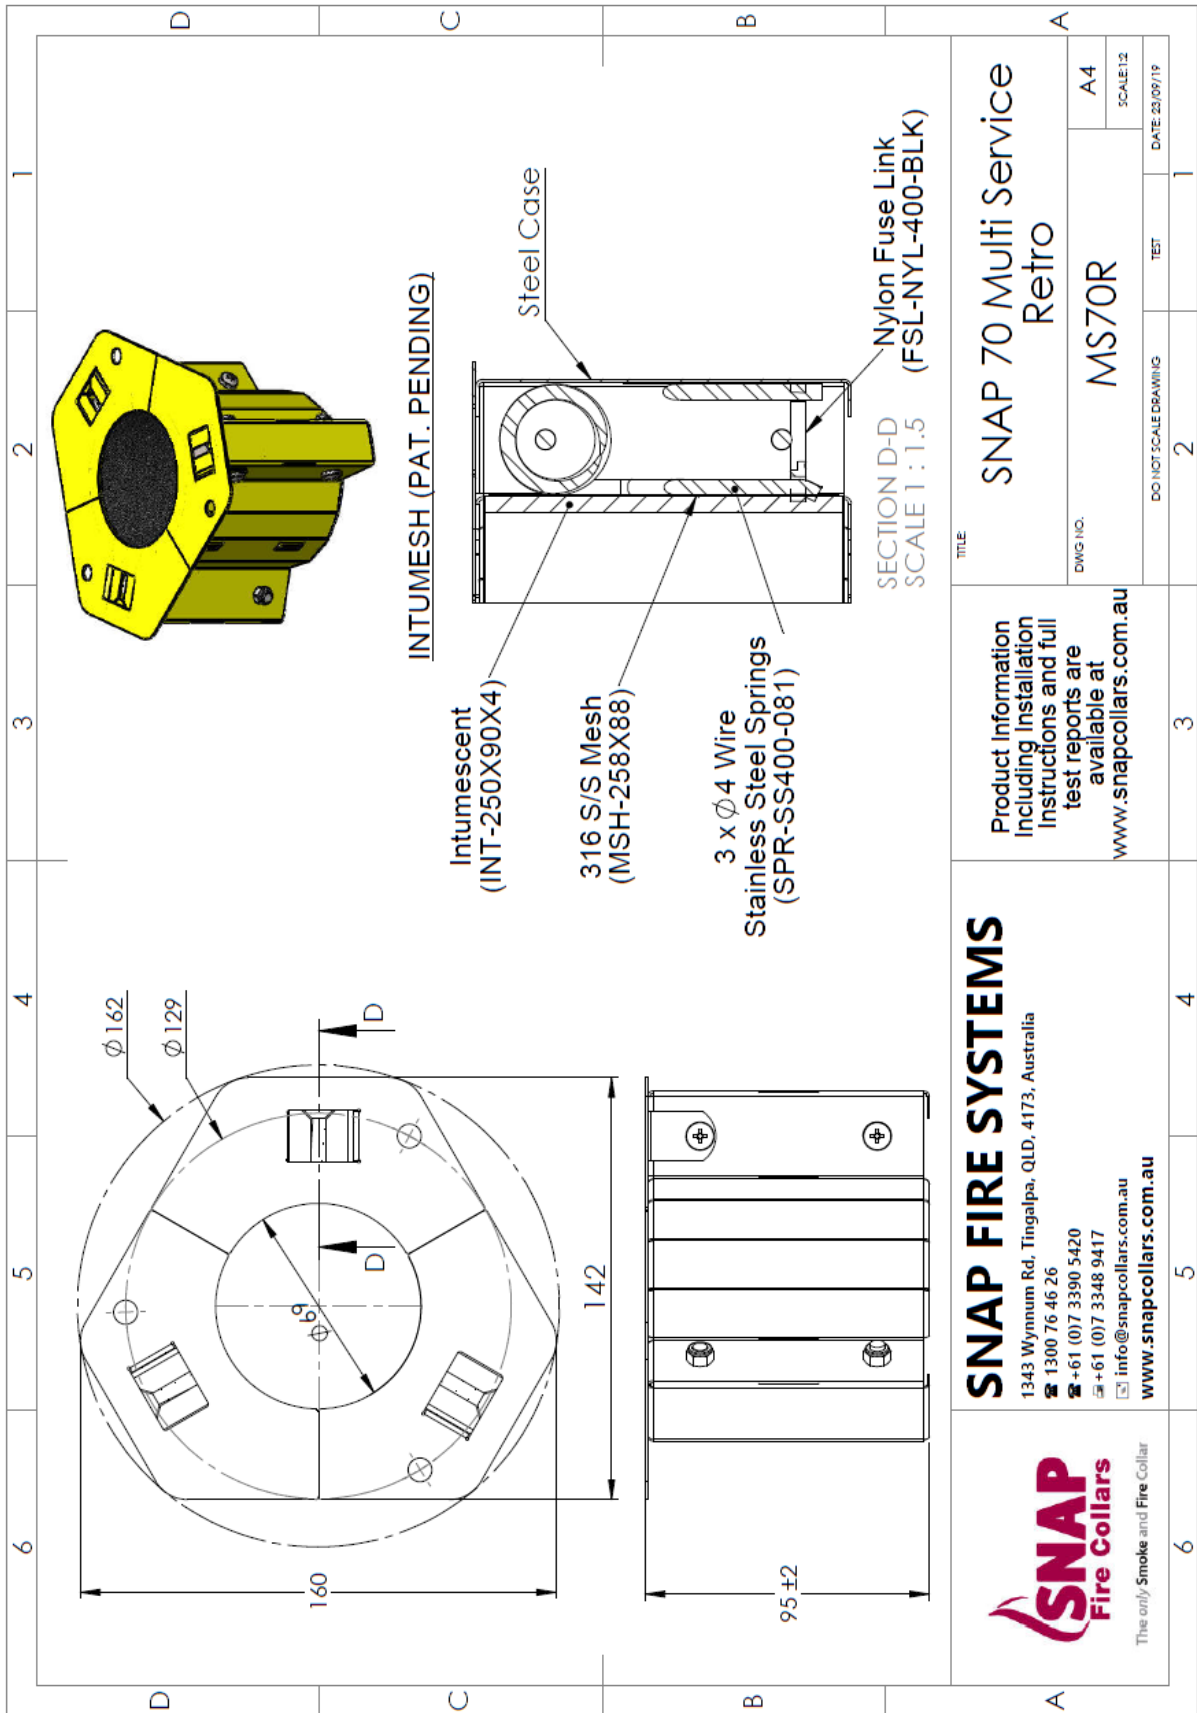
DRAWING TITLED "SNAP 70 MULTI SERVICE RETRO", DATED 23 SEPTEMBER 2019, BY SNAP FIRE SYSTEMS.
