# Fire-resistance test on retrofit fire collars protecting a plasterboard wall penetrated by services

## Test Report

**Author:** Peter Gordon  
**Report number:** FSP 2238  
**Date:** 22 December 2021  
**Client:** IG6 Pty Ltd

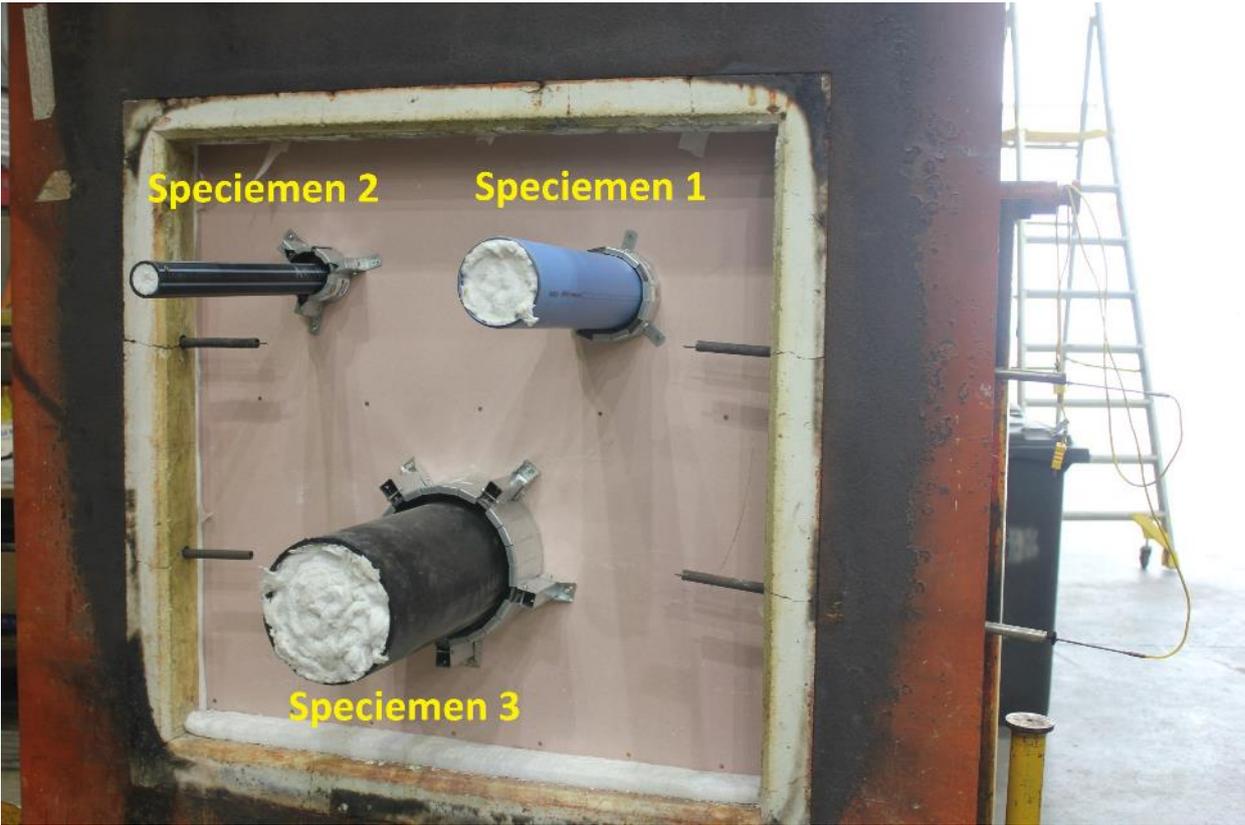
PHOTOGRAPH 1 – EXPOSED FACE OF SPECIMENS PRIOR TO TESTING

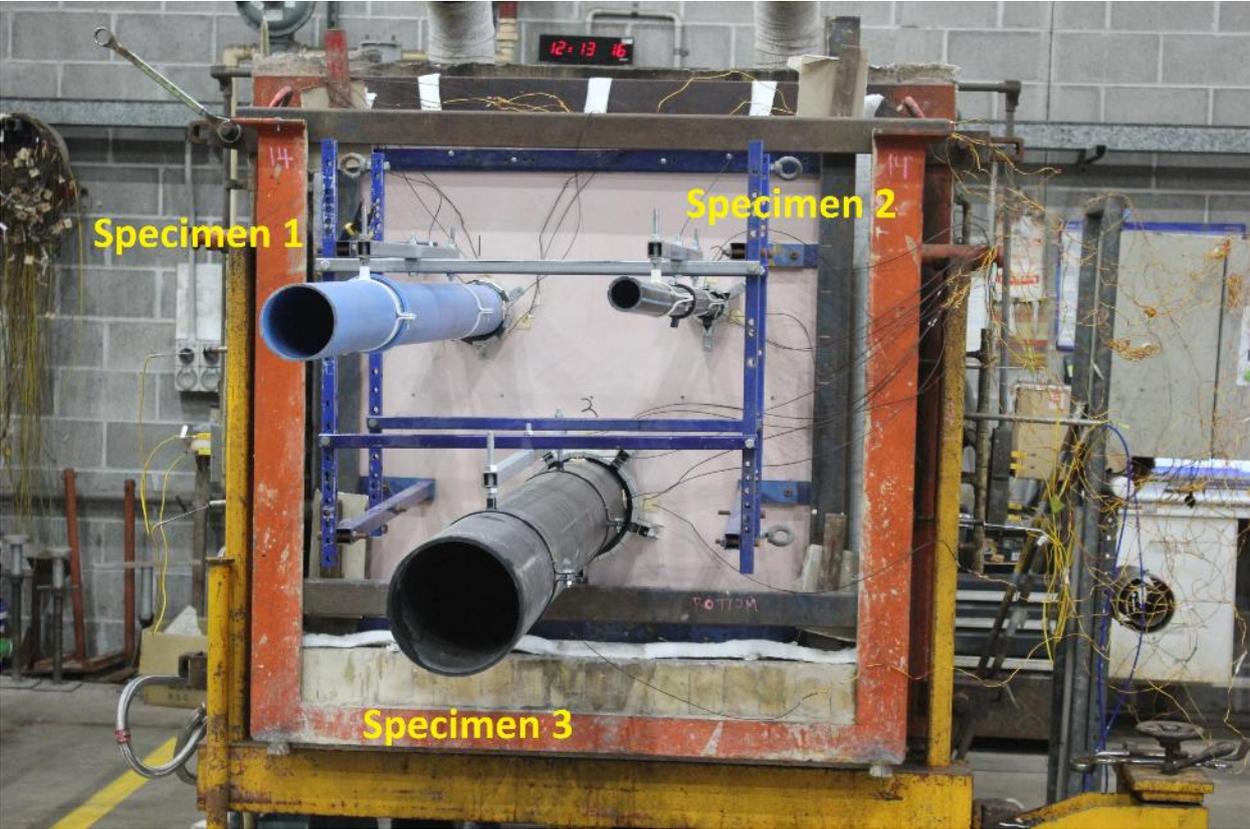
PHOTOGRAPH 2 – UNEXPOSED FACE OF SPECIMENS PRIOR TO TESTING

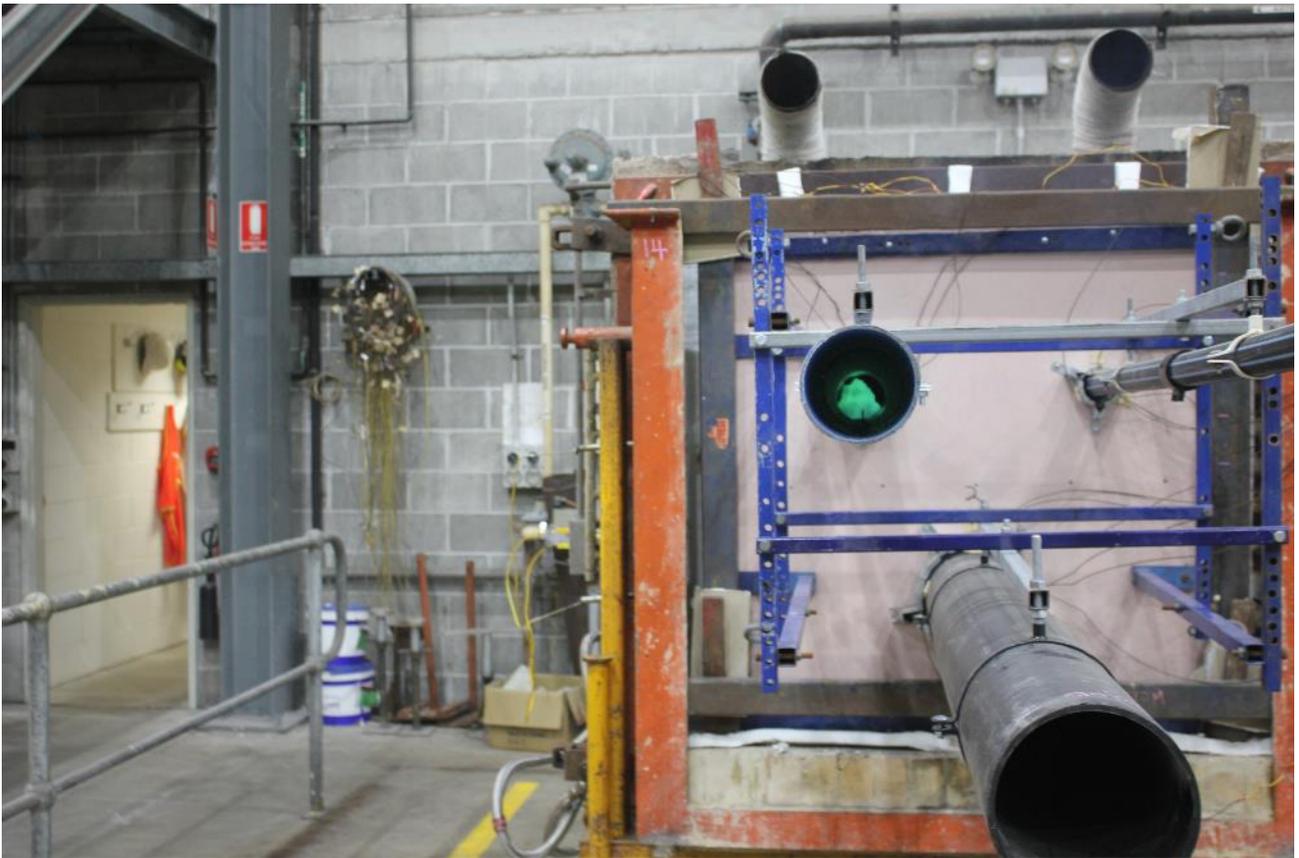
**PHOTOGRAPH 3 – SPECIMEN 1 AFTER 2 MINUTES OF TESTING**

Time	Observation
1 minute -	Smoke has started to flue from the end of the pipe of specimen 1.
2 minutes -	Loud clicks were emitted from the specimen wall, indicating the release a fusible link from one or more of the fire collars. The pipe inside the furnace of specimen 1 has melted with intumescent material swelling to close off the open pipe - photograph 3.
3 minutes -	Smoke is being emitted between the collar and the pipe at the base of specimens 1, 2 and 3 - photograph 4. The pipe inside the furnace of specimen 1 has closed off - photograph 5.

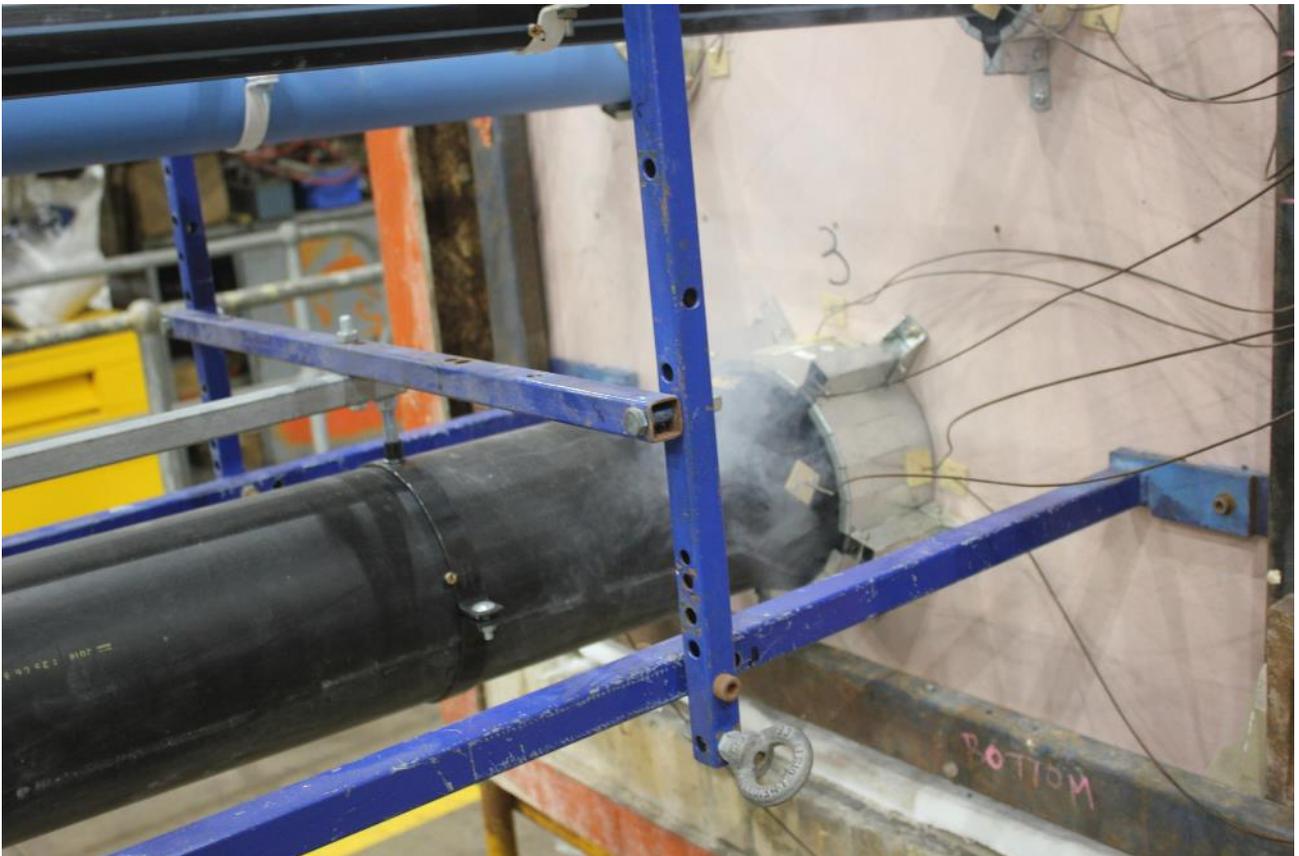
**PHOTOGRAPH 4 – SPECIMEN 3 AFTER 3 MINUTES OF TESTING**

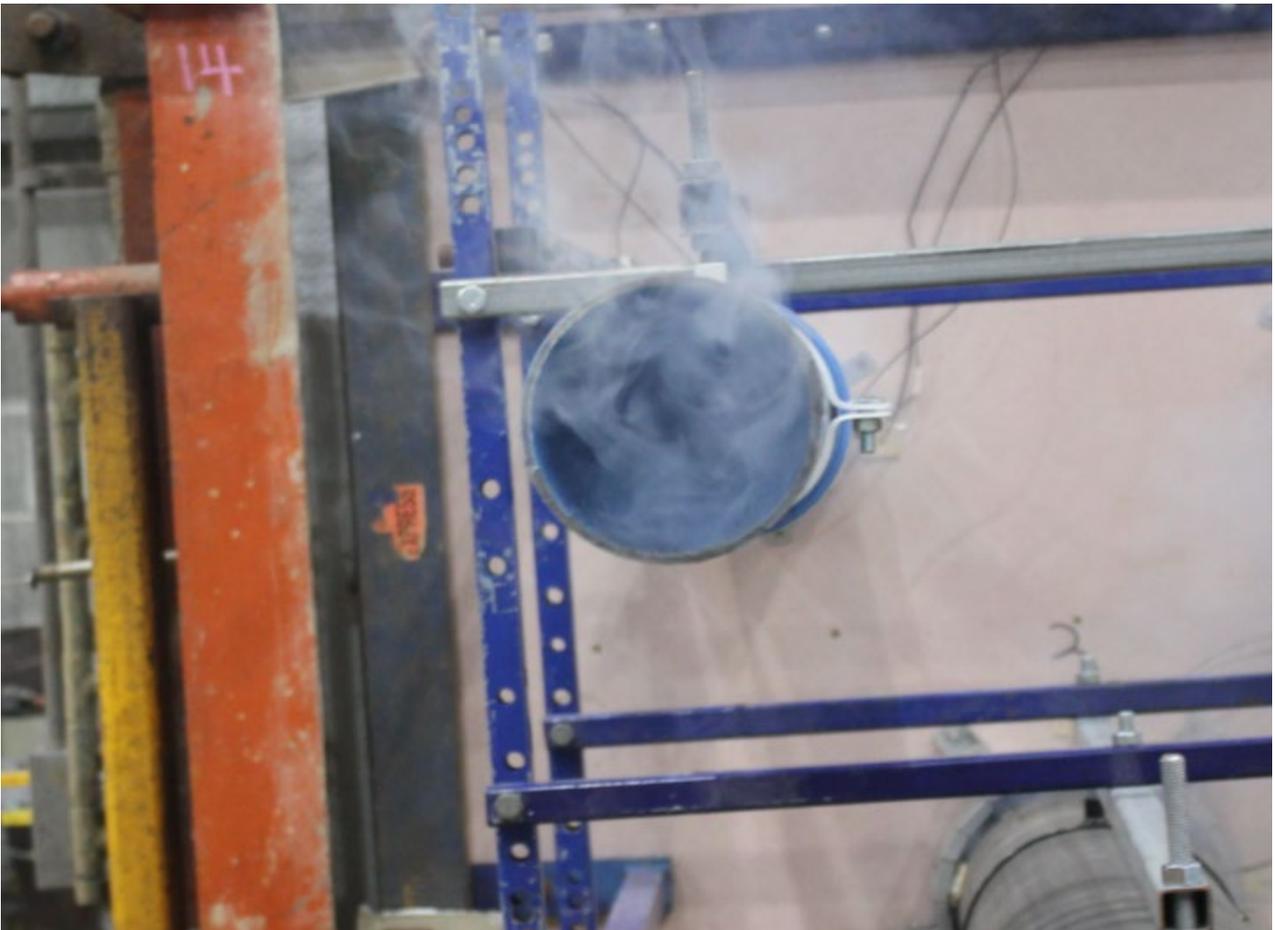
**PHOTOGRAPH 5 – SPECIMEN 1 AFTER 3 MINUTES OF TESTING**

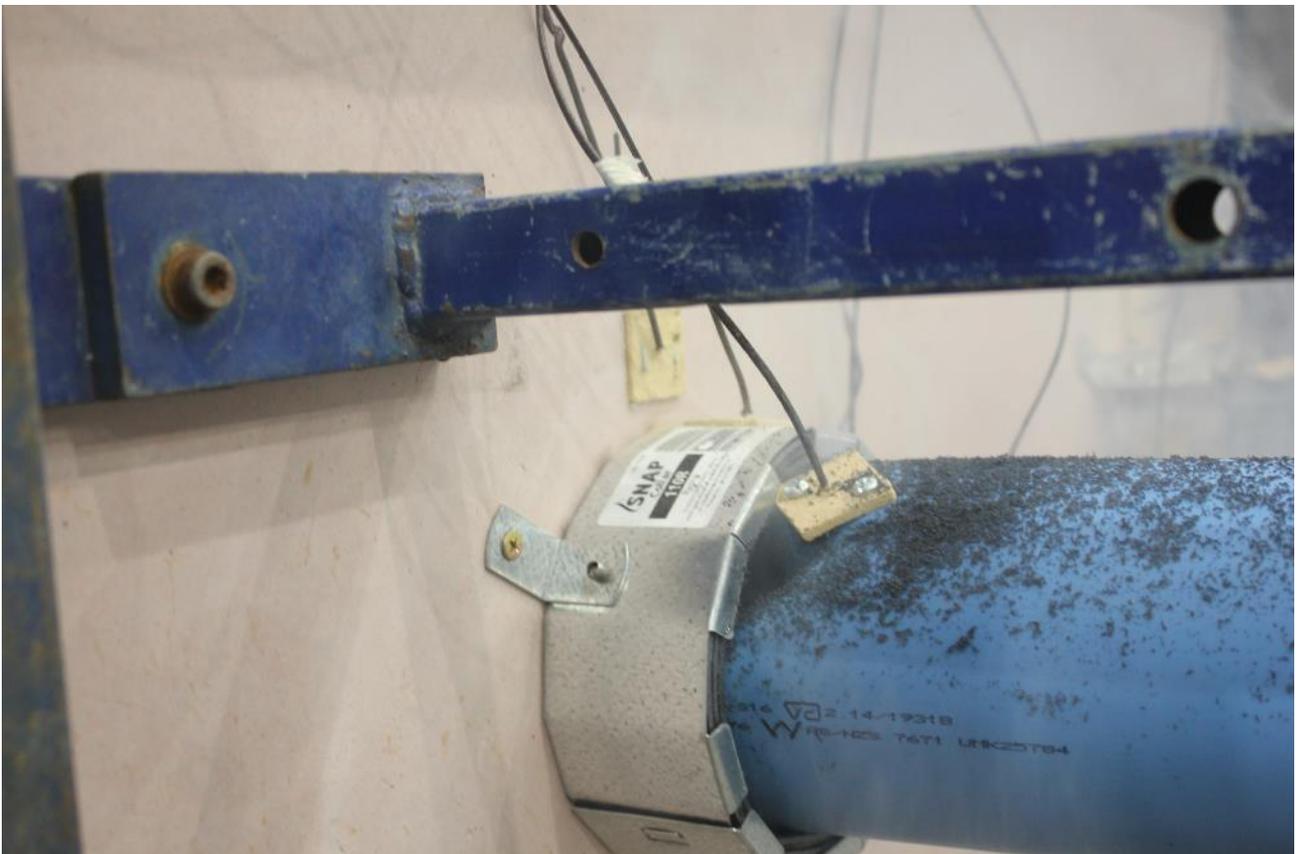
**PHOTOGRAPH 6 – SPECIMEN 1 AFTER 4 MINUTES OF TESTING**

- 4 minutes - The west side of the pipe inside the collar of specimen 1 has begun to deform with a small quantity of black intumescent material expelled from the collar - photograph 6.  
Smoke has ceased fluing from the end of the pipe of specimen 1.  
Condensation has formed around the base of the pipe of specimen 3.

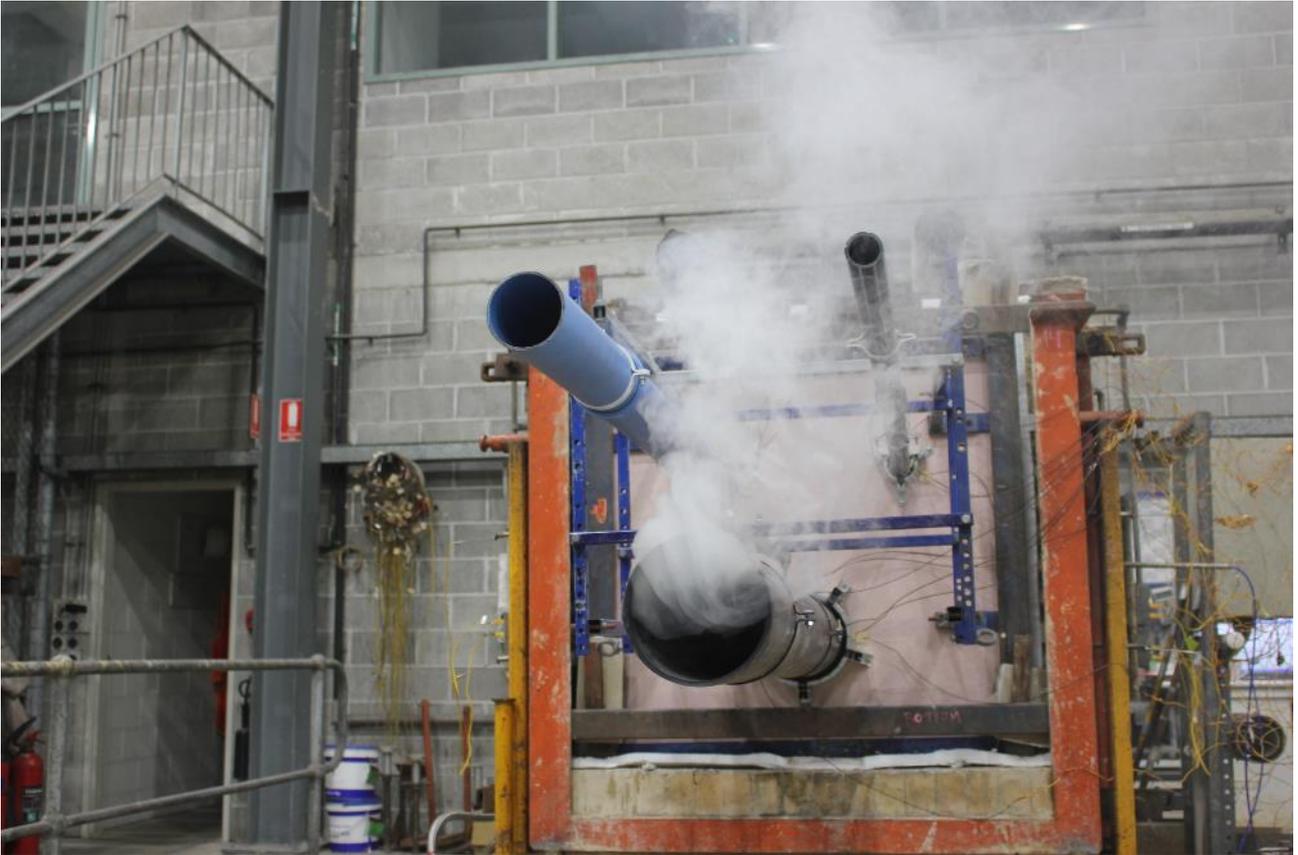
**PHOTOGRAPH 7 – SPECIMENS AFTER 6 MINUTES OF TESTING**

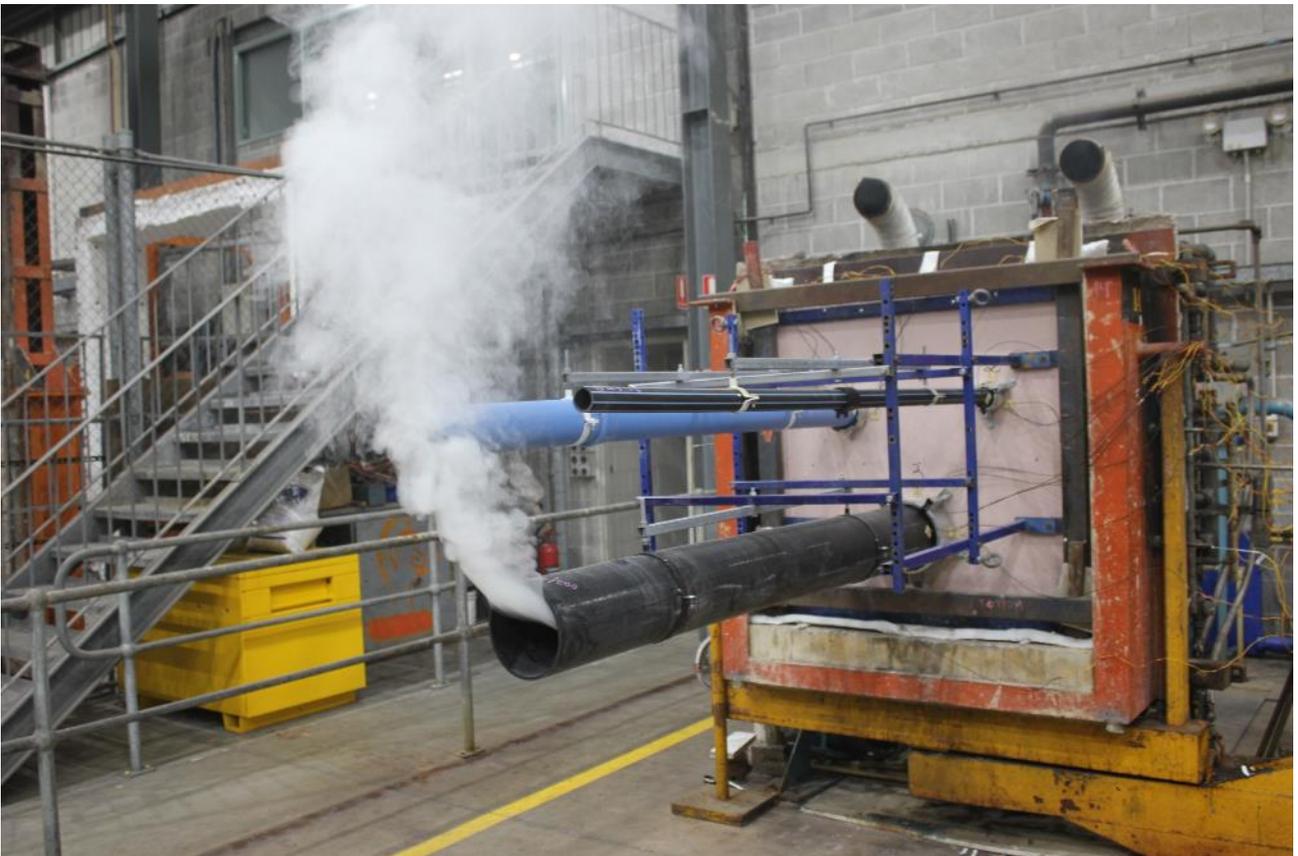
**PHOTOGRAPH 8 – SPECIMENS AFTER 10 MINUTES OF TESTING**

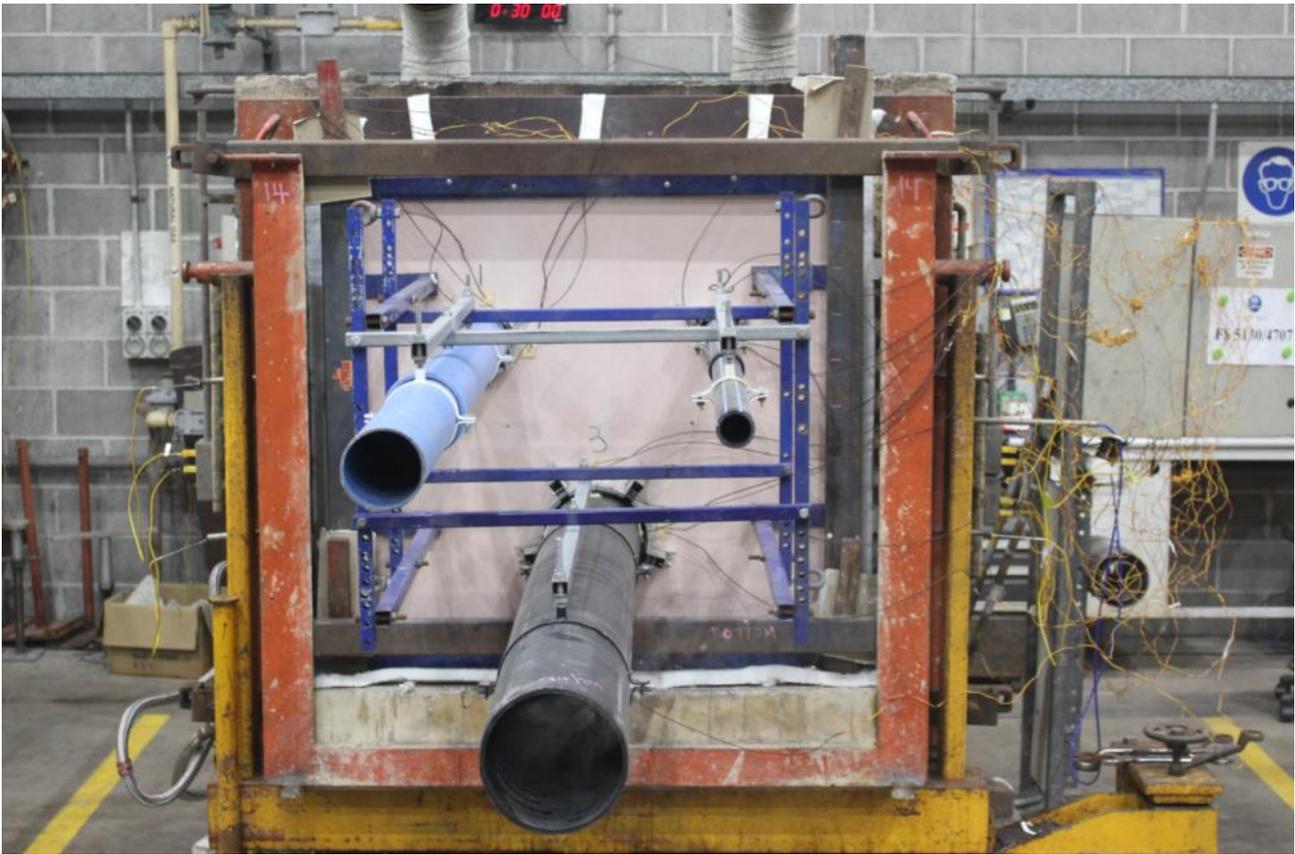
**PHOTOGRAPH 9 – SPECIMENS AFTER 30 MINUTES OF TESTING**

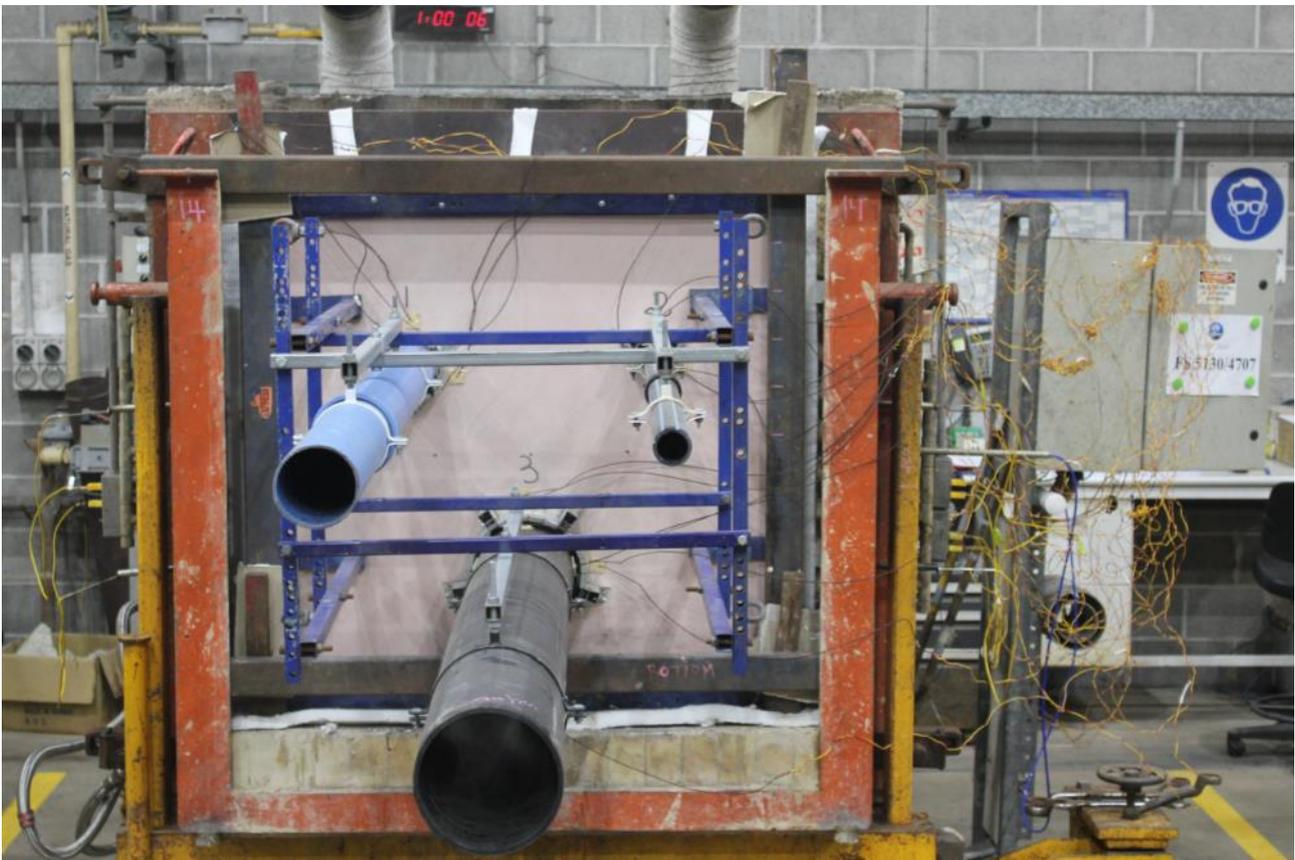
**PHOTOGRAPH 10 – SPECIMENS AFTER 60 MINUTES OF TESTING**

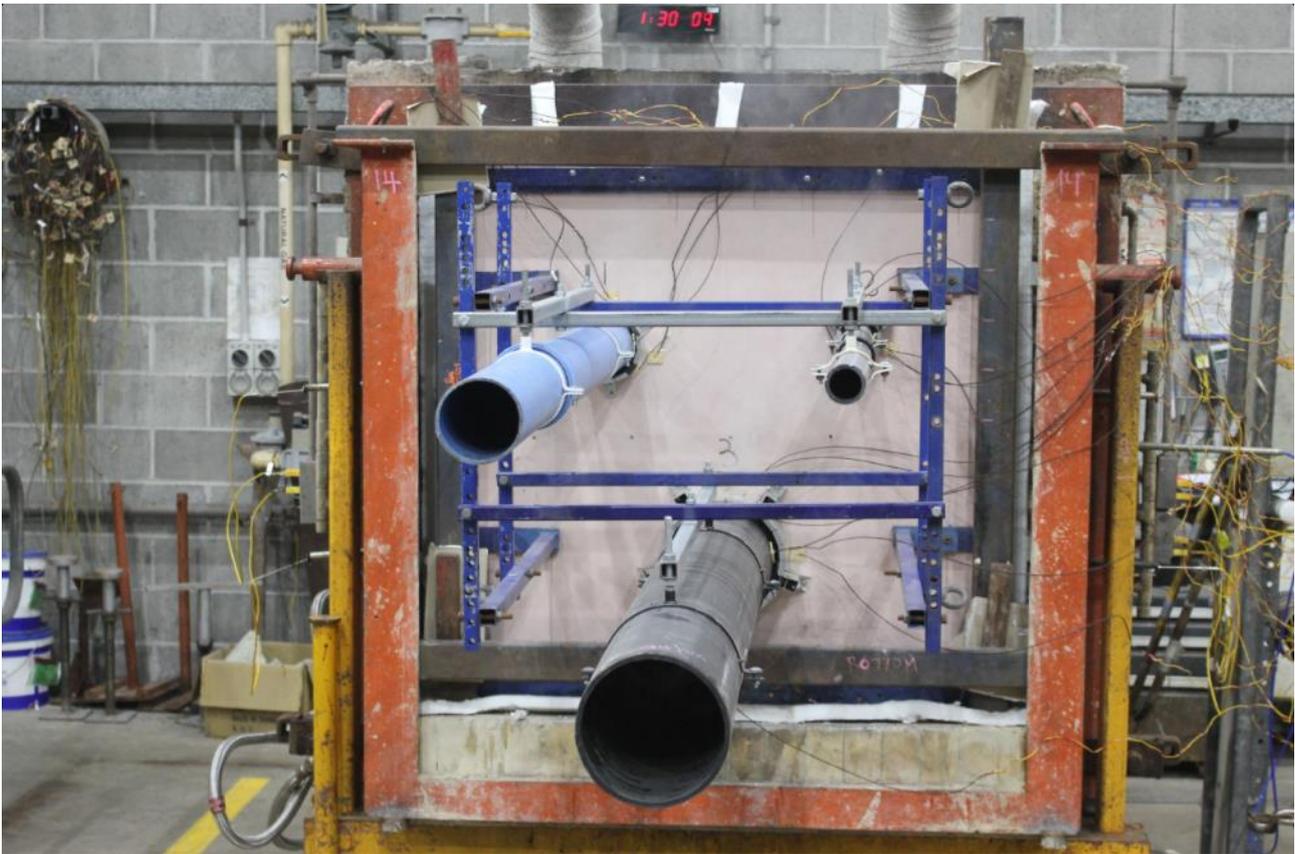
**PHOTOGRAPH 11 – SPECIMENS AFTER 90 MINUTES OF TESTING**

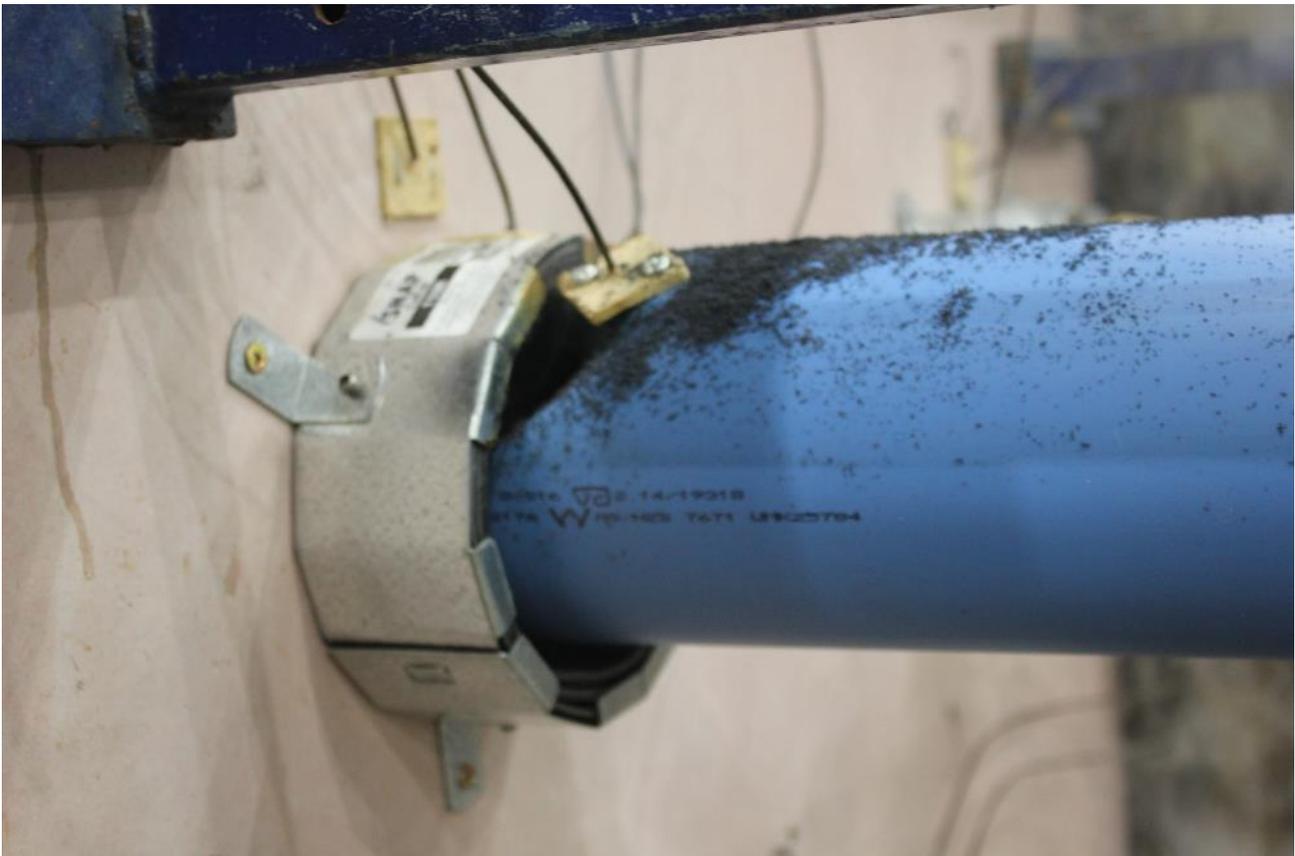
**PHOTOGRAPH 12 –SPECIMEN 1 AFTER 91 MINUTES OF TESTING**

- 91 minutes - The pipe inside the collar of specimen 1 continues to deform.
- 98 minutes - The level of smoke being emitted between the collar and the pipe at the base of specimen 3 has intensified, with visible smoke staining on the metal fire collar casing.

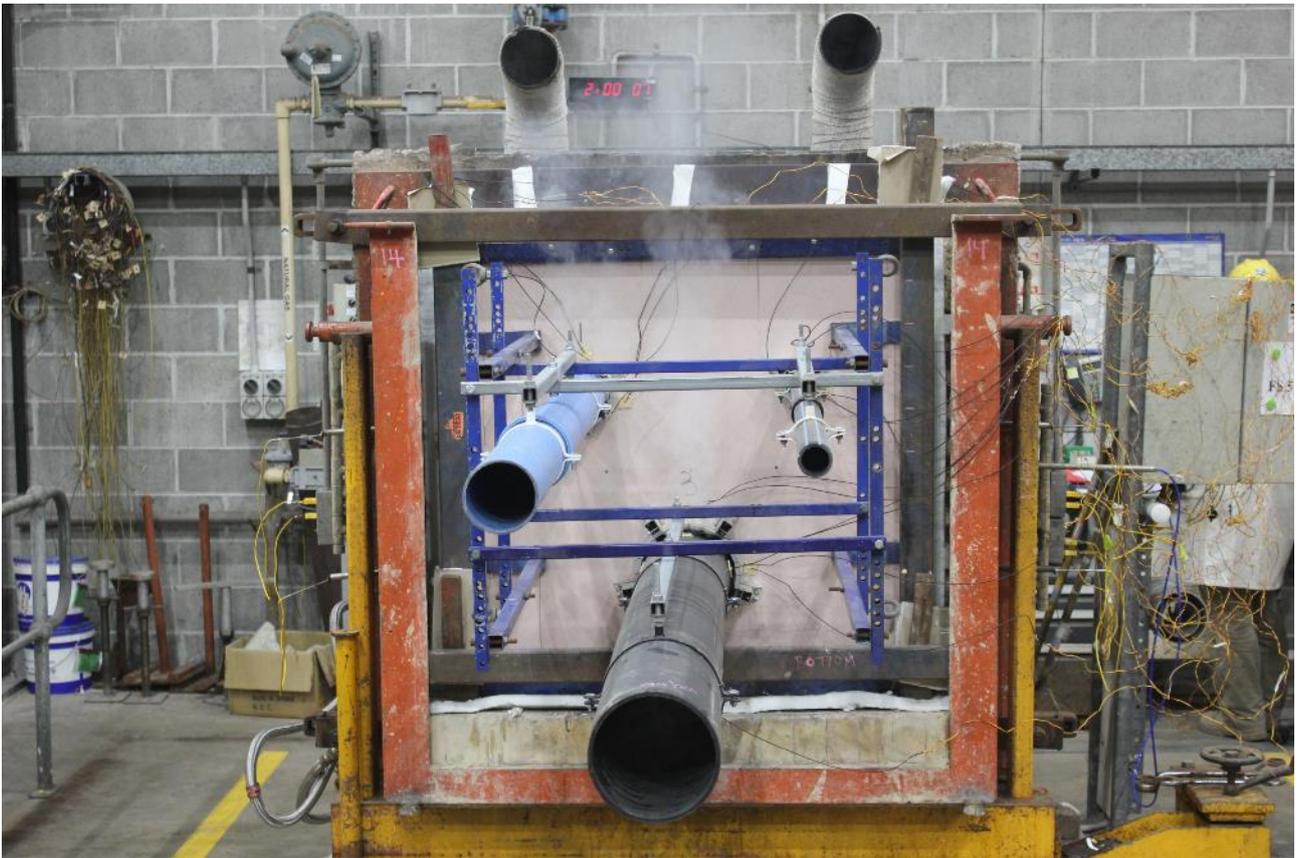
**PHOTOGRAPH 13 –SPECIMENS AFTER 120 MINUTES OF TESTING**

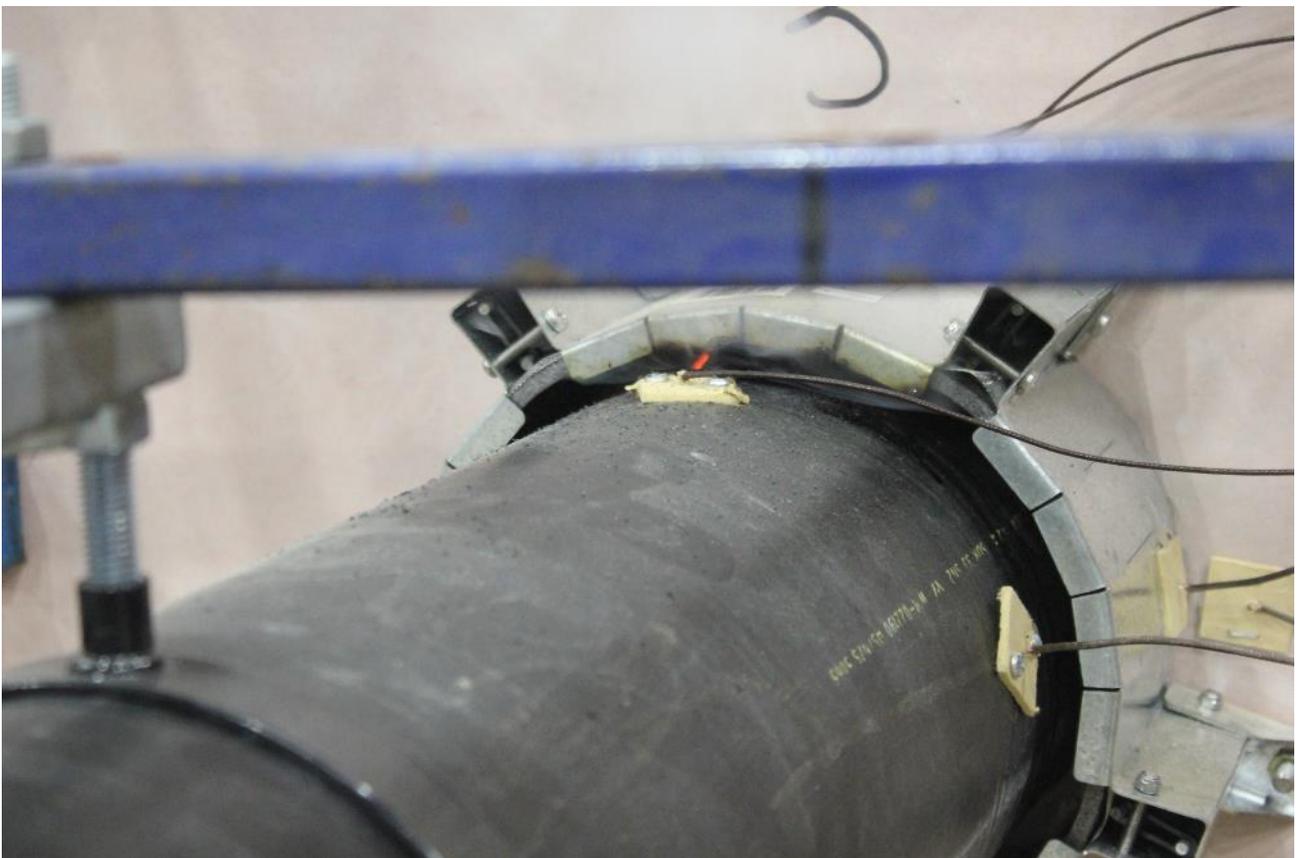
**PHOTOGRAPH 14 –SPECIMEN 3 AFTER 127 MINUTES OF TESTING**

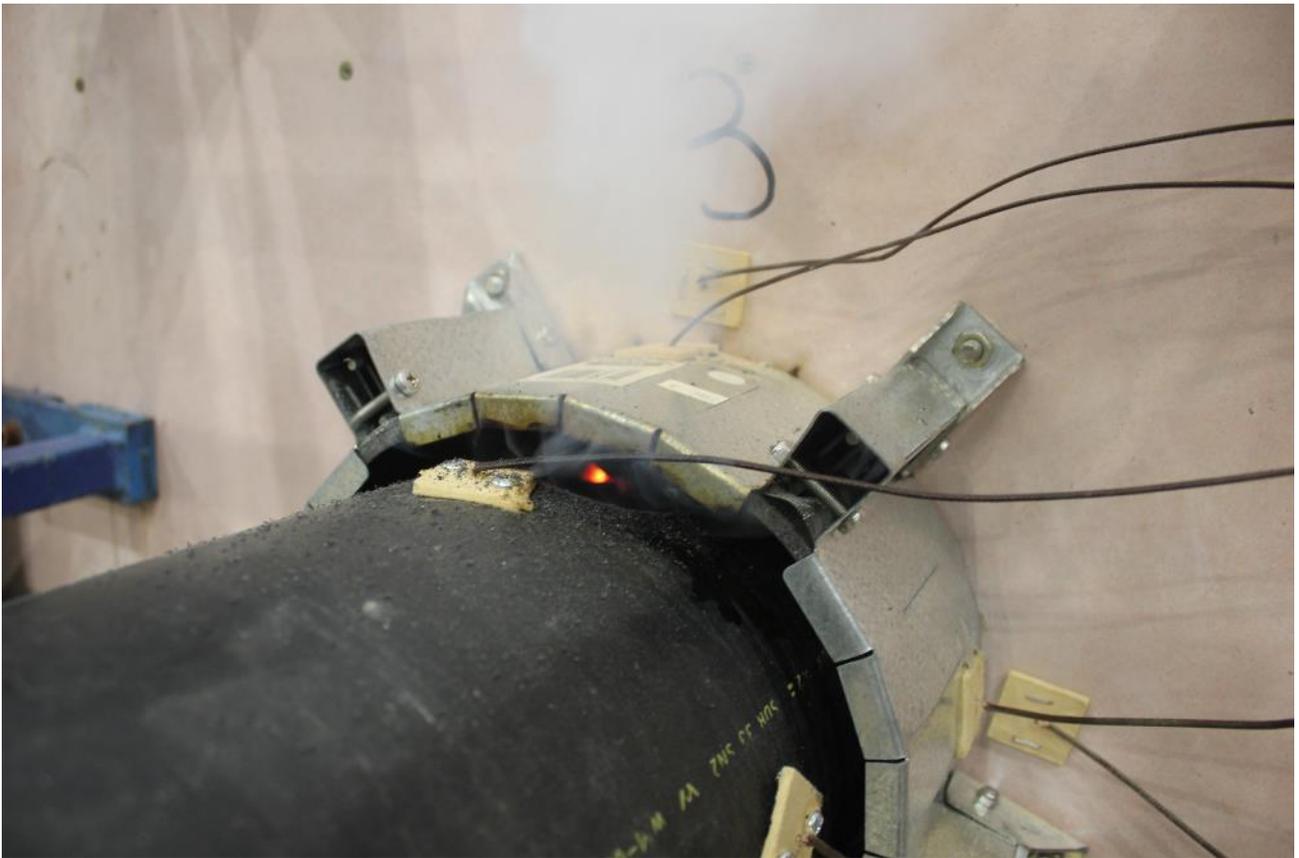
**PHOTOGRAPH 15 –SPECIMEN 3 AFTER 146 MINUTES OF TESTING**

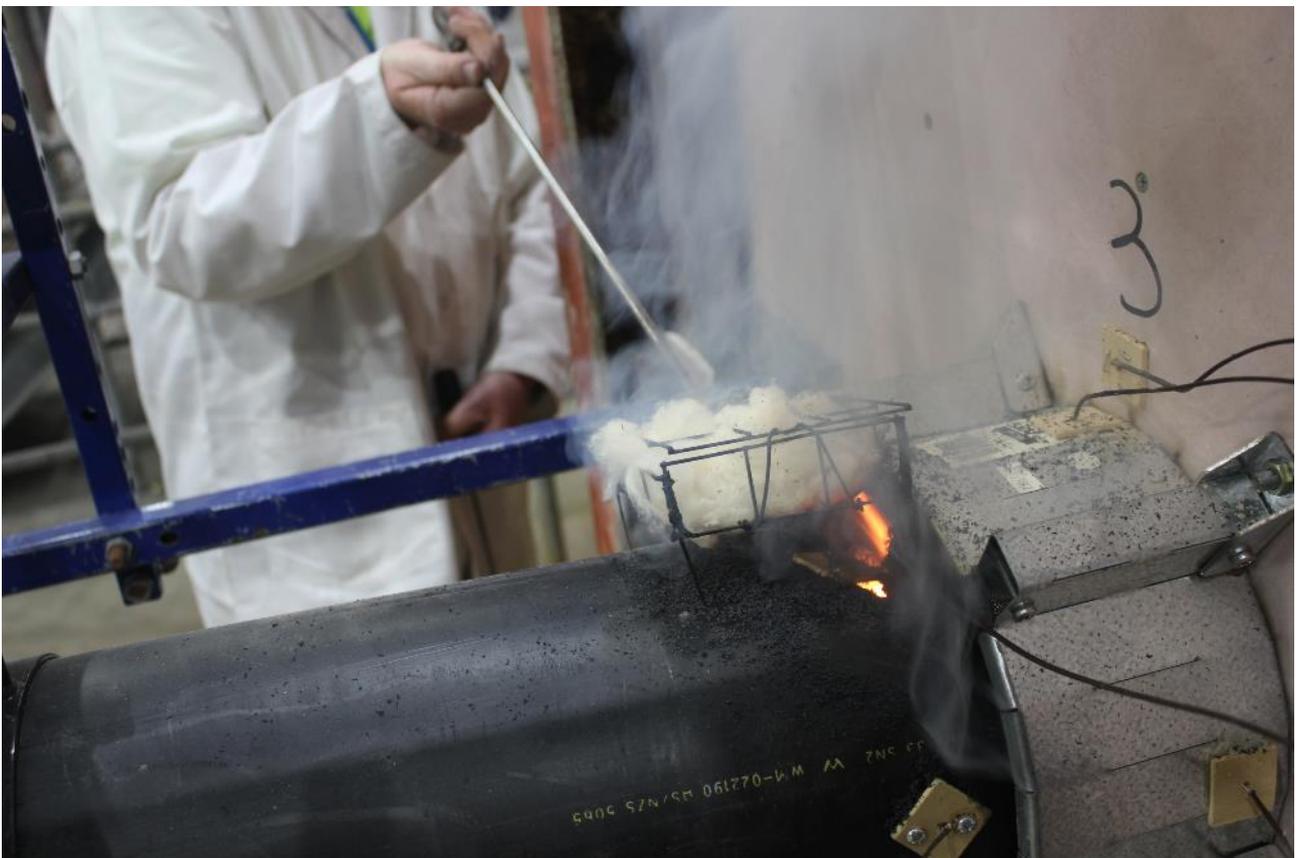
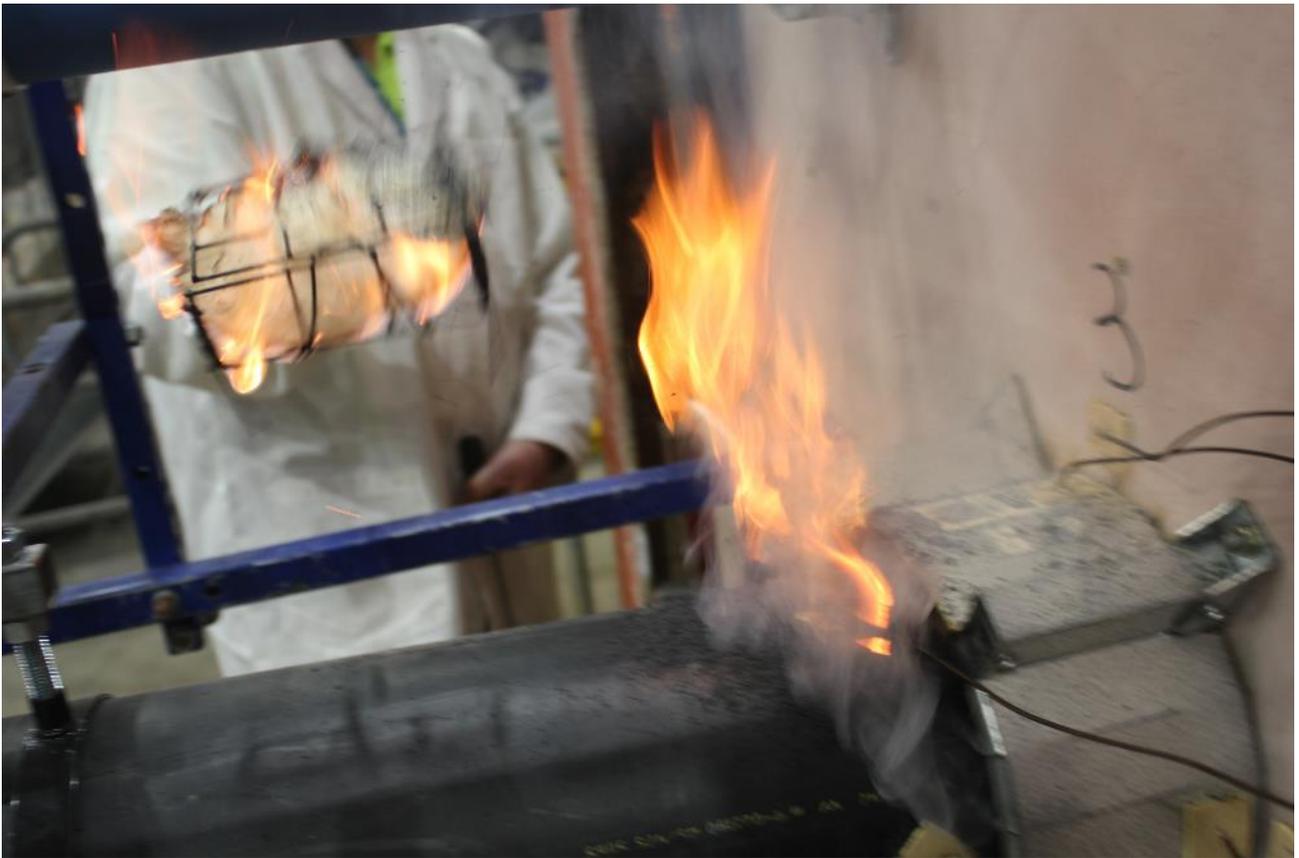
**PHOTOGRAPH 16 – COTON PAD TEST APPLIED TO SPECIMEN 3 AFTER 153 MINUTES OF TESTING**

**PHOTOGRAPH 17 – COTTON PAD TEST APPLIED TO SPECIMEN 3 AFTER 153 MINUTES OF TESTING**

- 153 minutes - Integrity failure of Specimen 3 - Cotton pad test applied over the gap between the pipe and collar of specimen 3, ignition of cotton pad noted at this time.

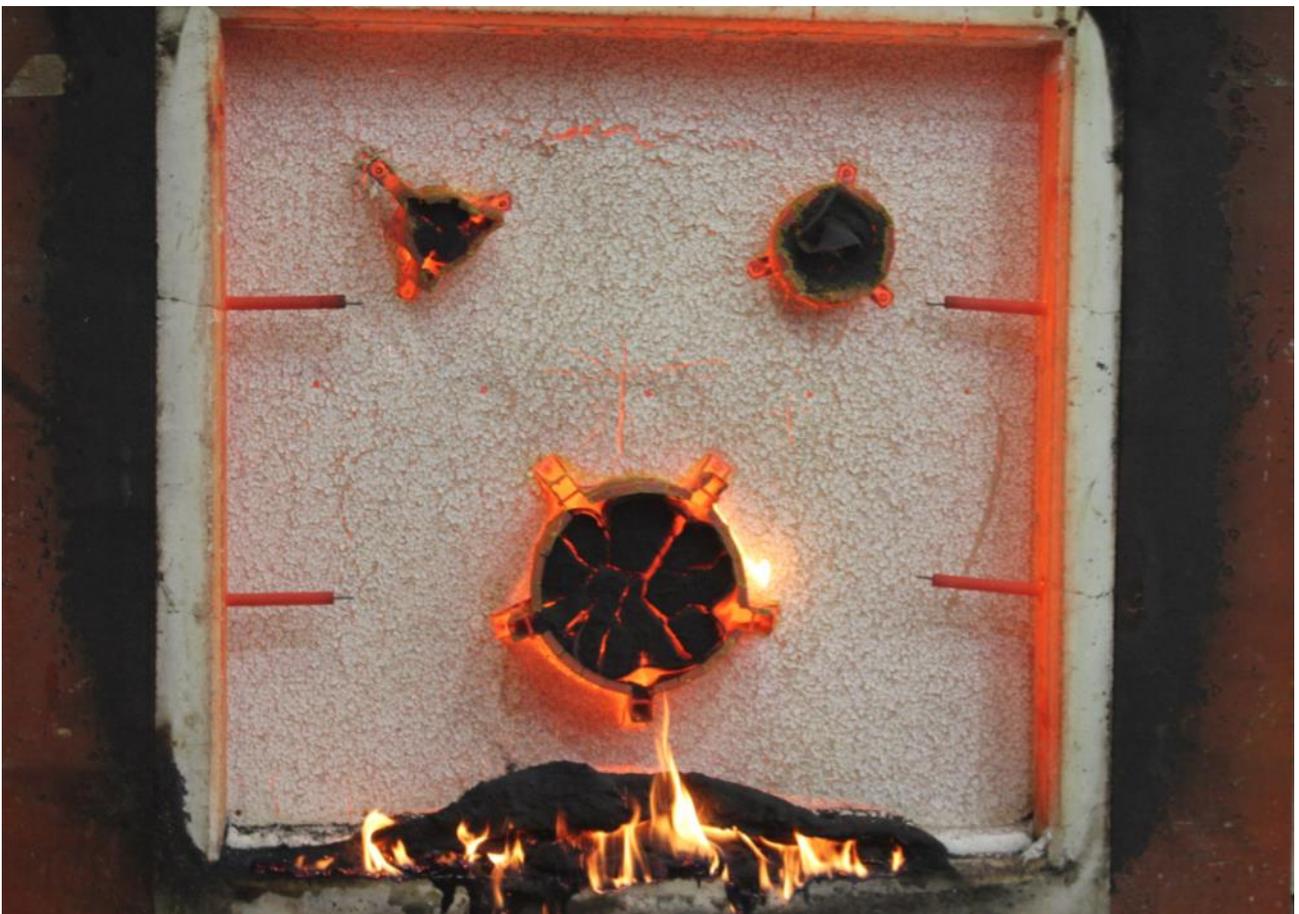
**PHOTOGRAPH 18 – EXPOSED FACE OF SPECIMENS AT CONCLUSION OF TESTING**

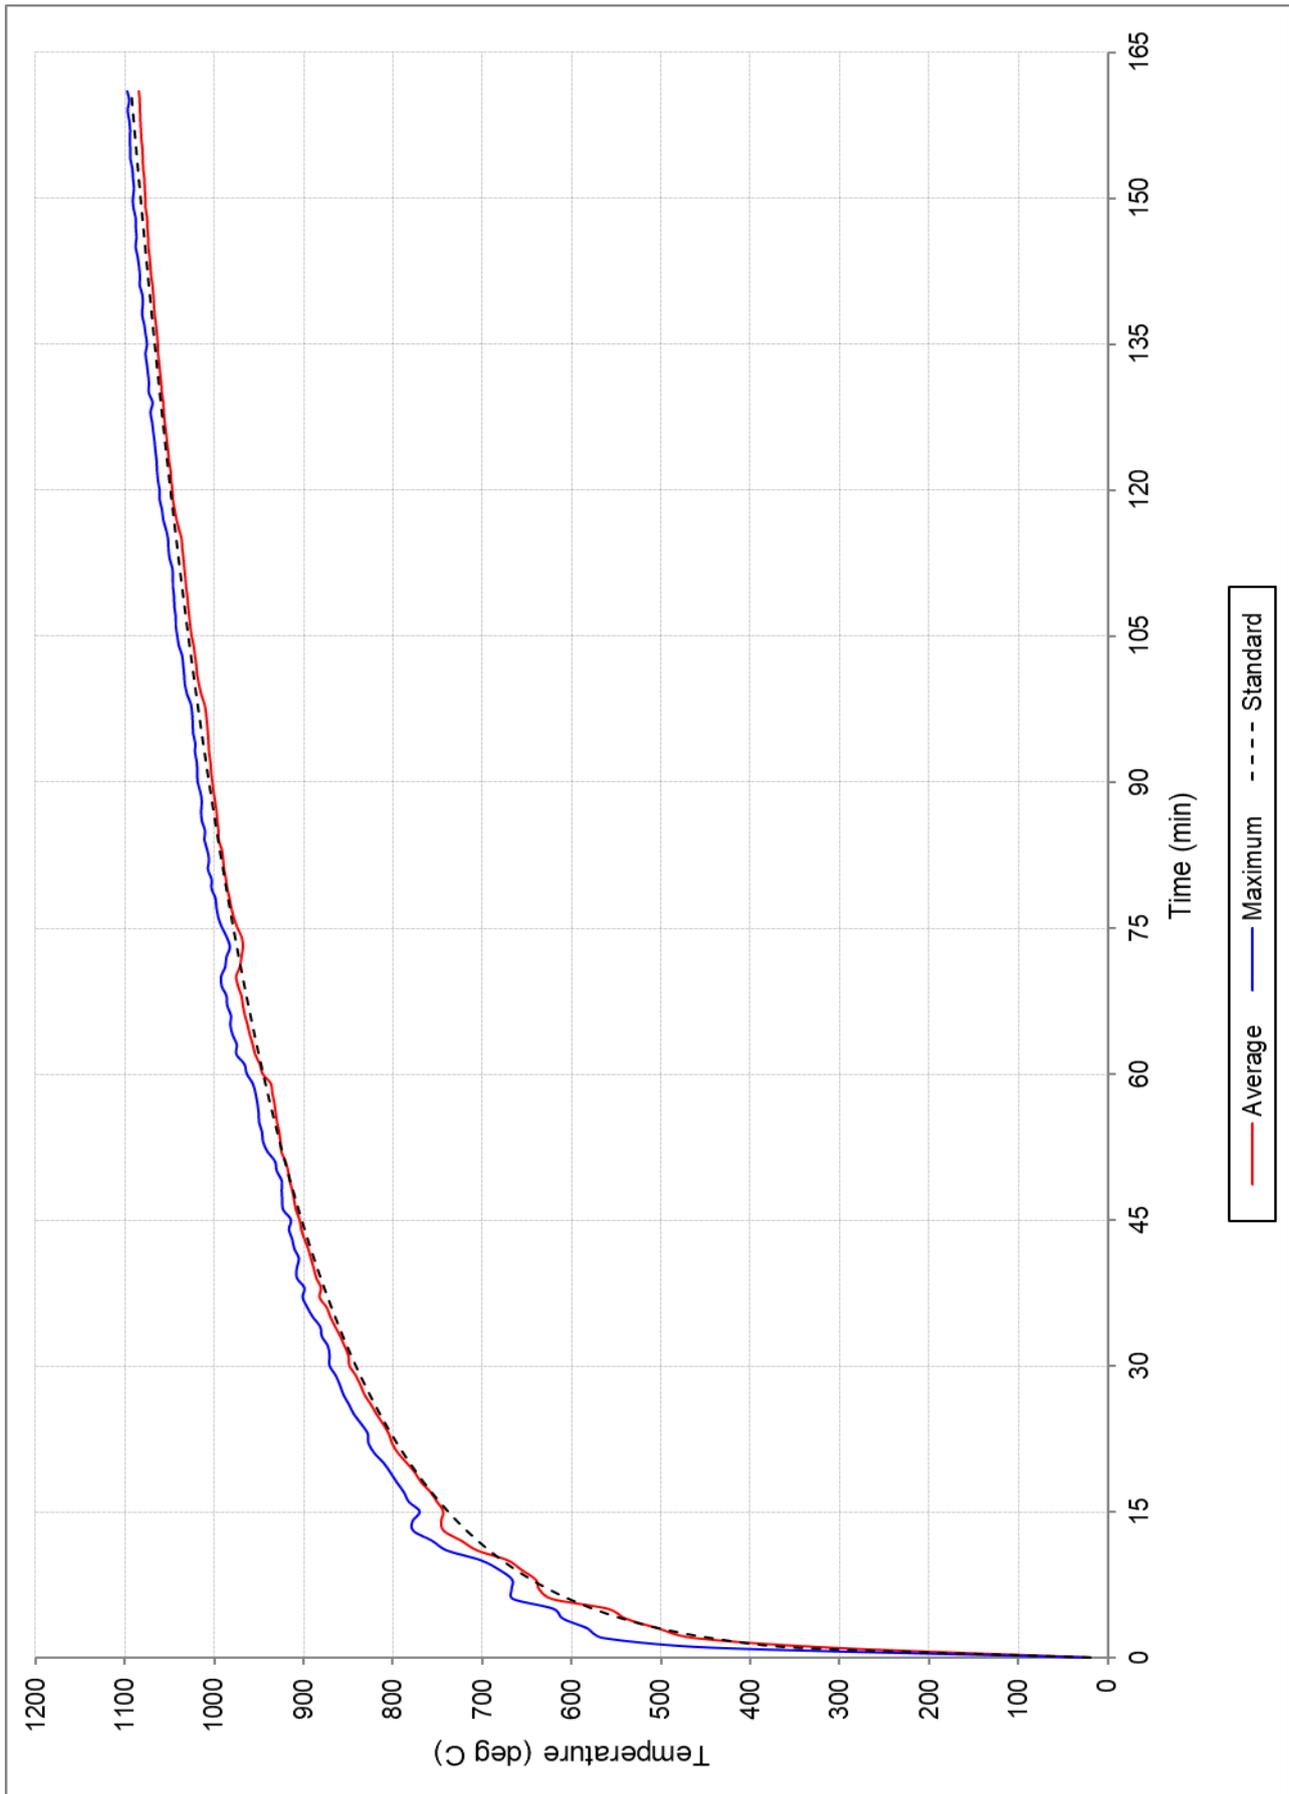
FIGURE 1 – FURNACE TEMPERATURE

Figure 1 shows the standard curves of temperature versus time for heating the furnace chamber and the actual curves of average and maximum temperature versus time recorded during the heating period.
