# Fire-resistance test on retrofit fire collars protecting a plasterboard wall penetrated by services

## Test Report

**Author:** Peter Gordon  
**Report number:** FSP 2238  
**Date:** 22 December 2021  
**Client:** IG6 Pty Ltd

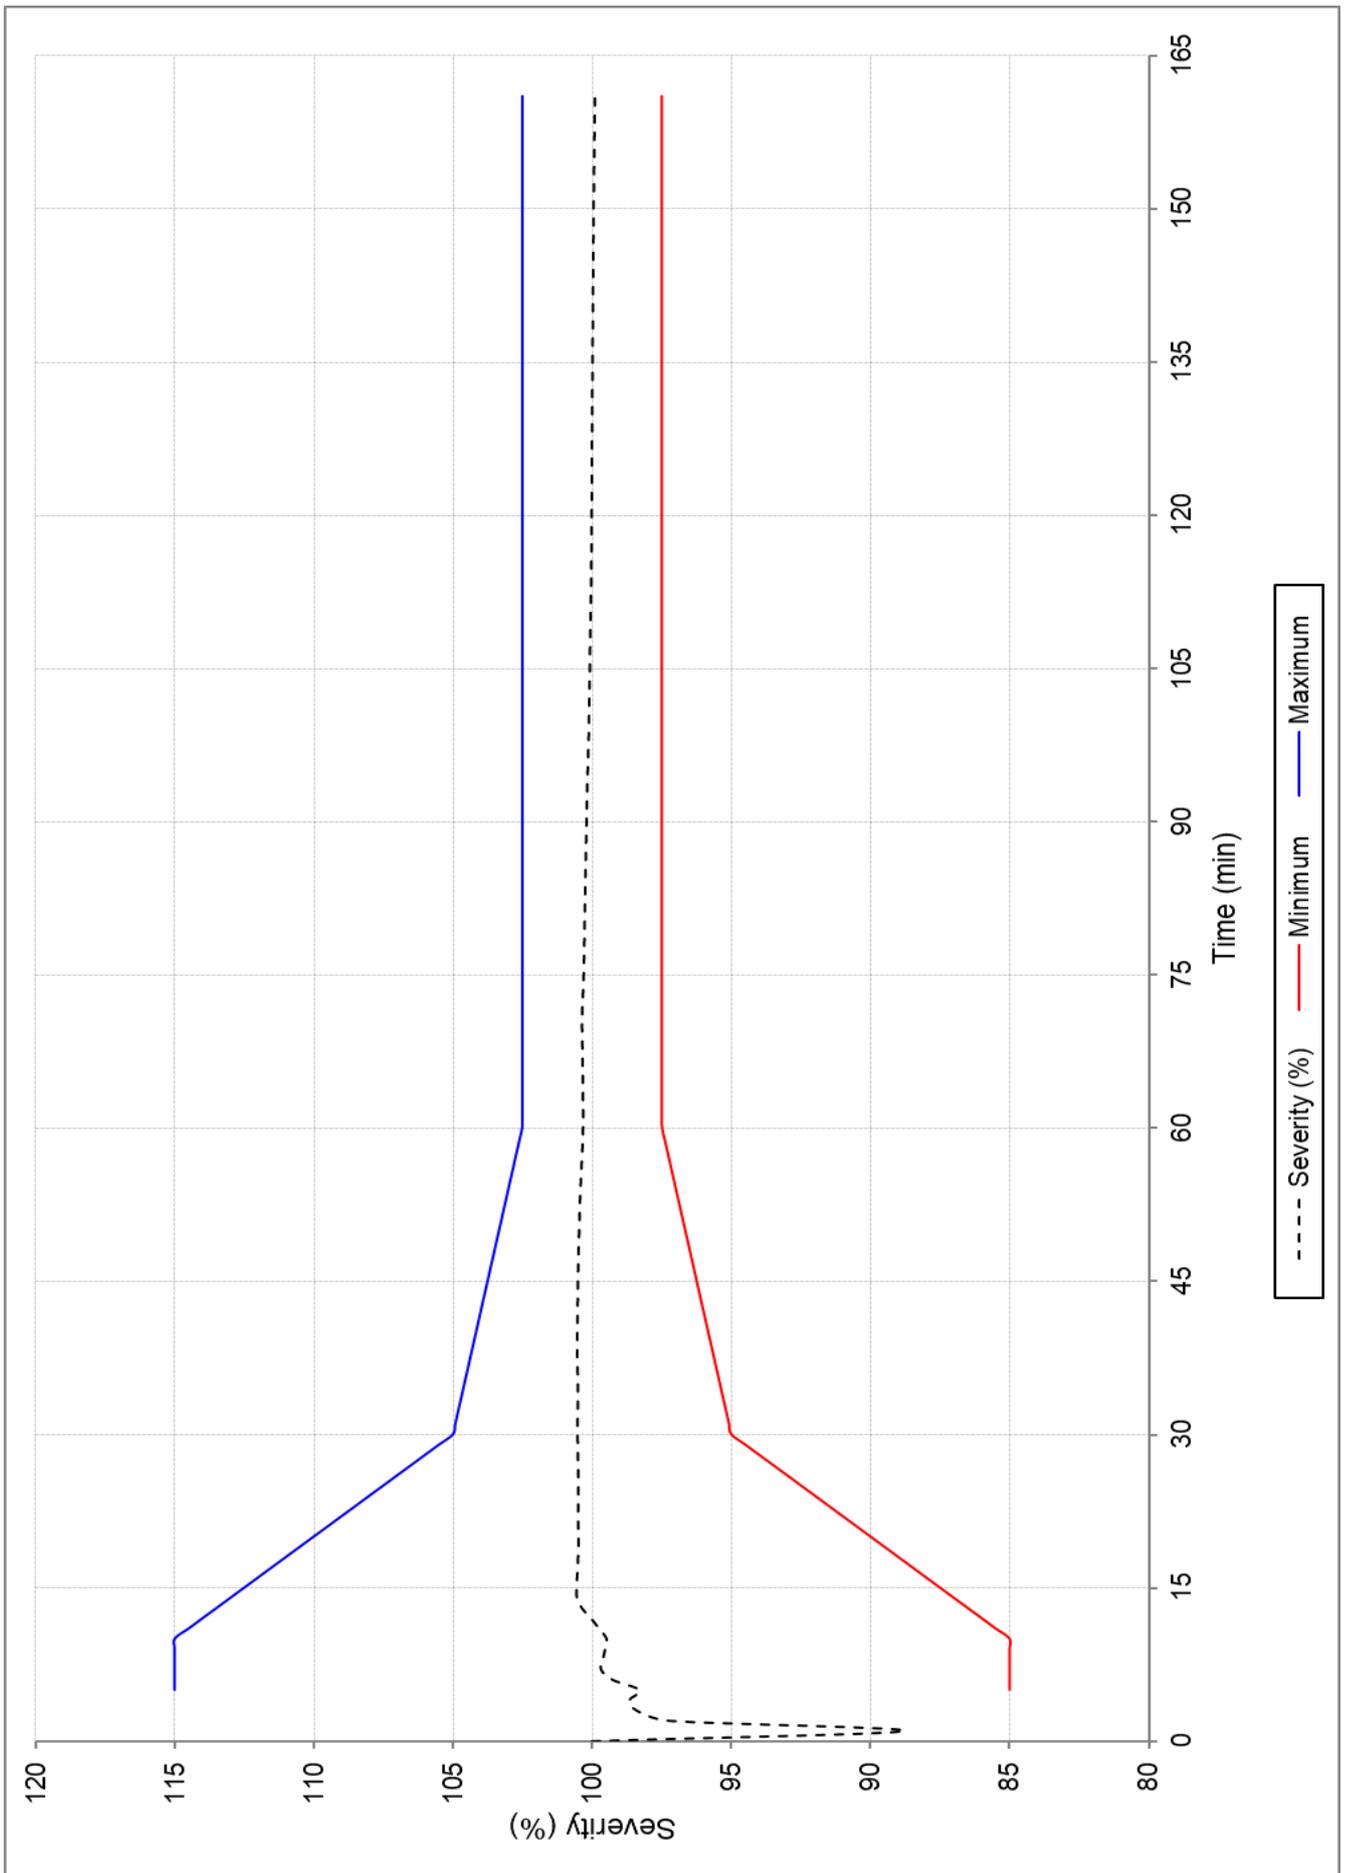
FIGURE 2 – FURNACE SEVERITY

Figure 2 shows the curve of furnace severity versus time during the heating period.

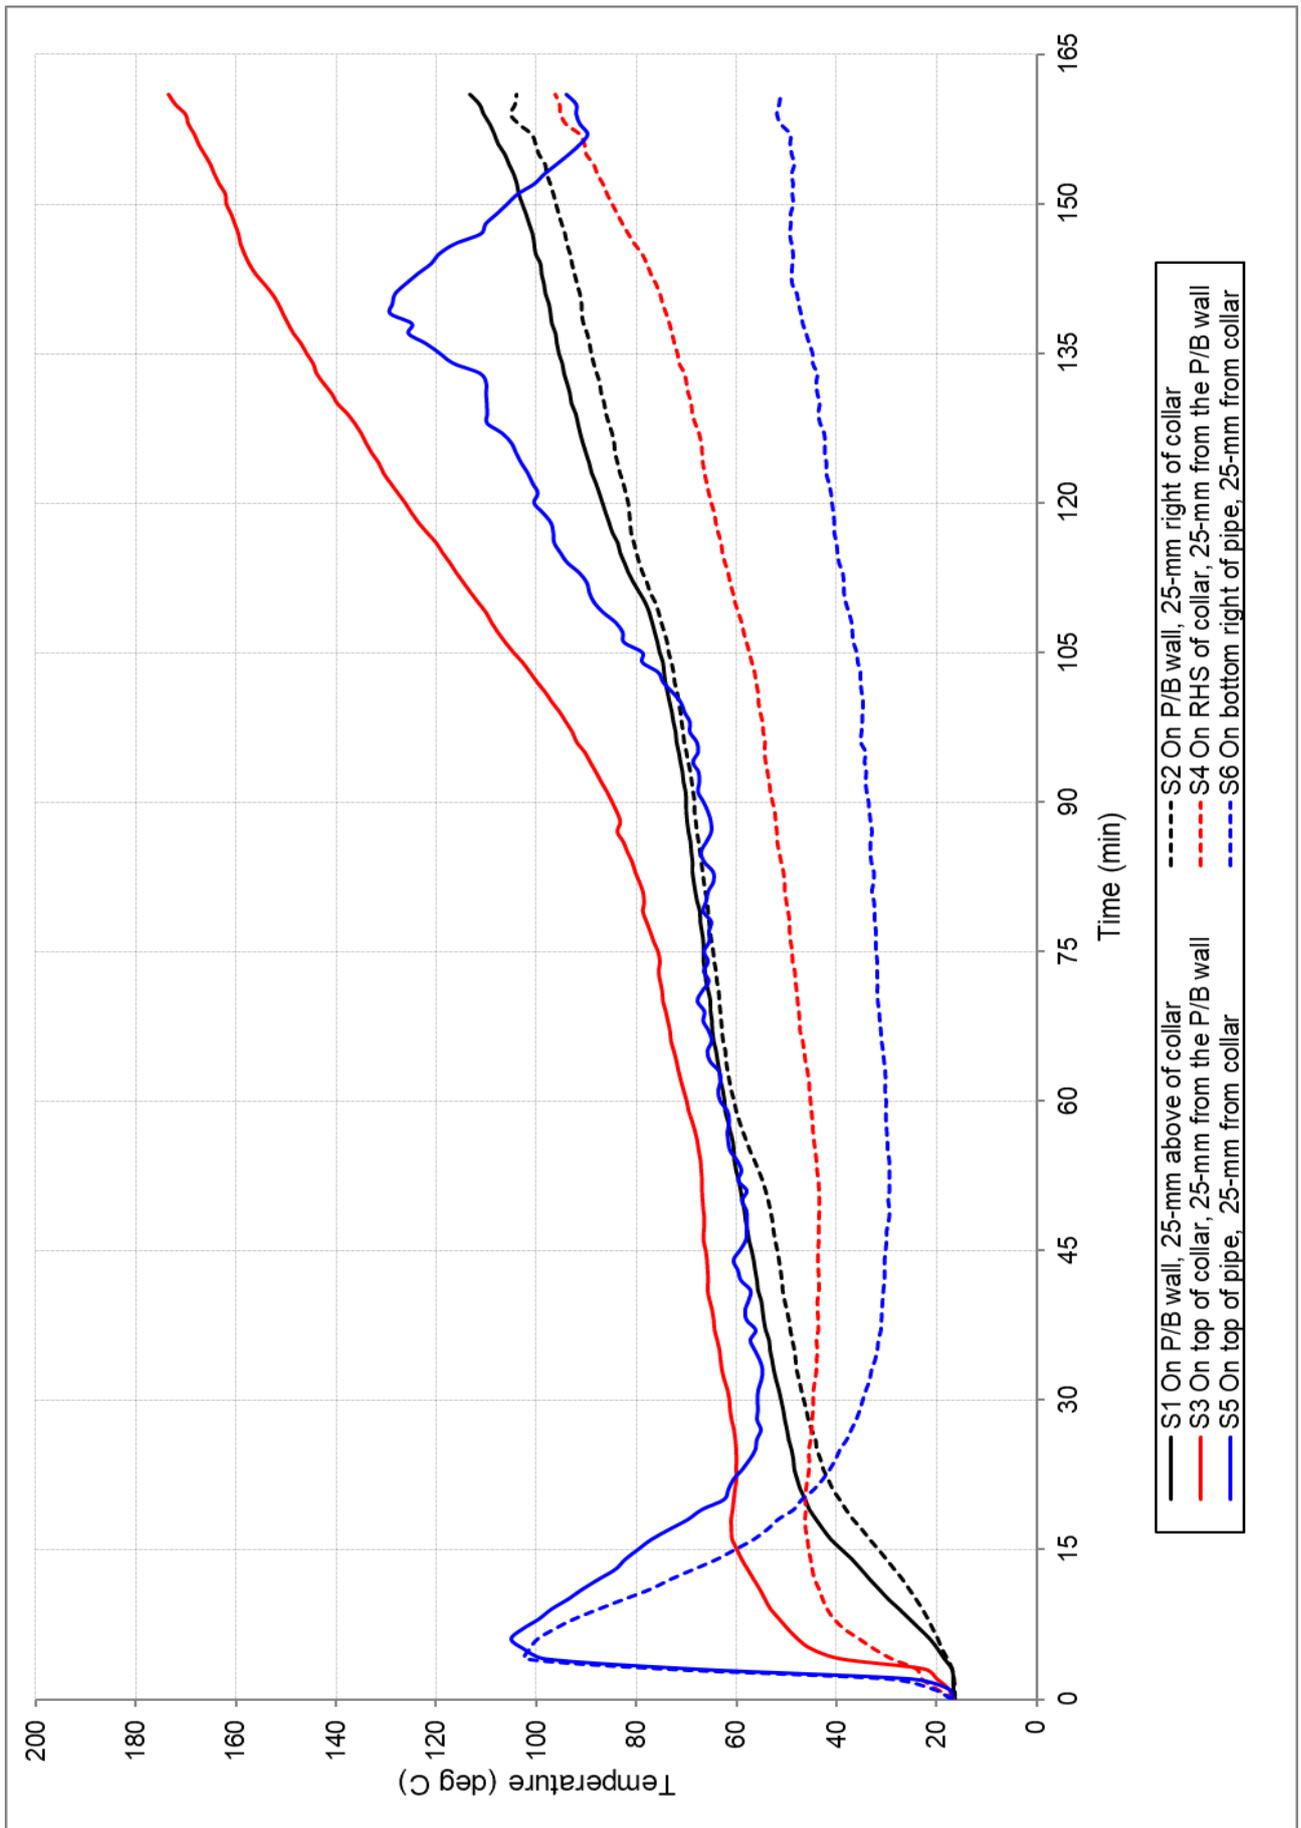
FIGURE 3 - TEMPERATURE VERSUS TIME ASSOCIATED WITH SPECIMEN #1

Figure 3 shows the curve of temperature versus time associated with Specimen 1.

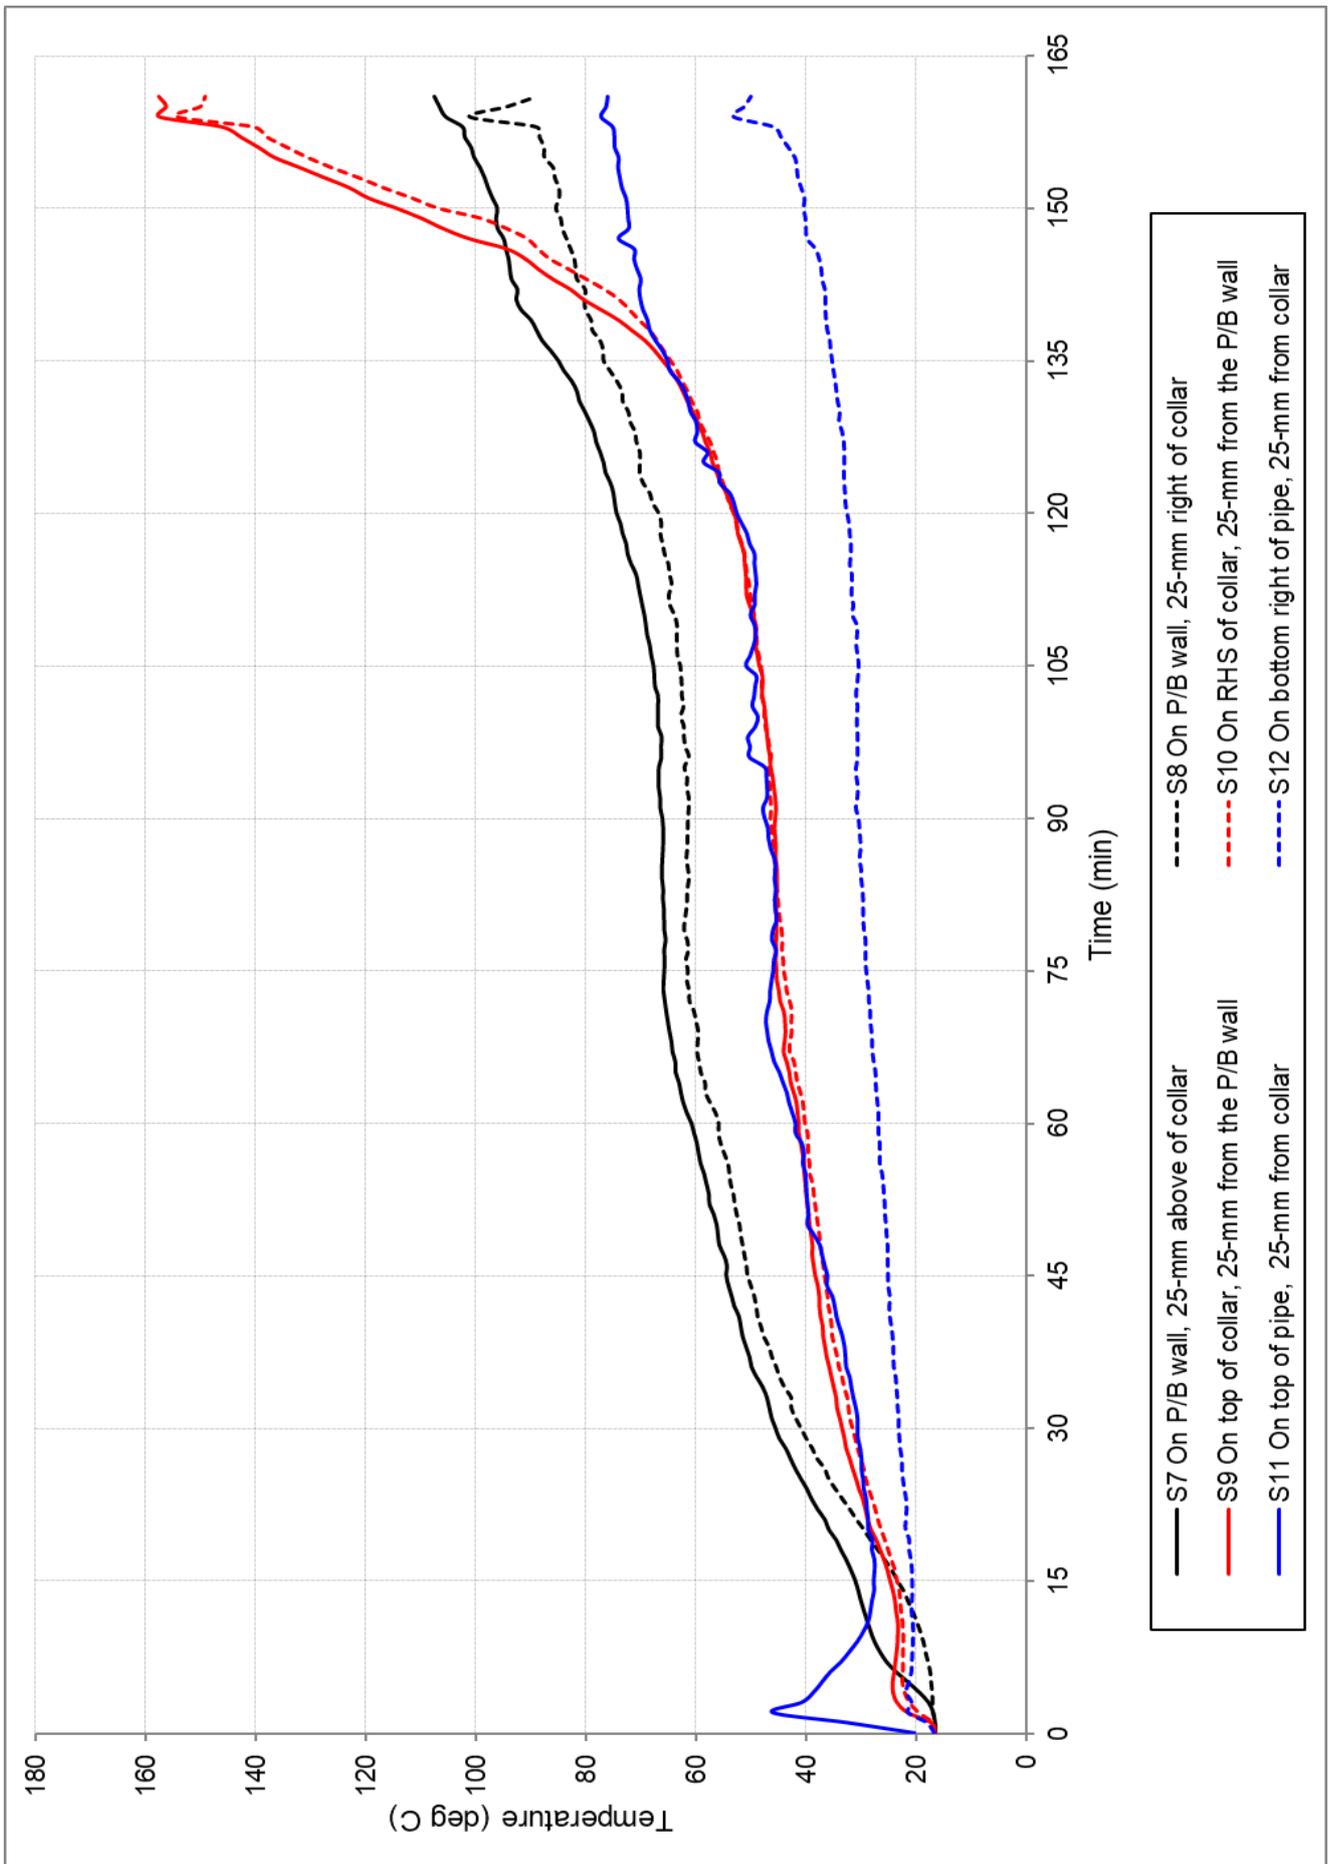
**FIGURE 4 - TEMPERATURE VERSUS TIME ASSOCIATED WITH SPECIMEN #2**

Figure 4 shows the curve of temperature versus time associated with Specimen 2.

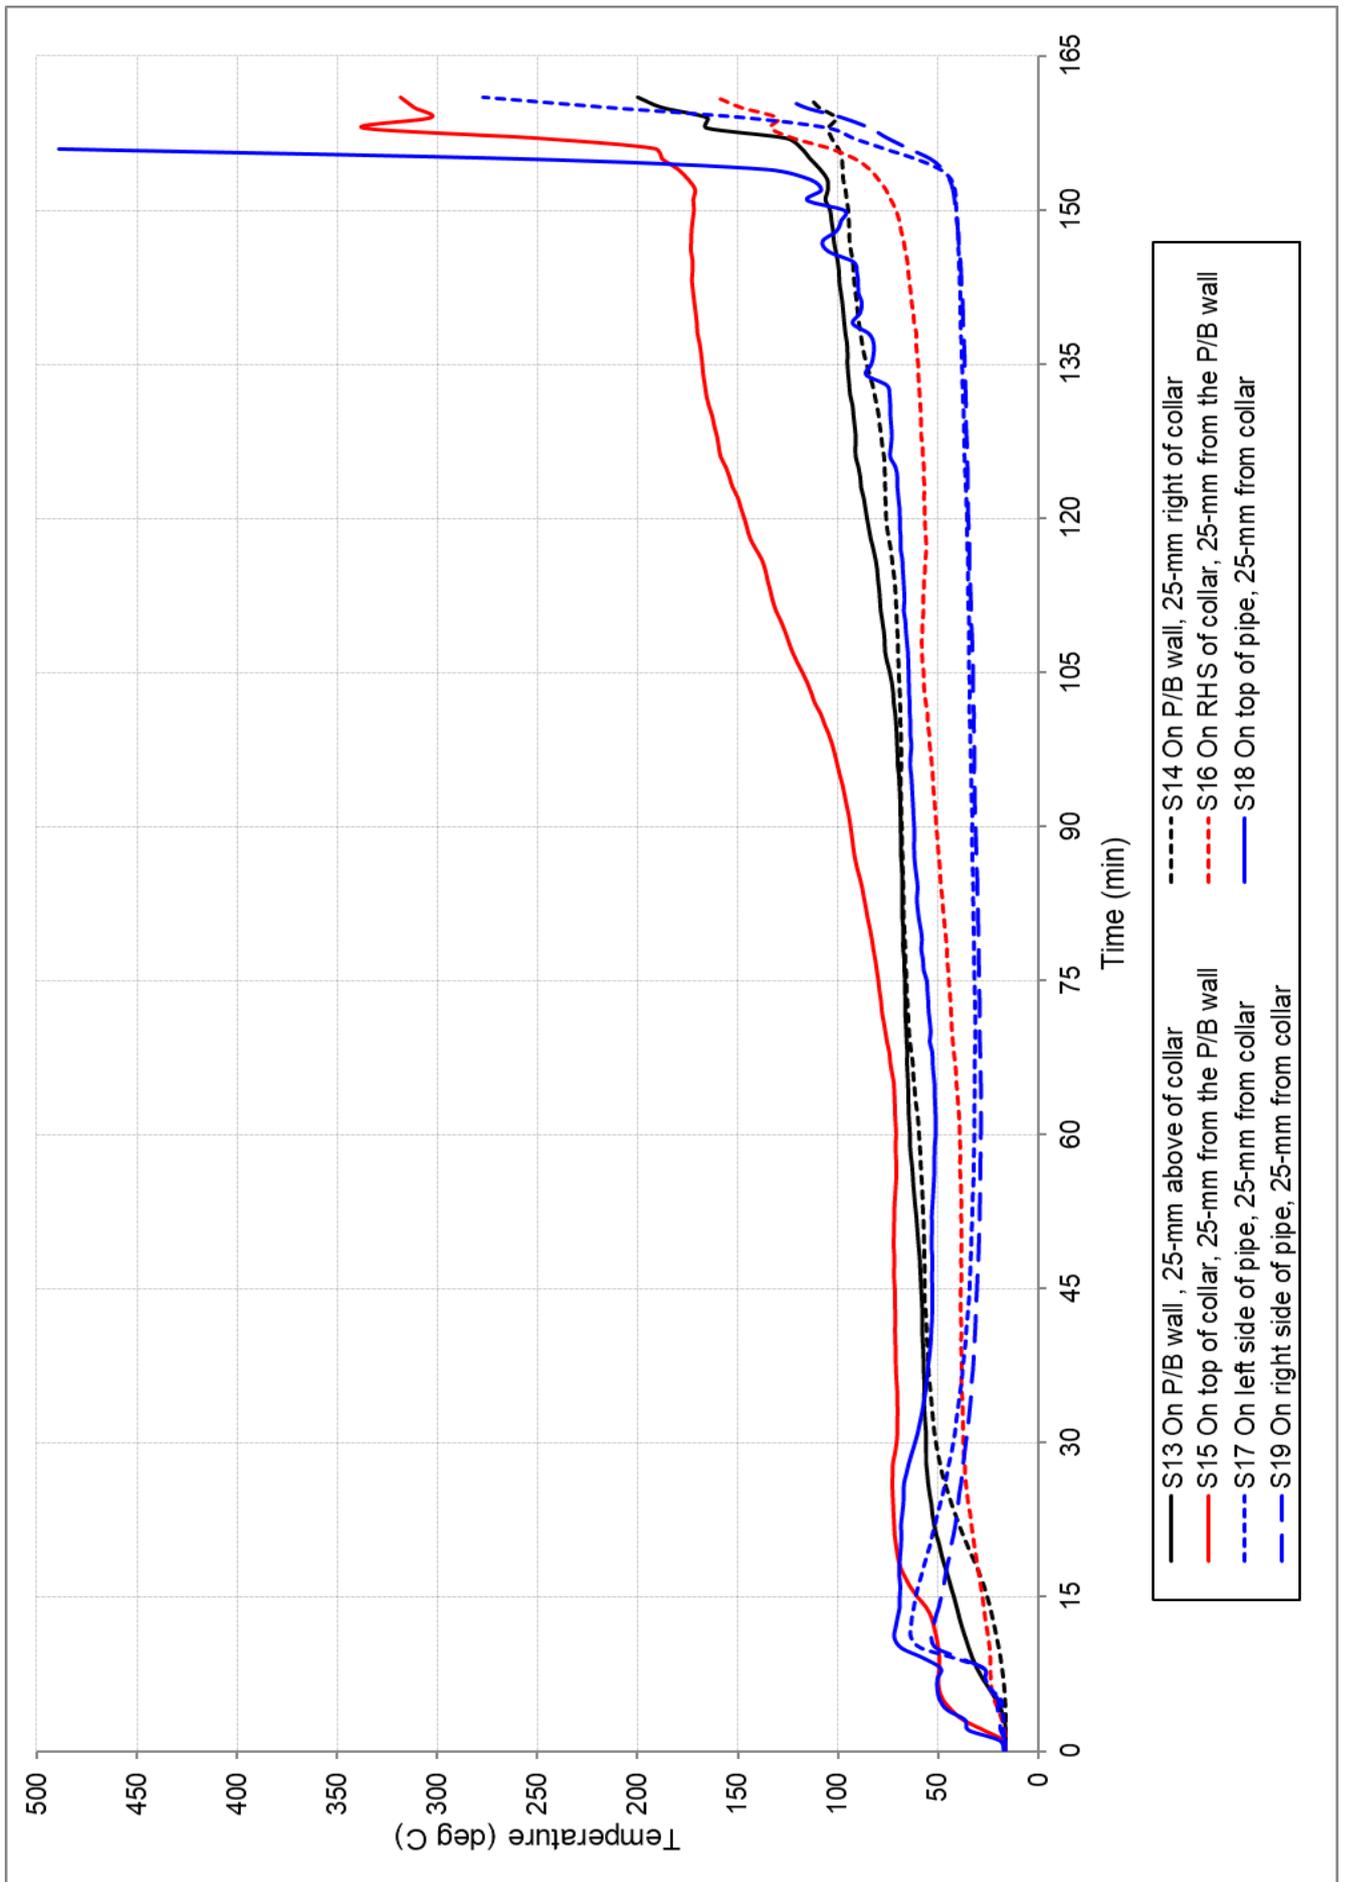
FIGURE 5 - TEMPERATURE VERSUS TIME ASSOCIATED WITH SPECIMEN #3

Figure 5 shows the curve of temperature versus time associated with Specimen 3.

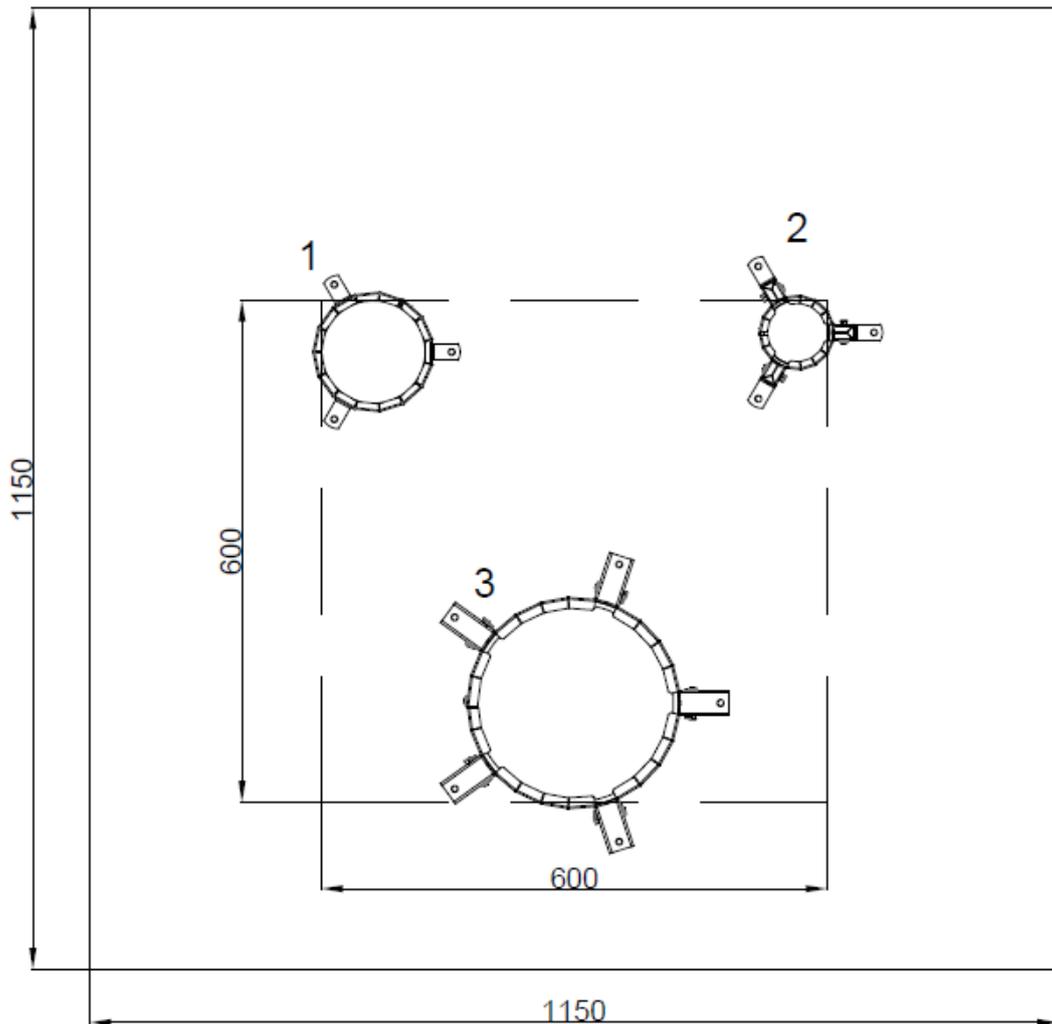
Test Wall W-21-A1 Layout

Penetration	Collar Code	Pipe Type	Pipe Diameter
1	110R	Triplus	110
2	LP50R	PN16 PE100	50
3	LP200R	HDPE	200

**DRAWING TITLED 'TEST WALL W-21-A1 LAYOUT, DATED 29 JULY 2021, BY SNAP FIRE SYSTEMS PTY LTD.**

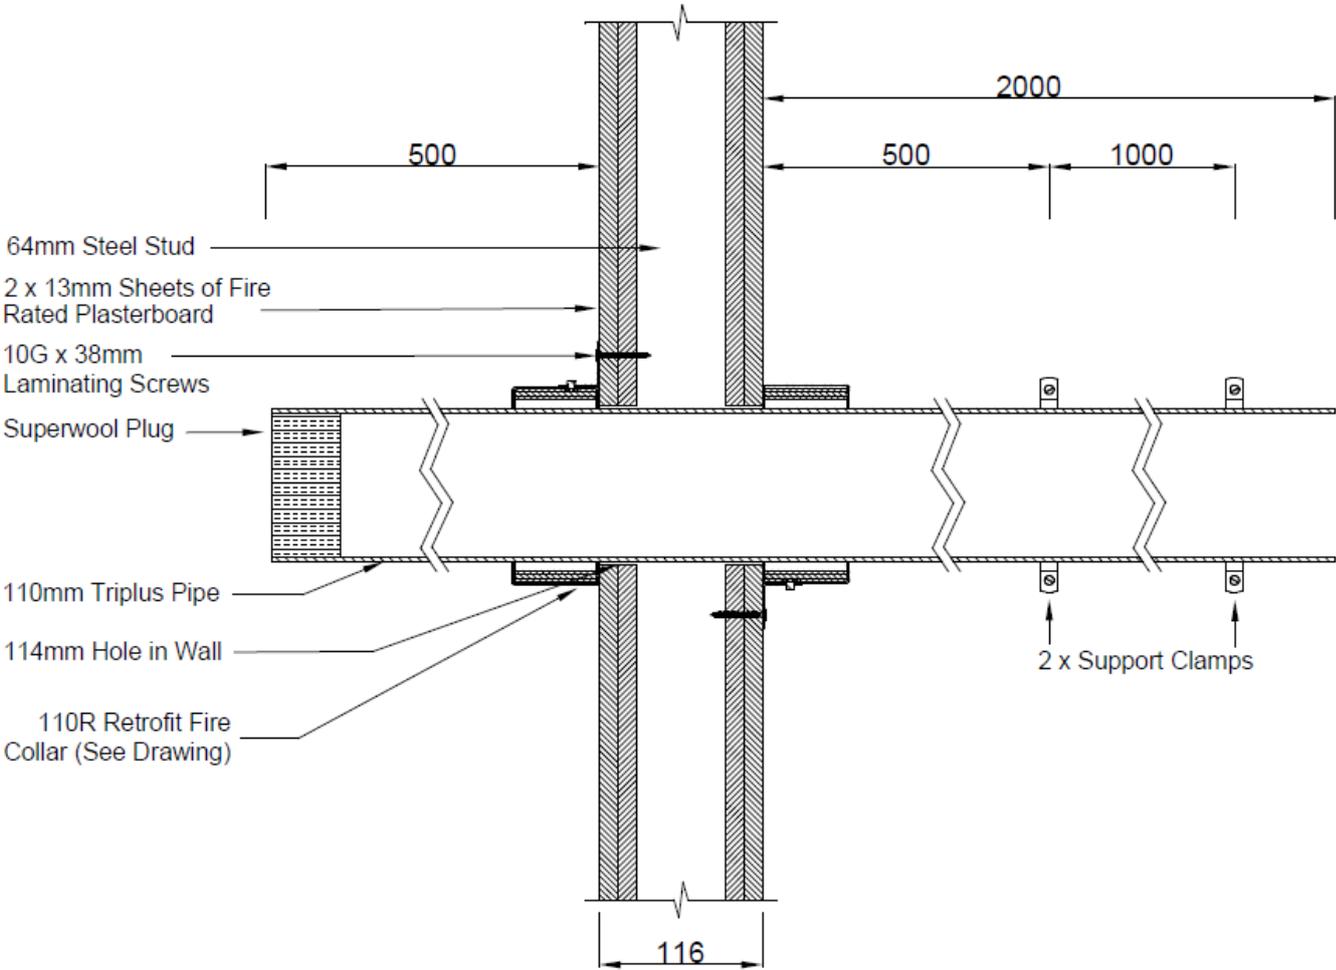
110 Triplus Stack & 110R

DRAWING TITLED 'SPECIMEN #1, 110 TRIPLUS STACK & 110R', DATED 13 SEPTEMBER 2021, BY SNAP FIRE SYSTEMS PTY LTD.

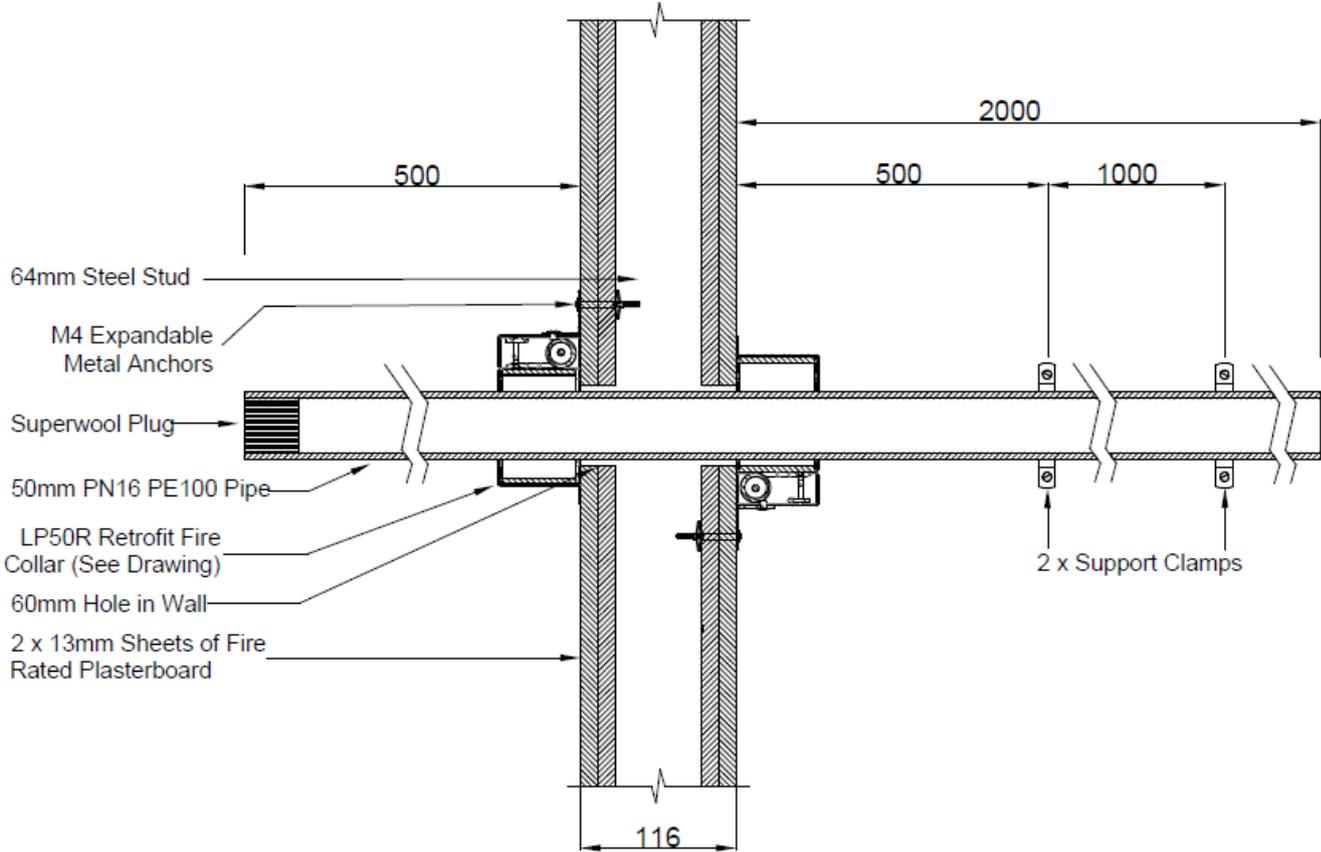
50 PN16 PE100 Stack & LP50R

**DRAWING TITLED 'SPECIMEN #2 50 PN16 PE100 PIPE & LP50R', DATED 16 AUGUST 2021, BY SNAP FIRE SYSTEMS PTY LTD**

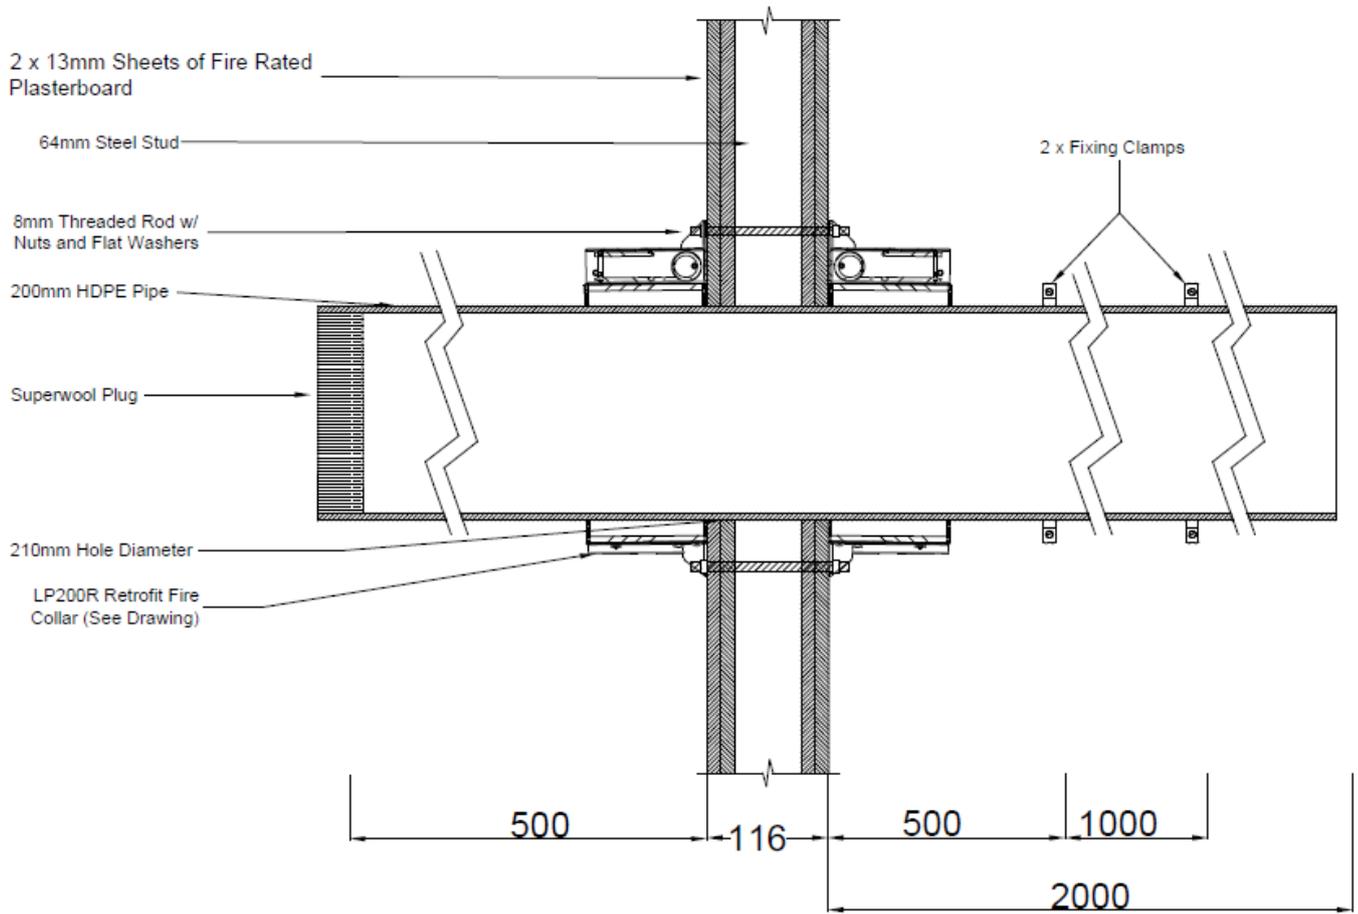
200 HDPE Pipe & LP200R

**DRAWING TITLED 'SPECIMEN #3, 200 HDPE PIPE & LP200R', DATED 16 AUGUST 2021, BY SNAP FIRE SYSTEMS PTY LTD**

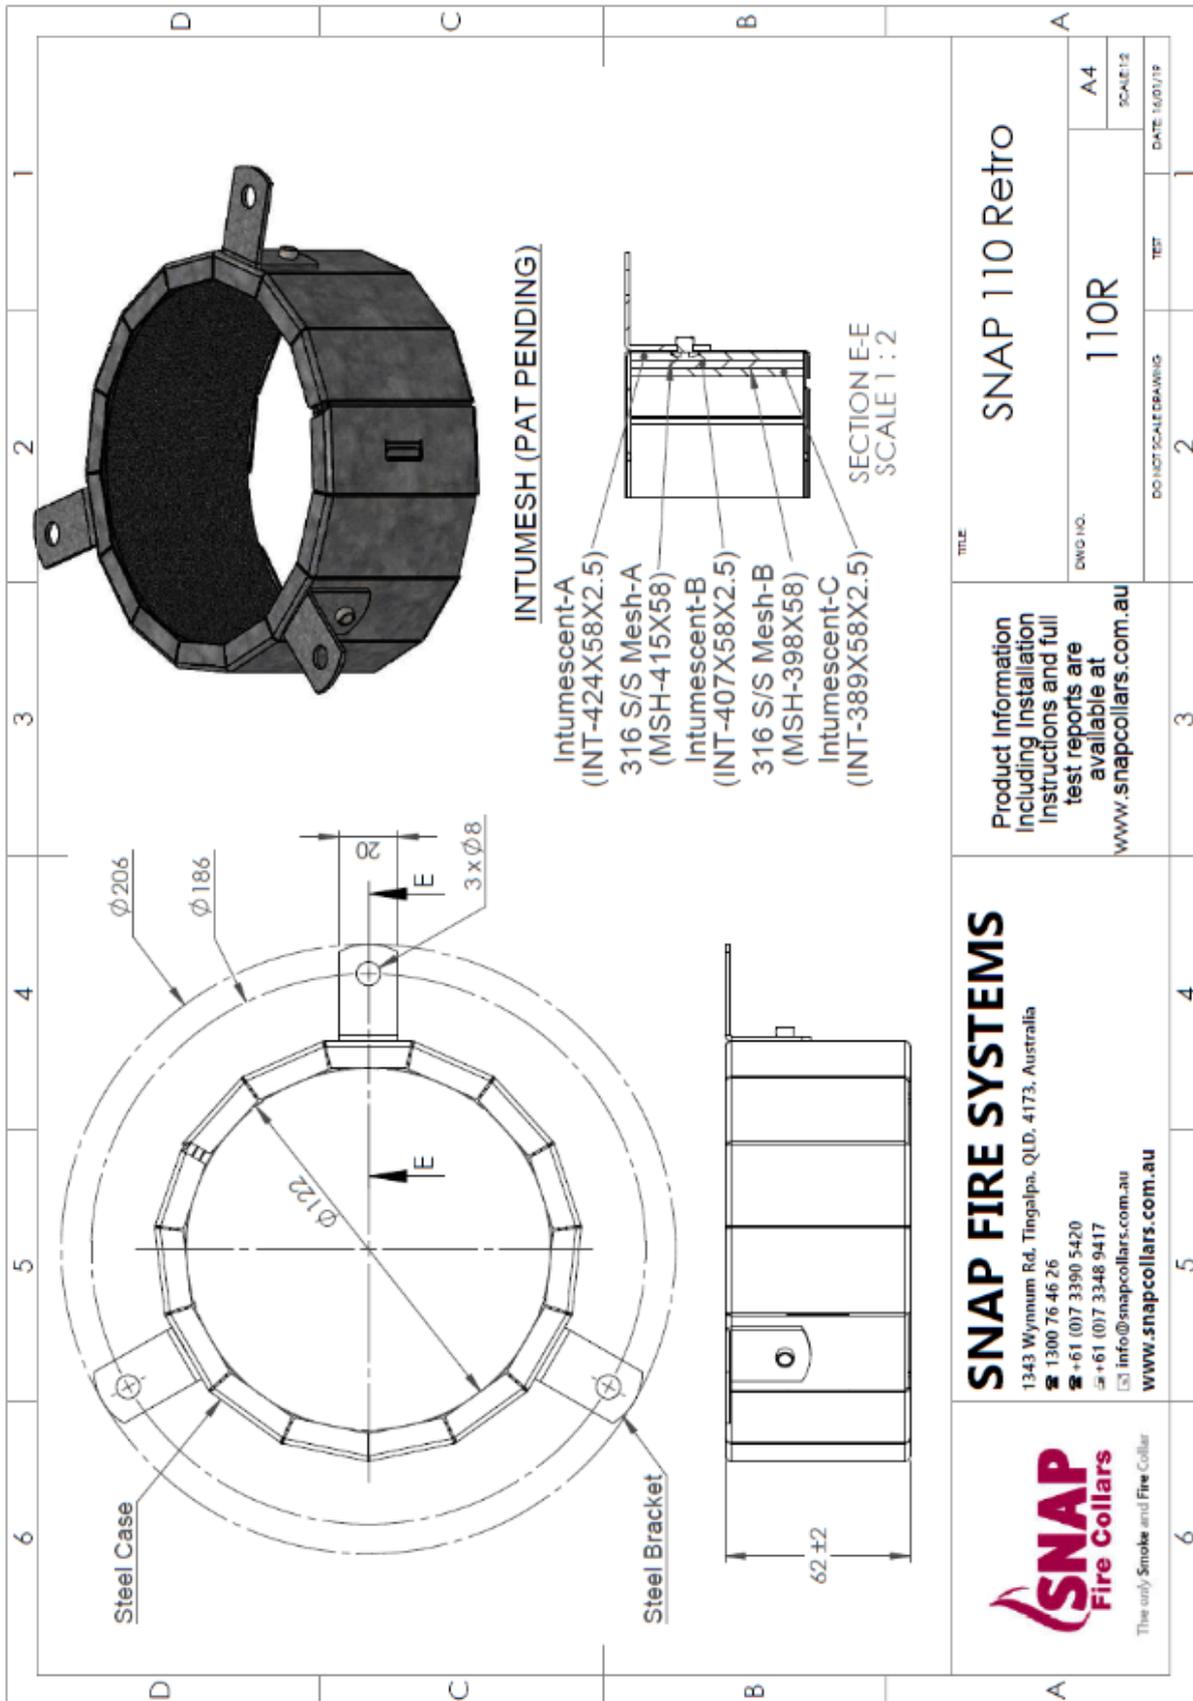
DRAWING TITLED 'SNAP 110 RETRO', DATED 16 JANUARY 2019, BY SNAP FIRE SYSTEMS PTY LTD

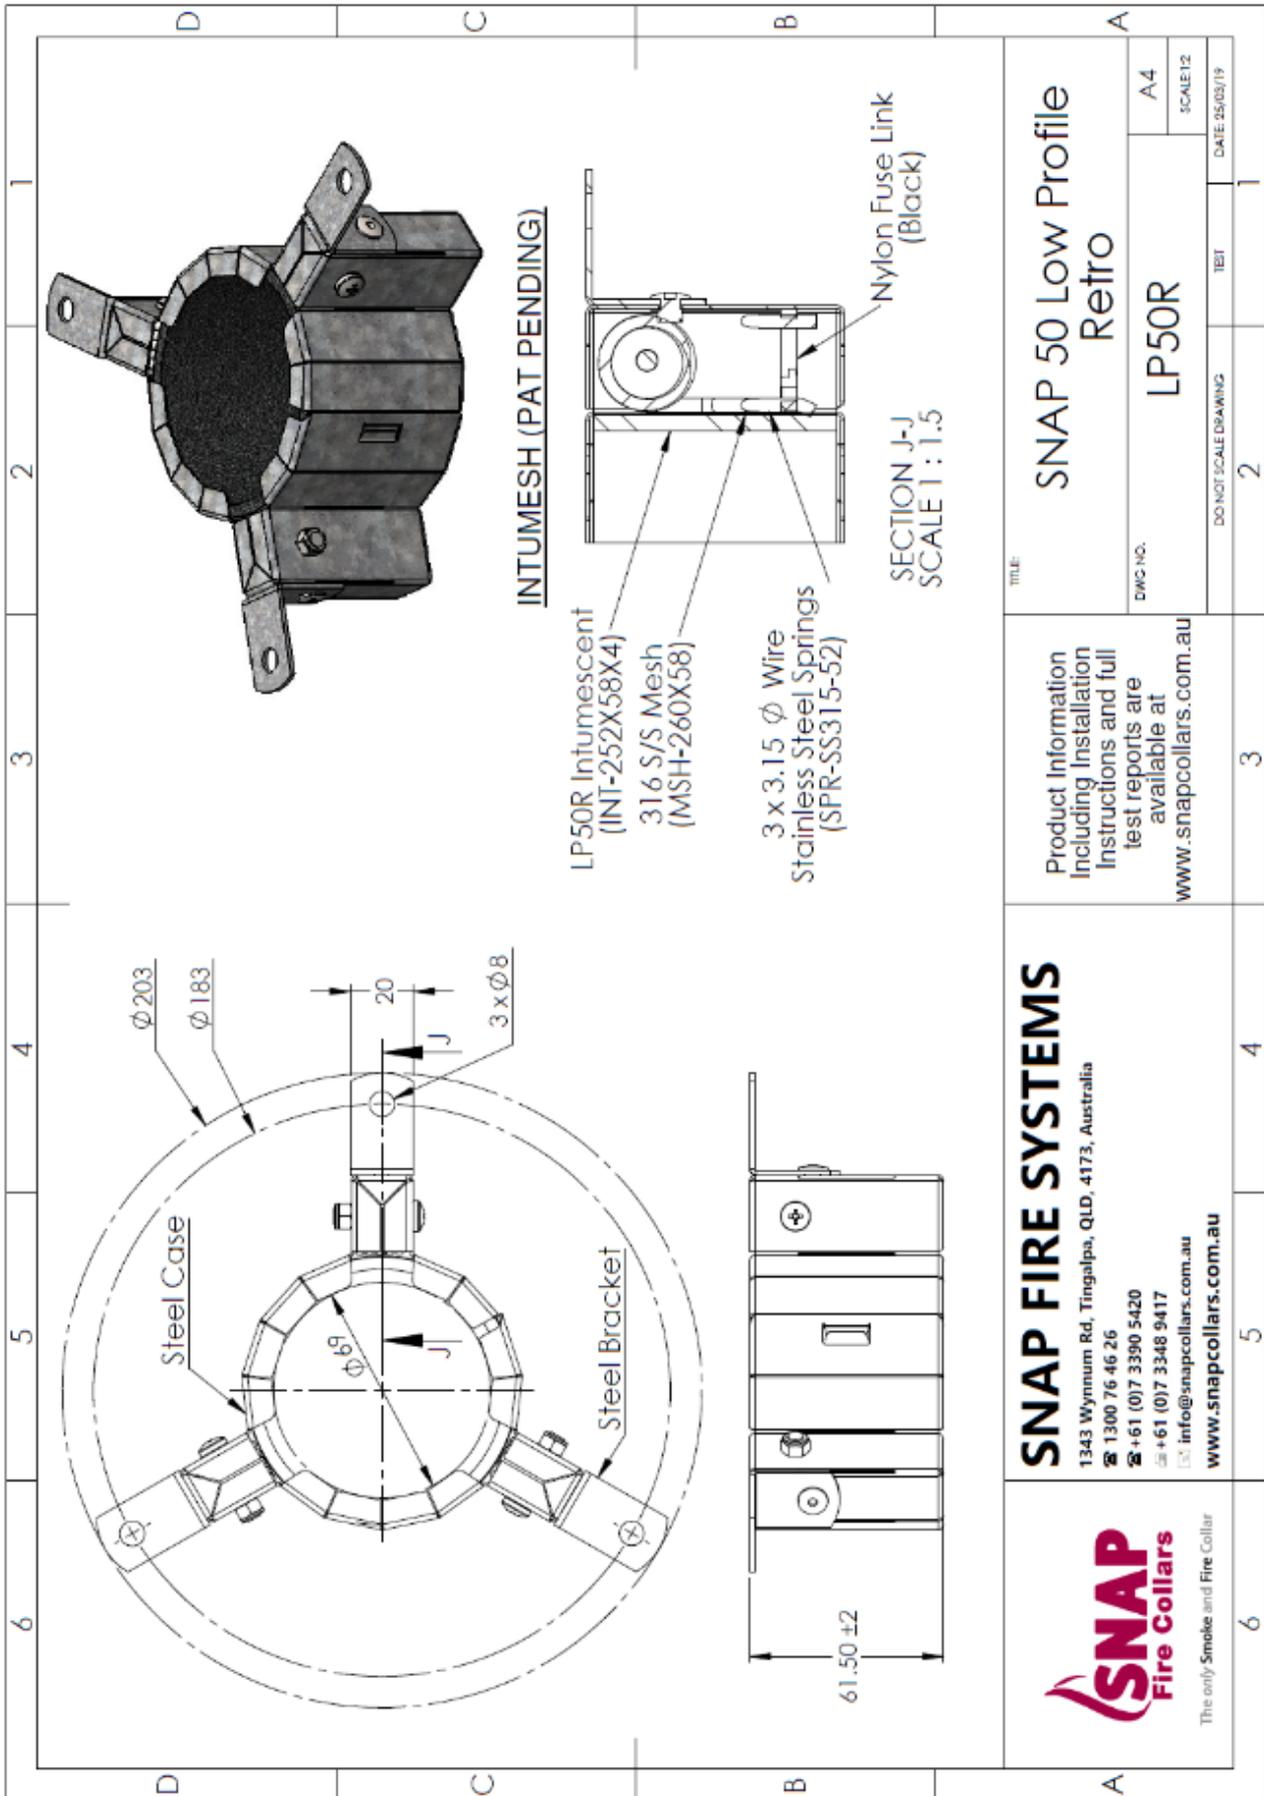
DRAWING TITLED 'SNAP 50 LOW PROFILE RETRO', DATED 25 MARCH 2019, BY SNAP FIRE SYSTEMS PTY LTD

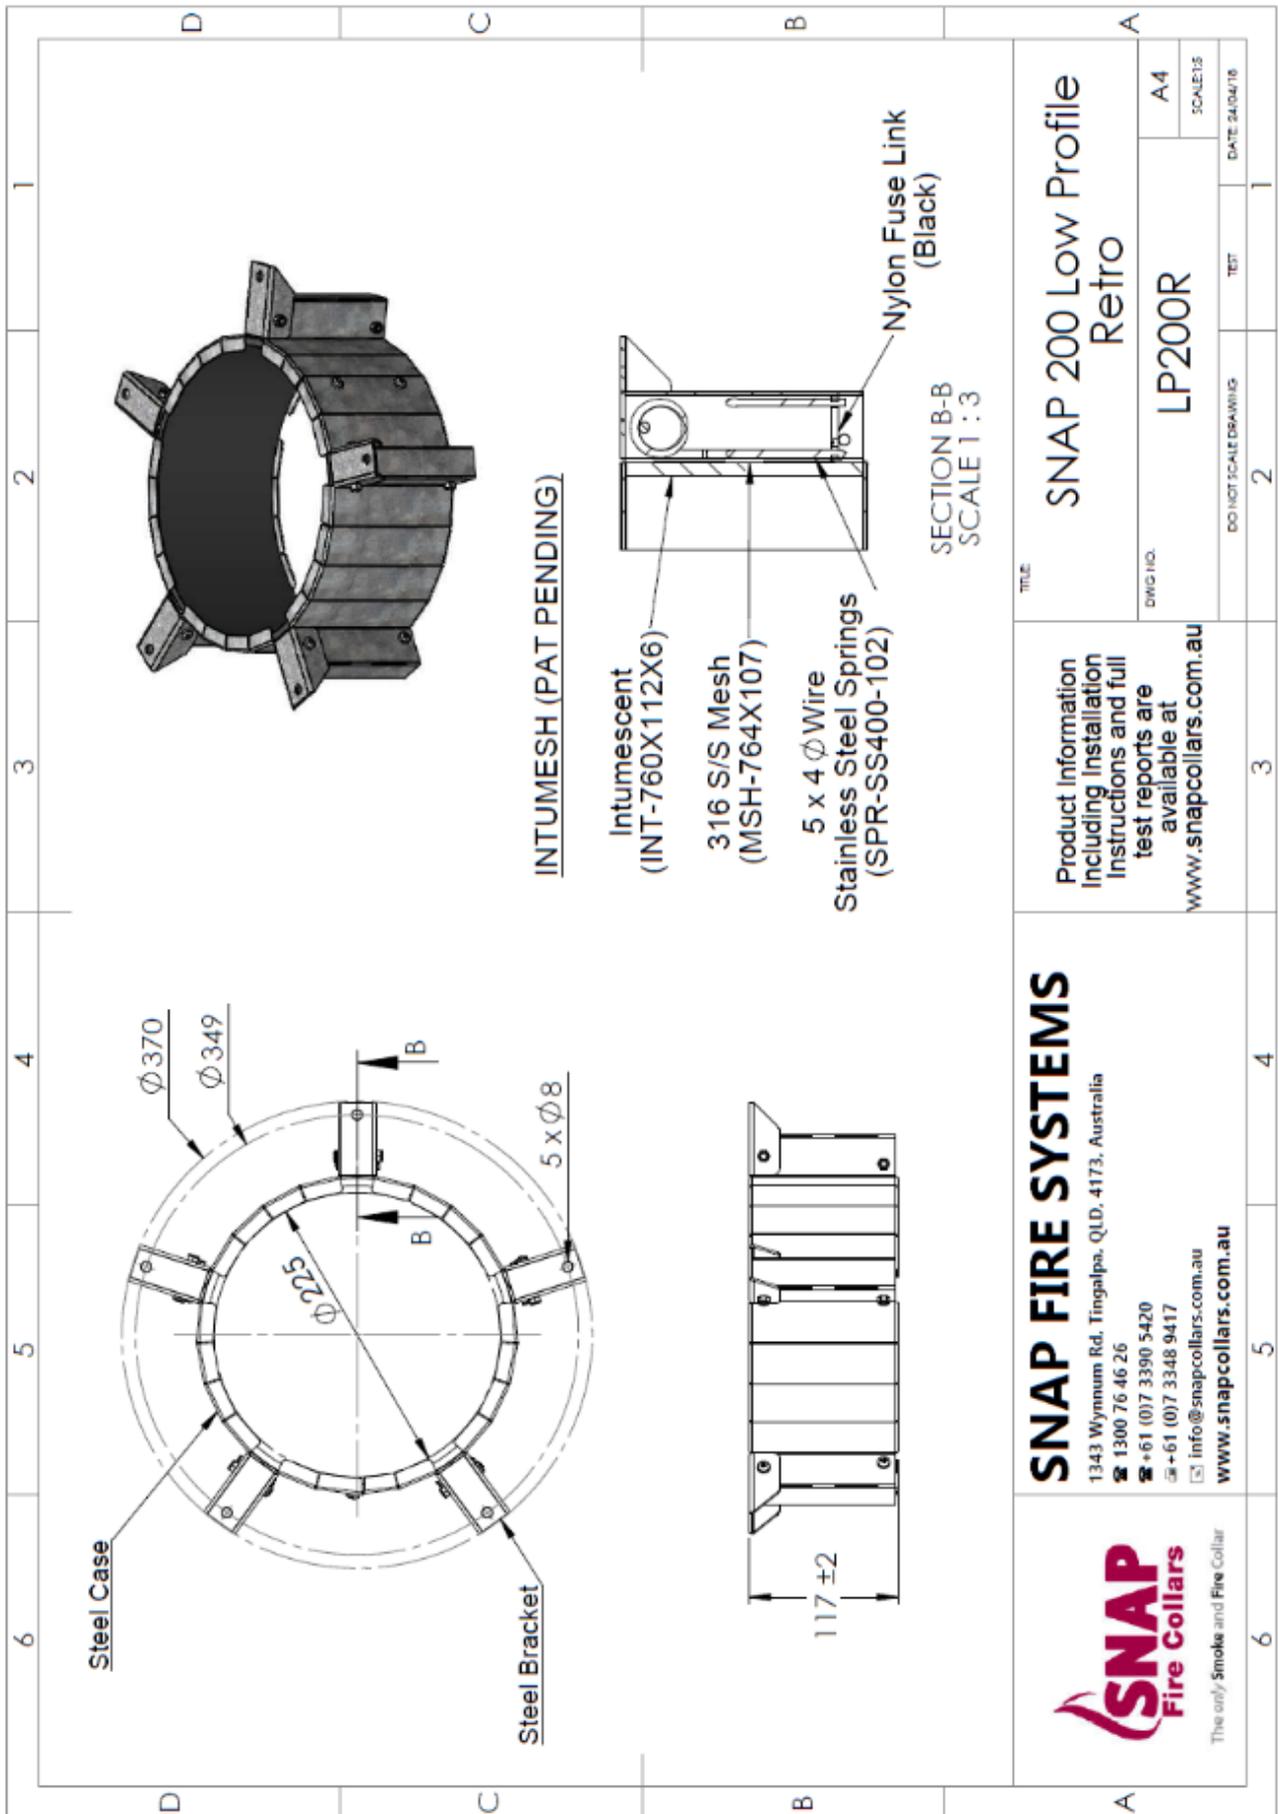
**INTUMESH (PAT PENDING)**

- Intumescent (INT-760X112X6)
- 316 S/S Mesh (MSH-764X107)
- 5 x 4  $\phi$  Wire
- Stainless Steel Springs (SPR-SS400-102)
- Nylon Fuse Link (Black)
