# Fire-resistance test on retrofit fire collars protecting a plasterboard wall penetrated by services

## Test Report

**Author:** Peter Gordon  
**Report number:** FSP 2242  
**Date:** 13 December 2021  
**Client:** IG6 Pty Ltd

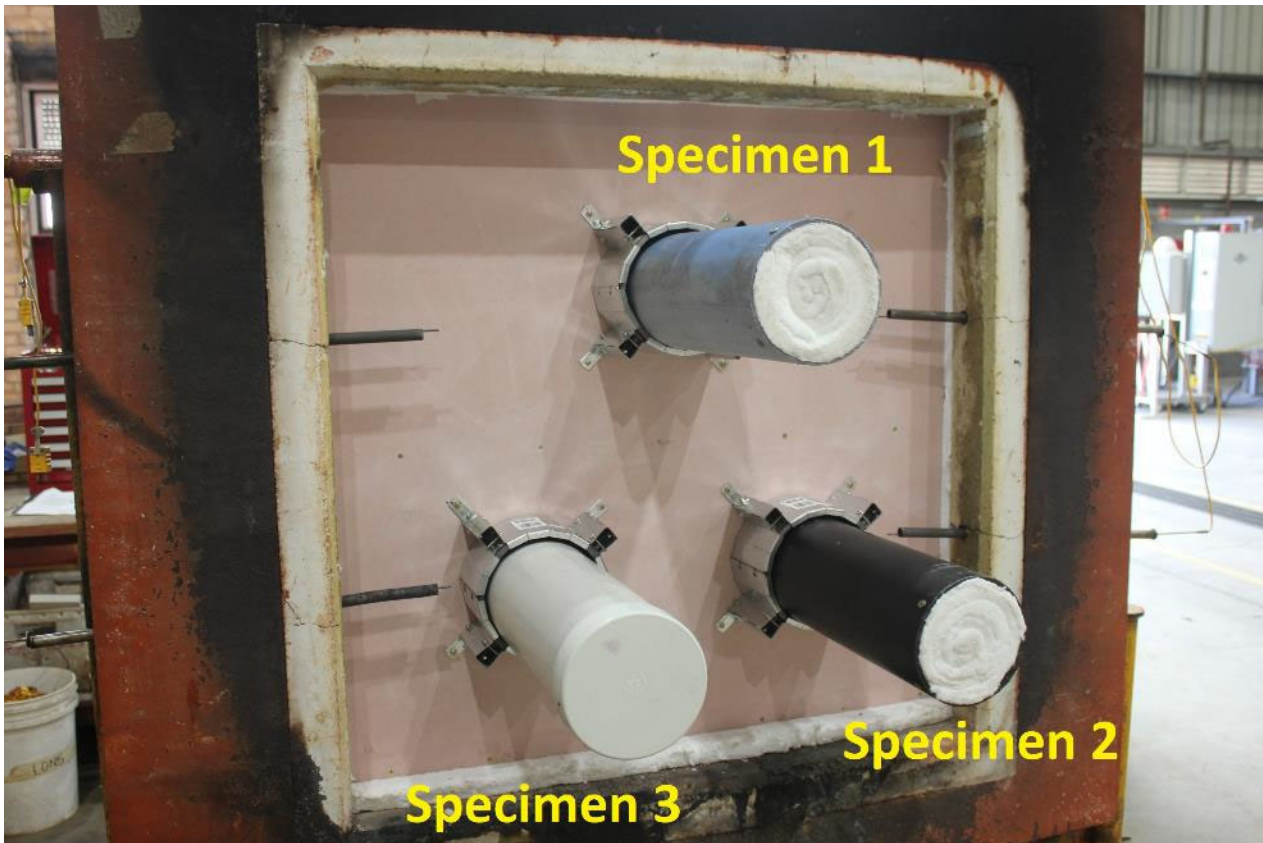
**PHOTOGRAPH 1 – EXPOSED FACE OF SPECIMENS PRIOR TO TESTING**

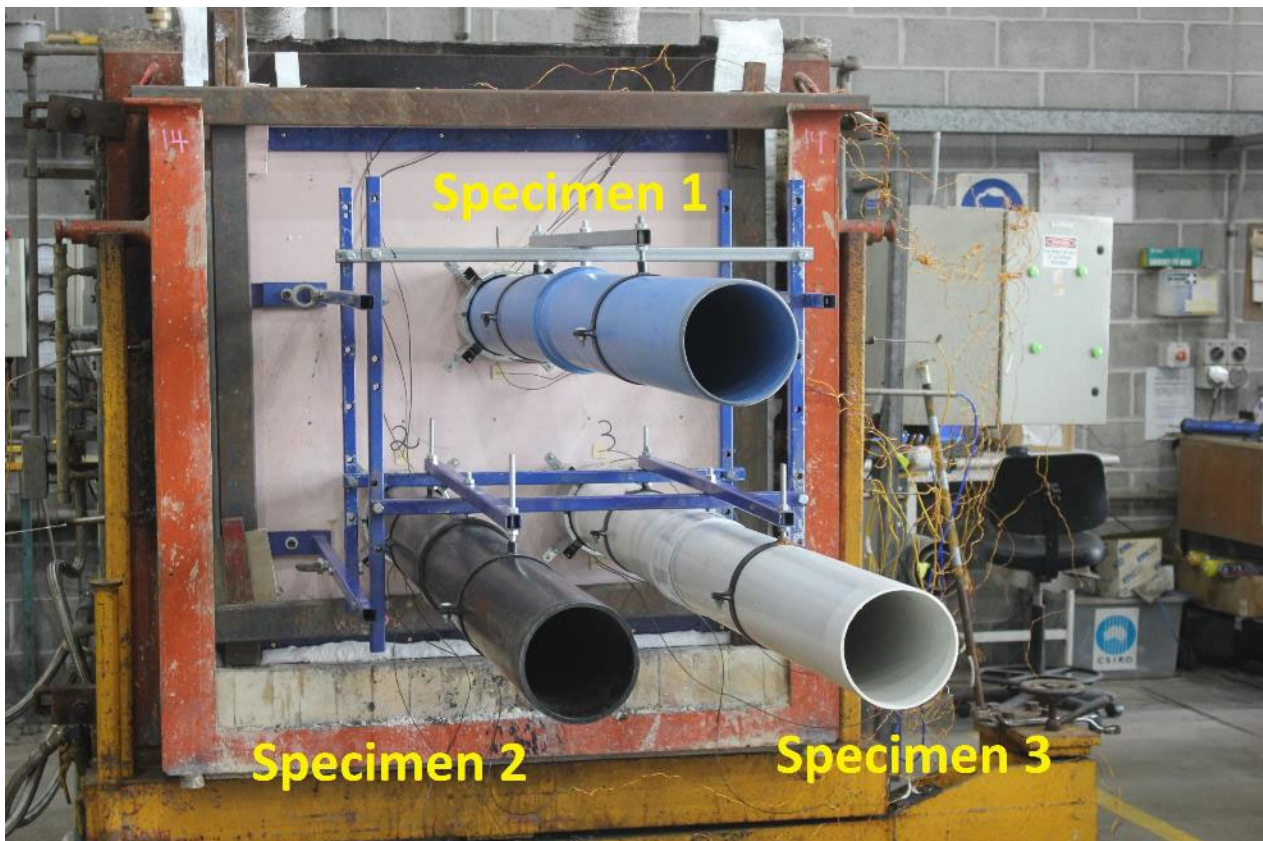
**PHOTOGRAPH 2 – UNEXPOSED FACE OF SPECIMENS PRIOR TO TESTING**

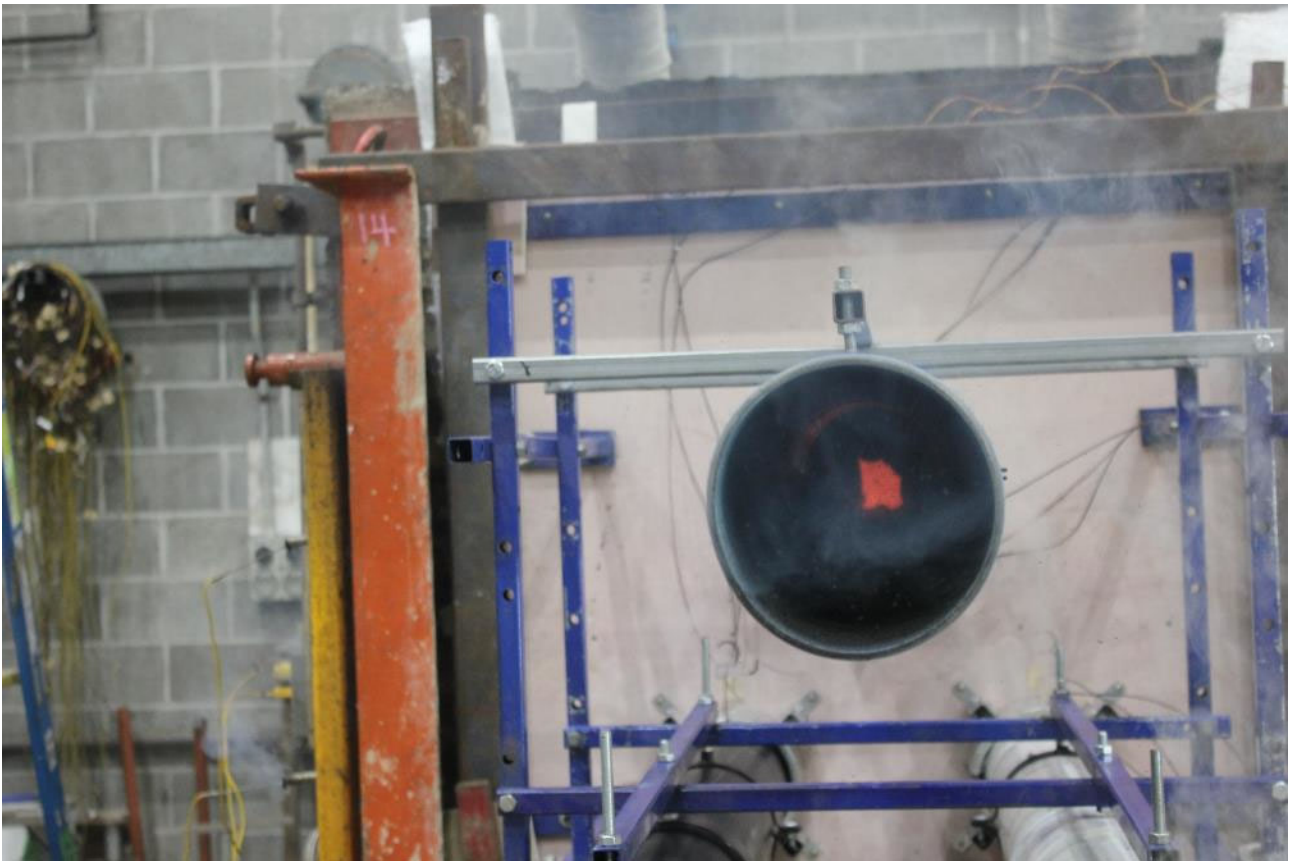
**PHOTOGRAPH 3 – SPECIMEN 1 AFTER 4 MINUTES OF TESTING**

Time	Observation
1 minute -	Smoke is being emitted between the collar and the pipe at the base of Specimens 1, 2 and 3.
2 minutes -	Smoke has started to flue from the end of the pipe of Specimen 3.
3 minutes -	The level of smoke being emitted between the collar and the pipe at the base of Specimens 1, 2 and 3 has intensified.
4 minutes -	Smoke has started to flue from the end of the pipe of Specimen 1. A glow of the furnace can be seen through the pipe of Specimen 1, intumescent material from the collar can be seen swelling and choking the pipe – Photograph 3.
5 minutes -	Smoke has started to flue from the end of the pipe of Specimen 2.
9 minutes -	The level of smoke being emitted between the collar and the pipe at the base of Specimens 1, 2 and 3 has reduced significantly.
11 minutes -	The level of smoke fluing from the pipes of Specimens 1, 2 and 3 has reduced significantly.
13 minutes -	Smoke has ceased fluing from the pipe of Specimen 2.

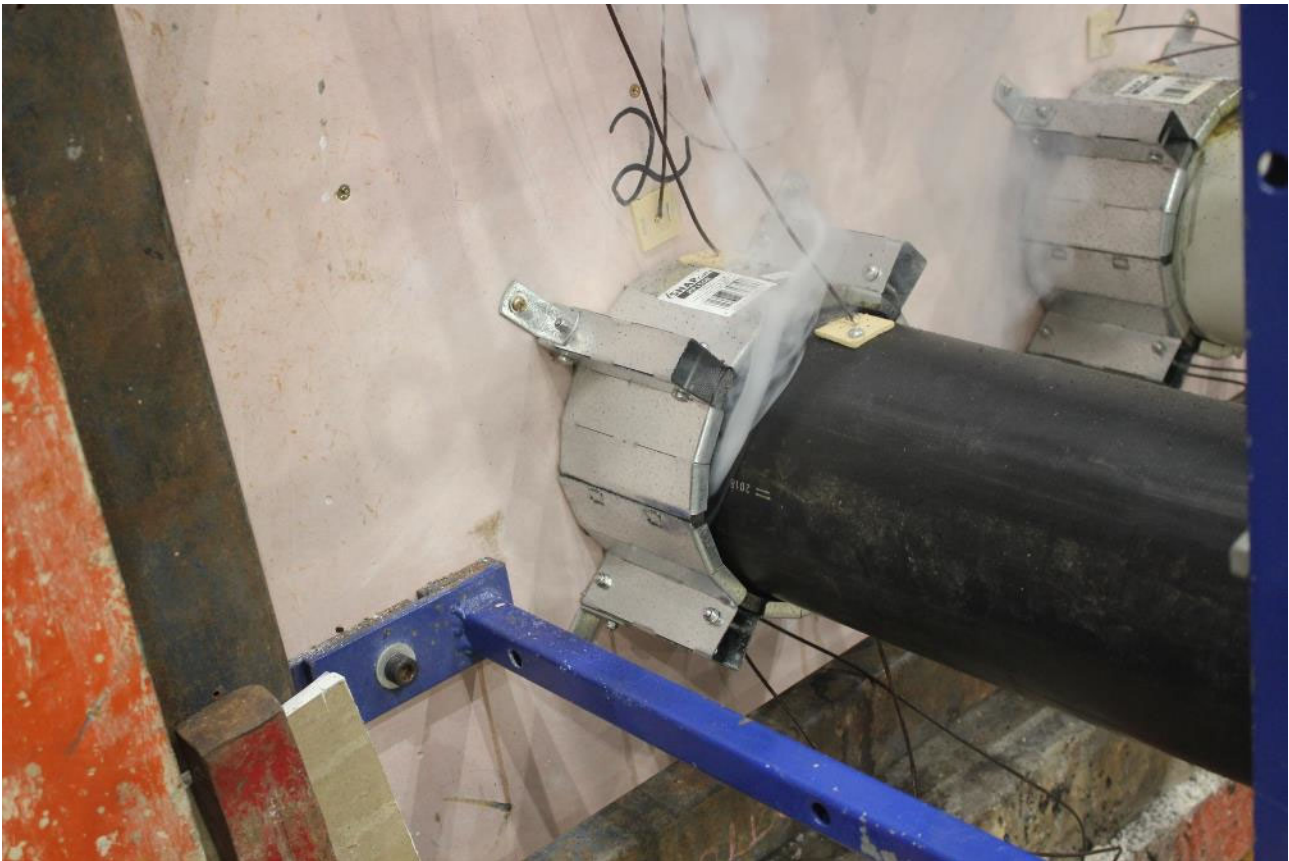
**PHOTOGRAPH 9 – SPECIMEN 2 AFTER 112 MINUTES OF TESTING**

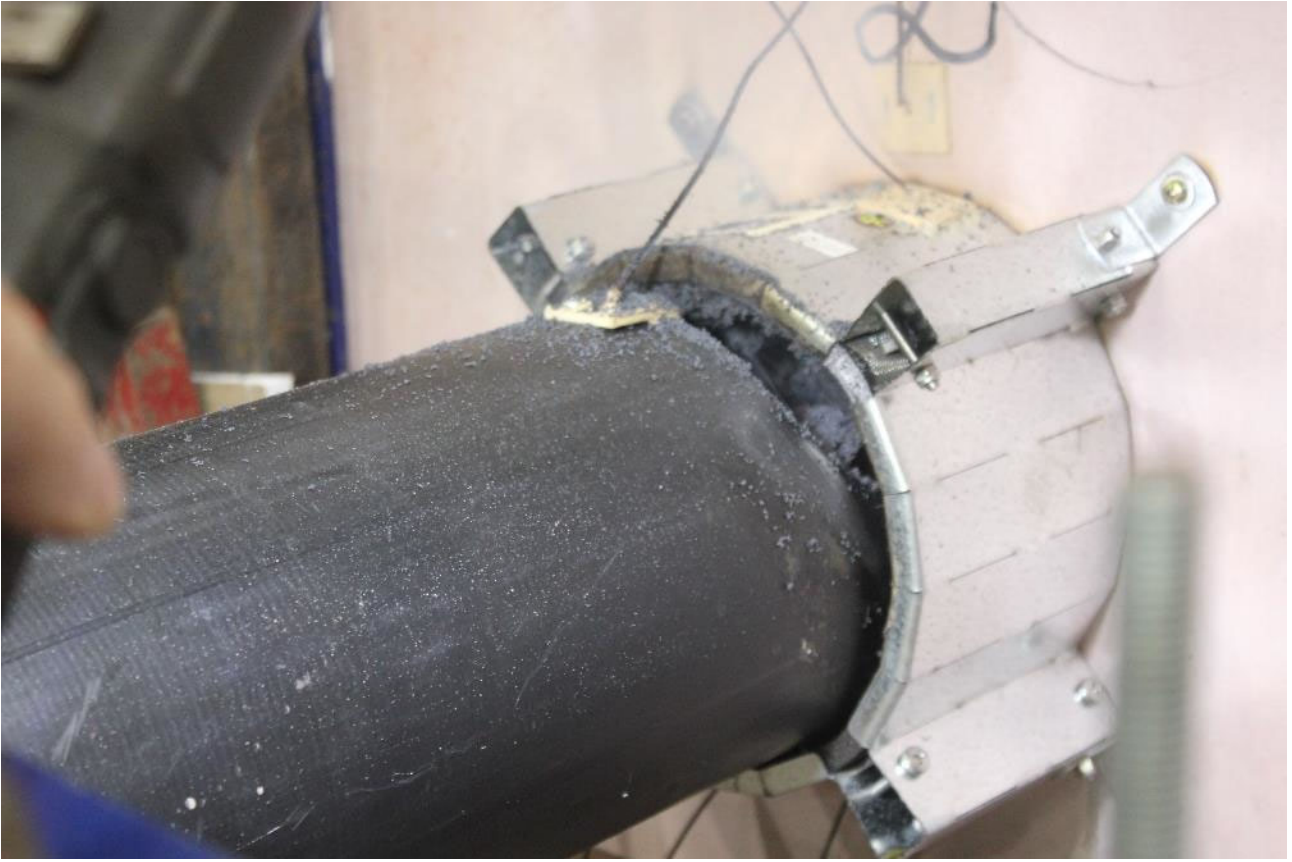
**PHOTOGRAPH 12 –SPECIMEN 2 AFTER 116 MINUTES OF TESTING**

- 116 minutes - The intumescent material has swollen and filled the gap between the pipe and the collar of Specimen 2.
- 129 minutes - The top of the pipe inside the collar of Specimen 3 has soften and collapsed, the level of smoke being emitted from the collar at the base of the specimen has increased. Cotton pad test applied over the gap between the deformed pipe and the collar at the base of Specimen 3, no ignition of cotton pad noted at this time.

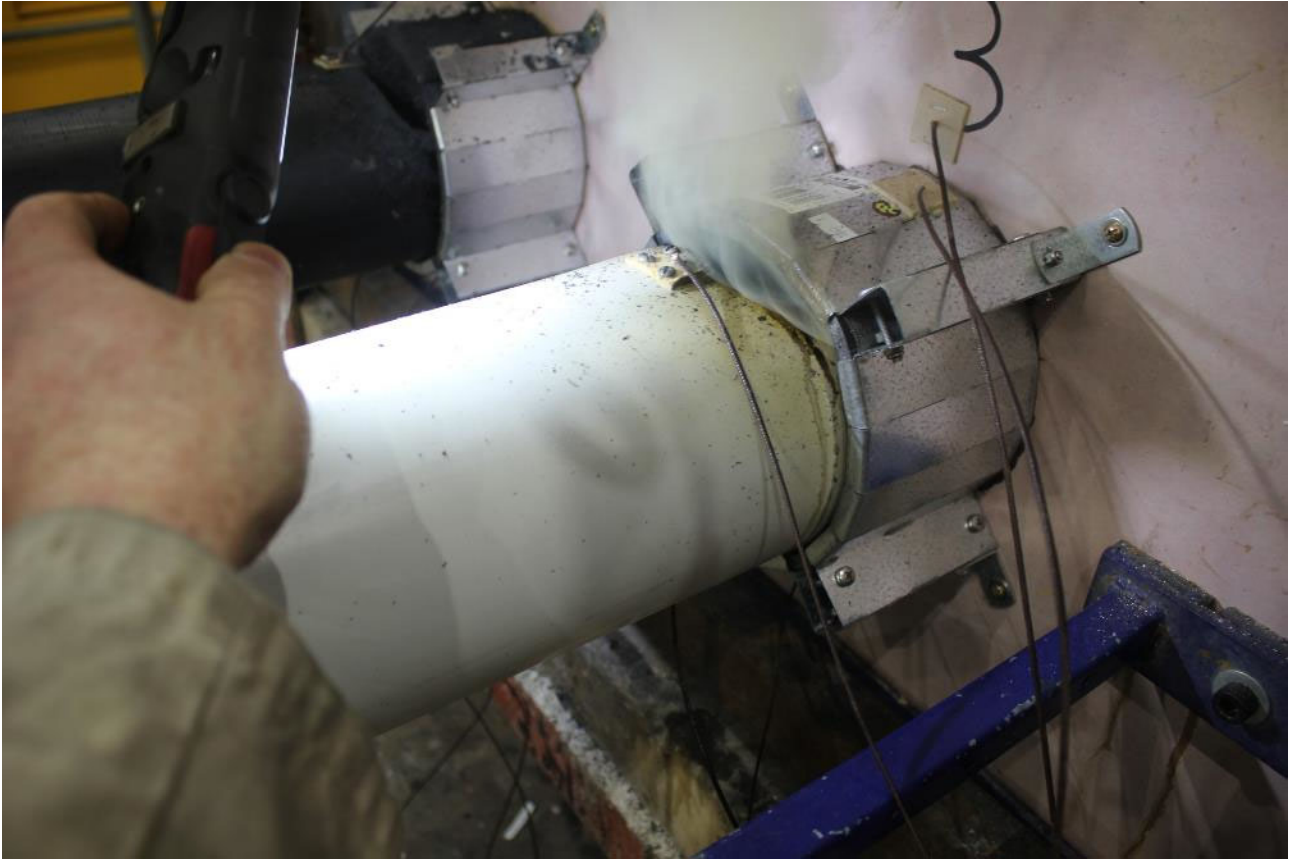
**PHOTOGRAPH 14 –SPECIMEN 2 AFTER 129 MINUTES OF TESTING**

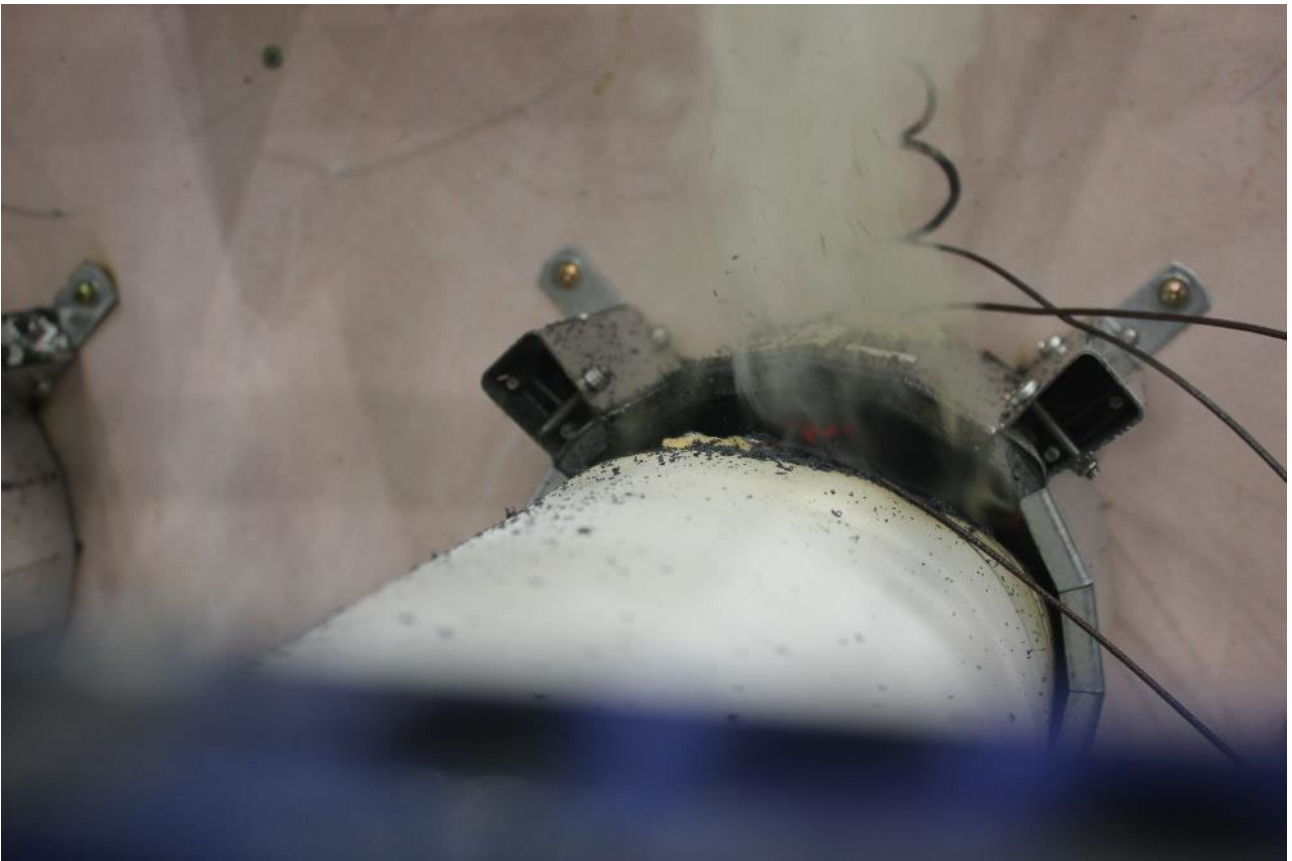
**PHOTOGRAPH 15 –SPECIMEN 3 AFTER 133 MINUTES OF TESTING**

- 130 minutes - Insulation failure of Specimen 2 – maximum temperature rise of 180K is exceeded on the top of the collar, 25-mm from the wall.
- 133 minutes - Insulation failure of Specimen 3 – maximum temperature rise of 180K is exceeded on the top of the pipe, 25-mm from the collar.  
A red glow of the furnace can be seen between the collar and the pipe at the base of specimen 3.

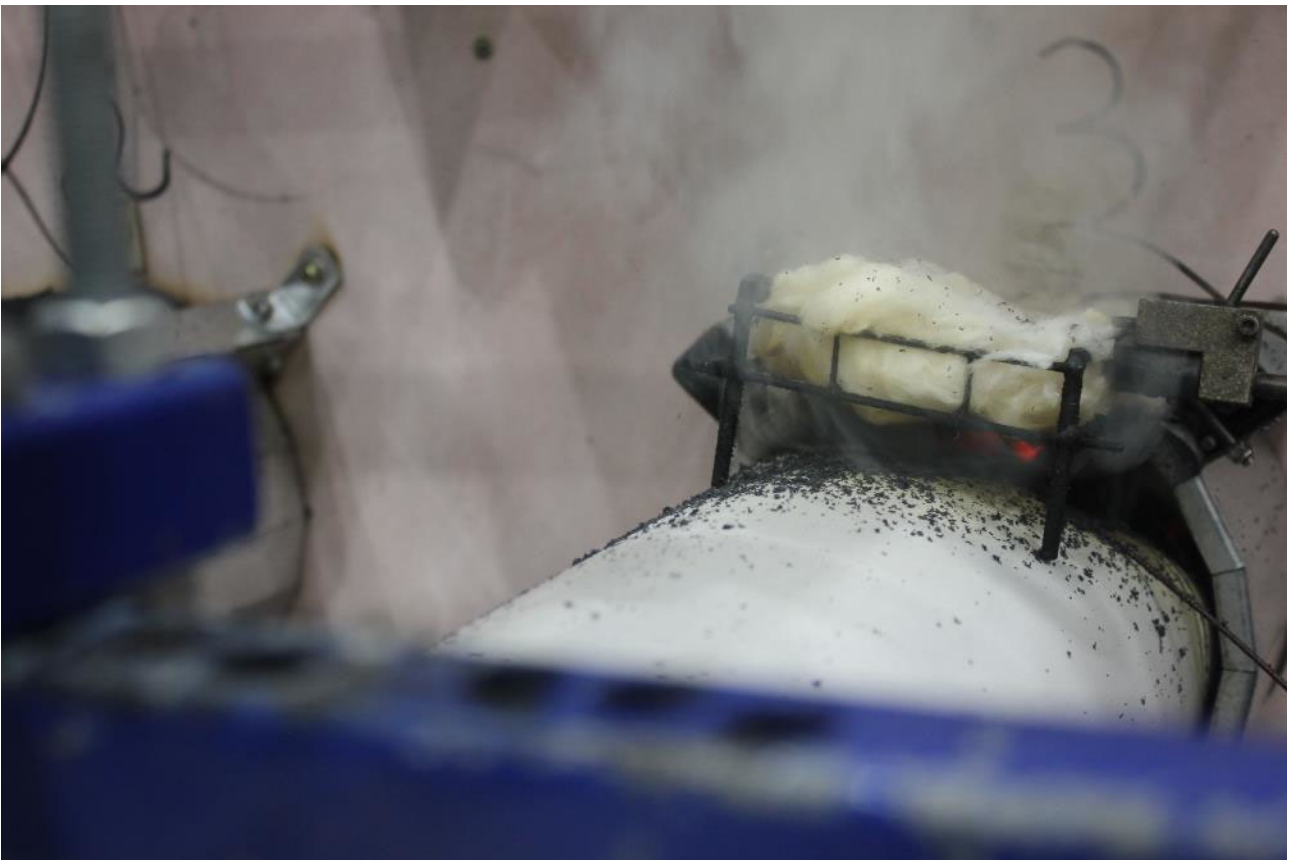
**PHOTOGRAPH 16 – COTON PAD TEST APPLIED TO SPECIMEN 3 AFTER 136 MINUTES OF TESTING**

- 136 minutes - A red glow of the furnace remains visible between the collar and the pipe at the base of specimen 3. The level of smoke fluing from the collar has increased. Cotton pad test applied over the gap between the deformed pipe and the collar at the base of Specimen 3, no ignition of cotton pad noted at this time.

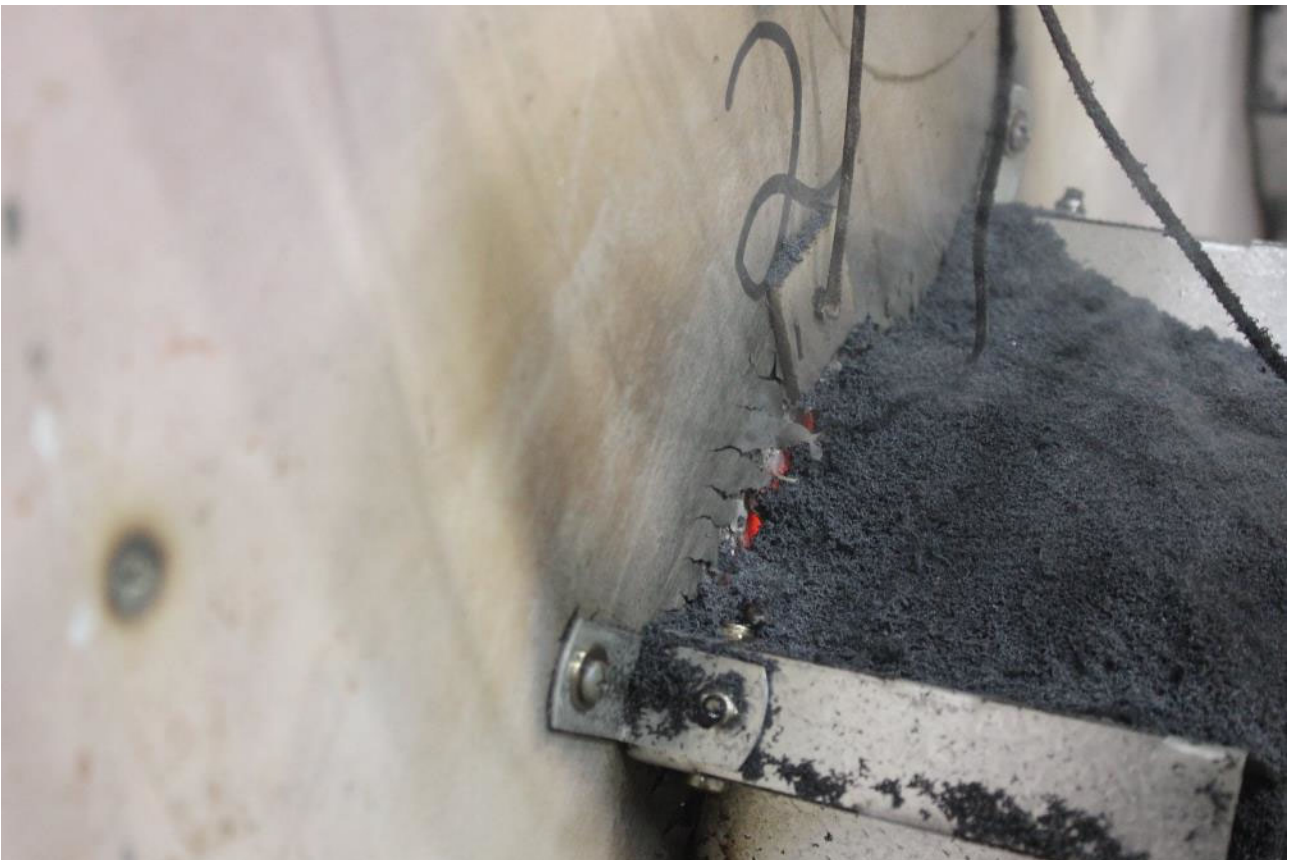
**PHOTOGRAPH 18 – SPECIMEN 2 AFTER 162 MINUTES OF TESTING**

- 162 minutes - A red glow can be seen on the plasterboard at the base of Specimen 2, adjacent to the top of the collar.  
Cotton pad test applied over the red glow between the plasterboard wall and the top of the collar at the base of Specimen 2, no ignition of cotton pad noted at this time.

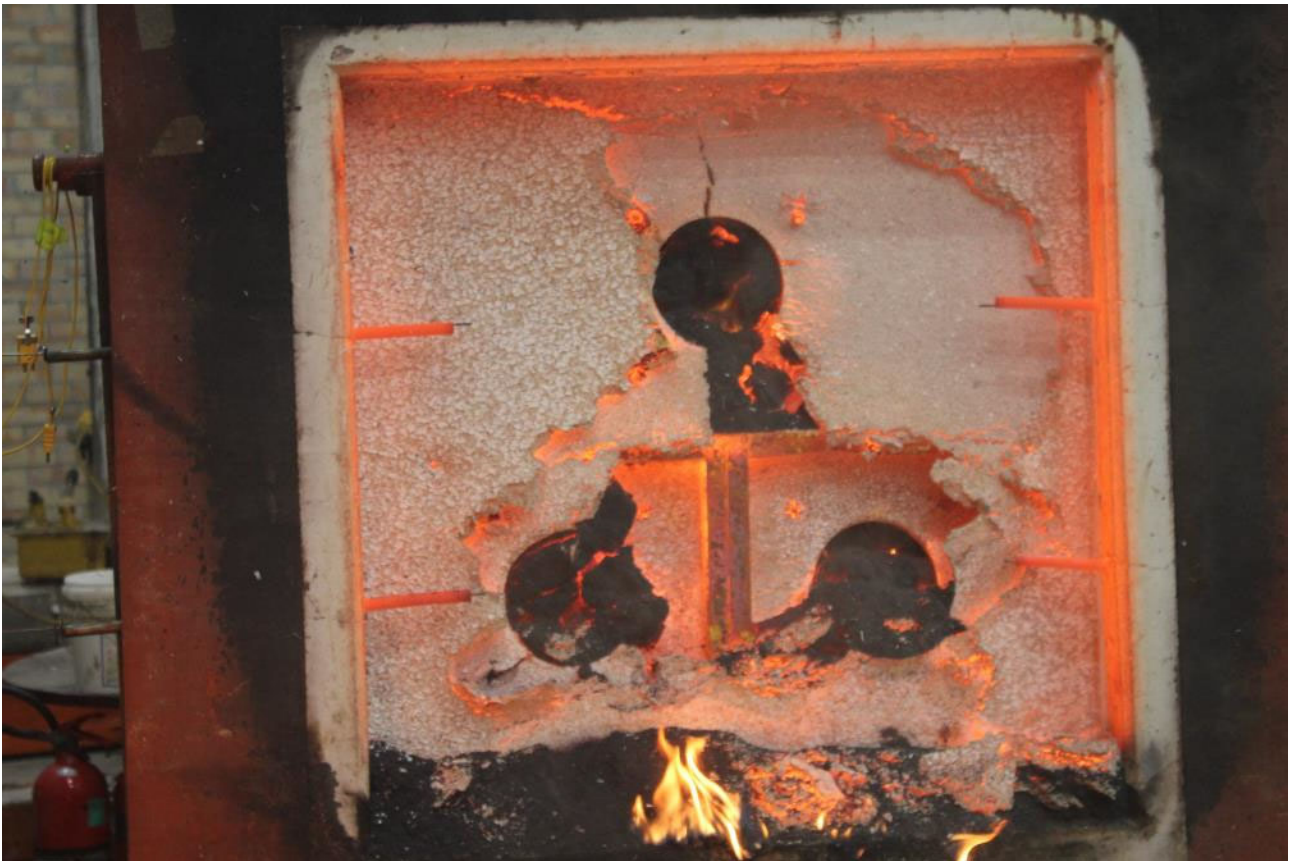
**PHOTOGRAPH 21 – EXPOSED FACE OF SPECIMENS AT CONCLUSION OF TESTING**

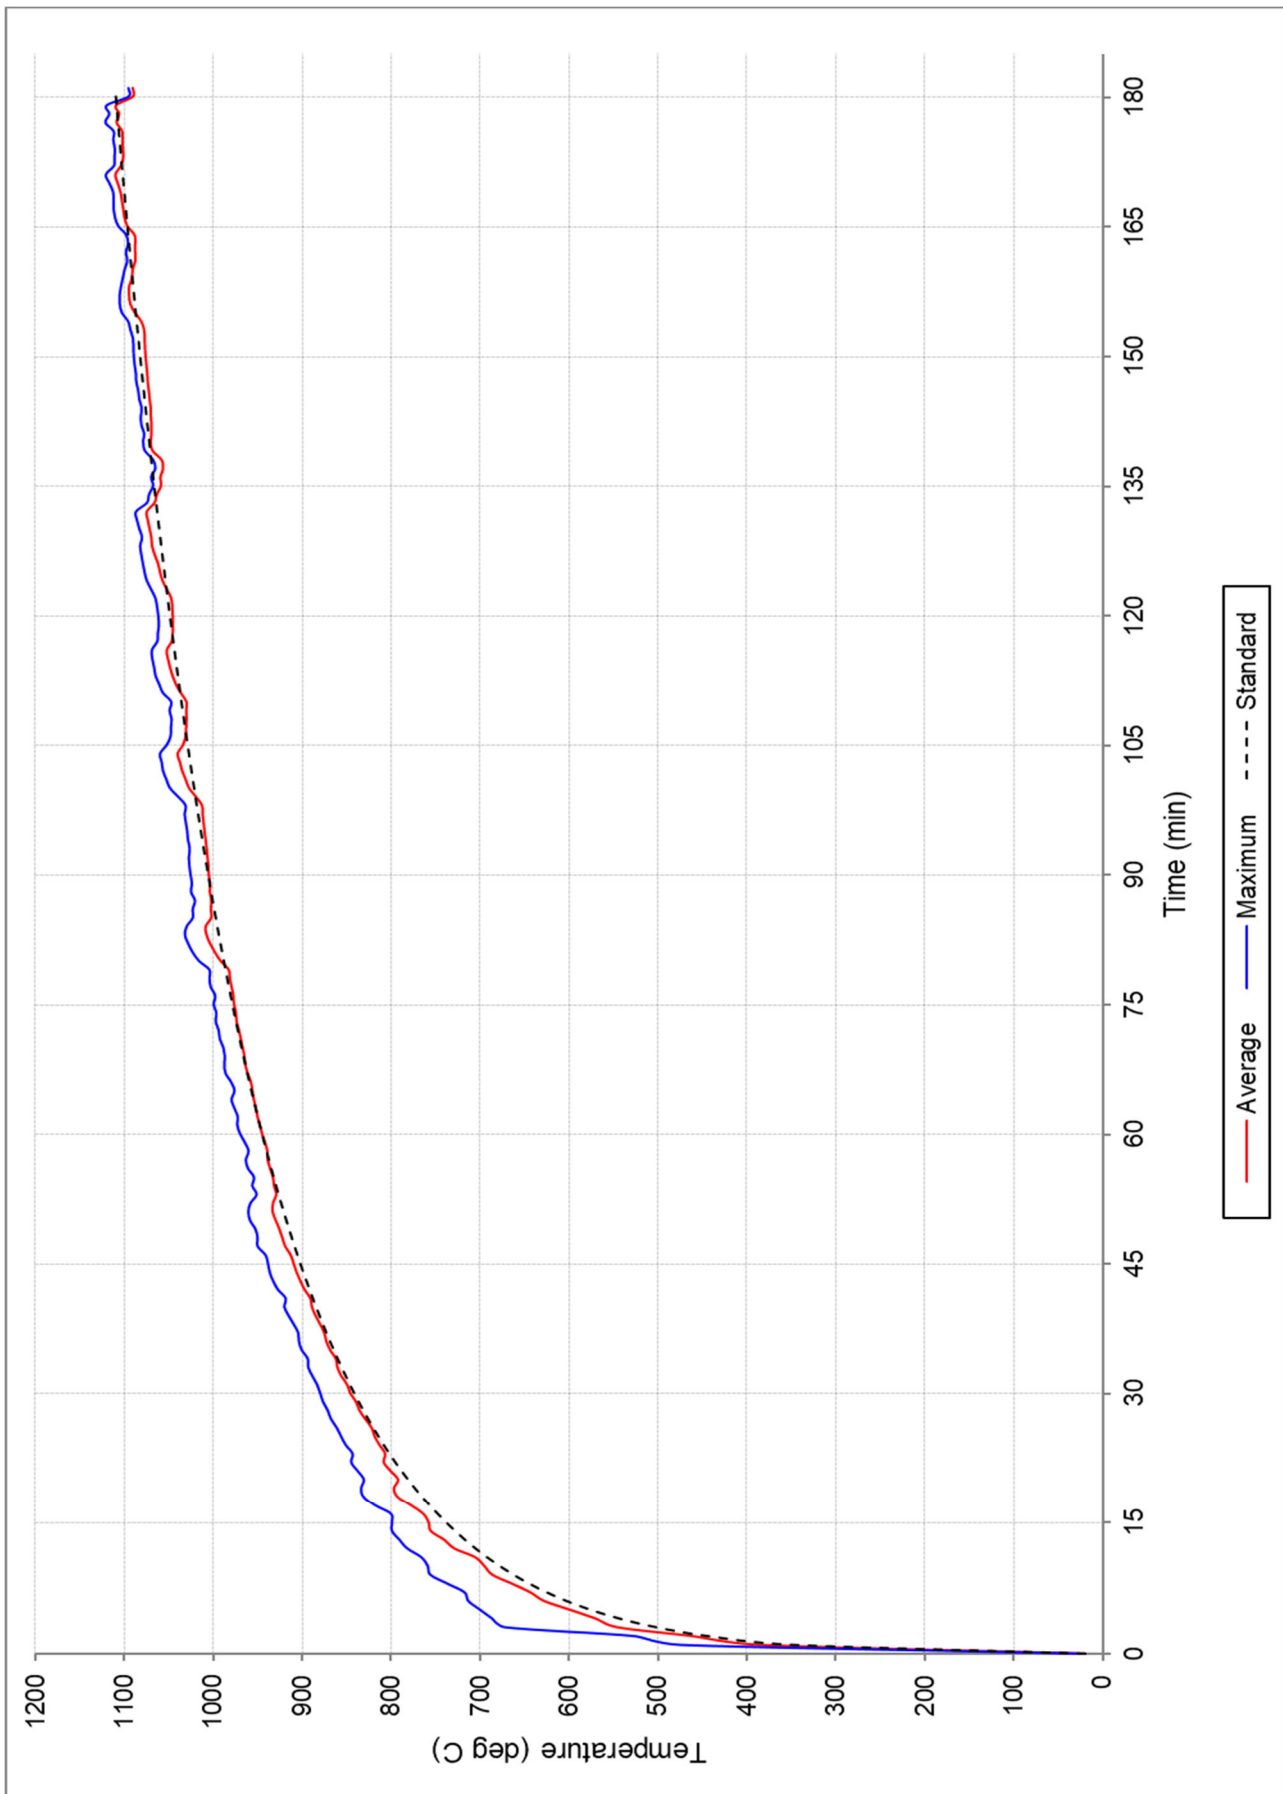
FIGURE 1 – FURNACE TEMPERATURE

The temperature in the furnace chamber was measured by four type K, 3-mm diameter, and 310 stainless steel Mineral Insulated Metal Sheathed (MIMS) thermocouples. Each thermocouple was housed in high-nickel steel tubes opened at the exposed end.

Figure 1 shows the standard curves of temperature versus time for heating the furnace chamber and the actual curves of average and maximum temperature versus time recorded during the heating period.

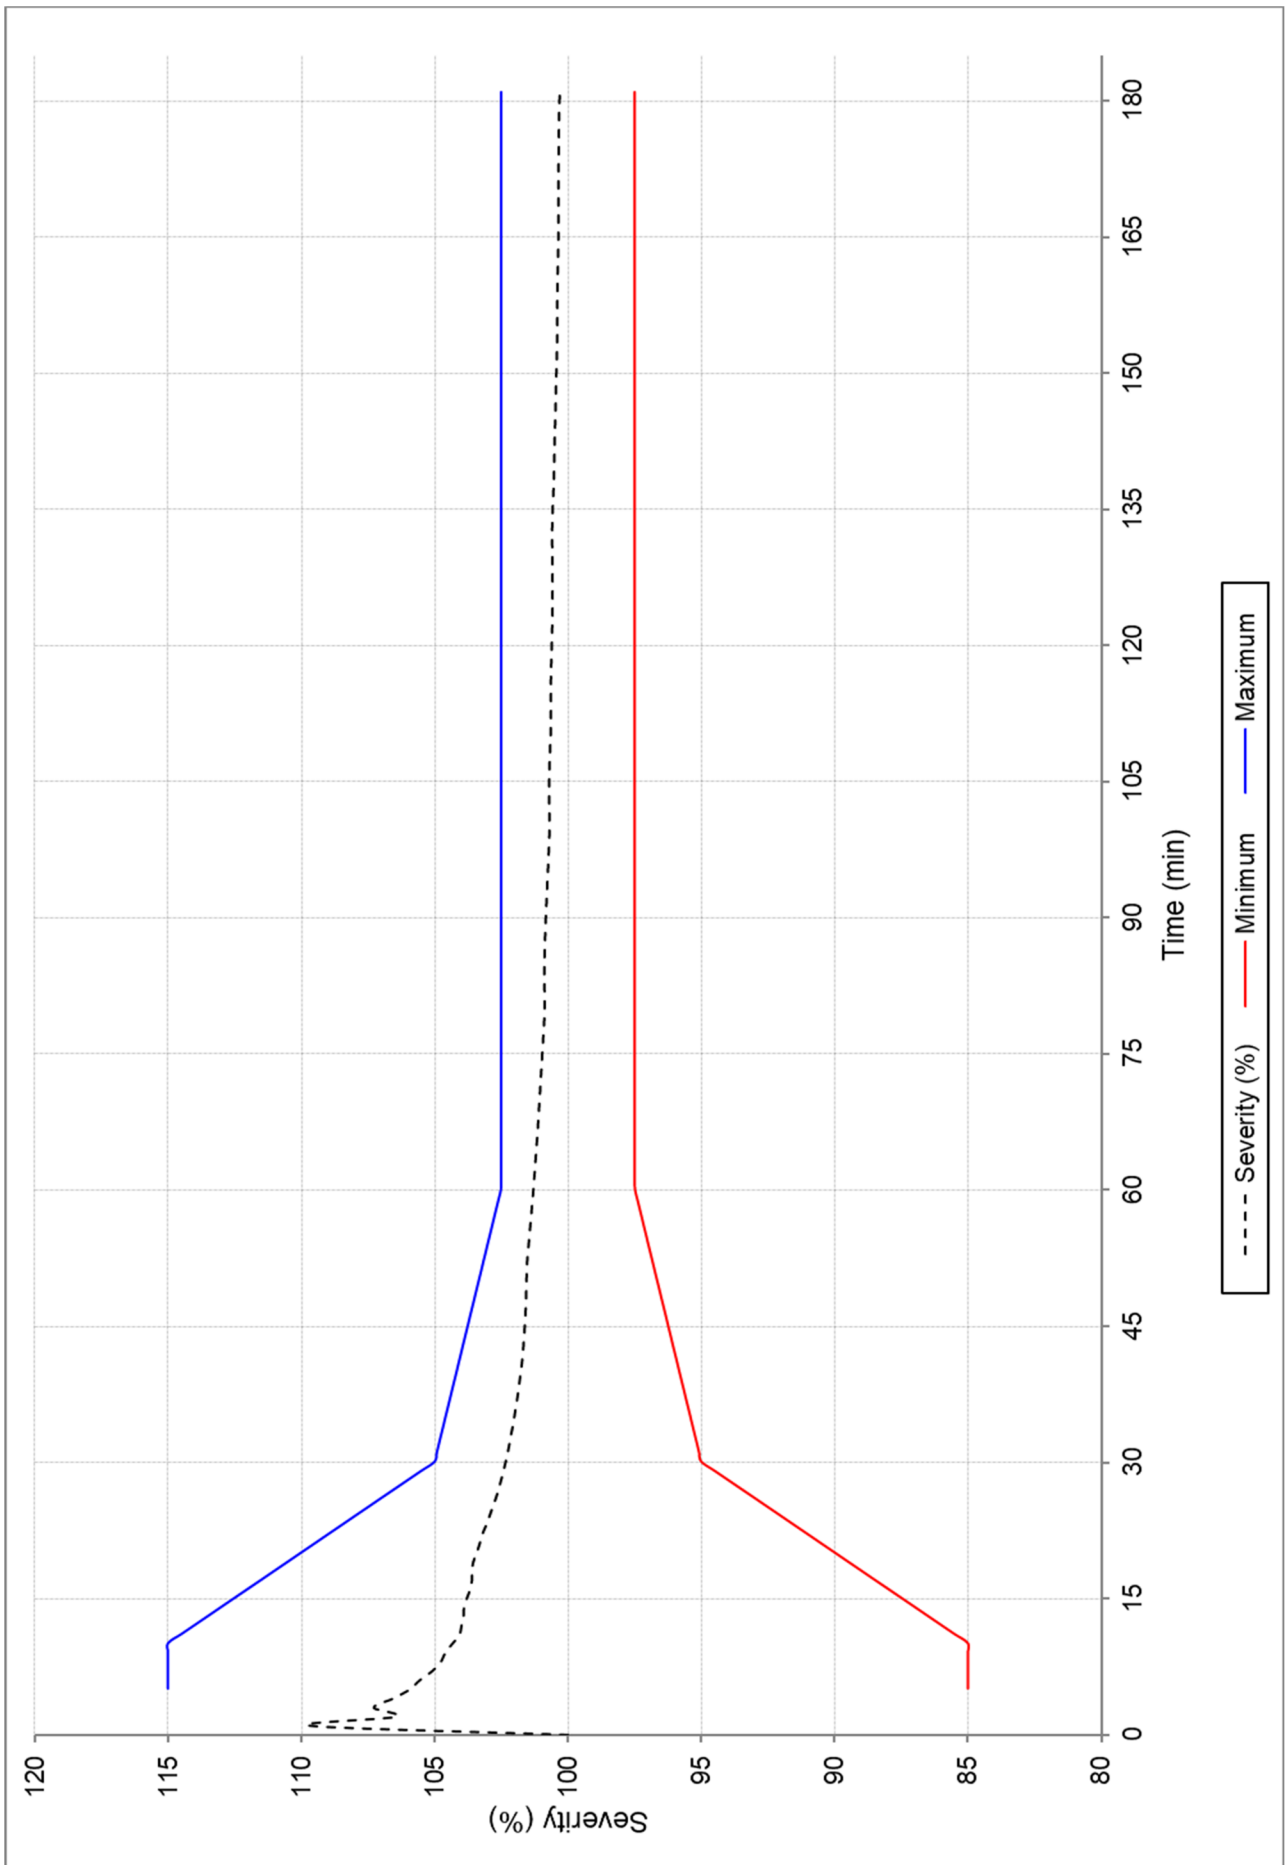
FIGURE 2 – FURNACE SEVERITY

Figure 2 shows the curve of furnace severity versus time during the heating period.

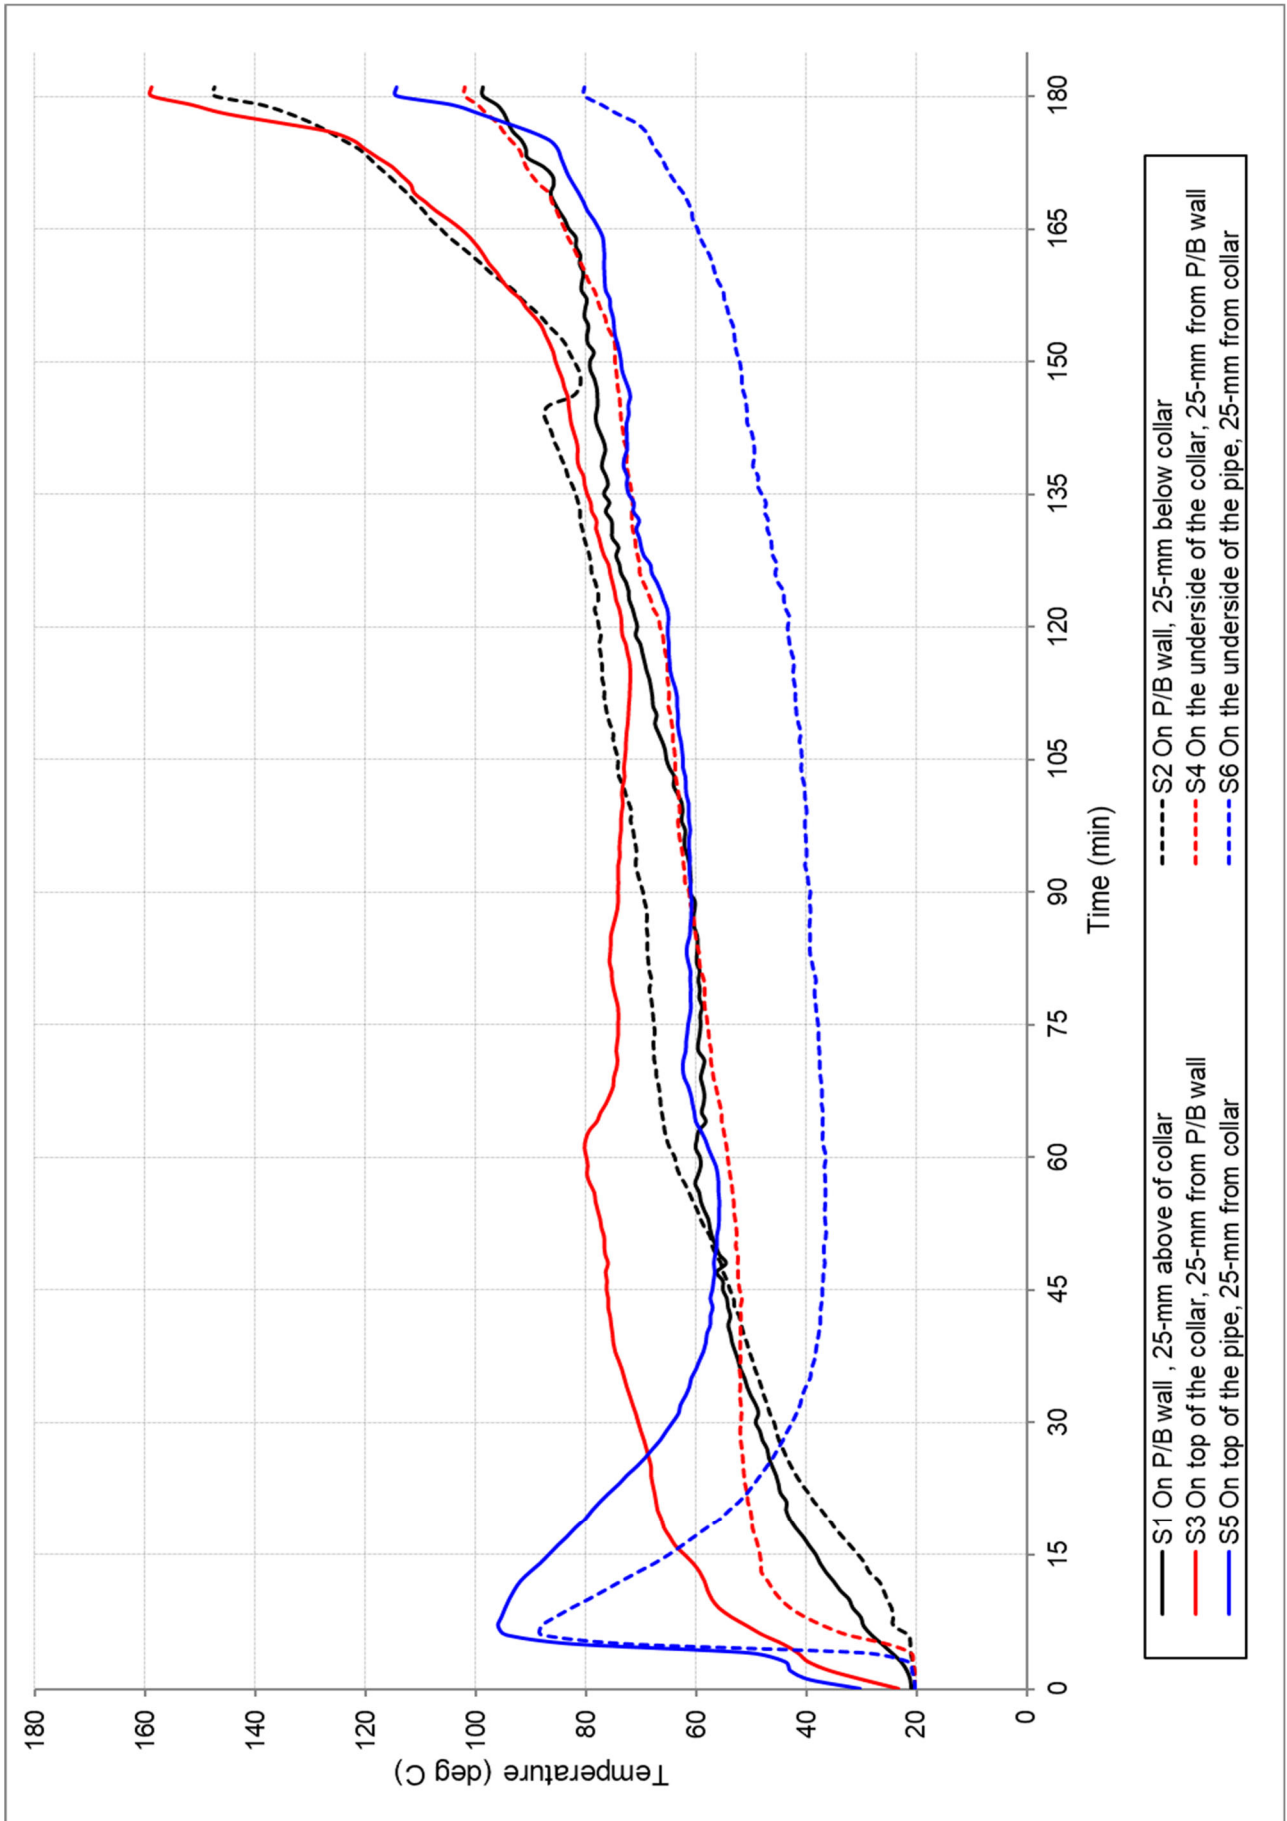
**FIGURE 3 - TEMPERATURE VERSUS TIME ASSOCIATED WITH SPECIMEN #1**

Figure 3 shows the curve of temperature versus time associated with Specimen 1.

Structural adequacy	-	not applicable
Integrity	-	no failure at 181 minutes
Insulation	-	no failure at 181 minutes

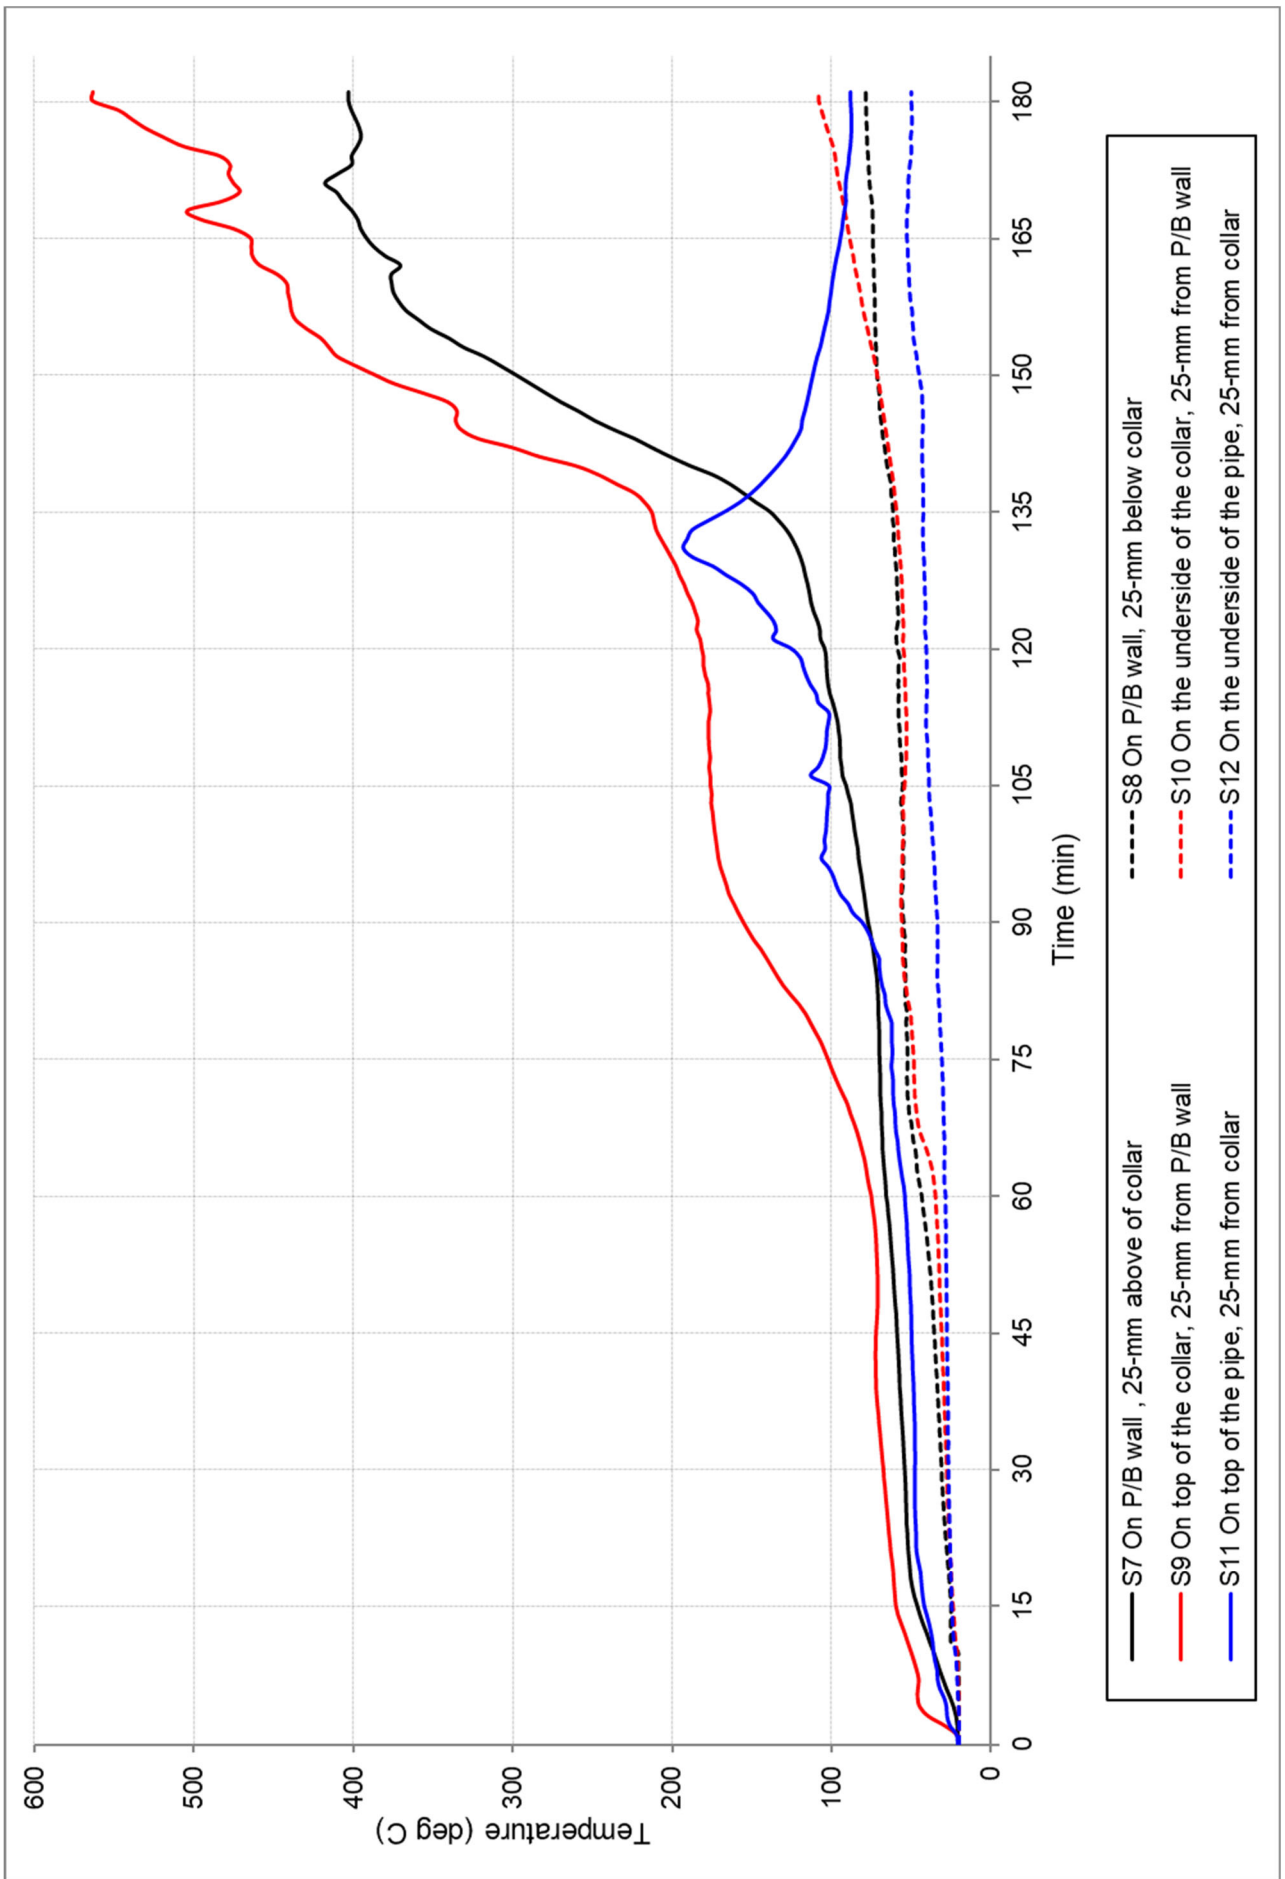
FIGURE 4 - TEMPERATURE VERSUS TIME ASSOCIATED WITH SPECIMEN #2

Figure 4 shows the curve of temperature versus time associated with Specimen 2.

Structural adequacy	-	not applicable
Integrity	-	no failure at 181 minutes
Insulation	-	130 minutes
