# Fire-resistance test on retrofit fire collars protecting a plasterboard wall penetrated by services

## Test Report

**Author:** Peter Gordon  
**Report number:** FSP 2242  
**Date:** 13 December 2021  
**Client:** IG6 Pty Ltd

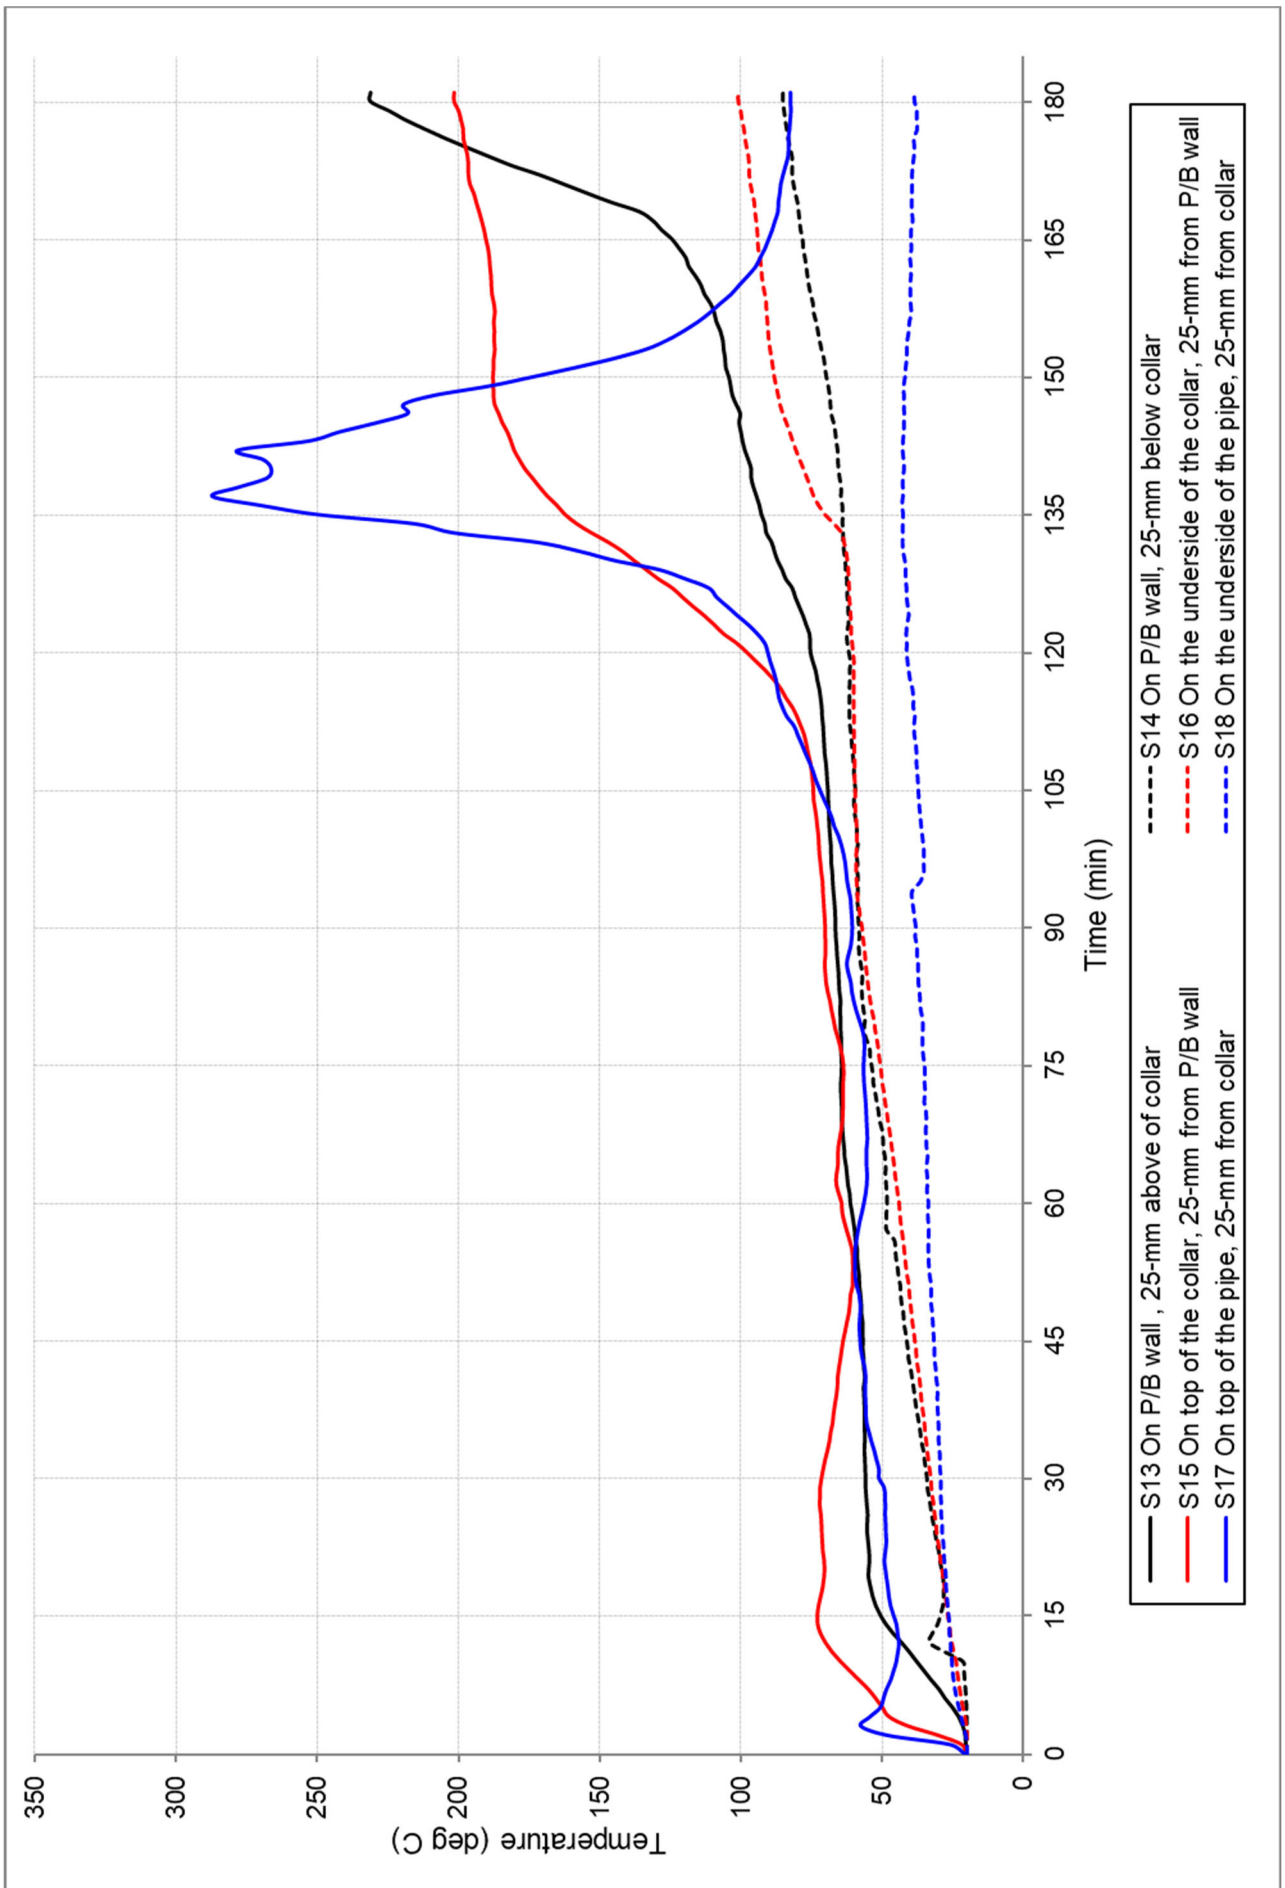
FIGURE 5 - TEMPERATURE VERSUS TIME ASSOCIATED WITH SPECIMEN #3

Figure 5 shows the curve of temperature versus time associated with Specimen 3.

Structural Adequacy	-	not applicable
Integrity	-	no failure at 181 minutes
Insulation	-	133 minutes

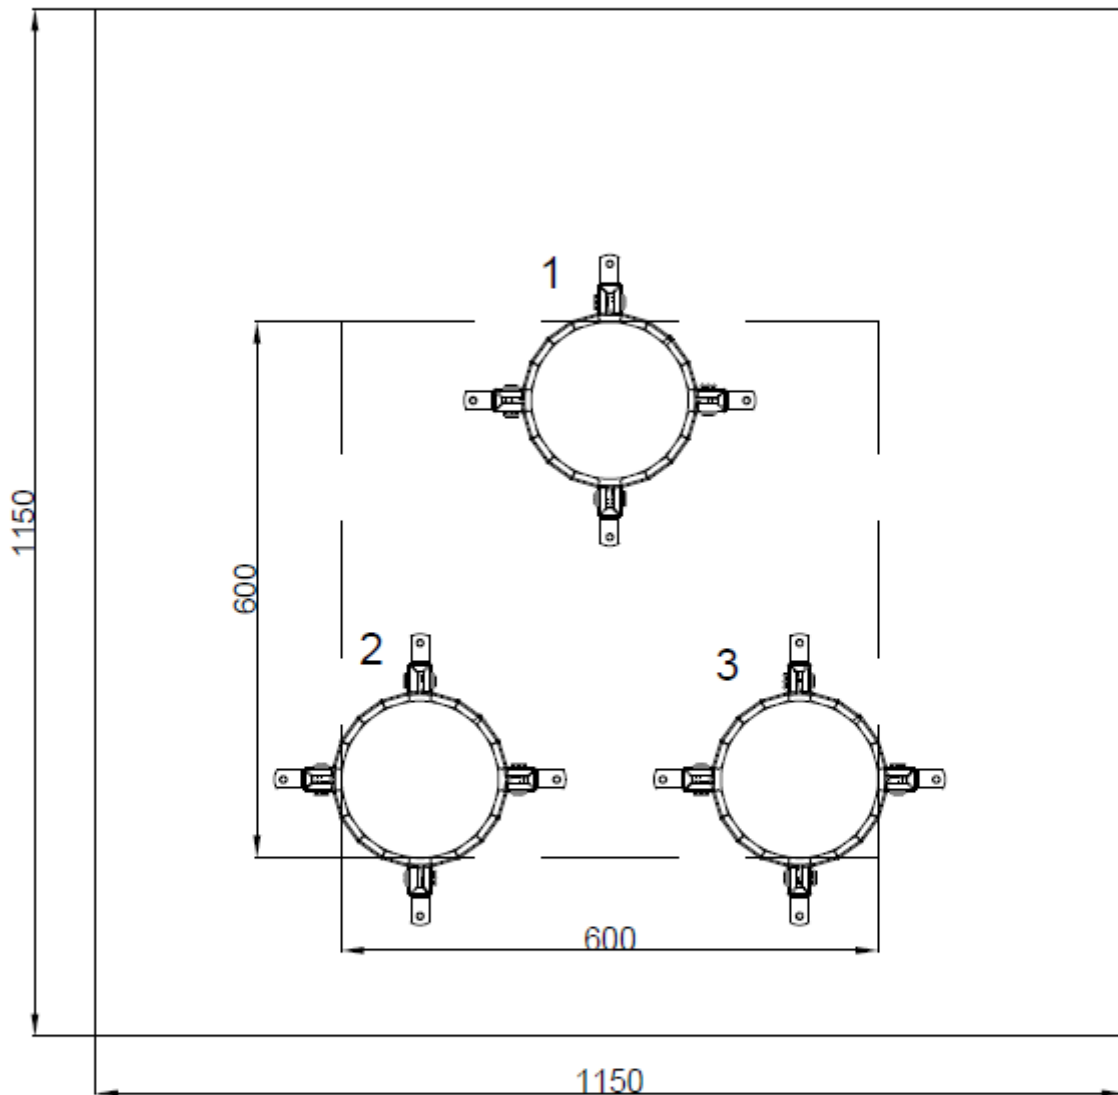
**Snap Fire Systems Pty Ltd**  
Test Wall W-21-A2 Layout  
Date:29 JUL 2021

Penetration	Collar Code	Pipe Type	Pipe Diameter
1	HP150R	Triplus	160
2	HP150R	HDPE	160
3	HP150R	PVC(SC)	150

**DRAWING TITLED 'TEST WALL W-21-A2 LAYOUT, DATED 29 JULY 2021, BY SNAP FIRE SYSTEMS PTY LTD.**

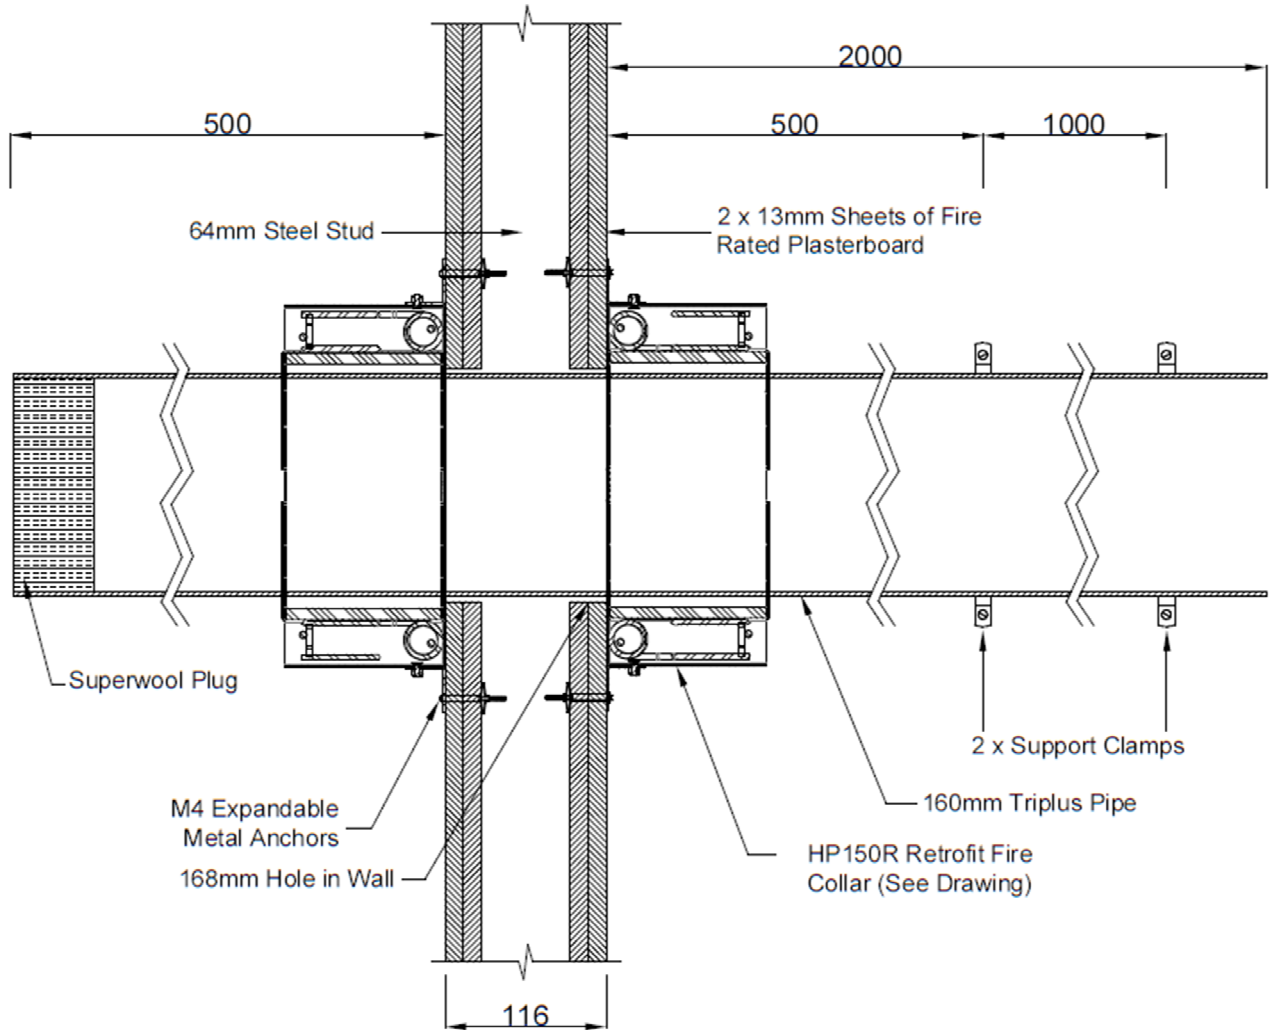
160 Triplus Stack & HP150R

**DRAWING TITLED 'SPECIMEN #1, 160 TRIPLUS STACK & HP150R', DATED 25 OCTOBER 2021, BY SNAP FIRE SYSTEMS PTY LTD.**

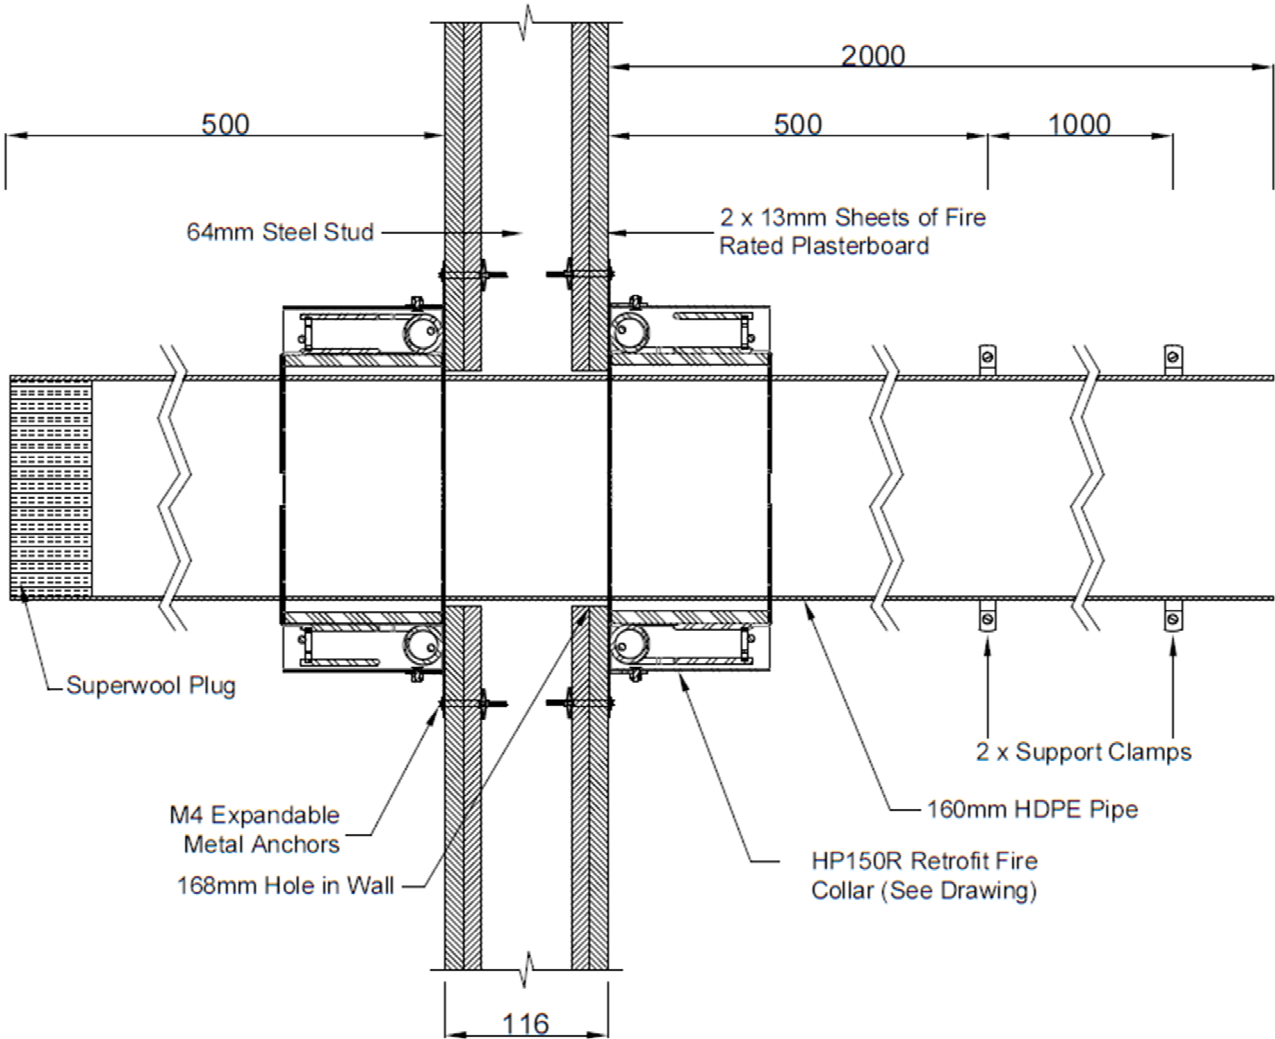
160 HDPE Stack & HP150R

DRAWING TITLED 'SPECIMEN #2 160 HDPE STACK & HP150R', DATED 25 OCTOBER 2021, BY SNAP FIRE SYSTEMS PTY LTD

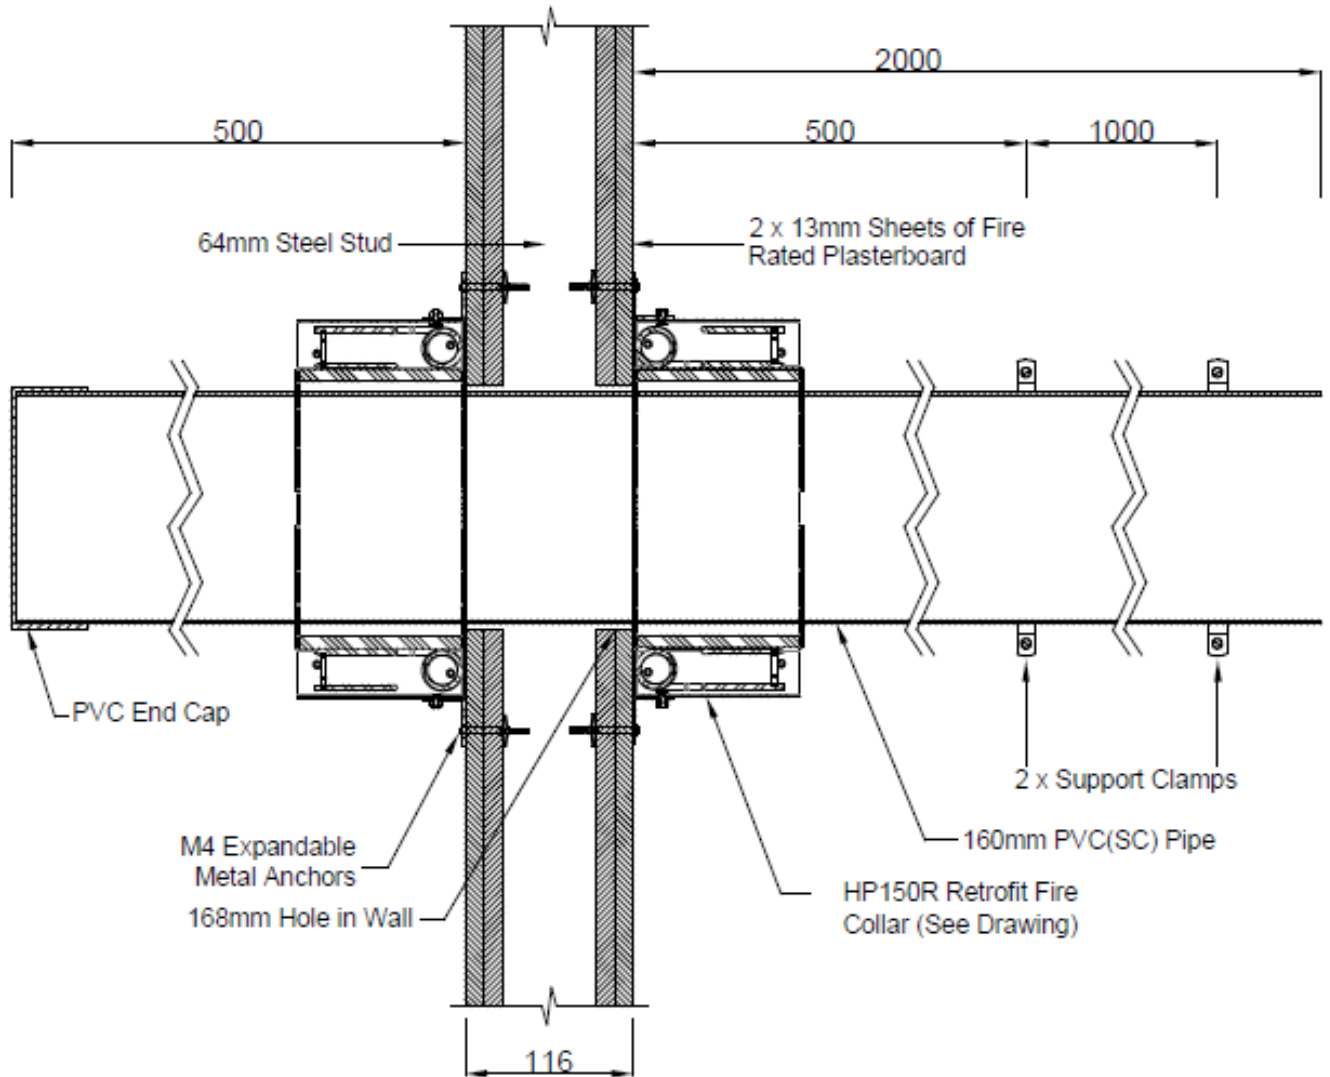
150 PVC(SC) Stack & HP150R

DRAWING TITLED 'SPECIMEN #3, 150 PVC(SC) STACK & HP150R', DATED 25 OCTOBER 2021, BY SNAP FIRE SYSTEMS PTY LTD

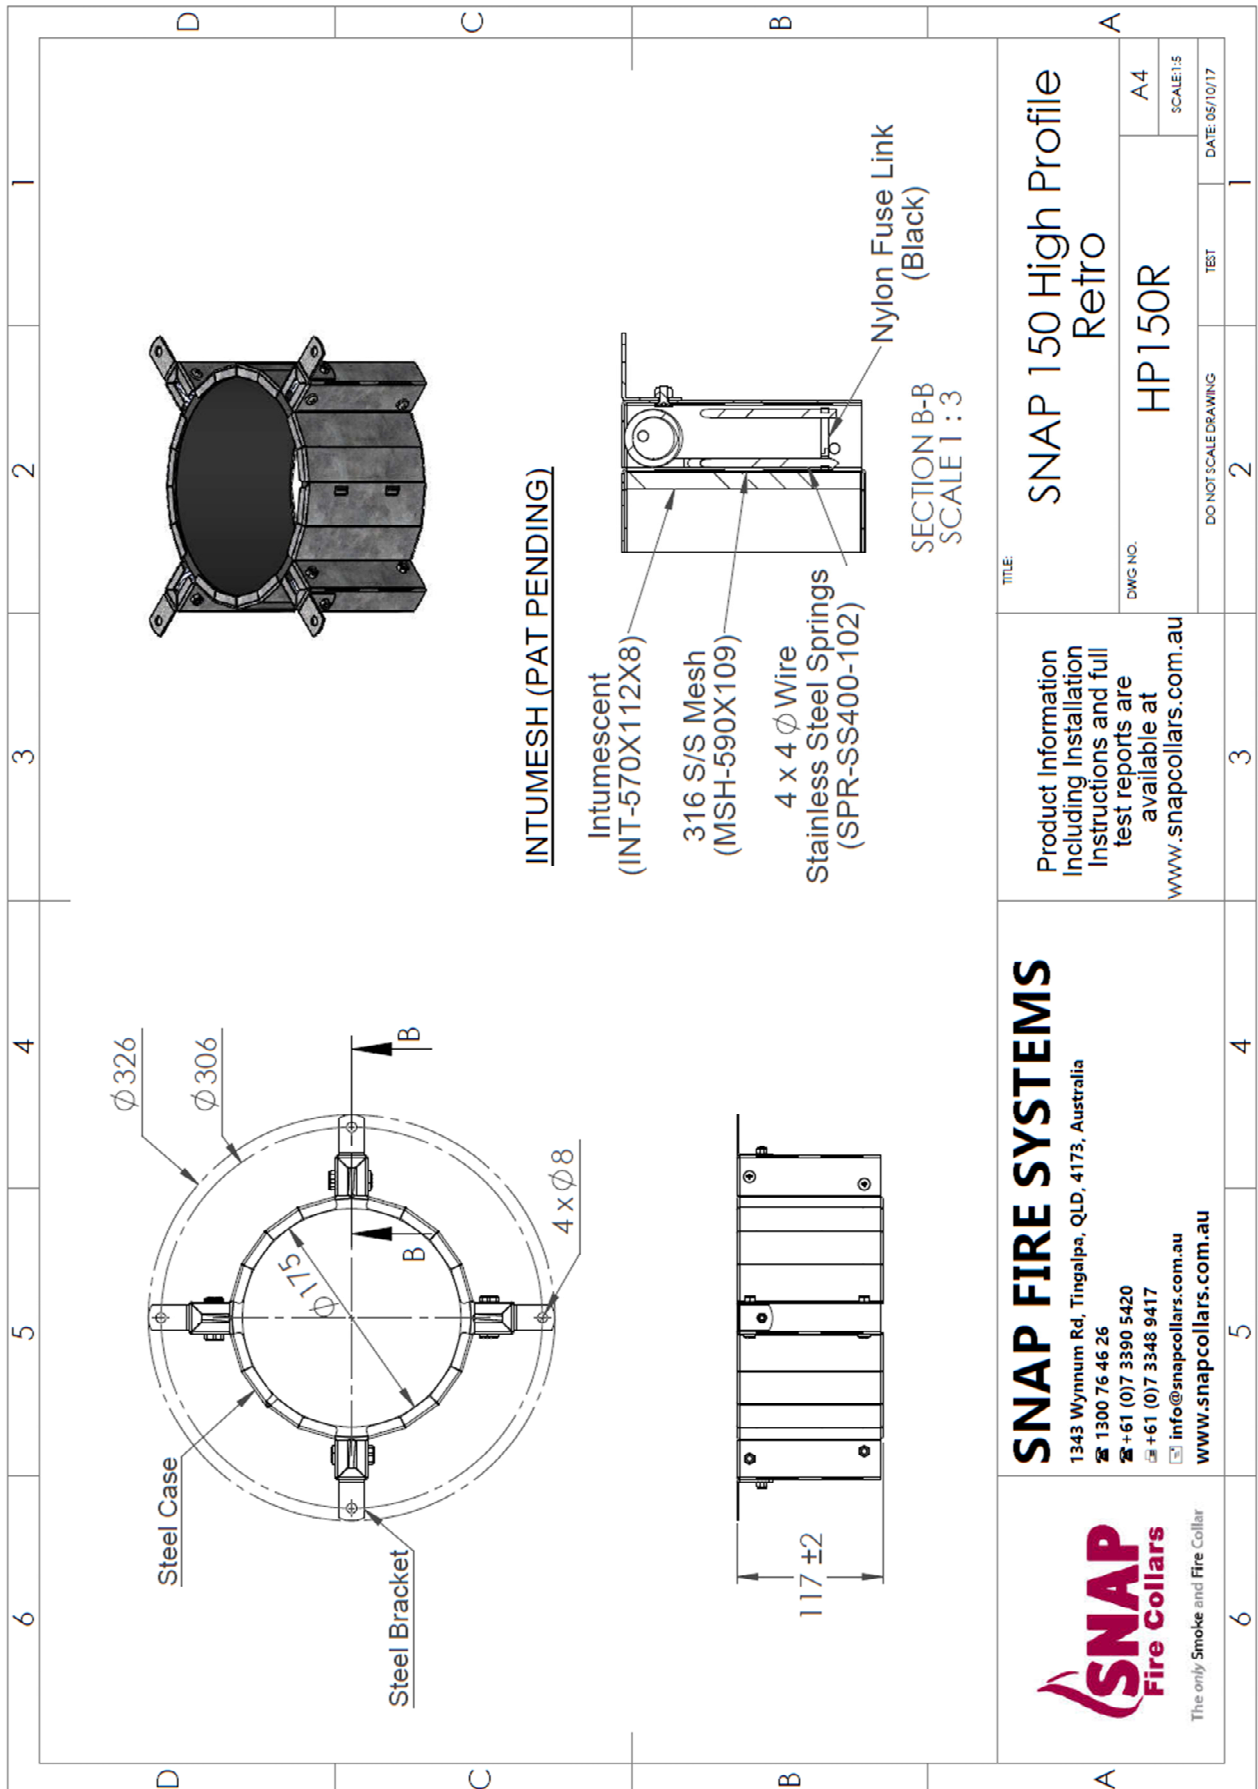
DRAWING 'SNAP 150 HIGH PROFILE RETRO', DATED 5 OCTOBER 2017, BY SNAP FIRE SYSTEMS PTY LTD
