# Fire-resistance test on retrofit fire collars protecting a plasterboard wall penetrated by services

## Test Report

**Author:** Peter Gordon  
**Report number:** FSP 2275  
**Date:** 22 April 2022  
**Client:** IG6 Pty Ltd

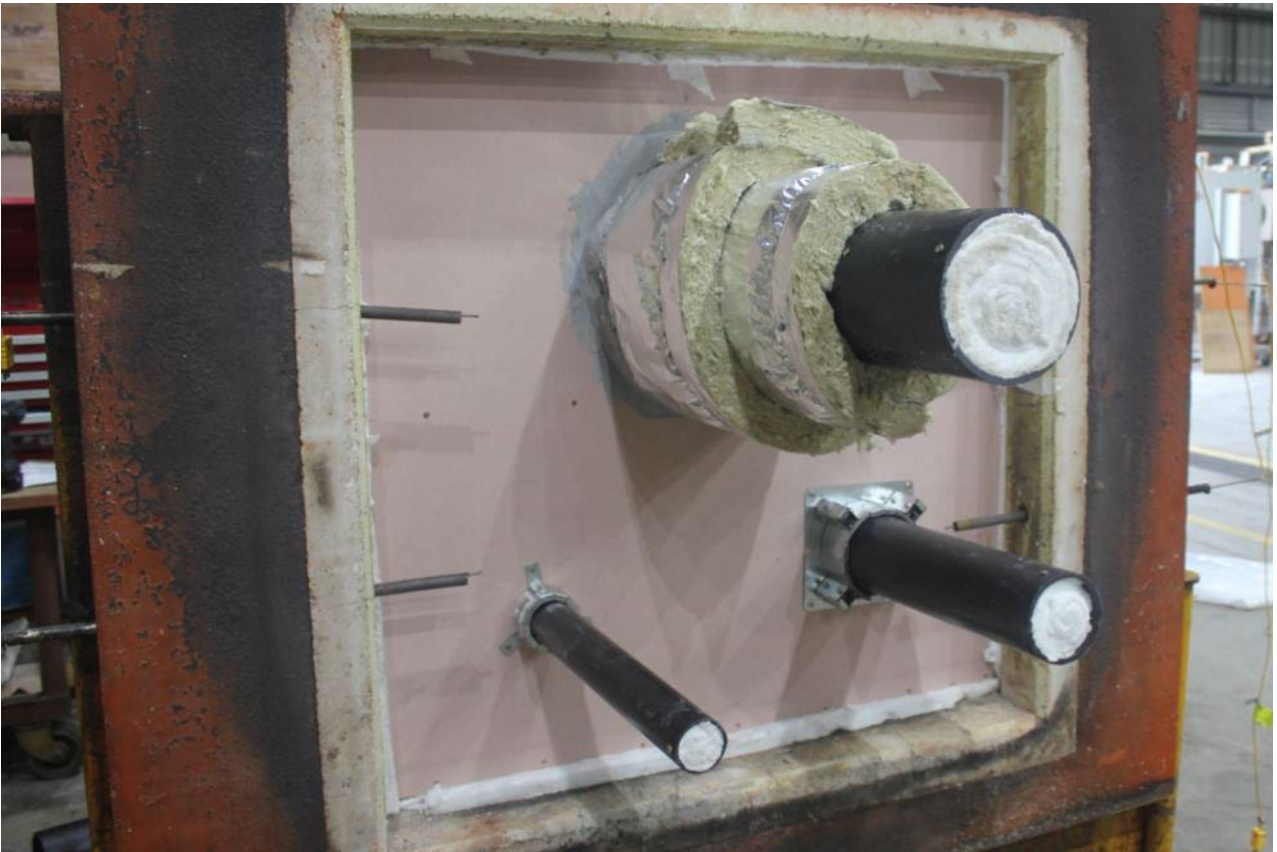
**PHOTOGRAPH 1 – EXPOSED FACE OF SPECIMENS PRIOR TO TESTING**

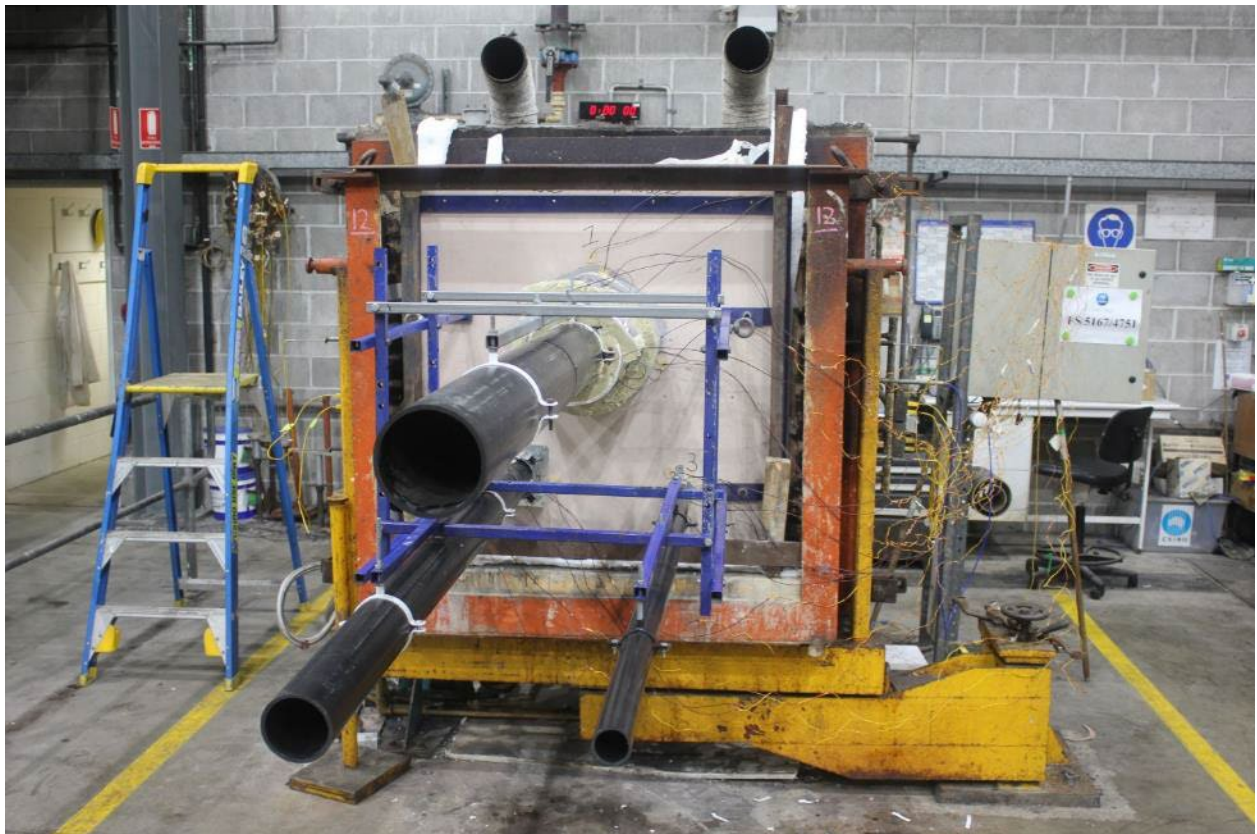
**PHOTOGRAPH 2 – UNEXPOSED FACE OF SPECIMENS PRIOR TO TESTING**

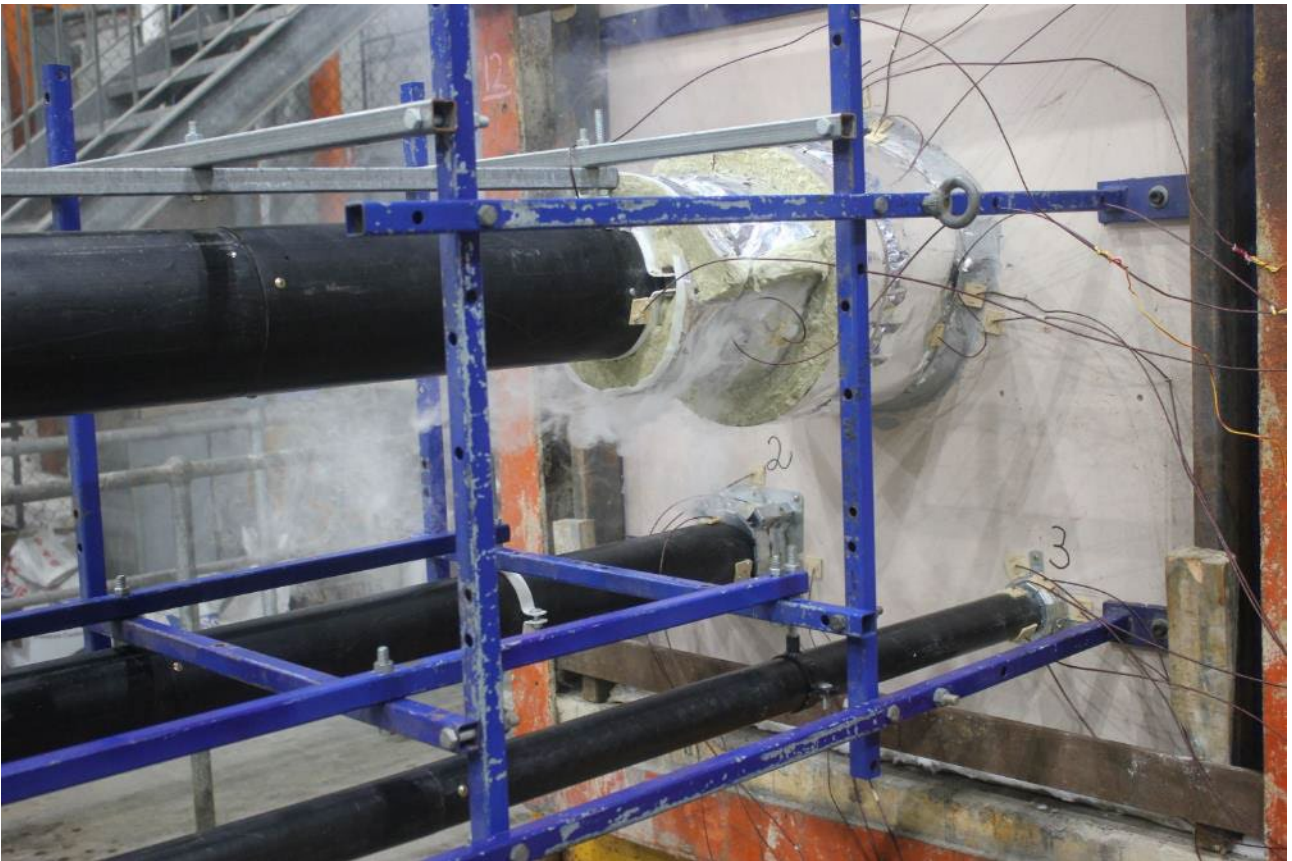
**PHOTOGRAPH 3 – SPECIMENS AFTER 4 MINUTES OF TESTING**

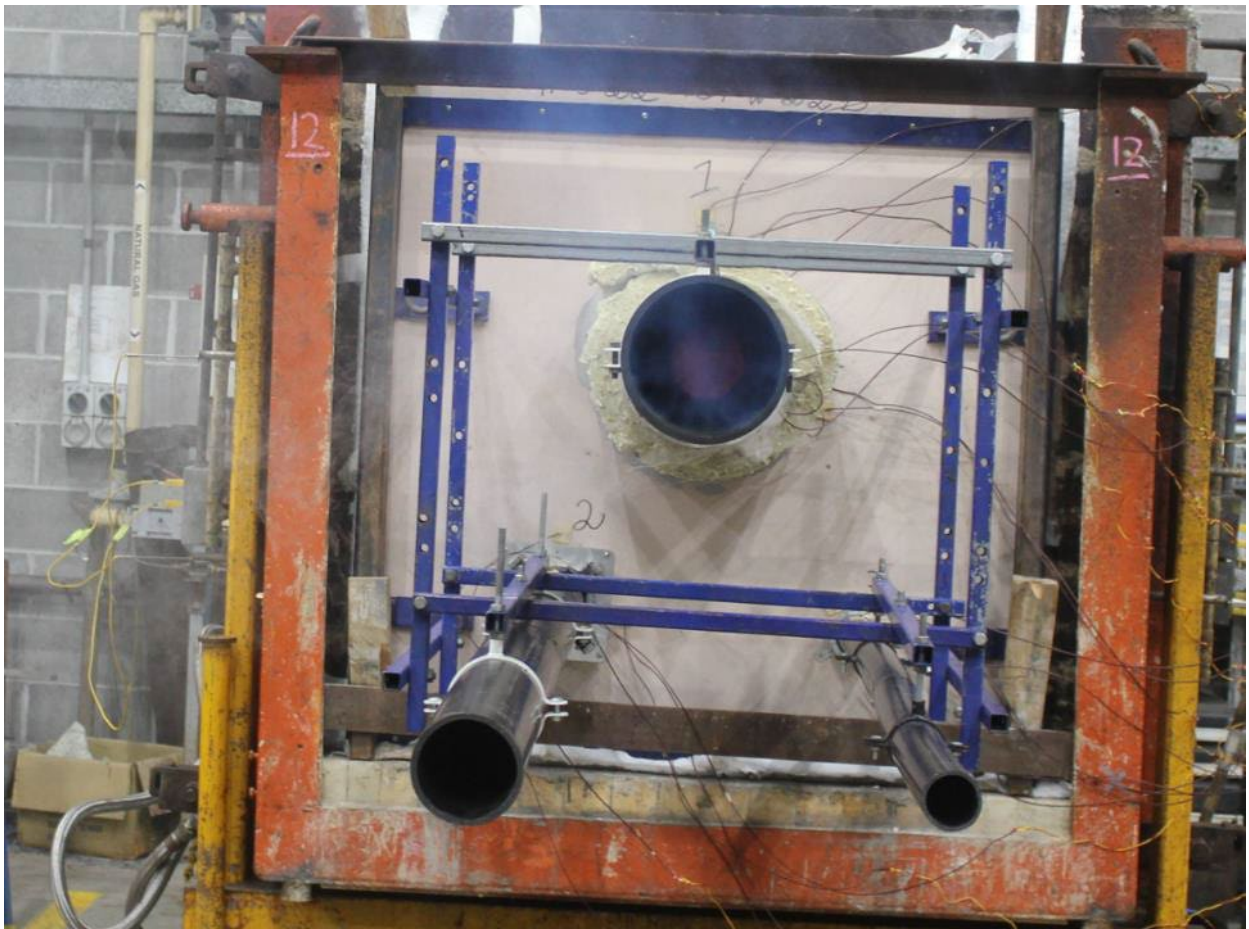
**PHOTOGRAPH 4 – SPECIMENS AFTER 5 MINUTES OF TESTING**

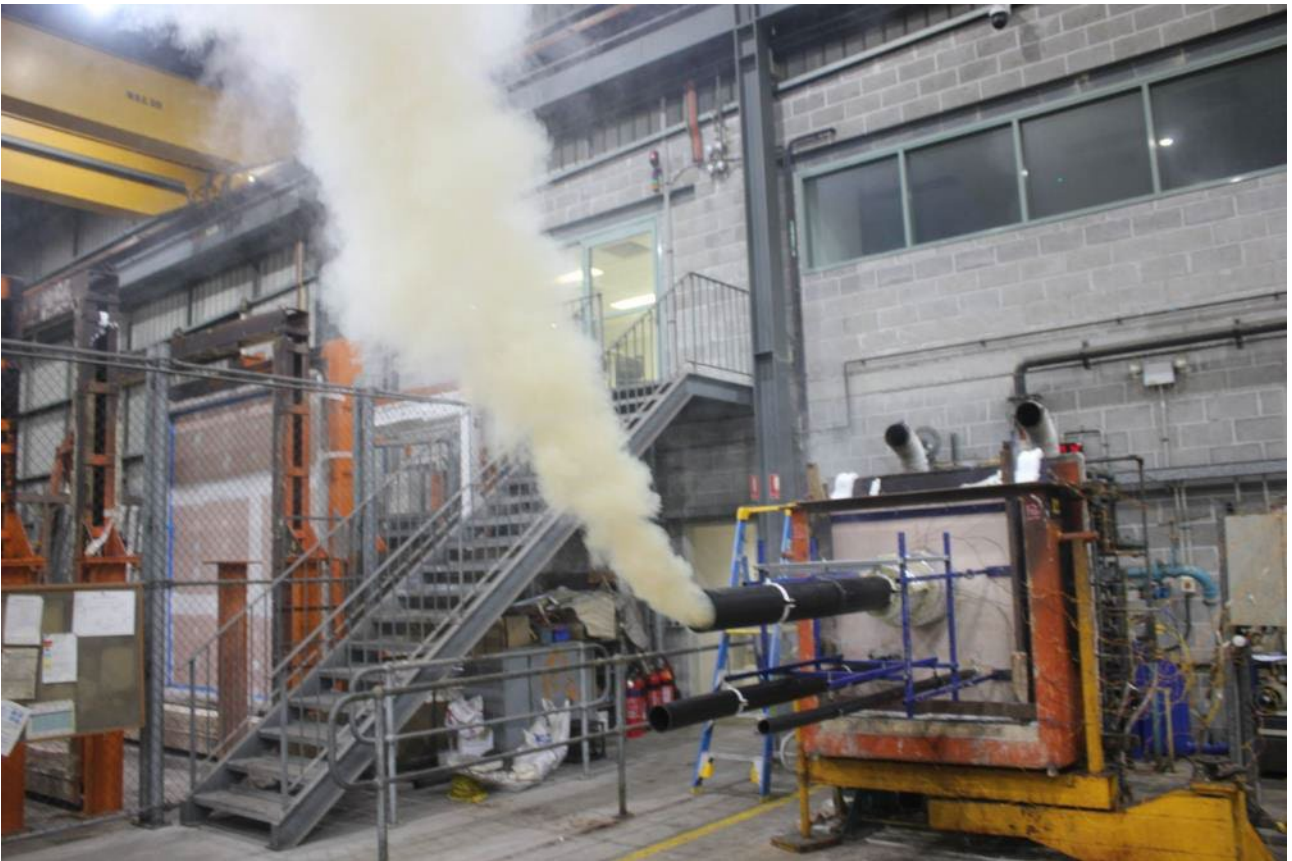
**PHOTOGRAPH 5 – SPECIMENS AFTER 5½ MINUTES OF TESTING**

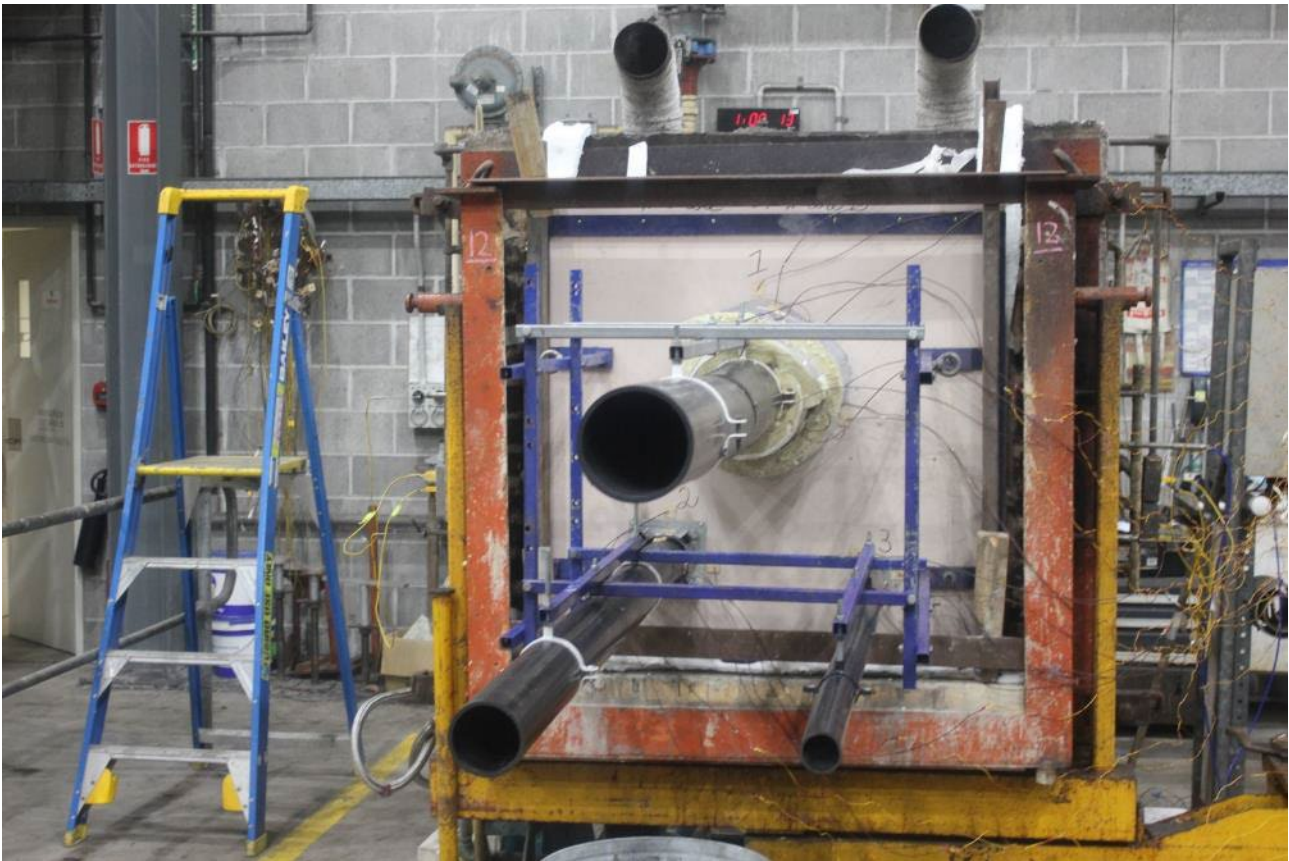
**PHOTOGRAPH 7 –SPECIMENS AFTER 60 MINUTES OF TESTING**

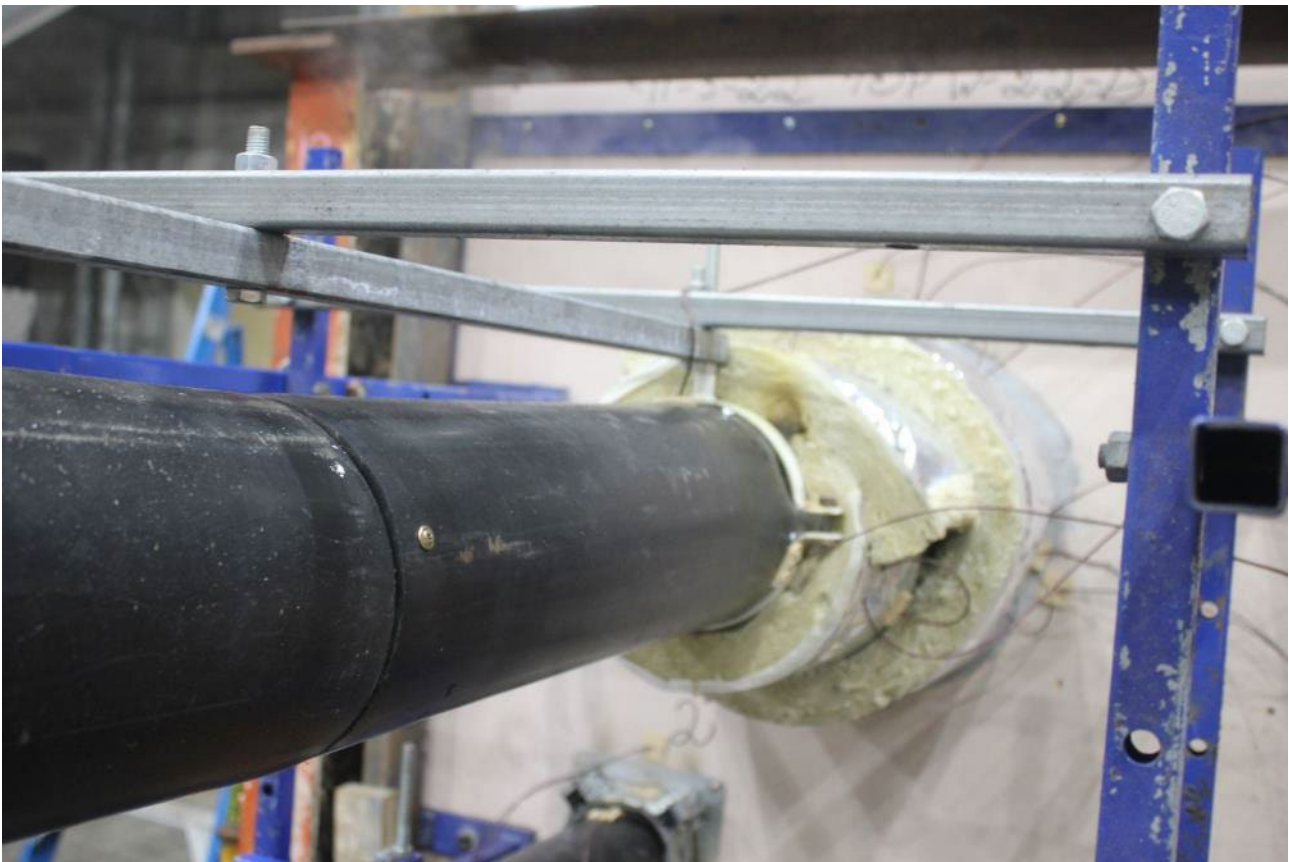
**PHOTOGRAPH 8 – SPECIMEN 1 AFTER 79 MINUTES OF TESTING**

- 79 minutes - The smoke staining around the first layer of the Rockwool adjacent to the pipe of specimen 1 has intensified.
  - 81 minutes - Light smoke has resumed fluing from the end of the pipe of specimen 3.

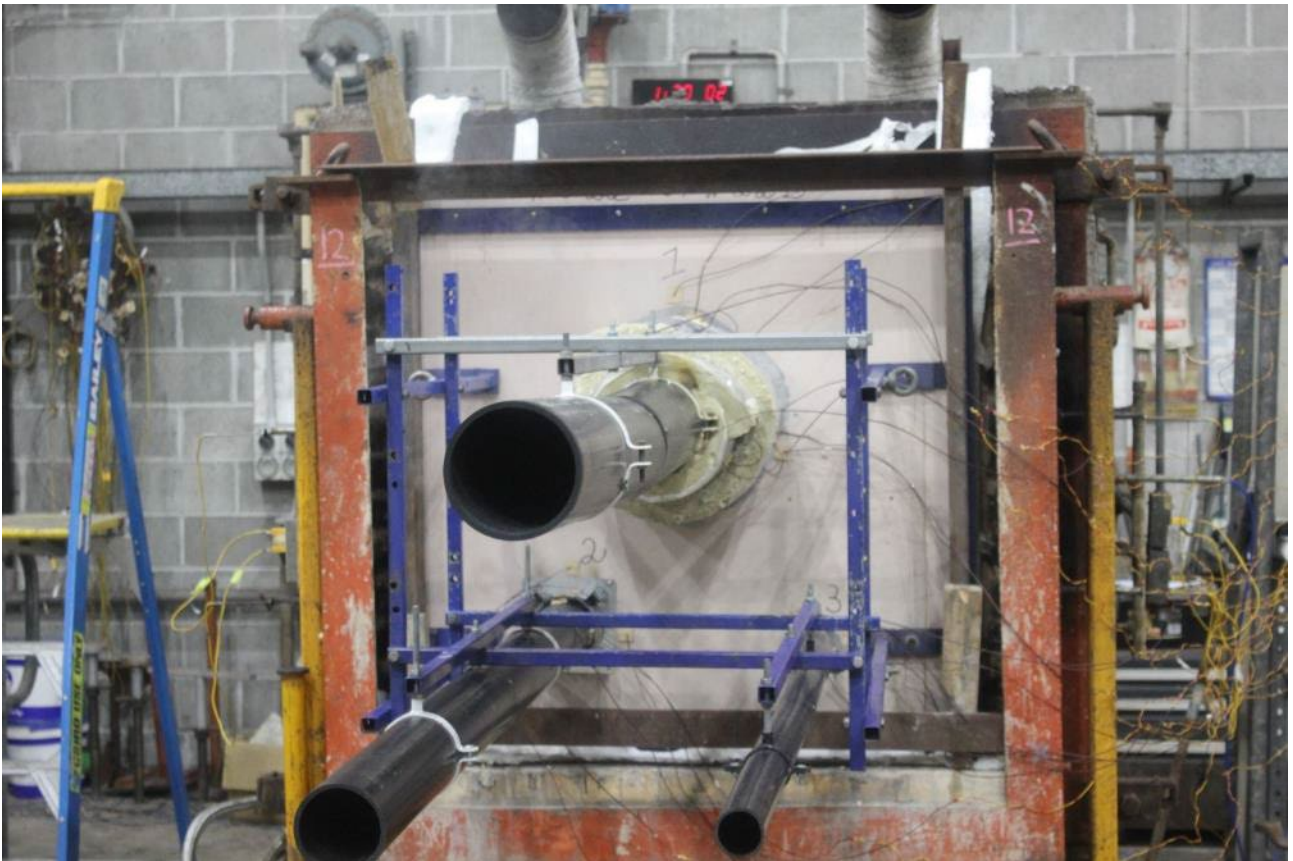
**PHOTOGRAPH 9 – SPECIMENS AFTER 90 MINUTES OF TESTING**

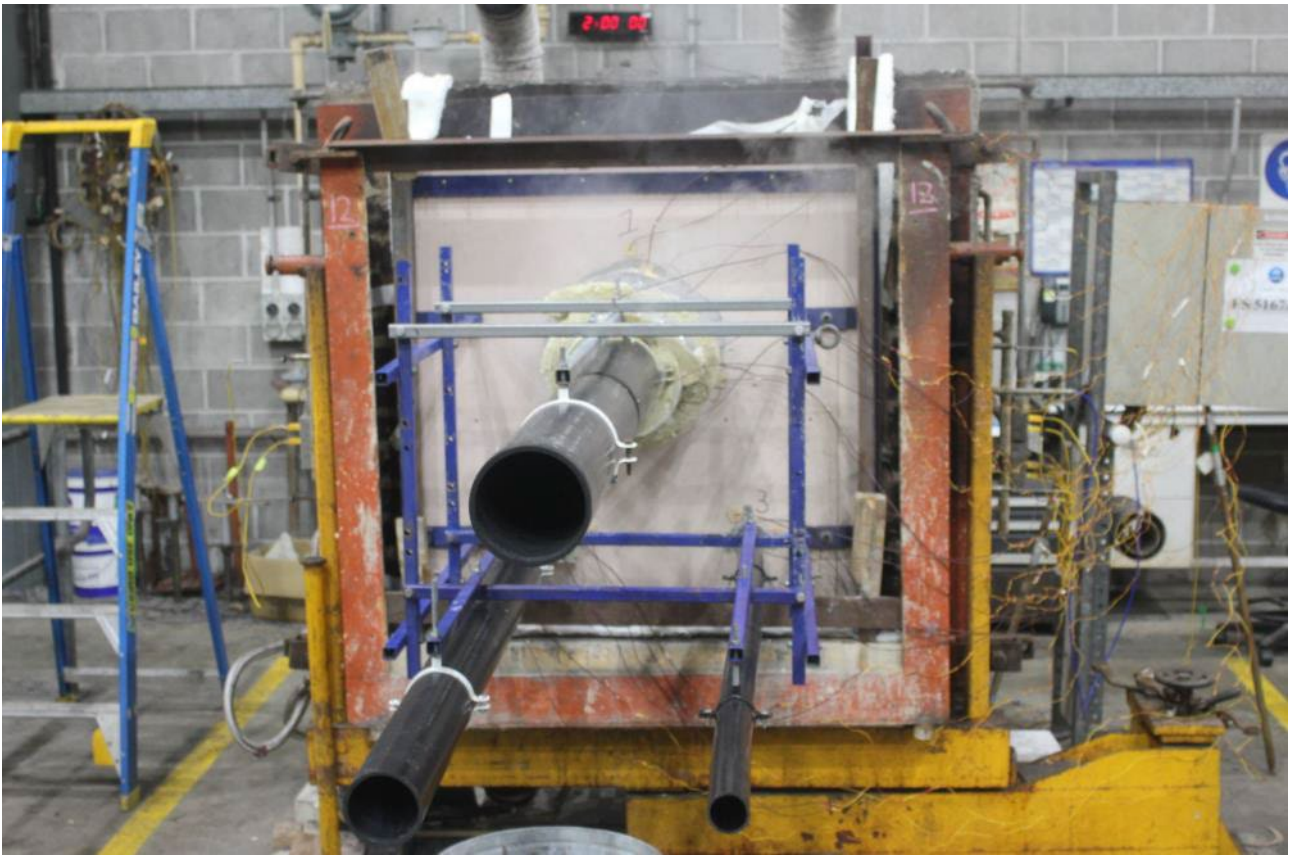
**PHOTOGRAPH 11 –SPECIMENS AFTER 120 MINUTES OF TESTING**

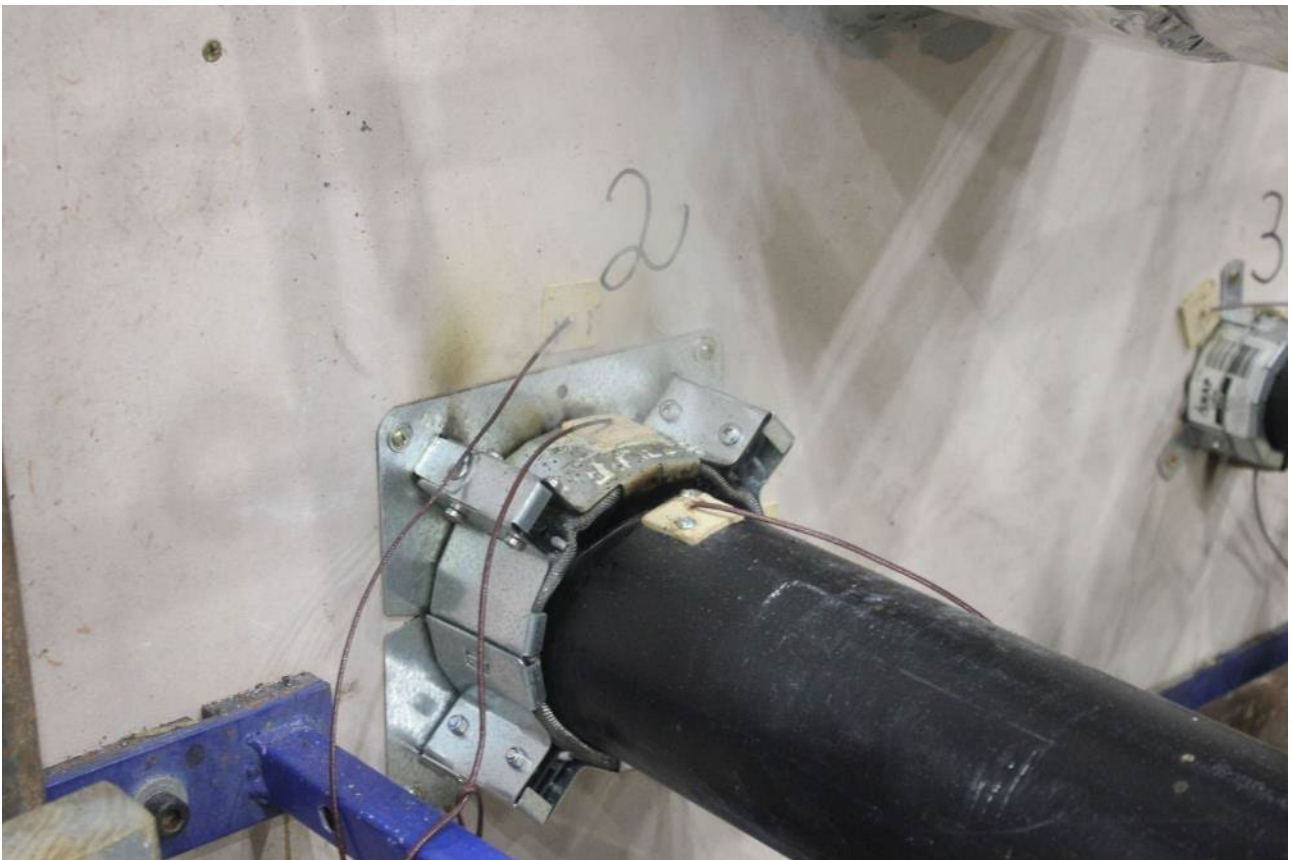
**PHOTOGRAPH 12 –SPECIMEN 2 AFTER 120 MINUTES OF TESTING**

- 110 minutes - The level of smoke venting from the Rockwool wrap of specimen 1 has intensified.
  - 118 minutes - The top of the pipe inside the collar of Specimen 2 has soften and collapsed with a larger gap visible. Cotton wool pad test applied over the pipe and collar above the gap, no ignition of cotton pad noted at this time.

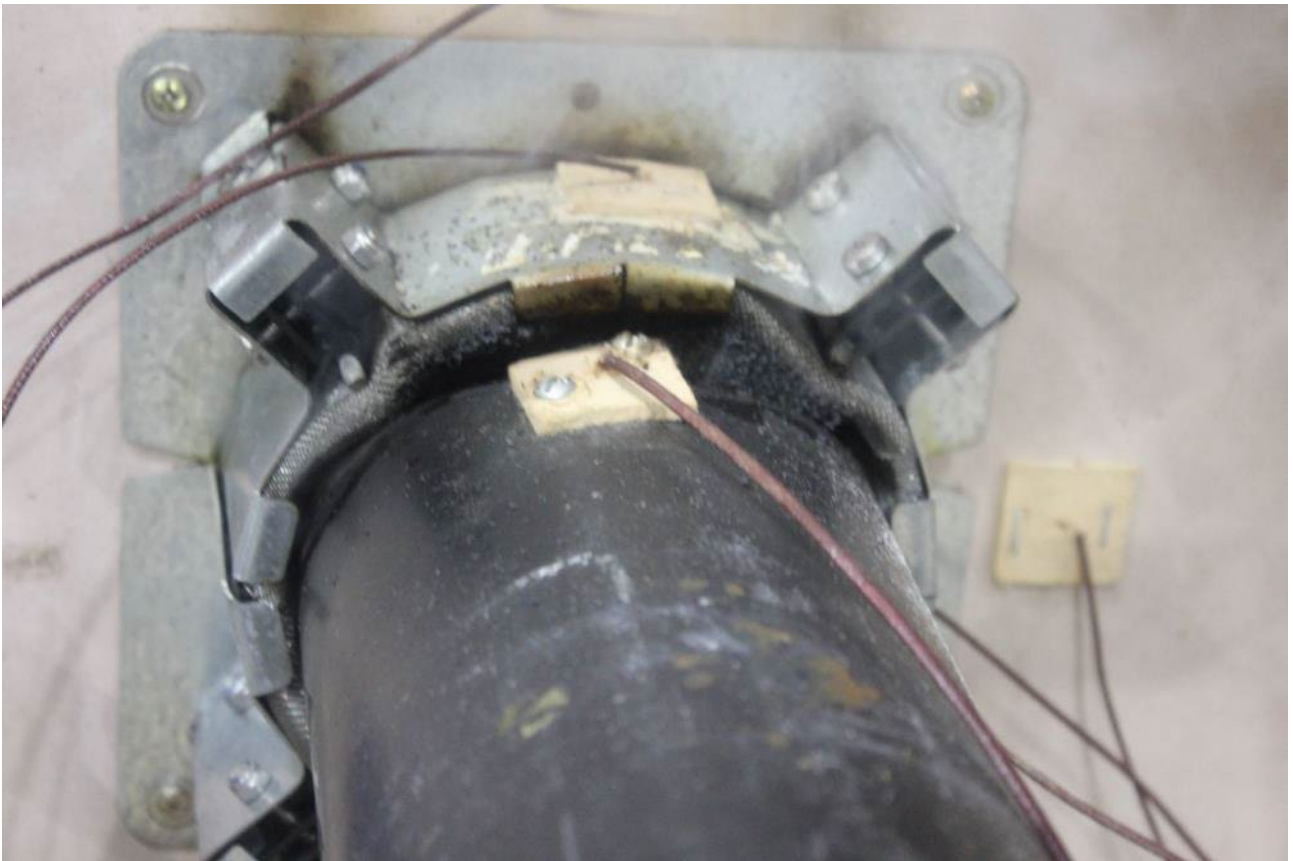
**PHOTOGRAPH 13 –SPECIMEN 2 AFTER 137 MINUTES OF TESTING**

- 131 minutes - Smoke staining is visible on the plasterboard wall above the collar of specimen 2.
  - 137 minutes - Black intumescent material has begun filling the gap between the collar and the pipe of specimen 2.

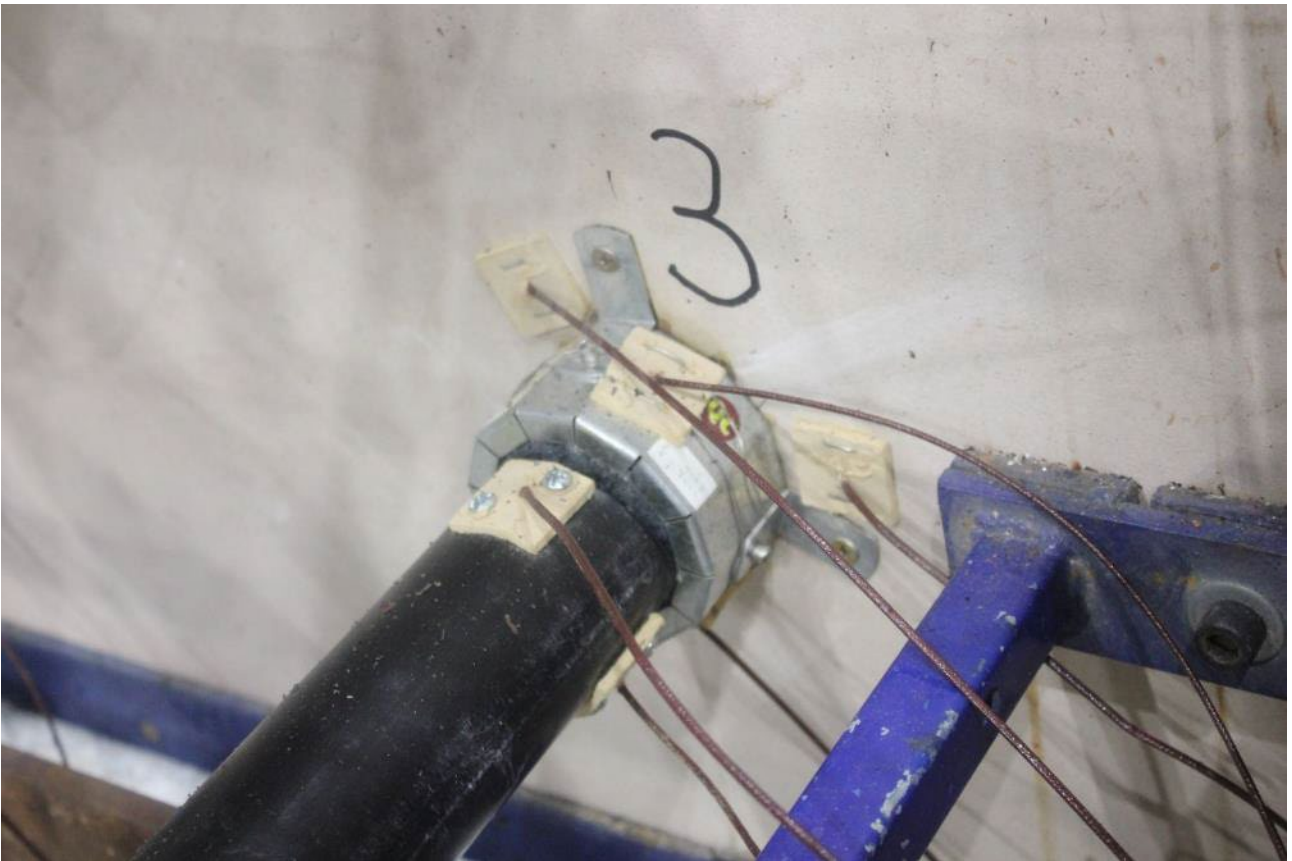
**PHOTOGRAPH 15 – SPECIMEN 3 AFTER 164 MINUTES OF TESTING**

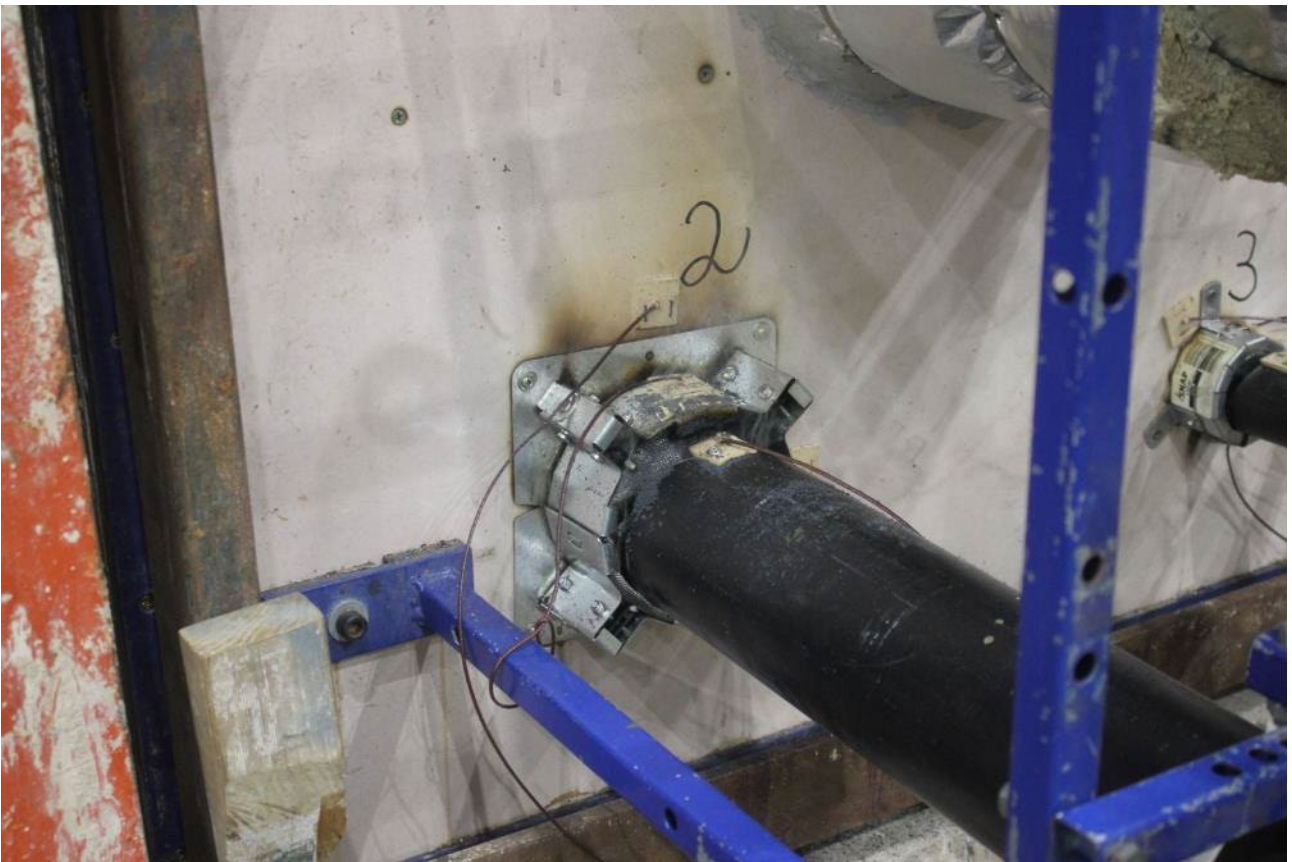
**PHOTOGRAPH 16 – SPECIMEN 2 AFTER 172 MINUTES OF TESTING**

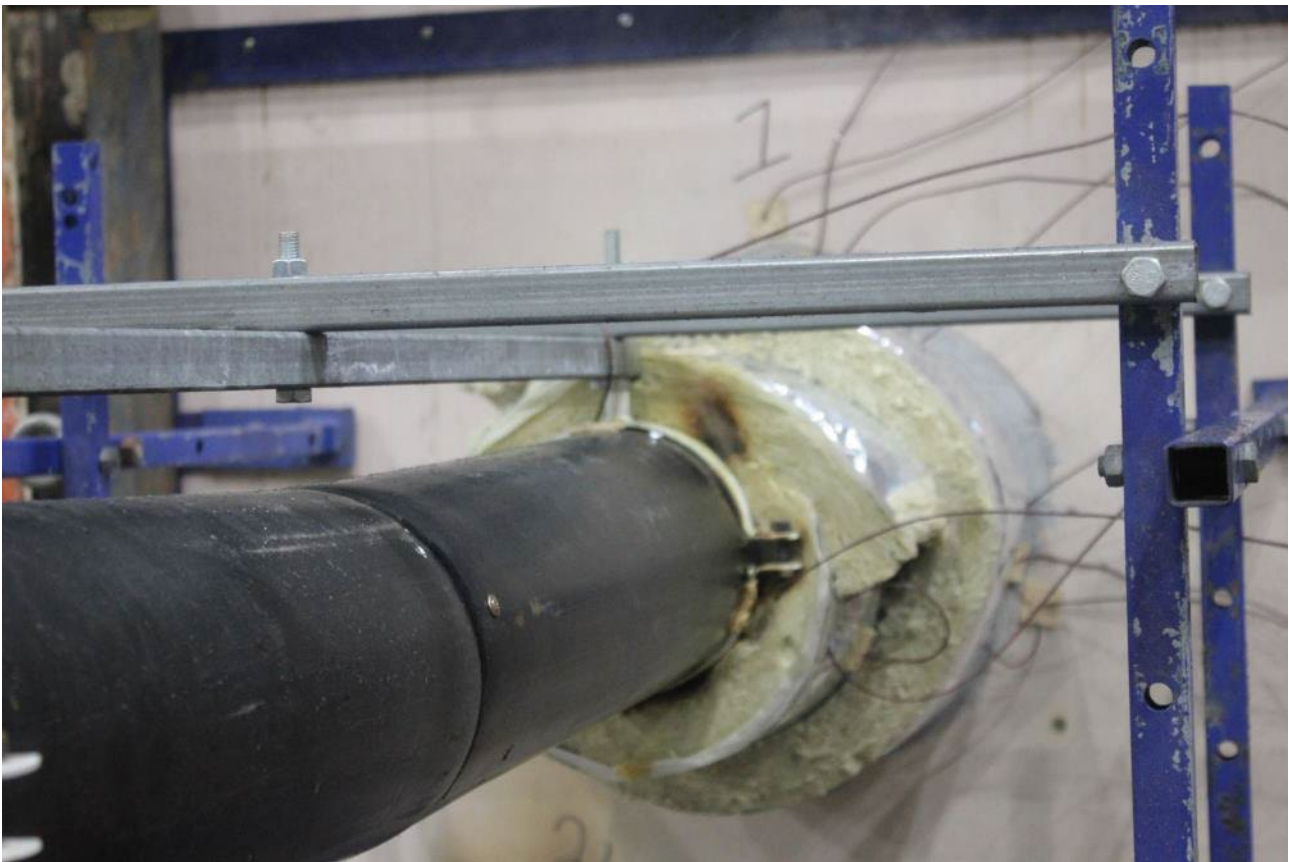
**PHOTOGRAPH 18 – SPECIMEN 1 AT THE CONCLUSION OF TESTING**

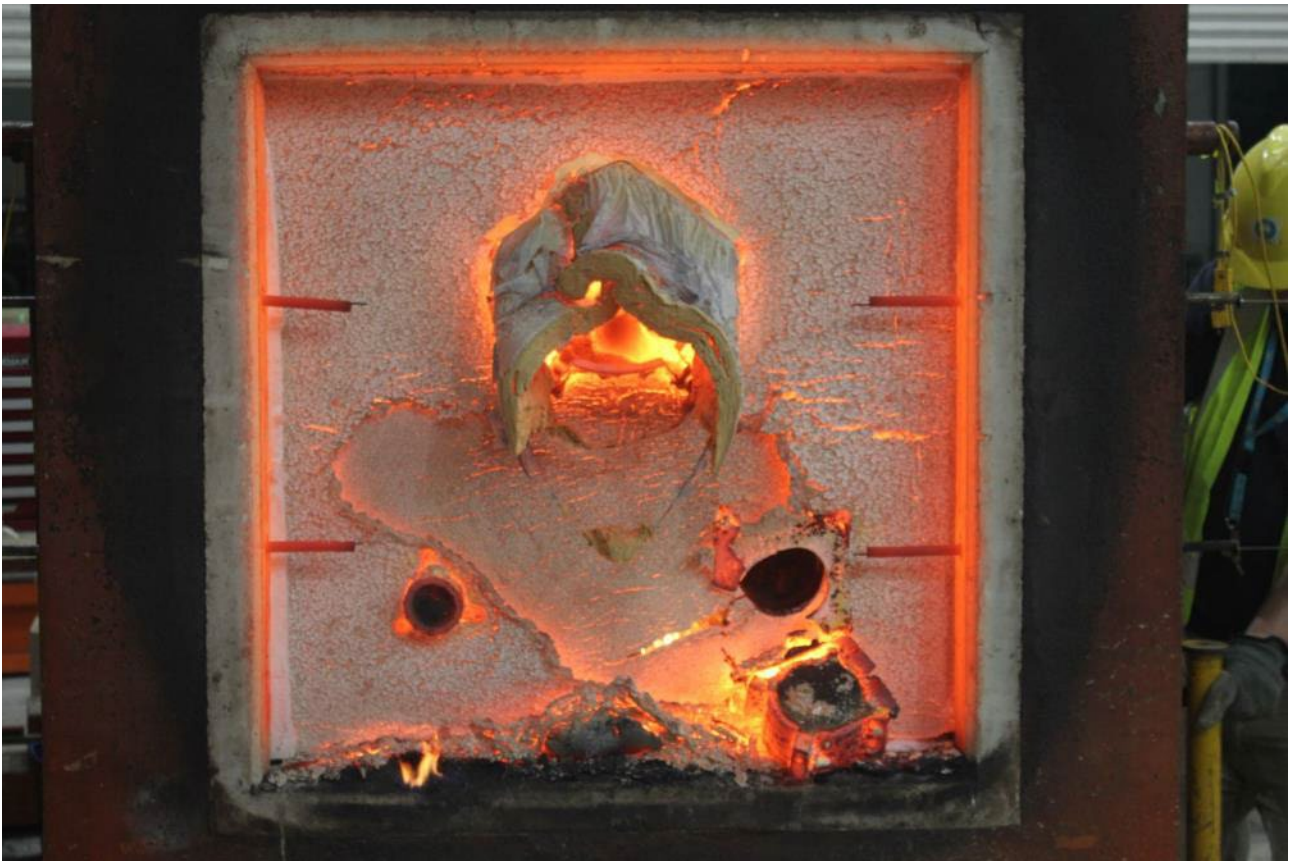
**PHOTOGRAPH 19 – EXPOSED FACE OF SPECIMENS AT THE CONCLUSION OF TESTING**

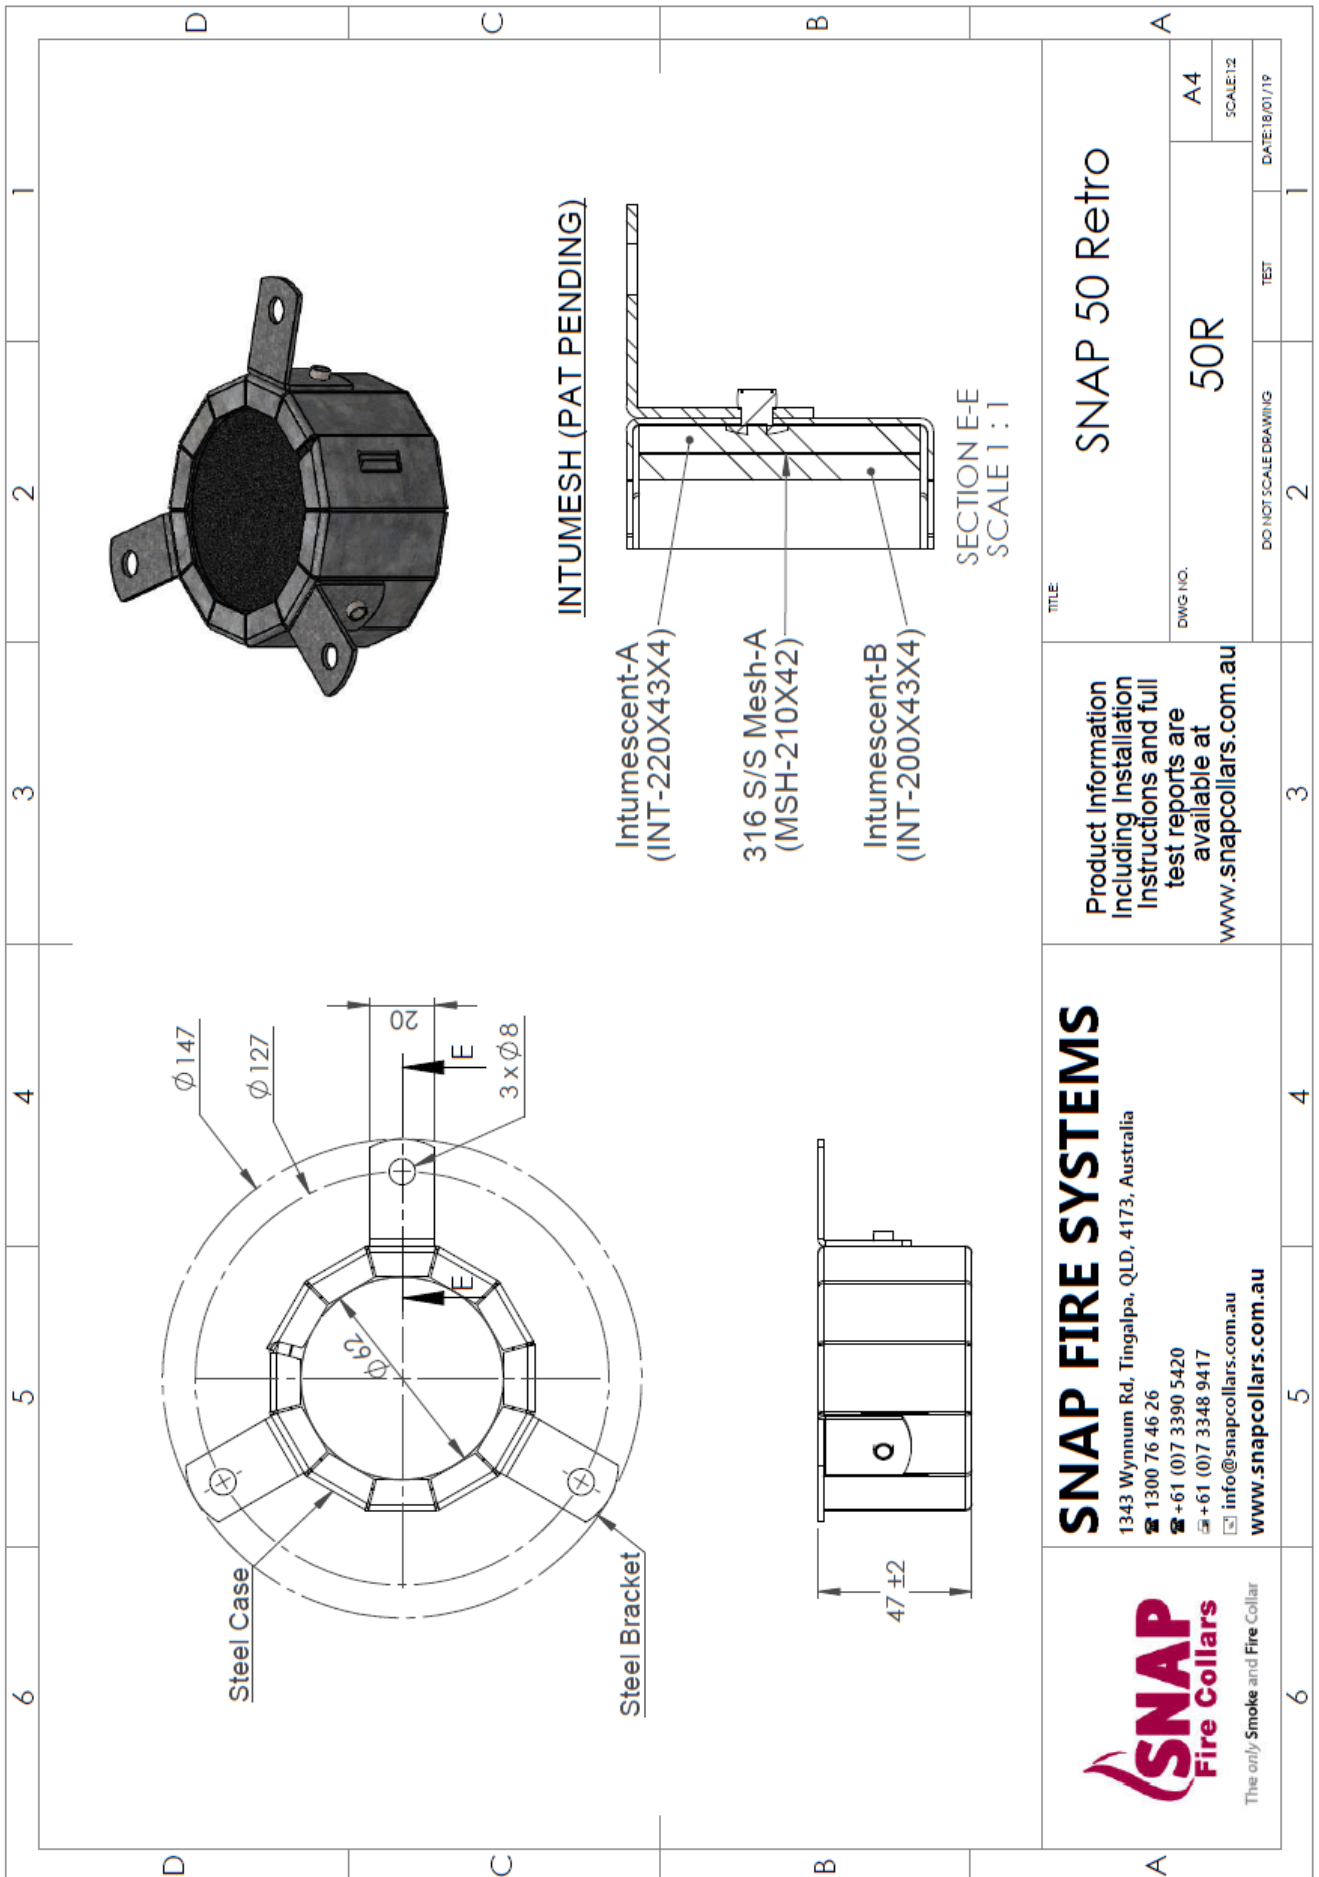
TITLE		SNAP 50 Retro	
DWG NO.	50R	DATE	18/01/19
DO NOT SCALE DRAWING	TEST	SCALE	A4 SCALE 1:1
