# Fire-resistance test on fire collars protecting a concrete slab penetrated by services

## Test Report

**Author:** Peter Gordon  
**Report number:** FSP 2049 (Revision D)  
**Date:** 4 July 2022

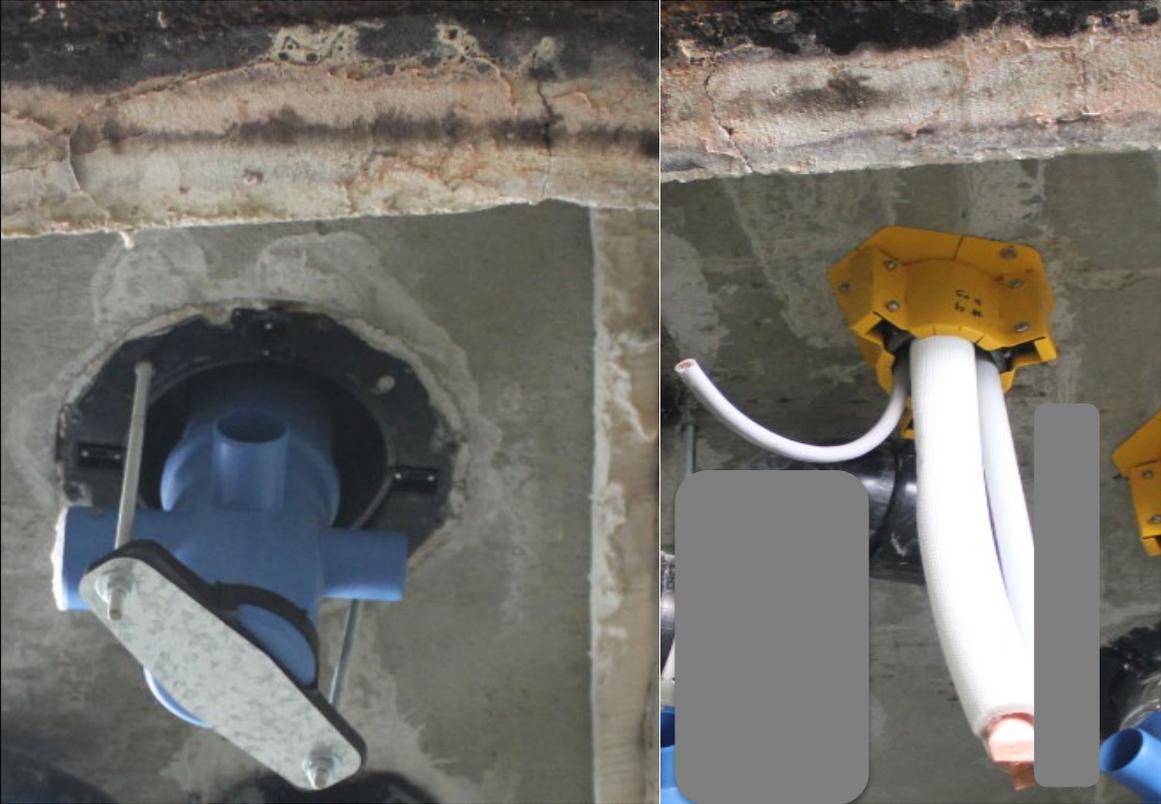
**PHOTOGRAPH 1 – EXPOSED FACE OF SPECIMENS 1 AND 4 PRIOR TO TESTING**

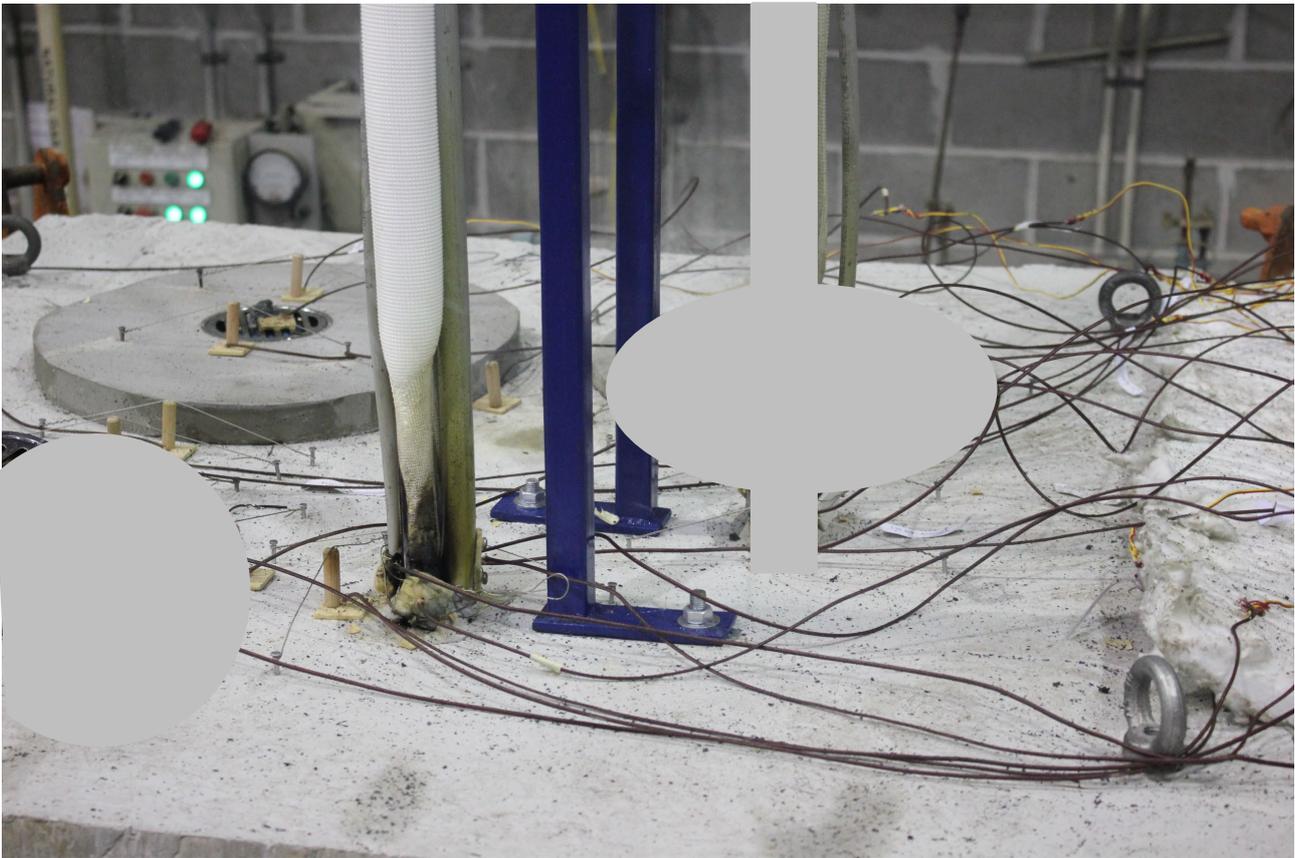
**PHOTOGRAPH 7 – SPECIMENS AFTER 120 MINUTES OF TESTING**
