Fire-resistance test on retrofit fire collars protecting a plasterboard wall penetrated by services

Test Report

Author: Peter Gordon
Report number: FSP 2267 Redacted
Date: 15 December 2022
Client: IG6 Pty Ltd

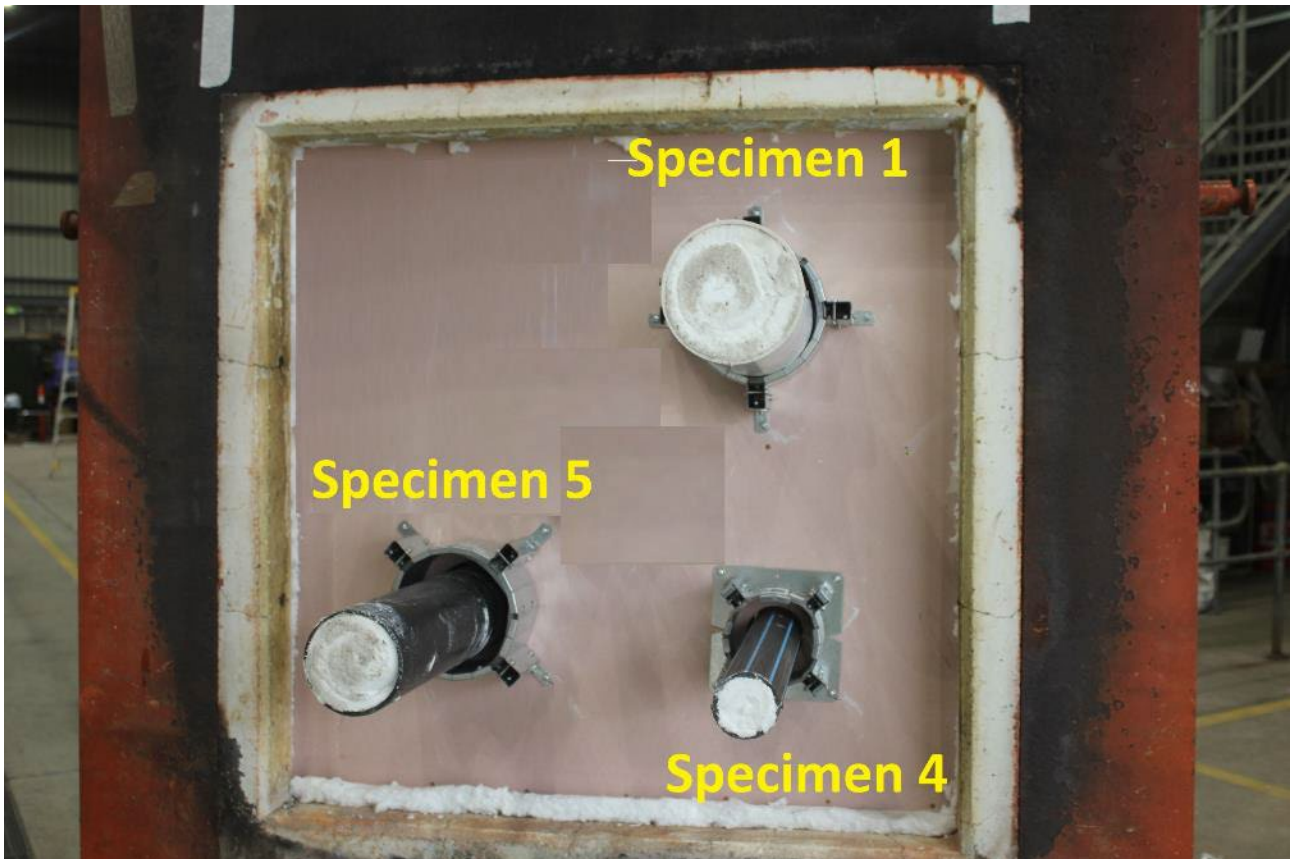
PHOTOGRAPH 1 – EXPOSED FACE OF SPECIMENS PRIOR TO TESTING

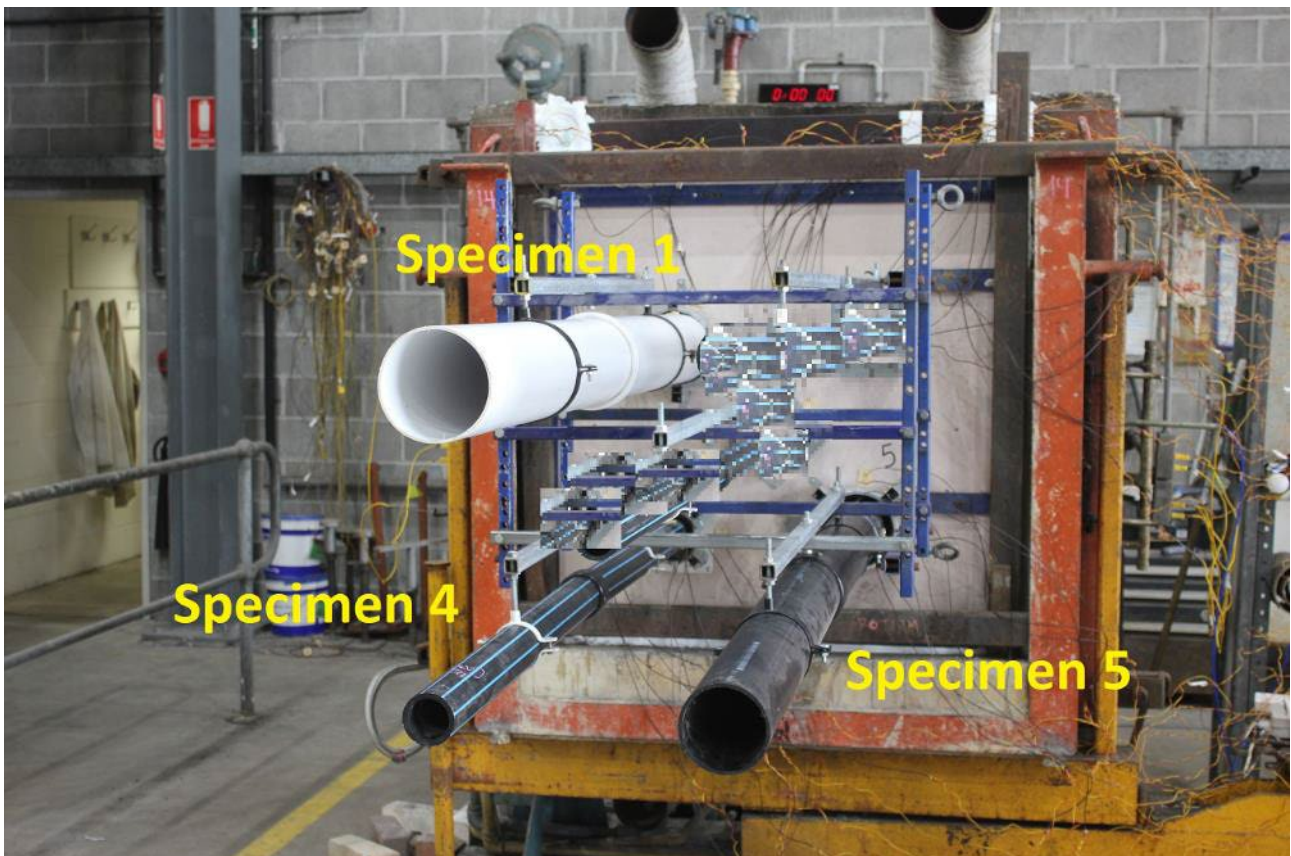
PHOTOGRAPH 2 – UNEXPOSED FACE OF SPECIMENS PRIOR TO TESTING

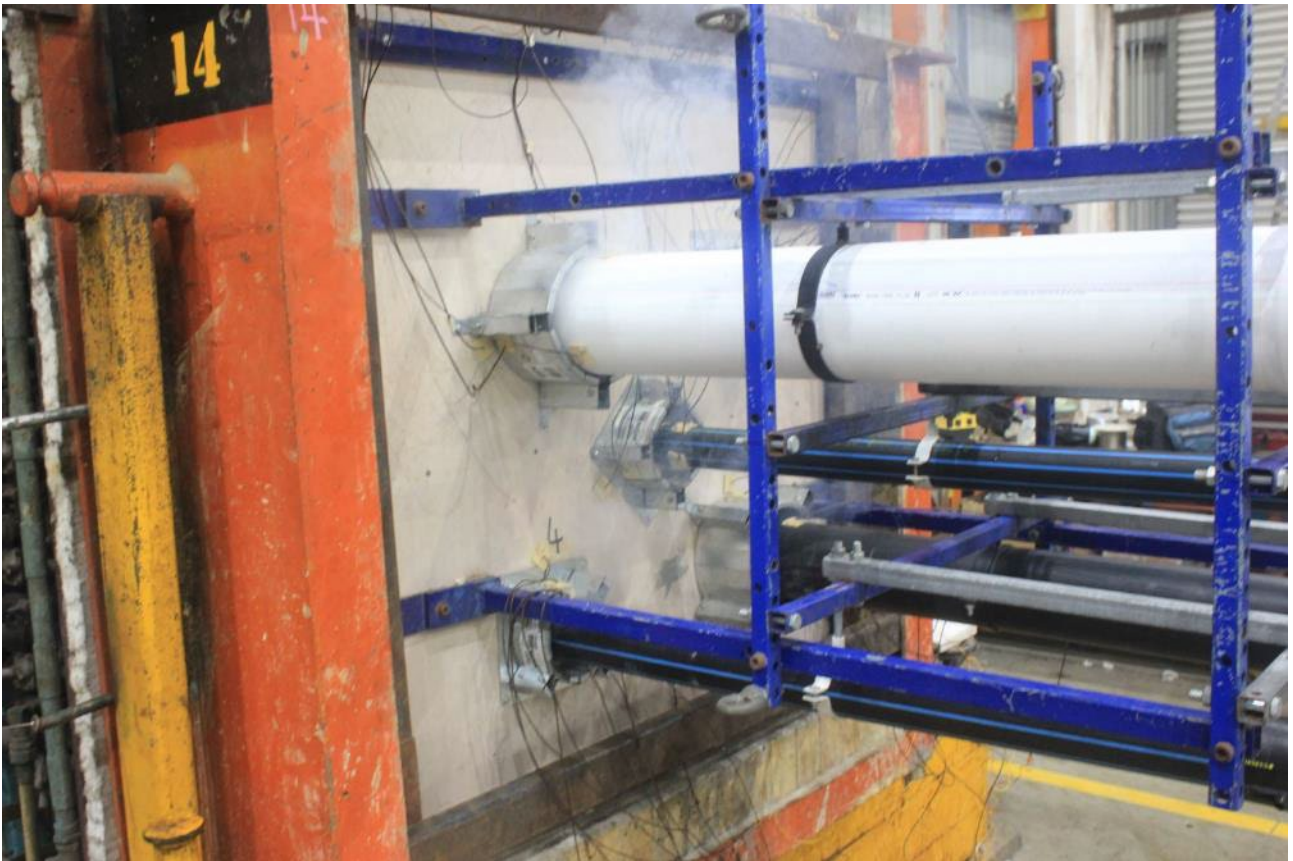
PHOTOGRAPH 3 – SPECIMENS AFTER 3 MINUTES OF TESTING

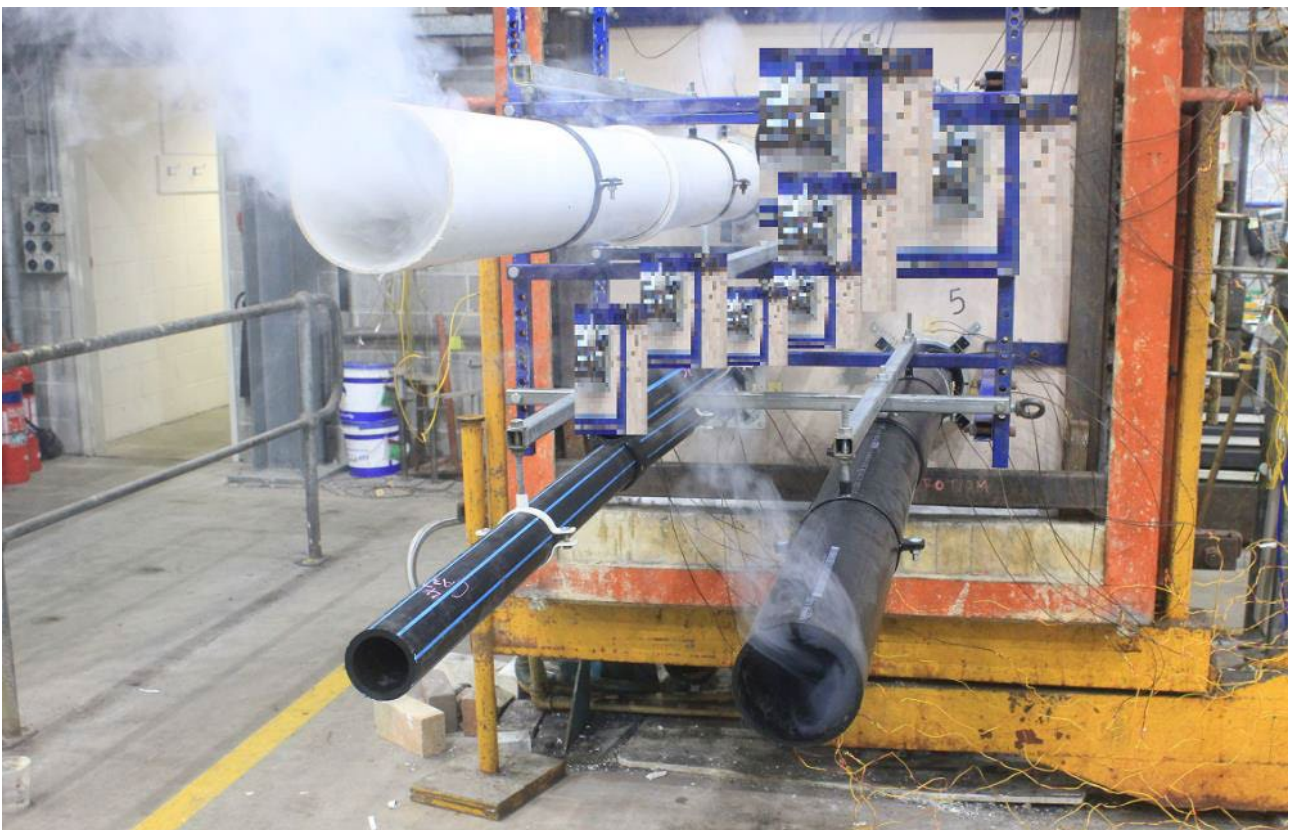
PHOTOGRAPH 4 – SPECIMENS AFTER 4 MINUTES OF TESTING

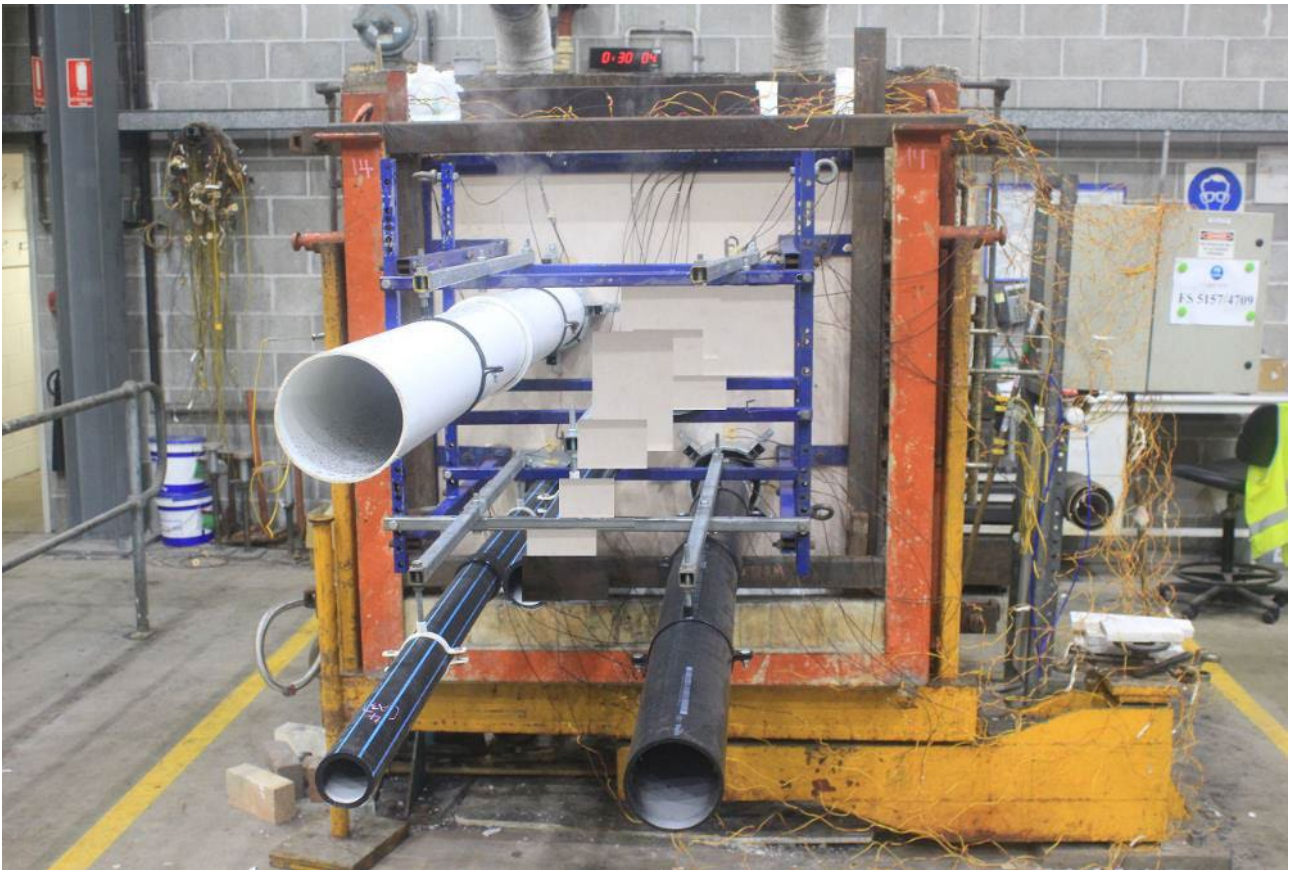
PHOTOGRAPH 5 – SPECIMENS AFTER 30 MINUTES OF TESTING

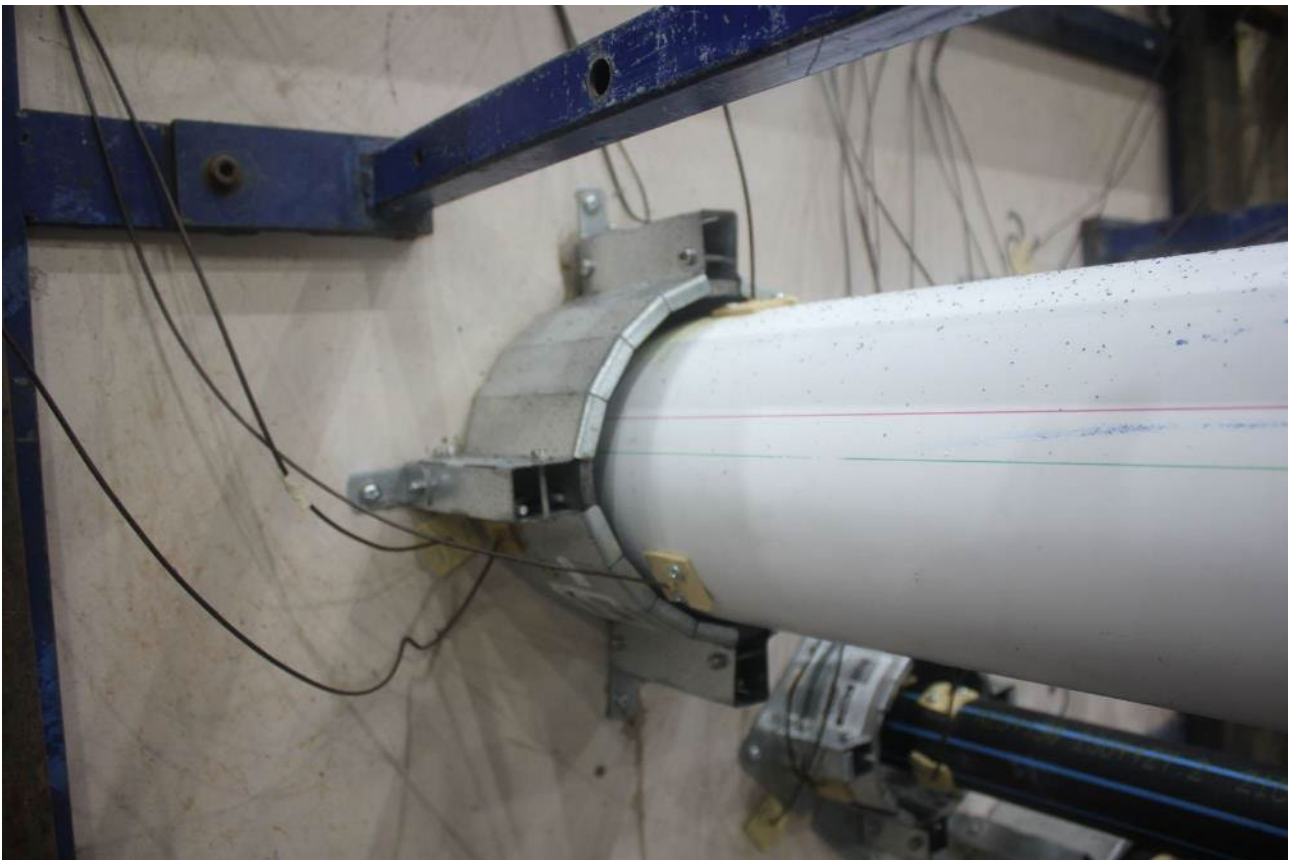
PHOTOGRAPH 6 – SPECIMEN 1 AFTER 41 MINUTES OF TESTING

54 minutes	Light smoke has resumed fluing from the end of the pipe of specimen 1.
121 minutes	Smoke has resumed being emitted between the collar and the pipe at the base of specimen 5.
123 minutes	<u>Insulation failure of specimen 5</u> – maximum temperature rise of 180K is exceeded on the top of the pipe, 25-mm from the wall.
145 minutes	The smoke being emitted between the collar and the pipe at the base of specimen 4 has intensified.
146 minutes	<u>Insulation failure of specimen 4</u> – maximum temperature rise of 180K is exceeded on the plasterboard wall (inside the collar) above the wall opening.
147 minutes	Flaming observed on the pipe inside the collar of specimen 4. Cotton pad test applied over the pipe and collar above the flaming at the base of specimen 4, no ignition of cotton pad noted at this time.
150 minutes	<u>Integrity failure of specimen 4</u> - Cotton pad test applied over the top of the pipe adjacent to the flaming inside the collar of specimen 4, ignition of cotton pad noted at this time. Sustained flaming at the base of specimen 4 noted at this time. The base of specimen 4 was covered with ceramic fibre.

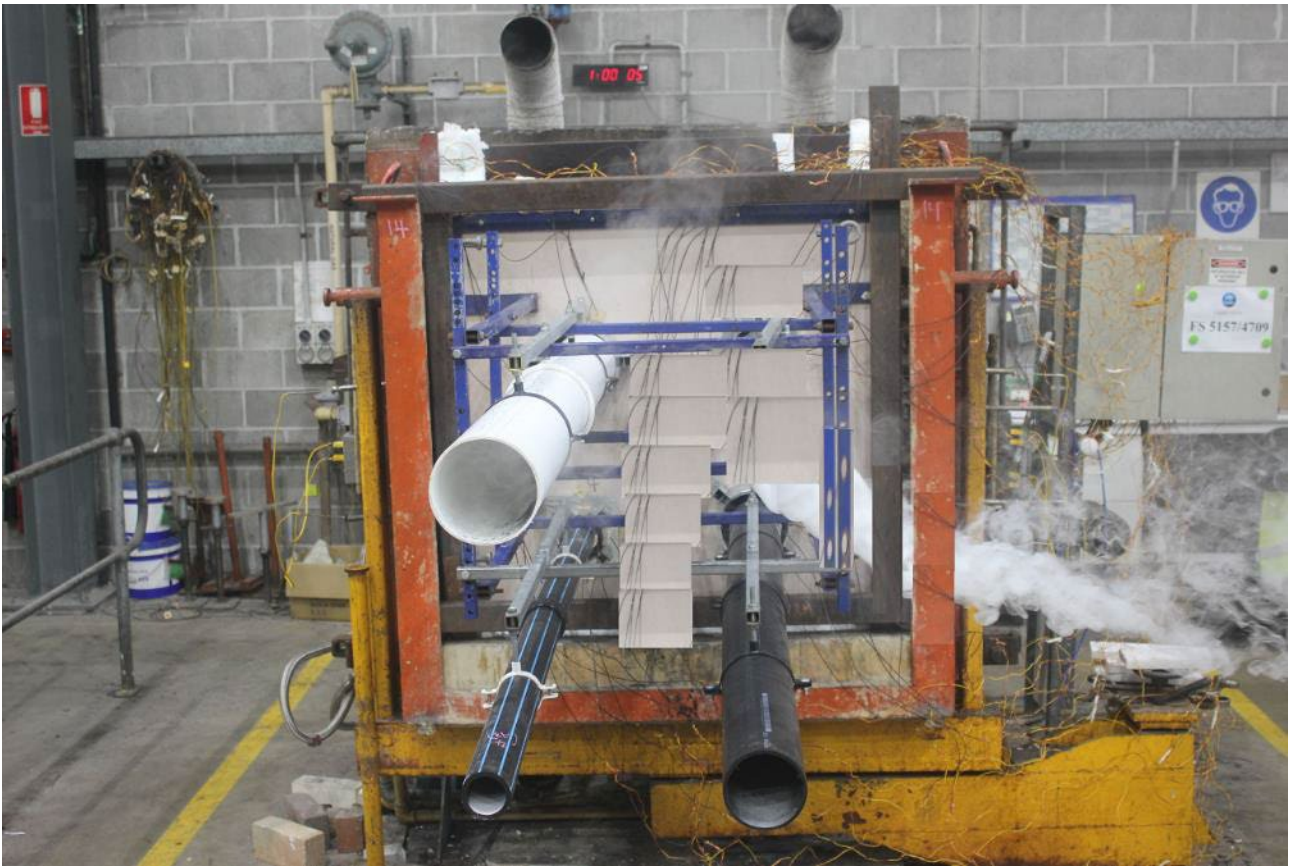
PHOTOGRAPH 7 – SPECIMENS AFTER 60 MINUTES OF TESTING

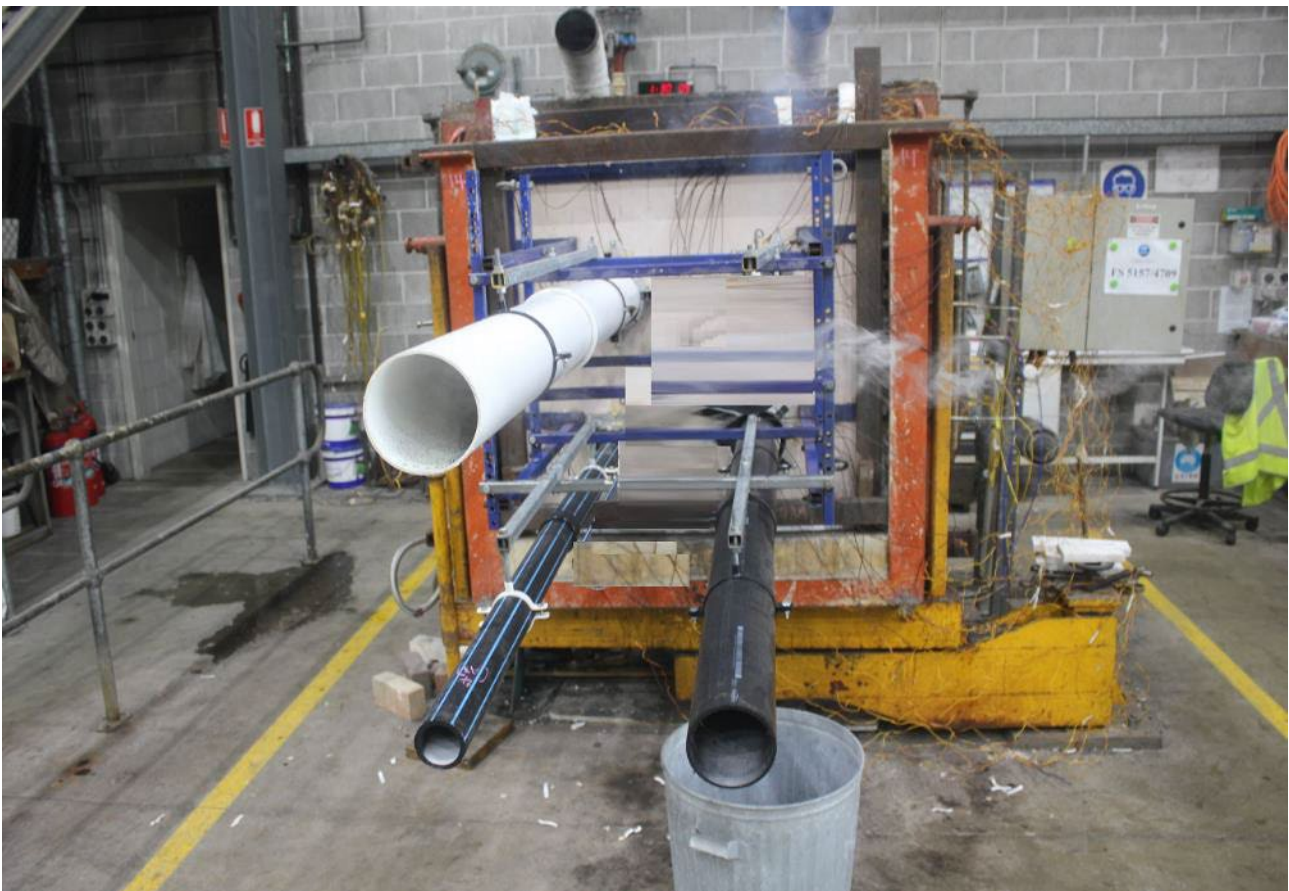
PHOTOGRAPH 8 – SPECIMENS AFTER 90 MINUTES OF TESTING

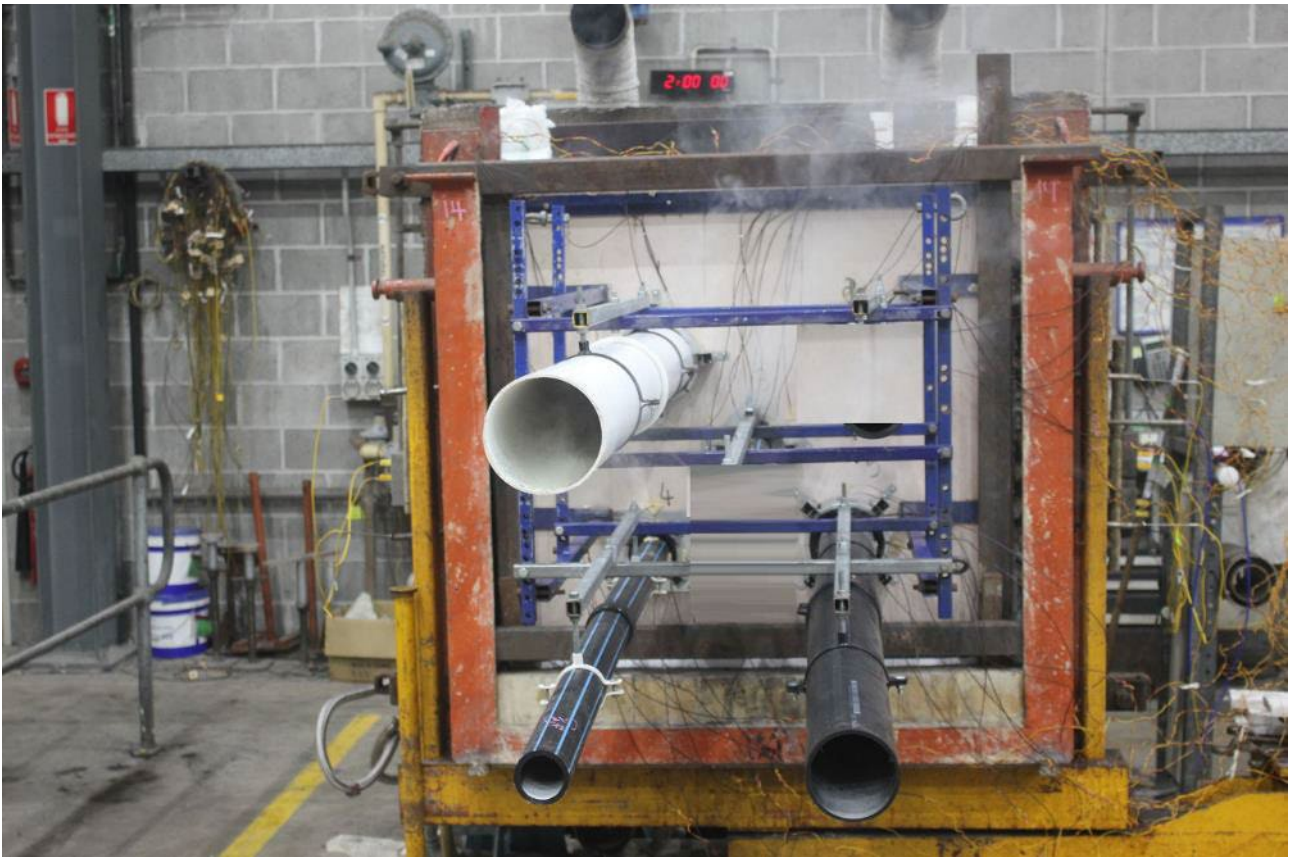
PHOTOGRAPH 9 –SPECIMENS AFTER 120 MINUTES OF TESTING

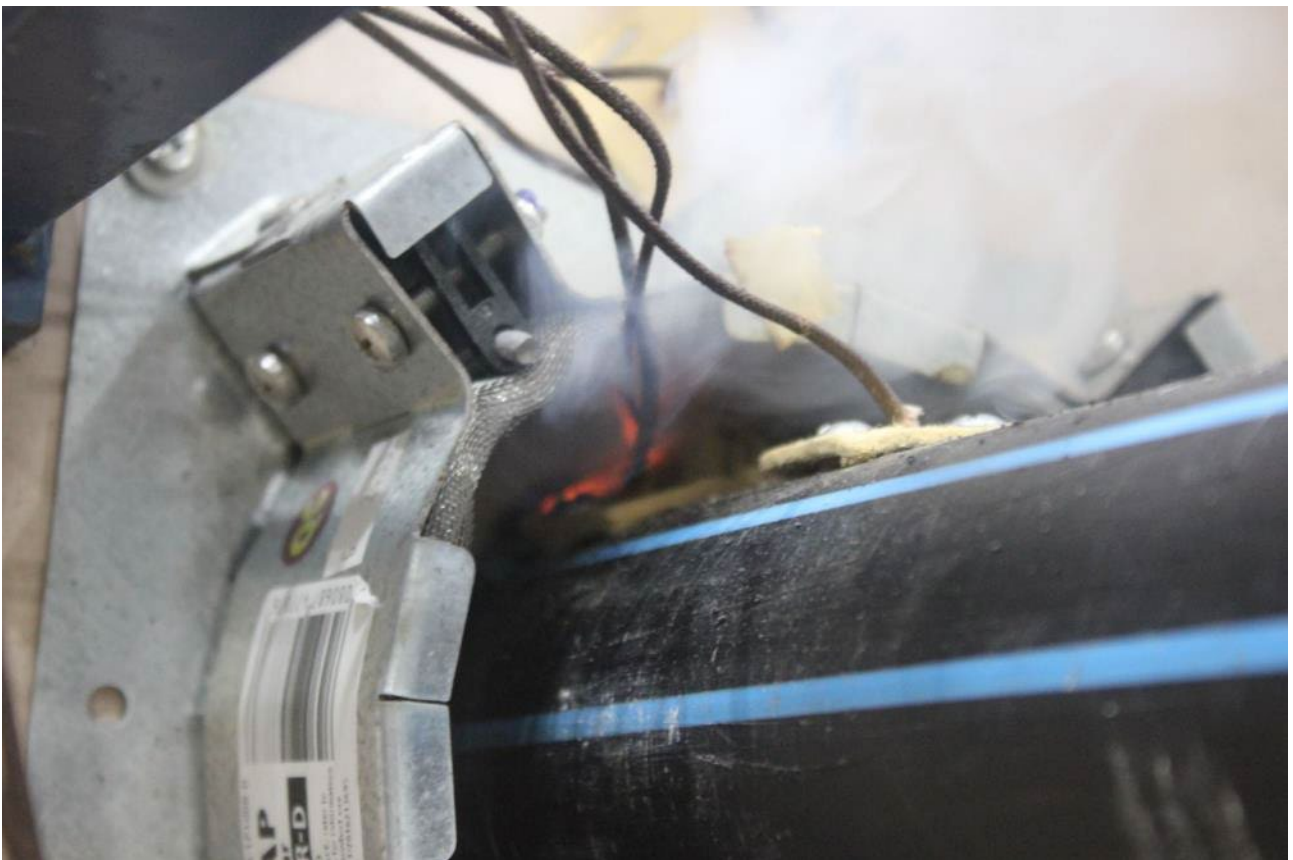
PHOTOGRAPH 10 –SPECIMEN 4 AFTER 147 MINUTES OF TESTING

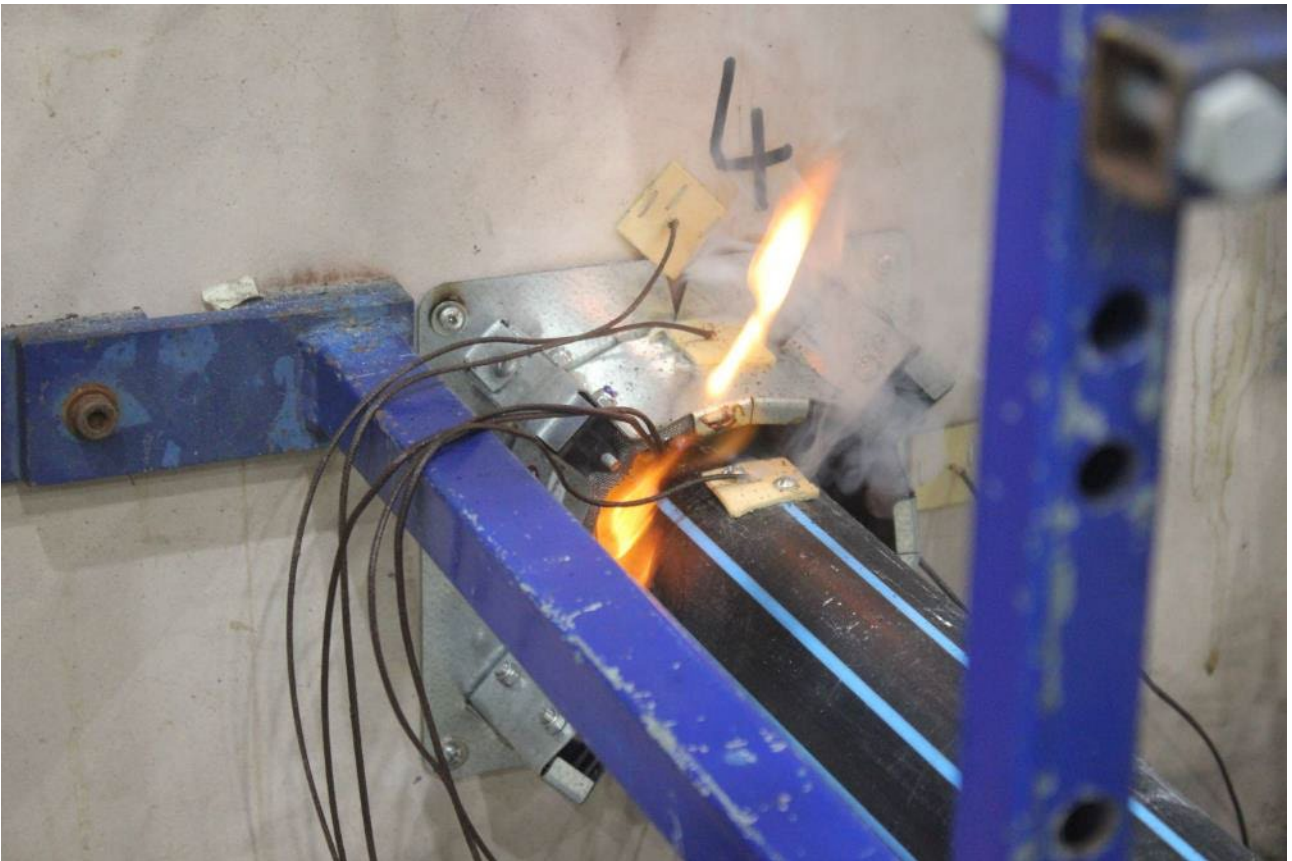
PHOTOGRAPH 11 –SPECIMEN 4 AFTER 150 MINUTES OF TESTING

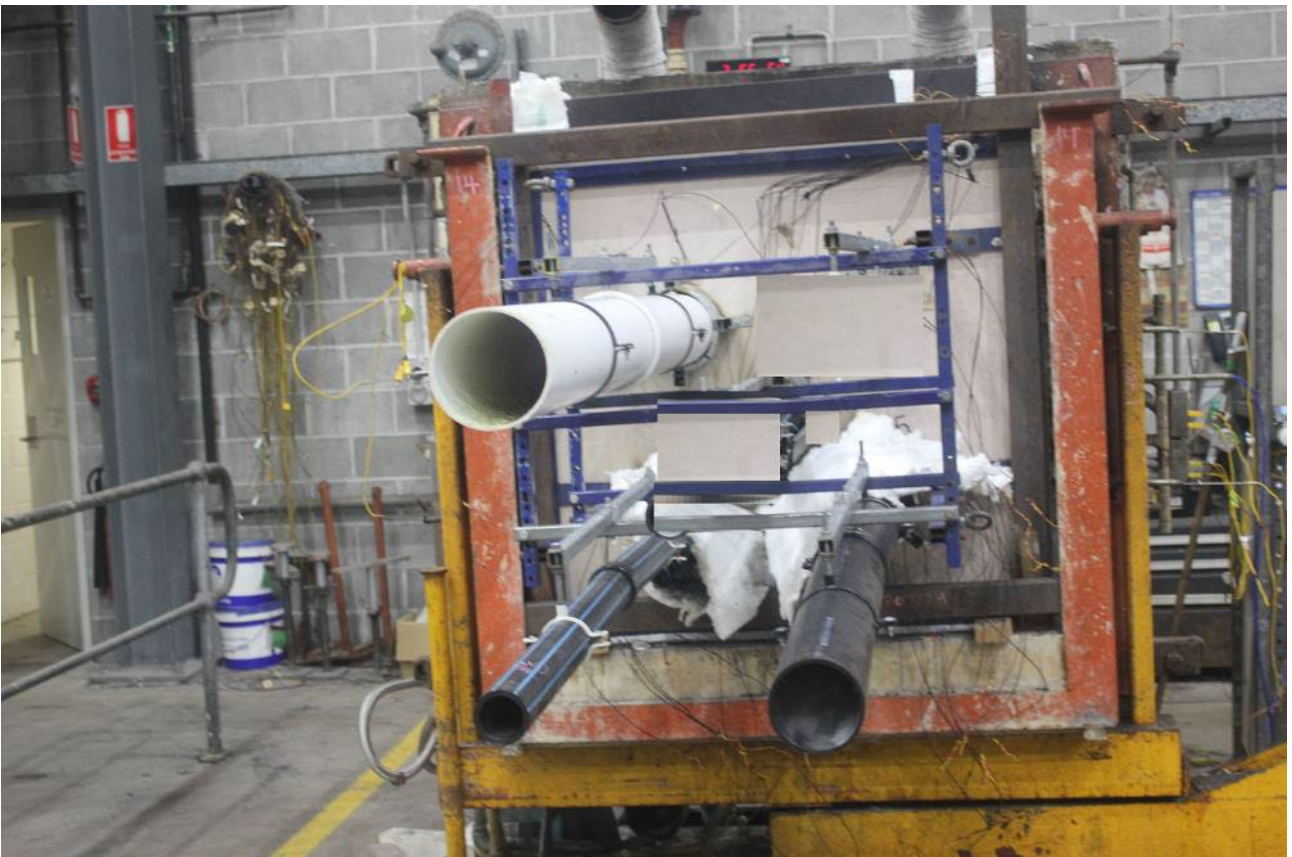
PHOTOGRAPH 12 – SPECIMENS AT CONCLUSION OF TESTING

- 165 minutes - The level of smoke being emitted from the collar at the base of specimen 5 has intensified.
- 167 minutes - Cotton pad test applied over the gap between the pipe and collar at the base of specimen 5, no ignition of cotton pad noted at this time.
- 172 minutes - Integrity failure of specimen 5 - Cotton pad test applied over the top of the pipe adjacent to the flaming inside the collar of specimen 5, ignition of cotton pad noted at this time.
Sustained flaming at the base of specimen 5 noted at this time.
- 173 minutes - Test terminated.

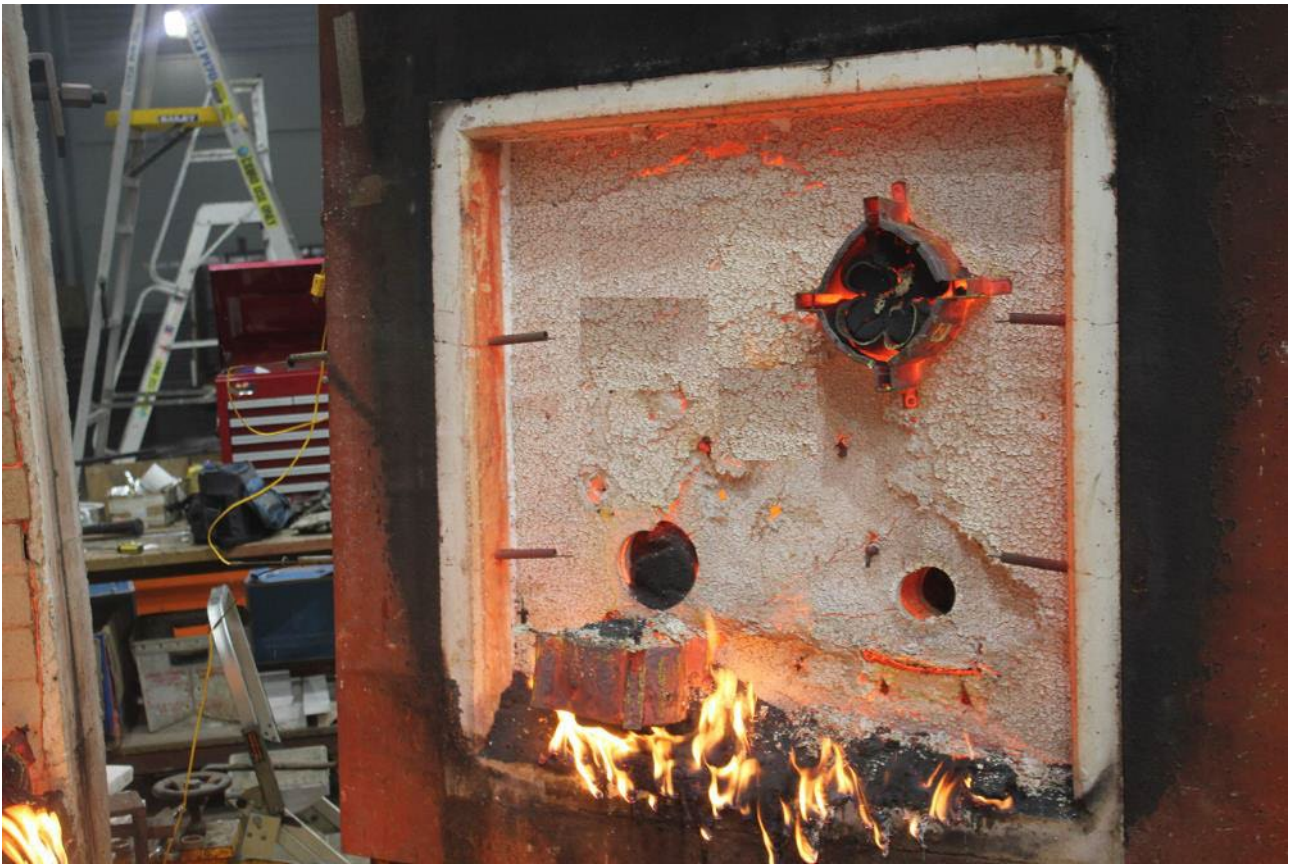
PHOTOGRAPH 13 – EXPOSED FACE OF SPECIMENS AT CONCLUSION OF TESTING

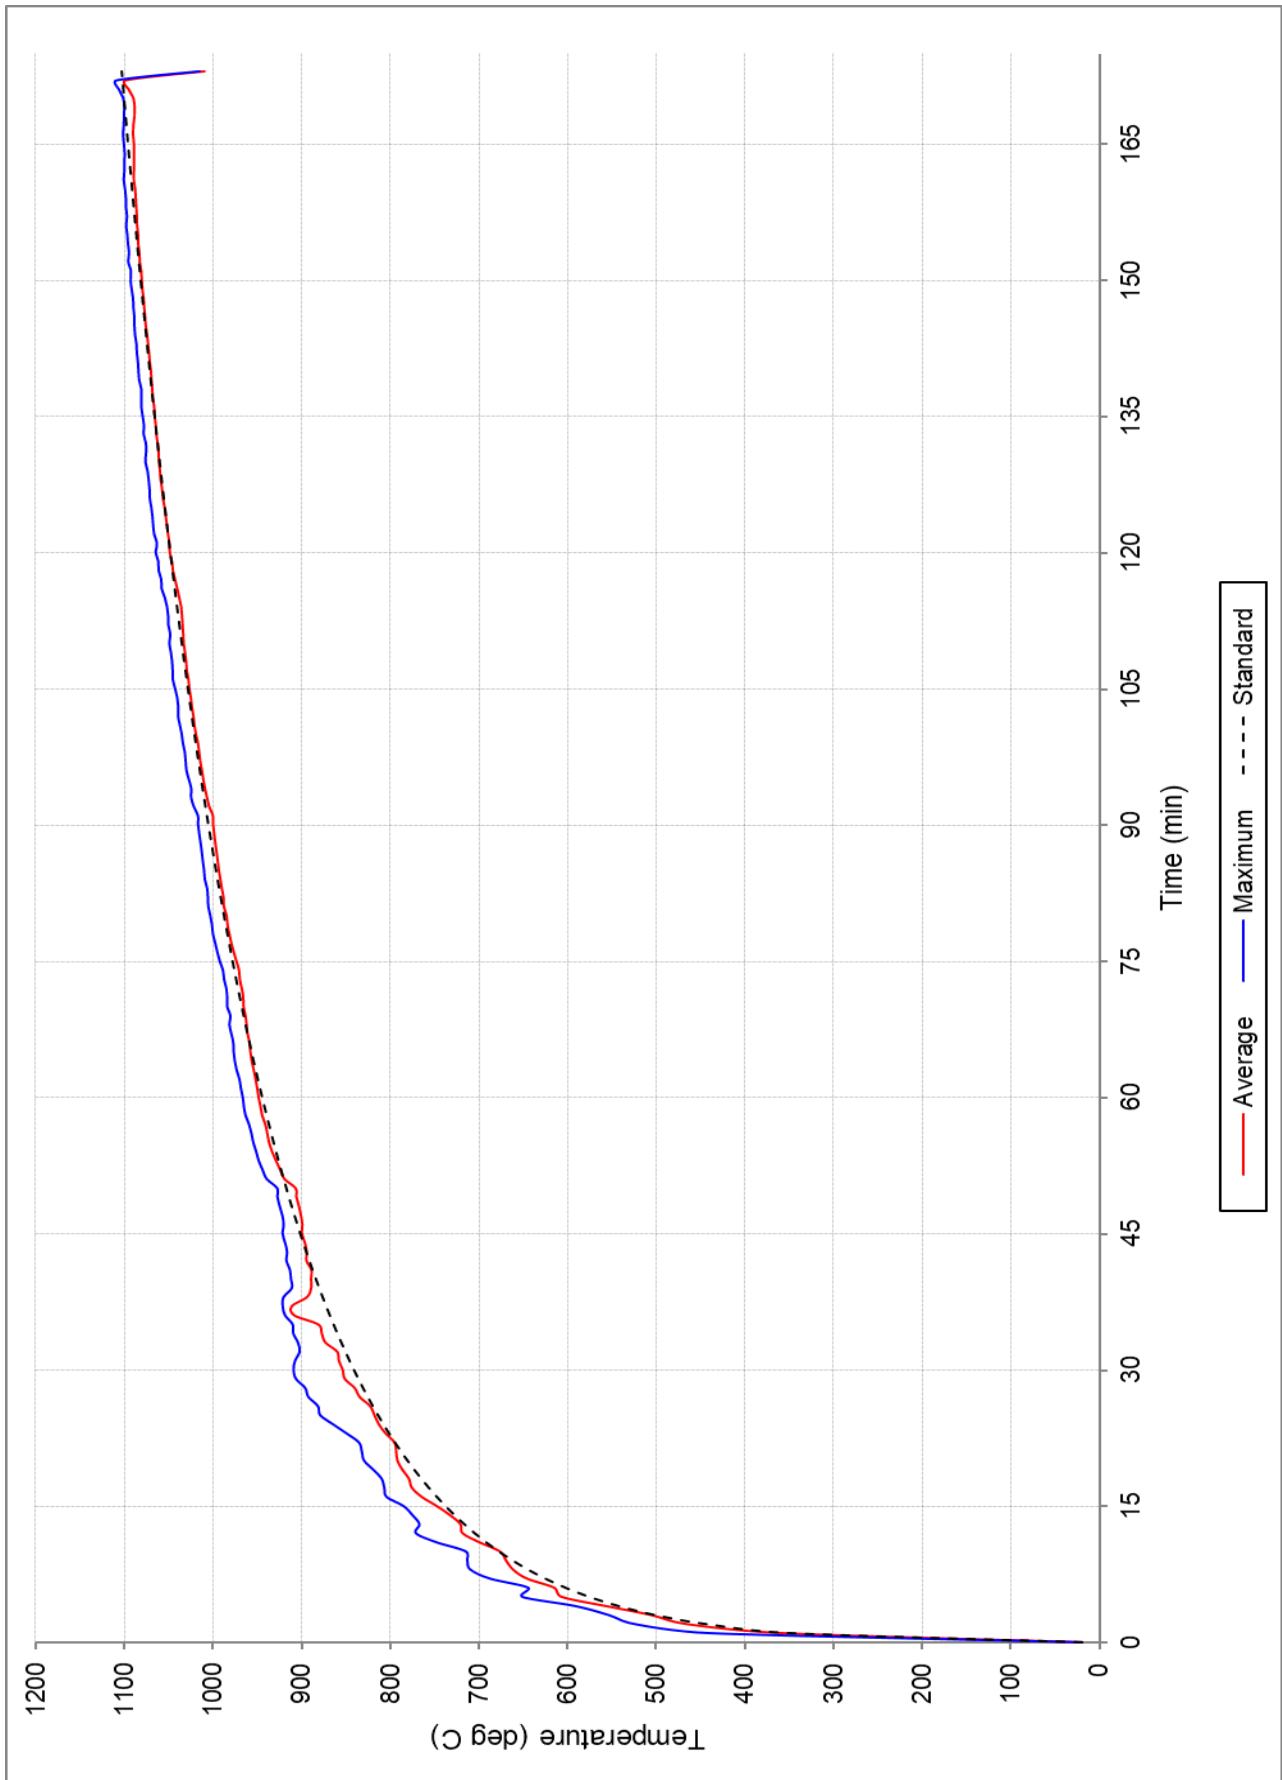
FIGURE 1 – FURNACE TEMPERATURE

Figure 1 shows the standard curves of temperature versus time for heating the furnace chamber and the actual curves of average and maximum temperature versus time recorded during the heating period.

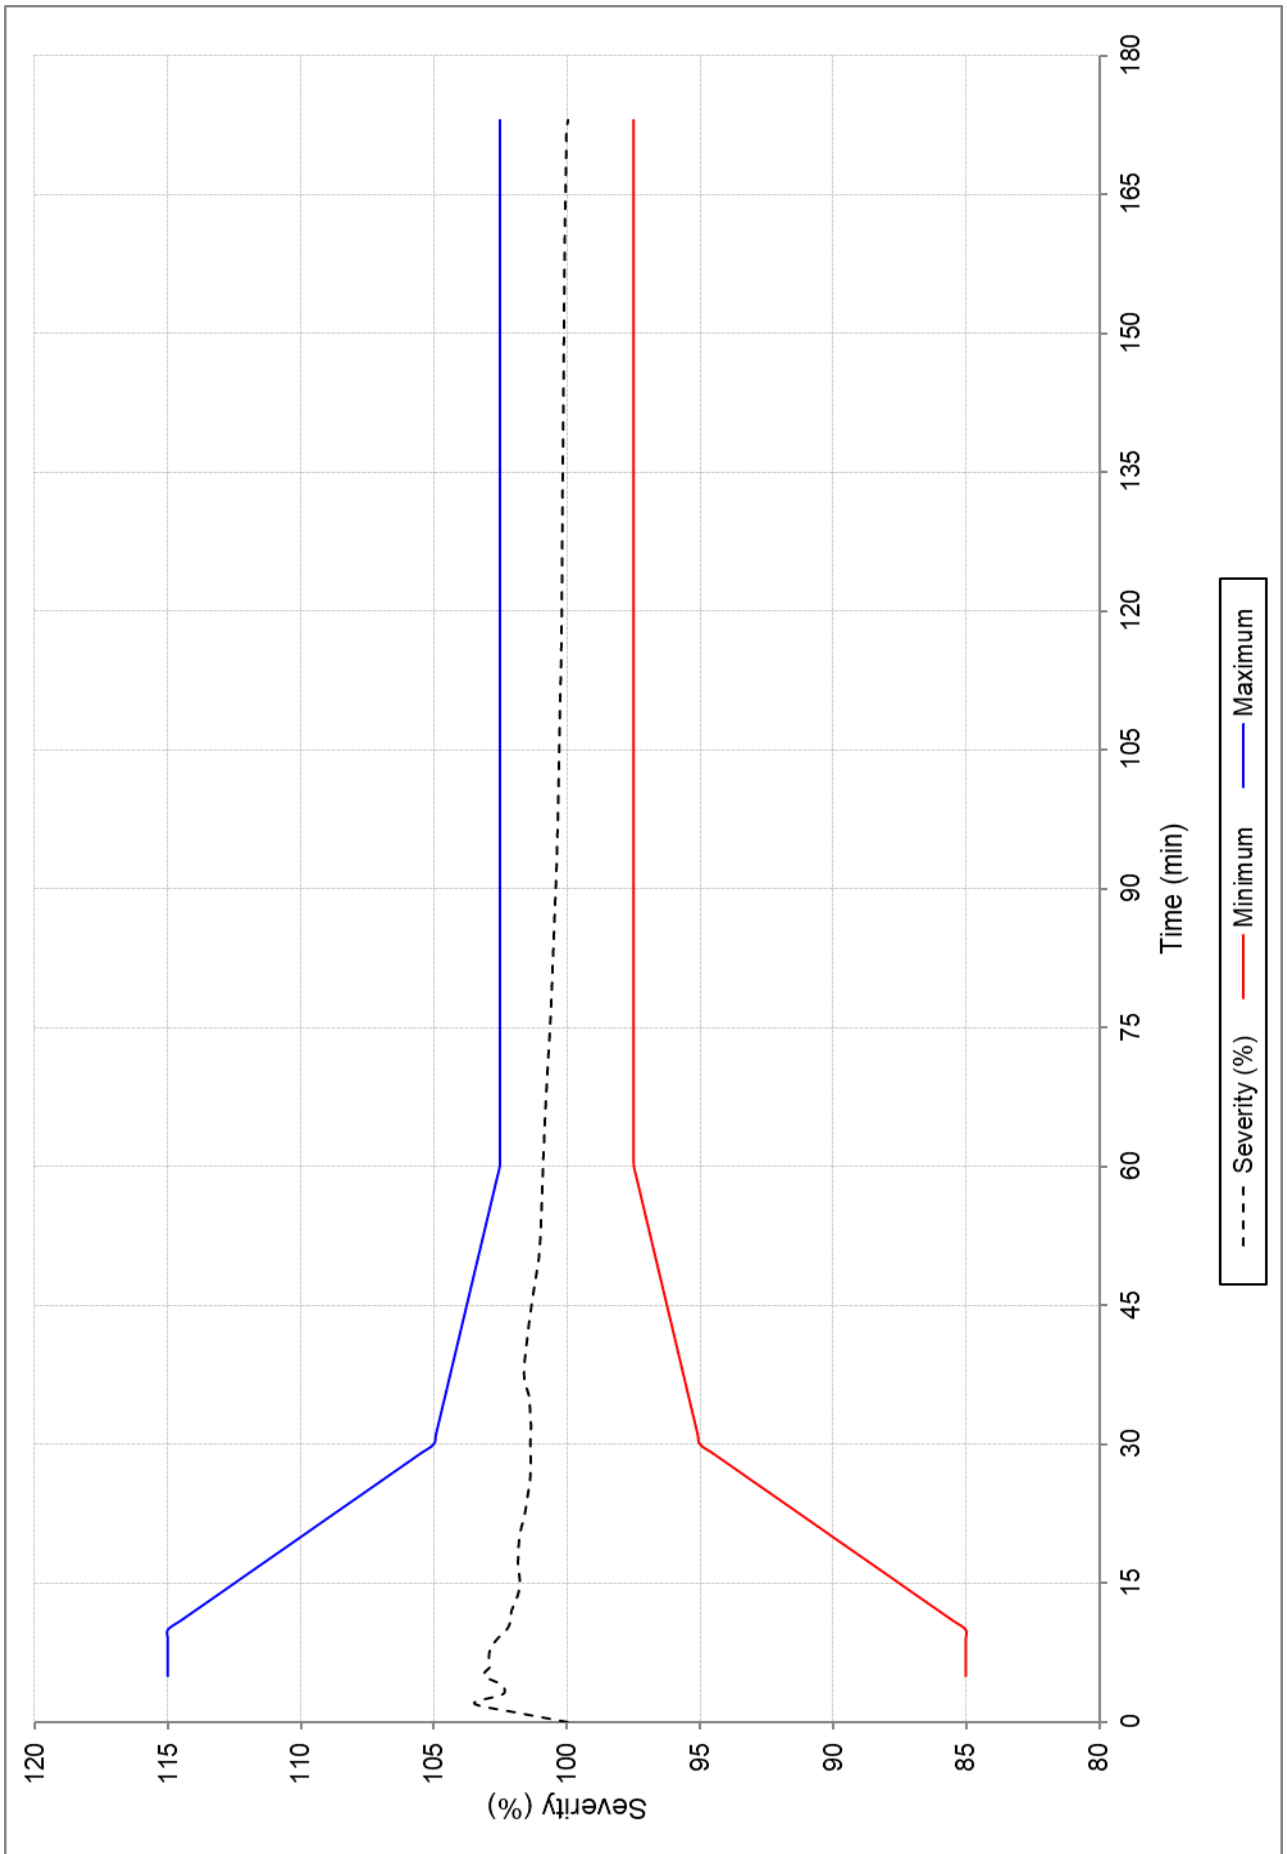
FIGURE 2 – FURNACE SEVERITY

Figure 2 shows the curve of furnace severity versus time during the heating period.

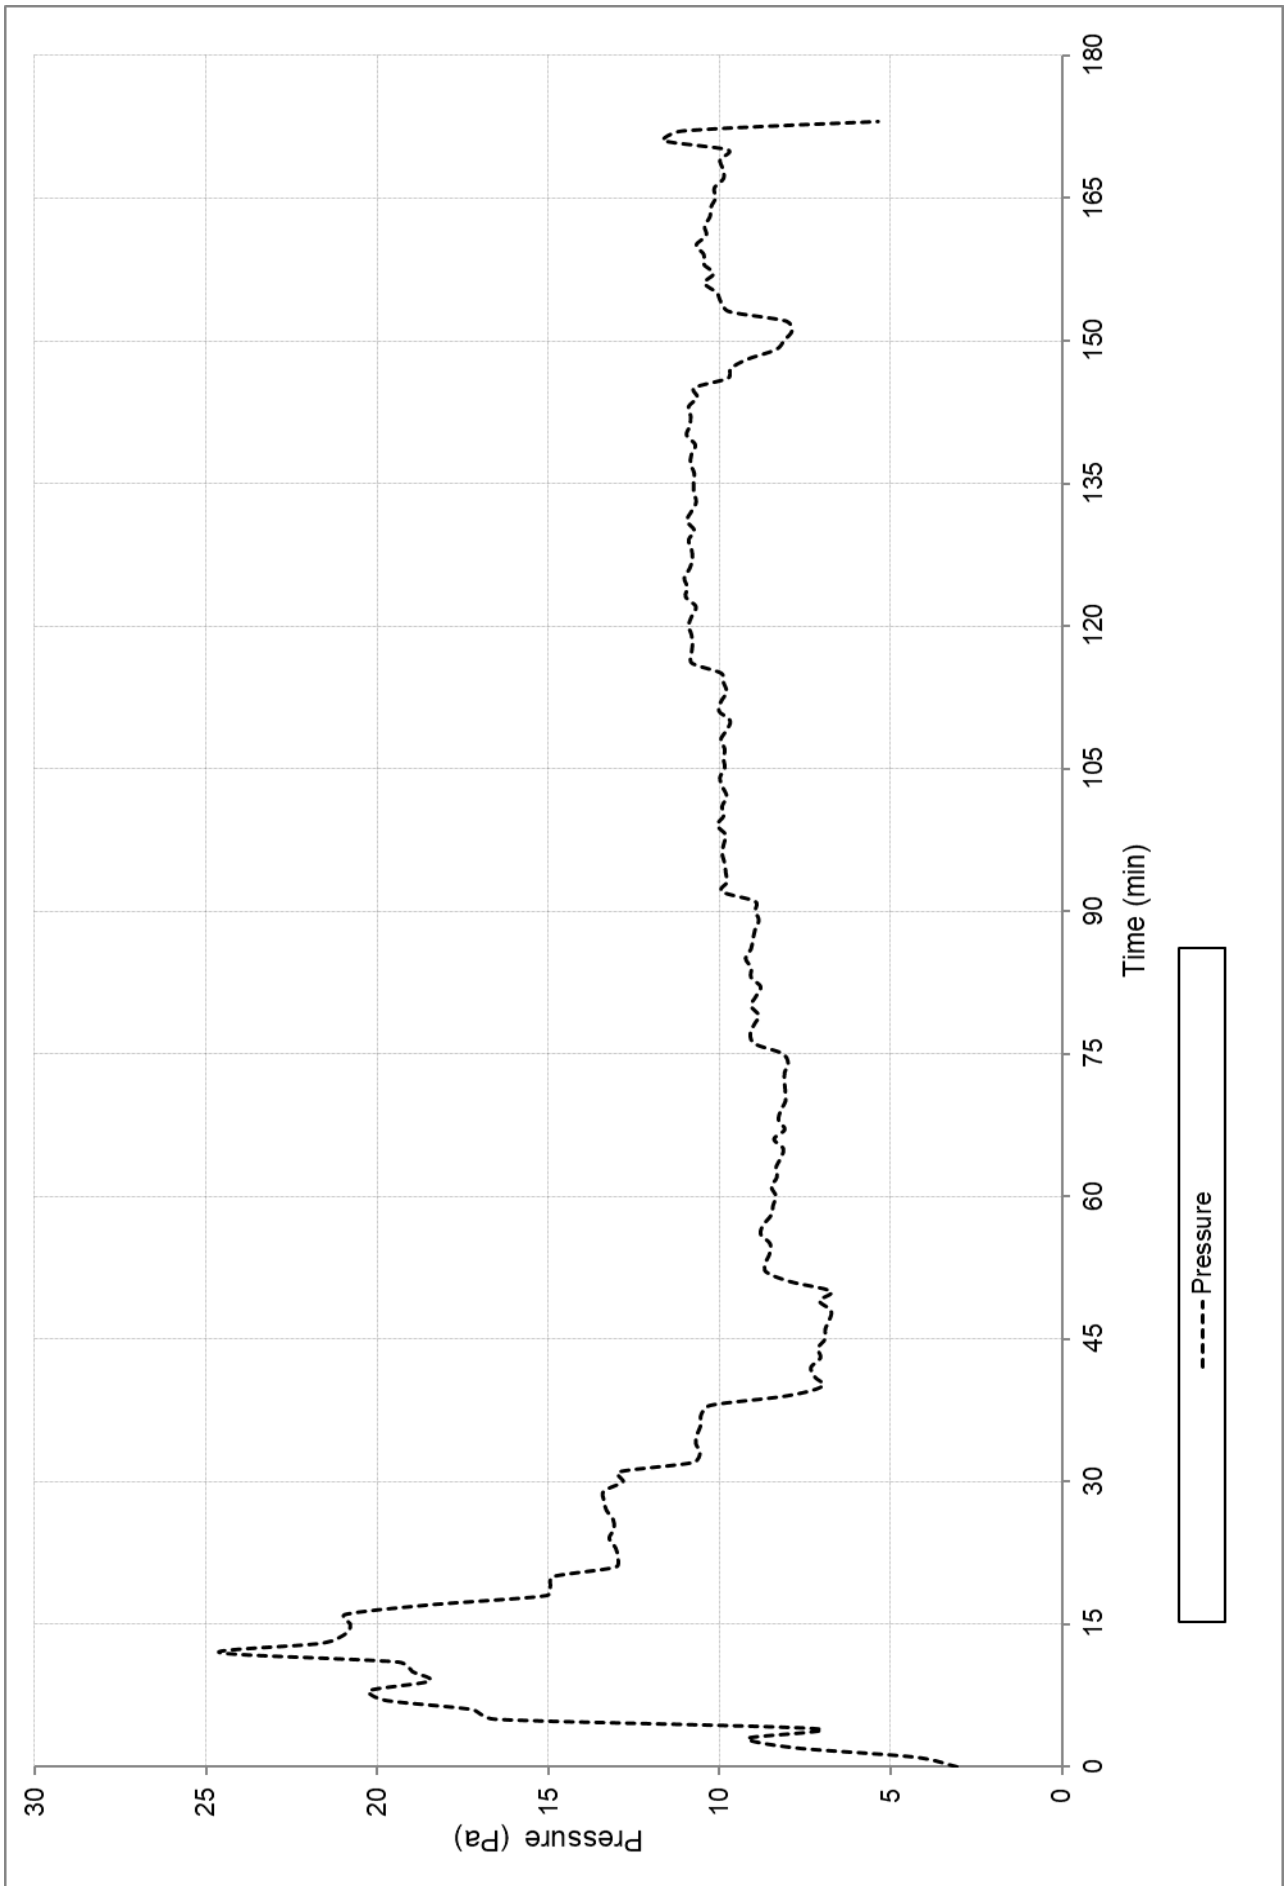
FIGURE 3 – FURNACE PRESSURE

The furnace pressure was outside of the tolerances of the requirements of AS 1530.4-2014 after the first 32 minutes of the test, as shown in Figure 3. The test laboratory confirms that this departure in furnace pressure would not have significantly affected the results of this test.

Figure 3 shows the curve of furnace pressure versus time during the heating period.
