Fire-resistance test on retrofit fire collars protecting a plasterboard wall penetrated by services

Test Report

Author: Peter Gordon
Report number: FSP 2267 Redacted
Date: 15 December 2022
Client: IG6 Pty Ltd

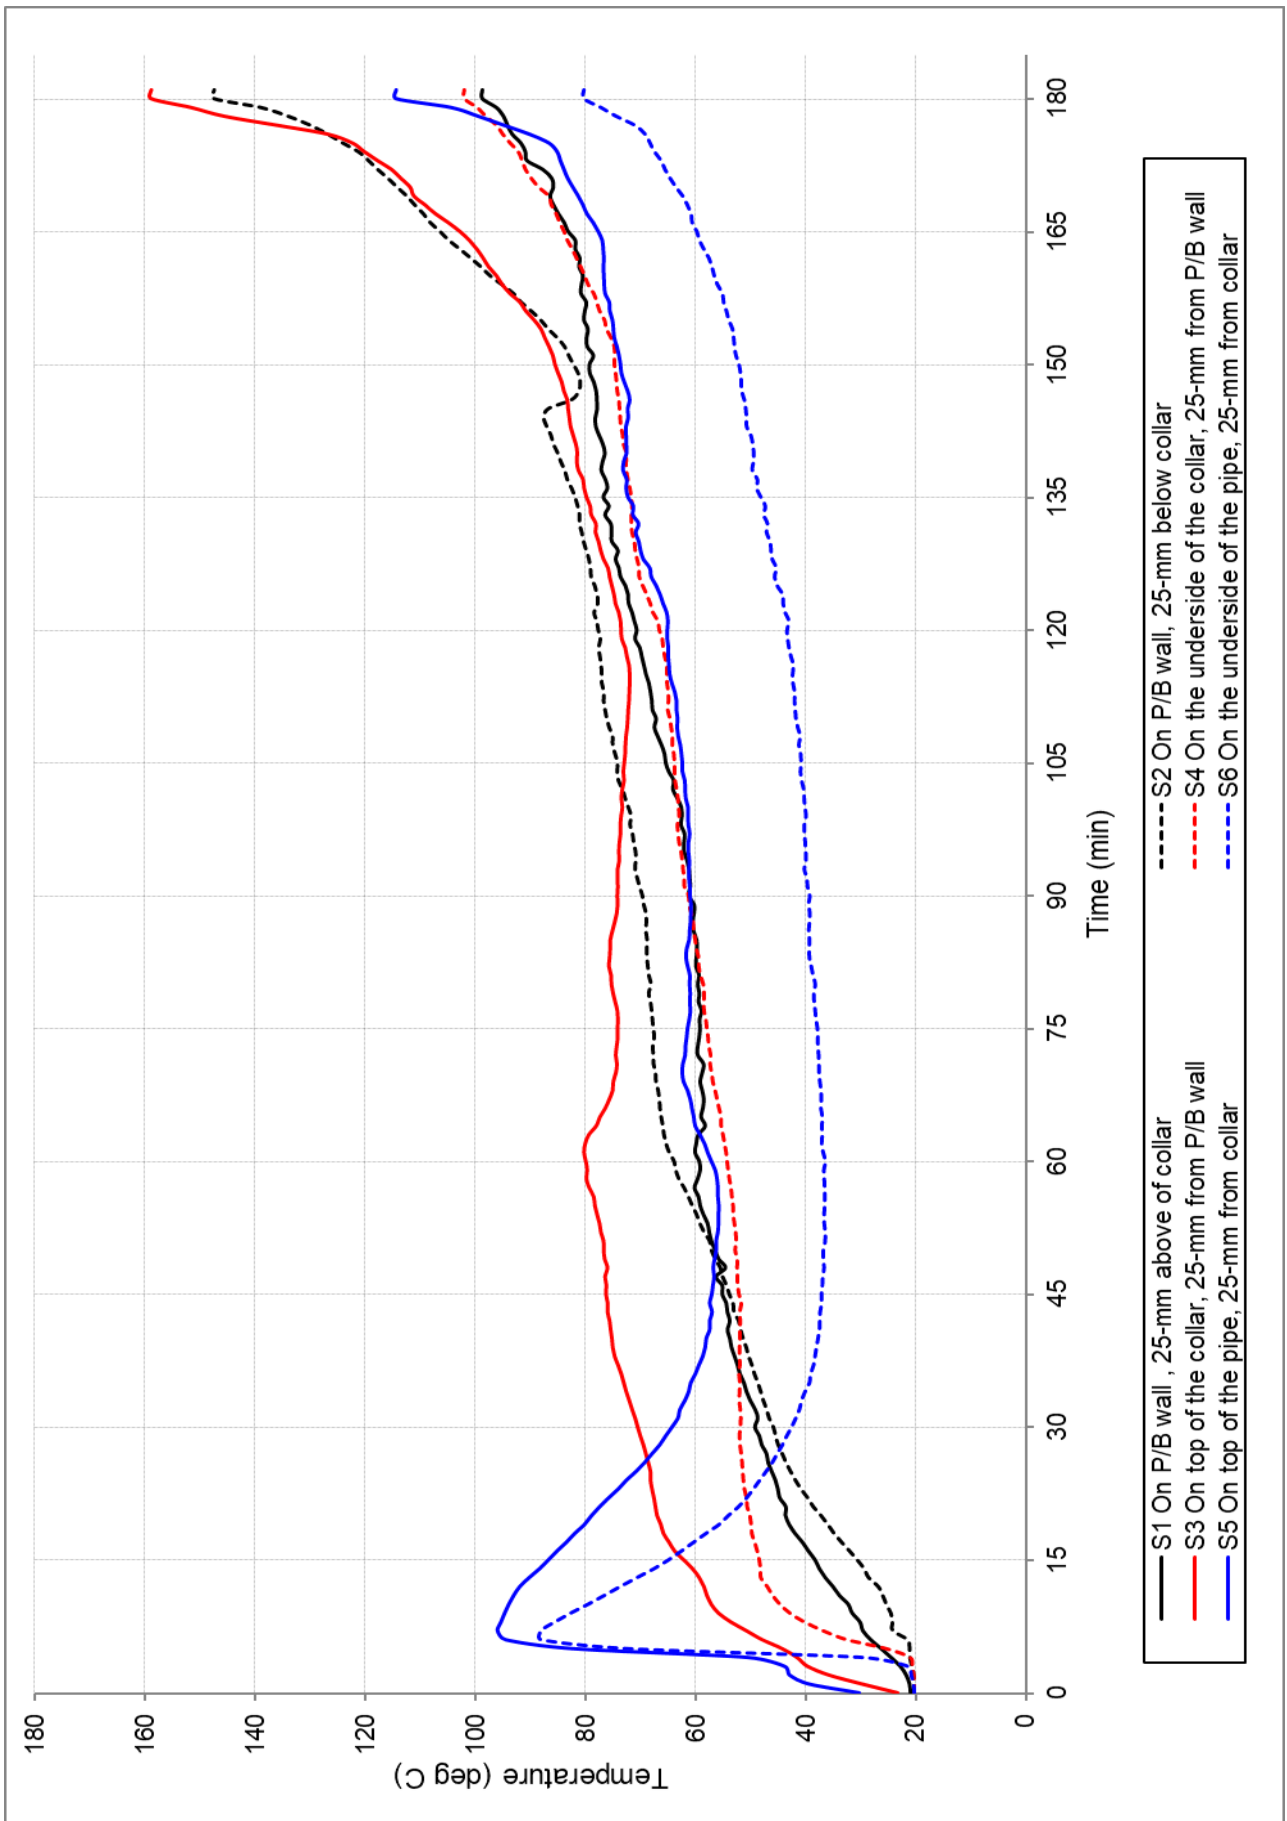
FIGURE 4 - TEMPERATURE VERSUS TIME ASSOCIATED WITH SPECIMEN #1

Figure 4 shows the curve of temperature versus time associated with Specimen 1.

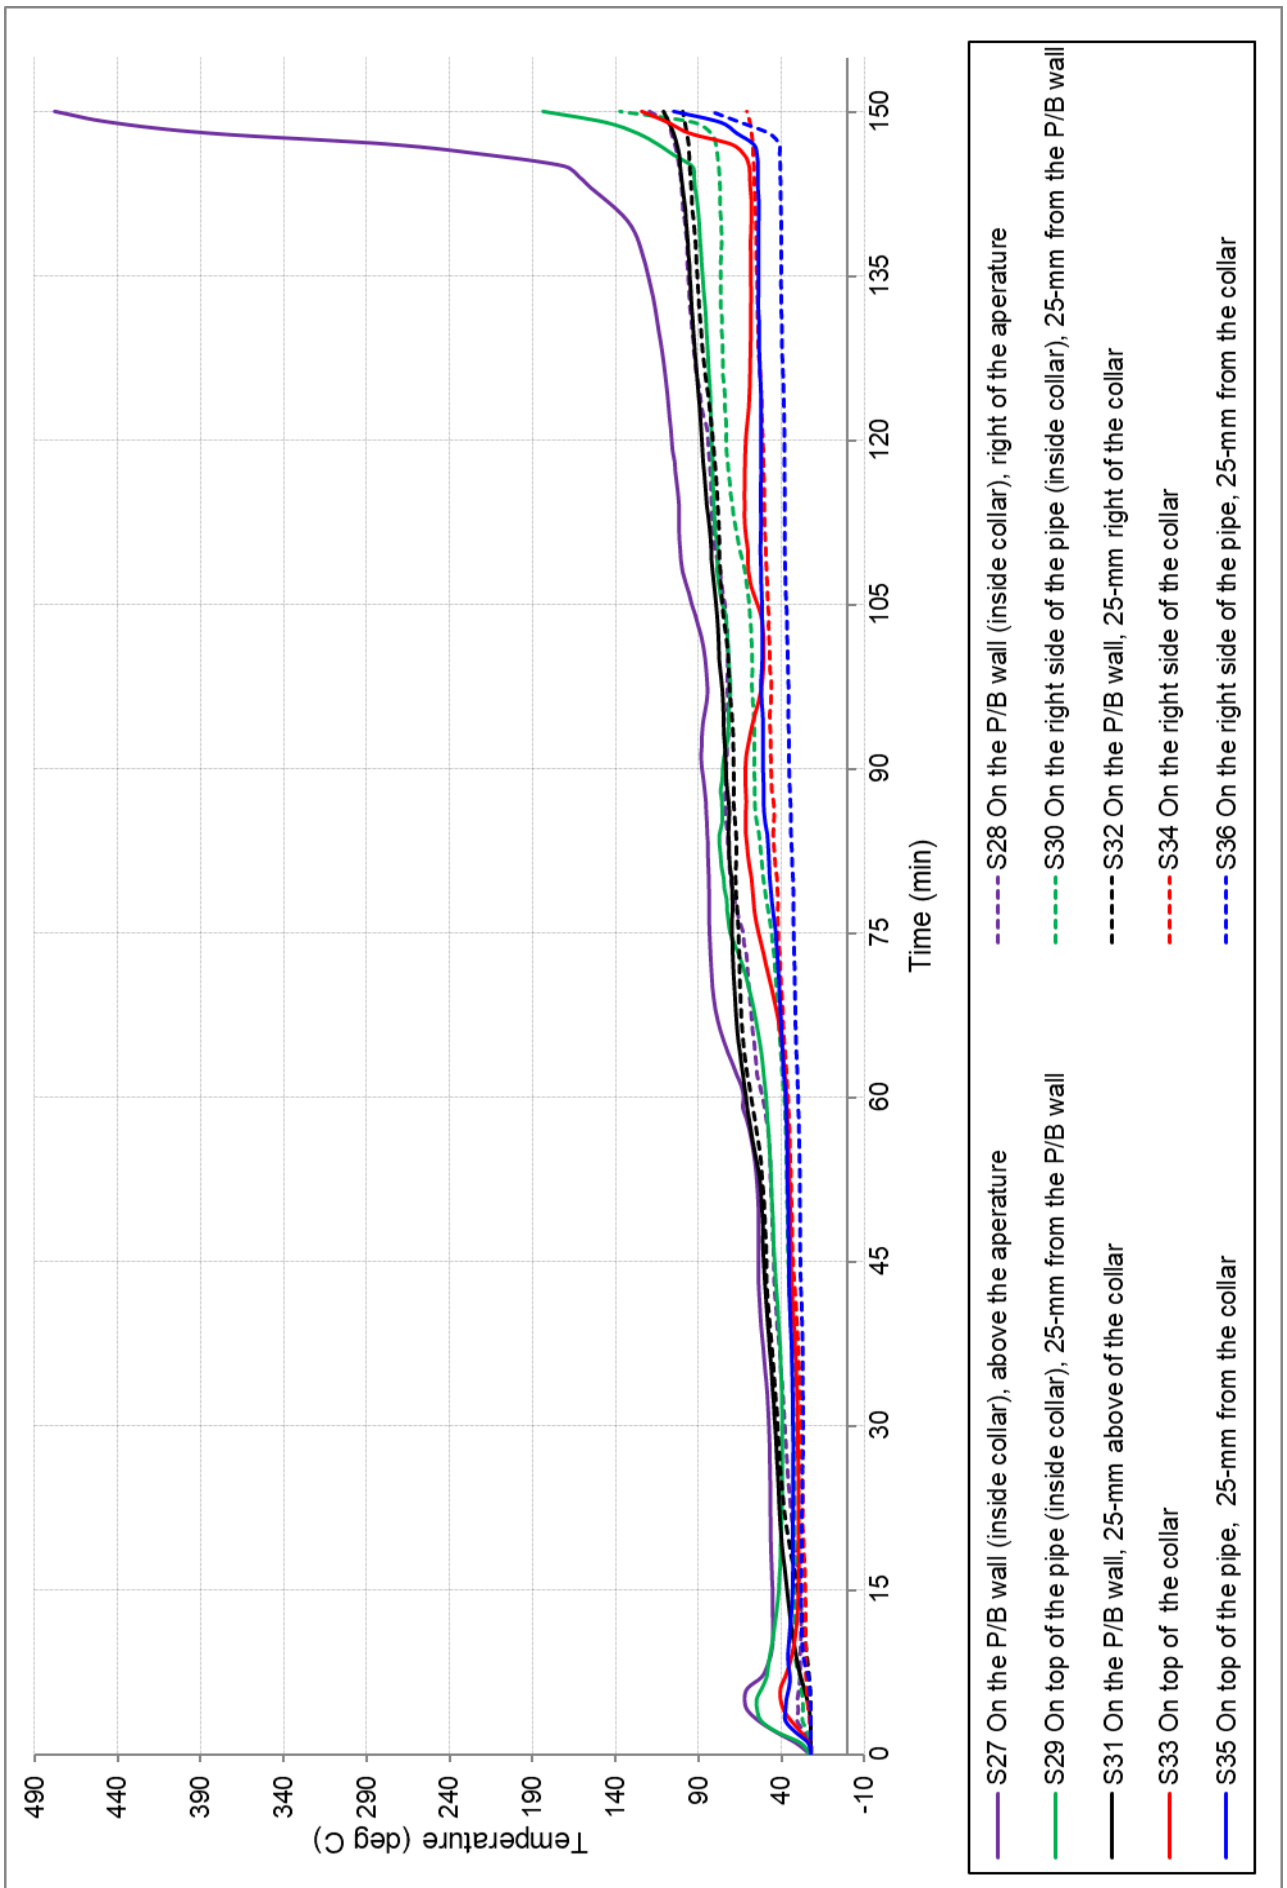
FIGURE 5 - TEMPERATURE VERSUS TIME ASSOCIATED WITH SPECIMEN #4

Figure 5 shows the curve of temperature versus time associated with Specimen 4.

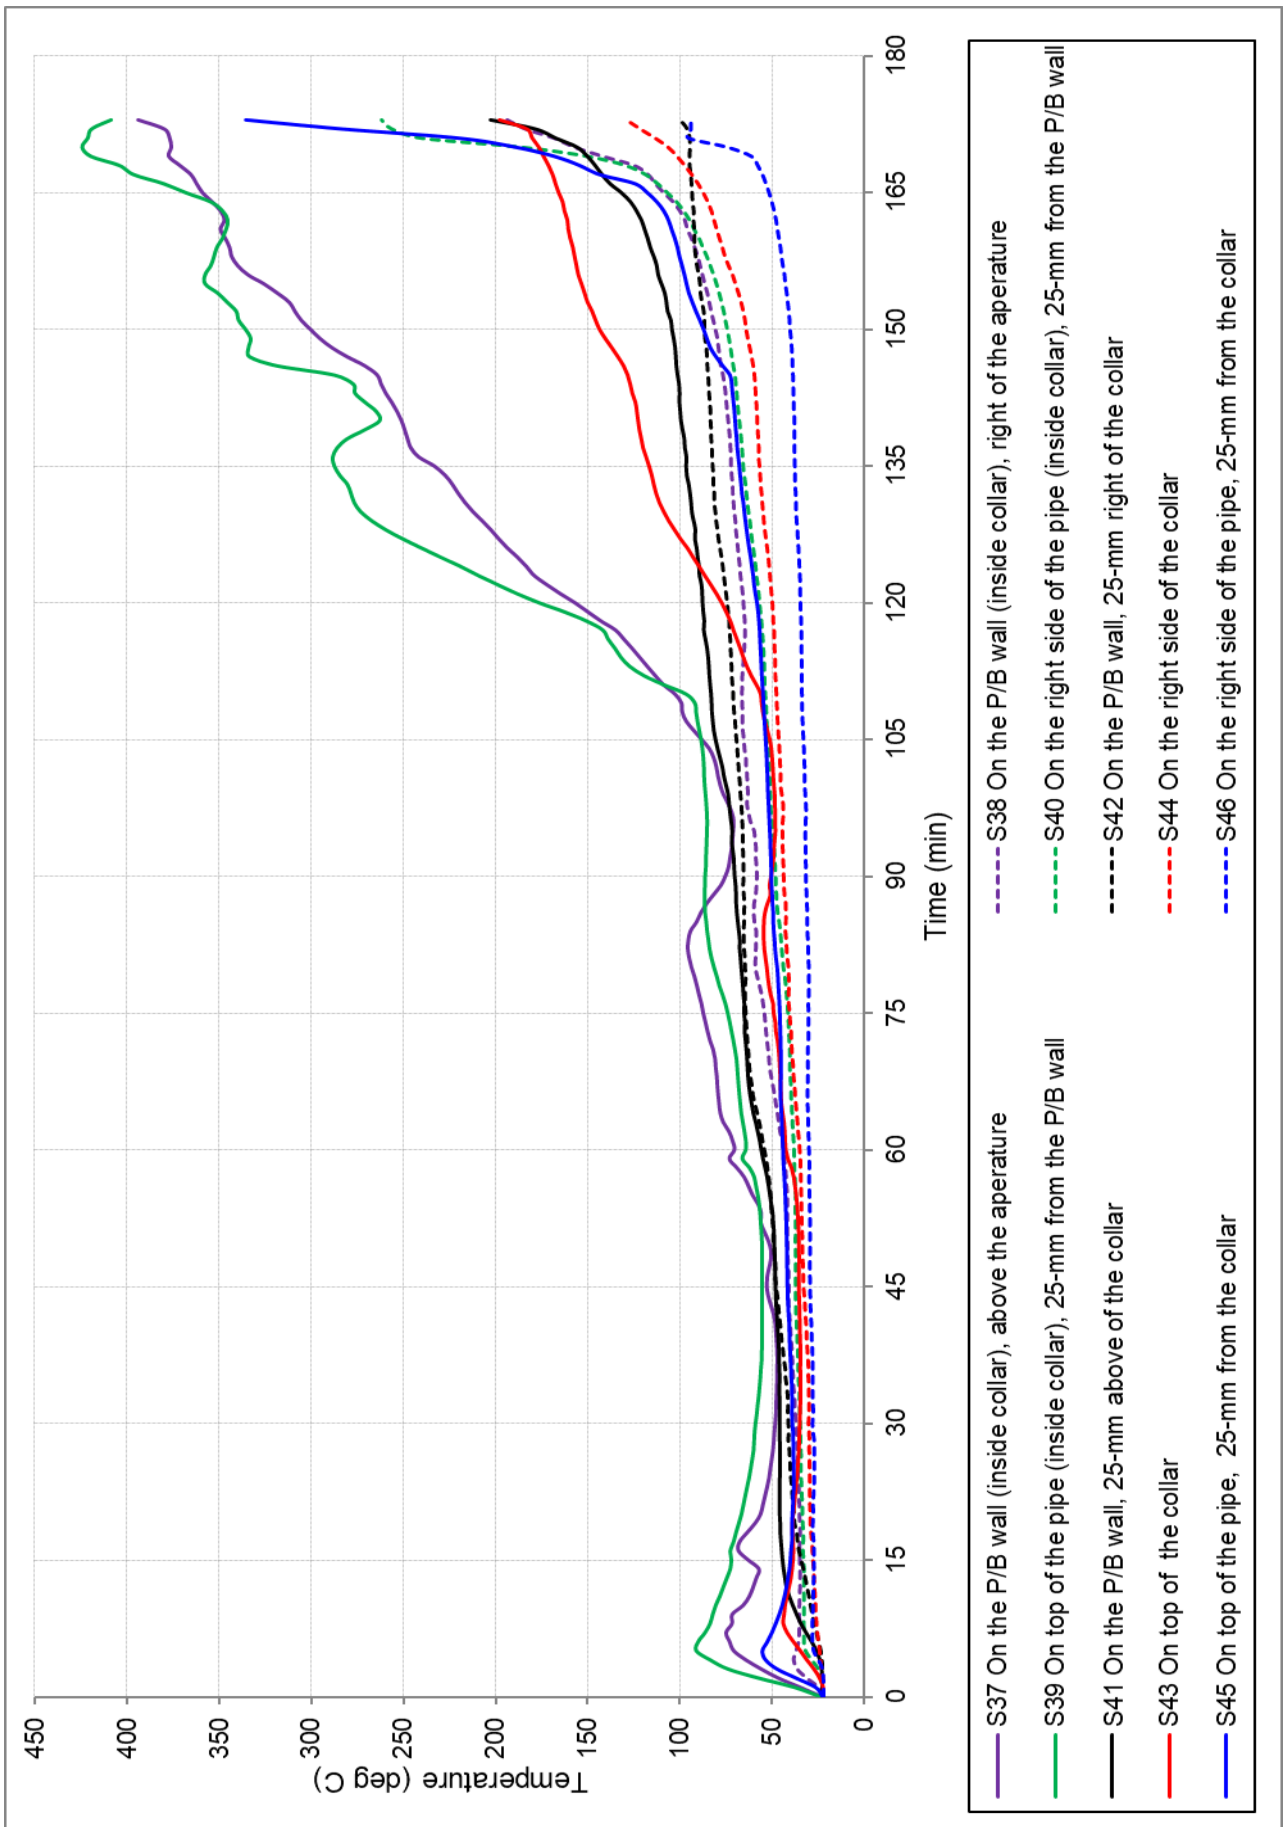
FIGURE 6 - TEMPERATURE VERSUS TIME ASSOCIATED WITH SPECIMEN #5

Figure 6 shows the curve of temperature versus time associated with Specimen 5.

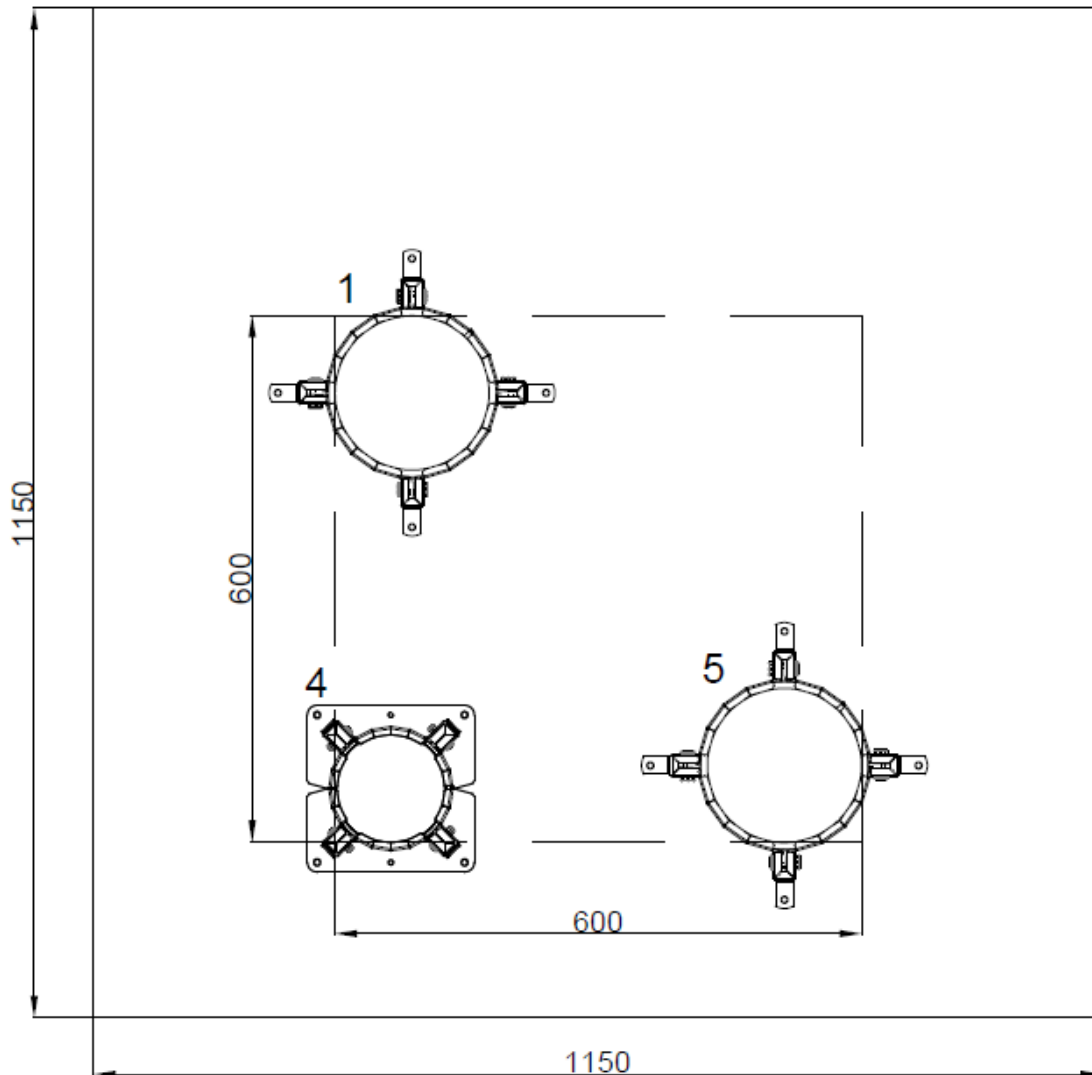
Test Wall W-21-A3 Layout

Penetration	Collar Code	Pipe Type	Pipe Diameter
1	HP150R	Raupiano	160
4	LP100R-D	PN16 PE100	75
5	HP150R	HDPE	125

DRAWING TITLED 'TEST WALL W-21-A3 LAYOUT, DATED 23 NOVEMBER 2021, BY SNAP FIRE SYSTEMS PTY LTD.

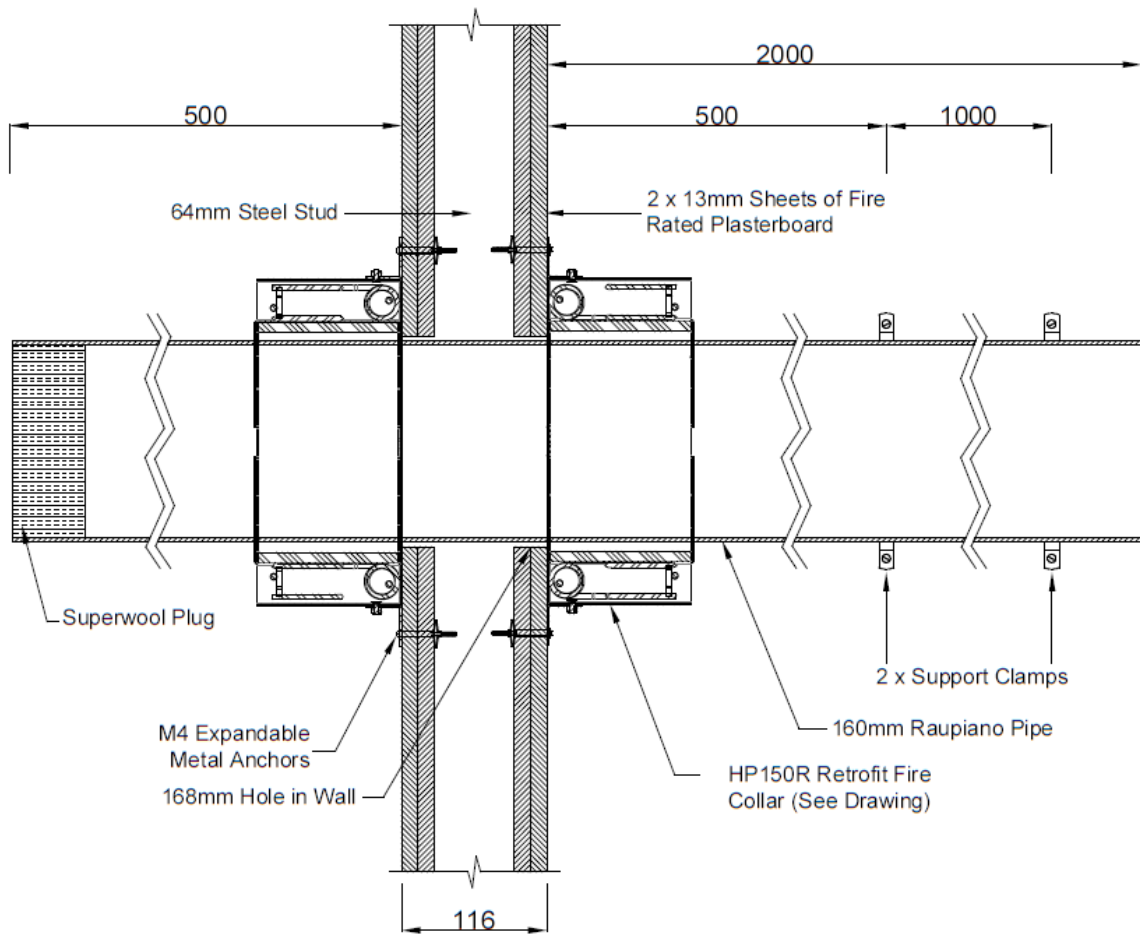
Specimen #1

160 Raupiano Stack & HP150R

DRAWING TITLED 'SPECIMEN #1 160 RAUPIANO STACK & HP150R', DATED 25 OCTOBER 2021, BY SNAP FIRE SYSTEMS PTY LTD.

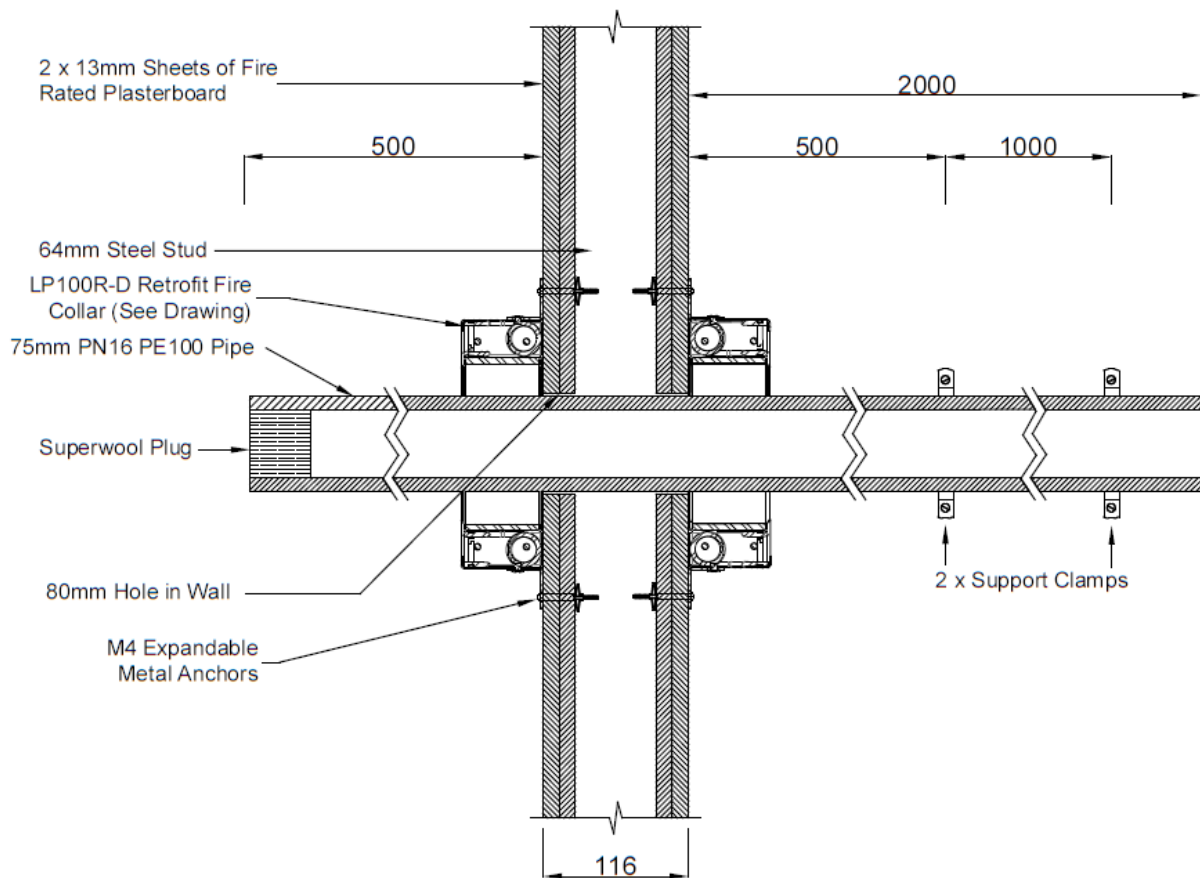
Specimen #4

75 PN16 PE100 Pipe & LP100R-D

DRAWING TITLED 'SPECIMEN #4 75 PN16 PE100 PIPE & LP100R-D', DATED 28 JANUARY 2022, BY SNAP FIRE SYSTEMS PTY LTD

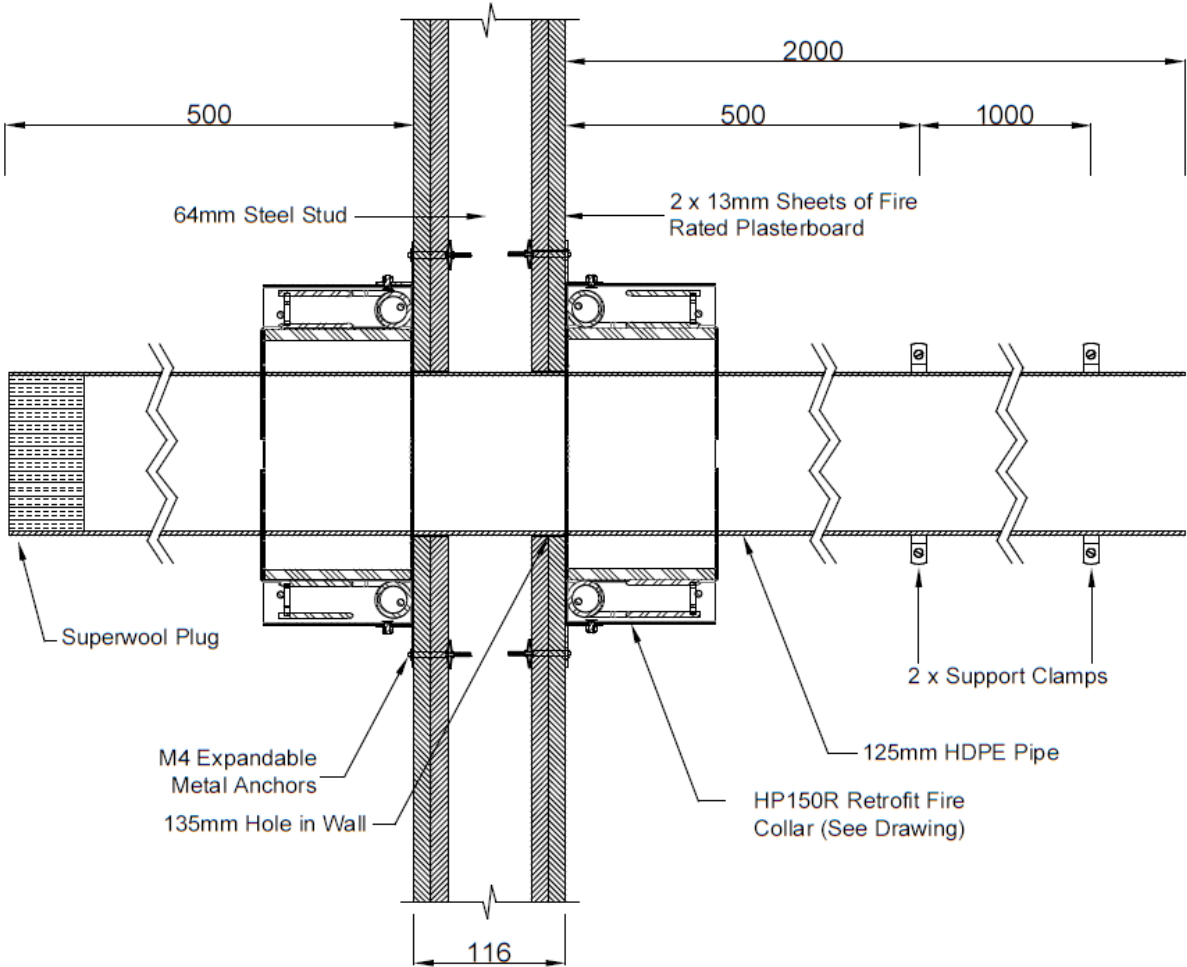
Specimen #5

125 HDPE Stack & HP150R

DRAWING TITLED 'SPECIMEN #5 125 HDPE STACK & HP150R', DATED 23 NOVEMBER 2021, BY SNAP FIRE SYSTEMS PTY LTD

On the right side of the collar	S34
	On top of the pipe, 25-mm from the collar	S35
Specimen 5 - SNAP HP150R Retrofit fire collars protecting a nominal 125 HDPE pipe penetrating a 133-mm diameter aperture.	On the right side of the pipe, 25-mm from the collar	S36
	On the P/B wall (inside collar), above the aperture	S37
	On the P/B wall (inside collar), right of the aperture	S38
	On top of the pipe (inside collar), 25-mm from the P/B wall	S39
	On the right side of the pipe (inside collar), 25-mm from the P/B wall	S40
	On the P/B wall, 25-mm above of the collar	S41
	On the P/B wall, 25-mm right of the collar	S42
	On top of the collar	S43
On the right side of the collar	S44	
On top of the pipe, 25-mm from the collar	S45	
On the right side of the pipe, 25-mm from the collar	S46	
Rover		S47
Ambient		S48

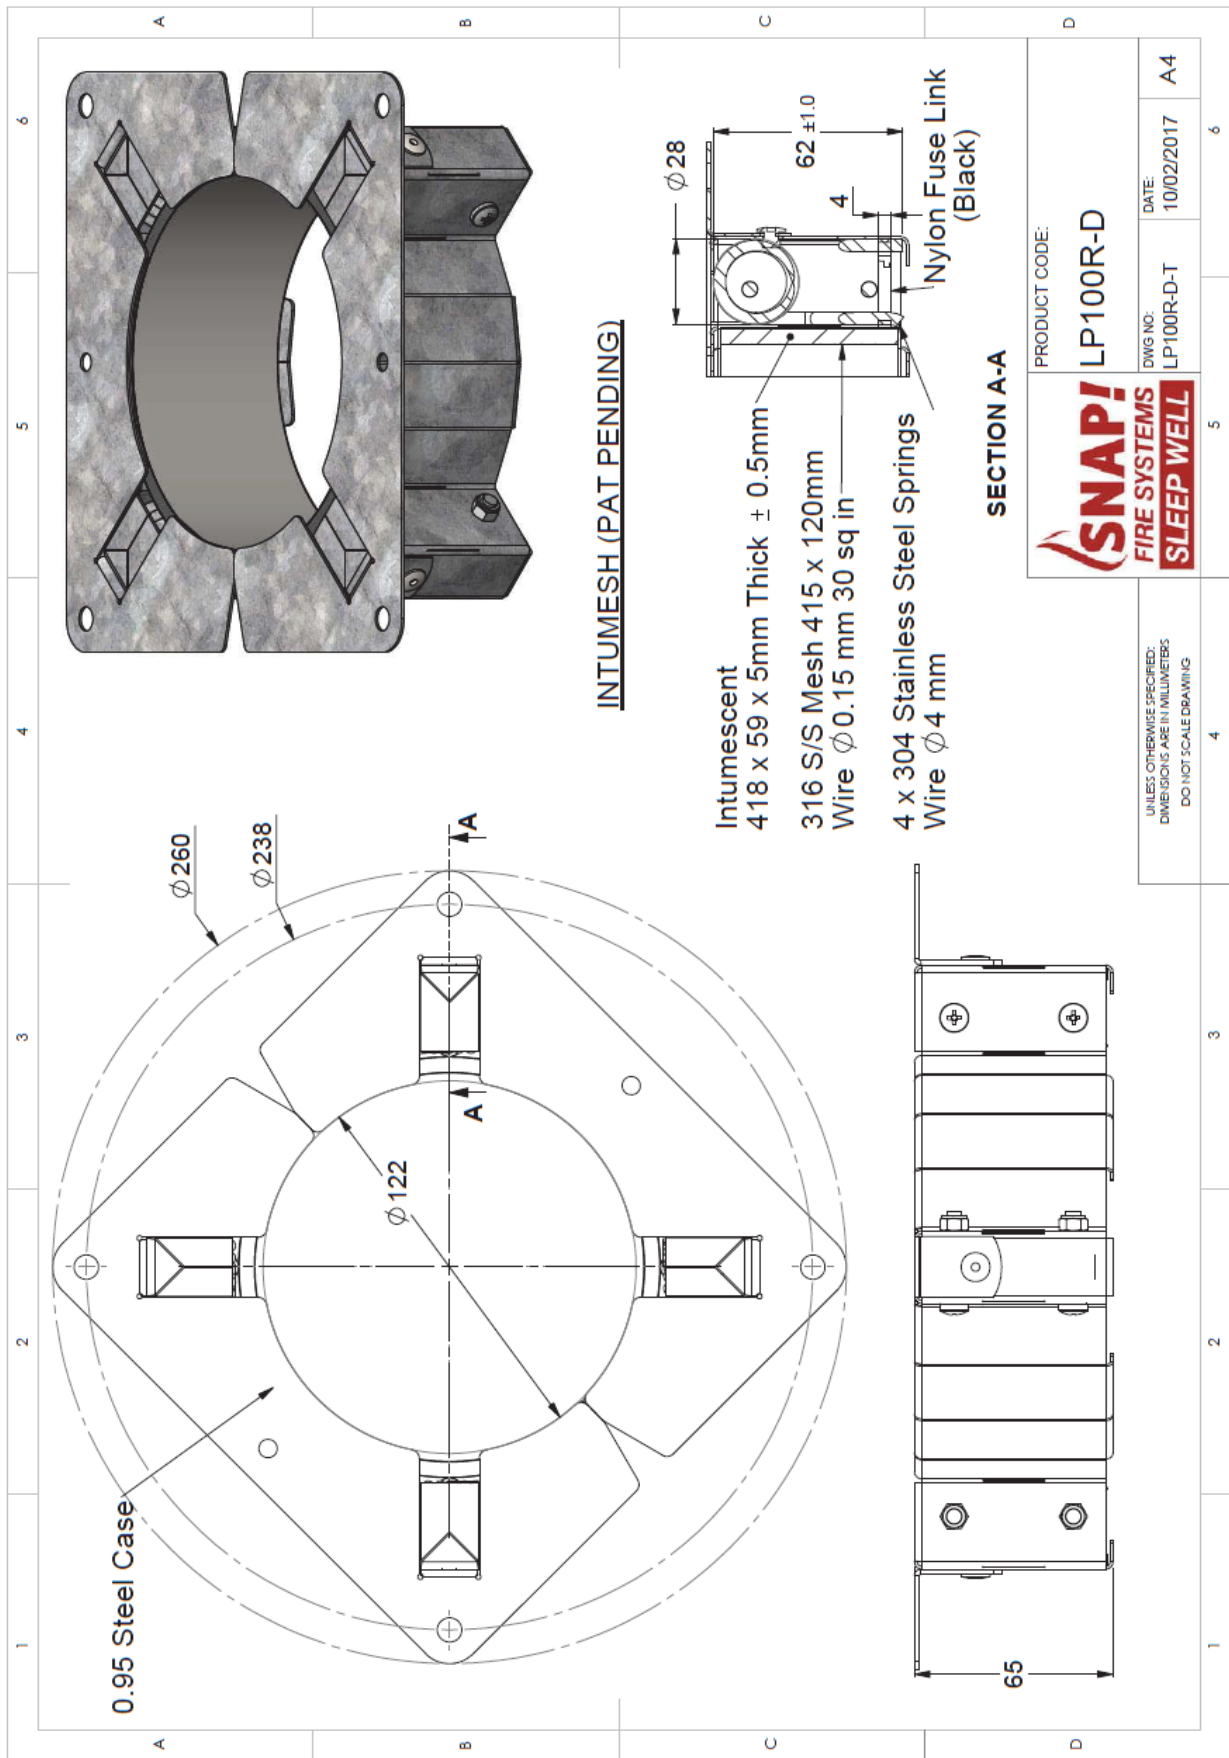
DRAWING NUMBERED LP100R-D-T, DATED 10 FEBRUARY 2017, BY SNAP FIRE SYSTEMS PTY LTD

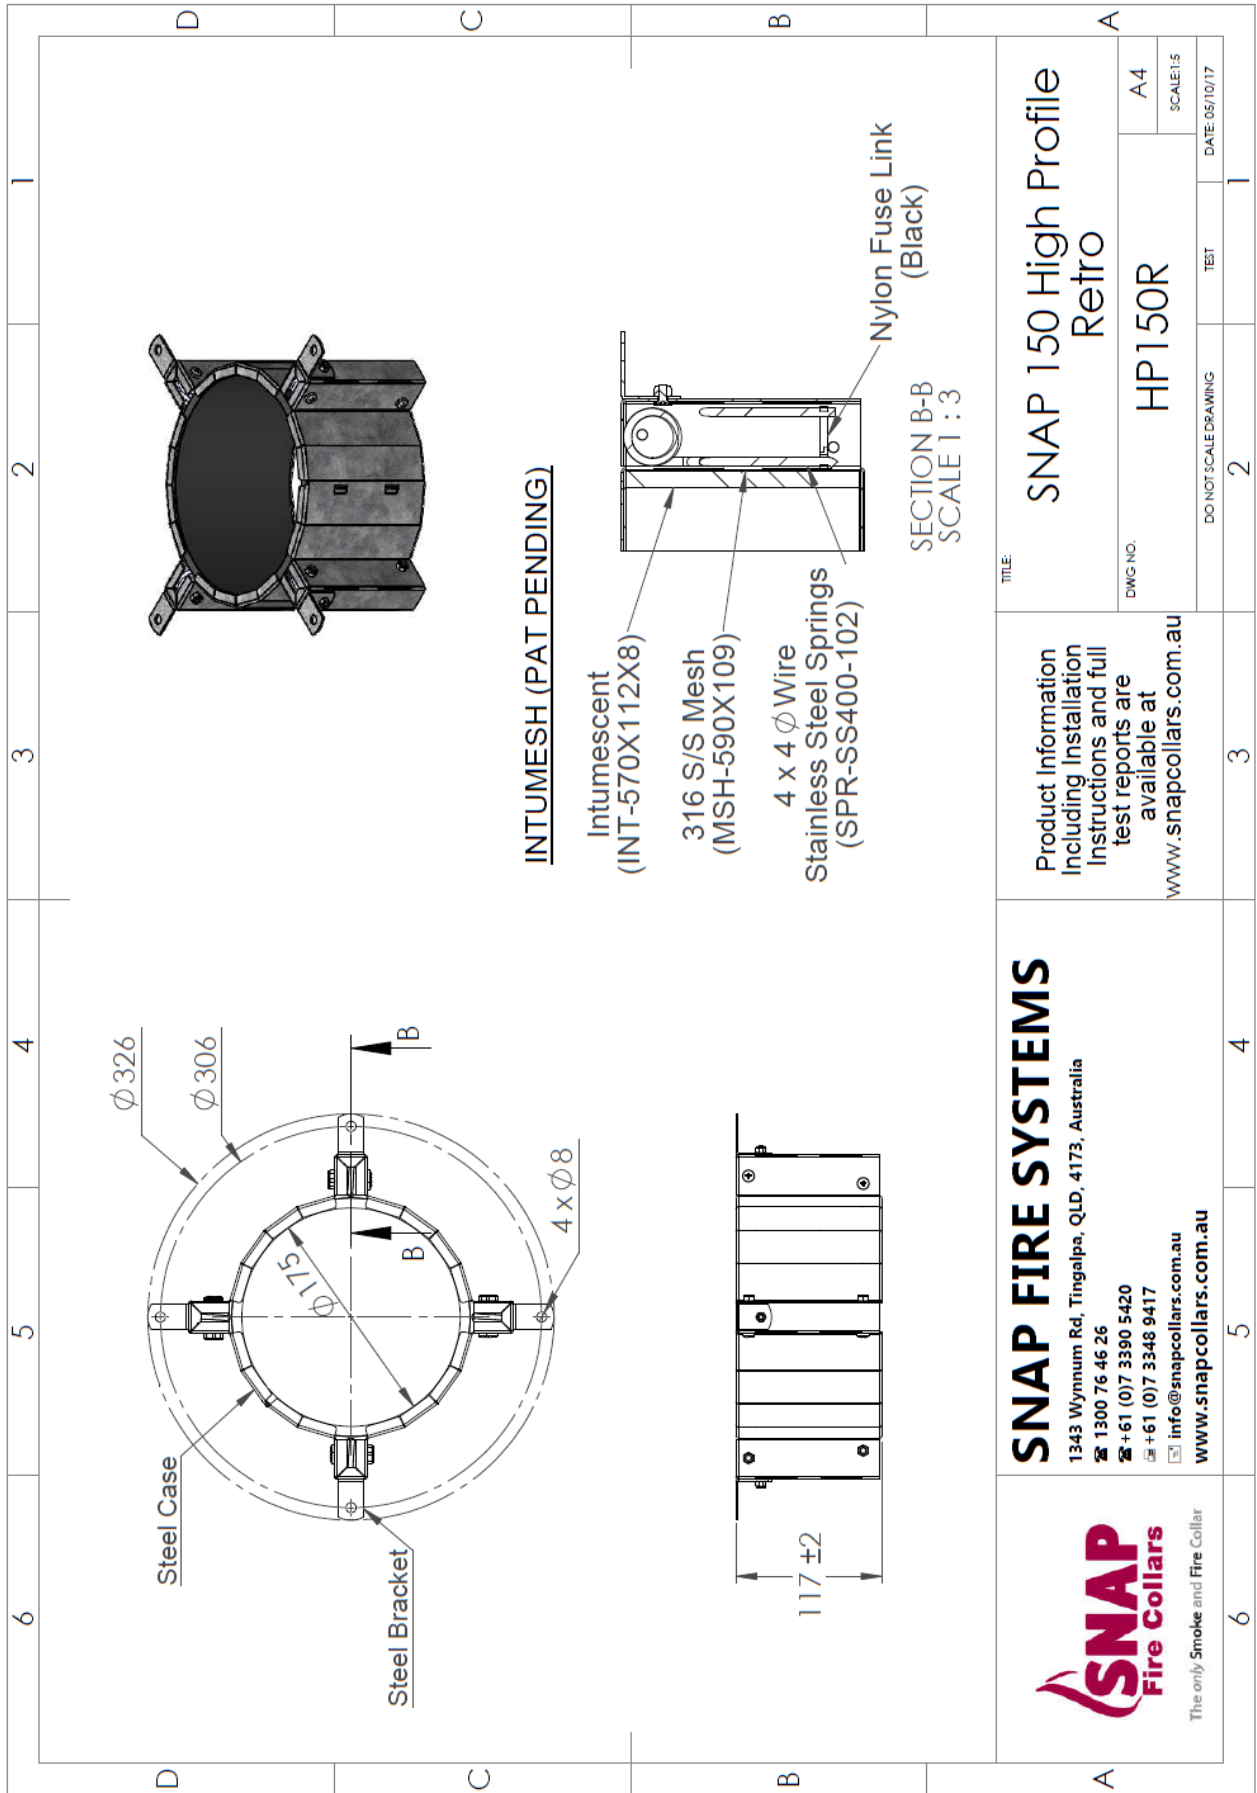
DRAWING 'SNAP 150 HIGH PROFILE RETRO', DATED 5 OCTOBER 2017, BY SNAP FIRE SYSTEMS PTY LTD
