Fire-resistance test on retrofit fire collars protecting a plasterboard wall penetrated by services

Test Report

Author: Peter Gordon
Report number: FSP 2275 Revision B
Date: 20 December 2023
Client: IG6 Pty Ltd

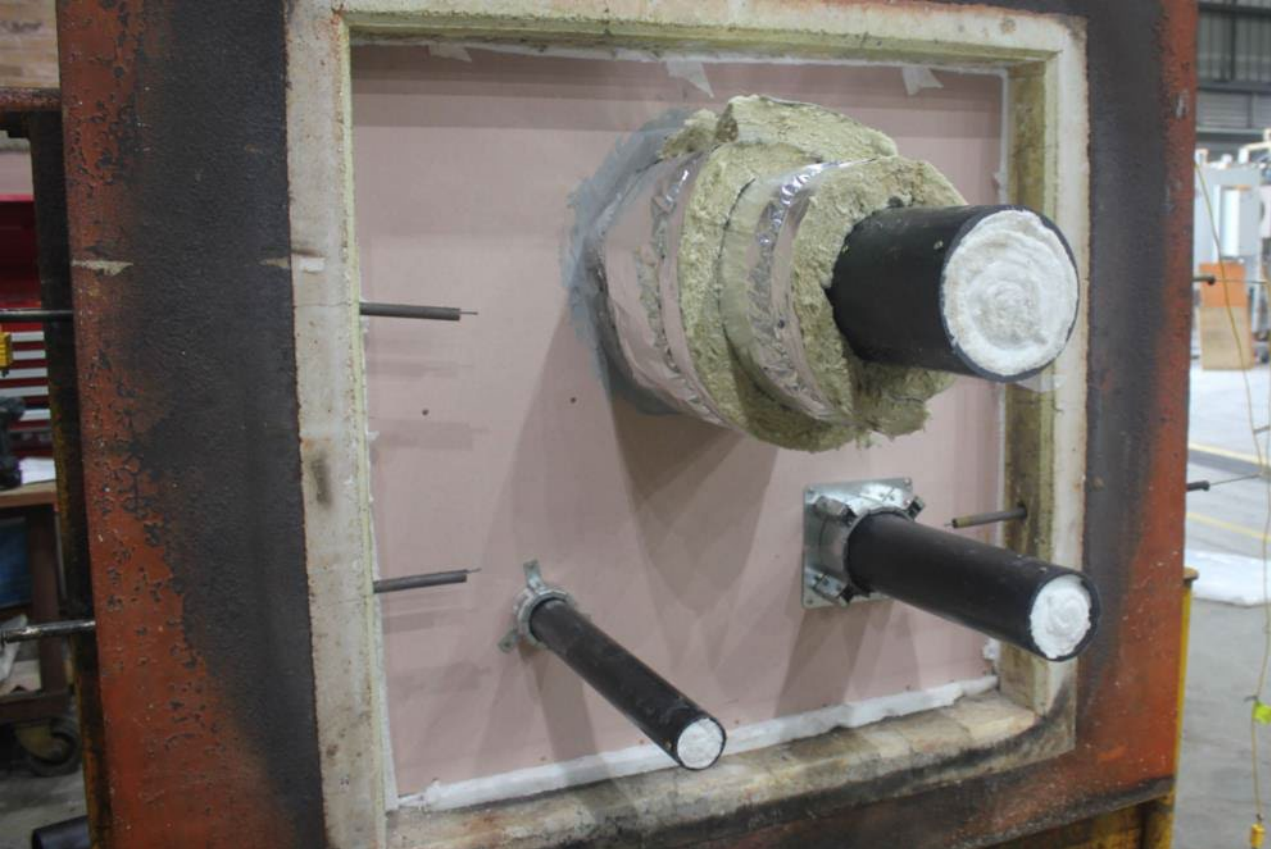
PHOTOGRAPH 1 – EXPOSED FACE OF SPECIMENS PRIOR TO TESTING

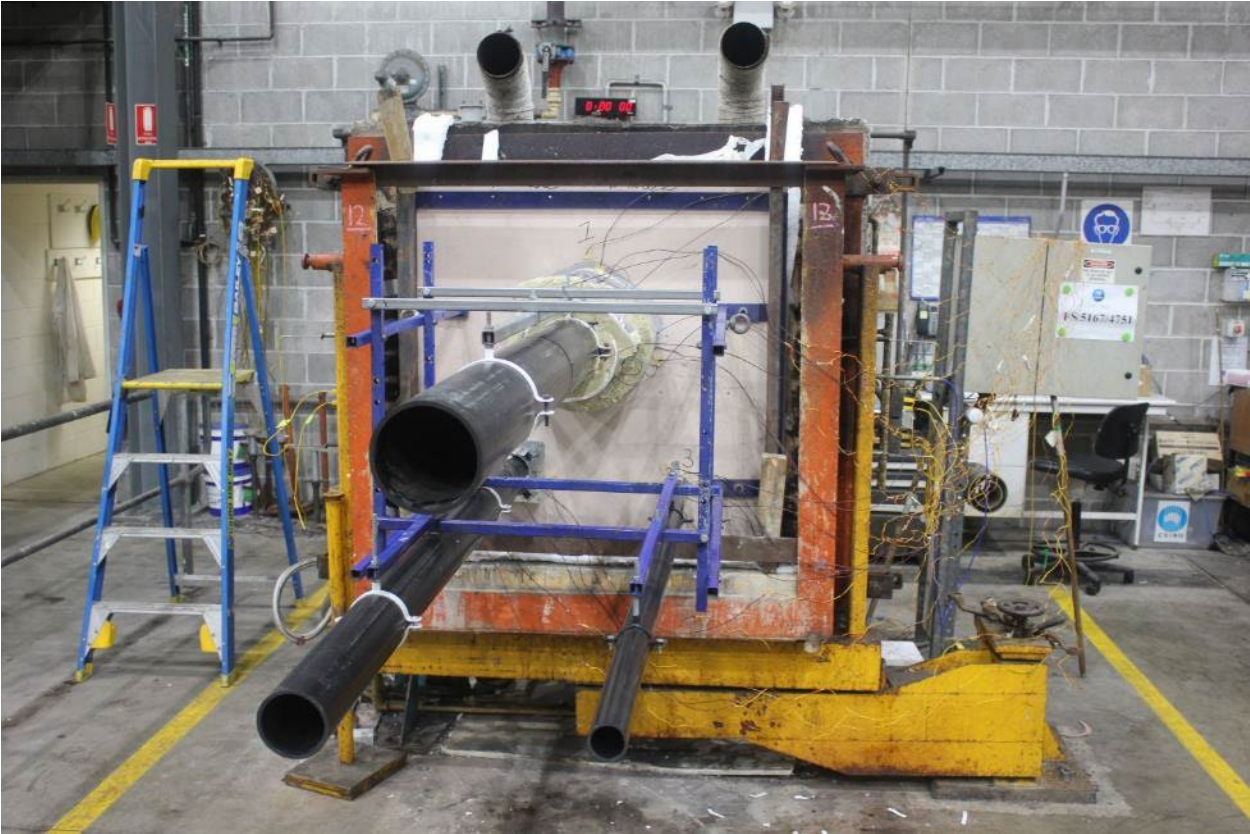
PHOTOGRAPH 2 – UNEXPOSED FACE OF SPECIMENS PRIOR TO TESTING

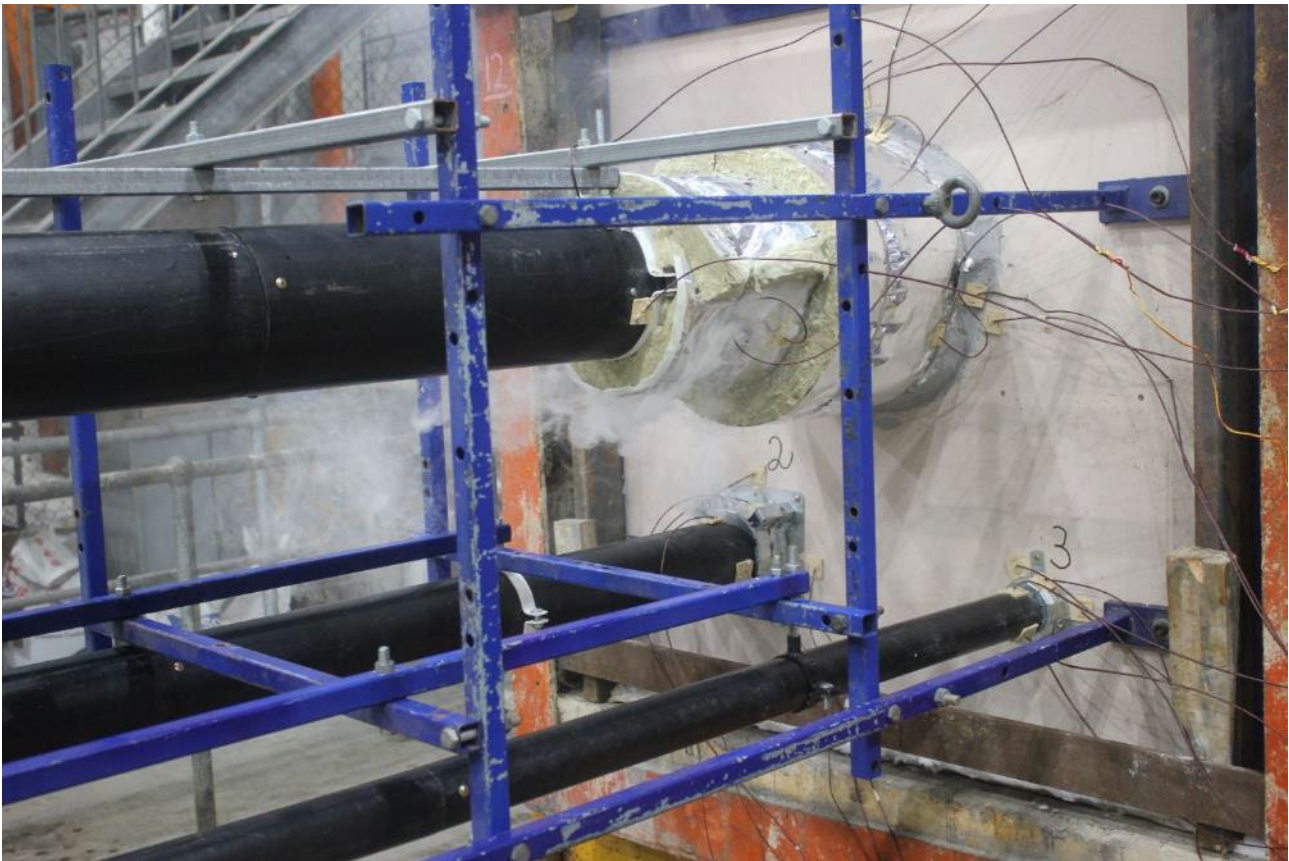
PHOTOGRAPH 3 – SPECIMENS AFTER 4 MINUTES OF TESTING

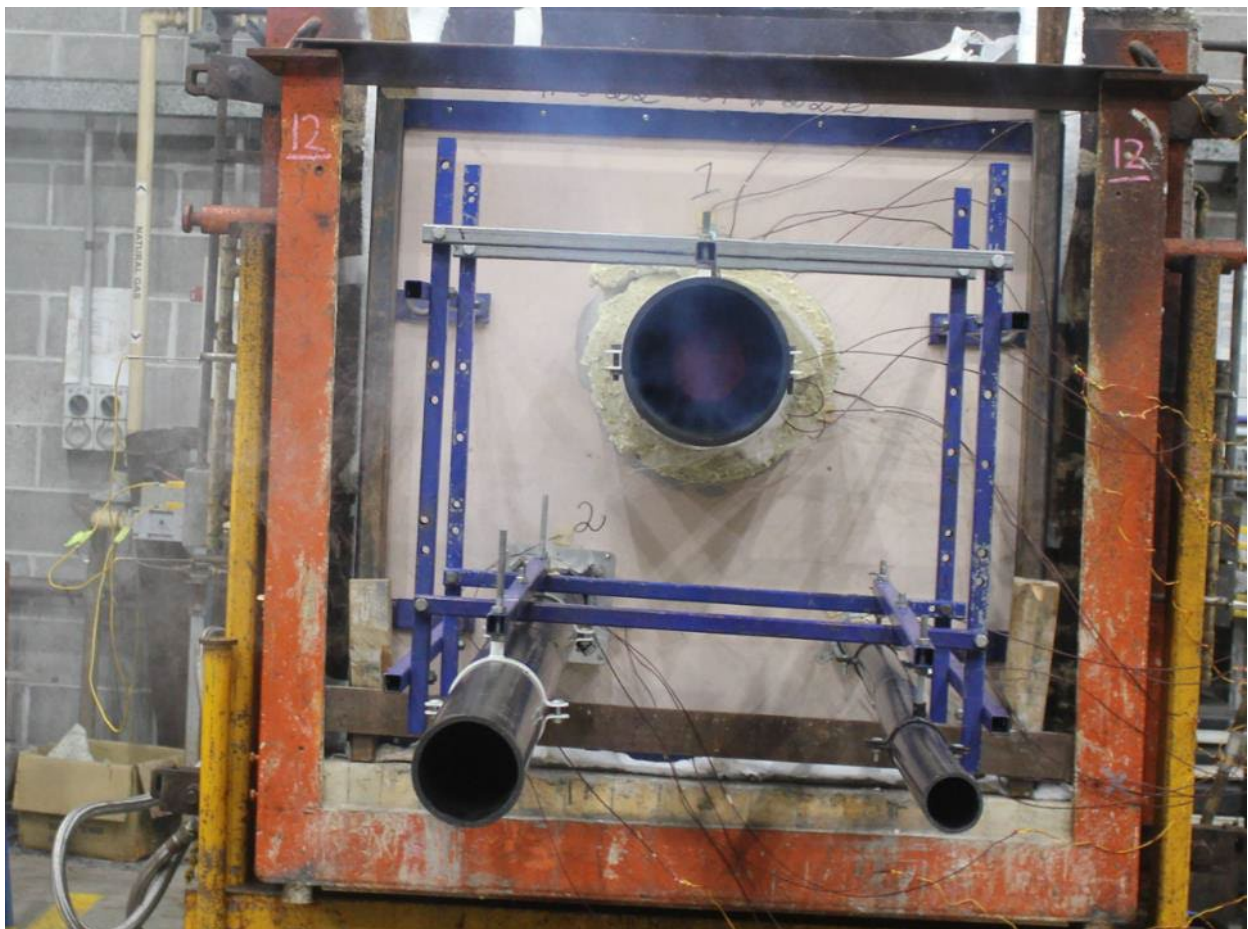
PHOTOGRAPH 4 – SPECIMENS AFTER 5 MINUTES OF TESTING

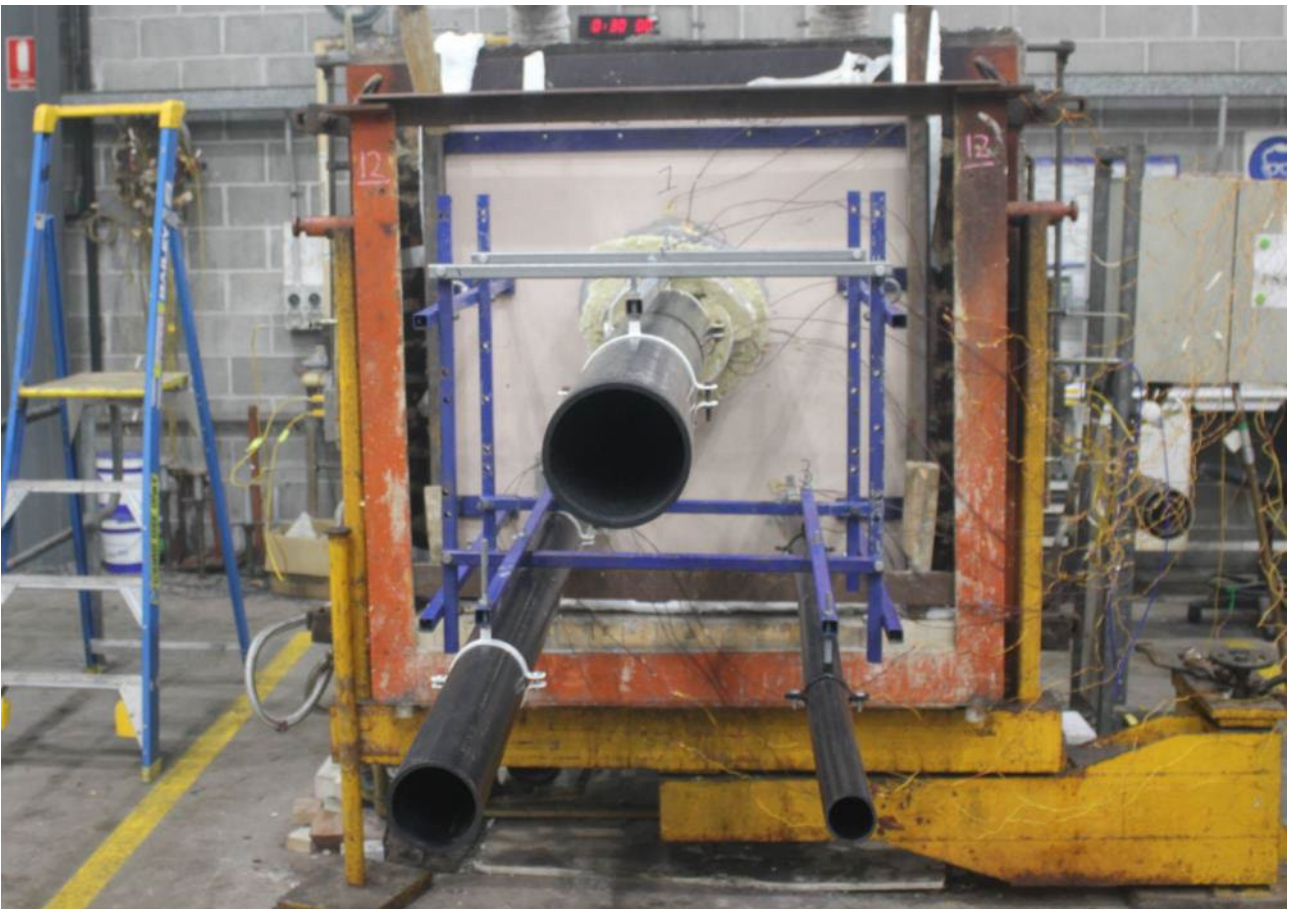
PHOTOGRAPH 6 – SPECIMENS AFTER 30 MINUTES OF TESTING

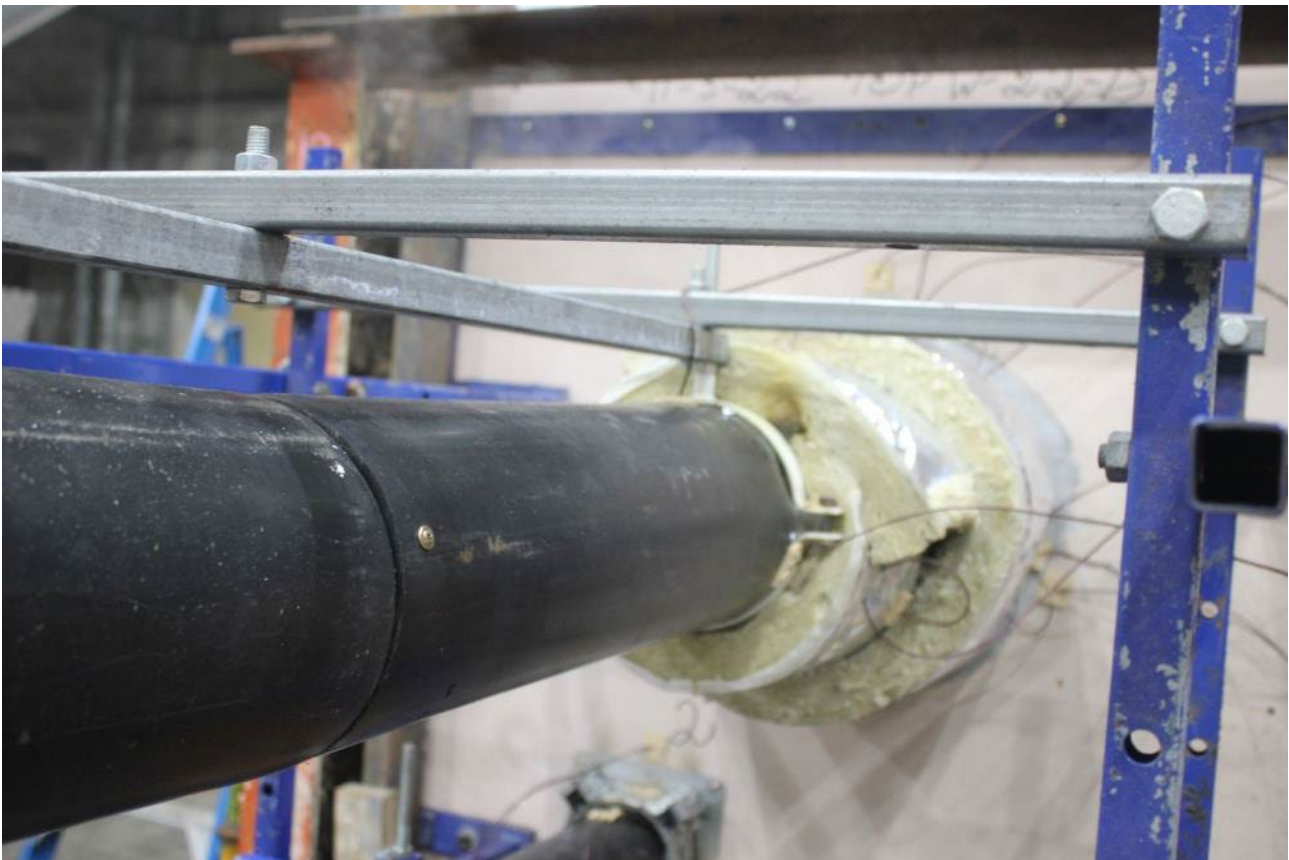
PHOTOGRAPH 8 – SPECIMEN 1 AFTER 79 MINUTES OF TESTING

- 79 minutes - The smoke staining around the first layer of the Rockwool adjacent to the pipe of specimen 1 has intensified.
 - 81 minutes - Light smoke has resumed fluing from the end of the pipe of specimen 3.

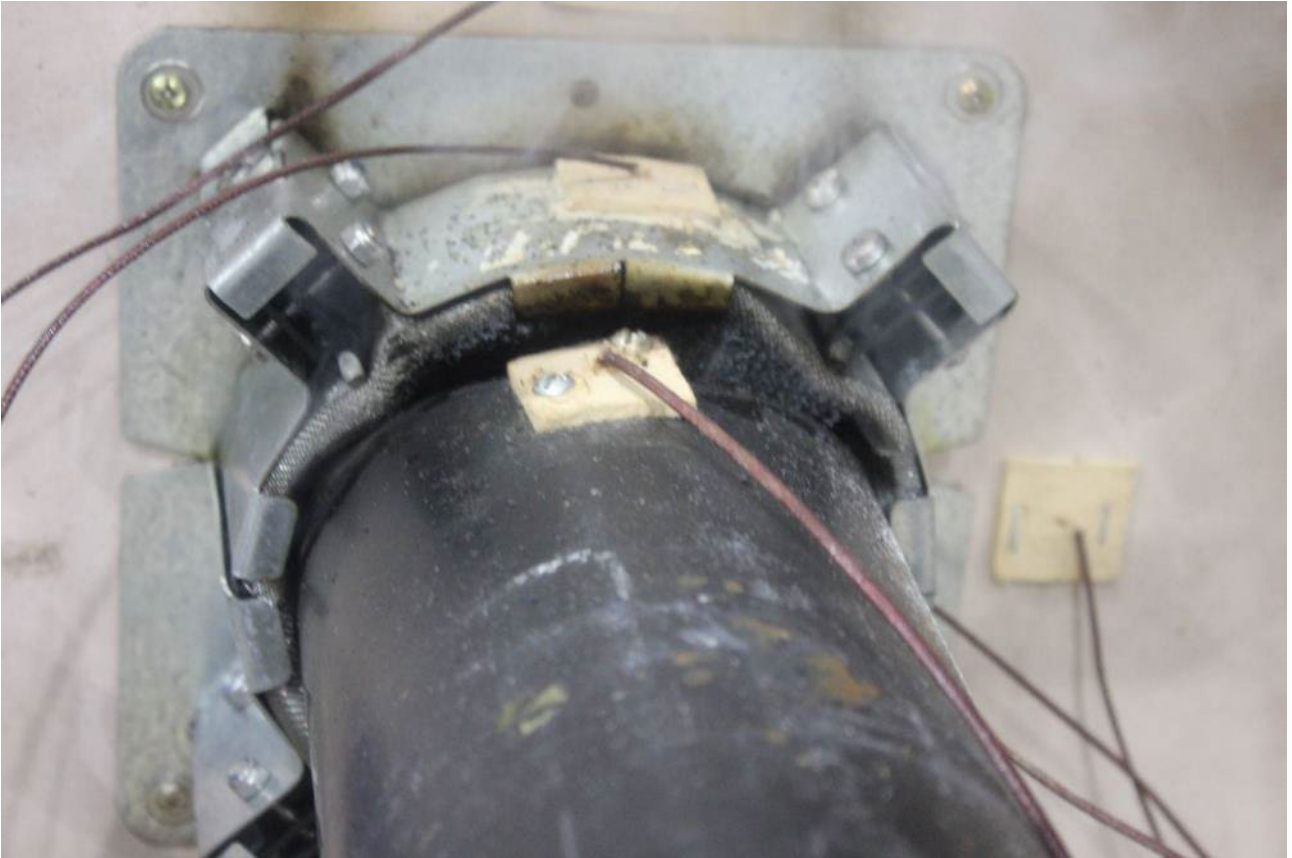
PHOTOGRAPH 13 –SPECIMEN 2 AFTER 137 MINUTES OF TESTING

- 131 minutes - Smoke staining is visible on the plasterboard wall above the collar of specimen 2.
 - 137 minutes - Black intumescent material has begun filling the gap between the collar and the pipe of specimen 2.

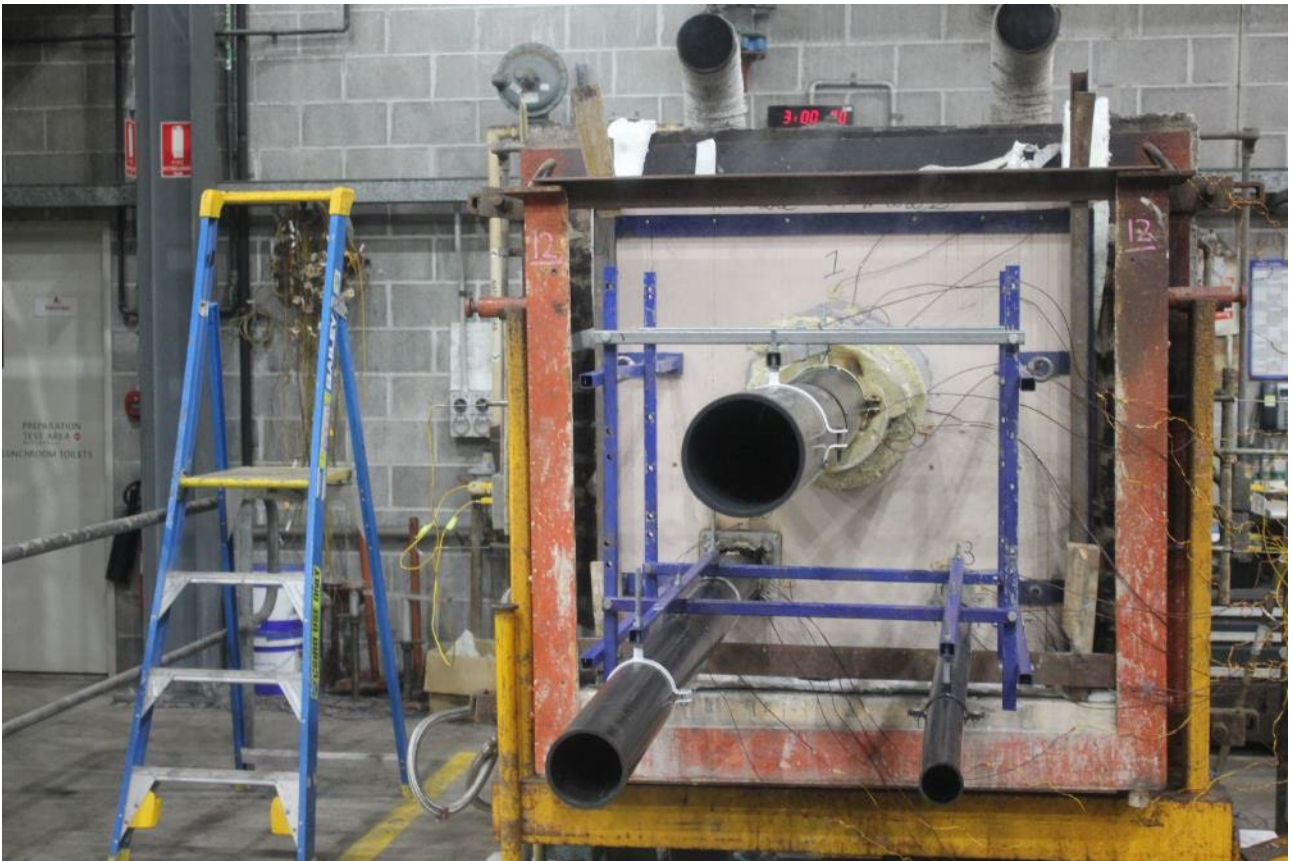
PHOTOGRAPH 17 – SPECIMENS AFTER 180 MINUTES OF TESTING
