**FIRE-RESISTANCE TEST ON
FIRE COLLARS PROTECTING A CONCRETE SLAB
PENETRATED BY SERVICES**

**Report number FSP 1359
CSIRO job number SP3242
Date of issue 31 JULY 2009**

**Client
SNAP FIRE SYSTEMS PTY LTD.**

SPONSORED INVESTIGATION No. FSP 1359**FIRE-RESISTANCE TEST ON FIRE COLLARS PROTECTING A
CONCRETE SLAB PENETRATED BY SERVICES****SUMMARY****IDENTIFICATION OF SPECIMEN:**

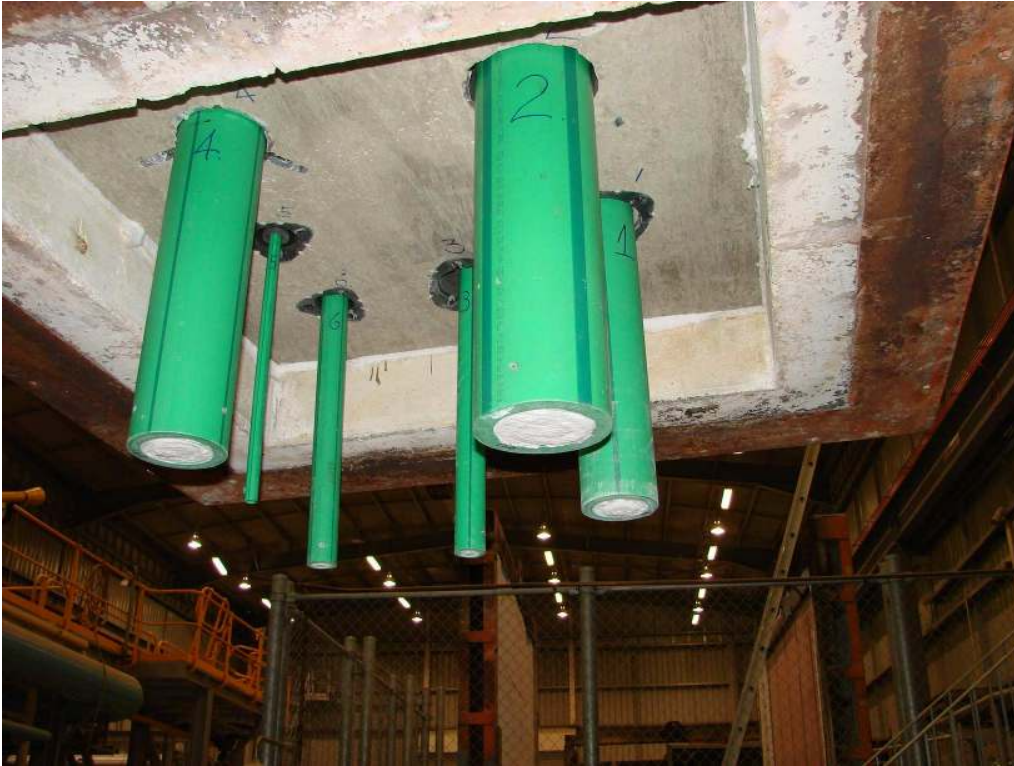
Photograph 1 – Exposed face of the specimen prior to testing

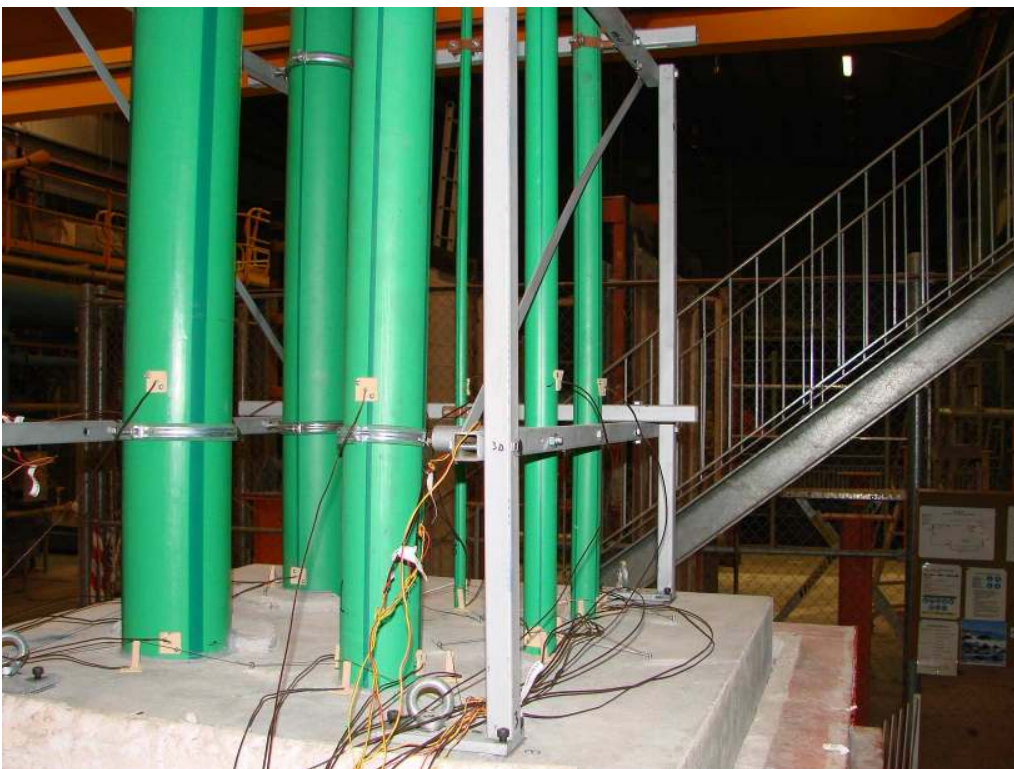
Photograph 2 – Unexposed face of the specimen prior to testing

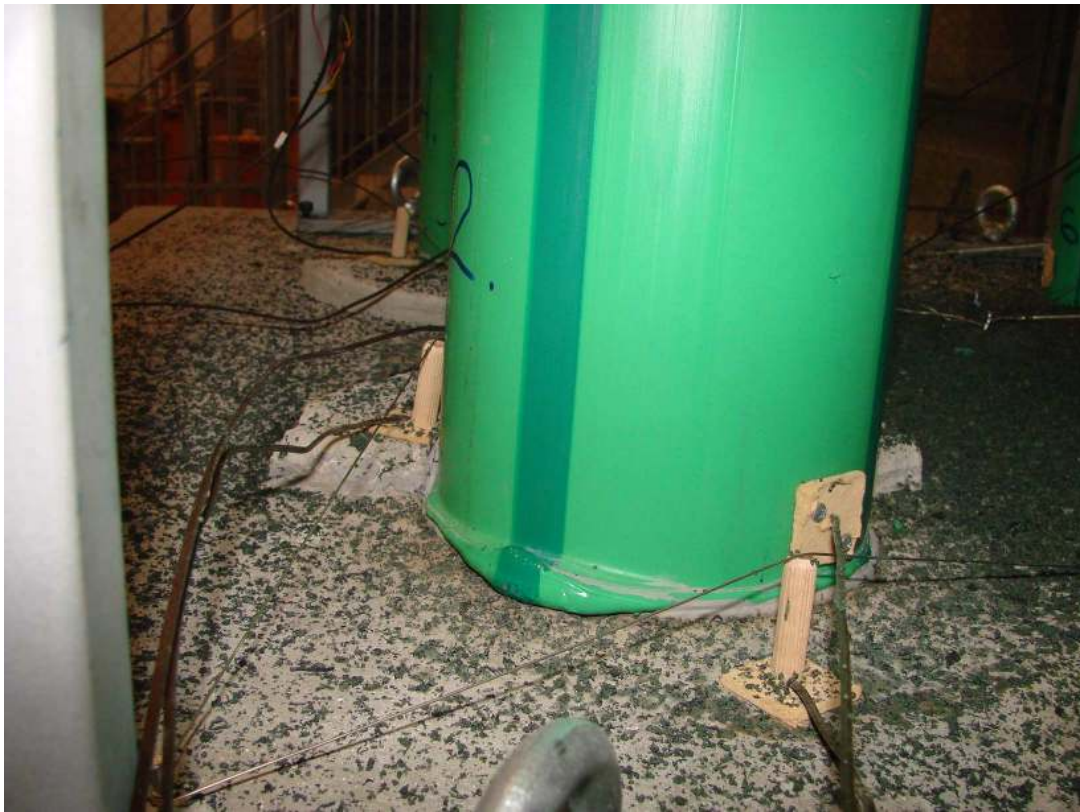
Photograph 7 – Pipe 2 after 200 minutes of testing

- 171 minutes - Smoke is being emitted from the base of the pipe #1.
- 200 minutes - Bases of pipes #2 & #4 start to deform (Photograph 7).
- 215 minutes - Smoke is fluing from pipe #3.

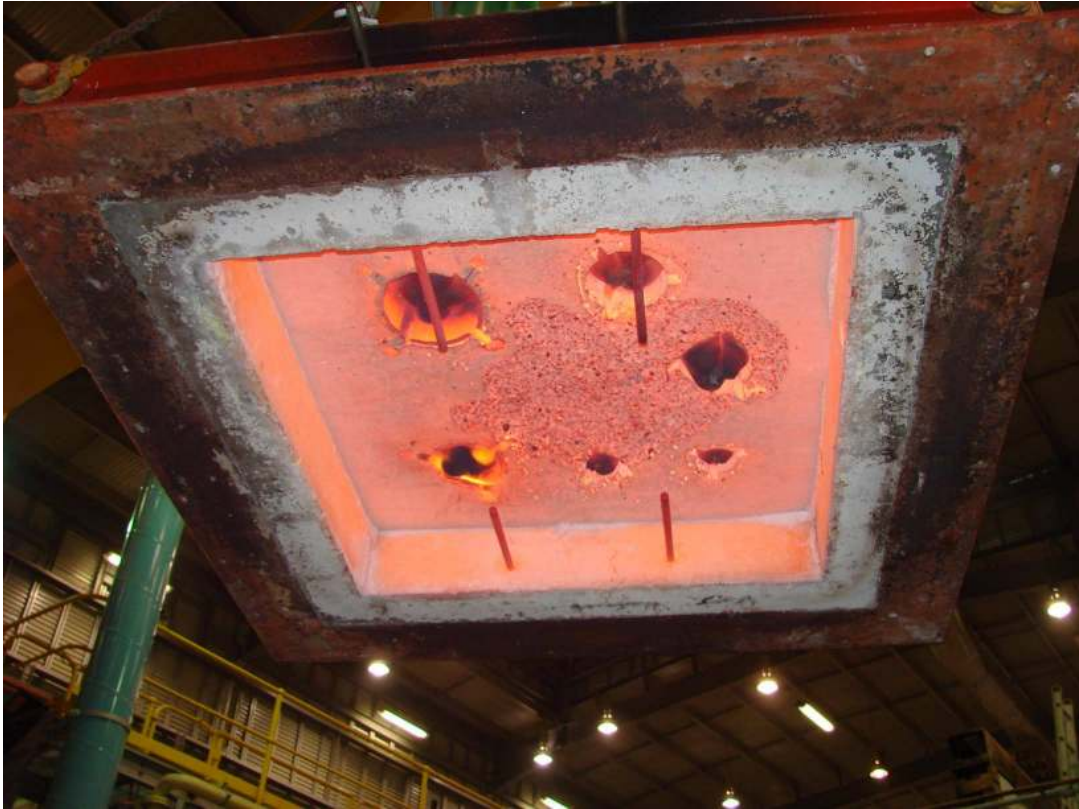
Photograph 9 – Exposed face after the conclusion of testing
