Fire-resistance test on fire collars protecting a concrete slab incorporating blank penetration seals

Test Report

Author: Peter Gordon
Report number: FSP 2153
Date: 23 November 2020

Sponsored Investigation No. FSP 2153

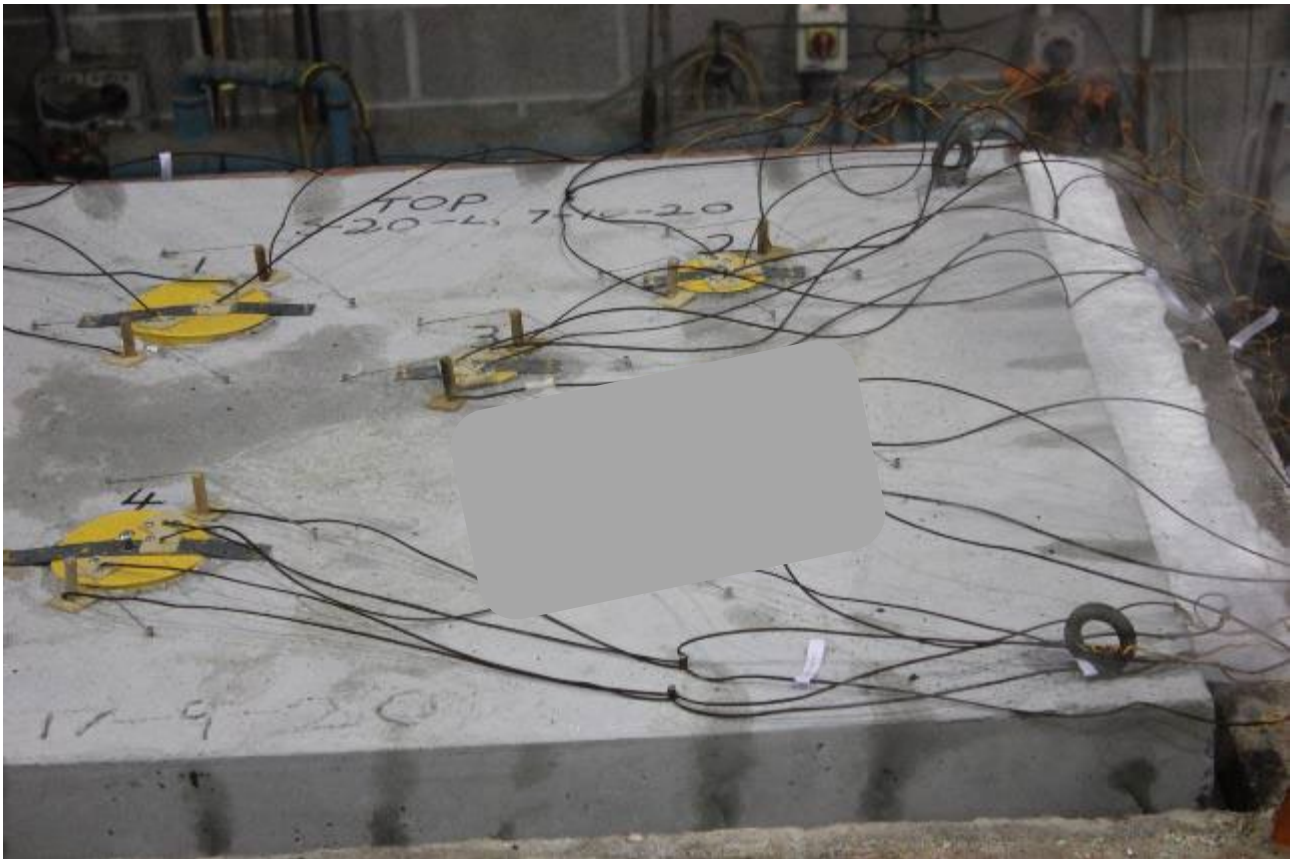
PHOTOGRAPH 5 – SPECIMENS AT 90 MINUTES INTO THE TEST

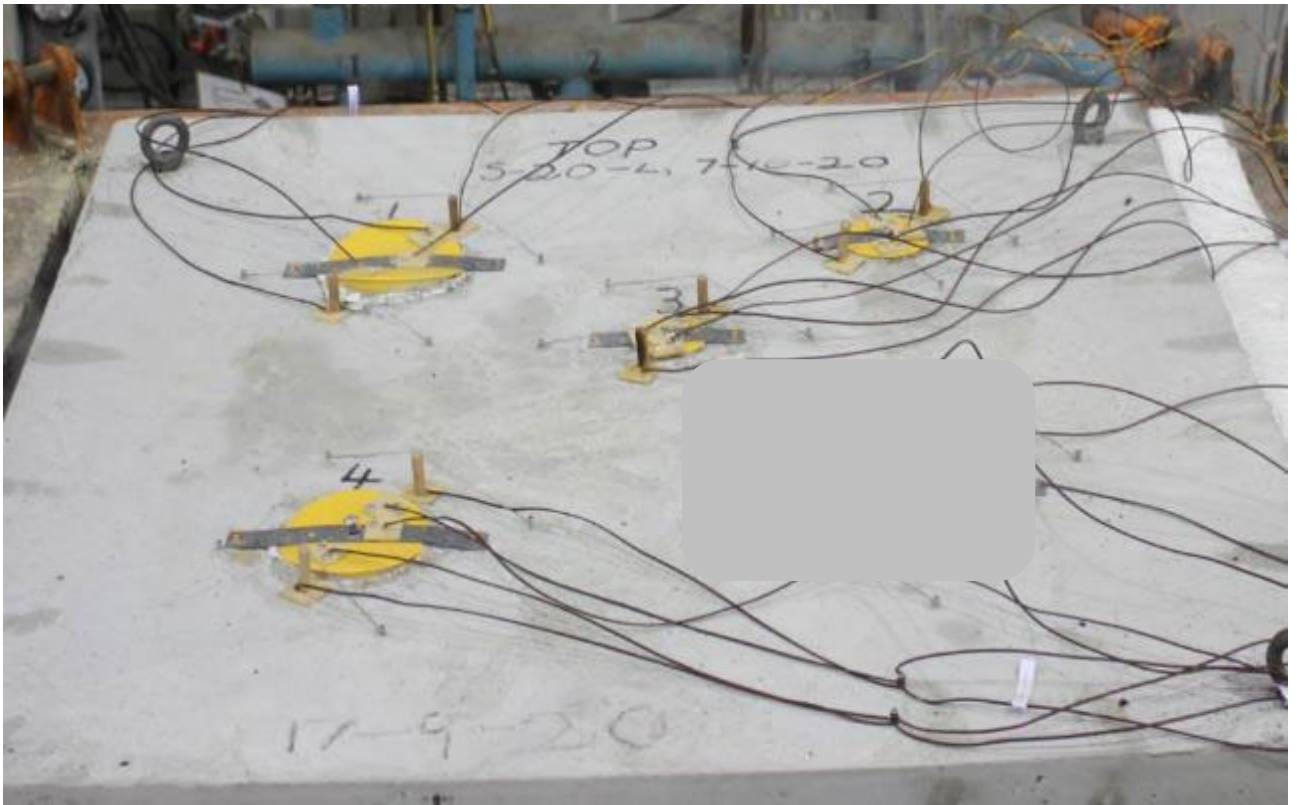
PHOTOGRAPH 7 – SPECIMENS AT 120 MINUTES INTO THE TEST
